State of Rhode Island
Department of Transportation

Underwater Inspection of

Bridge Nos. 020001 & 020021

**Washington Bridge South & Washington Bridge South
Pedestrian**

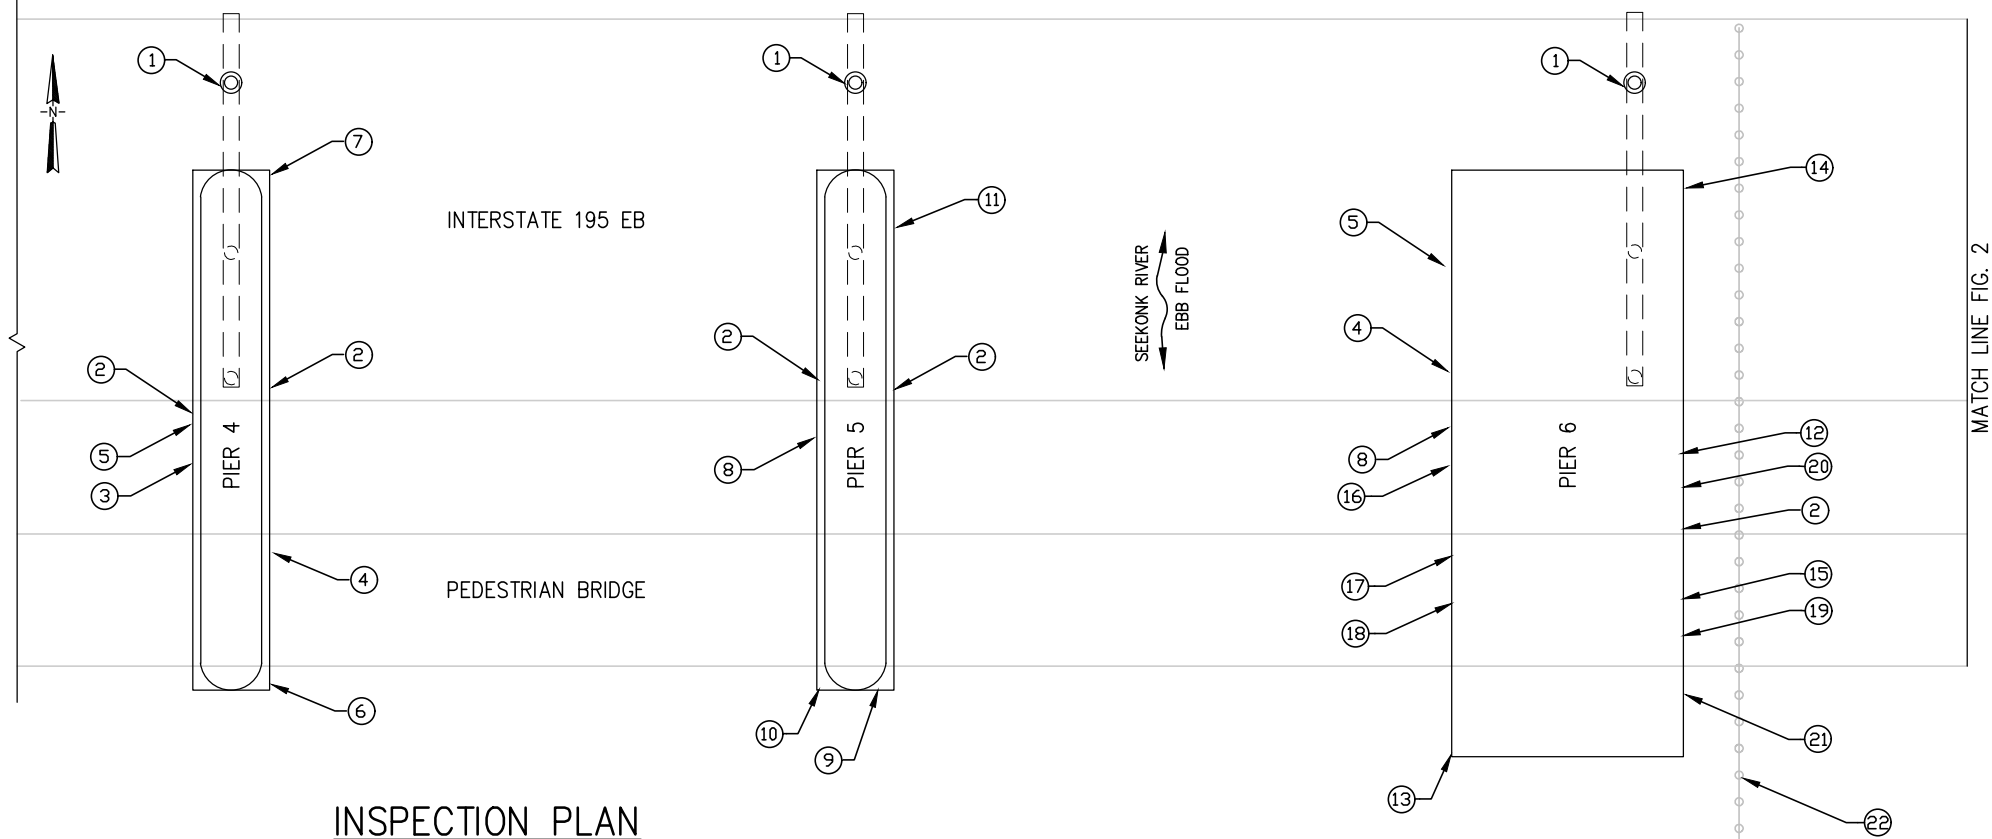
JACOBS	DESIGNED BY	EAST PROVIDENCE, RHODE ISLAND INTERSTATE 195 EASTBOUND & BIKE PATH/PEDESTRIAN BRIDGE OVER SEEKONK RIVER	SCALE	REVISION
	DRAWN BY		N.T.S.	
	CHECKED BY		DATE	
	PROJECT ENGR		06/07/2021	
BRIDGE NO. 020001 & 020021		INSPECTION PLAN		DRAWING NO. FIG. 3

- ① AT PIERS 4, 5, & 6 THE CAISSON PILE AT THE NORTH (UPSTREAM) END OF THE PIER EXHIBITS MINOR CORROSION WITH LIGHT PITTING UP TO 1/16" DEEP ON THE EXPOSED PORTIONS OF THE STEEL CASING. THE FIBERGLASS WRAP EXTENDS 8 TO 10 FEET DOWN FROM THE UNDERSIDE OF THE CONCRETE CAP.

- ② AT PIERS 4, 5, & 6 THE STONE MASONRY EXHIBITS LESS THAN 5% DETERIORATED MORTAR WITH 3" TO 6" OF PENETRATION BETWEEN STONES.
- ③ THE EXPOSED SURFACES OF THE REINFORCED CONCRETE STEP/PILE CAP EXHIBIT ABRASION UP TO 1/2" DEEP.

- ④ THE CHANNEL BOTTOM CONSISTS OF SILT, SAND, SHELLS, AND SCATTERED CONSTRUCTION DEBRIS WITH UP TO 12" OF PROBE ROD PENETRATION.
- ⑤ AT PIER 4, THERE IS A FULL HEIGHT CRACK UP TO 1/4" WIDE THAT EXTENDS TO CHANNEL BOTTOM NEAR THE MIDPOINT ON THE WEST FACE.

- ⑥ AT PIER 4, THERE IS A CRACKED STONE BELOW WATER, 1/4" WIDE x FULL HEIGHT, IN THE FOURTH STONE COURSE NEAR THE SOUTH END ON THE EAST FACE OF THE PIER.

- ⑦ AT PIER 4, THE REINFORCED CONCRETE STEP/PILE CAP IS EXPOSED UP TO 2' VERTICALLY FROM THE NORTHEAST SHOULDER AND ALONG THE ENTIRE EAST FACE WITH MAXIMUM EXPOSURE AT THE SOUTHEAST SHOULDER.

- ⑧ AT PIERS 5 & 6, THERE IS ABRASION UP TO 1/2" DEEP ON THE REINFORCED CONCRETE PIER SHAFT BELOW THE STONE MASONRY.
- ⑨ AT PIER 5, THERE IS A BAND OF SCALING ON THE SOUTH NOSE NEAR THE CHANNEL BOTTOM THAT MEASURES FULL WIDTH x 3' HIGH x UP TO 3/4" PENETRATION.

- ⑩ AT PIER 5, THE REINFORCED CONCRETE STEP/PILE CAP IS EXPOSED UP TO 6" VERTICALLY ALONG THE SOUTH NOSE AND 4' ALONG THE WEST FACE.
- ⑪ AT PIER 5, THERE IS INTERMITTENT CONCRETE RUBBLE UP TO 2' IN DIAMETER ALONG THE FULL LENGTH OF THE EAST FACE OF THE PIER.

- ⑫ AT PIER 6, THERE IS MISSING MASONRY STONE AT THE MIDPOINT OF THE EAST FACE 2' LONG x 2.5' HIGH.
- ⑬ AT PIER 6, THERE ARE VOIDS AT THE CONCRETE/GRANITE INTERFACE MEASURING UP TO 3' LONG x 6" HIGH x 6" DEEP ALONG THE SOUTH AND WEST FACES OF THE PIER.

- ⑭ AT PIER 6, THERE IS A TIMBER PILE CUT OFF AT 10 FEET ABOVE CHANNEL BOTTOM AT THE NORTHEAST SHOULDER AND THREE TIMBER PILES LYING ON THE CHANNEL BOTTOM AT THE SOUTHEAST SHOULDER.

- ⑮ AT PIER 6, AT 15' NORTH OF THE SOUTHEAST CORNER THERE IS A 1/16" TO 1/8" WIDE VERTICAL CRACK ON THE EAST FACE THAT EXTENDS FROM THE 6TH MASONRY COURSE TO THE CHANNEL BOTTOM.

- ⑯ AT PIER 6, THE FIRST, THIRD, AND FOURTH MASONRY COURSES AT THE MIDPOINT ON THE WEST FACE EXHIBIT VERTICAL CRACKS UP TO 1/4" WIDE AND EXTENDING INTO THE CONCRETE FOOTING STEP 1/2" WIDE AT CHANNEL BOTTOM.

- ⑰ AT PIER 6, VERTICAL CRACK 1/16" WIDE IN 2nd MASONRY COURSE NEAR NORTH 1/4 POINT ON WEST FACE.
- ⑱ AT PIER 6, VERTICAL CRACK 1/8" WIDE IN 4th MASONRY COURSE NEAR THE MIDPOINT OF THE PEDESTRIAN BRIDGE ON WEST FACE.

- ⑲ AT PIER 6, VERTICAL CRACK, HAIRLINE TO 1/4" WIDE IN TOP FOUR MASONRY COURSES NEAR MIDPOINT OF PEDESTRIAN BRIDGE ON EAST FACE.
- ⑳ AT PIER 6, VERTICAL CRACK IN TOP FOUR MASONRY COURSES BETWEEN PEDESTRIAN AND EASTBOUND BRIDGES ON EAST FACE THAT MEASURES 1/16" WIDE IN TOP MASONRY COURSE AND 1/4" WIDE IN 4th MASONRY COURSE.
- ㉑ AT PIER 6, INTERMITTENT BANDS OF POOR CONCRETE CONSOLIDATION ON ALL FACES OF CONCRETE PIER SHAFT BELOW MASONRY THAT MEASURE 6-12" HIGH AND 1/2" TO 1" DEEP.
- ㉒ THE TIMBER FENDER SYSTEM TOP WALE ALONG THE EAST SIDE OF THE PIER 6 EXHIBITS MINOR CHECKS AND SPLITS IN THE TIDAL ZONE AND THERE IS A FRACTURED HANDRAIL IN TWO LOCATIONS WITH ONE BROKEN POST.

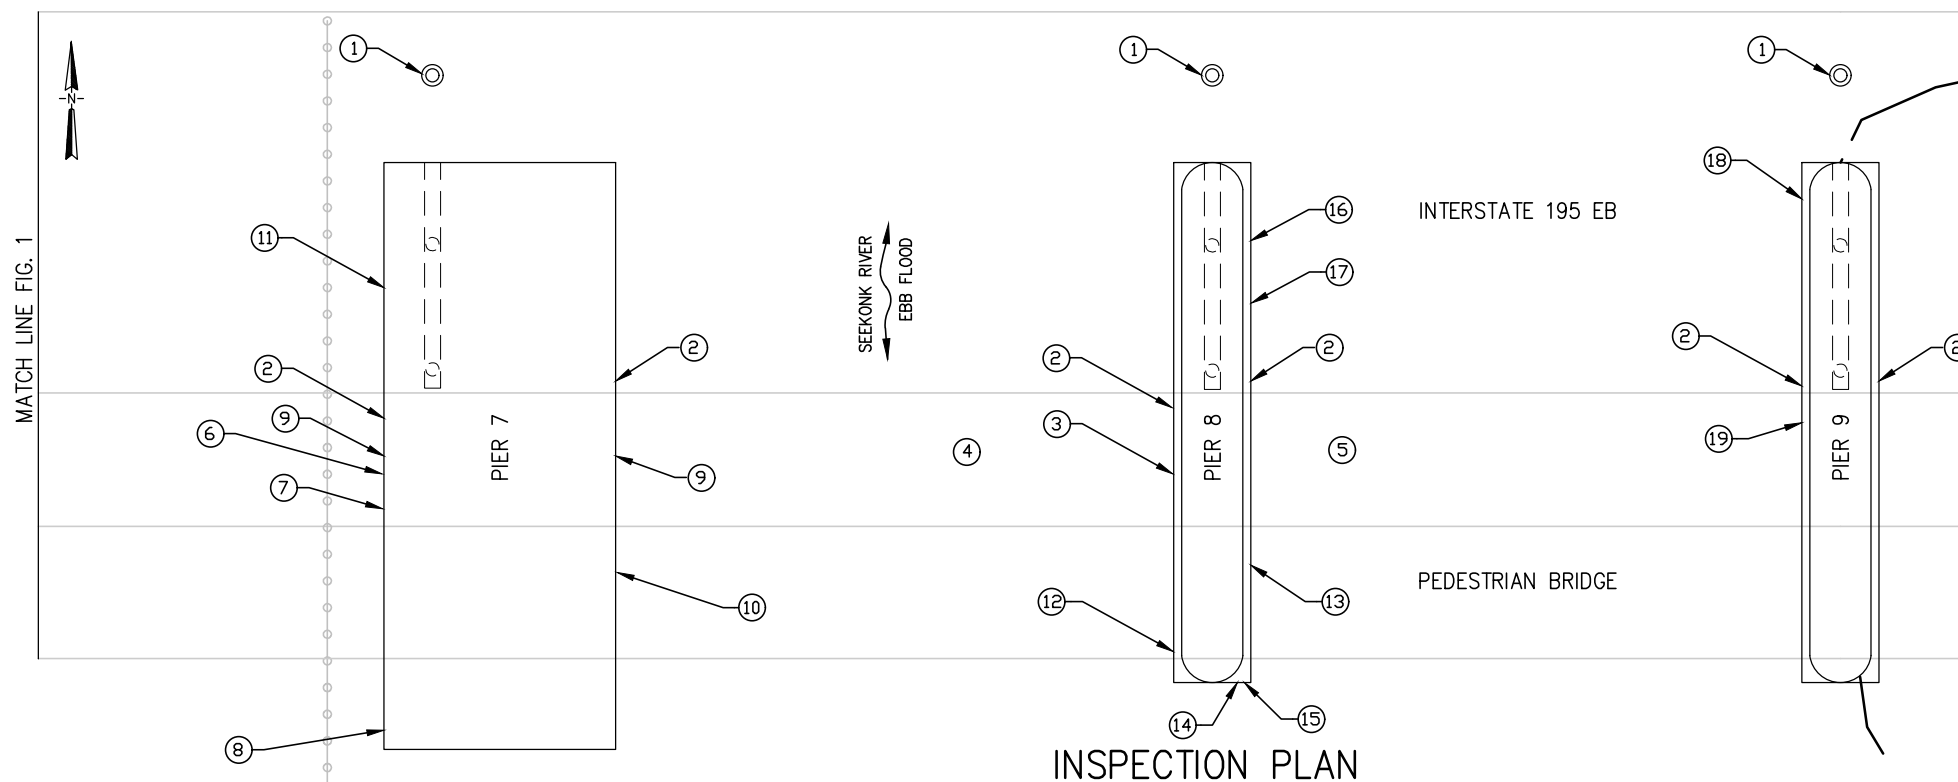
JACOBS	DESIGNED BY	EAST PROVIDENCE, RHODE ISLAND	SCALE	REVISION
	DRAWN BY	INTERSTATE 195 EASTBOUND & BIKE	N.T.S.	
	CHECKED BY	PATH/PEDESTRIAN BRIDGE OVER SEEKONK RIVER	DATE	
	PROJECT ENGR		06/07/2021	
		BRIDGE NO. 020001 & 020021	DRAWING NO.	
		INSPECTION PLAN	FIG. 4

- ① AT PIERS 7, 8, & 9, THE CAISSON PILE AT THE NORTH (UPSTREAM) END OF THE PIER EXHIBITS MINOR CORROSION WITH LIGHT PITTING UP TO 1/16" DEEP ON THE EXPOSED PORTIONS OF THE STEEL CASING. THE FIBERGLASS WRAP EXTENDS 8 TO 10 FEET DOWN FROM THE UNDERSIDE OF THE CONCRETE CAP.

- ② AT PIERS 7, & 9, THE STONE MASONRY EXHIBITS LESS THAN 5% DETERIORATED MORTAR WITH 3" TO 6" OF PENETRATION BETWEEN STONES.
- ③ AT PIER 8, THE STONE MASONRY EXHIBITS LESS THAN 15% DETERIORATED MORTAR WITH UP TO 6" OF PENETRATION BETWEEN STONES.

- ④ THE EXPOSED SURFACES OF THE REINFORCED CONCRETE STEP/PILE CAP EXHIBIT ABRASION UP TO 2" DEEP.
- ⑤ THE CHANNEL BOTTOM CONSISTS OF SILT, SAND, SHELLS, AND SCATTERED CONSTRUCTION DEBRIS WITH UP TO 12" OF PROBE ROD PENETRATION.

- ⑥ AT PIER 7, THERE IS 2" DEEP SCALING ON THE WEST FACE OF THE REINFORCED CONCRETE PIER SHAFT BELOW THE STONE MASONRY.
- ⑦ AT PIER 7, ISOLATED AREAS OF CONCRETE SCALING/SECTION LOSS NEAR THE CHANNEL BOTTOM:

- a. 2' HIGH x 3" DEEP ON WEST FACE FROM NORTHWEST CORNER TO 25' SOUTH
 - b. 1' HIGH x 3.5" DEEP ON NORTH FACE FROM NORTHWEST CORNER TO MIDPOINT
 - c. ALONG NORTHEAST CORNER 13' HIGH x 5' WIDE x 2" DEEP

- d. 6' HIGH x 2.5" DEEP ON EAST FACE NEAR SOUTH QUARTER-POINT
 - e. 4" HIGH x 3' LONG x 3" DEEP ON EAST FACE NEAR SOUTHEAST CORNER
 - f. 4' HIGH x 2.5" DEEP ALONG SOUTH FACE AT CHANNEL BOTTOM

- g. ALONG SOUTHWEST CORNER 16.5' HIGH x 2' WIDE x UP TO 5" DEEP AT CHANNEL BOTTOM

- ⑧ AT PIER 7, SPALL IN TOP OF REINFORCED CONCRETE AT CABLE LOCATION ON EAST FACE AT 3' FROM SOUTHEAST CORNER THAT MEASURES 4" HIGH x 20" WIDE x 3" DEEP.

- ⑨ AT PIER 7, VERTICAL CRACKS 1/8" TO 1/4" WIDE THAT EXTEND FROM THE TOP DOWN TO THE CHANNEL BOTTOM NEAR THE MIDPOINTS ON THE EAST AND WEST FACES. ON THE EAST FACE THE CRACK IS UP TO 1/2" WIDE AT THE 4th MASONRY COURSE AND THERE IS SECTION LOSS WITH SOFT CONCRETE IN THE AREA OF THE CRACK 14" WIDE x 24" HIGH x 2.5" DEEP. WEST FACE EXHIBITS SECTION LOSS ALONG CRACK FROM CHANNEL BOTTOM UP 8.5' x 5" WIDE x 3" DEEP.

- ⑩ AT PIER 7, THE STONES IN THE FIRST AND SECOND MASONRY COURSES ARE BROKEN WITH 3.5' LONG x 5' HIGH SECTIONS OF STONE MISSING ON THE WEST FACE OF THE PIER.

- ⑪ AT PIER 7, THERE IS A STONE REVETMENT ALONG THE EAST FACE FROM THE NORTHEAST CORNER TO THE MIDPOINT OF THE PIER.
- ⑫ AT PIER 8, THERE IS A VOID IN THE CONCRETE STEP/PILE CAP 2' LONG x 8" HIGH x 5" DEEP AT THE SOUTH END OF THE EAST FACE OF THE PIER.

- ⑬ AT PIER 8, THE CONCRETE STEP/PILE CAP IS EXPOSED AROUND THE PIER NOSES AND INTERMITTENTLY ALONG THE PIER FACES WITH UP TO 4.5' VERTICAL EXPOSURE AT THE NORTHEAST CORNER. AT THE SOUTH NOSE THE CONCRETE STEP/PILE CAP IS FULLY EXPOSED, AND THE SEAL IS ALSO EXPOSED WHICH EXTENDS 2' WIDER WITH UP TO 15" OF VERTICAL EXPOSURE AND SOFT LATENT CONCRETE.

- ⑭ AT PIER 8, THERE ARE TWO TIMBER PILES PROTRUDING UP THROUGH THE CONCRETE PILE CAP WITH 12" EXPOSED ON THE SOUTH FACE AT 10' AND 15' FROM THE SOUTHEAST CORNER. THE TIMBER PILES AT ARE 60% AND 25% NON-BEARING AND EXHIBIT 15% AND 20% SECTION LOSS, RESPECTIVELY.

- ⑮ AT PIER 8, AREA OF SECTION LOSS ON THE CONCRETE STEP/PILE CAP AT THE SOUTHEAST CORNER THAT MEASURES 2' LONG x 8" HIGH x 5" DEEP.
- ⑯ AT PIER 8, THERE IS A VERTICAL CRACK IN THE TOP TWO STONE COURSES BELOW THE CAP UP TO 1/2" WIDE. THE CRACK ALSO EXTENDS THROUGH THE CONCRETE STEP/PILE CAP ON BOTH FACES UP TO 1/4" WIDE.

- ⑰ AT PIER 8, THERE IS 50% MORTAR LOSS IN THE JOINT AT THE MASONRY/CONCRETE INTERFACE.
- ⑱ AT PIER 9, THE CONCRETE STEP/PILE CAP IS EXPOSED ALONG THE WEST FACE FROM 6' SOUTH OF THE NORTHWEST CORNER TO 18' NORTH OF THE SOUTHWEST CORNER WITH UP TO 4.5' OF VERTICAL EXPOSURE AND AREAS OF POOR CONSOLIDATION/SECTION LOSS UP TO 2" DEEP.

- ⑲ AT PIER 9, THERE IS A 1/2" WIDE CRACK THROUGH THE FIRST THREE STONE COURSES NEAR THE MIDPOINT ON THE WEST FACE OF THE PIER. THE CRACK ALSO EXTENDS THROUGH THE CONCRETE STEP/PILE CAP TO THE CHANNEL BOTTOM.

- ⑳ THE FENDER SYSTEM MEMBERS ALONG THE WEST SIDE OF PIER 7 EXHIBIT MINOR CHECKS AND SPLITS IN THE TIDAL ZONE AND A MISSING SECTION OF HANDRAIL NEAR THE NORTH END OF THE PEDESTRIAN BRIDGE.

- ㉑ THERE ARE TWO ABANDONED TIMBER DOLPHINS IN SEVERE CONDITION ON THE SOUTH SIDE OF PIER 7. NEW TIMBER DOLPHINS HAVE BEEN CONSTRUCTED TO REPLACE THEM.

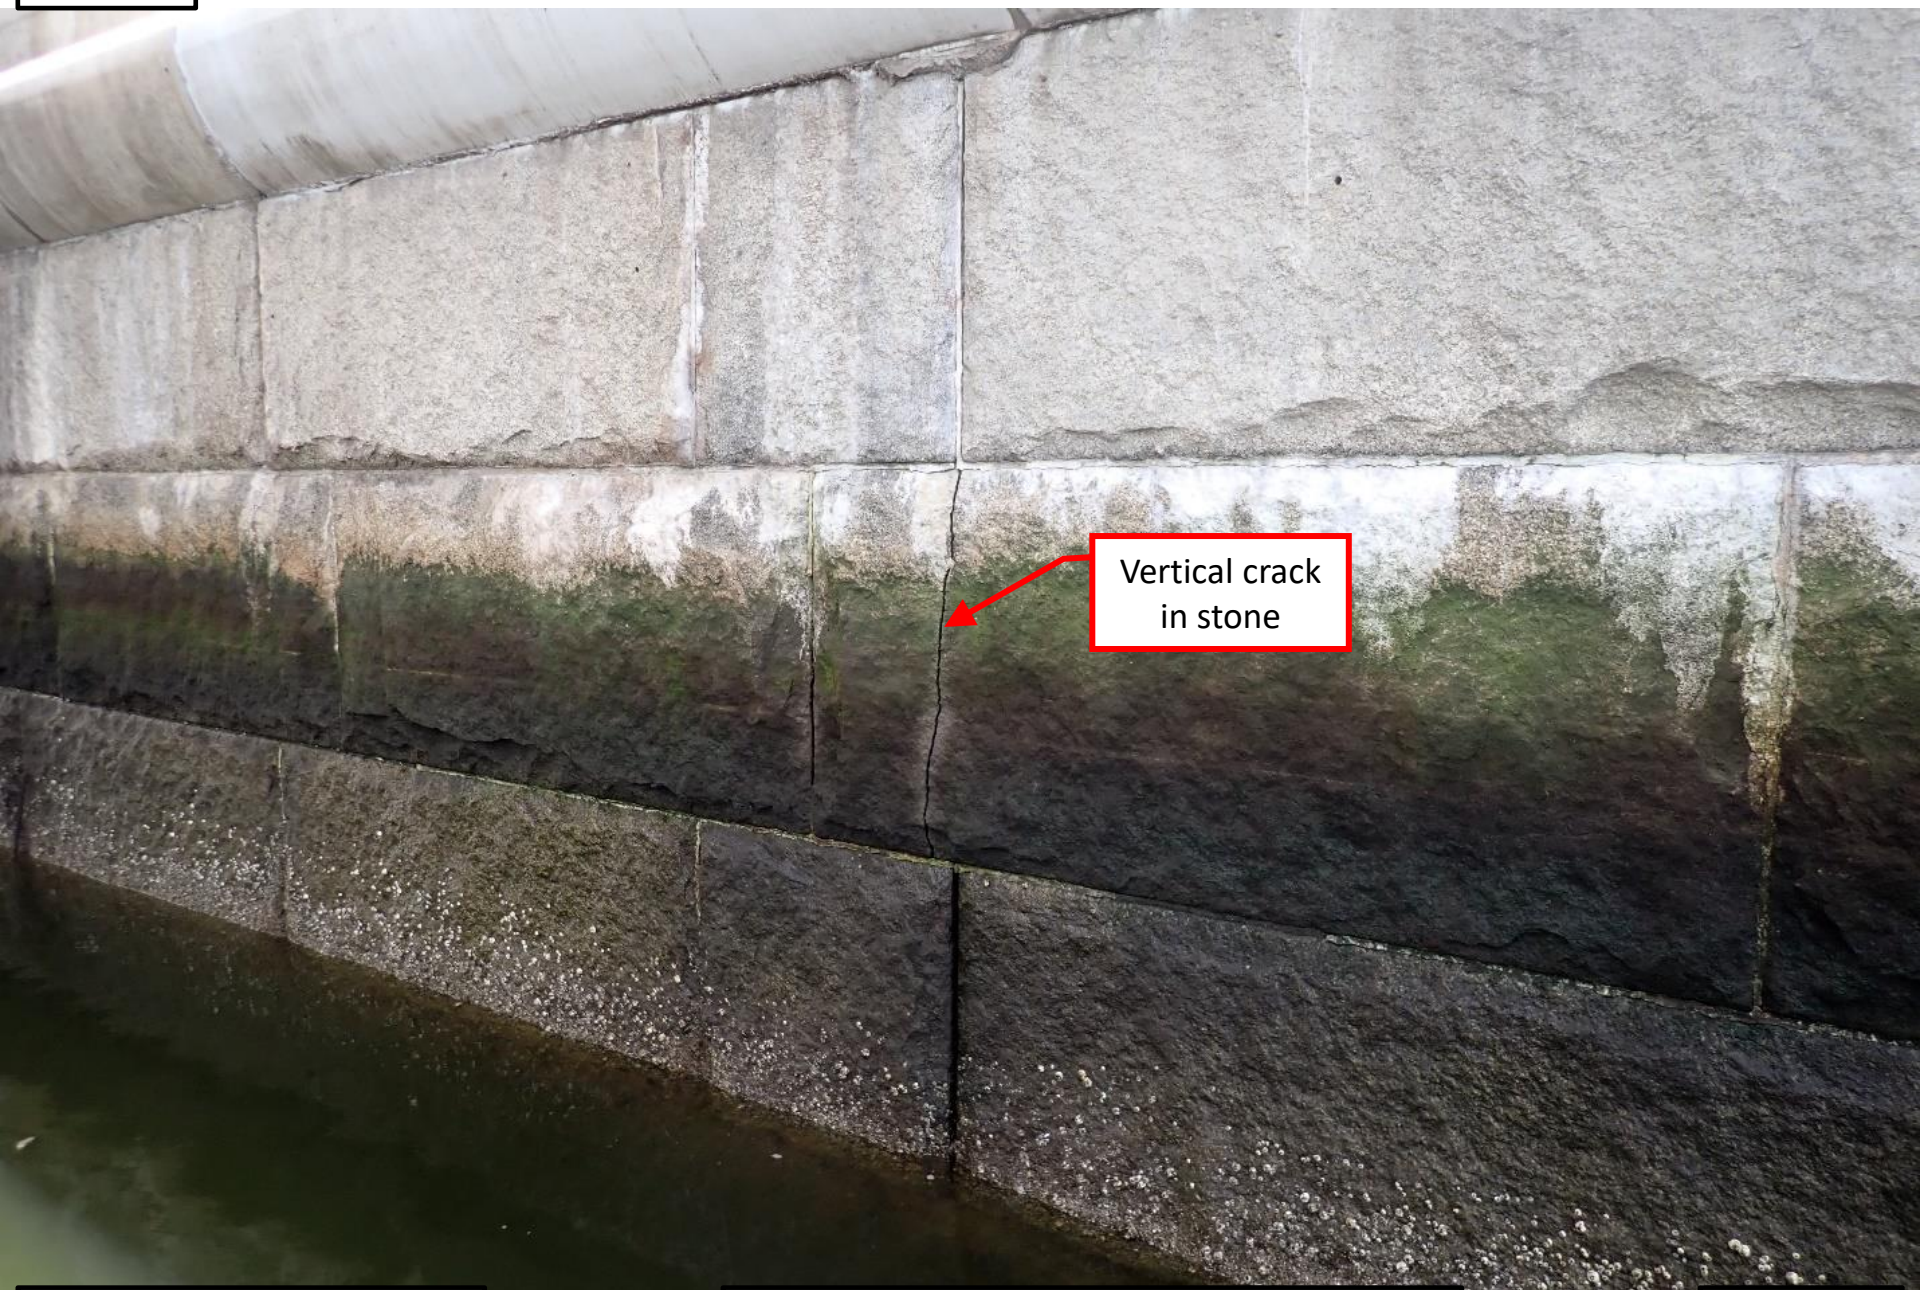
Photo #7

Vertical crack
in stone

View of west face of Pier 4, looking northeast.

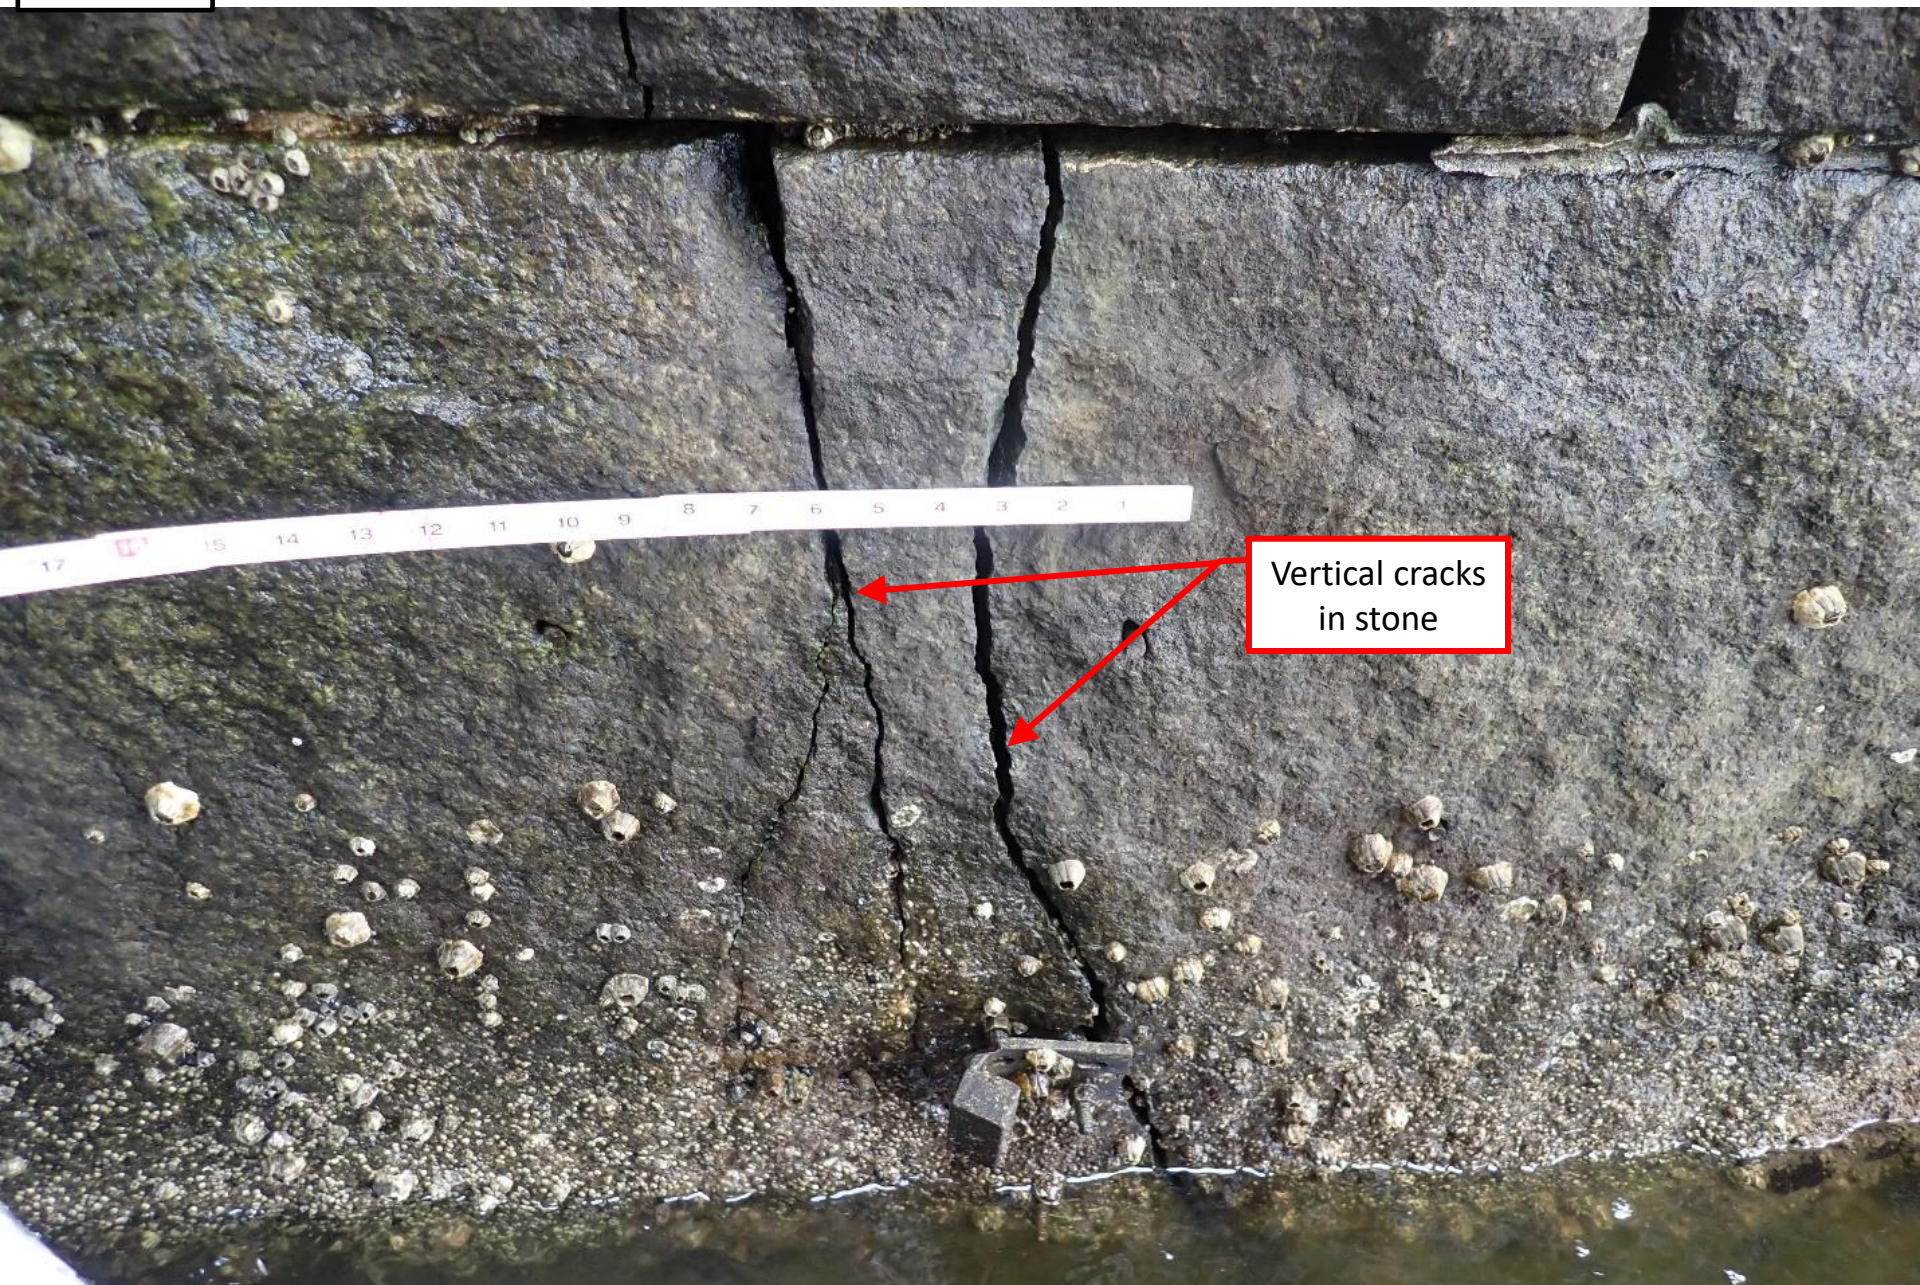
Vertical cracks
in stone

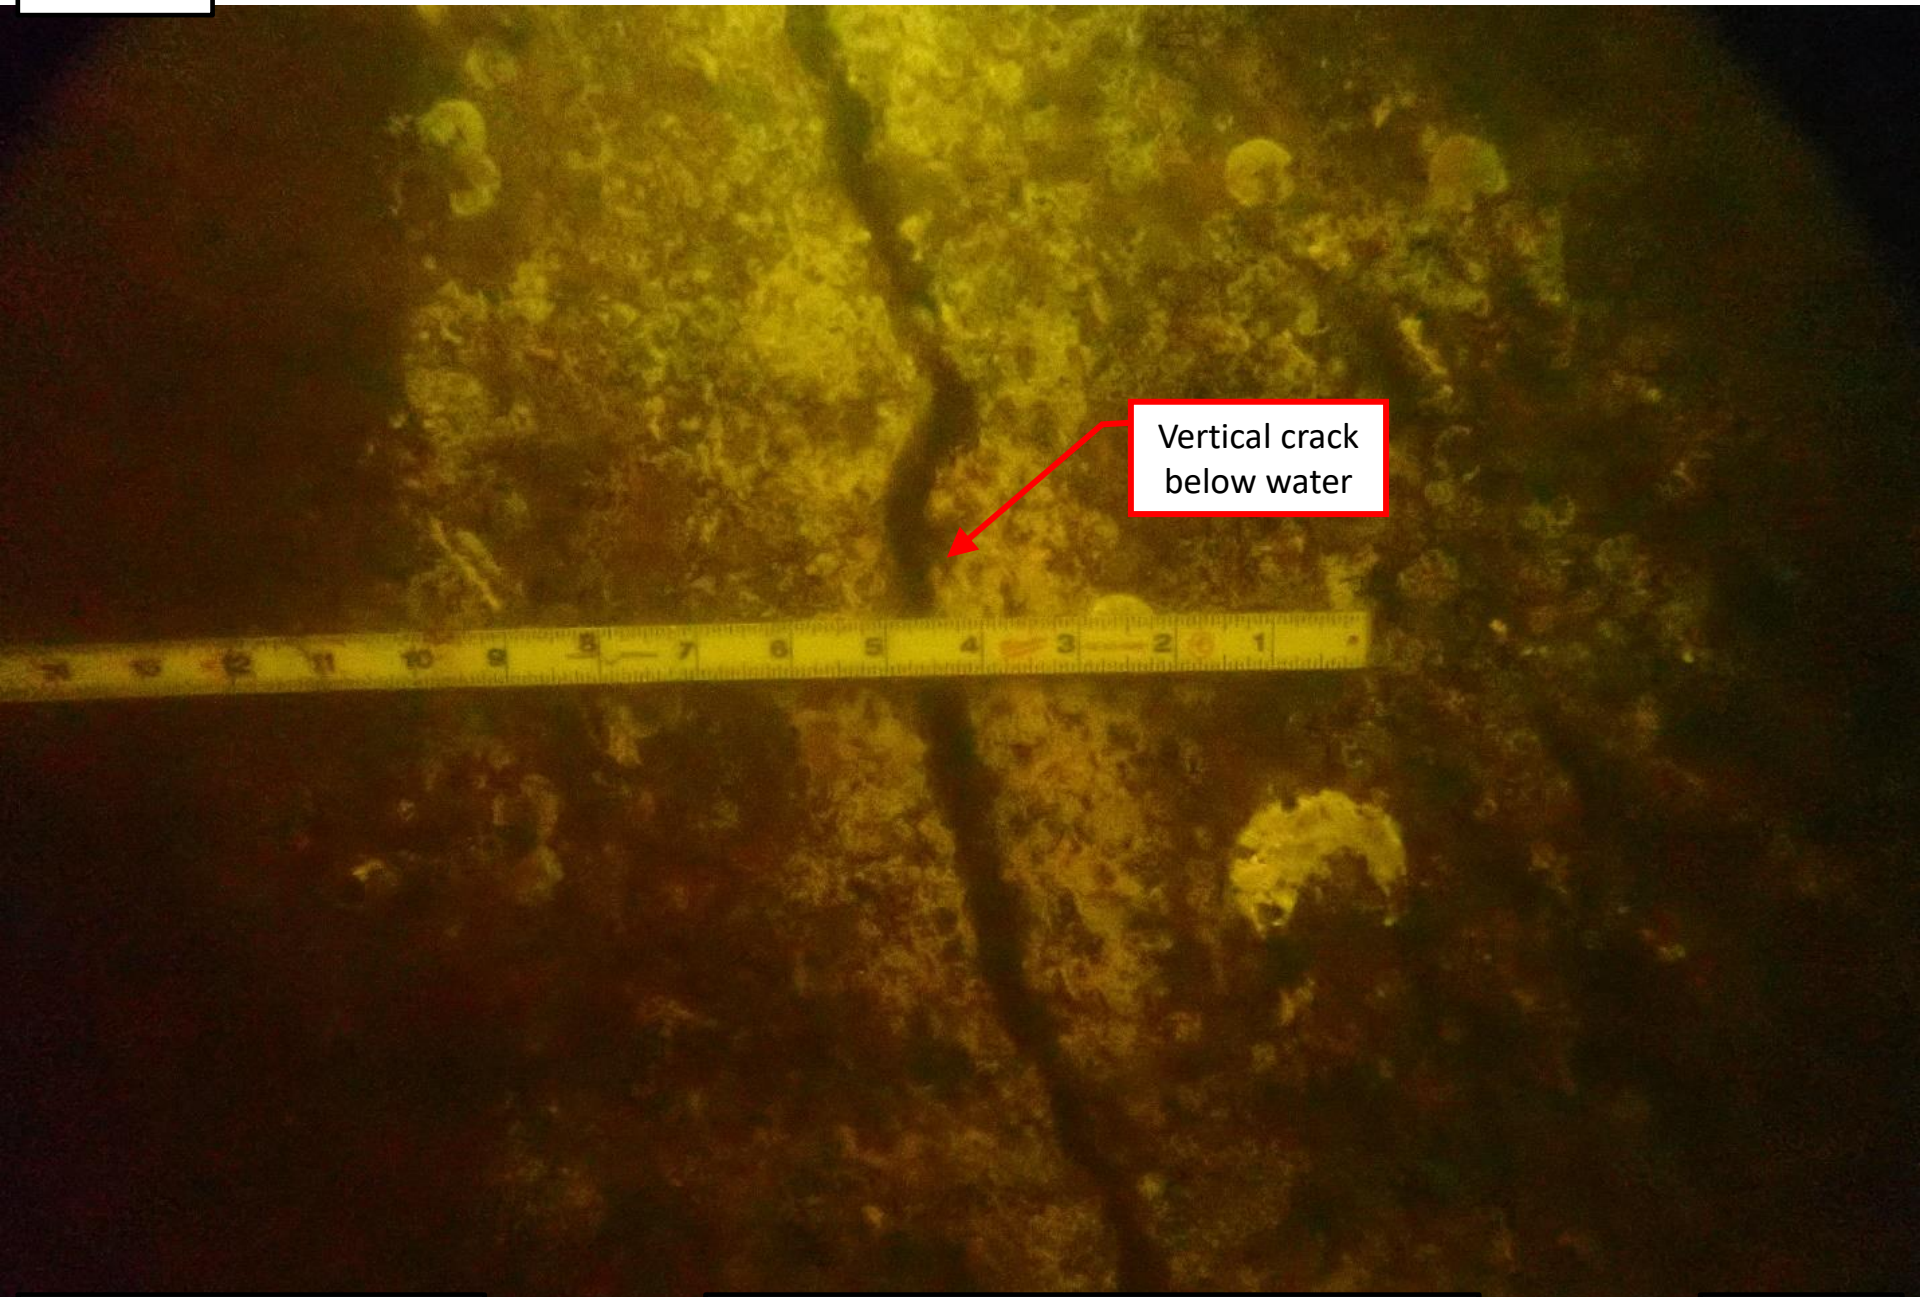
Photo #14

Vertical crack
below water

West face of Pier 6 near midpoint, looking east.

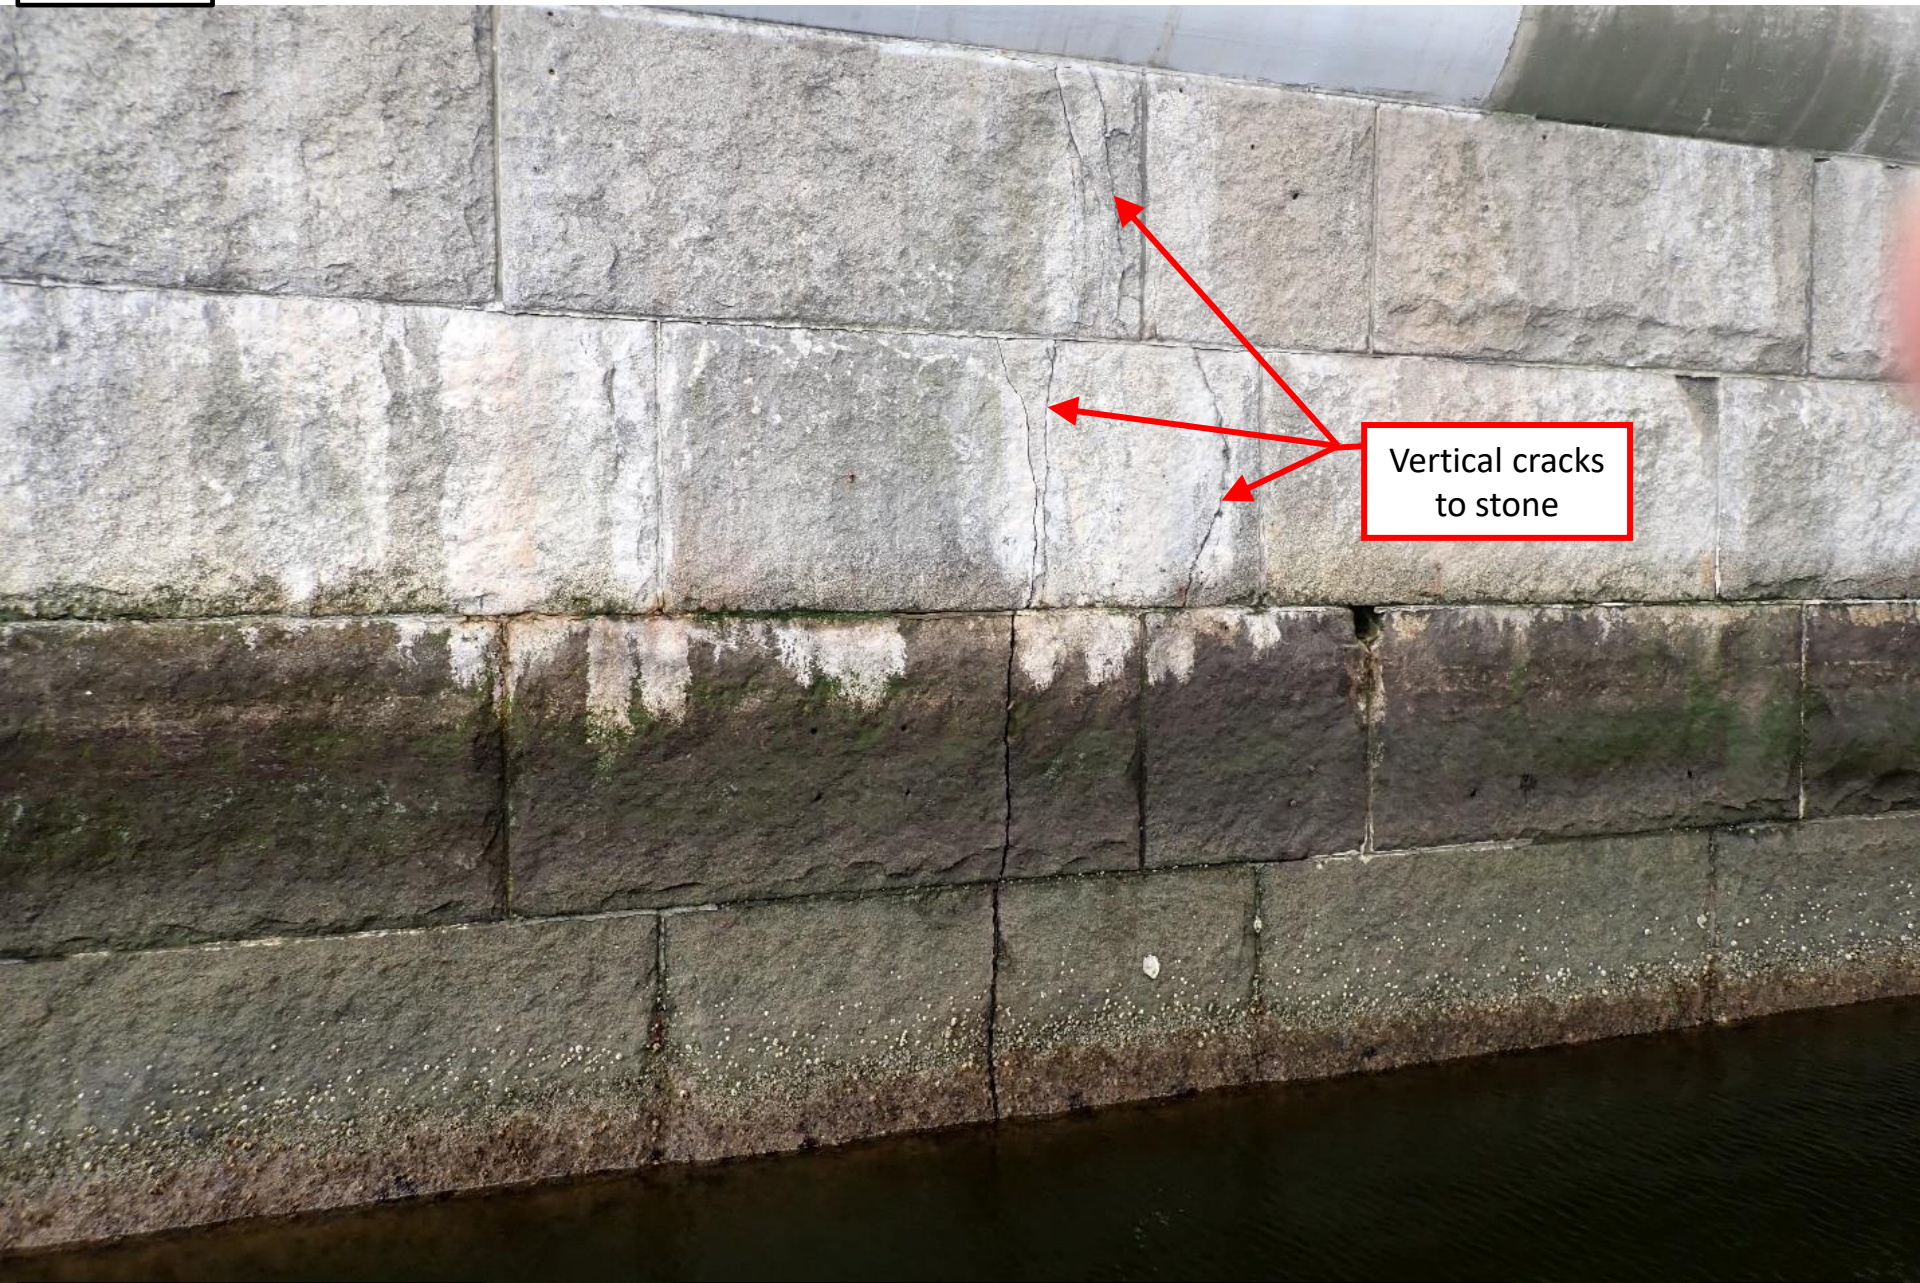
Photo #17

Vertical cracks
to stone

East face of Pier 7 near midpoint, looking northwest.

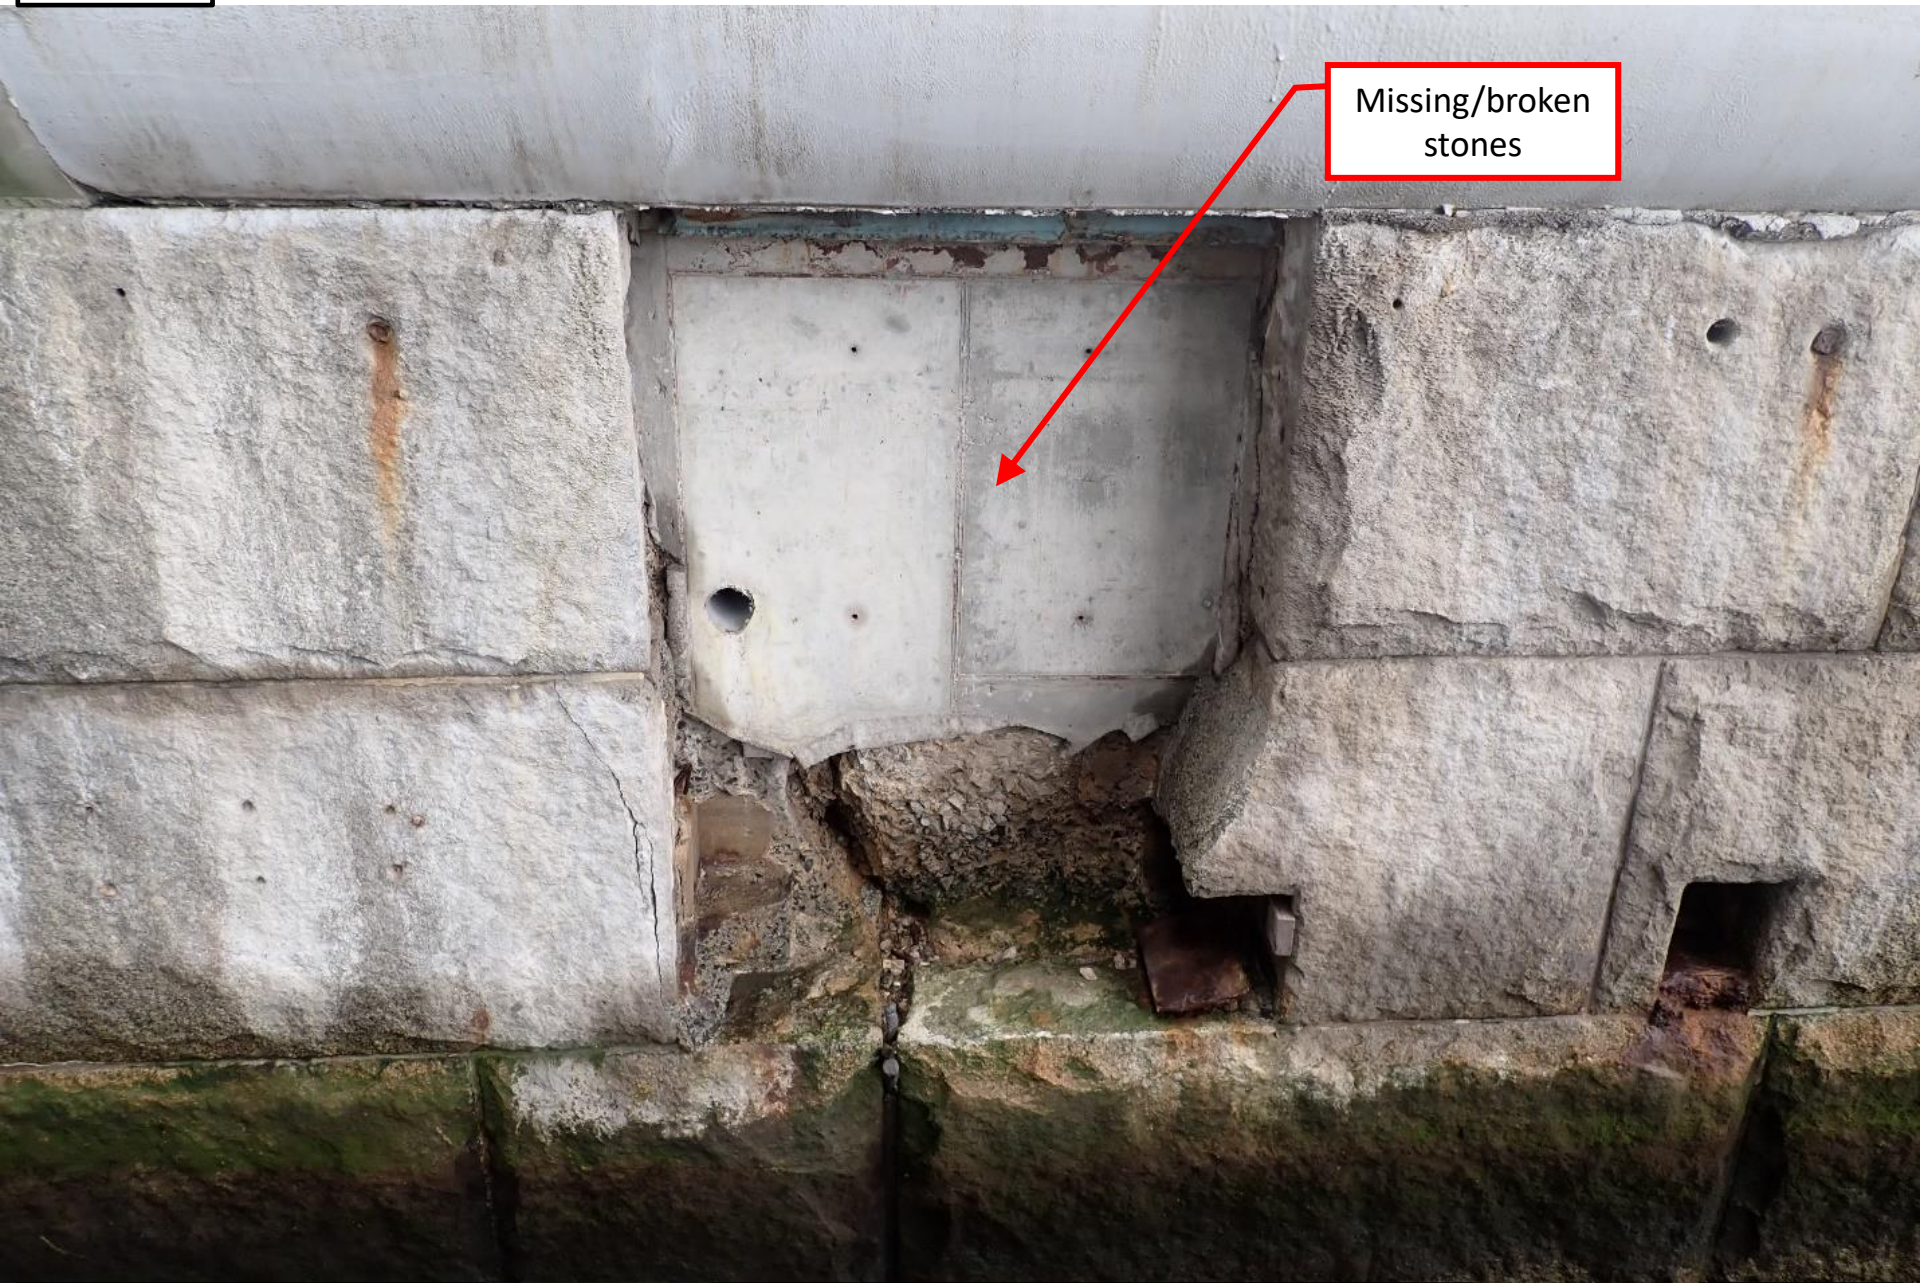
Photo #18

Missing/broken
stones

West face of Pier 7 near midpoint, looking east.

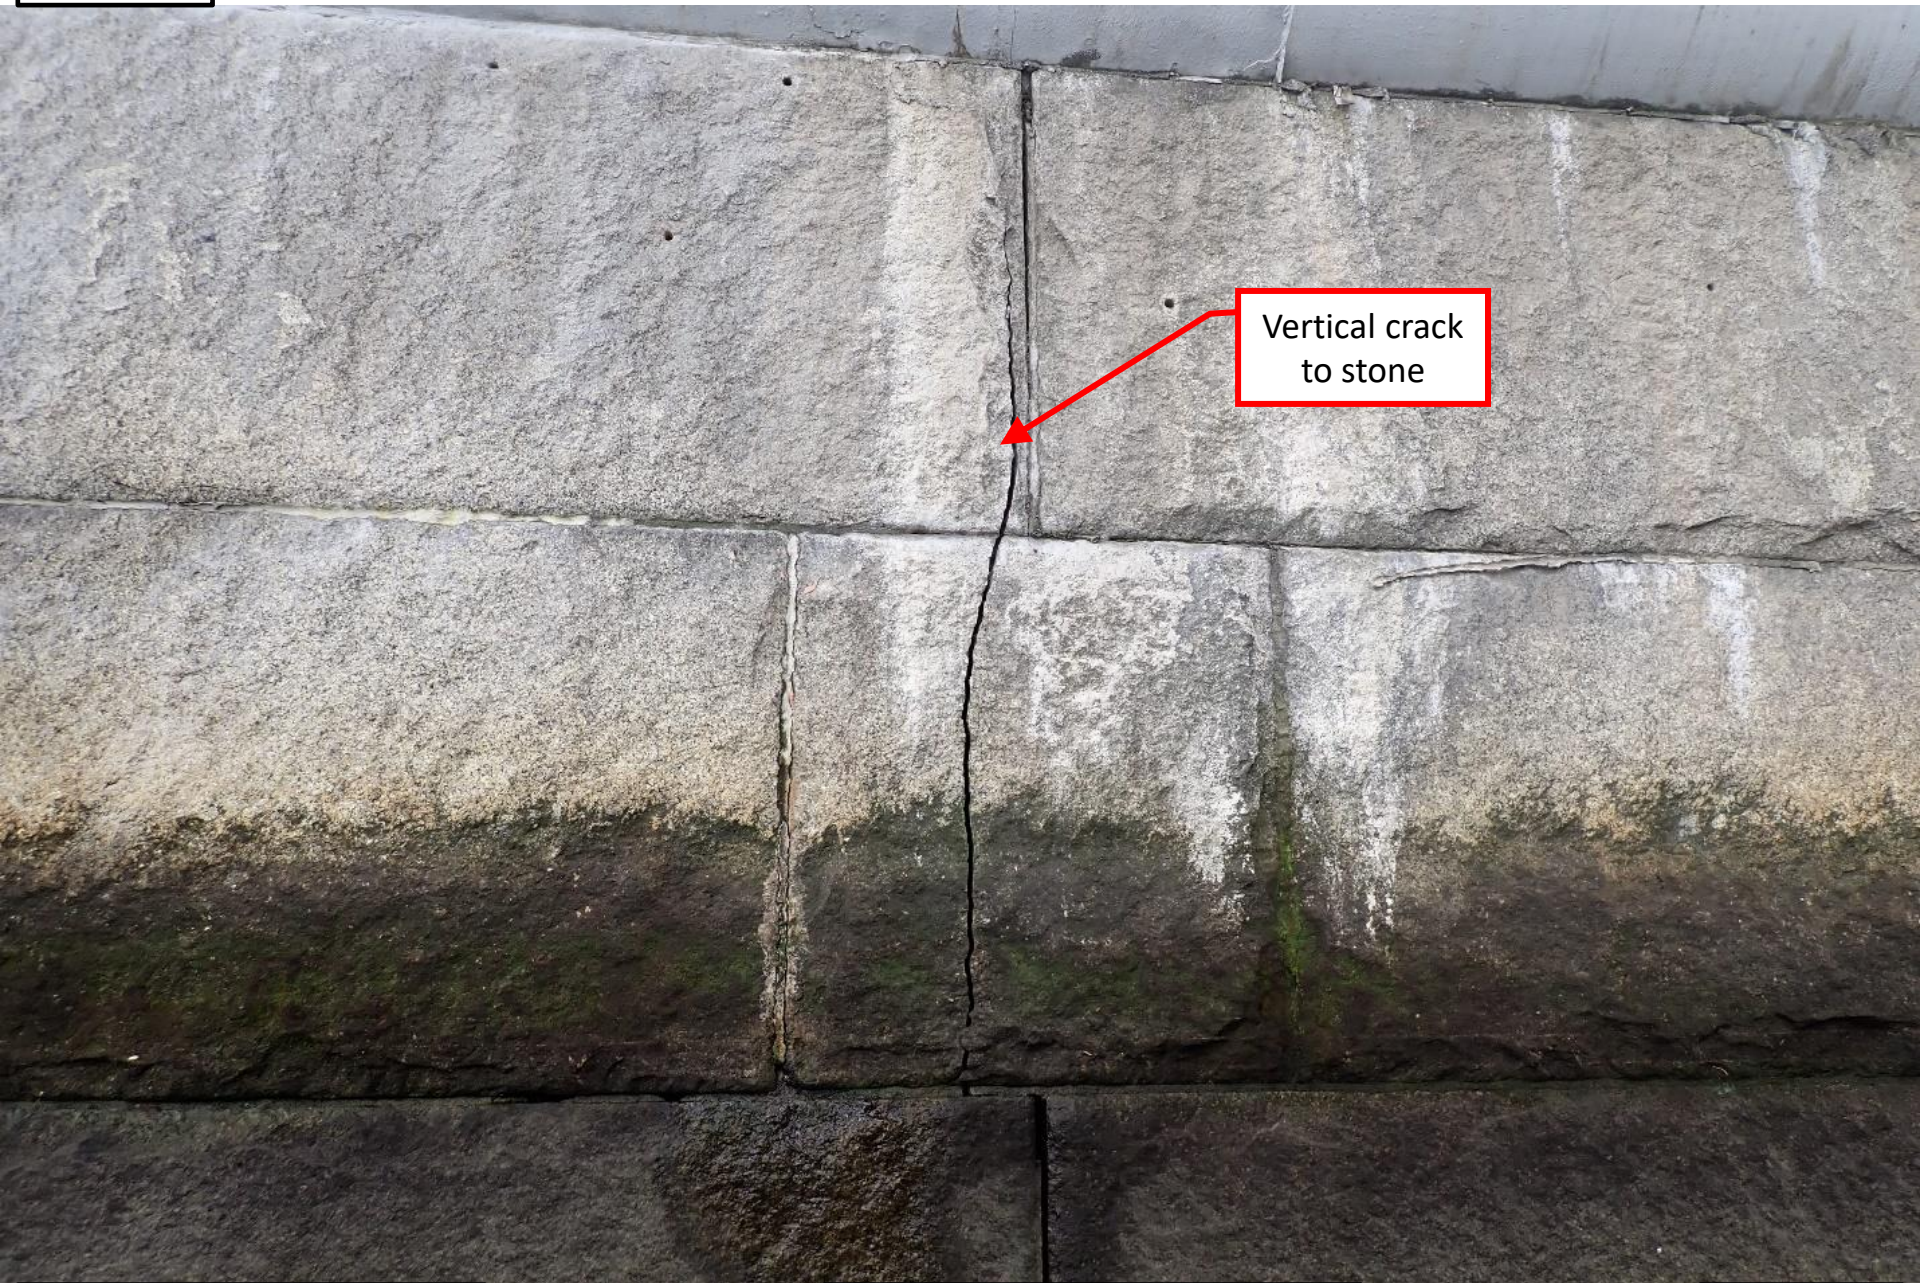
Photo #21

Vertical crack
to stone

East face of Pier 8, looking west.

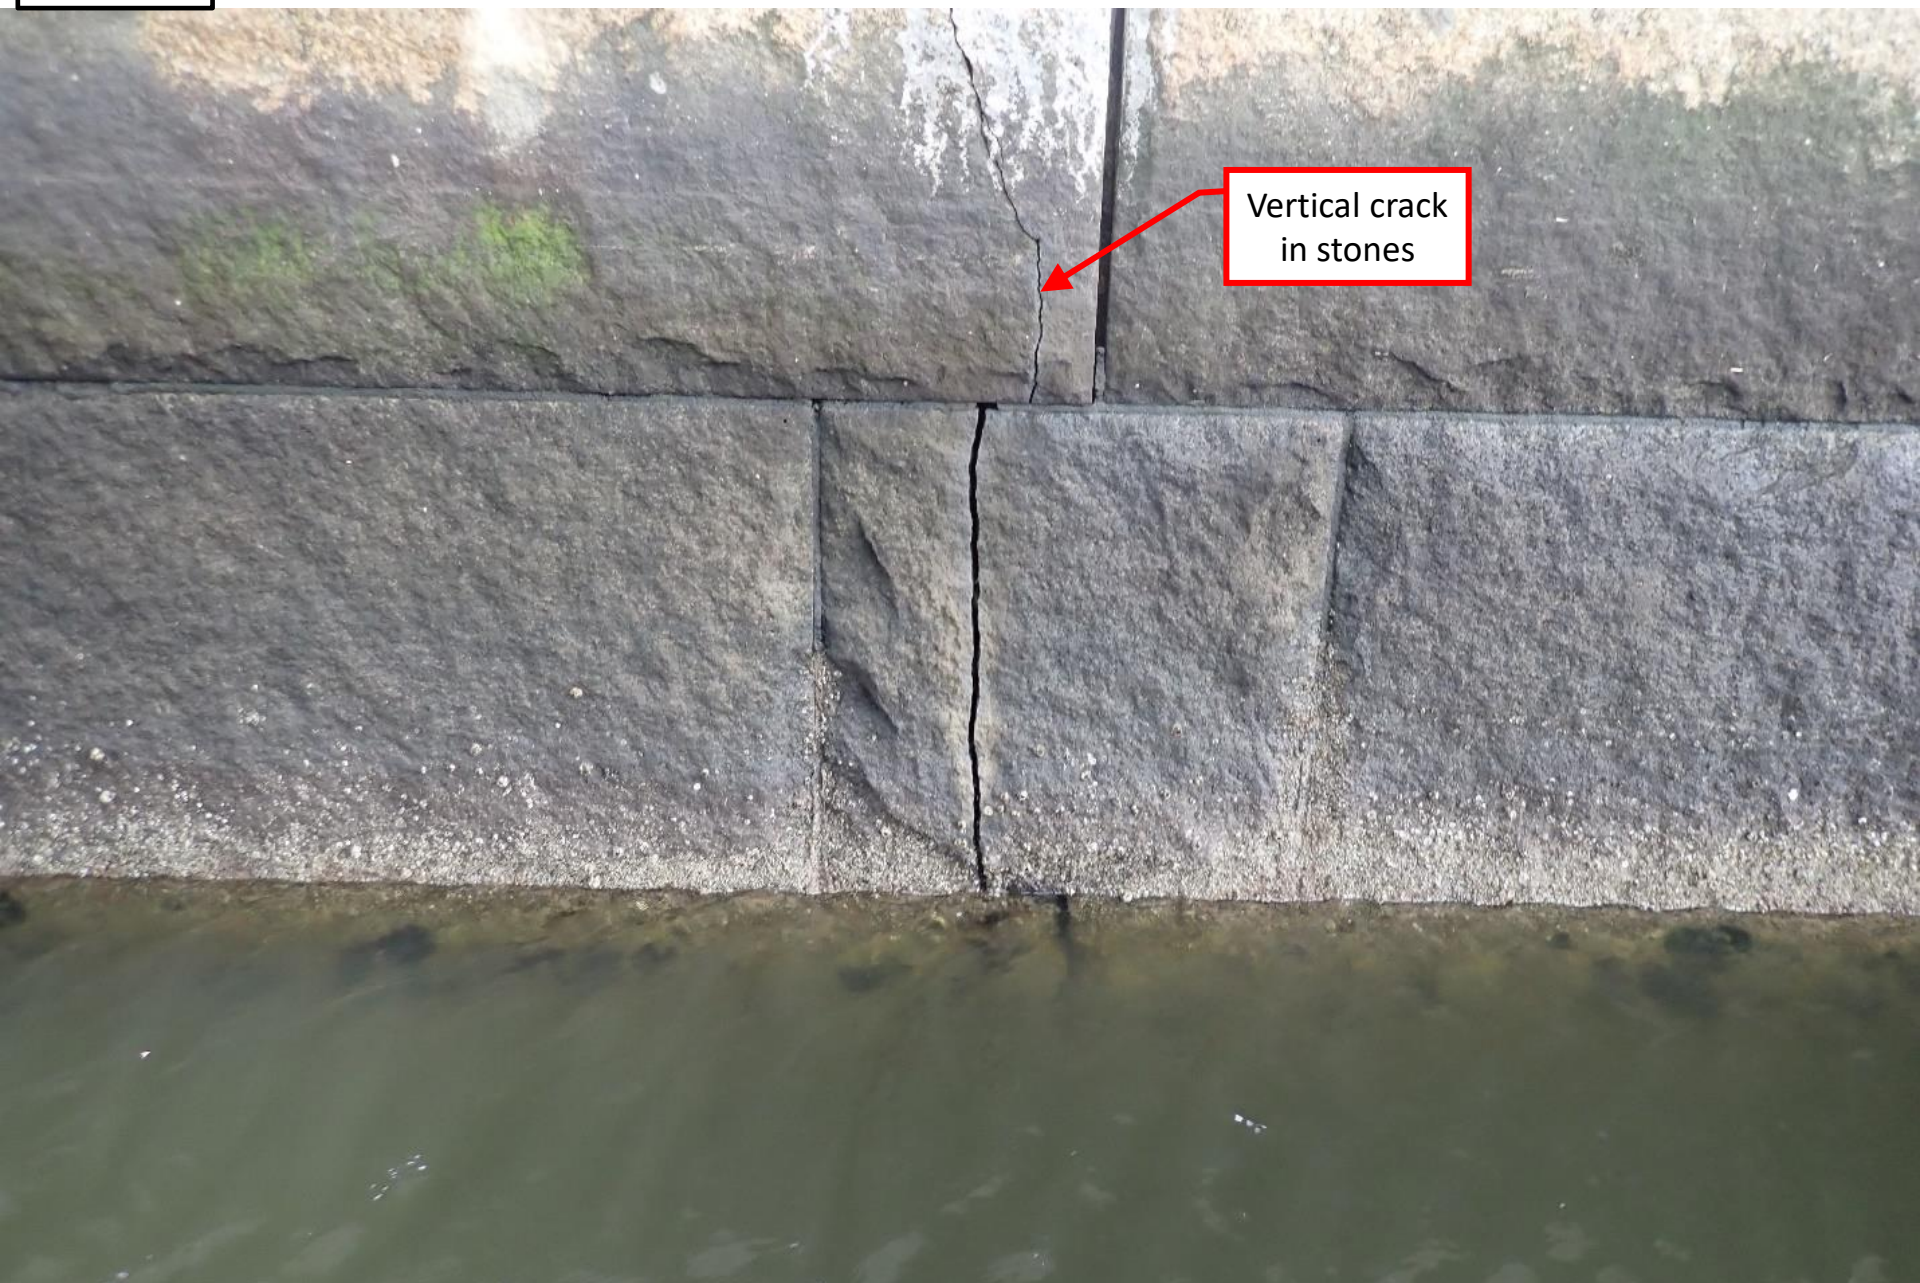
Photo #24

Vertical crack
in stones

West face of Pier 9, looking east.
