# Underwater Inspection Report

Washington Bridge South & Washington Bridge South  
Pedestrian  
Interstate 195 Eastbound & Bike/Pedestrian Bridge  
Over  
Seekonk River

Bridge ID: 020001 & 020021  
Ebb (South) Elevation

Bridge No.: 020001 & 020021 Inspection Date: 2/9/2024  
 Bridge Name: Washington Bridge South & Washington Bridge South Pedestrian  
 Facility Carried: Interstate 195 Eastbound & Bike Path/Pedestrian  
 Feature Intersected: Seekonk River  
 City/Town: East Providence

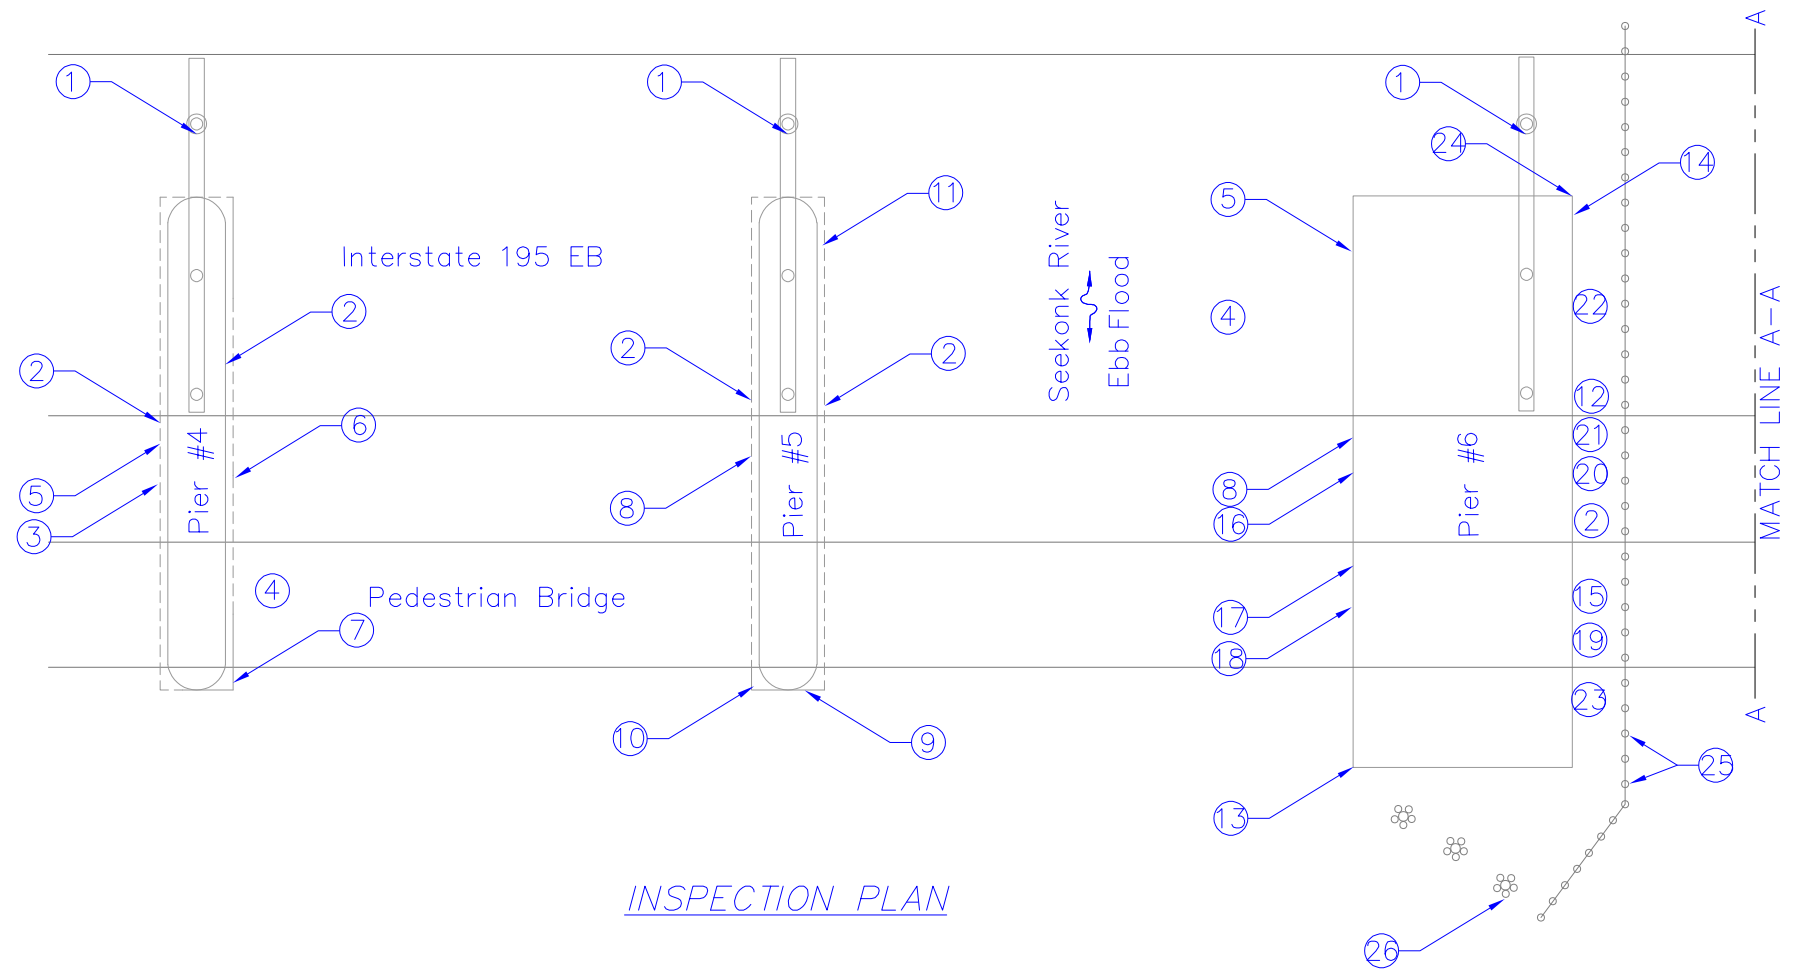
- ① At Piers 4, 5 and 6 the caisson pile at the North (Upstream) end of the pier has a fiberglass jacket in place that extends 8' – 10' down from the underside of the concrete cap section. The exposed steel below the jacket has minor corrosion with light pitting up to 1/16" deep.

- ② At Piers 4, 5 and 6 the stone masonry has less than 5% deteriorated mortar with 3" to 6" penetration between stones.
- ③ The exposed surfaces of the reinforced concrete footing have abrasion up to 1/2" deep.

- ④ The channel bottom consists of silt, sand, shells and scattered construction debris with up to 12" of probe rod penetration.
- ⑤ At Pier 4, West Face near the centerline, 2nd and 4th courses have a vertical crack 1/4" wide.

- ⑥ At Pier 4, East Face near the centerline, 4th masonry course there is a cracked stone below the water 1/4" wide x full height that extends through the concrete pier shaft to channel bottom.

- ⑮ At Pier 6, East Face 20' North of the Southeast Corner, in the 6th masonry course there is a vertical crack up to 3/16" wide that extends to channel bottom.

- ⑯ At Pier 6, West Face at the centerline, the 1st, 3rd and 4th stone masonry courses have vertical cracks up to 1/4" wide extending into the concrete stem 1/2" wide at the channel bottom.

- ⑰ At Pier 6, West Face near the North Quarter Point, the 1st and 2nd masonry courses have vertical cracks 1/4" wide.
- ⑱ At Pier 6, West Face near the centerline of the pedestrian bridge, the 4th masonry course has two (2) vertical cracks full height x up to 3/8" wide, the 3rd course has a vertical crack 1/8" wide with chips.

- ⑲ At Pier 6, East Face near the centerline of the pedestrian bridge, top four masonry courses have a vertical crack, hairline to 1/4" wide.
- ⑳ At Pier 6, East Face 6th stone from the Southeast Corner, top four masonry courses have a vertical crack that measures 1/16" wide in the 1st course, 1/8" wide in the 2nd course, 3/16" wide in the 3rd course and 1/4" wide in the 4th course.

- ㉑ At Pier 6, East Face 8th stone from the Southeast Corner, 1st masonry course has a cracked stone full height x 1/8" wide.
- ㉒ At Pier 6, East Face 9th stone from the Northeast Corner, 2nd masonry course has a cracked stone 18" high x 3/16" wide.

- ㉕ The timber fender system members in the tidal zone have minor checks and splits in the tidal zone and there is a fractured handrail in two locations with one (1) broken post.

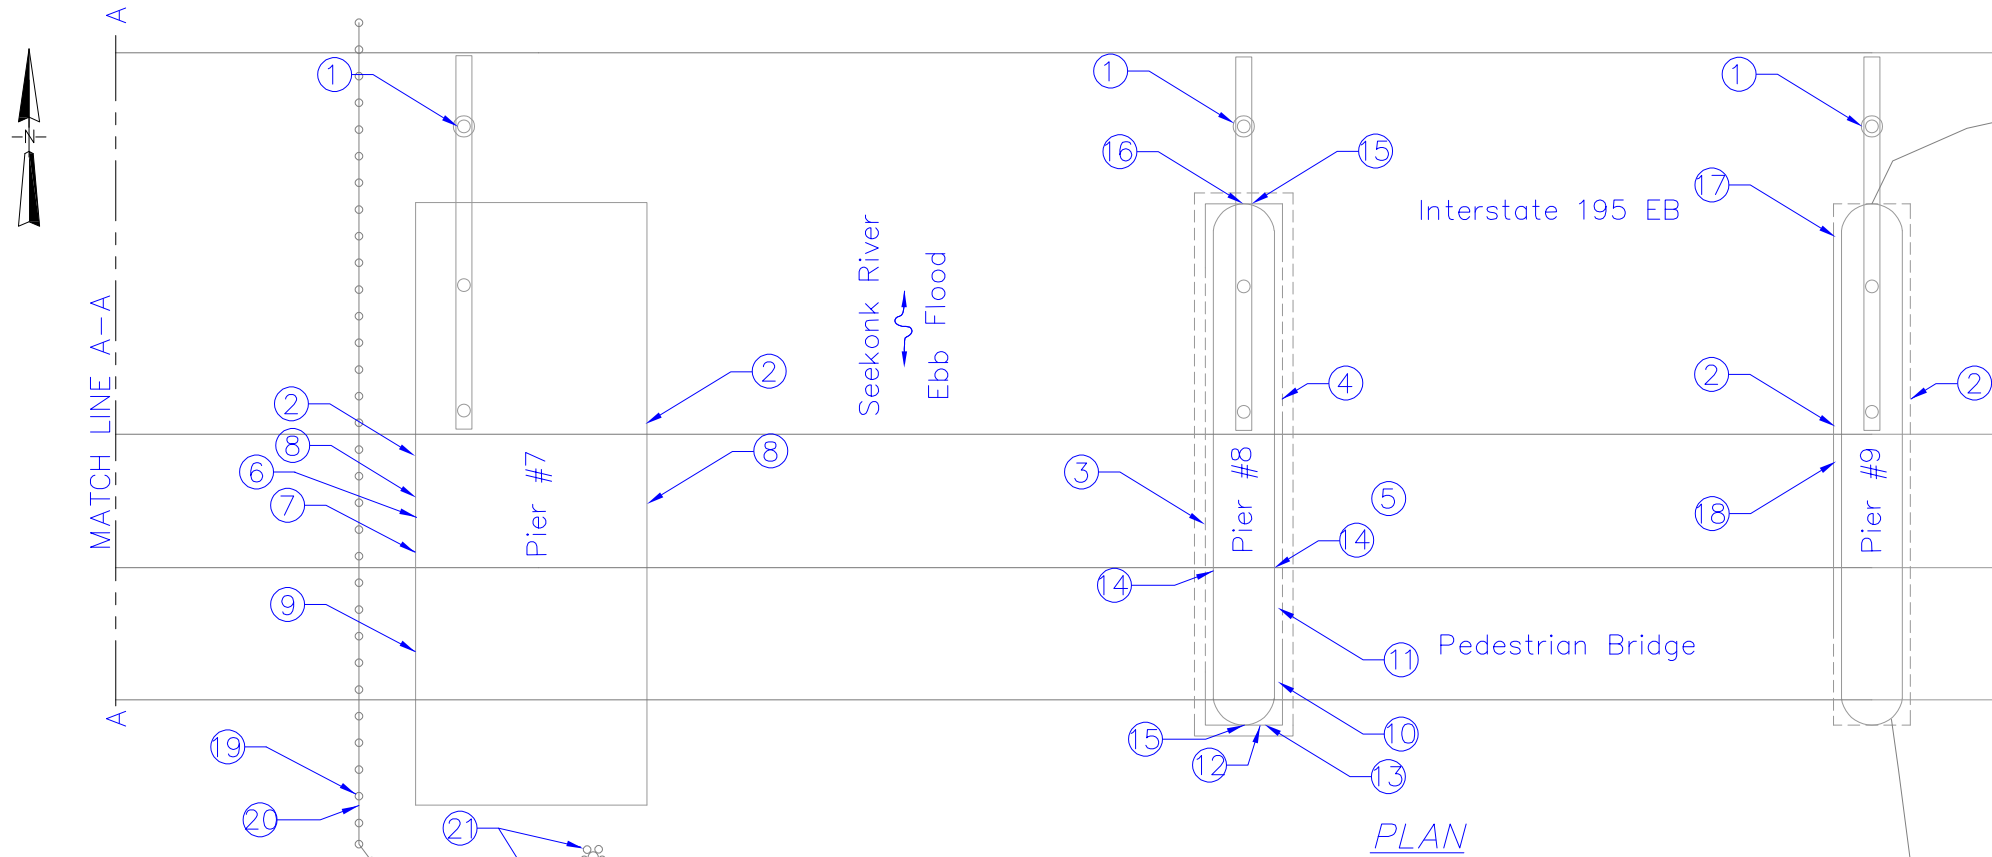
- ① At Piers 7, 8 and 9 the caisson pile at the North (Upstream) End the Pier, has a fiberglass jacket in place that extends 8' - 10' down from the underside of the concrete cap section. The exposed steel below the jacket has minor corrosion with light pitting up to 1/16" deep.

- ② At Piers 7 and 9, the stone masonry has less than 5% deteriorated mortar with 3" to 6" of penetration between stones.
- ③ At Pier 8, the stone masonry has less than 15% deteriorated mortar with up to 12" of penetration between stones.

- ⑥ At Pier 7, West Face on the reinforced concrete pier shaft below the stone masonry, there is abrasion 2" deep.
- ⑦ At Pier 7 concrete stem, there are isolated areas of poor consolidation/spalls near the channel bottom:

- ⑧ At Pier 7, East and West Faces near centerline, there are vertical cracks full height of the masonry facade x up to 1/2" wide with chipped stones up to 8'-6" high x 5" wide x 3" deep. The crack in the East Face continues through the reinforced concrete stem below the masonry facade and has edge spalls up to 14" wide x 2' high x 2-1/2" deep with soft concrete.

- ⑫ At Pier 8, South Face at 10' and 15' from the Southeast Corner, two (2) timber piles protruding up through the concrete pile cap with 12" exposed. The timber piles are at 60% and 25% non-bearing and exhibit 15% and 20% section loss, respectively. (Not found during 2024 inspection).

- ⑬ At Pier 8, Southeast corner on the footing, there is an edge spall 2' long x 8" high x 5" deep.

- ⑭ At Pier 8, 23' North of the South Nose, stone masonry, top two stone courses below the cap, there is a vertical crack 1/2" wide. The crack also extends through the concrete footing on both faces up to 1/4" wide with edge spalls 6" long x 2" wide x 1" deep.

- ⑱ At Pier 9, West Face of masonry at centerline 2nd and 3rd courses, there is a crack 1/2" wide. The crack also extends through the concrete footing to the channel bottom.

- ⑲ The fender system members in the tidal zone have minor checks and splits in the tidal zone and a missing section of handrail near the North End of the pedestrian bridge.

- ㉒ Off of the Southeast Corner of the East Fender System, there is a sunken boat ±48' long x up to 20' high off the channel bottom that is a navigational hazard to boat traffic outside of the main channel.

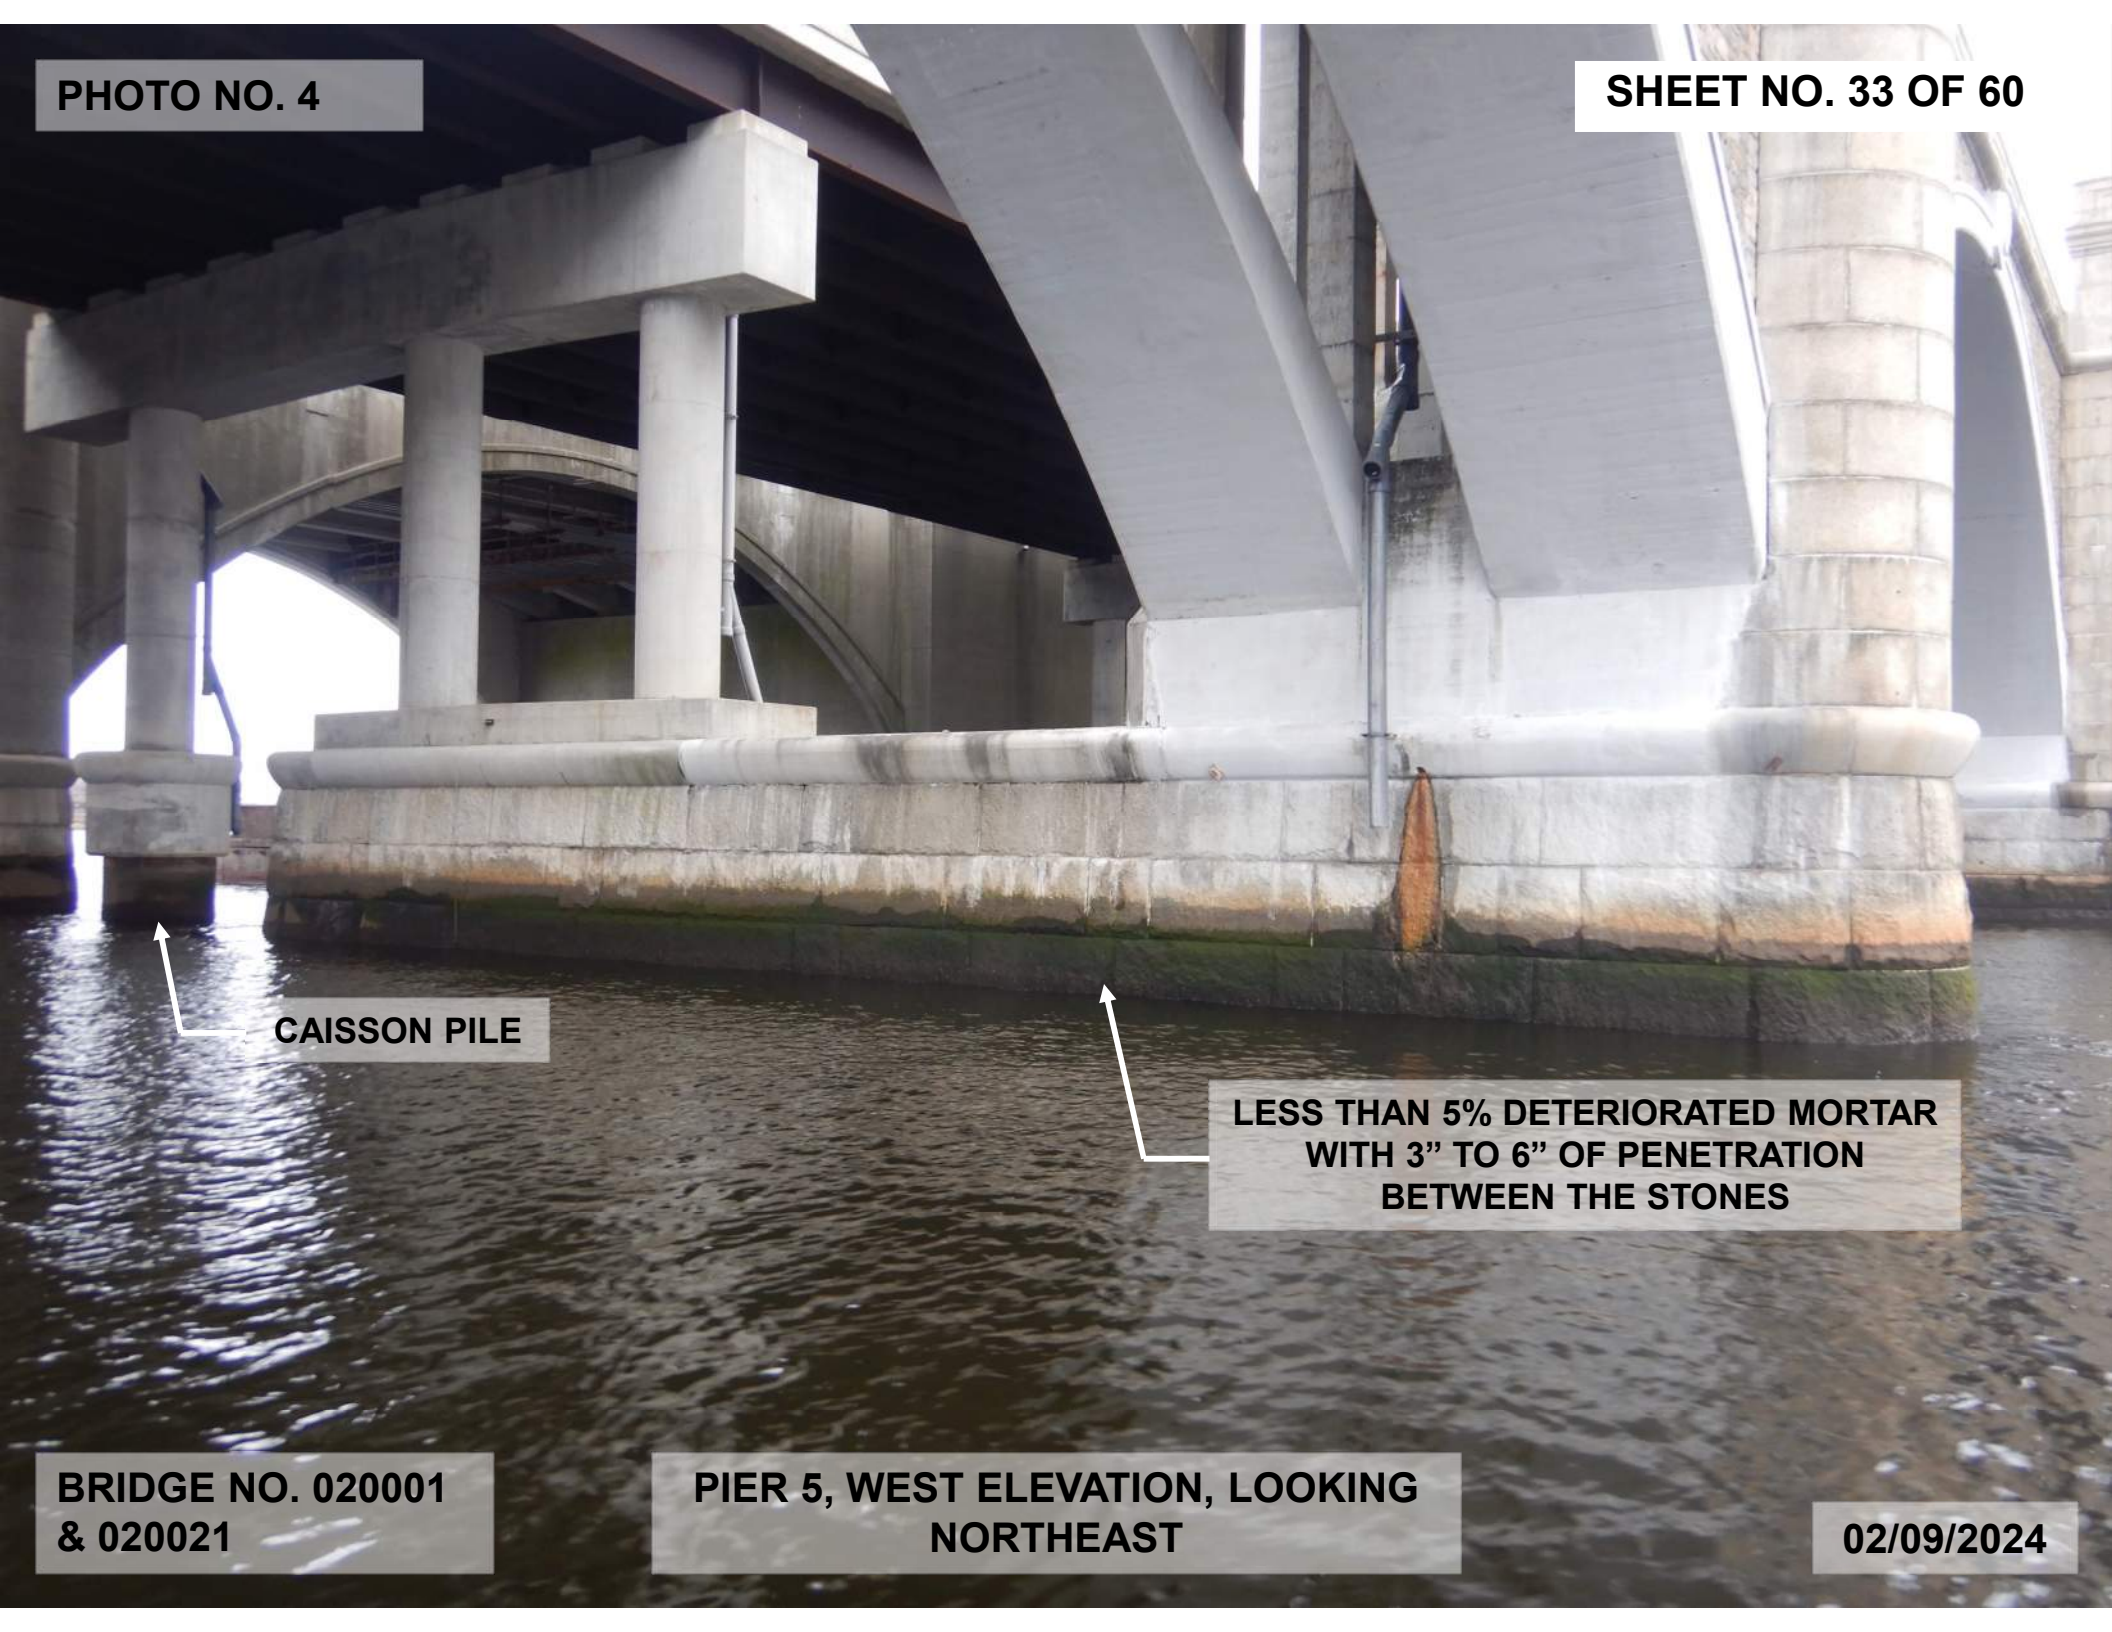
PHOTO NO. 5

CAISSON PILE

LESS THAN 5% DETERIORATED MORTAR  
WITH 3" TO 6" OF PENETRATION  
BETWEEN THE STONES

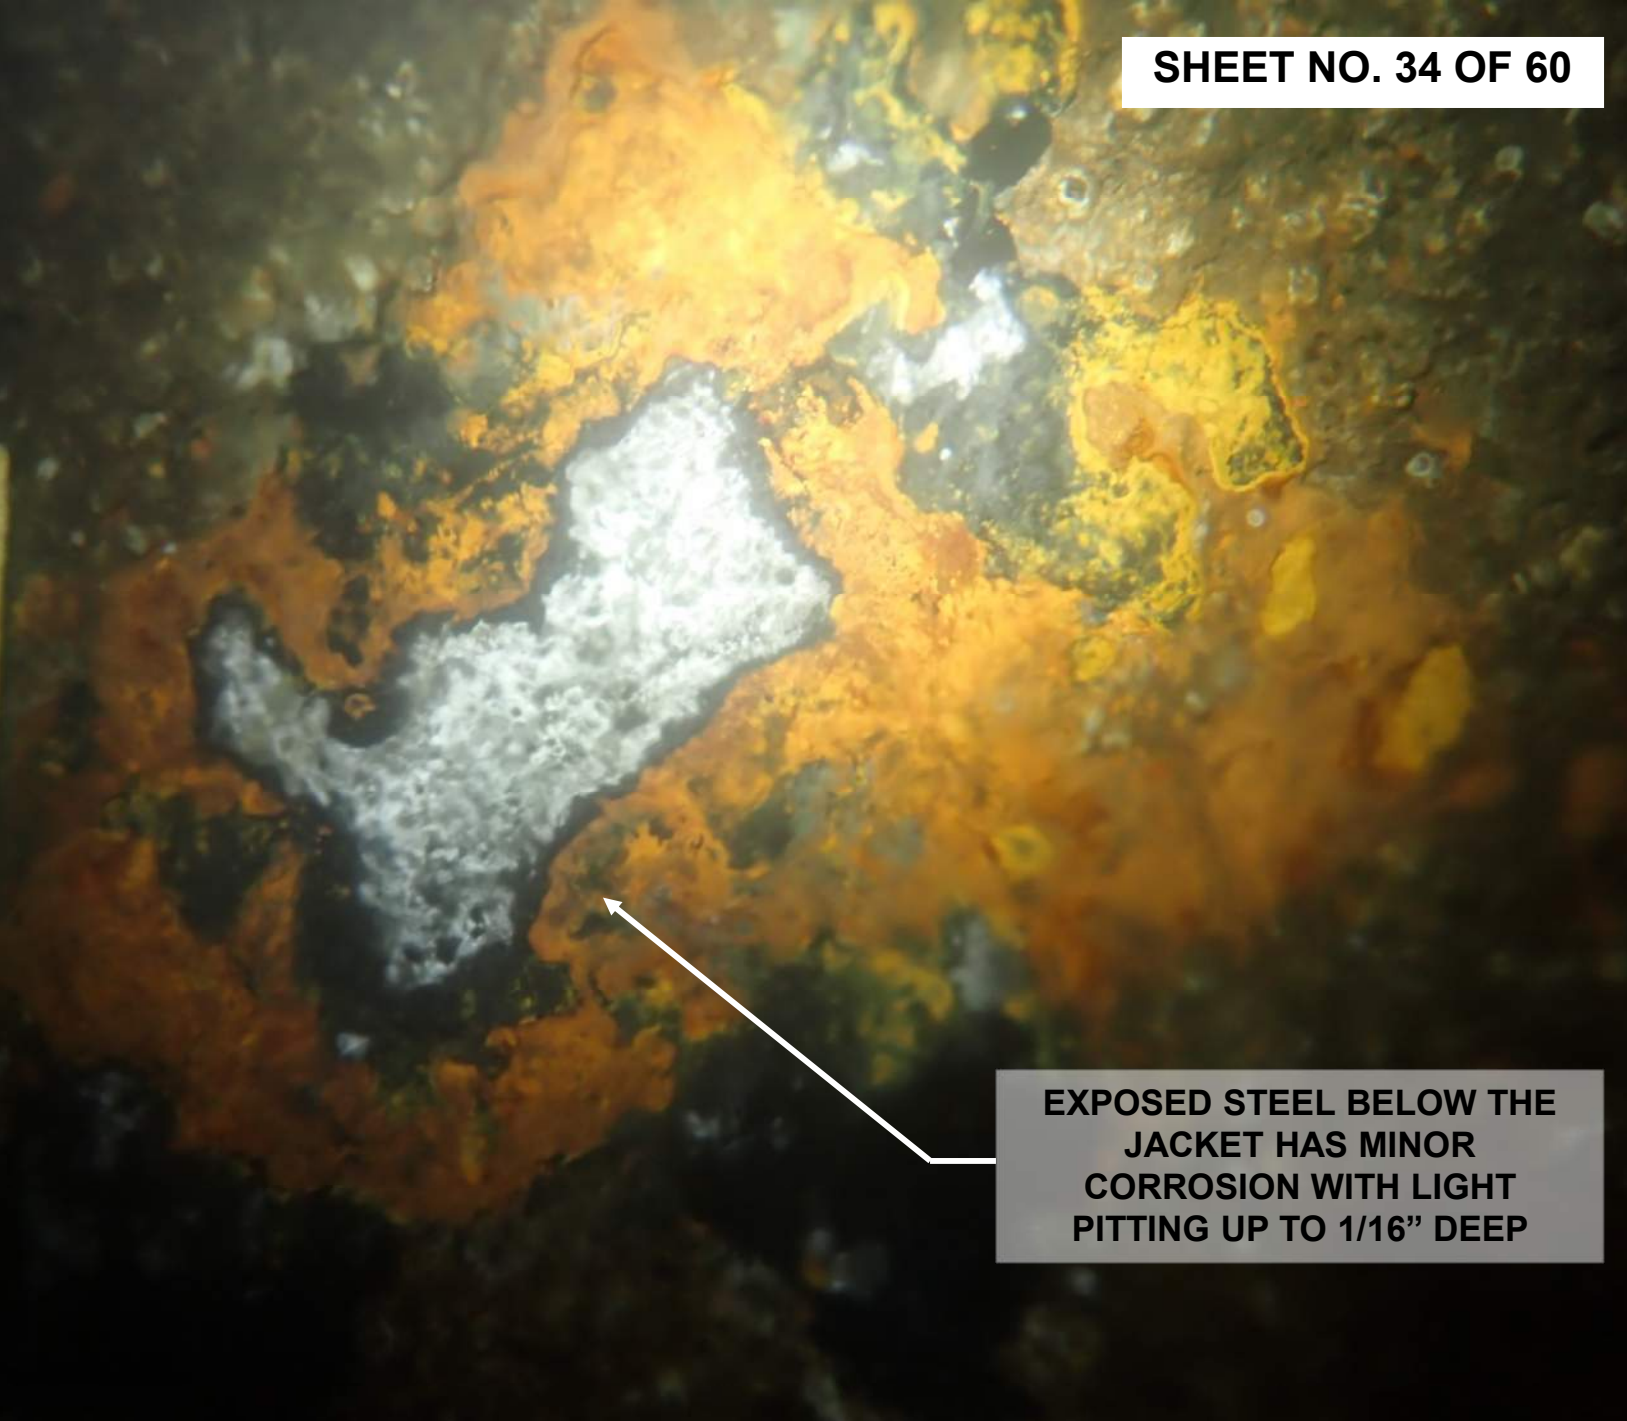
PHOTO NO. 6

EXPOSED STEEL BELOW THE  
JACKET HAS MINOR  
CORROSION WITH LIGHT  
PITTING UP TO 1/16" DEEP

There is a steel encased reinforced concrete caisson pile at the north (upstream) ends of the pier. The caisson piles have fiberglass jackets in place that extends up to 10' down from the underside of the concrete cap section. The caisson piles, steel below the jacket has minor corrosion with light pitting up to 1/16" deep (See Photo No. 5).

- The caisson piles, steel below the jacket has minor corrosion with light pitting up to 1/16" deep (See Photo No. 5).

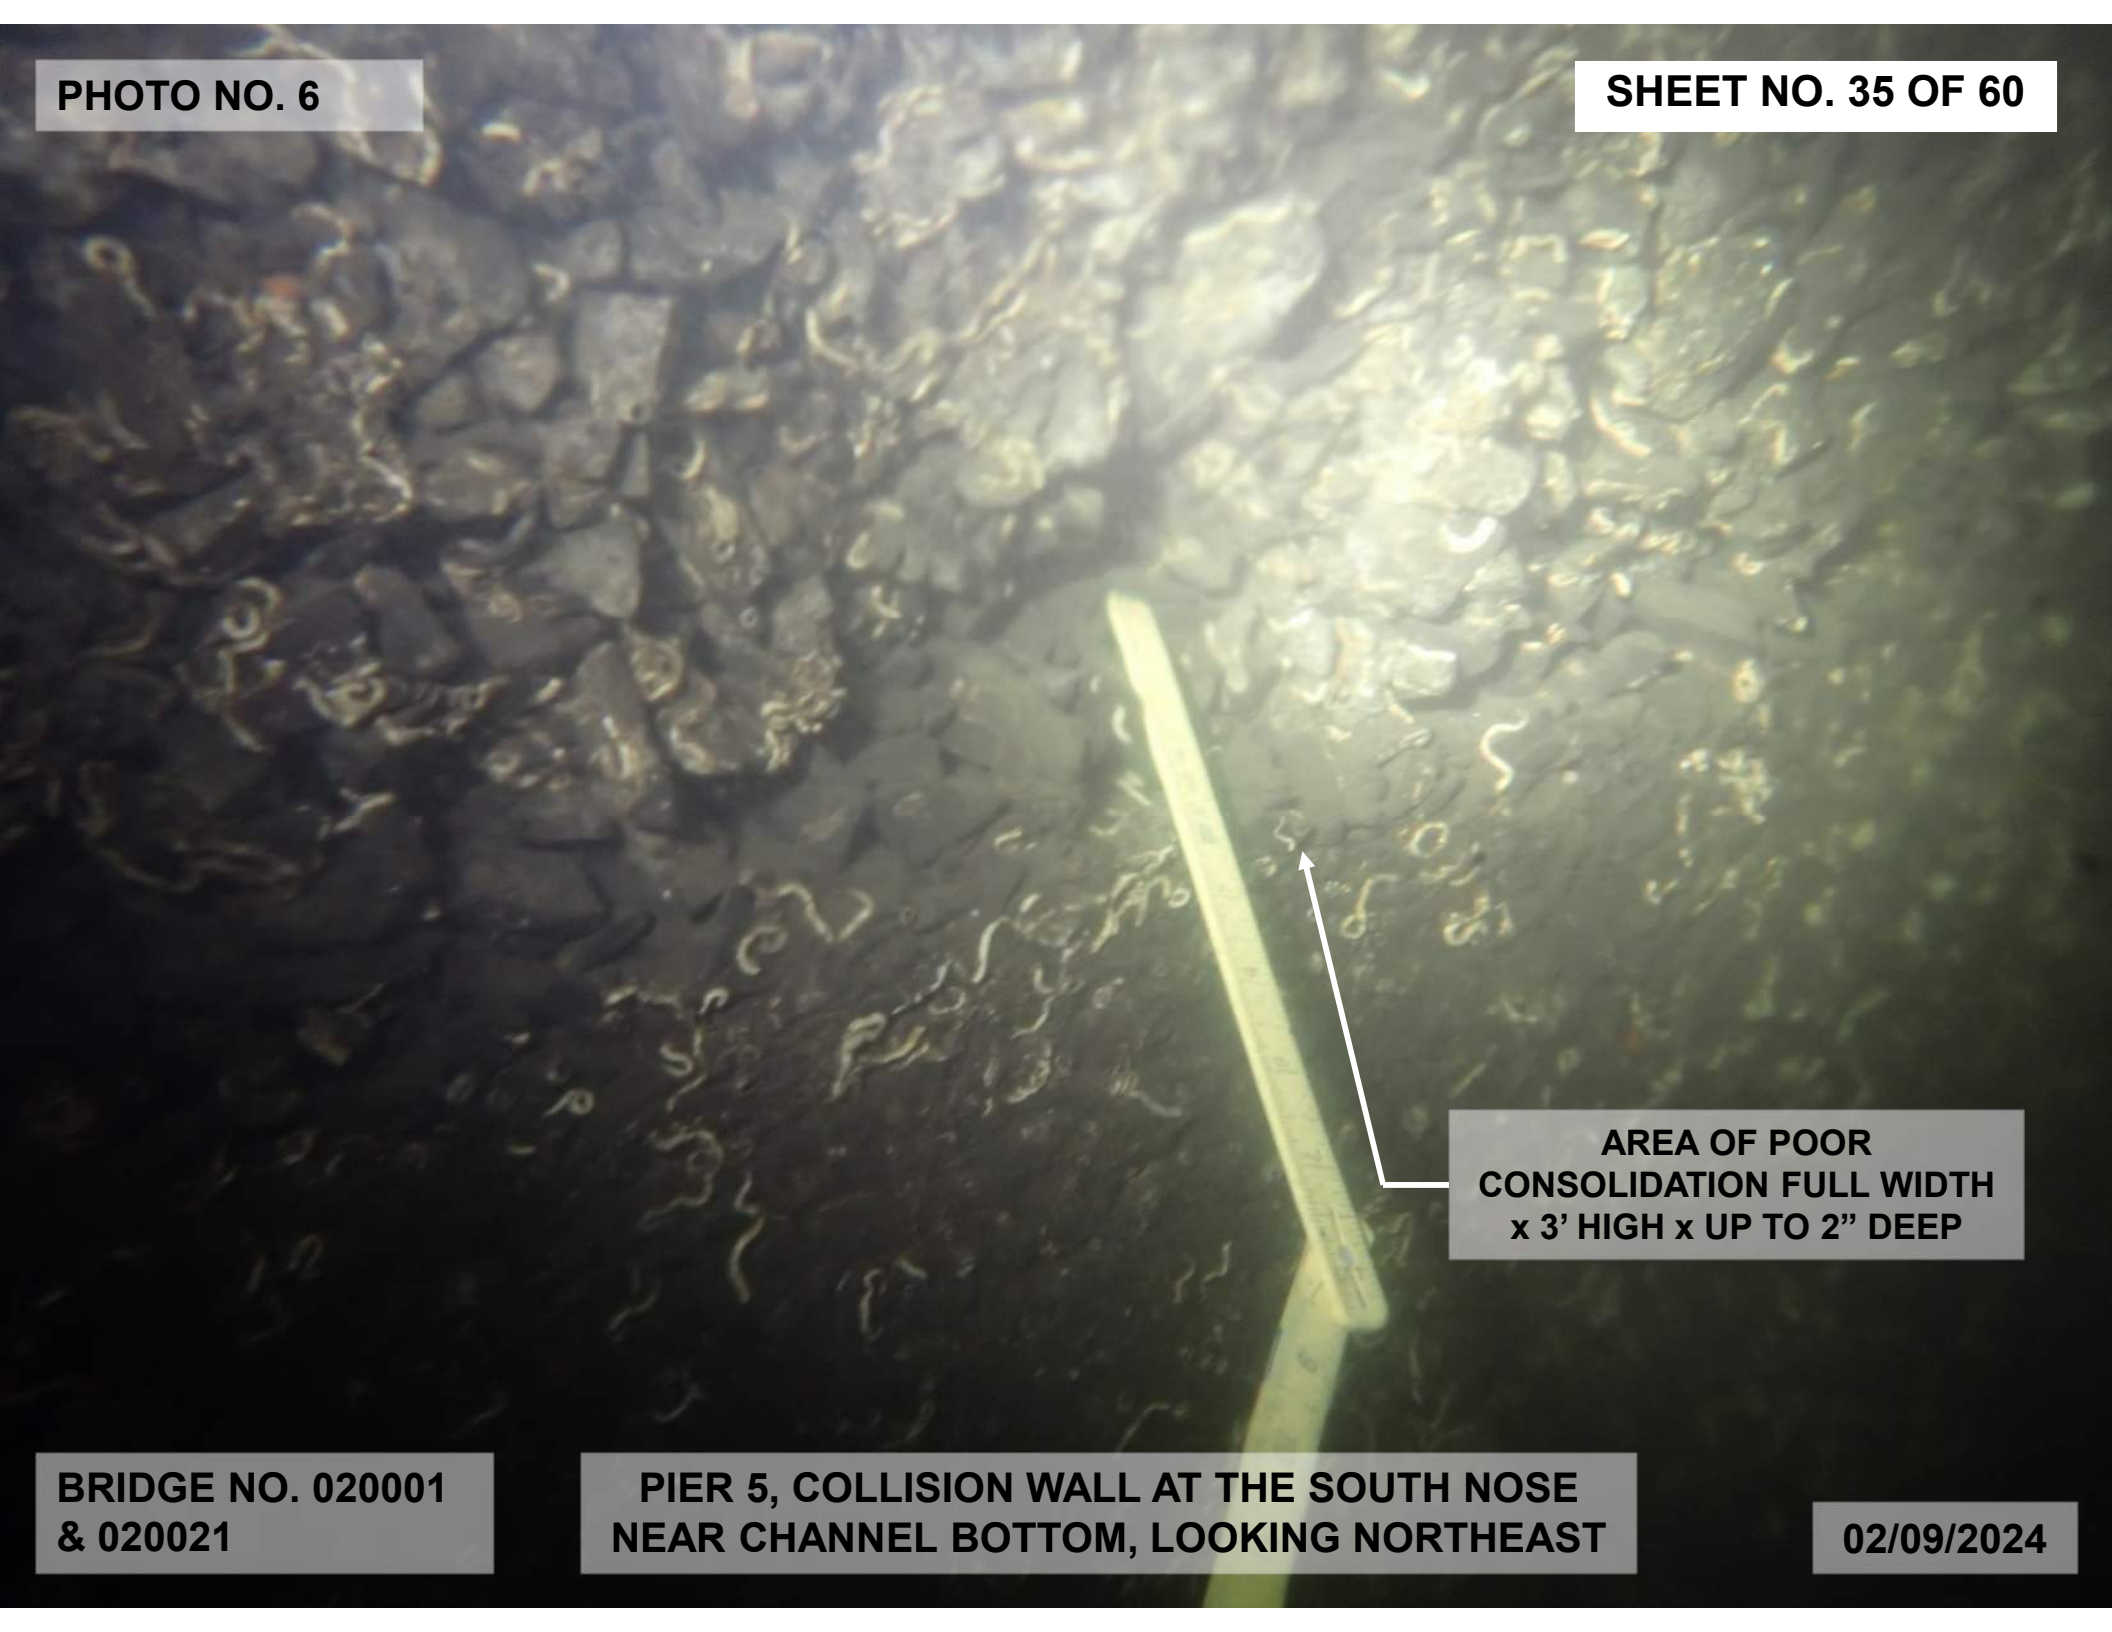
PHOTO NO. 7

AREA OF POOR  
CONSOLIDATION FULL WIDTH  
x 3' HIGH x UP TO 2" DEEP

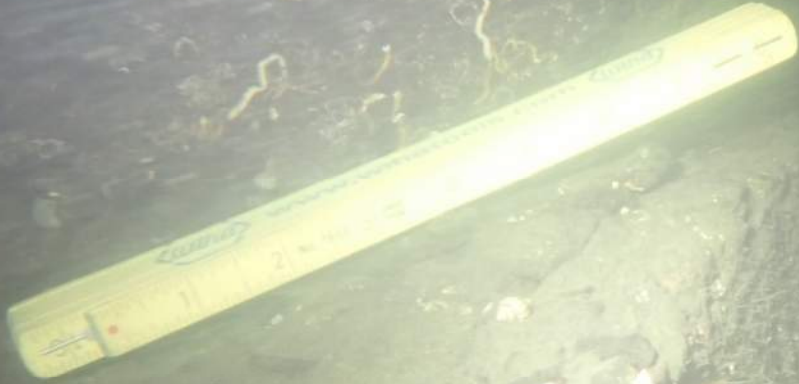
PHOTO NO. 8

ABRASION UP TO 1/2" DEEP

SOUTH FACE IS FLUSH WITH THE  
COLLISION WALL AND EXPOSED  
15' LONG x UP TO 10" HIGH

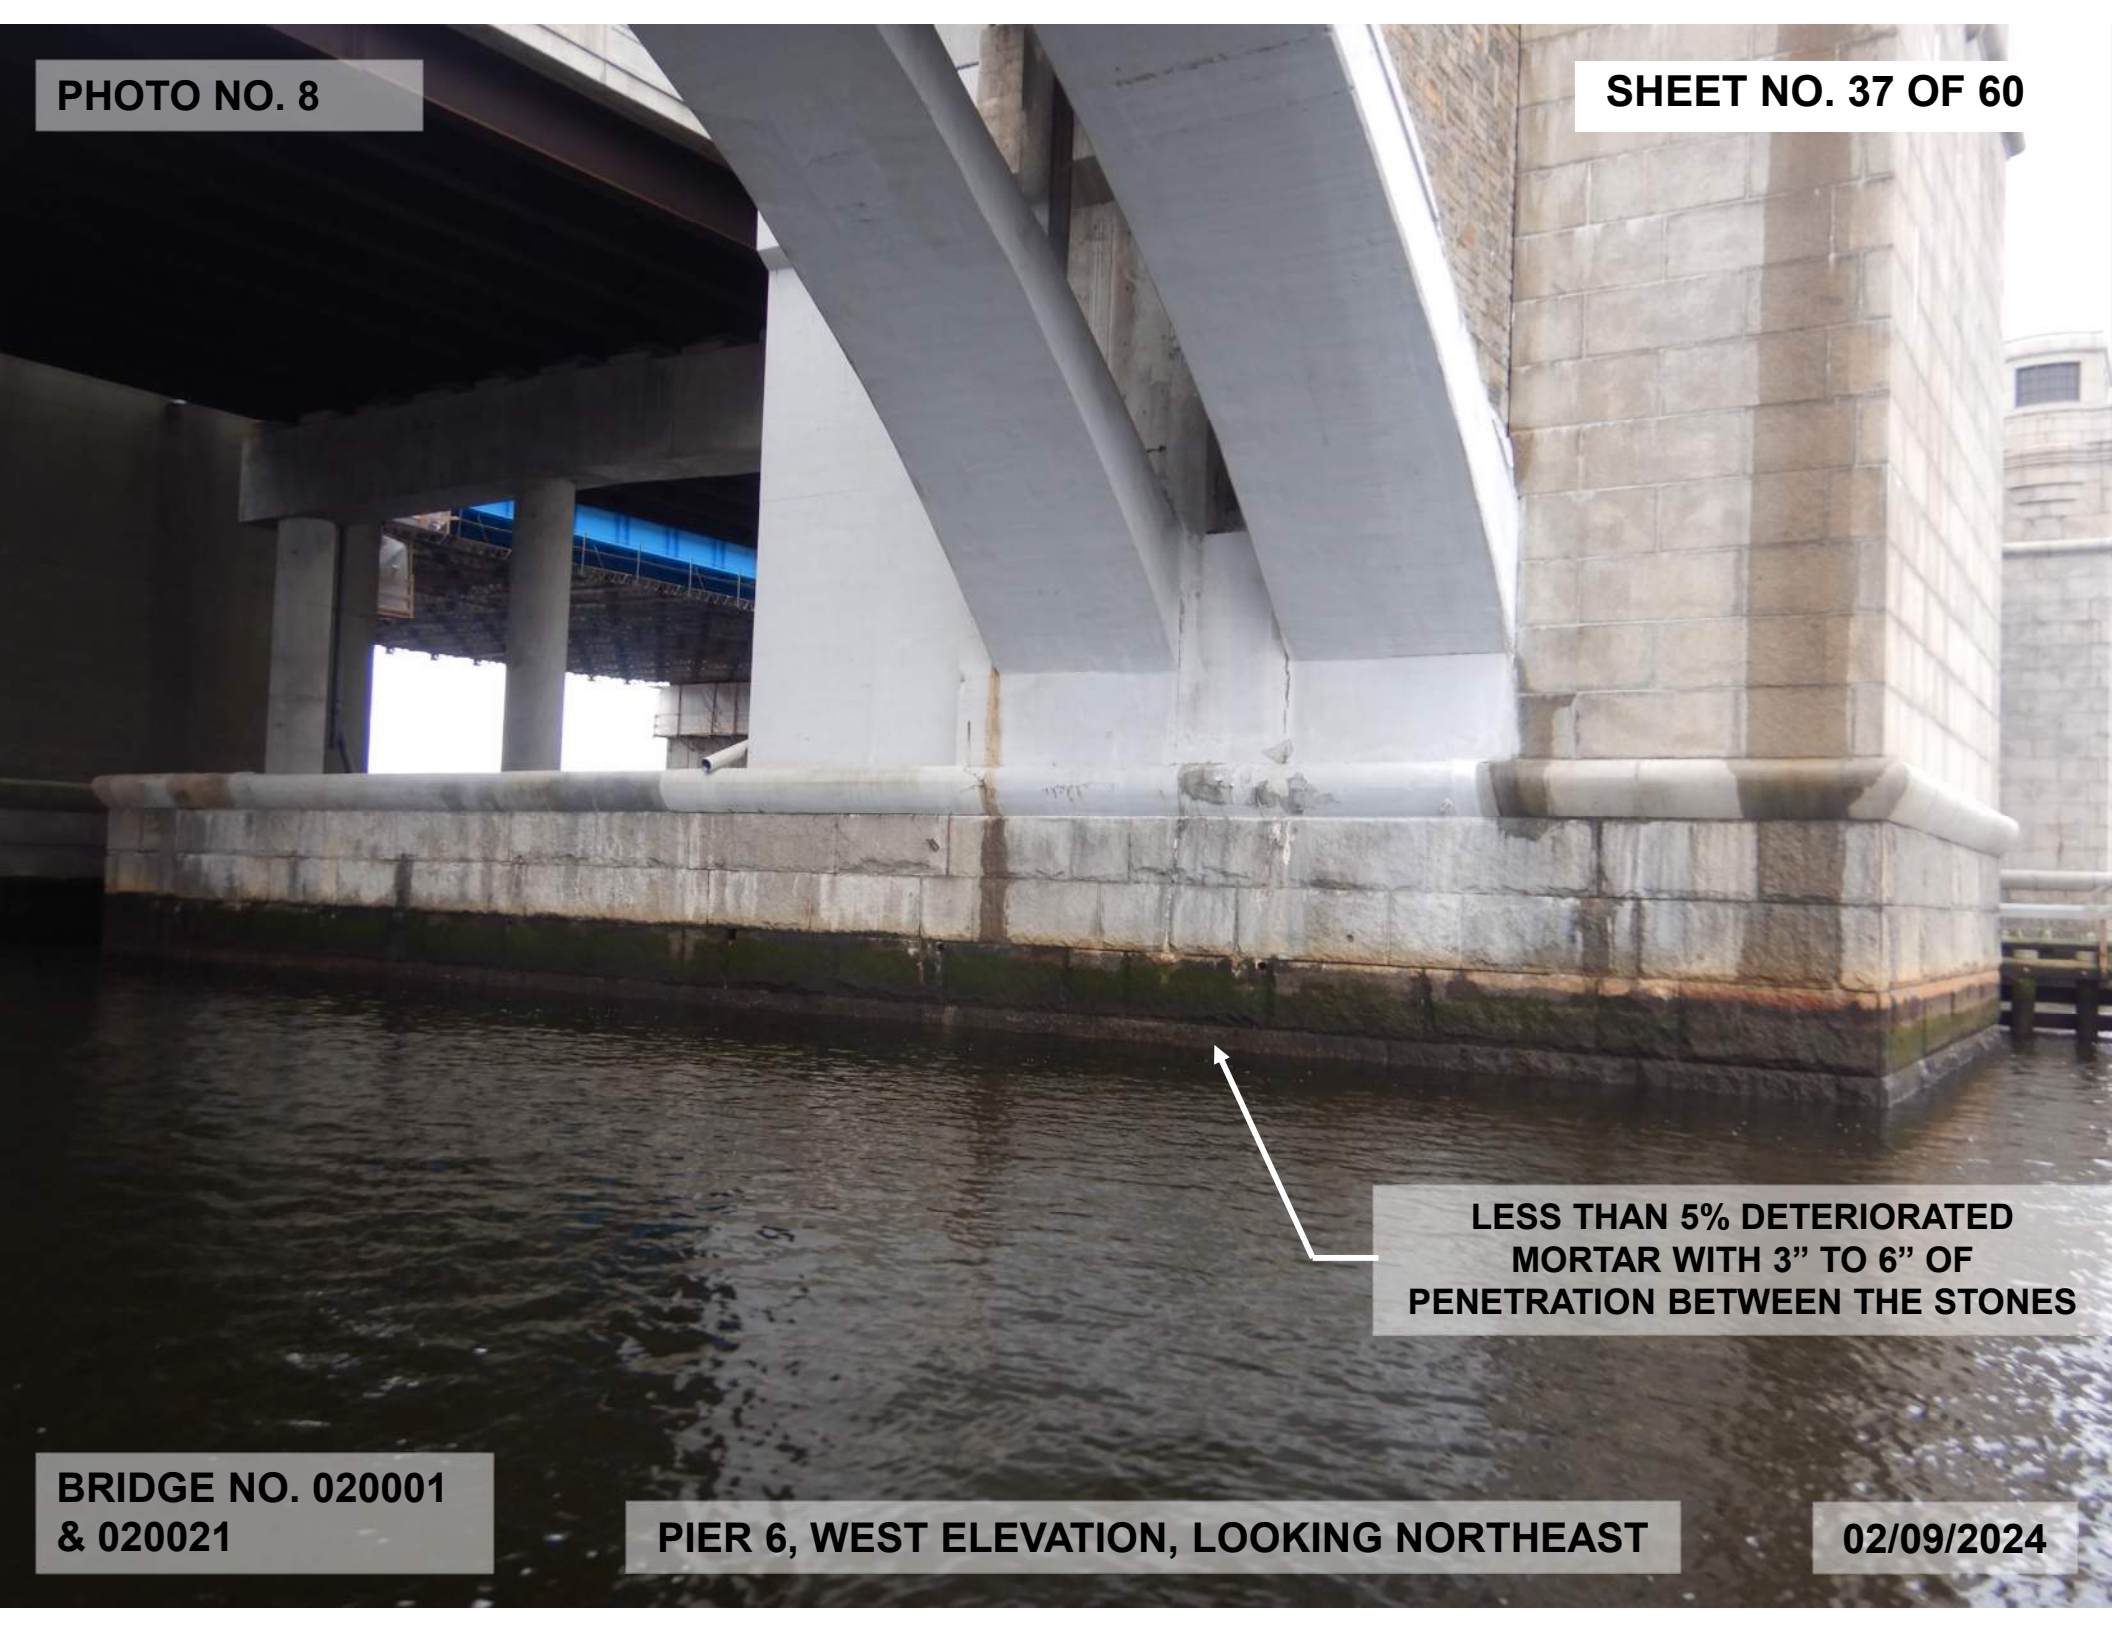
PIER 6, WEST ELEVATION, LOOKING NORTHEAST

LESS THAN 5% DETERIORATED  
MORTAR WITH 3" TO 6"  
PENETRATION BETWEEN THE STONES

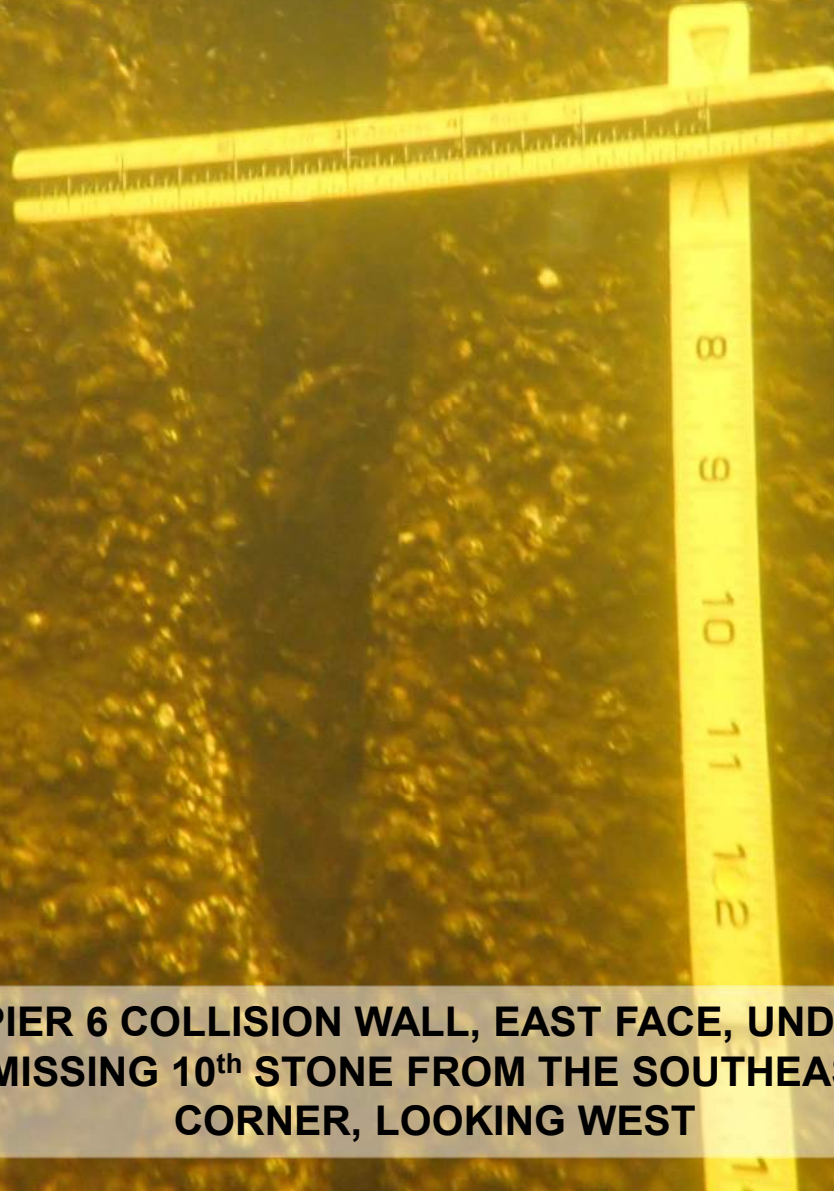
PIER 6 COLLISION WALL, EAST FACE, UNDER  
MISSING 10<sup>th</sup> STONE FROM THE SOUTHEAST  
CORNER, LOOKING WEST

BOTTOM COURSE CRACKED UP  
TO 1/4" WIDE WITH CHIPPED  
STONE 9" HIGH x 2-1/2"W

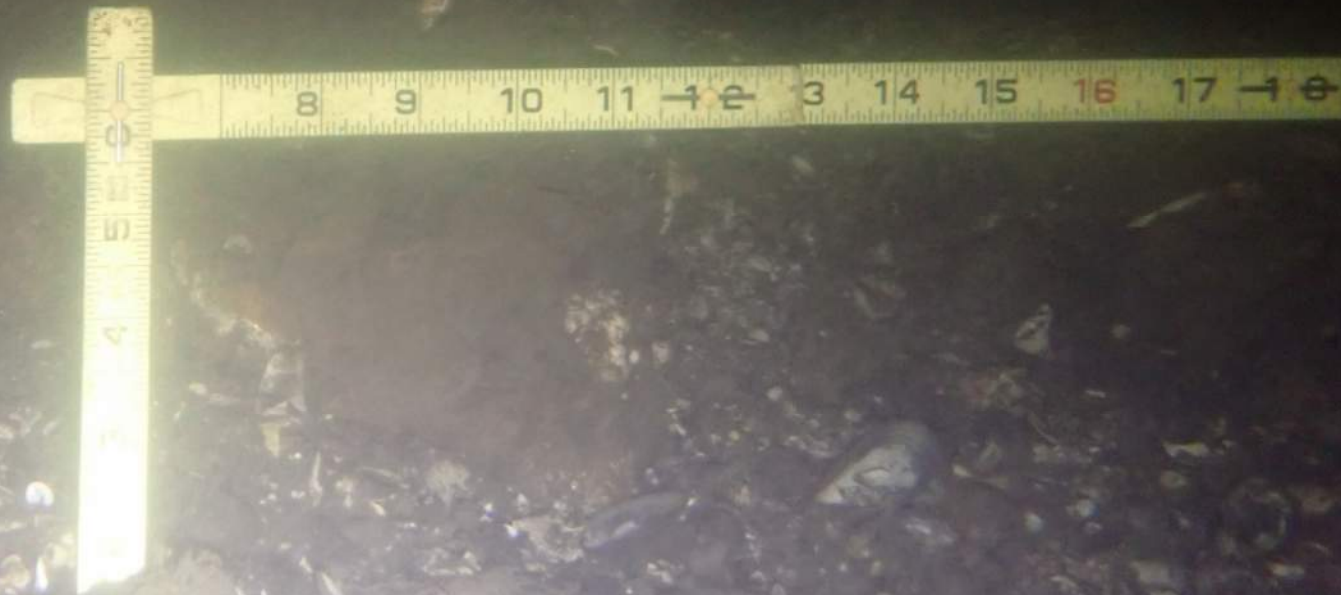
PIER 6 COLLISION WALL, NORTHEAST CORNER  
AT CHANNEL BOTTOM, LOOKING SOUTHWEST

POOR CONSOLIDATION 3'-6"  
LONG DOWN THE EAST FACE x  
4' LONG DOWN THE NORTH  
FACE x 16" HIGH x 2" DEEP

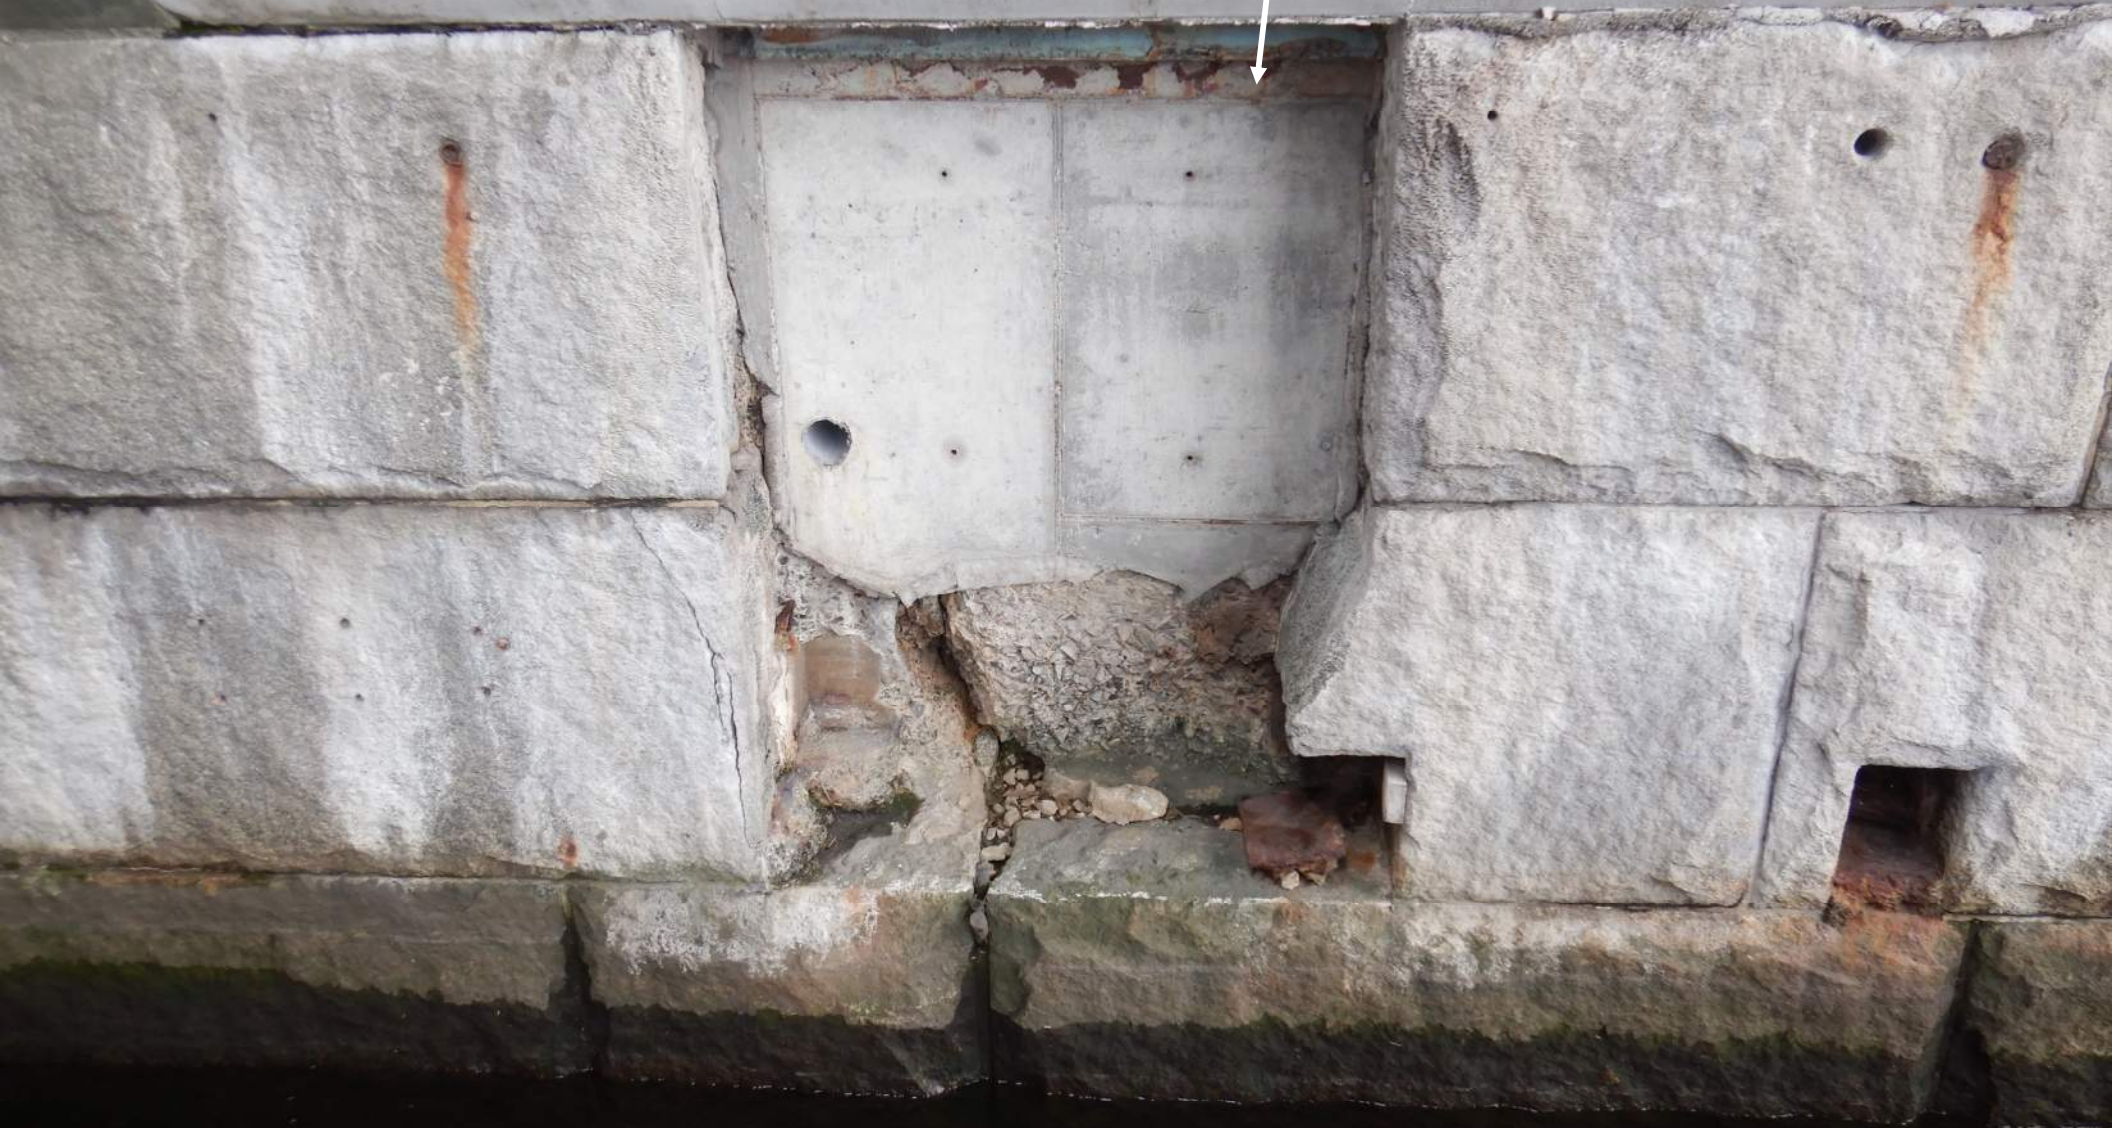
PIER 7 COLLISION WALL, WEST FACE NEAR THE  
SOUTH QUARTERPOINT, LOOKING EAST

- ⑨ At Pier 7, West Face of the stone masonry near the south quarter point the stones in the 1st and 2nd masonry courses, are broken with 3'-6" long x 5' high sections of stone.

BROKEN / MISSING STONES UP TO  
3'-6" LONG x 5' HIGH

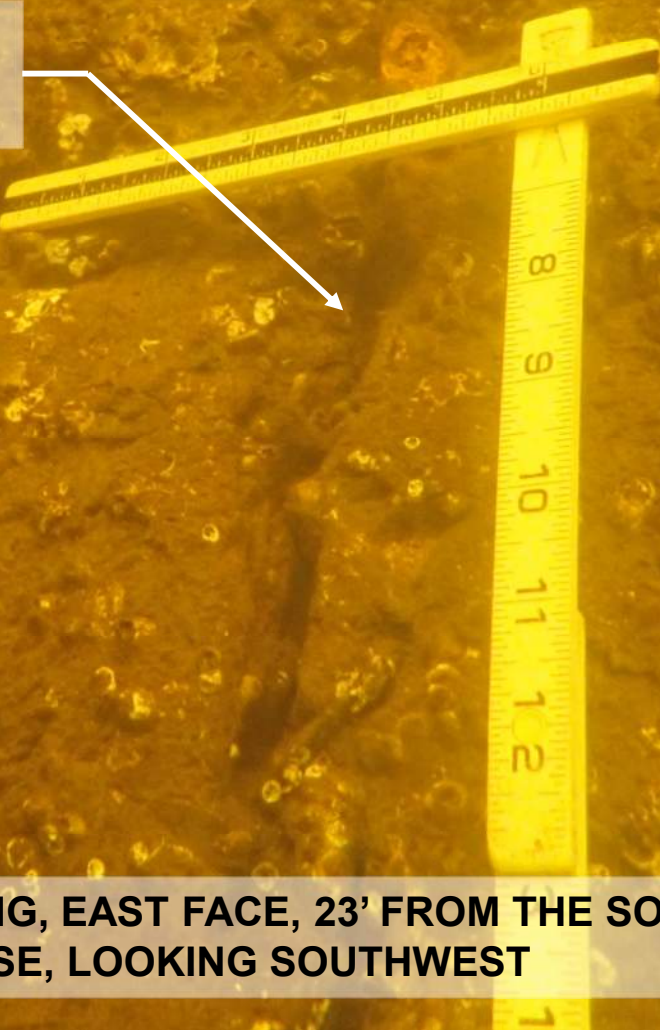
VERTICAL CRACKS UP TO 1/4" WIDE  
WITH EDGE SPALLS UP TO 6" LONG x  
2" WIDE x 1" DEEP

- West and East Faces, 23' from the South Nose, footing has vertical cracks up to 1/4" wide with edge spalls up to 6" high x 2" wide x 1" deep (See Photo No. 19).
