# Underwater Inspection Report

Washington Bridge South & Washington Bridge South  
Pedestrian  
Interstate 195 Eastbound & Bike/Pedestrian Bridge  
Over  
Seekonk River

Bridge ID: 020001 & 020021  
Ebb (South) Elevation

Bridge No.: 020001 & 020021 Inspection Date: 2/9/2024  
 Bridge Name: Washington Bridge South & Washington Bridge South Pedestrian  
 Facility Carried: Interstate 195 Eastbound & Bike Path/Pedestrian  
 Feature Intersected: Seekonk River  
 City/Town: East Providence

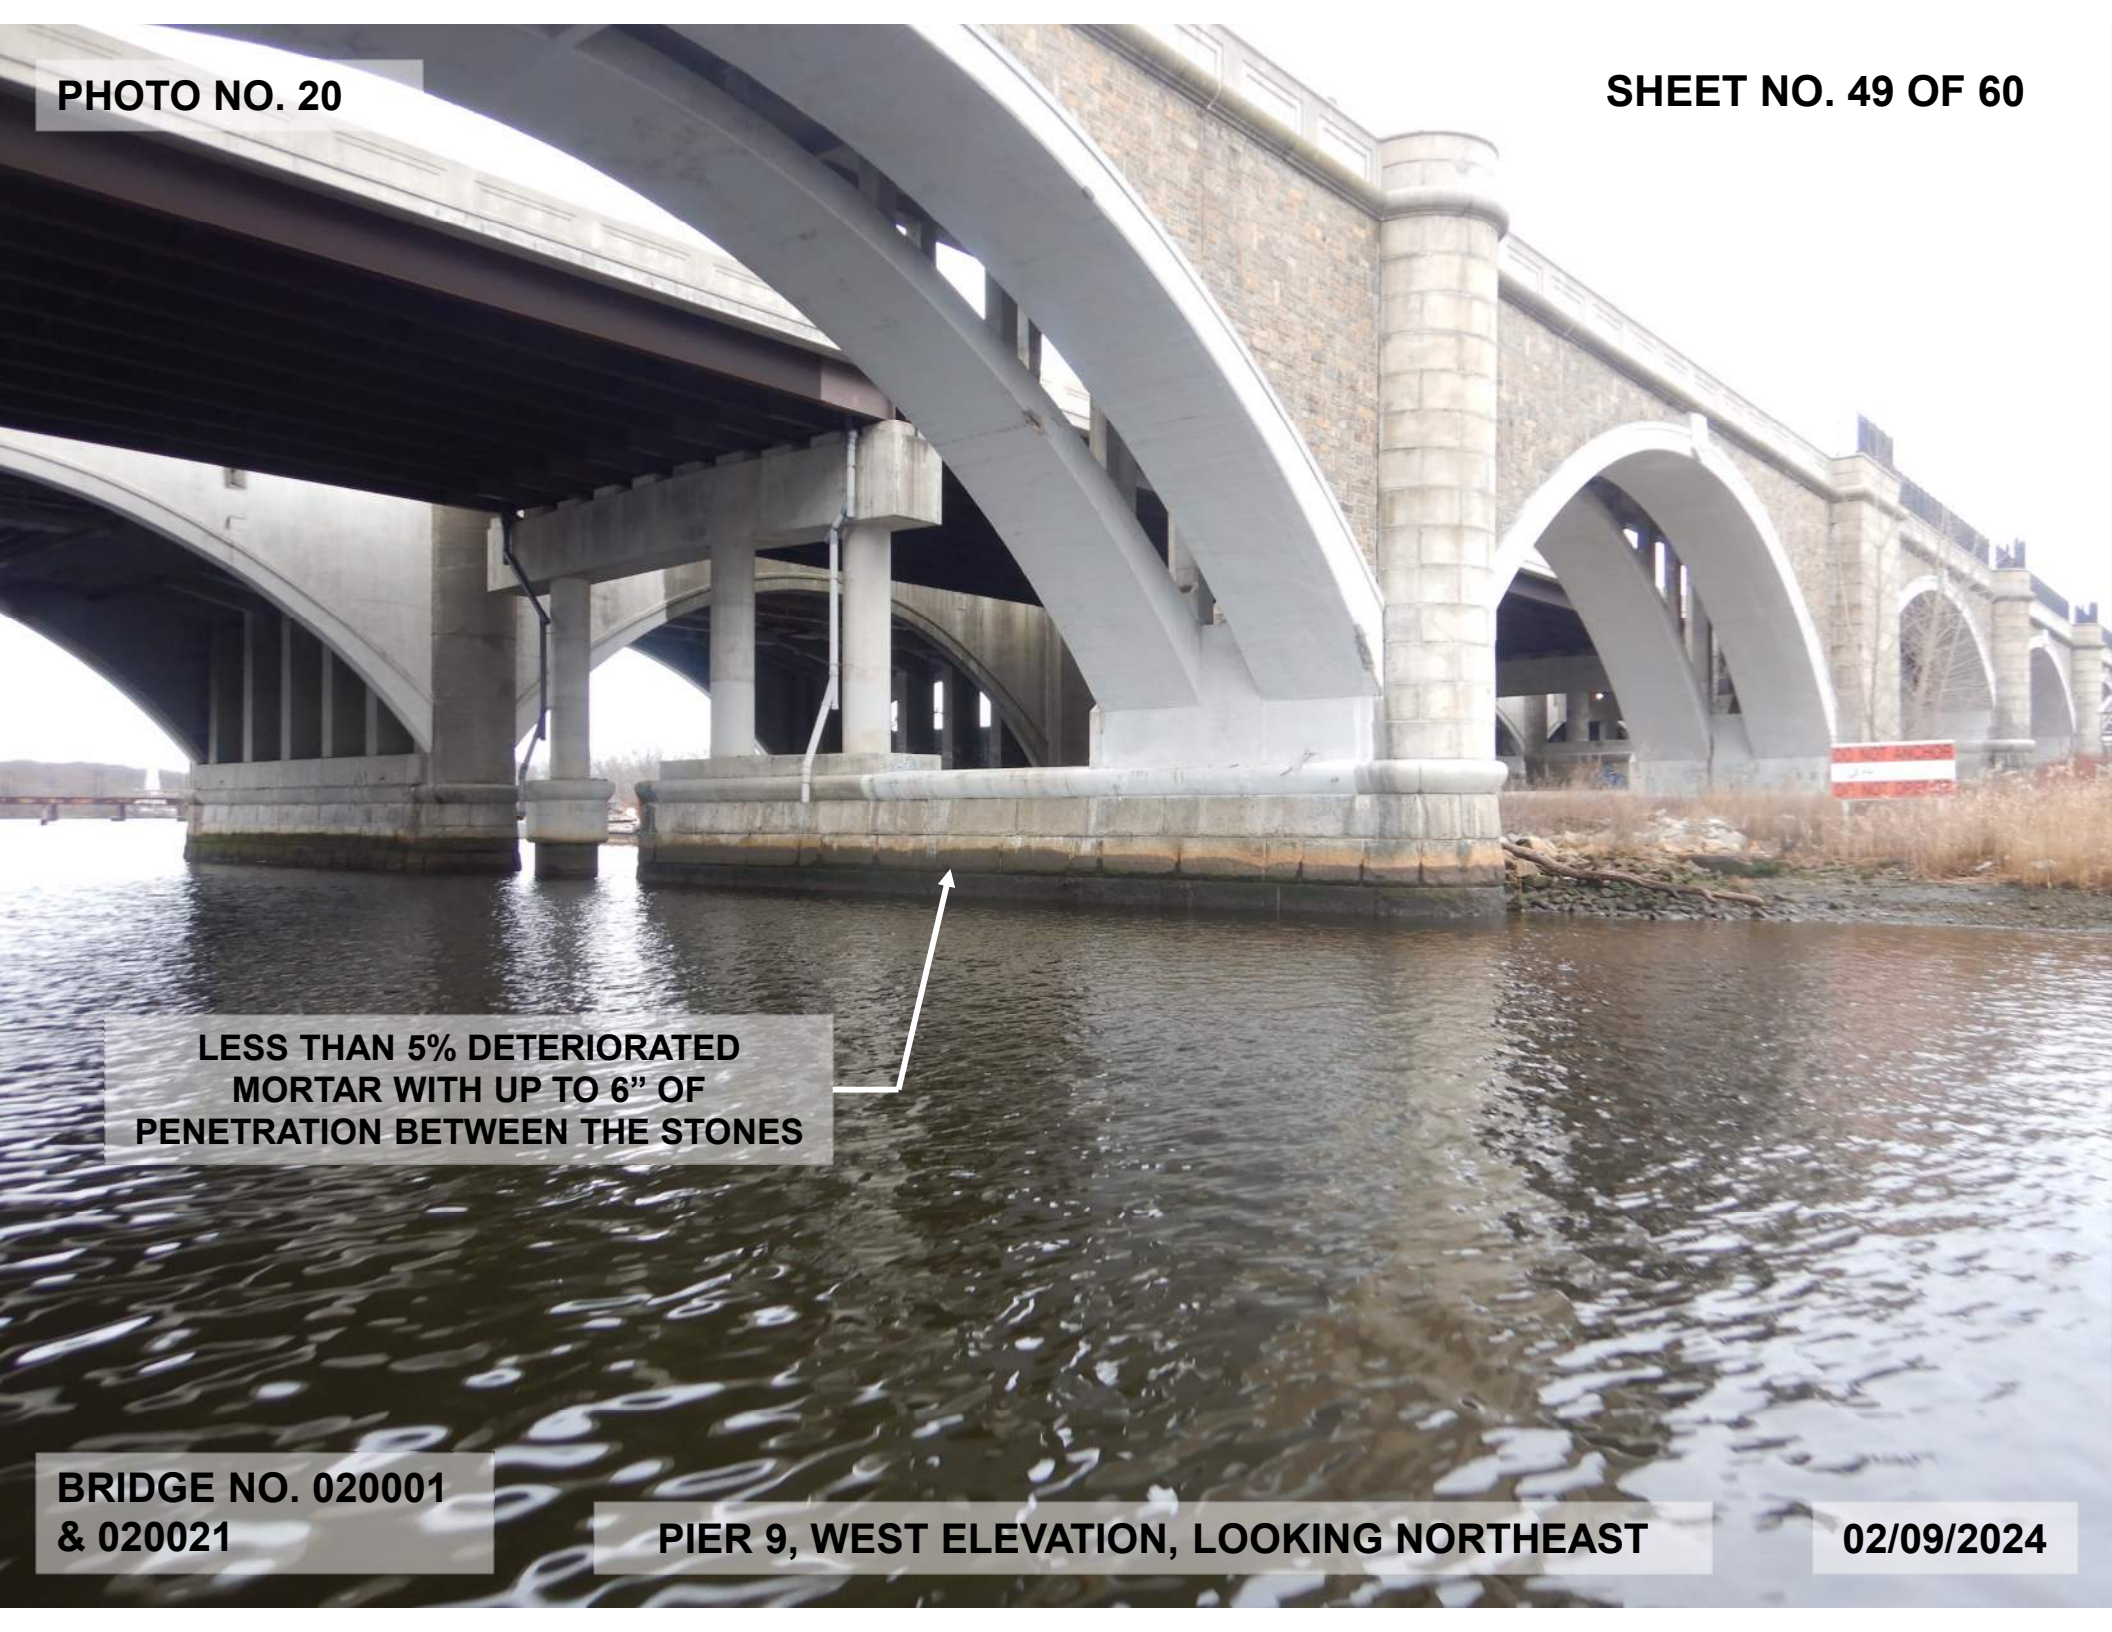
**LESS THAN 5% DETERIORATED  
MORTAR WITH UP TO 6" OF  
PENETRATION BETWEEN THE STONES**

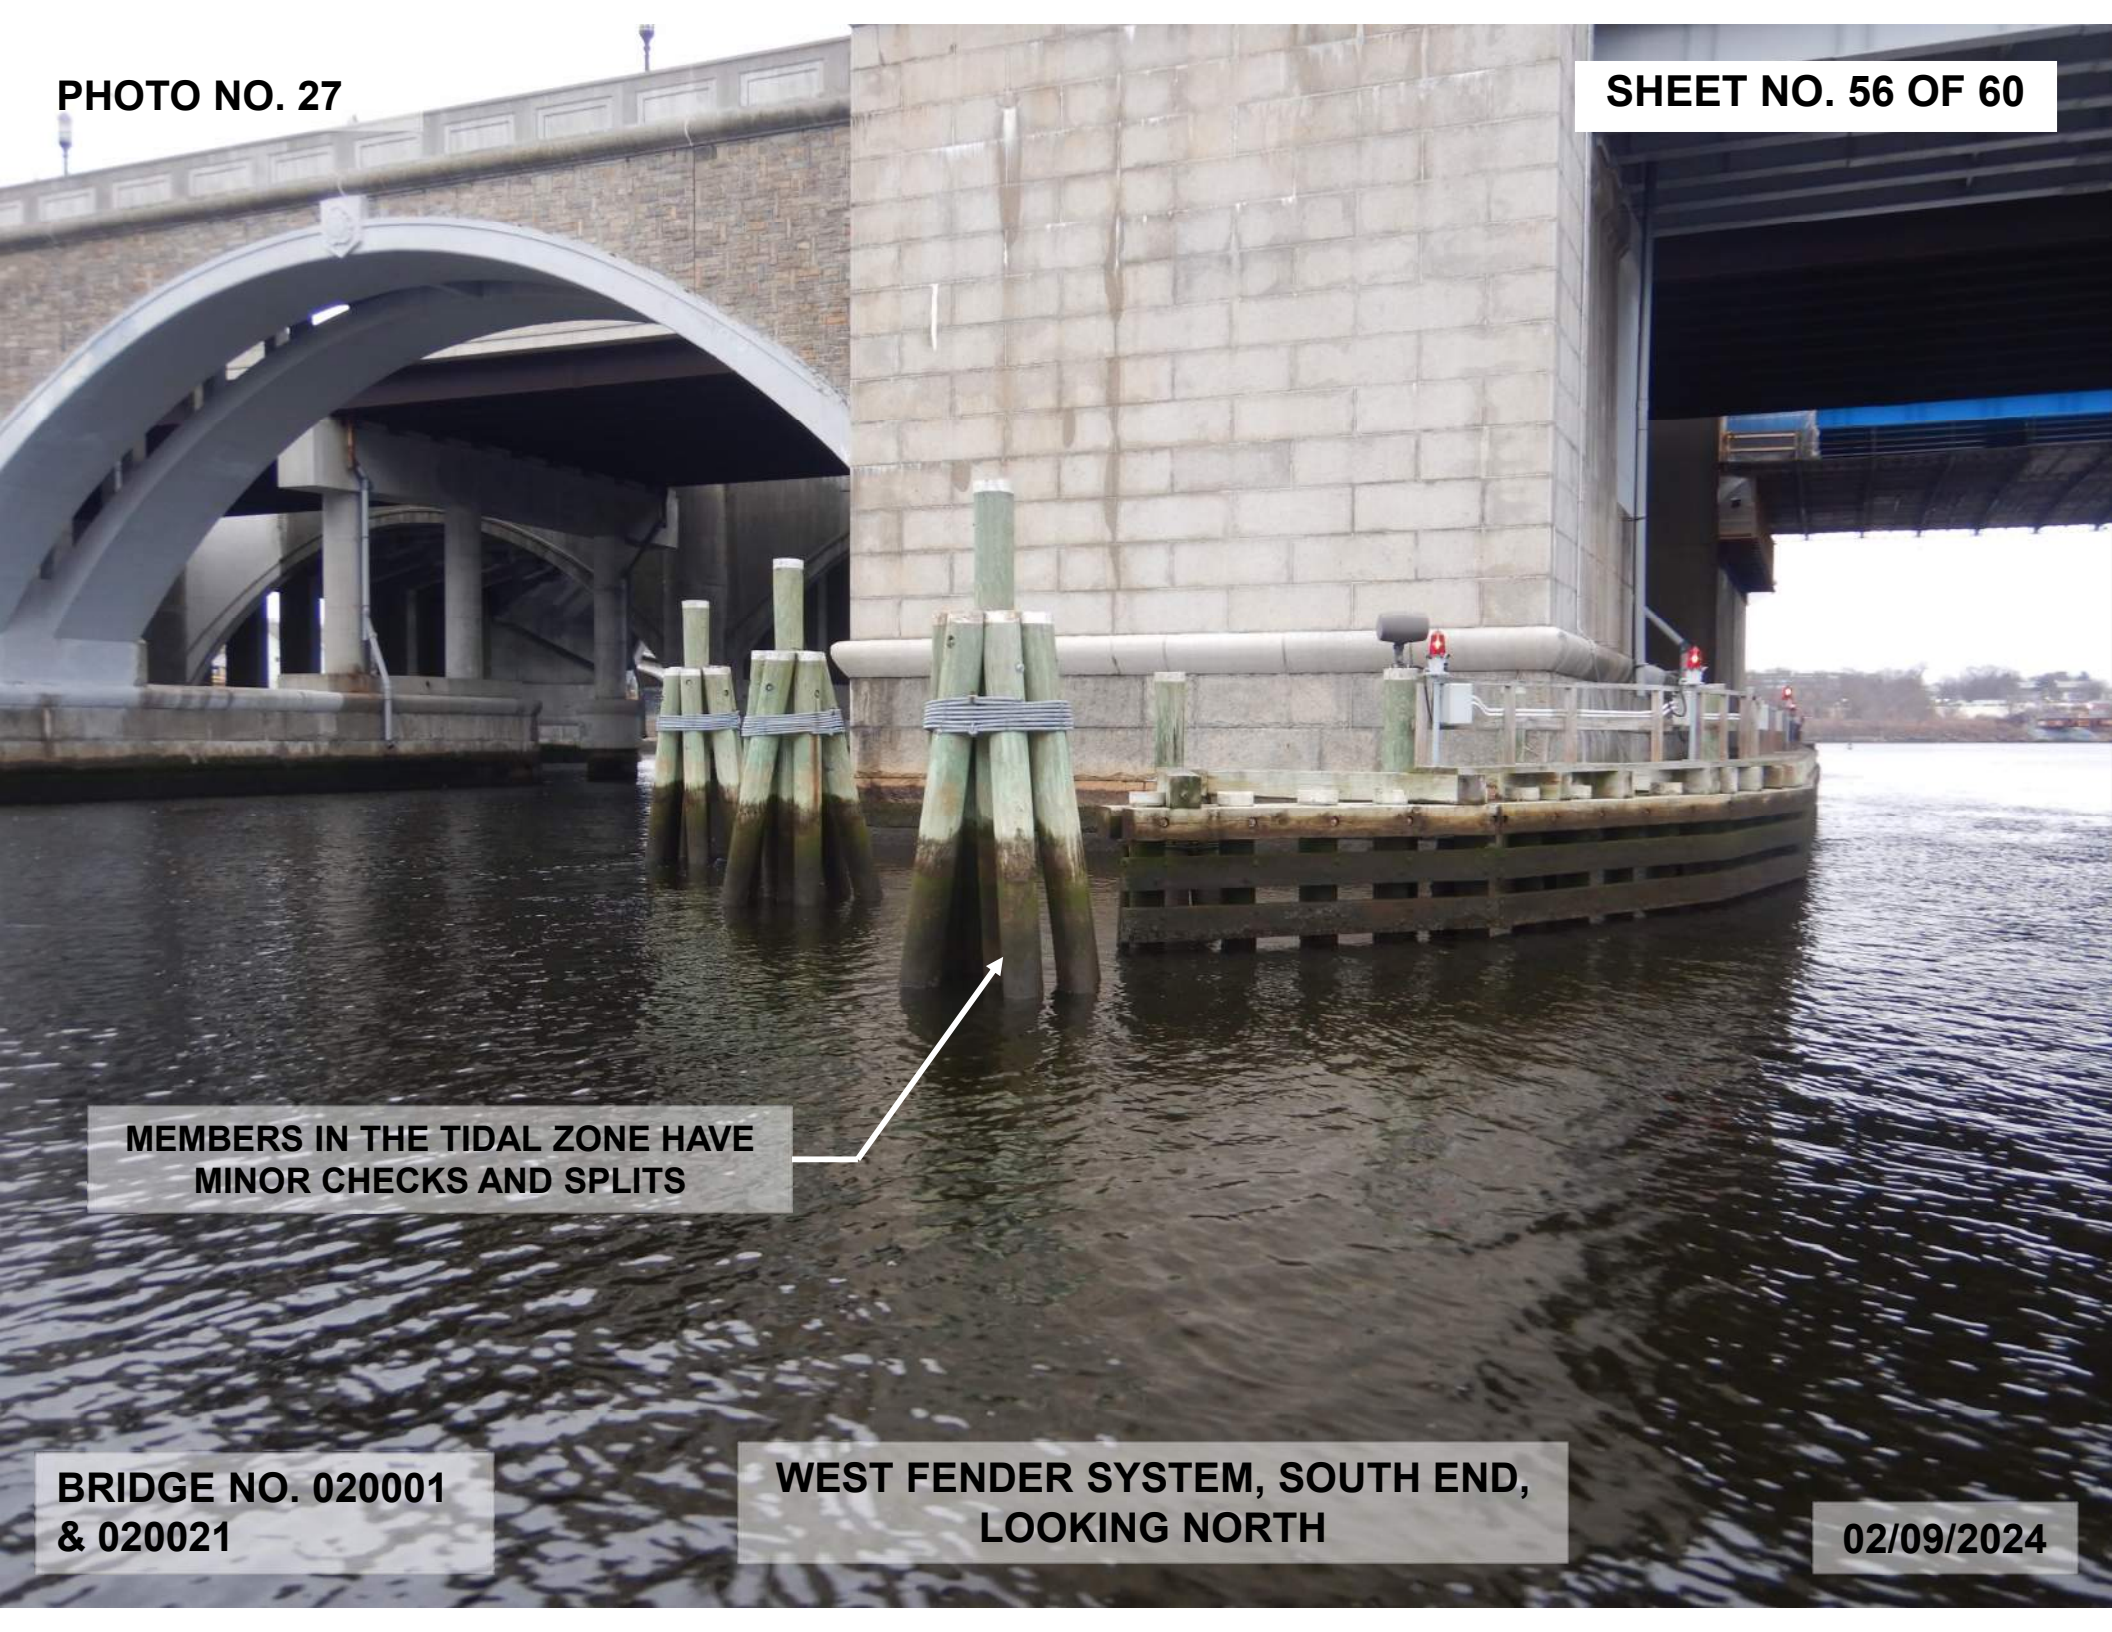
MEMBERS IN THE TIDAL ZONE HAVE  
MINOR CHECKS AND SPLITS

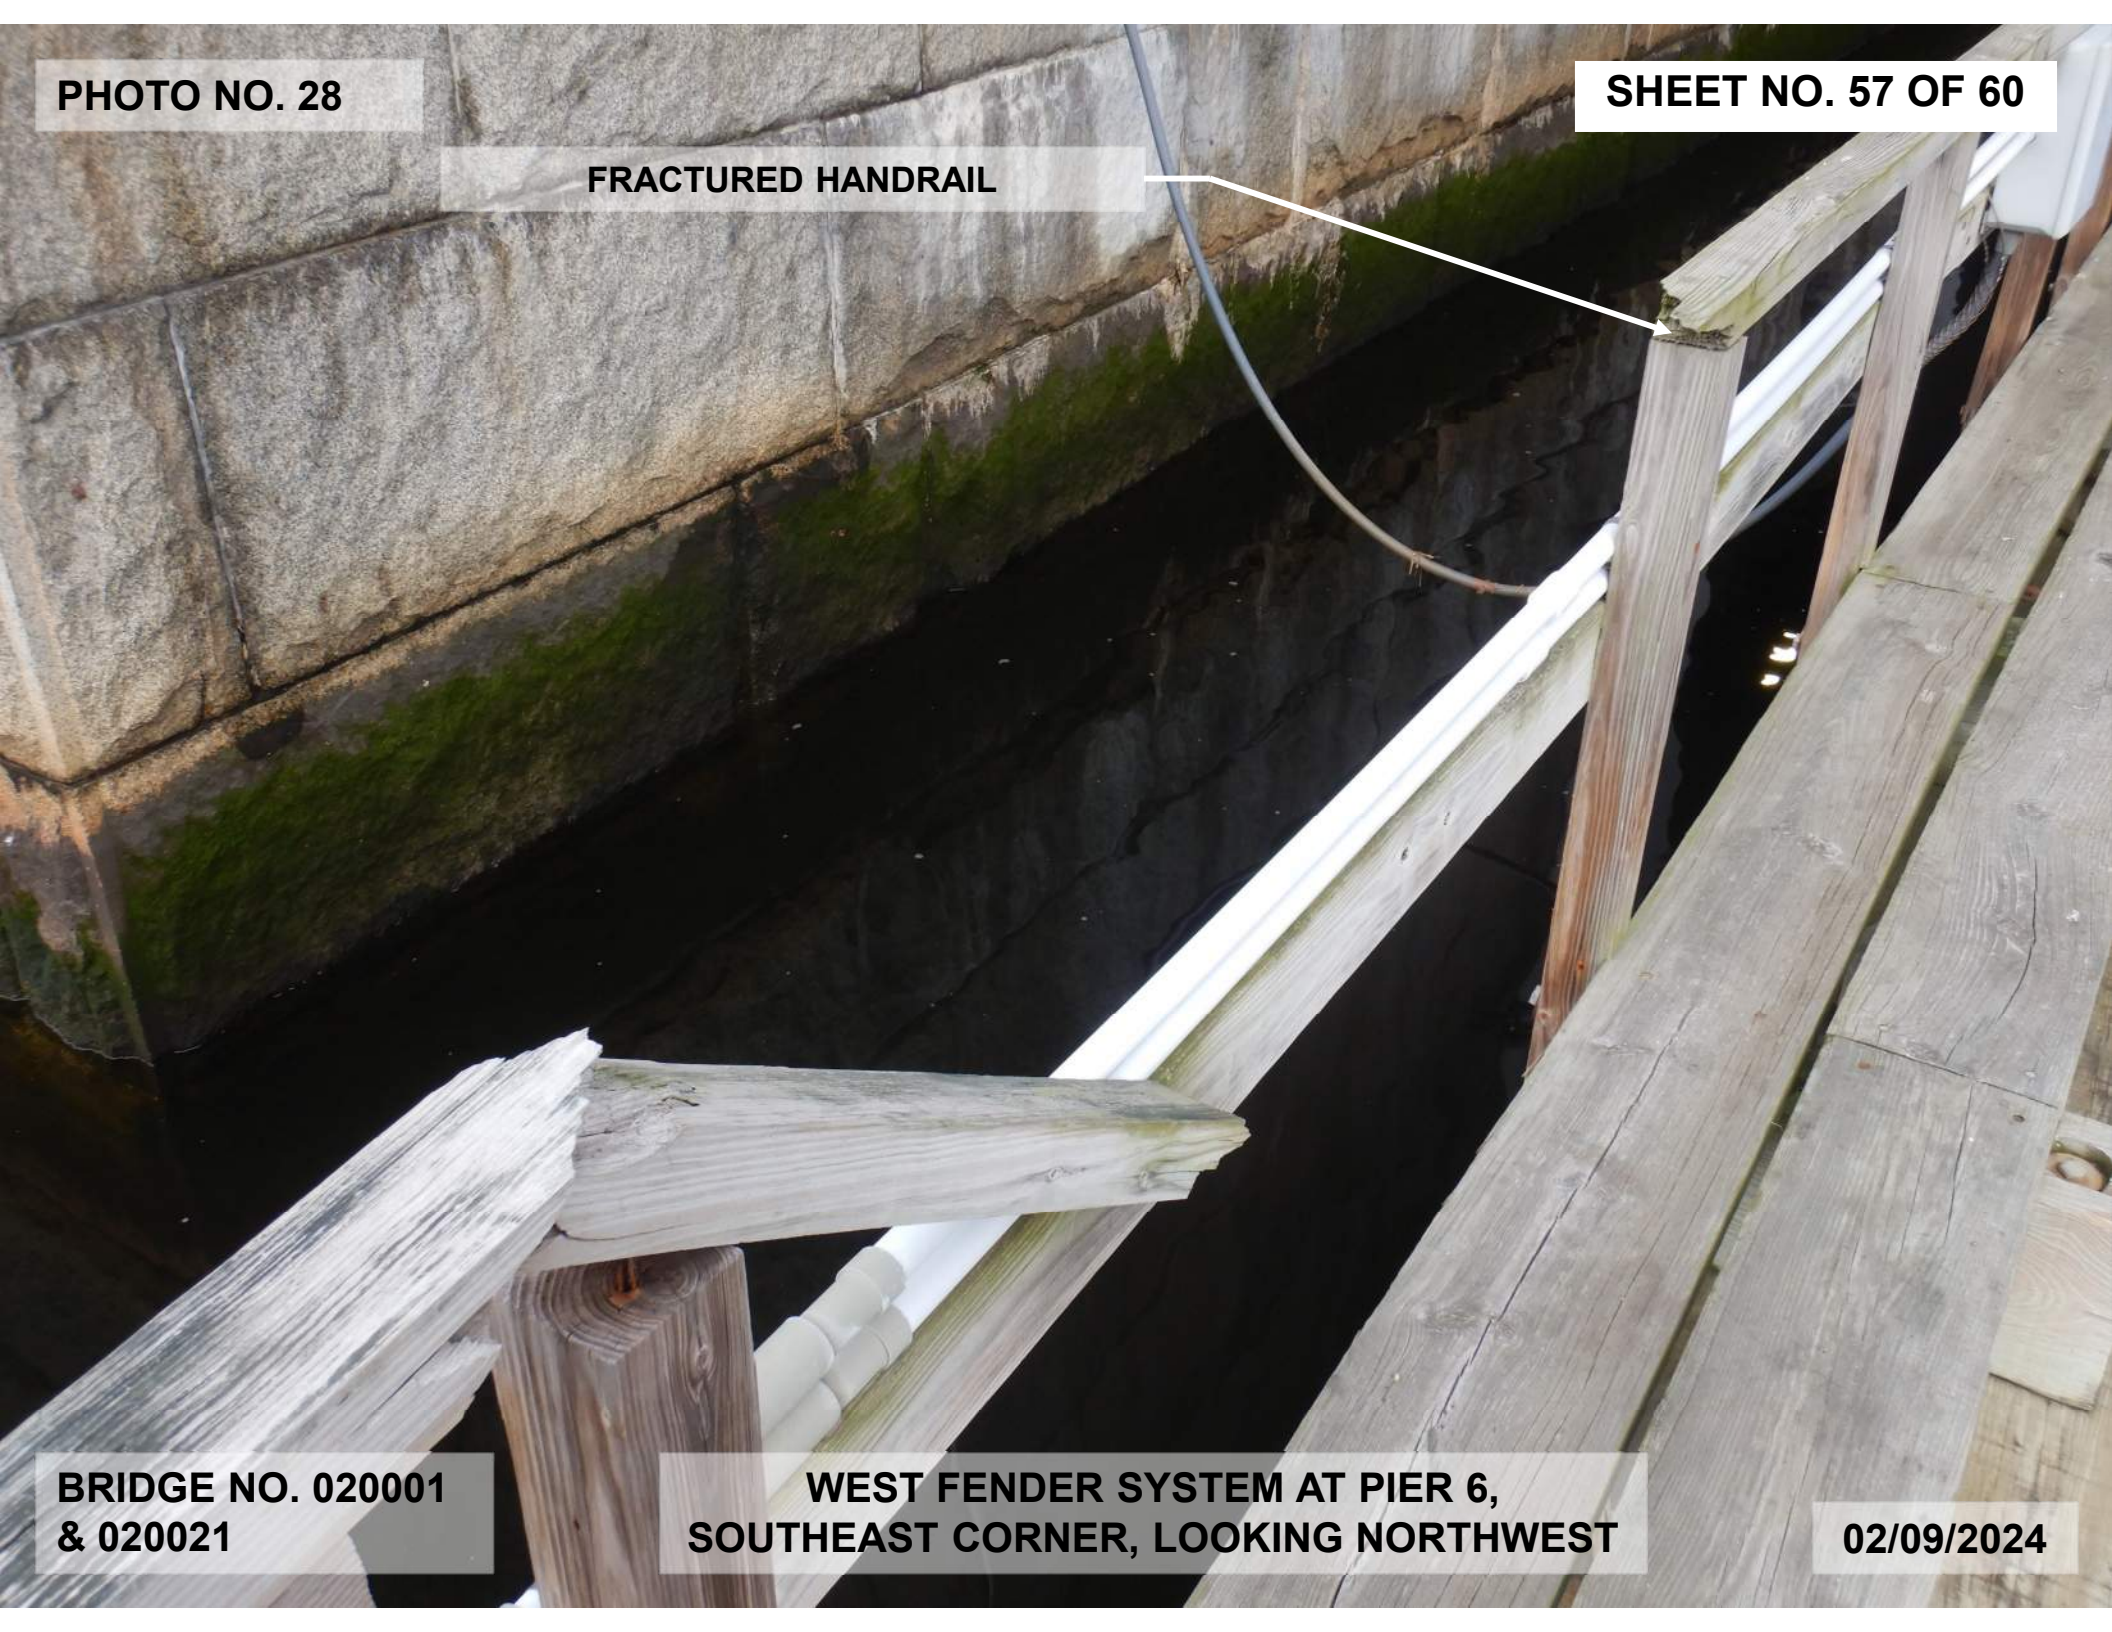
**WEST FENDER SYSTEM AT PIER 6,  
SOUTHEAST CORNER, LOOKING NORTHWEST**

**FRACTURED HANDRAIL**

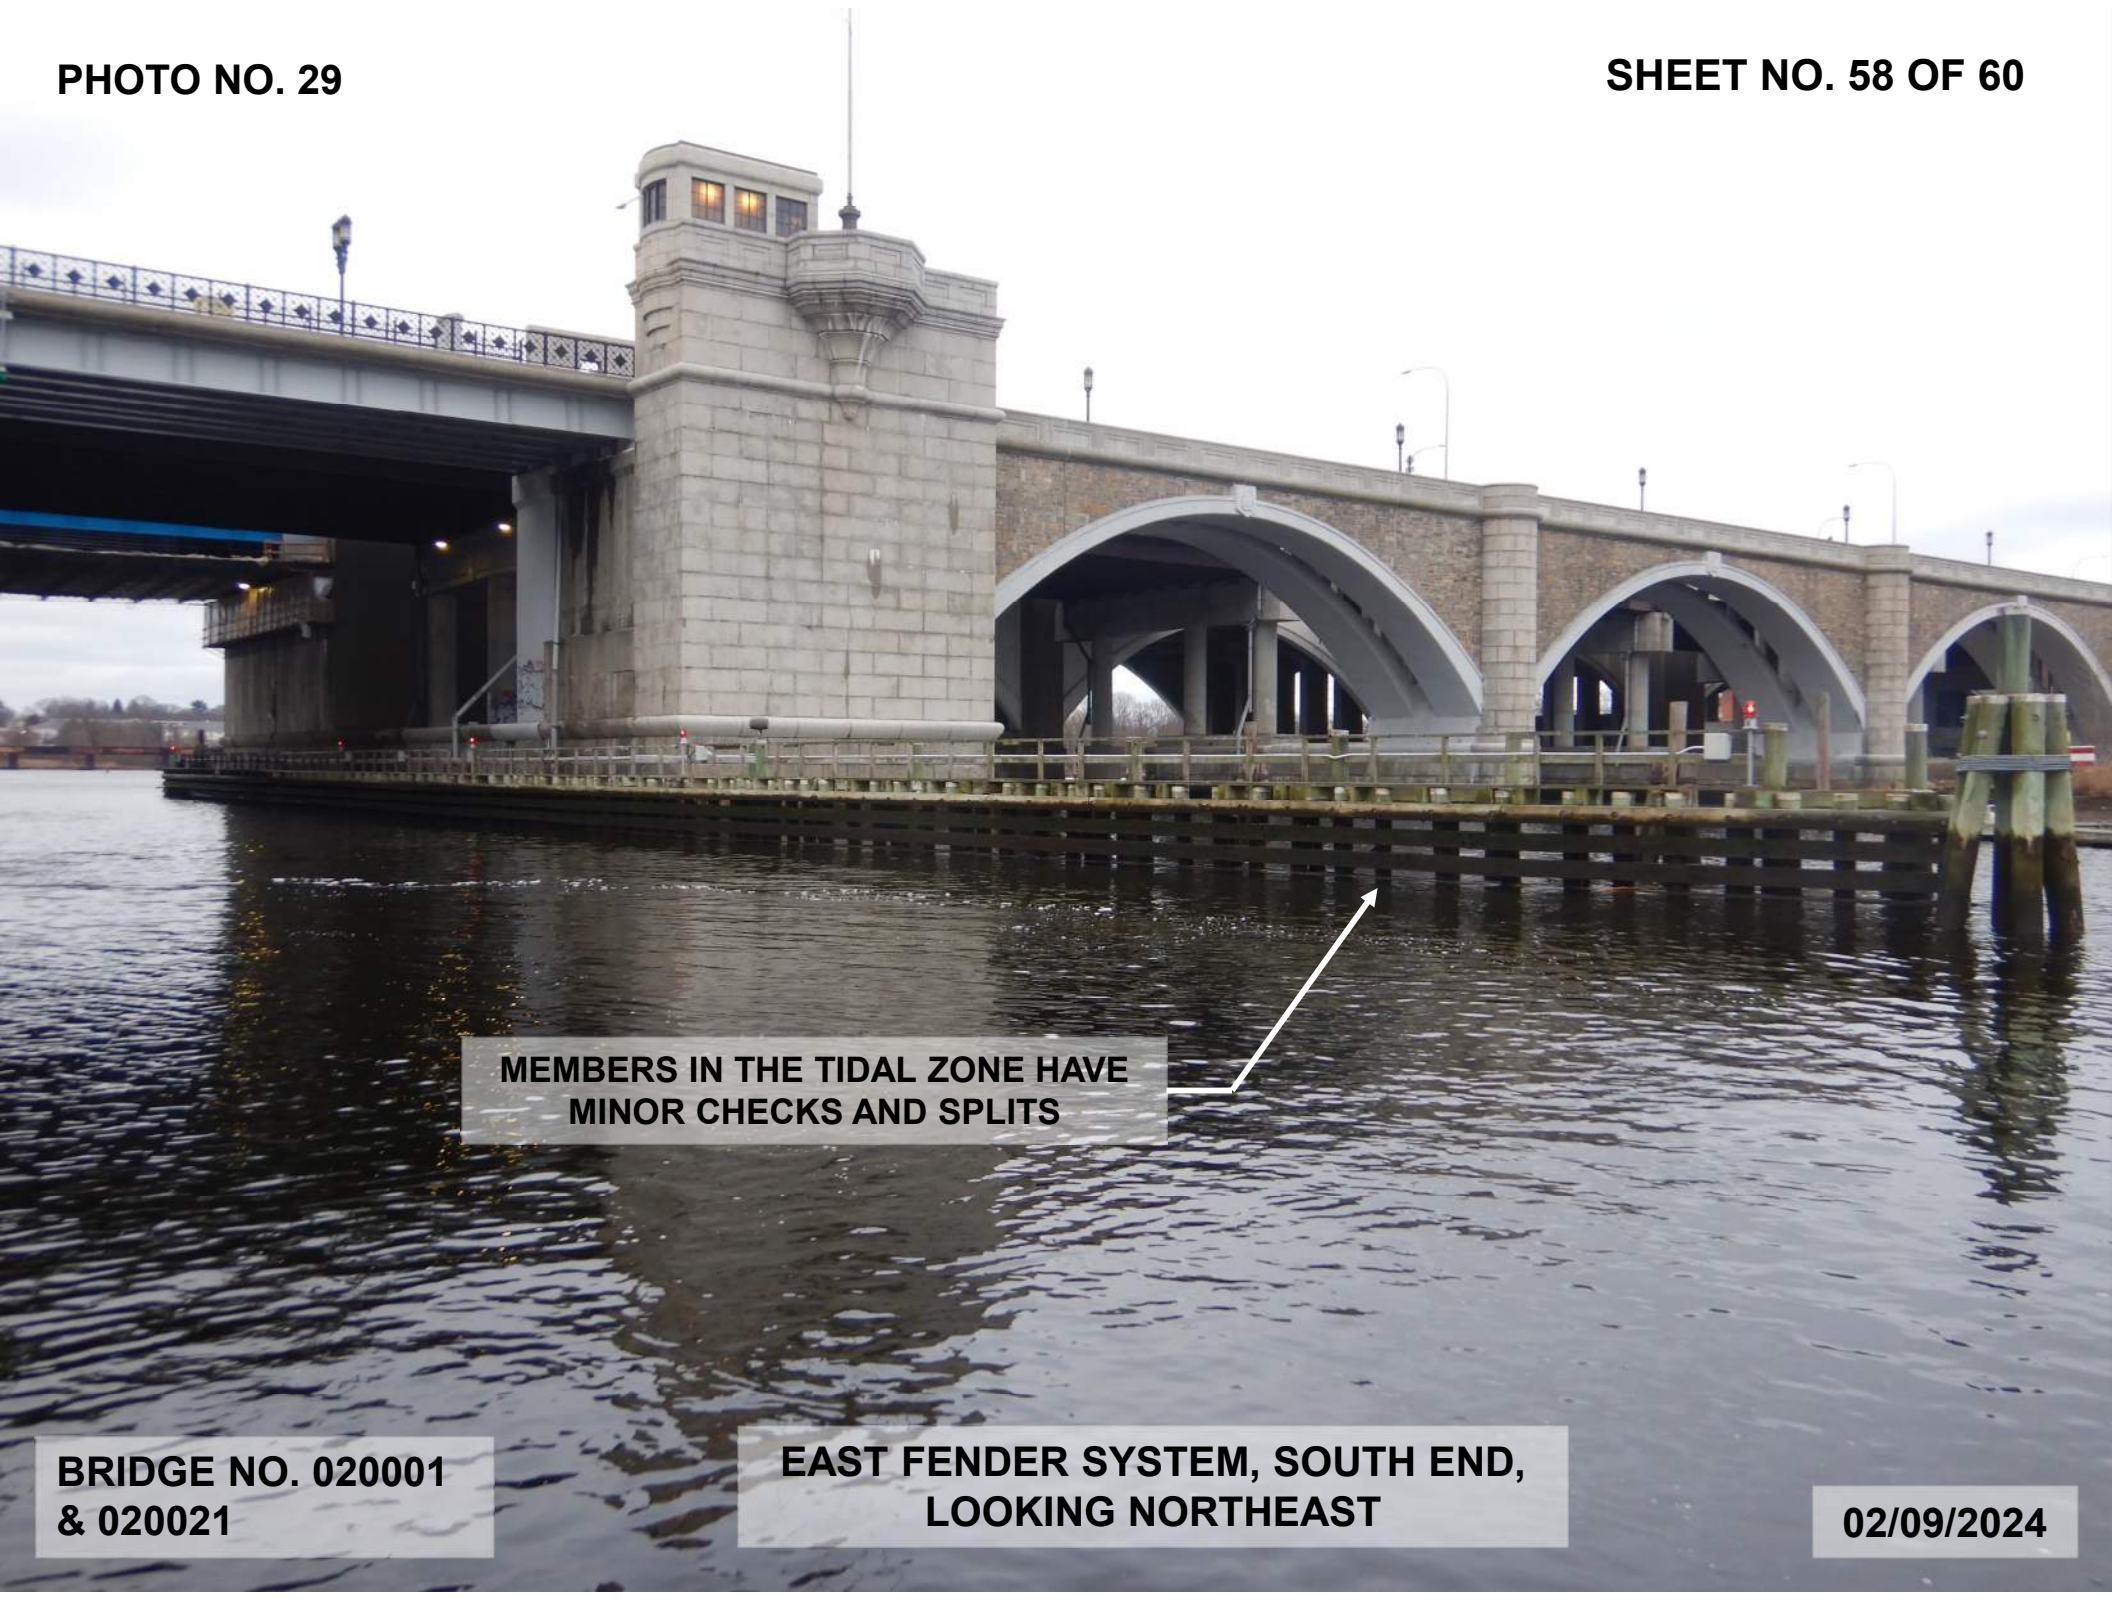
**EAST FENDER SYSTEM, SOUTH END,  
LOOKING NORTHEAST**

**MEMBERS IN THE TIDAL ZONE HAVE  
MINOR CHECKS AND SPLITS**

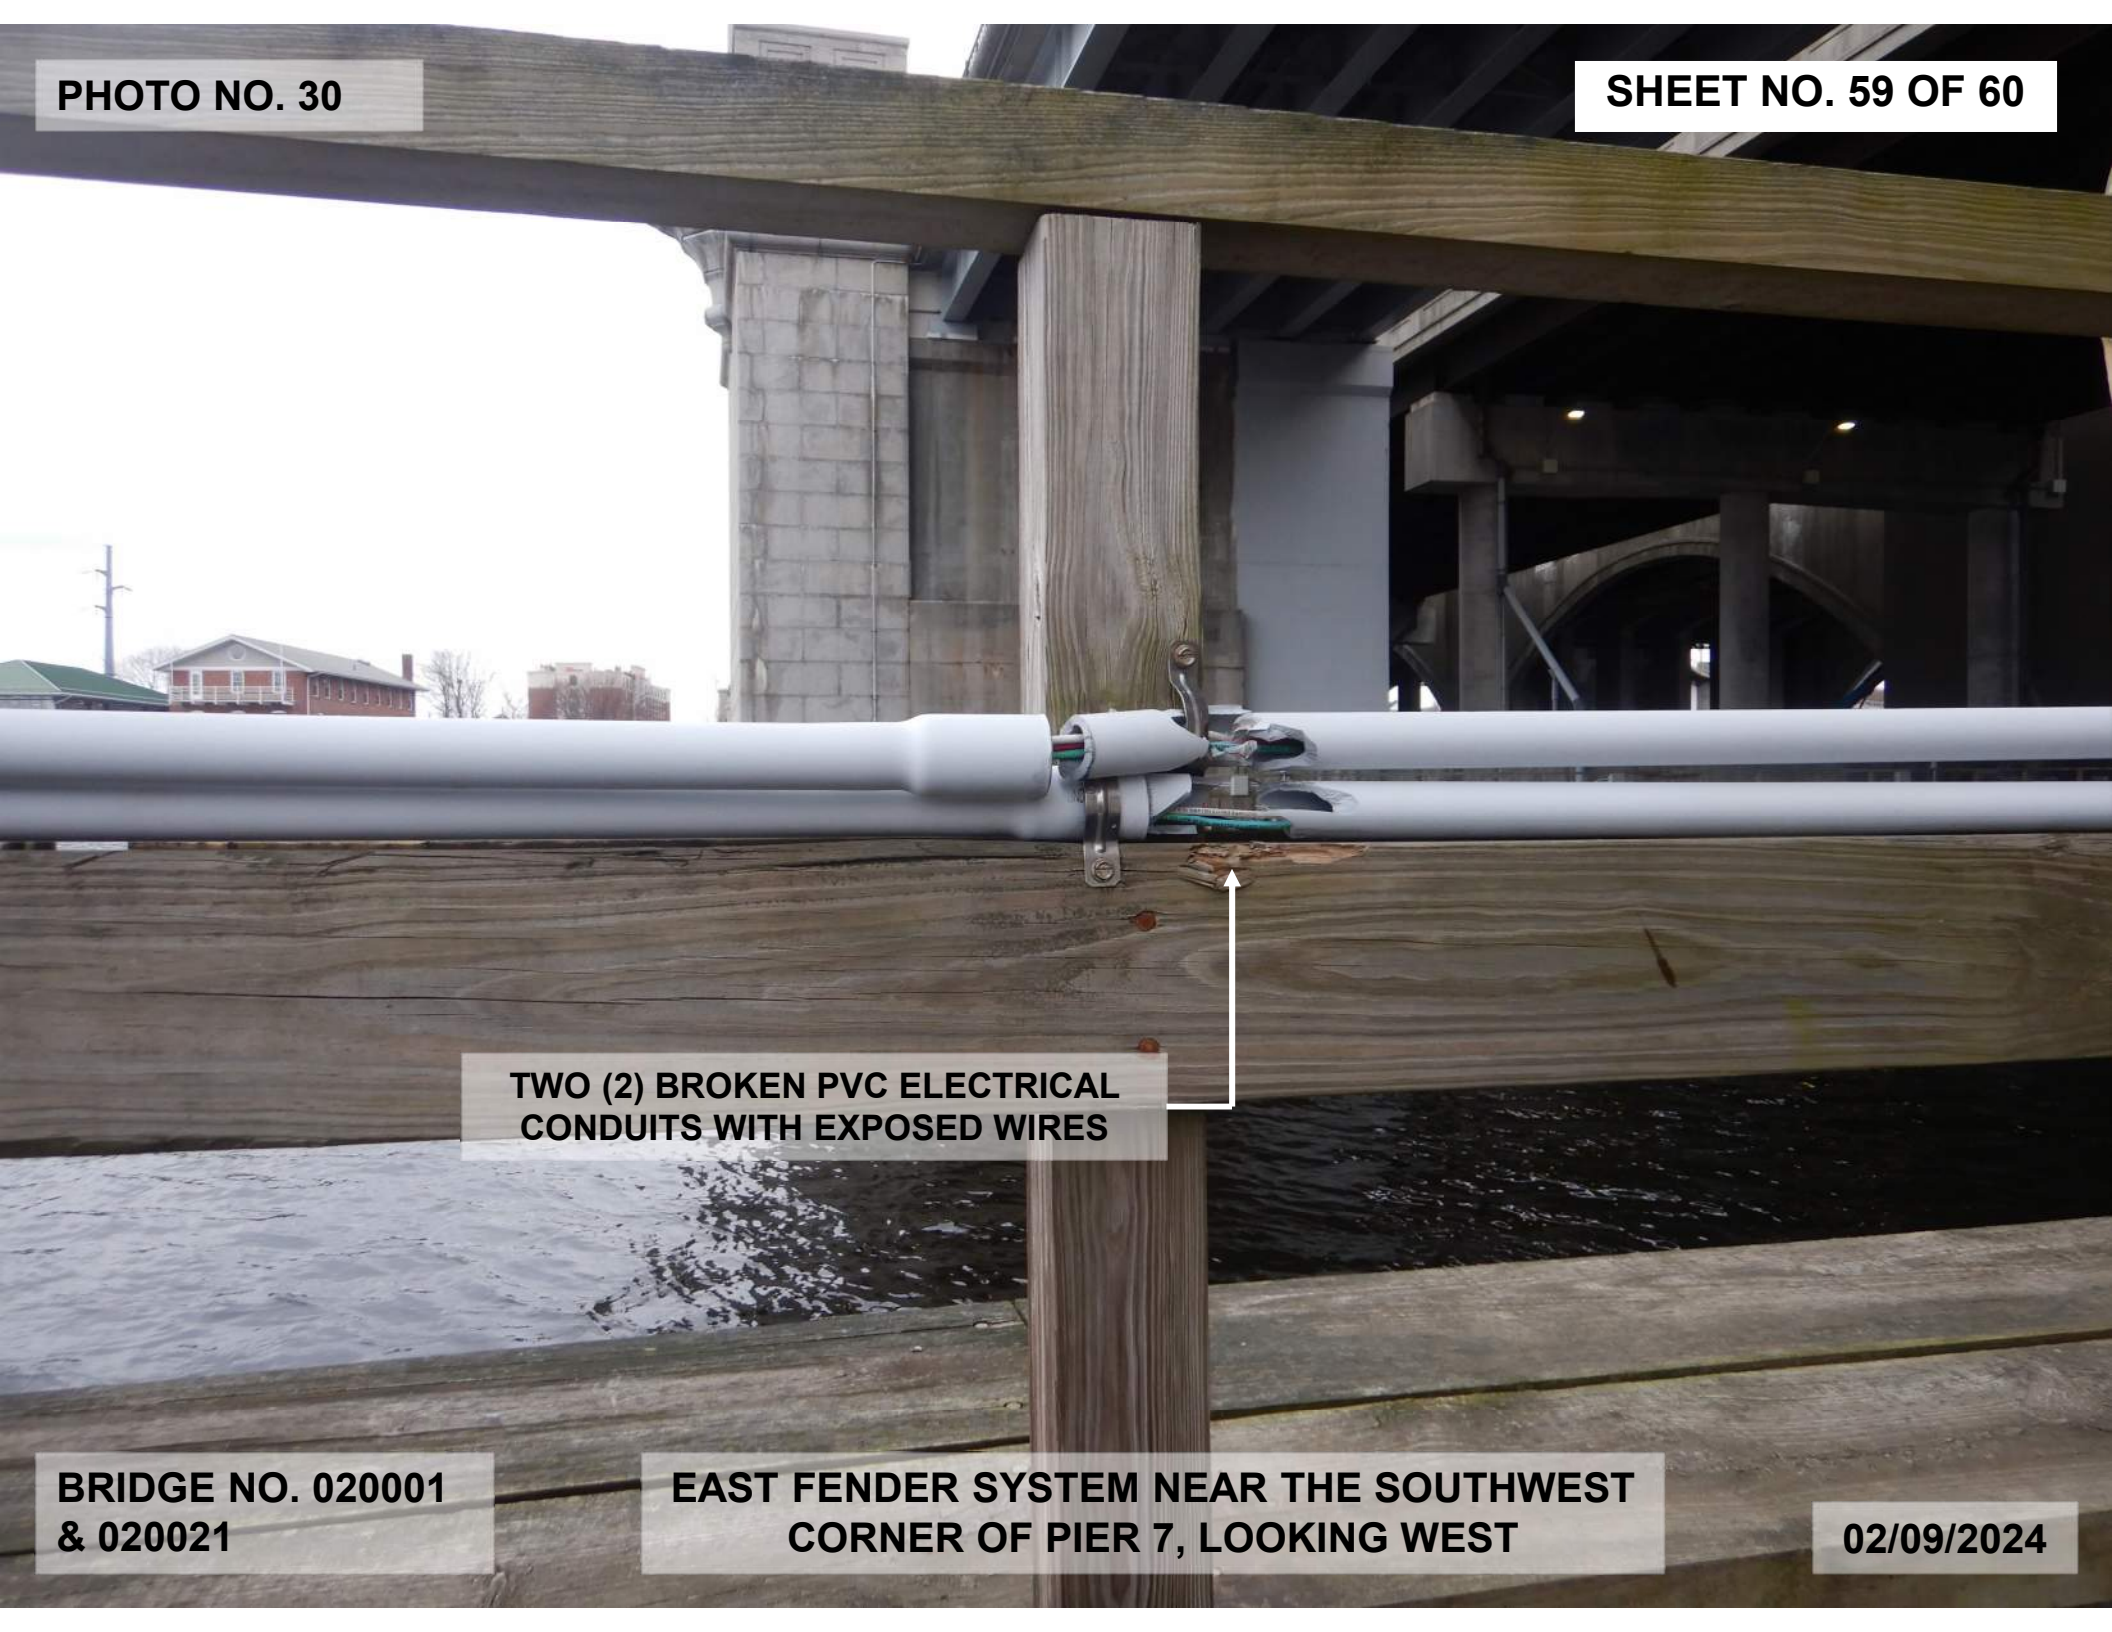
- ⑳ The Fender System at the Southwest Corner of Pier 7, has two (2) broken PVC electrical conduits with exposed wires.
- ㉑ South side of Pier 7, there are two older timber dolphins in poor condition with end rot up to 90% x 6' high.

**TWO (2) BROKEN PVC ELECTRICAL  
CONDUITS WITH EXPOSED WIRES**

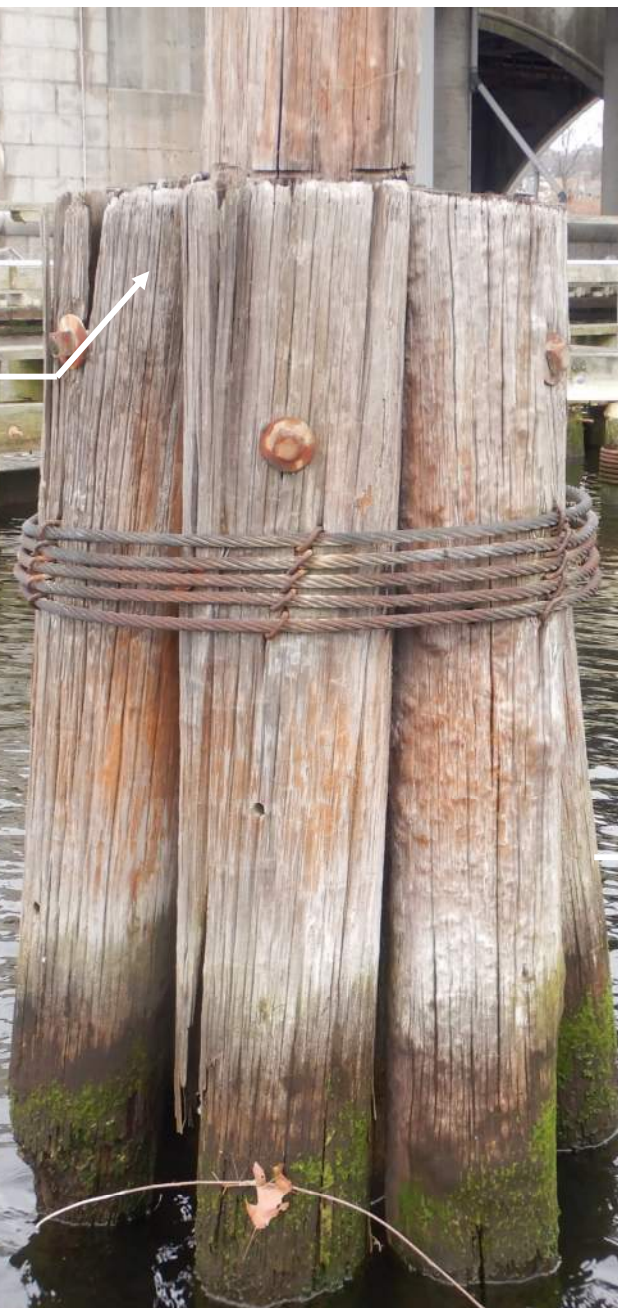
PILES ARE IN POOR CONDITION WITH  
END ROT UP TO 90% x 6' HIGH
