Bridge #020001 North Elevation, Looking South

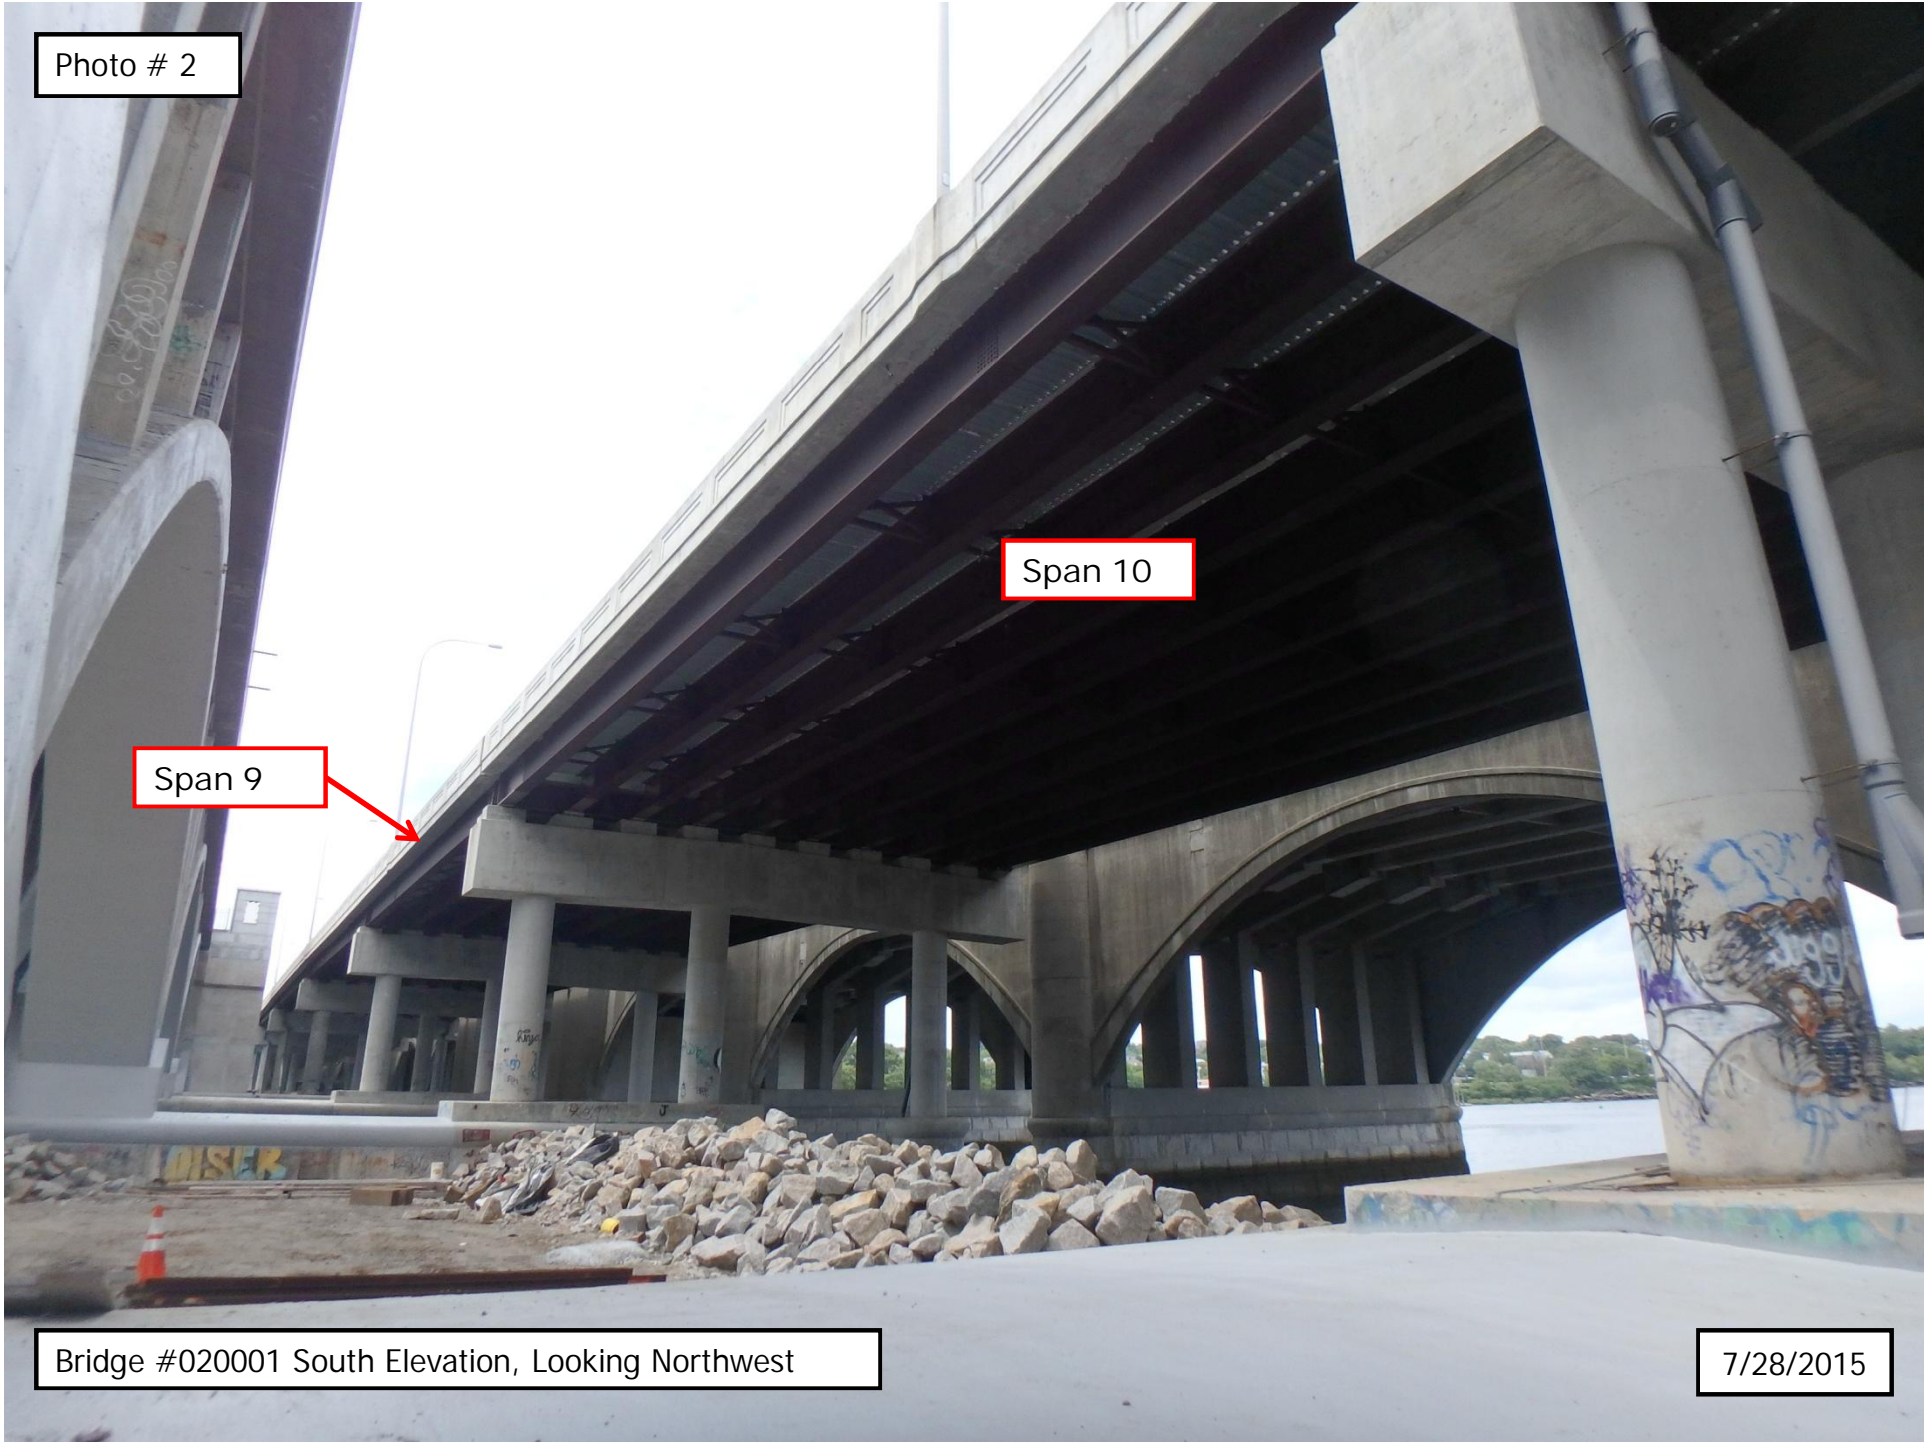
Photo # 2

Bridge #020001 South Elevation, Looking Northwest

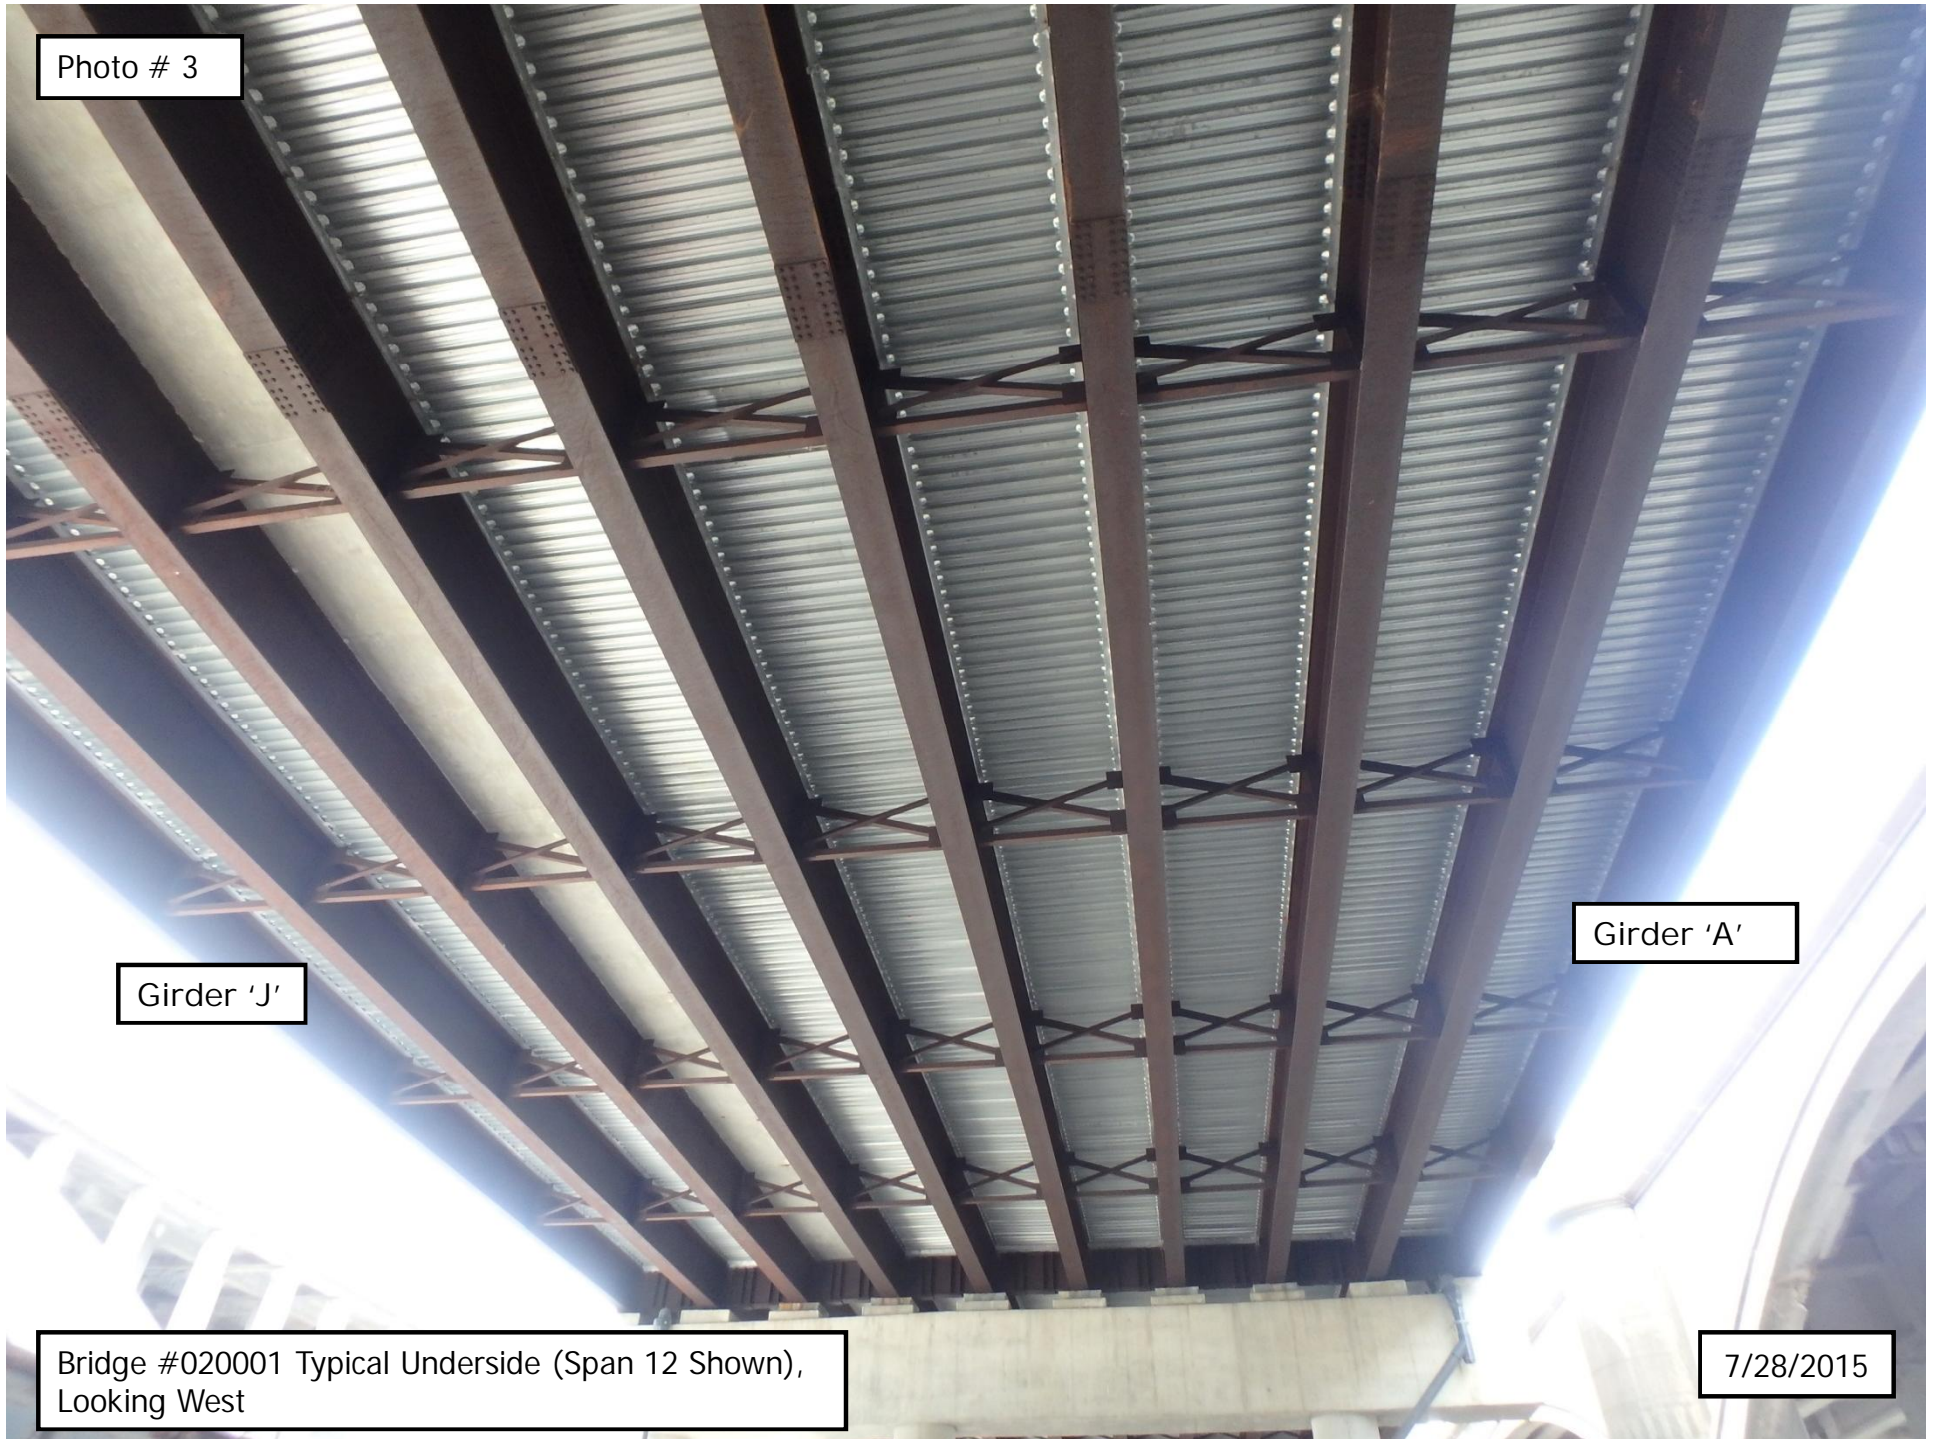
Photo # 3

Bridge #020001 Typical Underside (Span 12 Shown),
Looking West

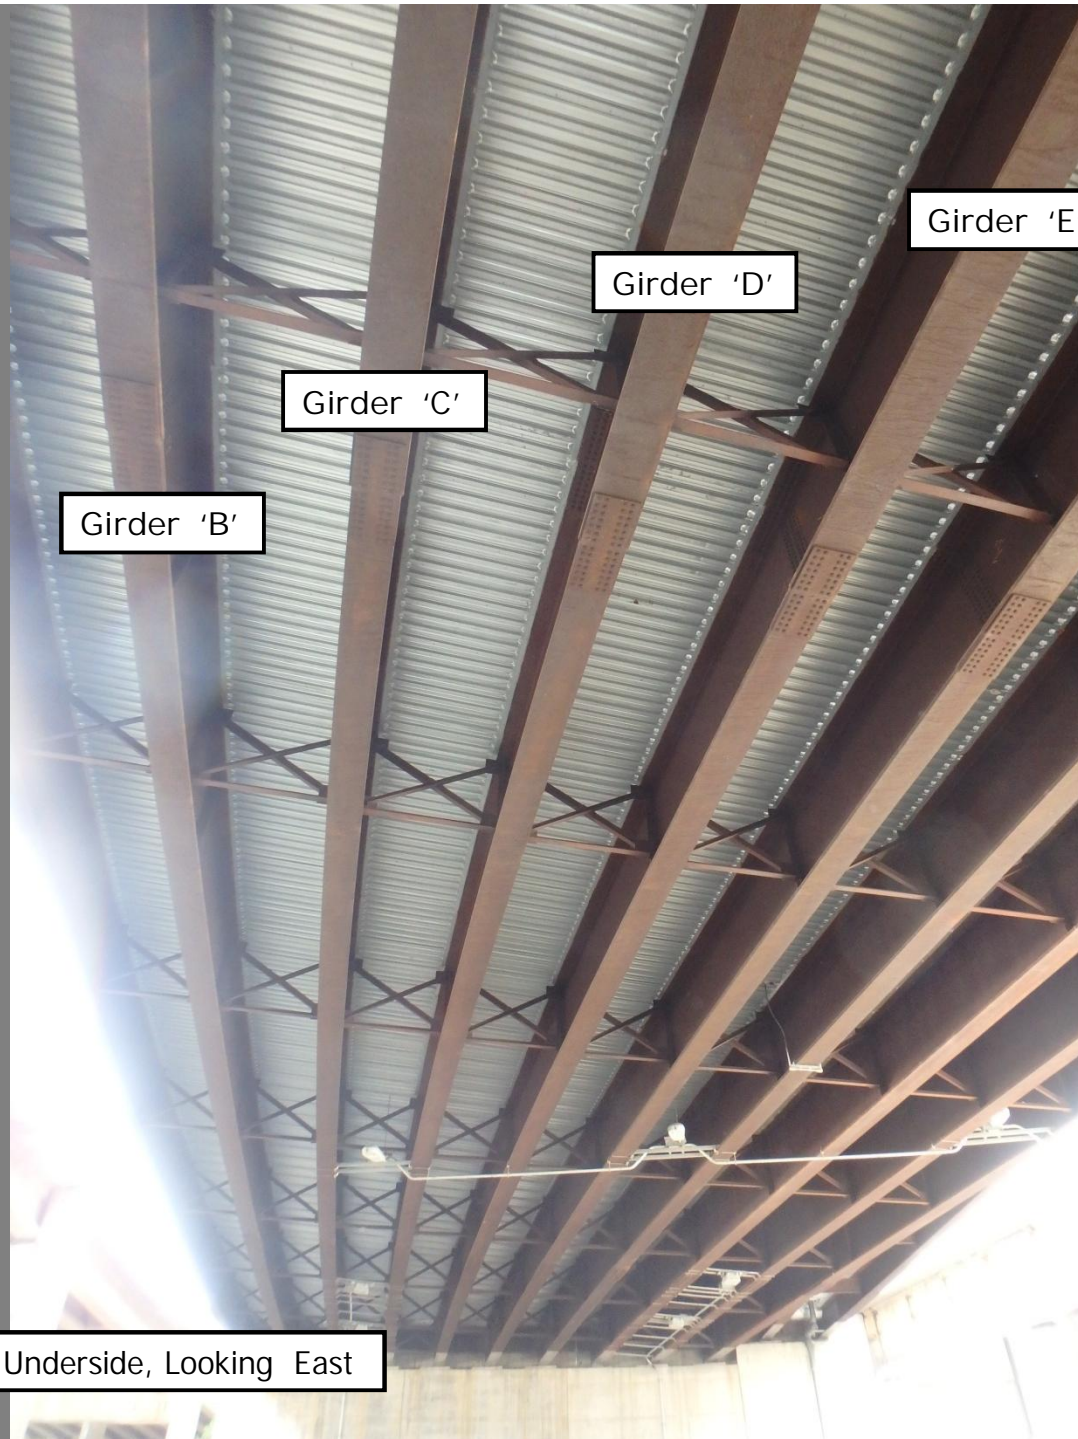
Photo # 4

Bridge #020001 Span 14 Underside, Looking East

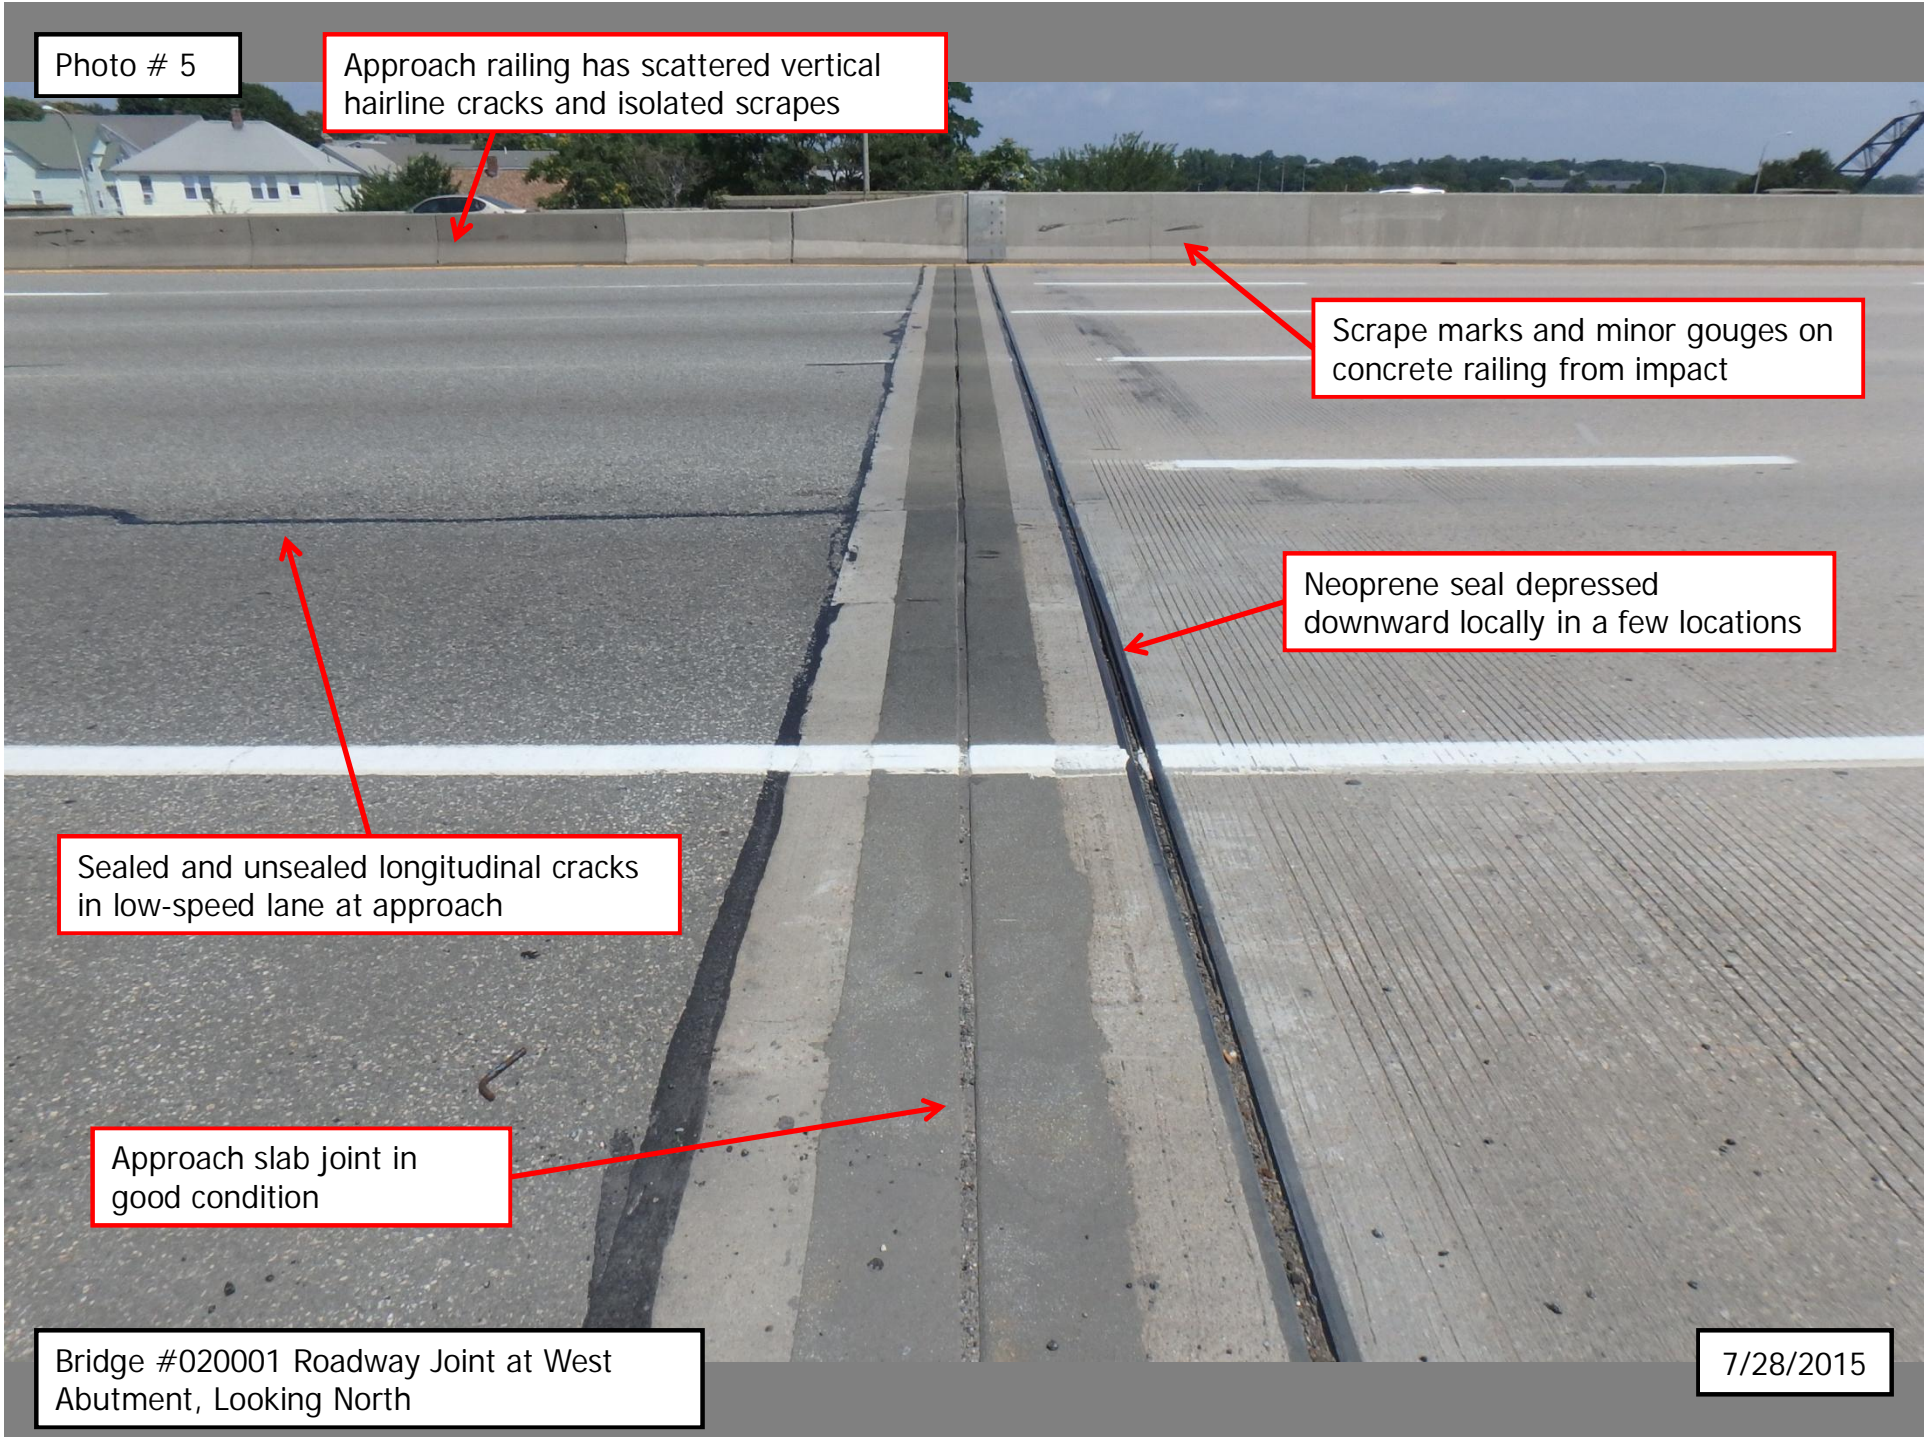
Photo # 5

Approach railing has scattered vertical hairline cracks and isolated scrapes

Scrape marks and minor gouges on concrete railing from impact

Neoprene seal depressed downward locally in a few locations

Sealed and unsealed longitudinal cracks in low-speed lane at approach

Approach slab joint in good condition

Bridge #020001 Roadway Joint at West Abutment, Looking North

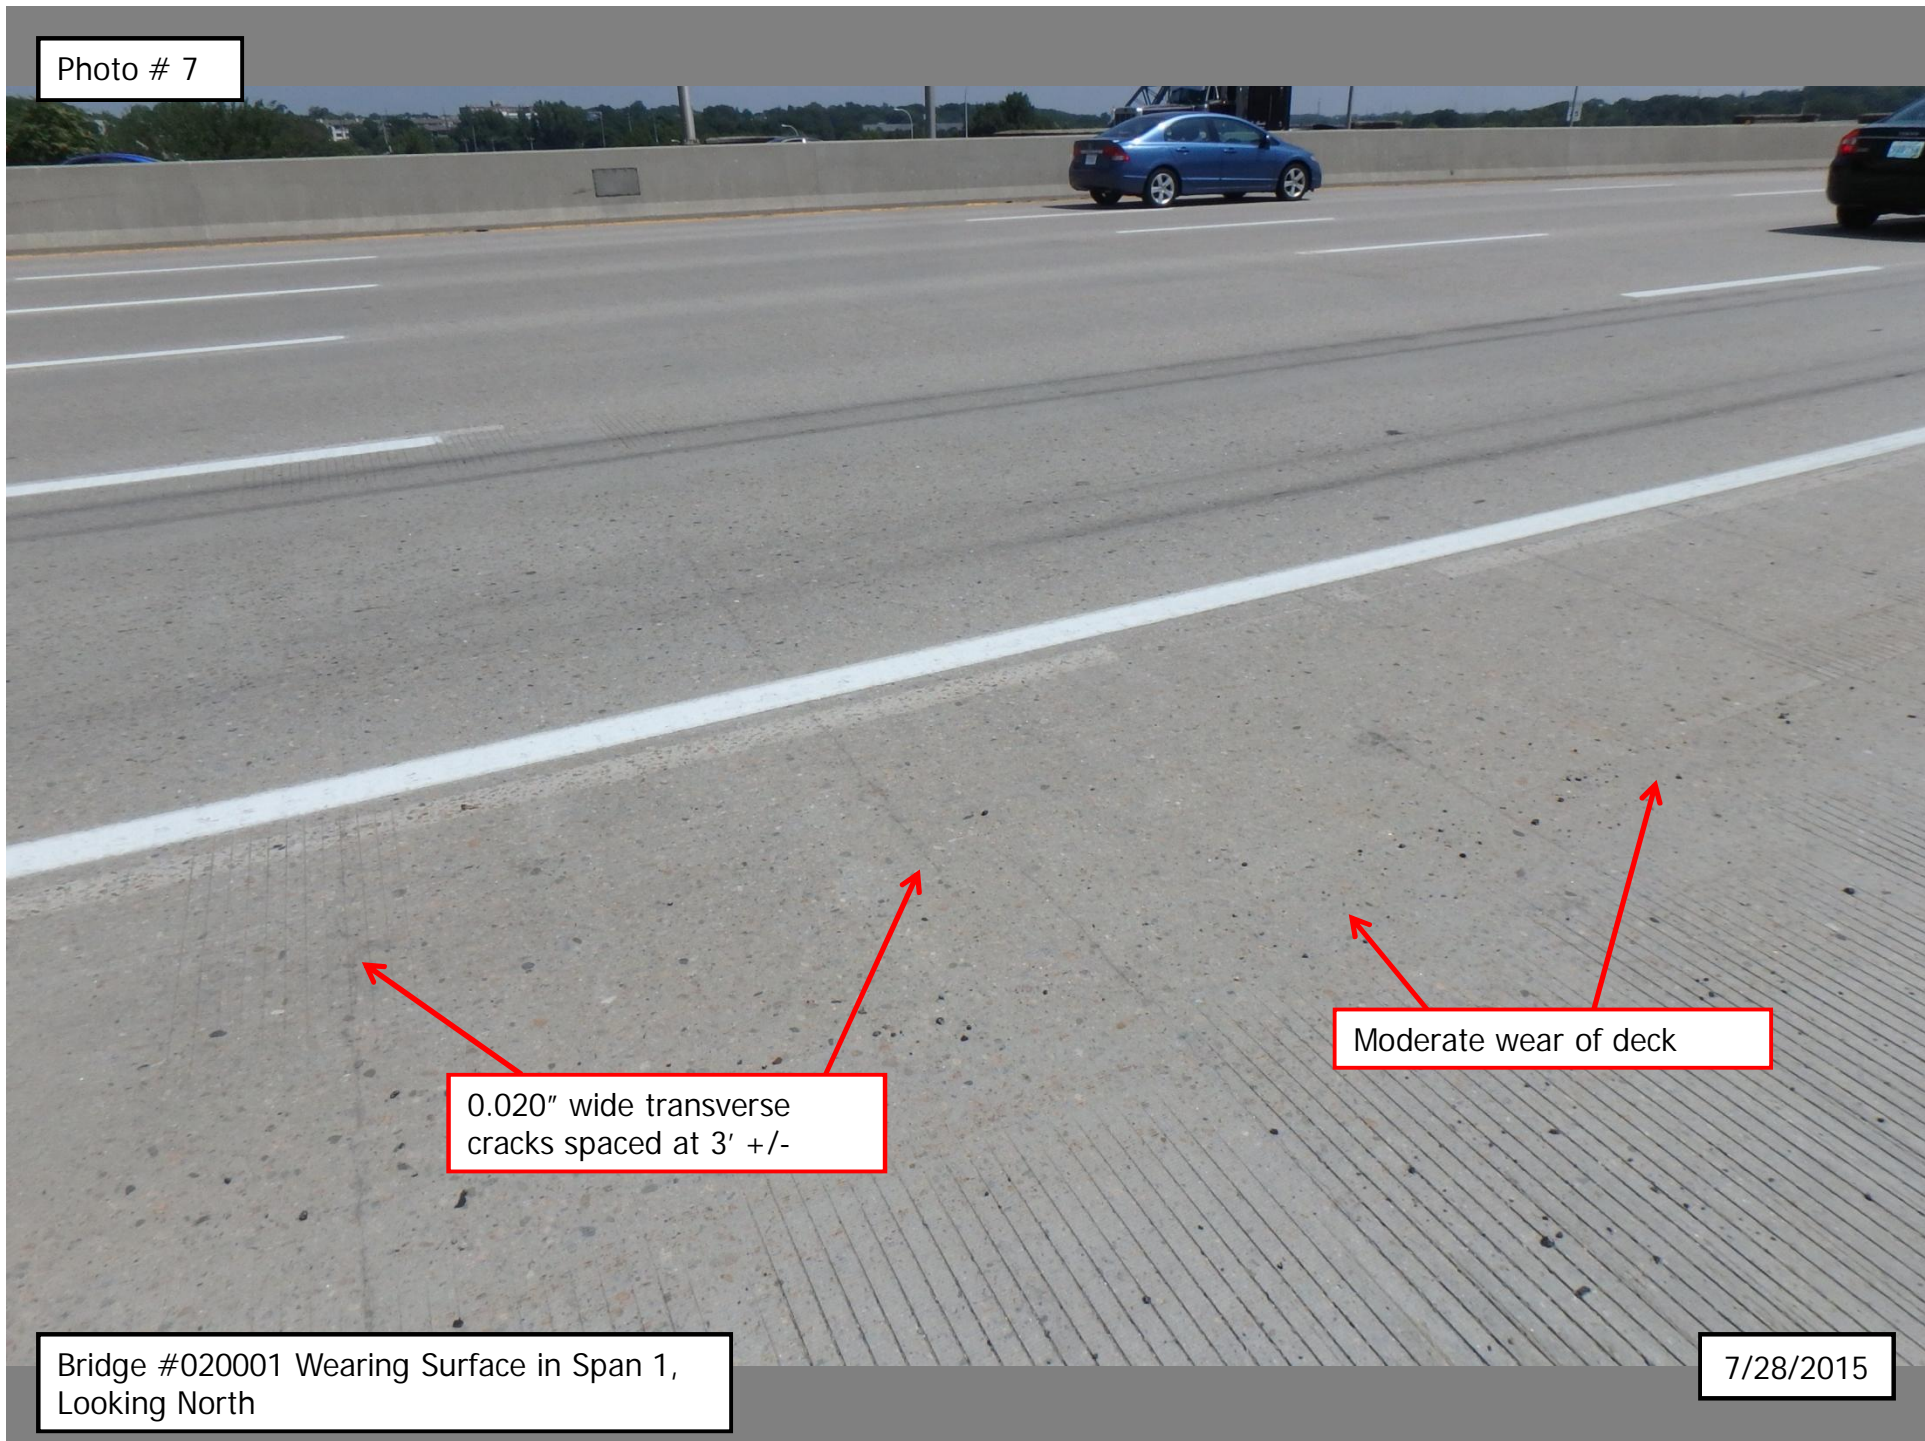
Photo # 7

0.020" wide transverse cracks spaced at 3' +/-

Moderate wear of deck

Bridge #020001 Wearing Surface in Span 1, Looking North

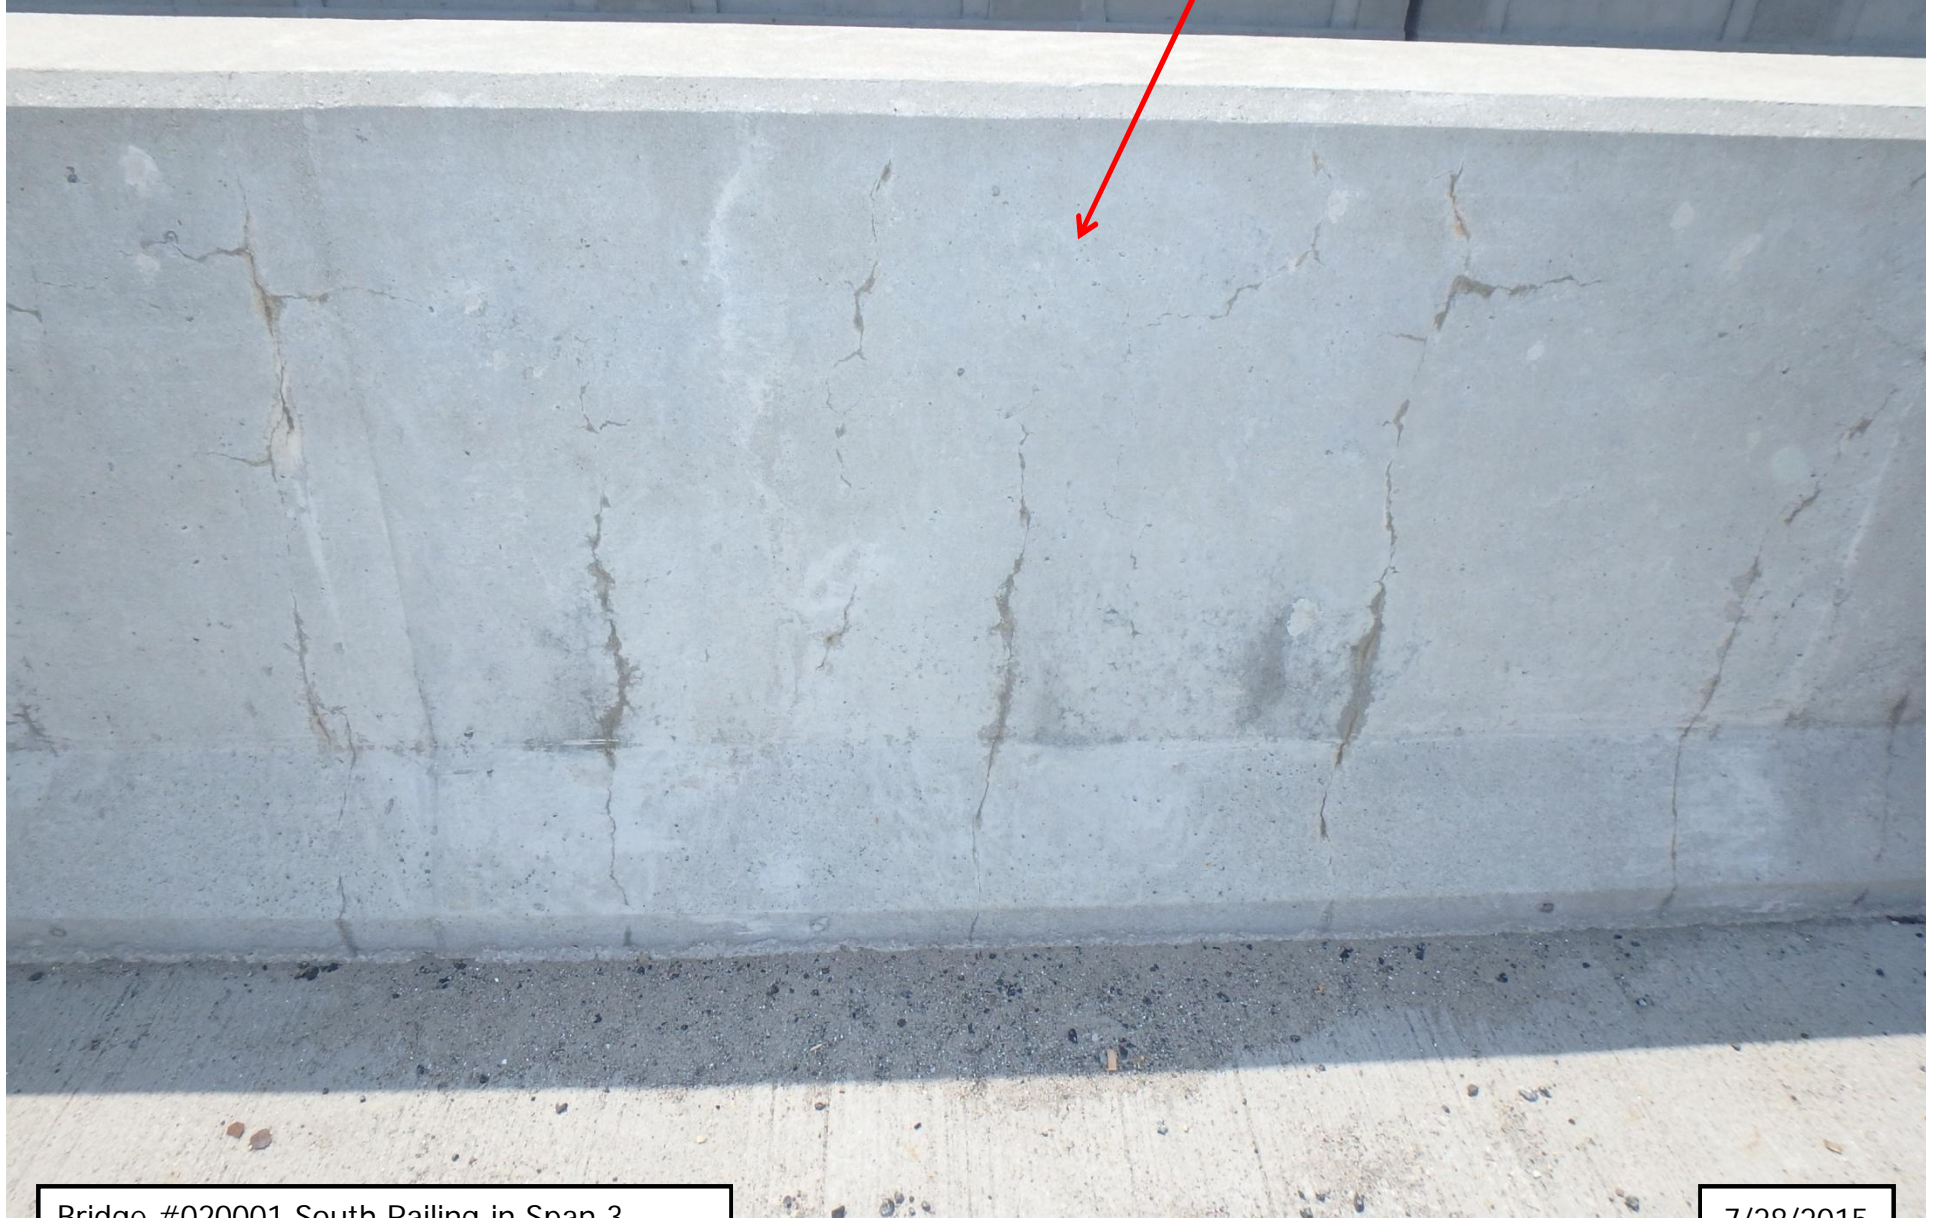
Photo # 8

Vertical cracks, from
hairline up to 0.030" wide

Bridge #020001 South Railing in Span 3,
Looking South

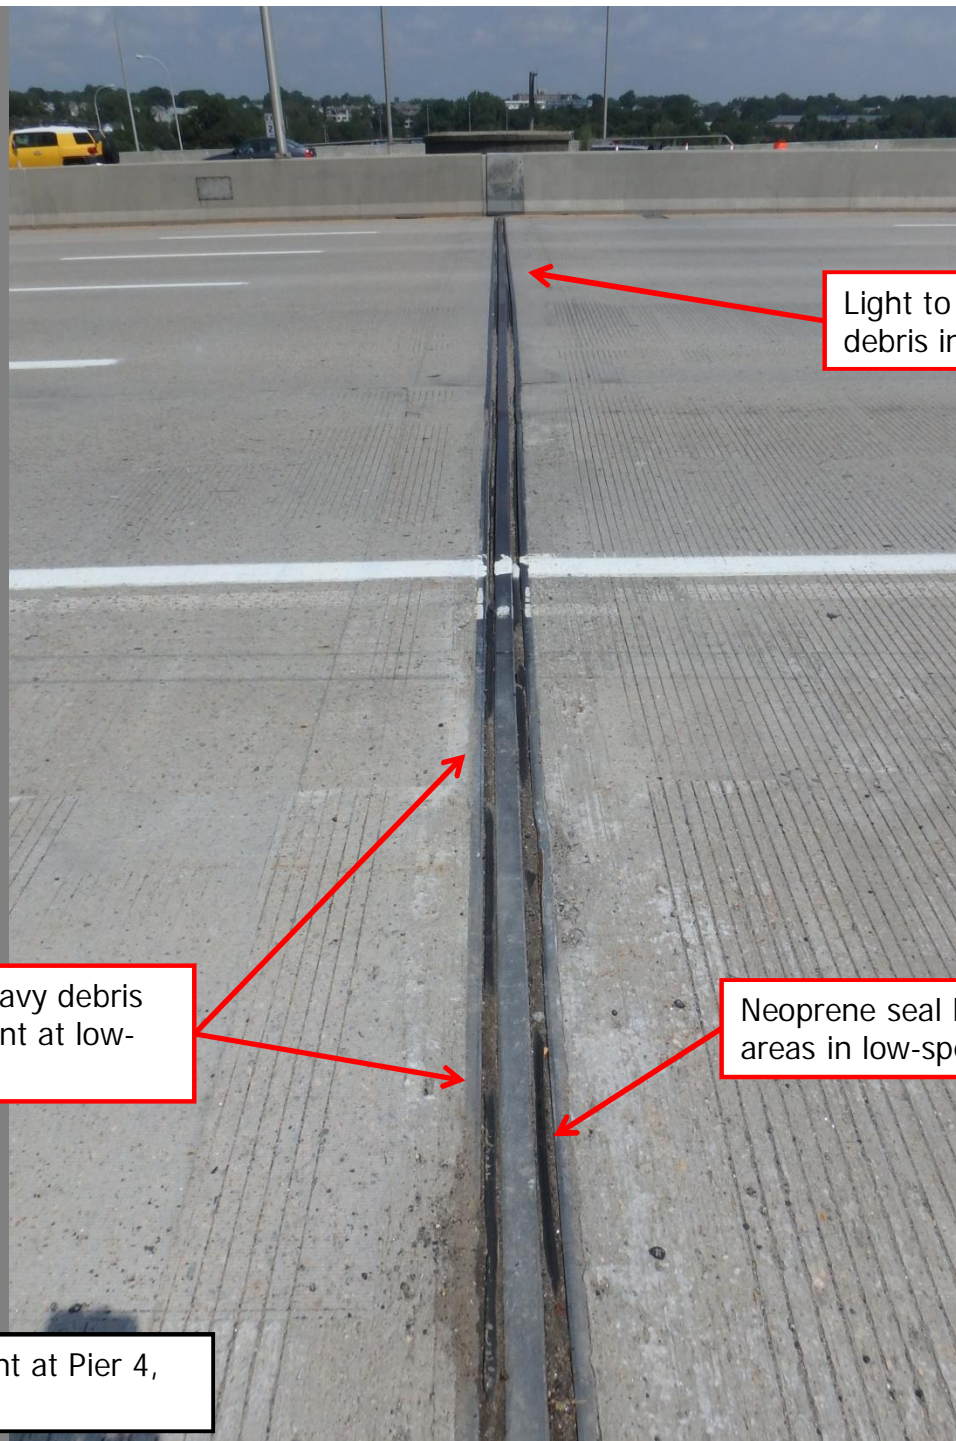
Photo # 9

Light to moderate dirt and debris in joint along travel lanes

Moderate to heavy debris impactation in joint at low-speed shoulder

Neoprene seal bulging in a few areas in low-speed lane

Bridge #020001 Roadway Joint at Pier 4, Looking North

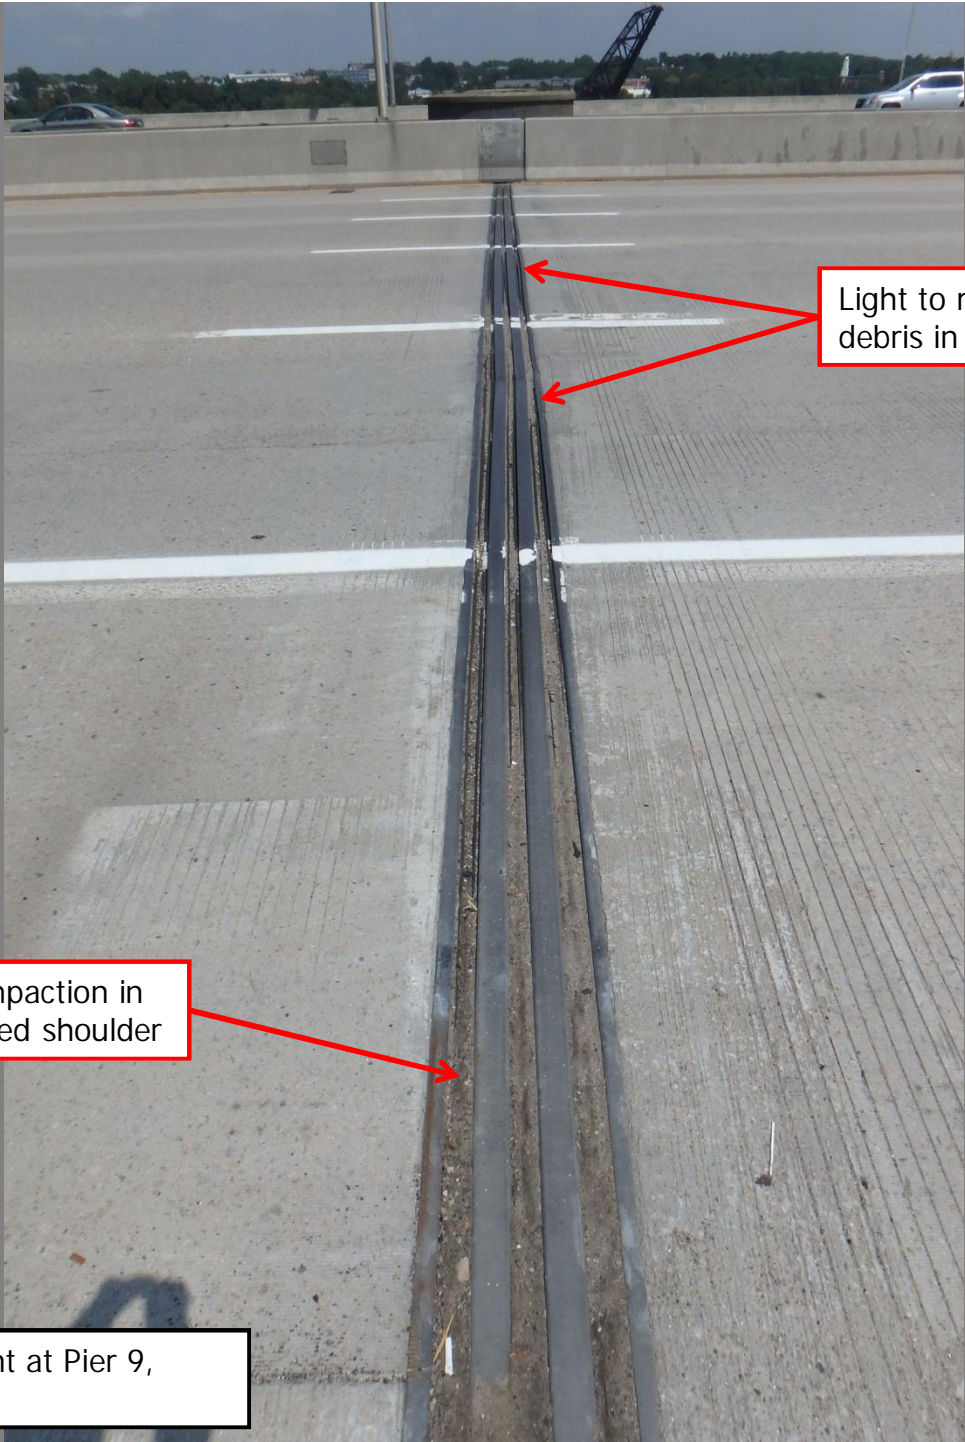
Photo # 10

Light to moderate dirt and debris in joint along travel lanes

Heavy debris impaction in joint at low-speed shoulder

Bridge #020001 Roadway Joint at Pier 9, Looking North

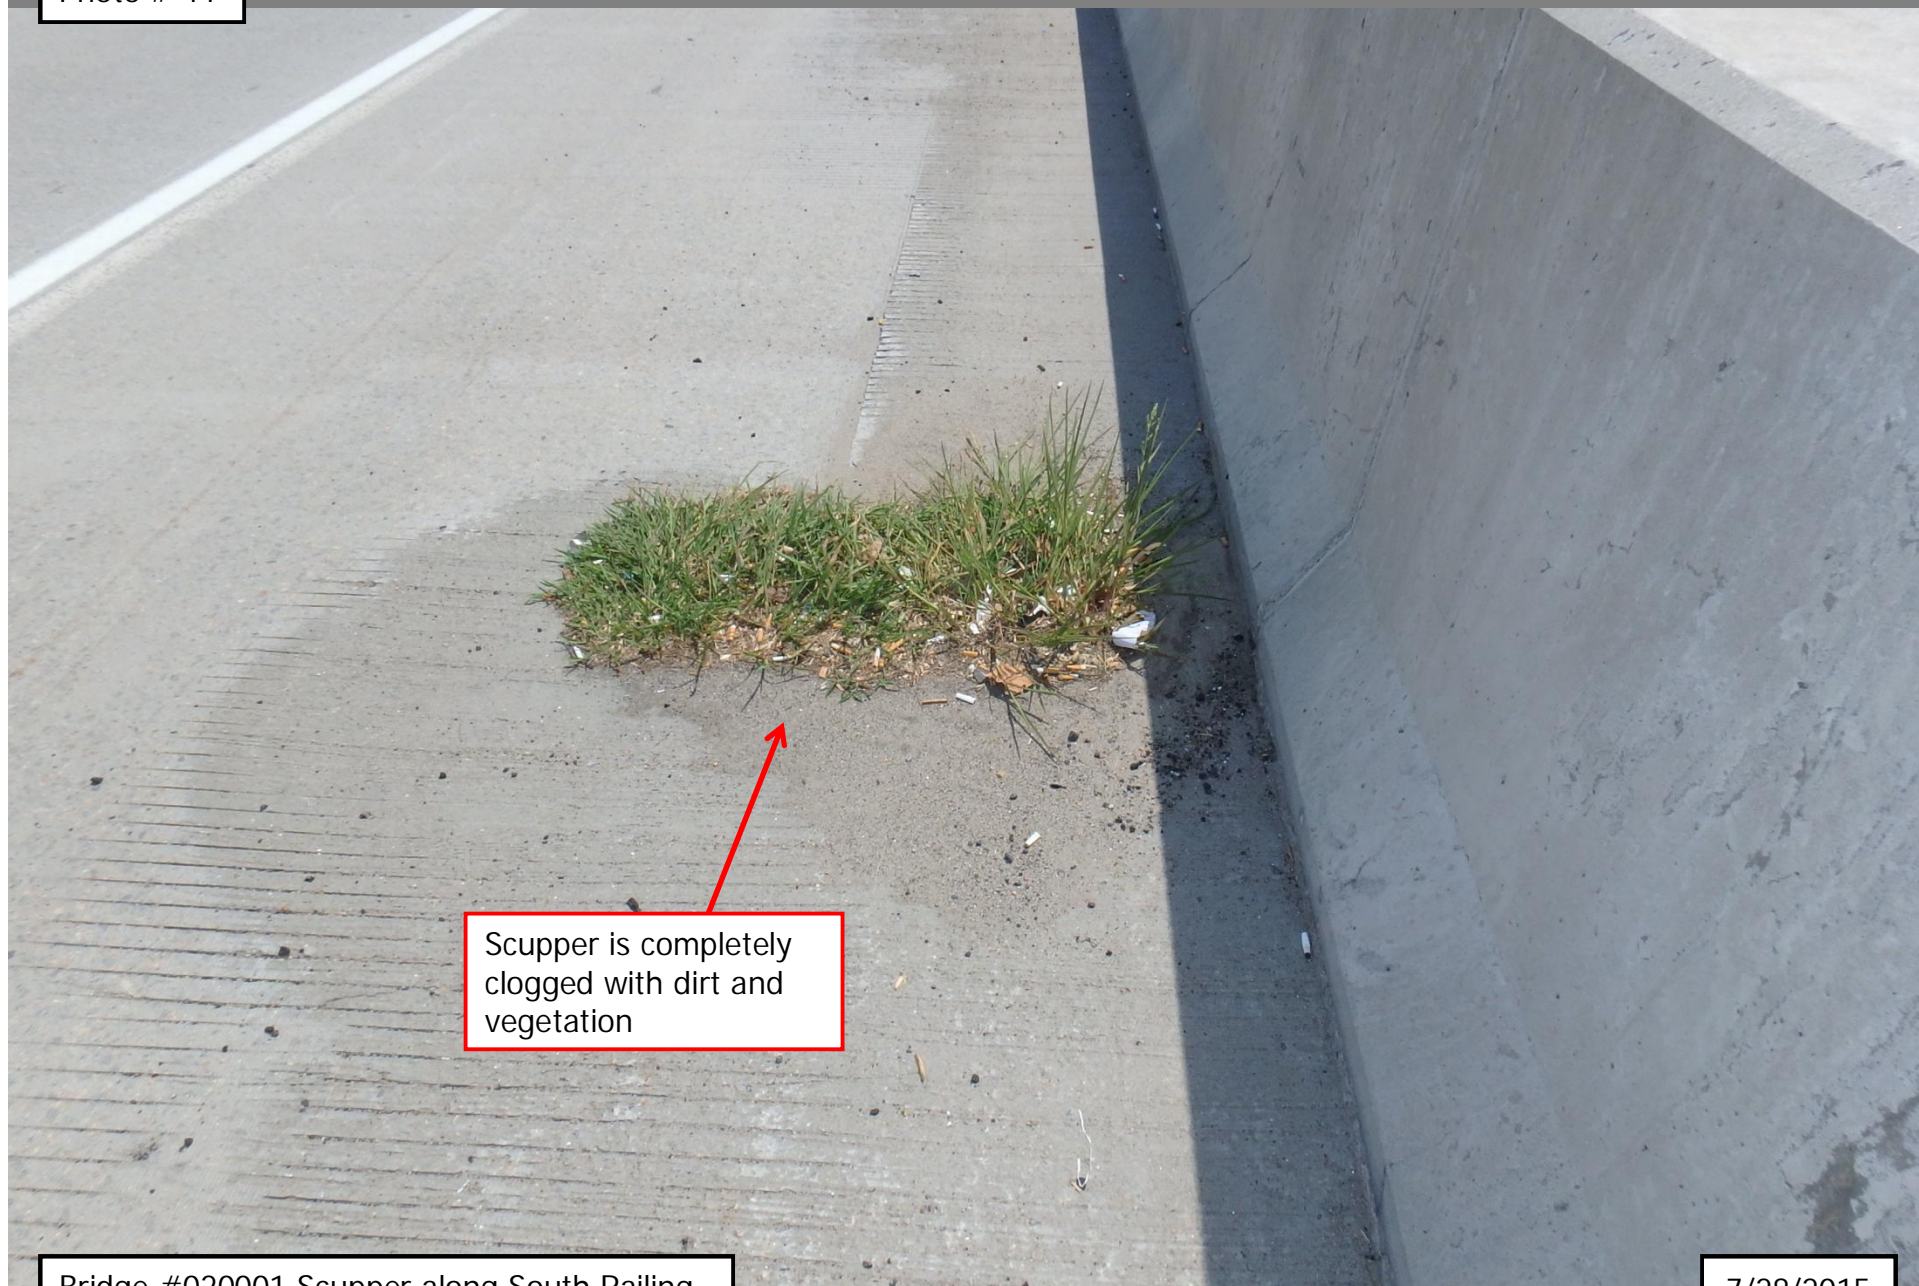
Photo # 11

Scupper is completely clogged with dirt and vegetation

Bridge #020001 Scupper along South Railing at Pier 11, Looking East

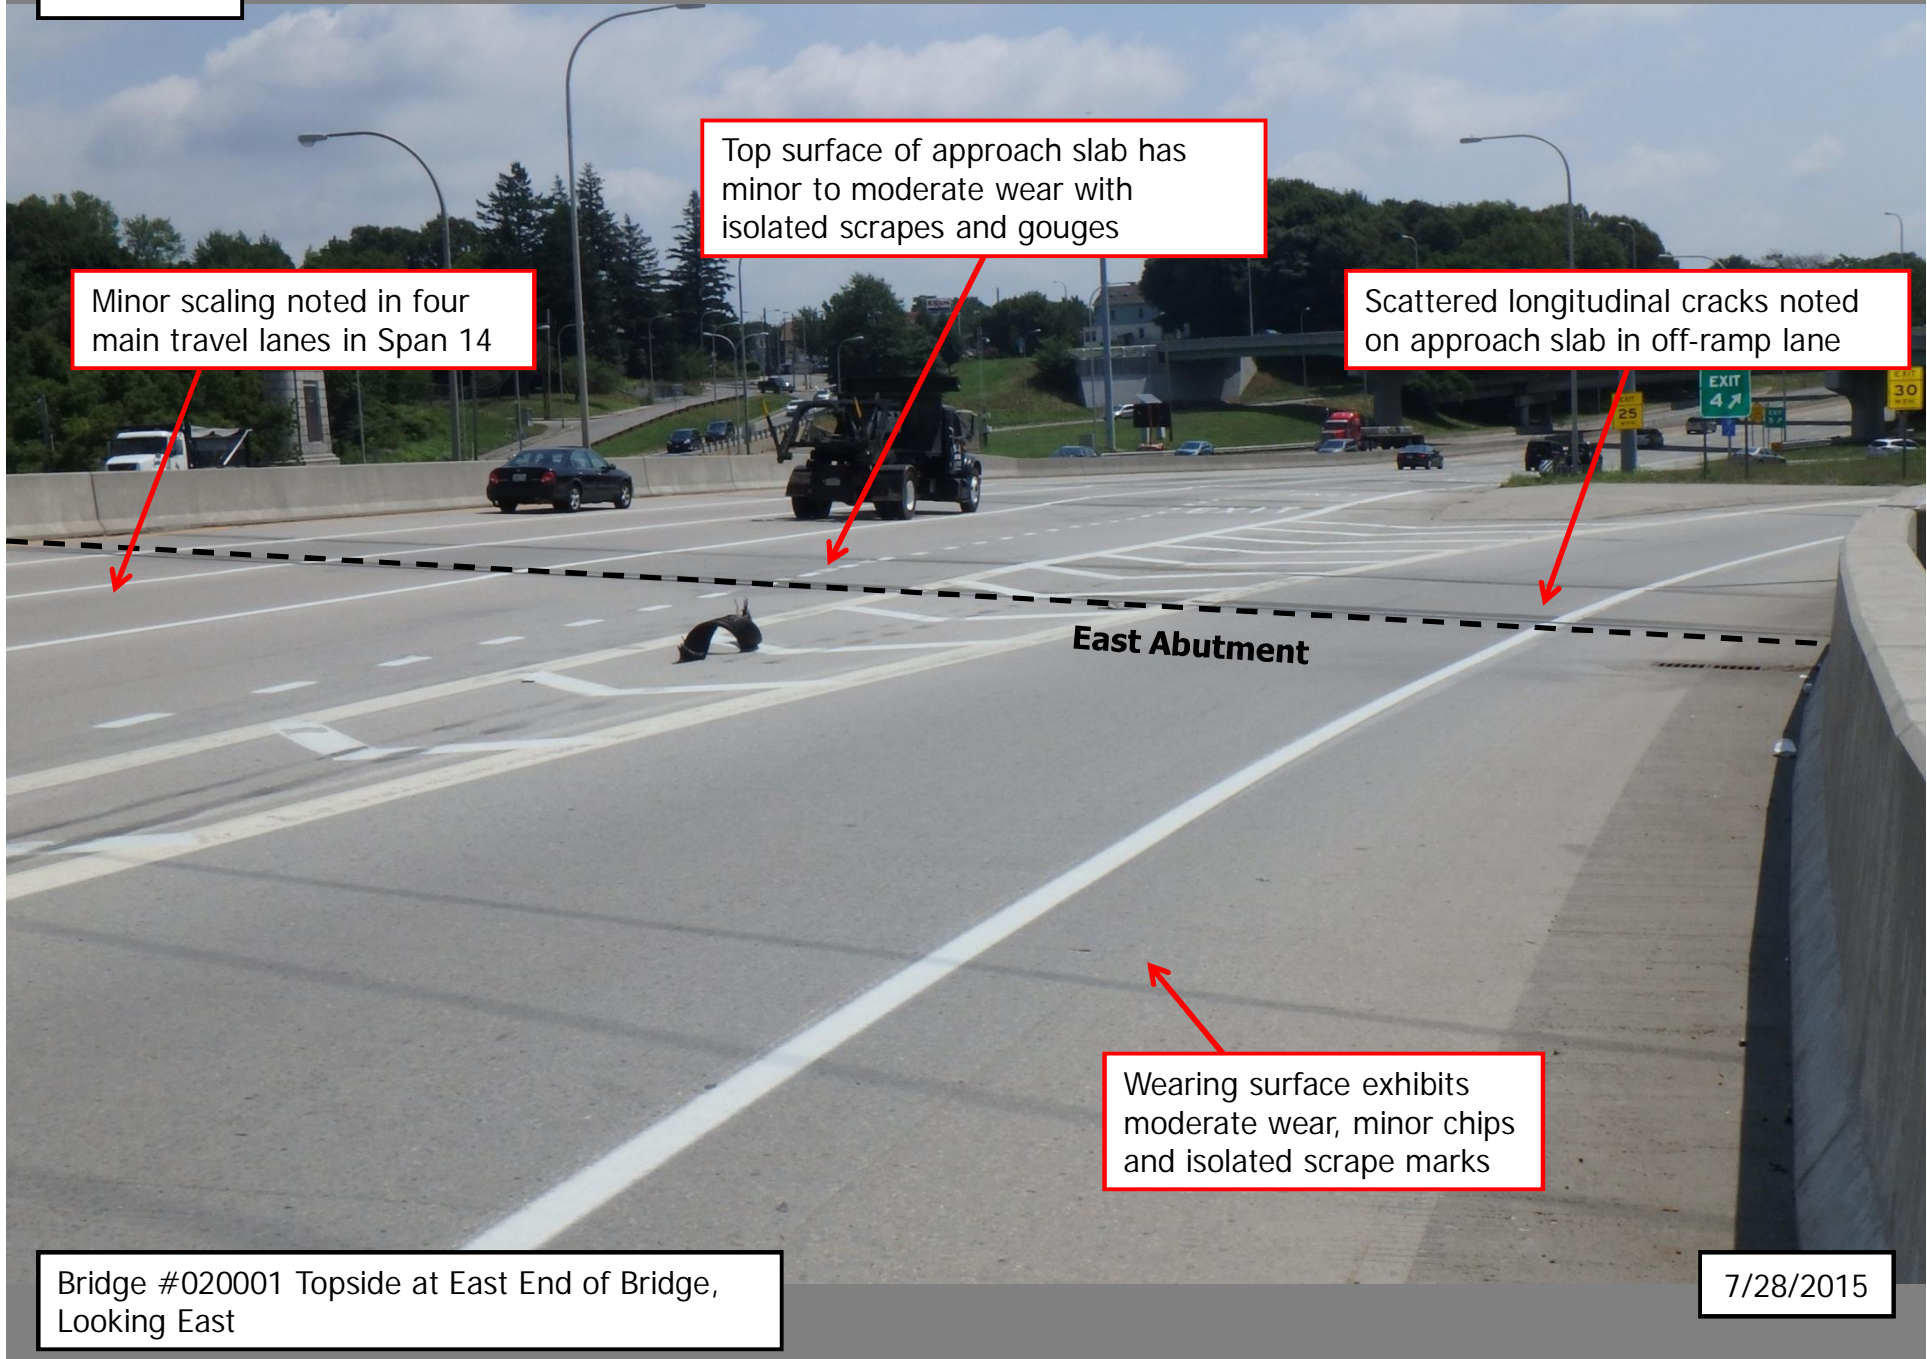
Photo # 12

Minor scaling noted in four main travel lanes in Span 14

Top surface of approach slab has minor to moderate wear with isolated scrapes and gouges

Scattered longitudinal cracks noted on approach slab in off-ramp lane

Wearing surface exhibits moderate wear, minor chips and isolated scrape marks

Bridge #020001 Topside at East End of Bridge, Looking East
