Bridge #020001 North Elevation, Looking South

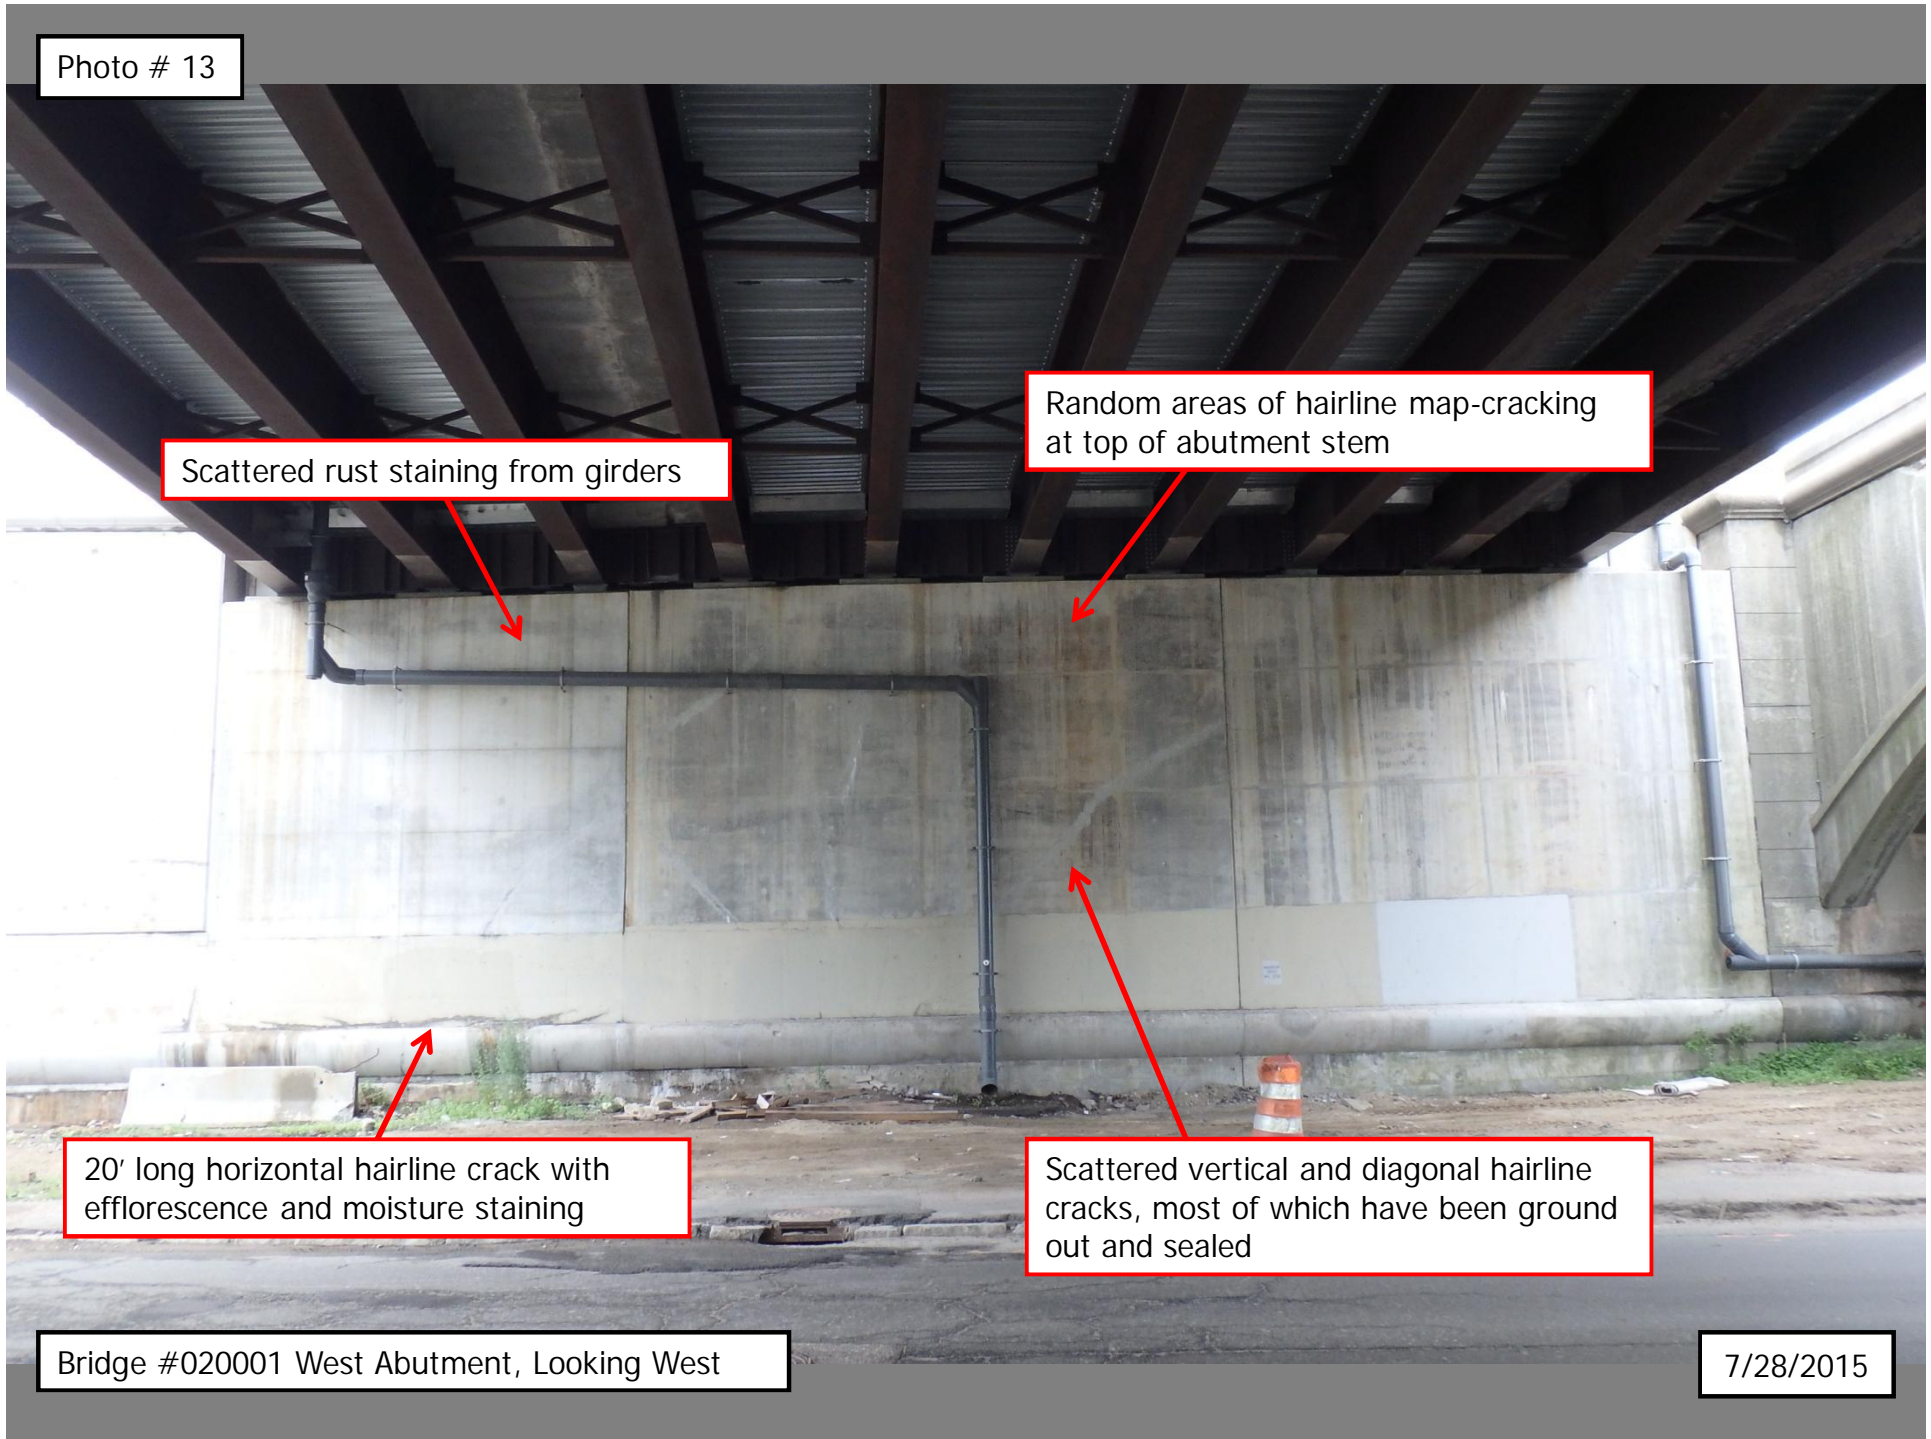
Photo # 13

Scattered rust staining from girders

Random areas of hairline map-cracking at top of abutment stem

20' long horizontal hairline crack with efflorescence and moisture staining

Scattered vertical and diagonal hairline cracks, most of which have been ground out and sealed

Bridge #020001 West Abutment, Looking West

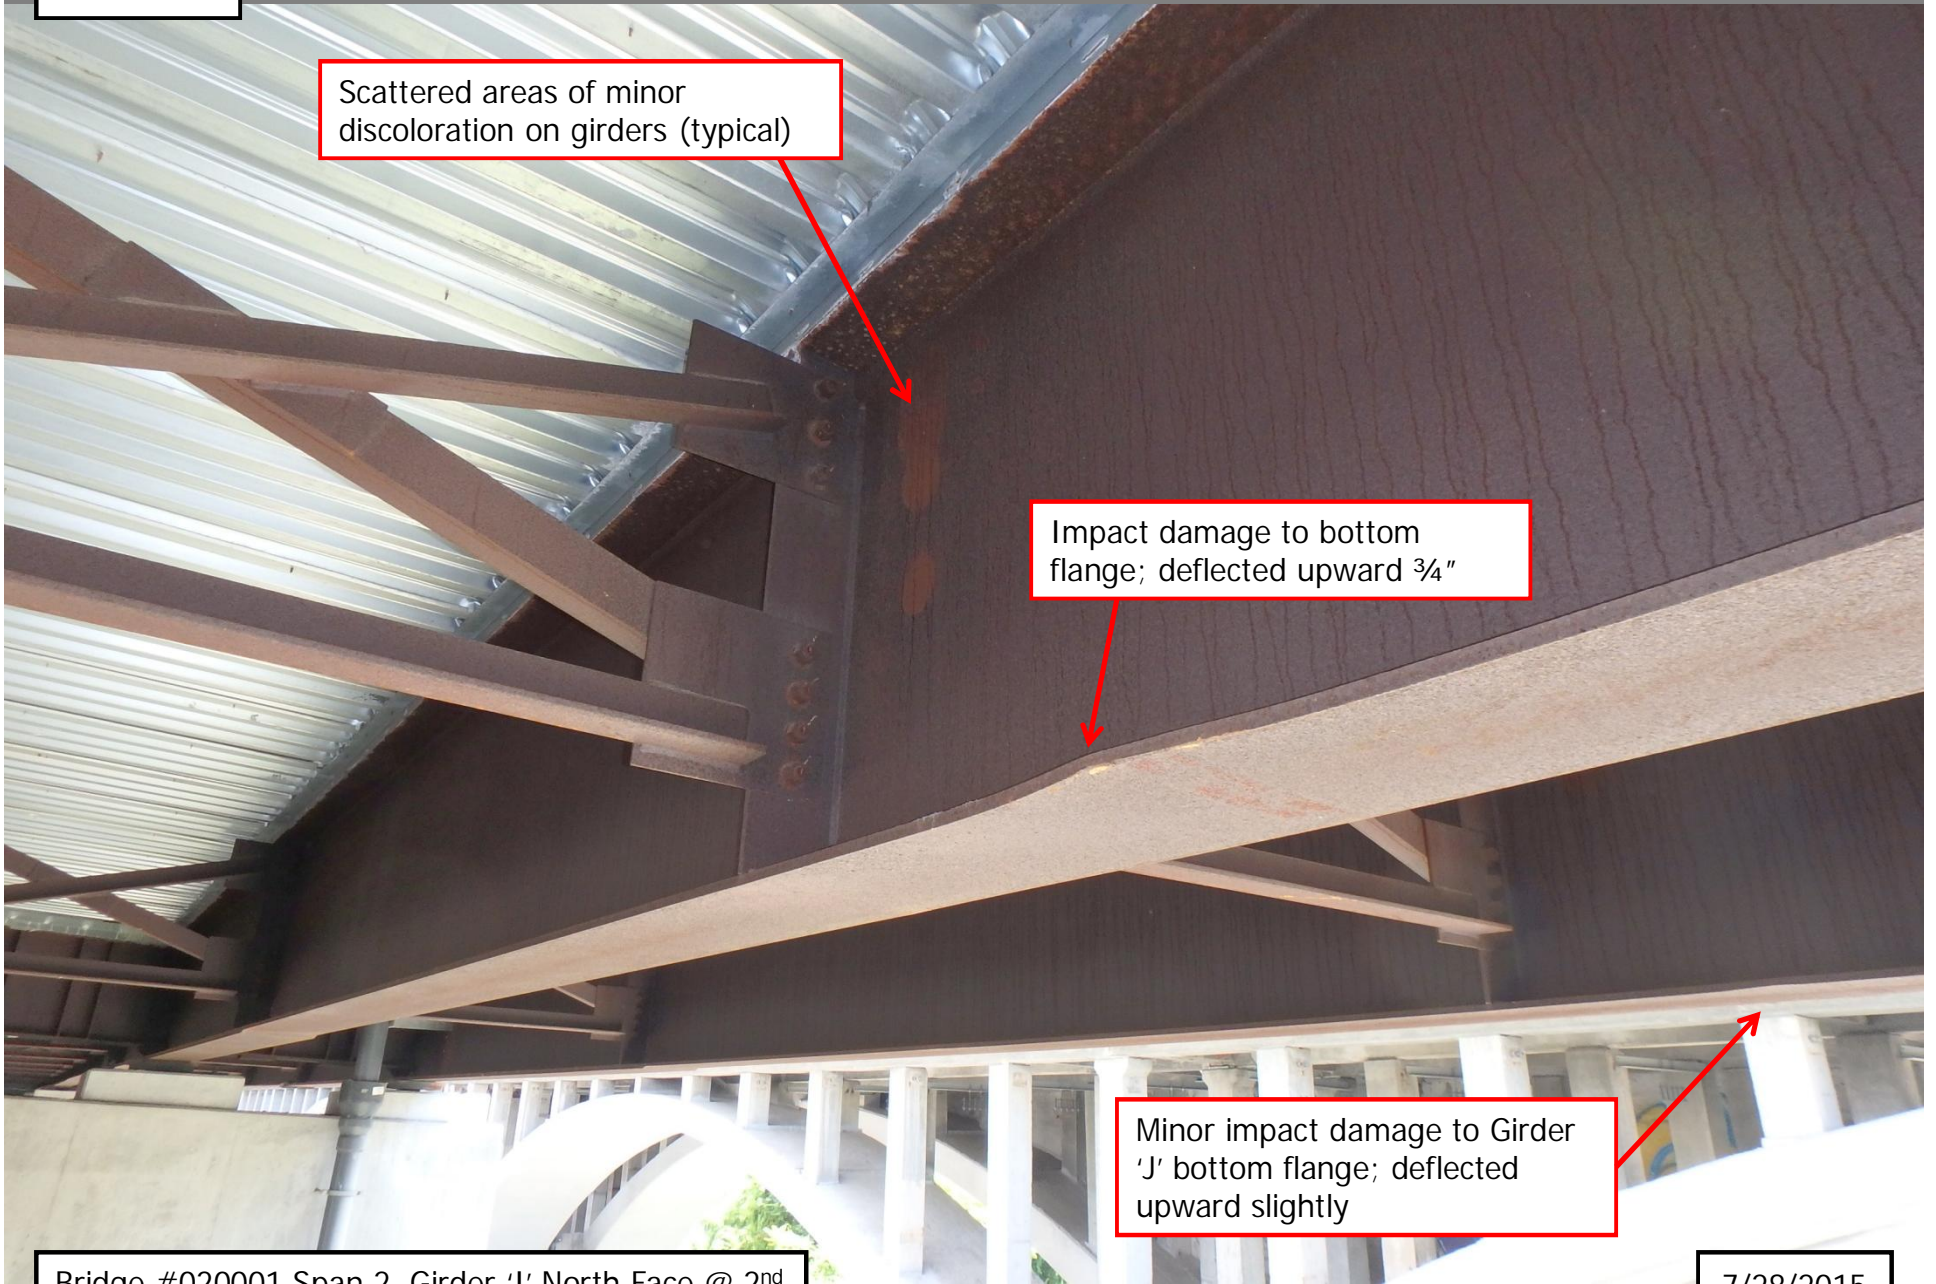
Photo # 14

Scattered areas of minor discoloration on girders (typical)

Impact damage to bottom flange; deflected upward $\frac{3}{4}$ "

Minor impact damage to Girder 'J' bottom flange; deflected upward slightly

Bridge #020001 Span 2, Girder 'I' North Face @ 2nd
Interior Cross-frame from Pier 2, Looking East

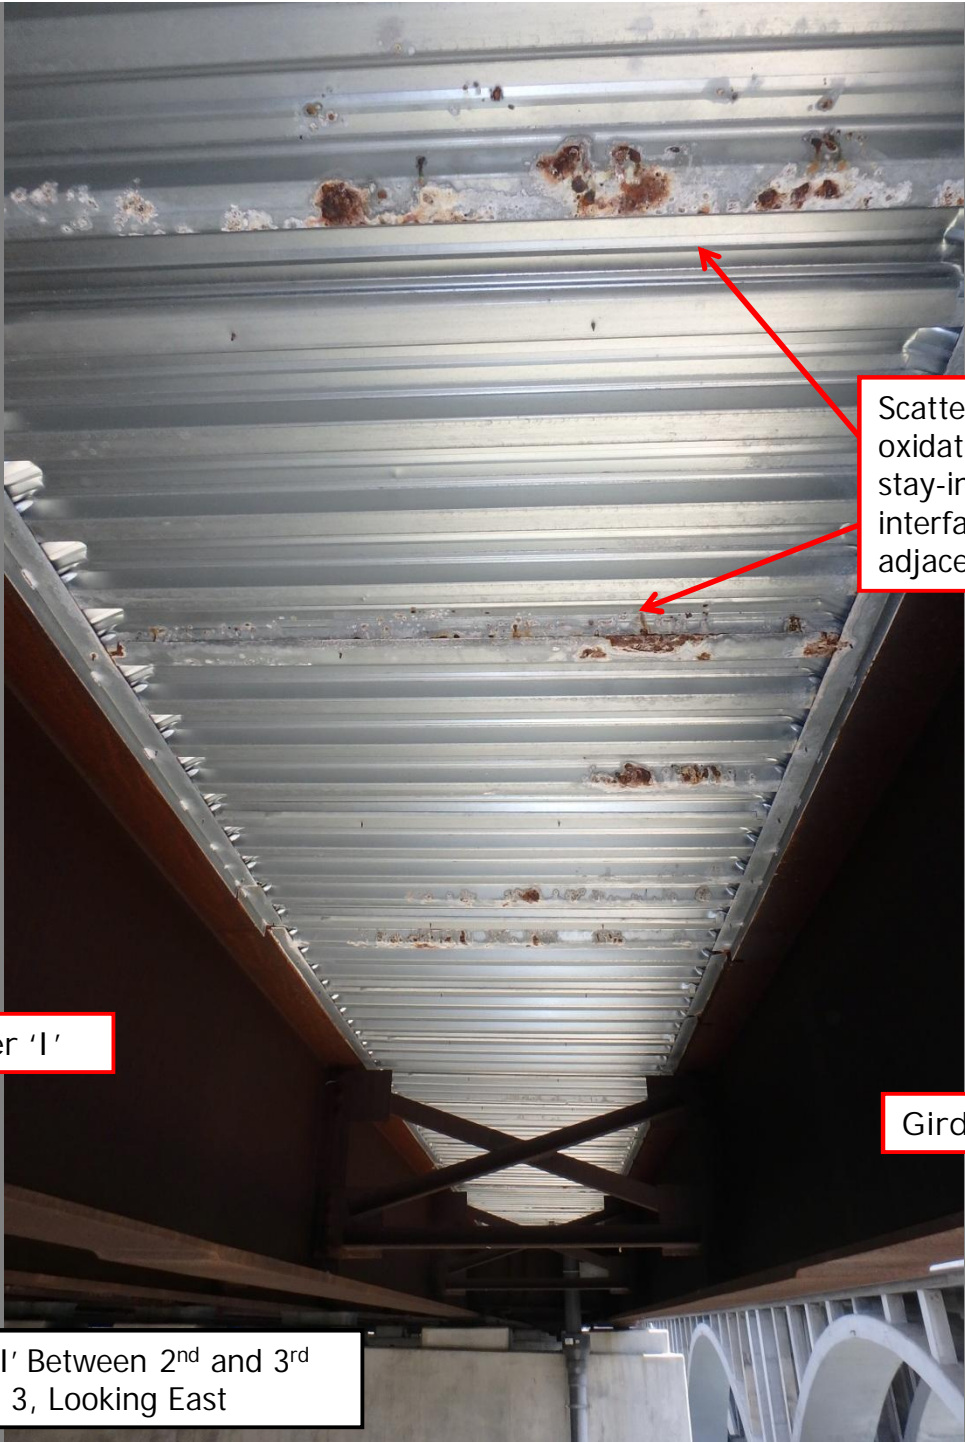
Photo # 16

Scattered areas of oxidation and rust on stay-in-place forms at interface between adjacent form sections

Bridge #020001 Span 3, Bay 'I' Between 2nd and 3rd
Interior Cross-frame from Pier 3, Looking East

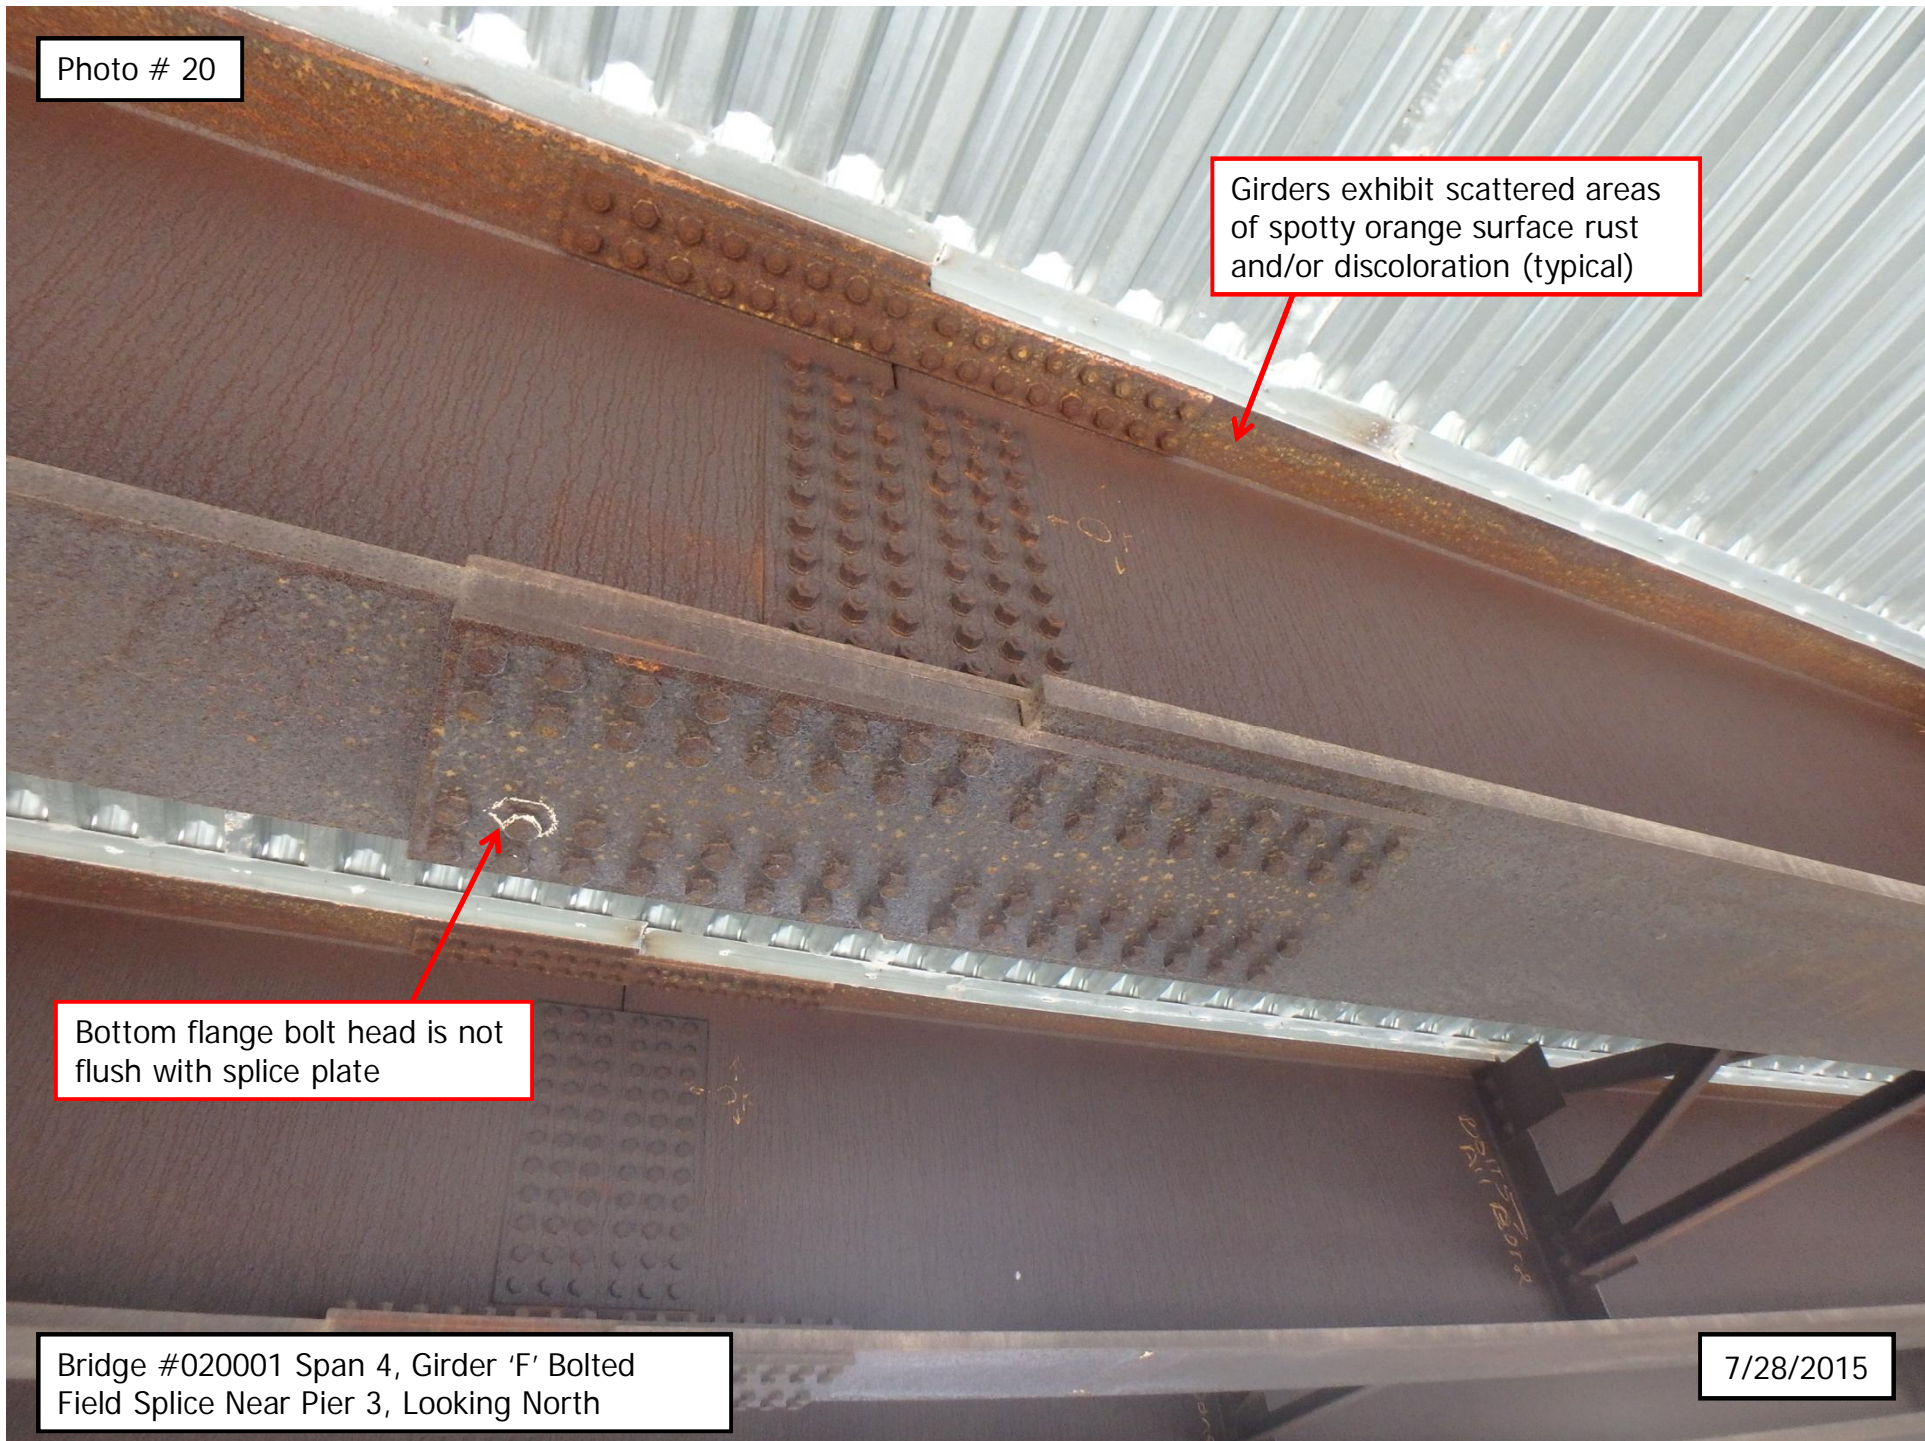
Photo # 20

Girders exhibit scattered areas of spotty orange surface rust and/or discoloration (typical)

Bottom flange bolt head is not flush with splice plate

Bridge #020001 Span 4, Girder 'F' Bolted Field Splice Near Pier 3, Looking North

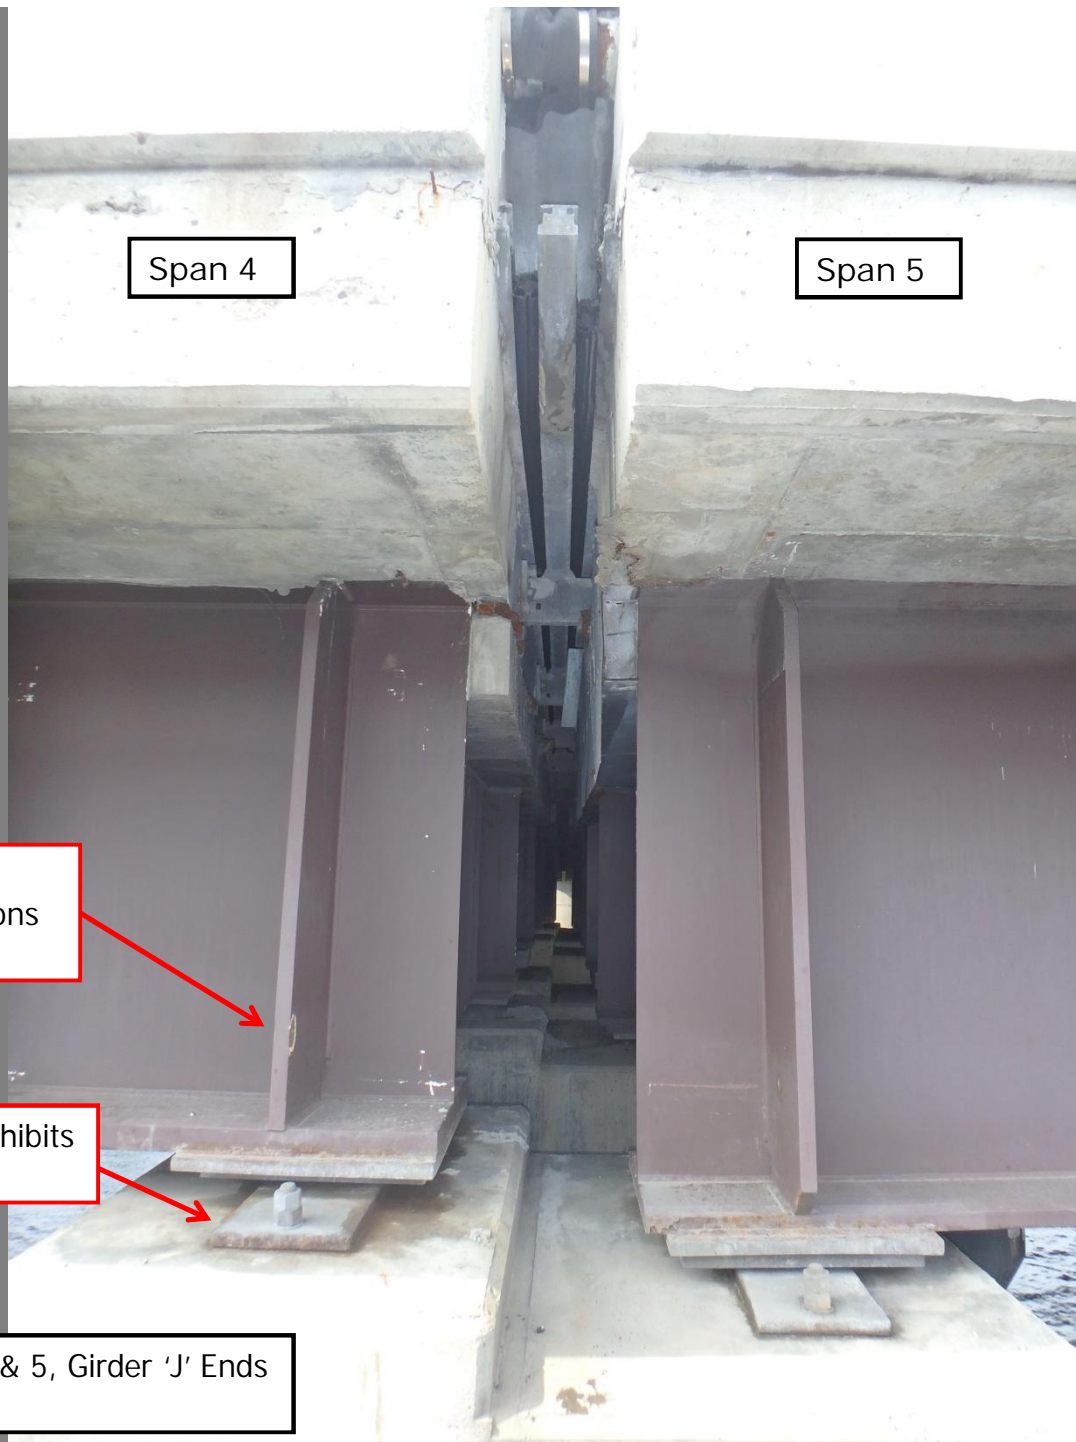
Photo # 21

Painted girder ends exhibit isolated locations of chipped paint

Bearing masonry plate exhibits moderate surface rust

Bridge #020001 Spans 4 & 5, Girder 'J' Ends @ Pier 4, Looking North

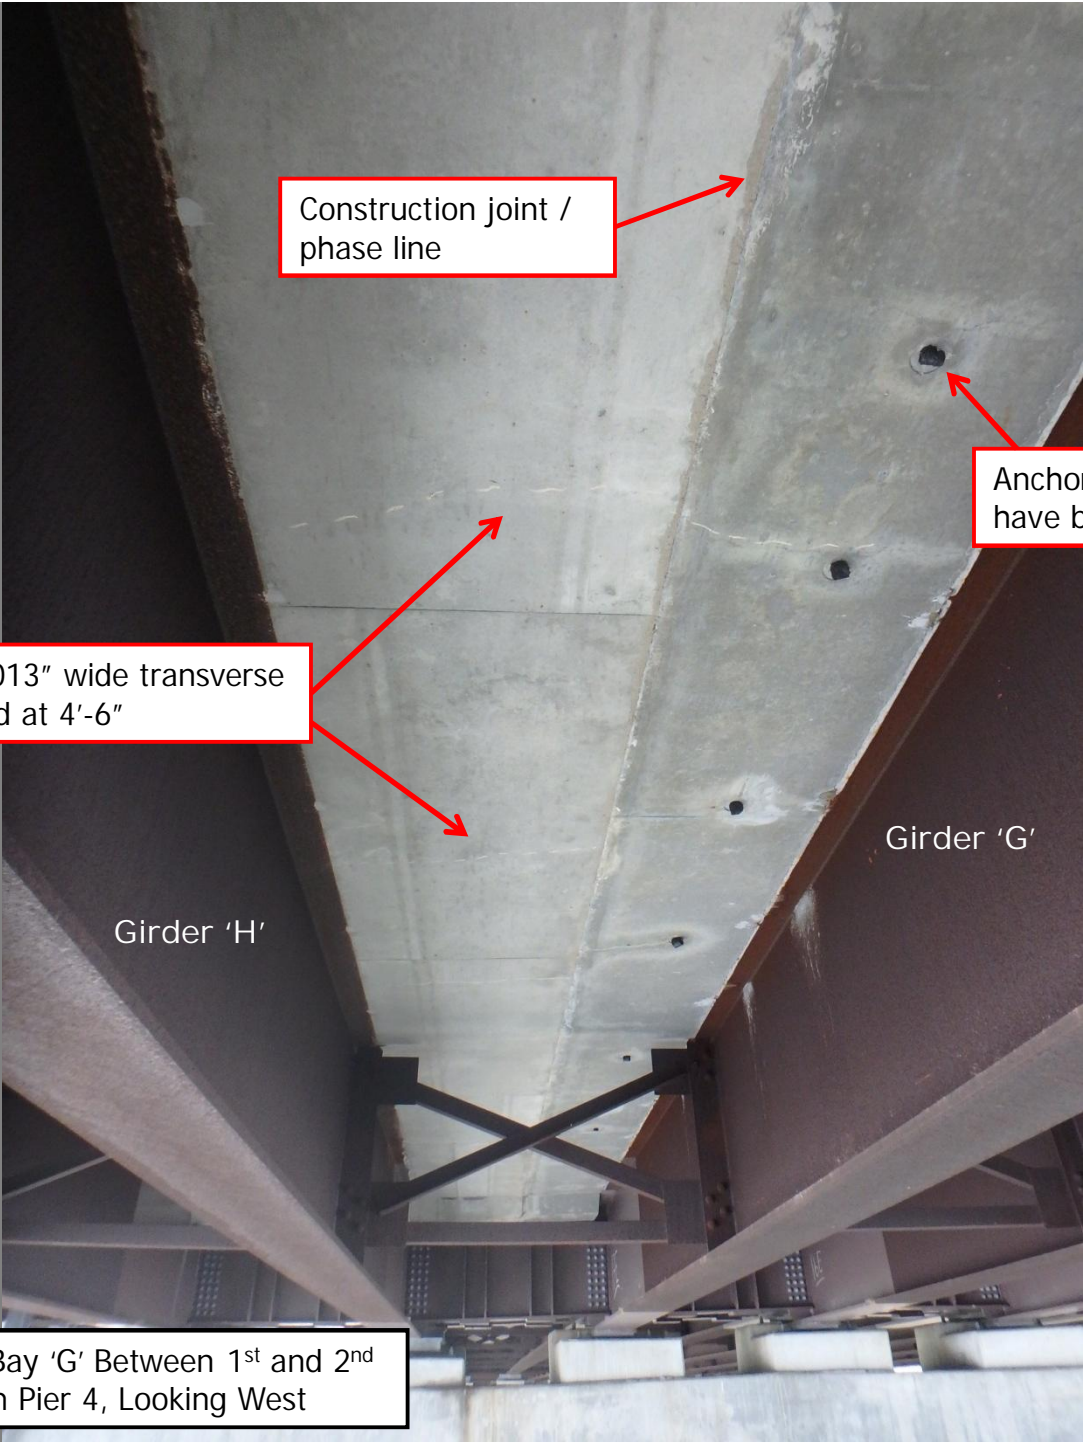
Photo # 24

Anchor bolt holes
have been filled

Hairline to 0.013" wide transverse
cracks, spaced at 4'-6"

Bridge #020001 Span 5, Bay 'G' Between 1st and 2nd
Interior Cross-Frame From Pier 4, Looking West

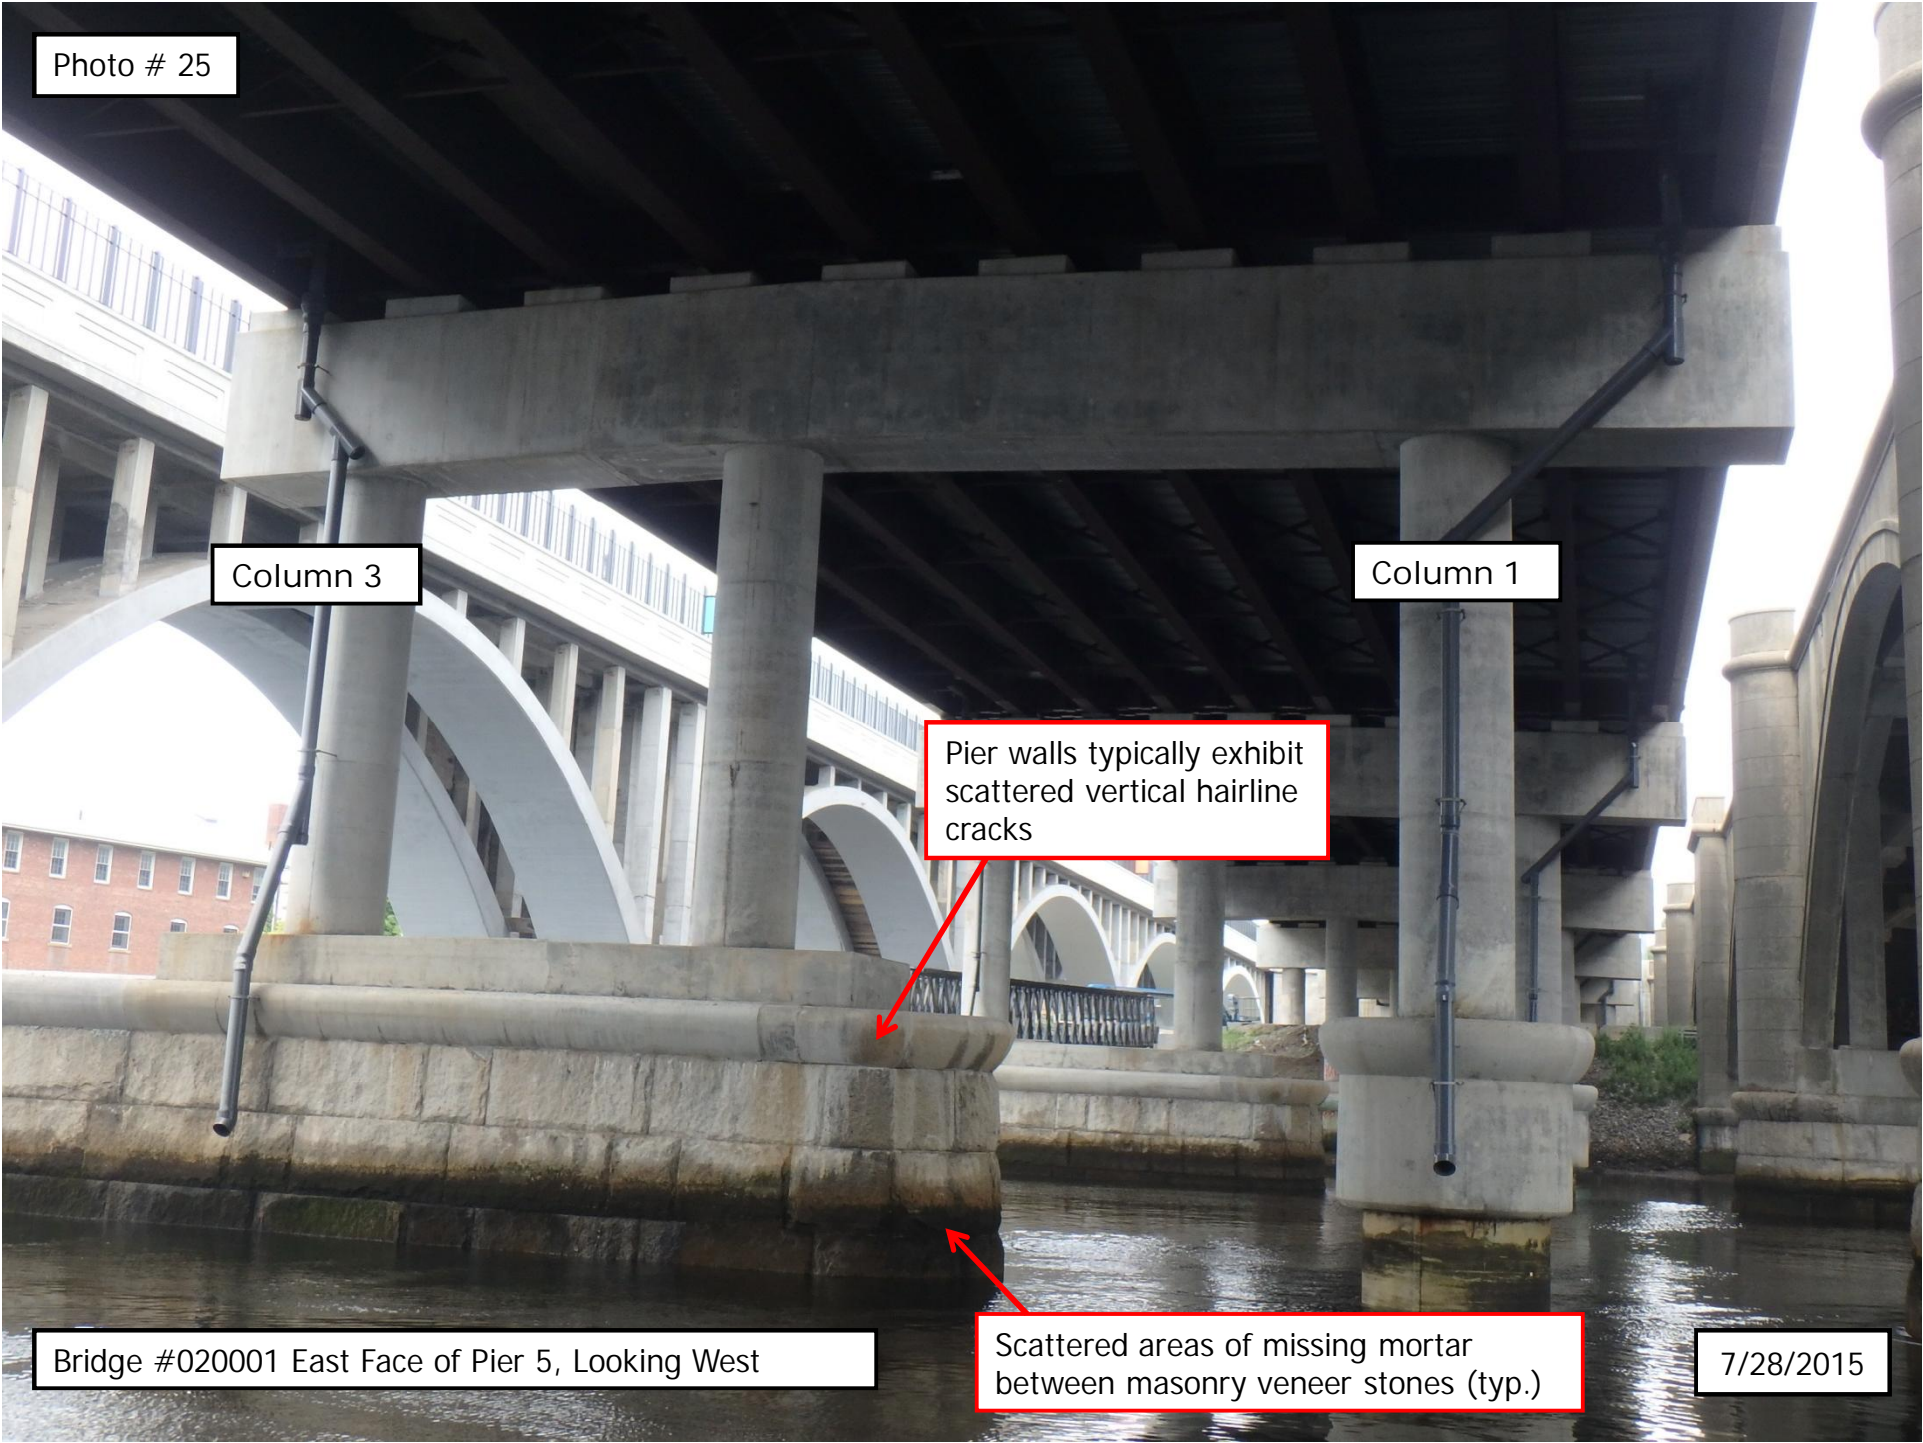
Photo # 25

Pier walls typically exhibit scattered vertical hairline cracks

Scattered areas of missing mortar between masonry veneer stones (typ.)

Bridge #020001 East Face of Pier 5, Looking West

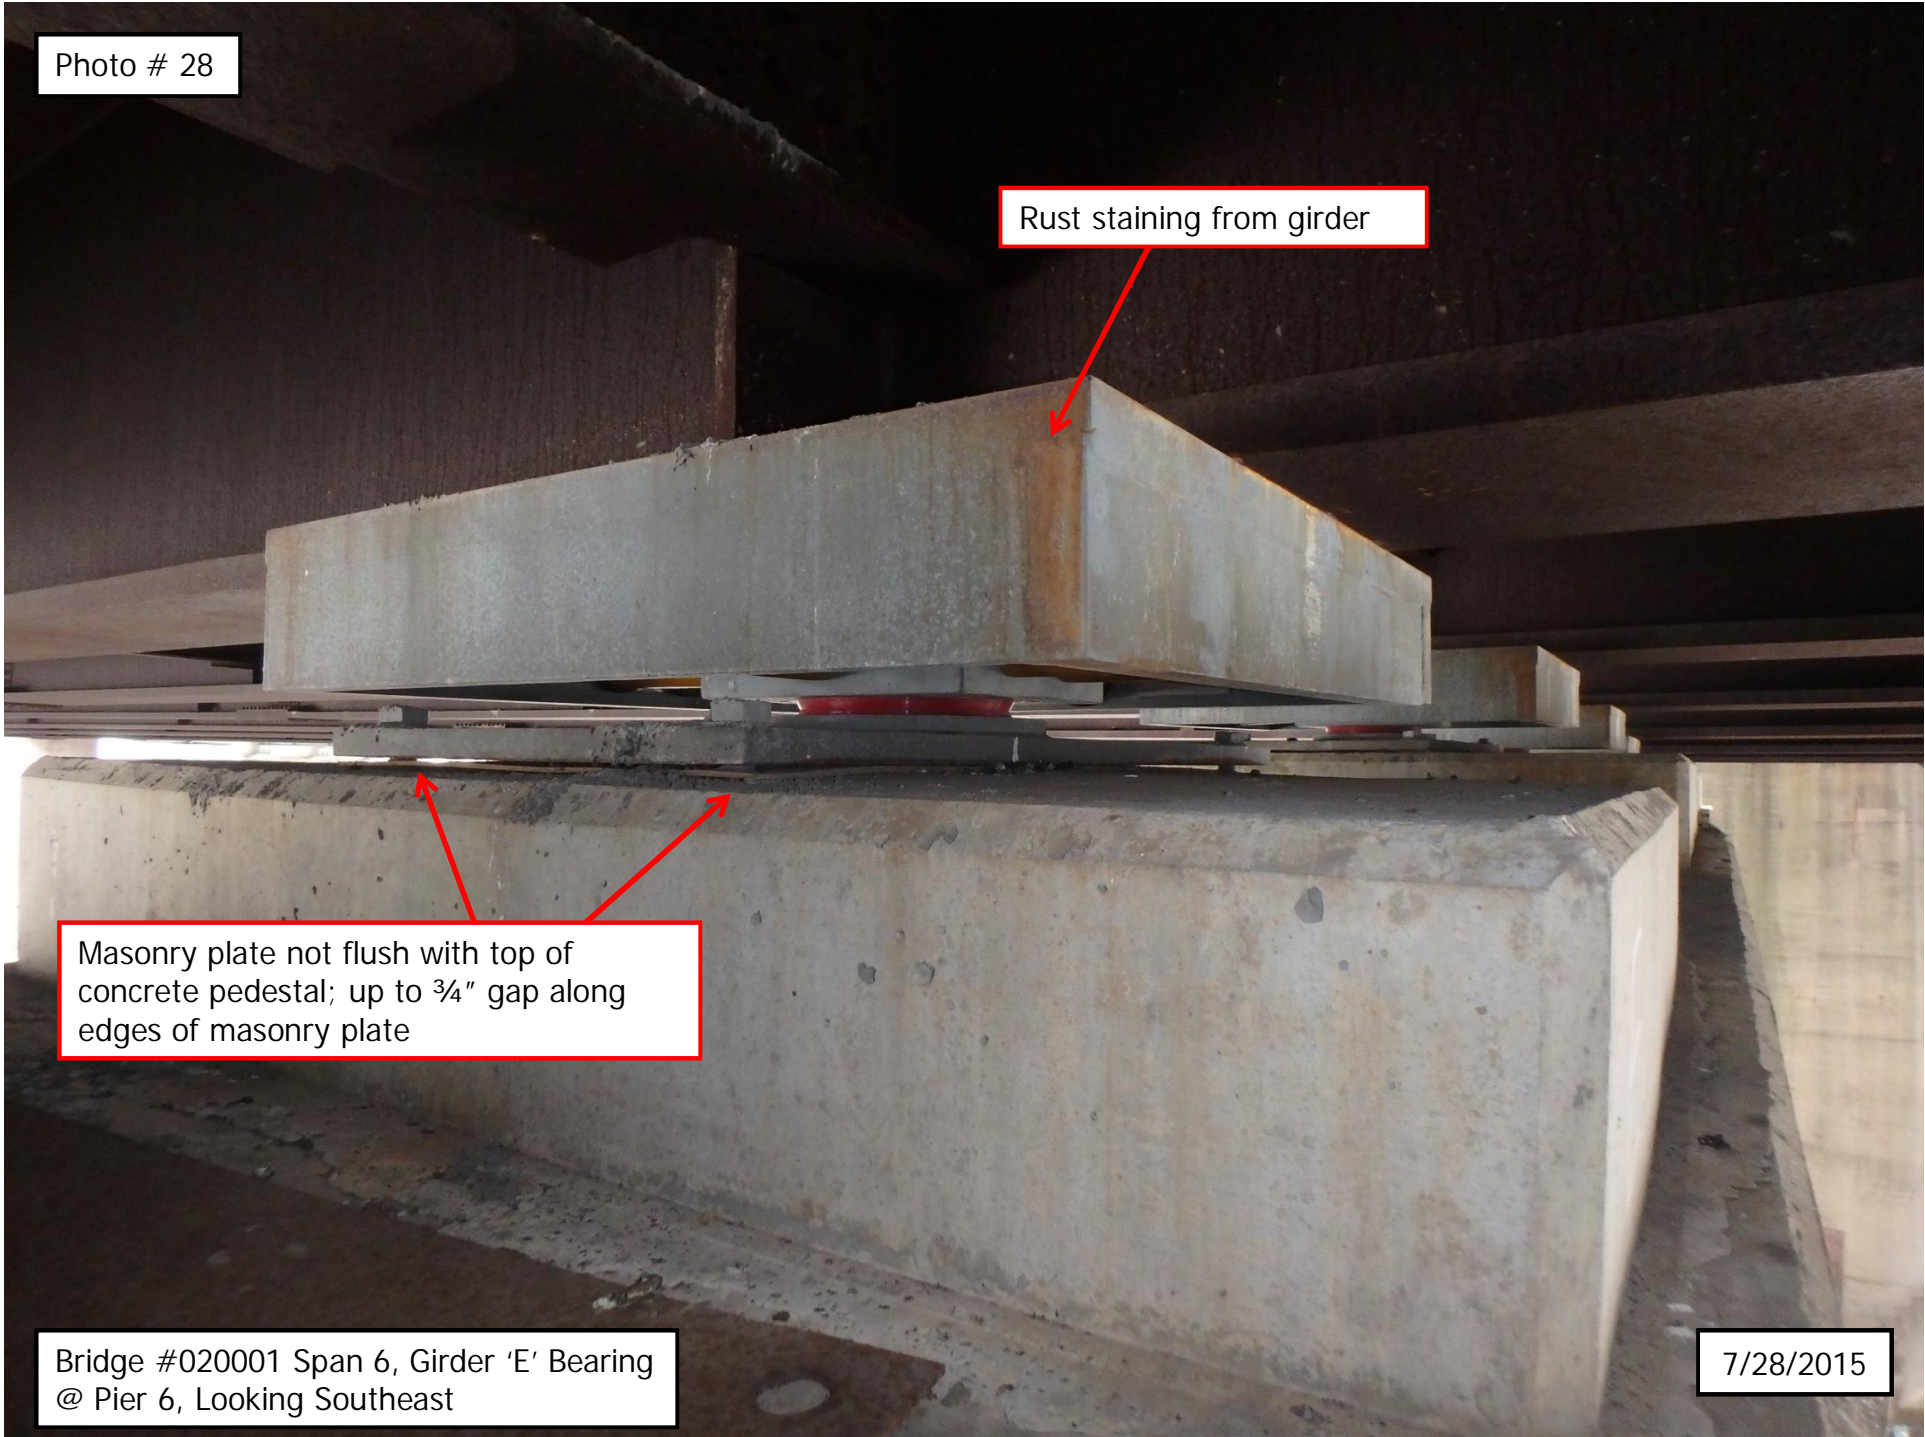
Photo # 28

Rust staining from girder

Masonry plate not flush with top of concrete pedestal; up to $\frac{3}{4}$ " gap along edges of masonry plate

Bridge #020001 Span 6, Girder 'E' Bearing
@ Pier 6, Looking Southeast

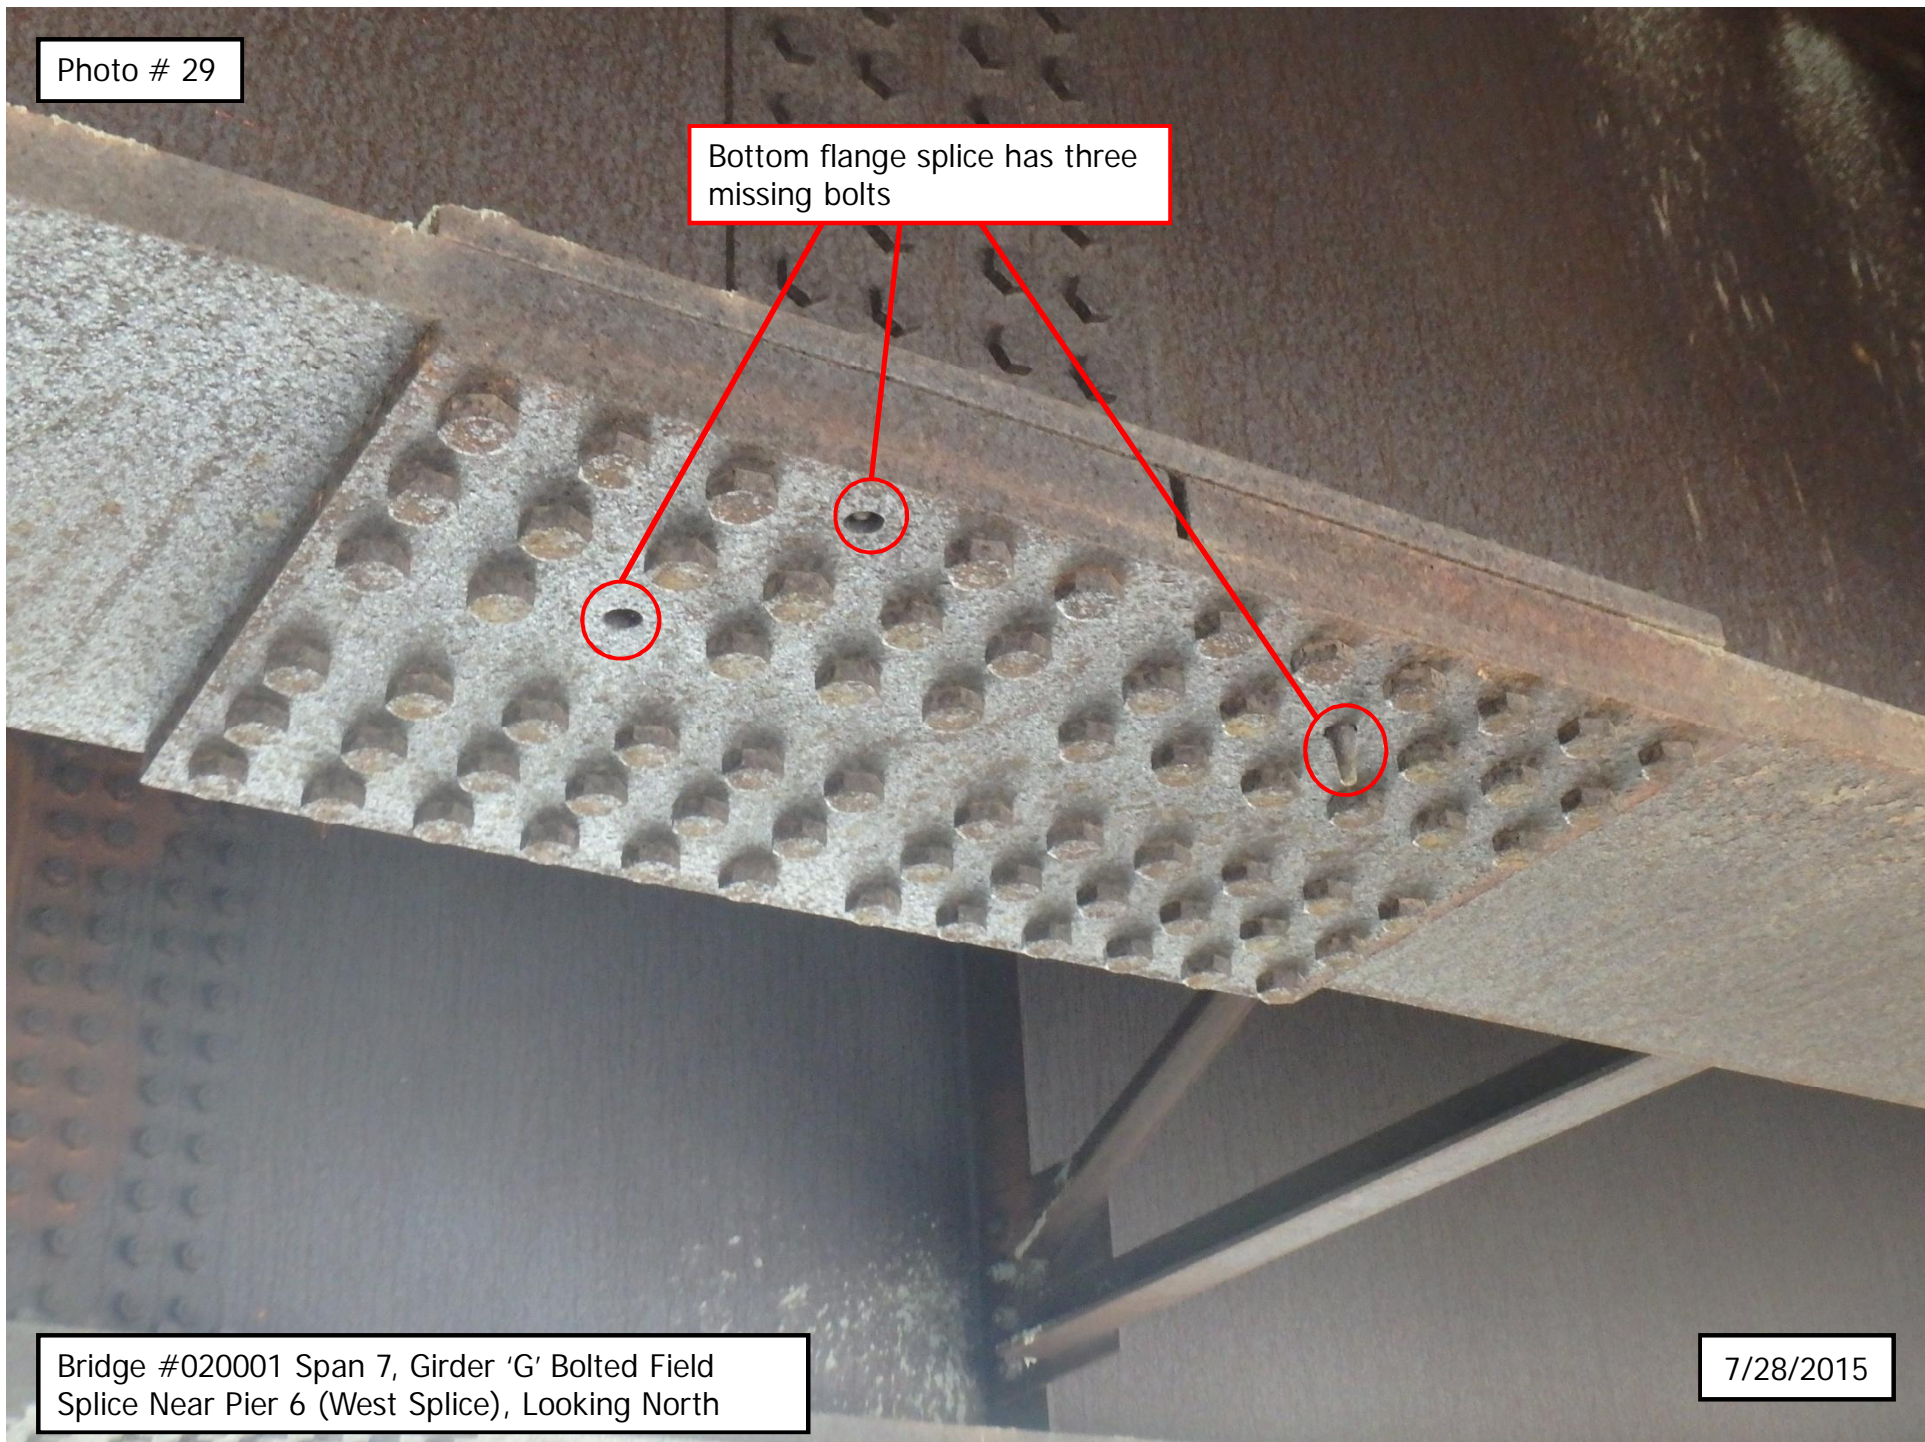
Photo # 29

Bottom flange splice has three missing bolts

Bridge #020001 Span 7, Girder 'G' Bolted Field Splice Near Pier 6 (West Splice), Looking North
