Bridge #020001 North Elevation, Looking South

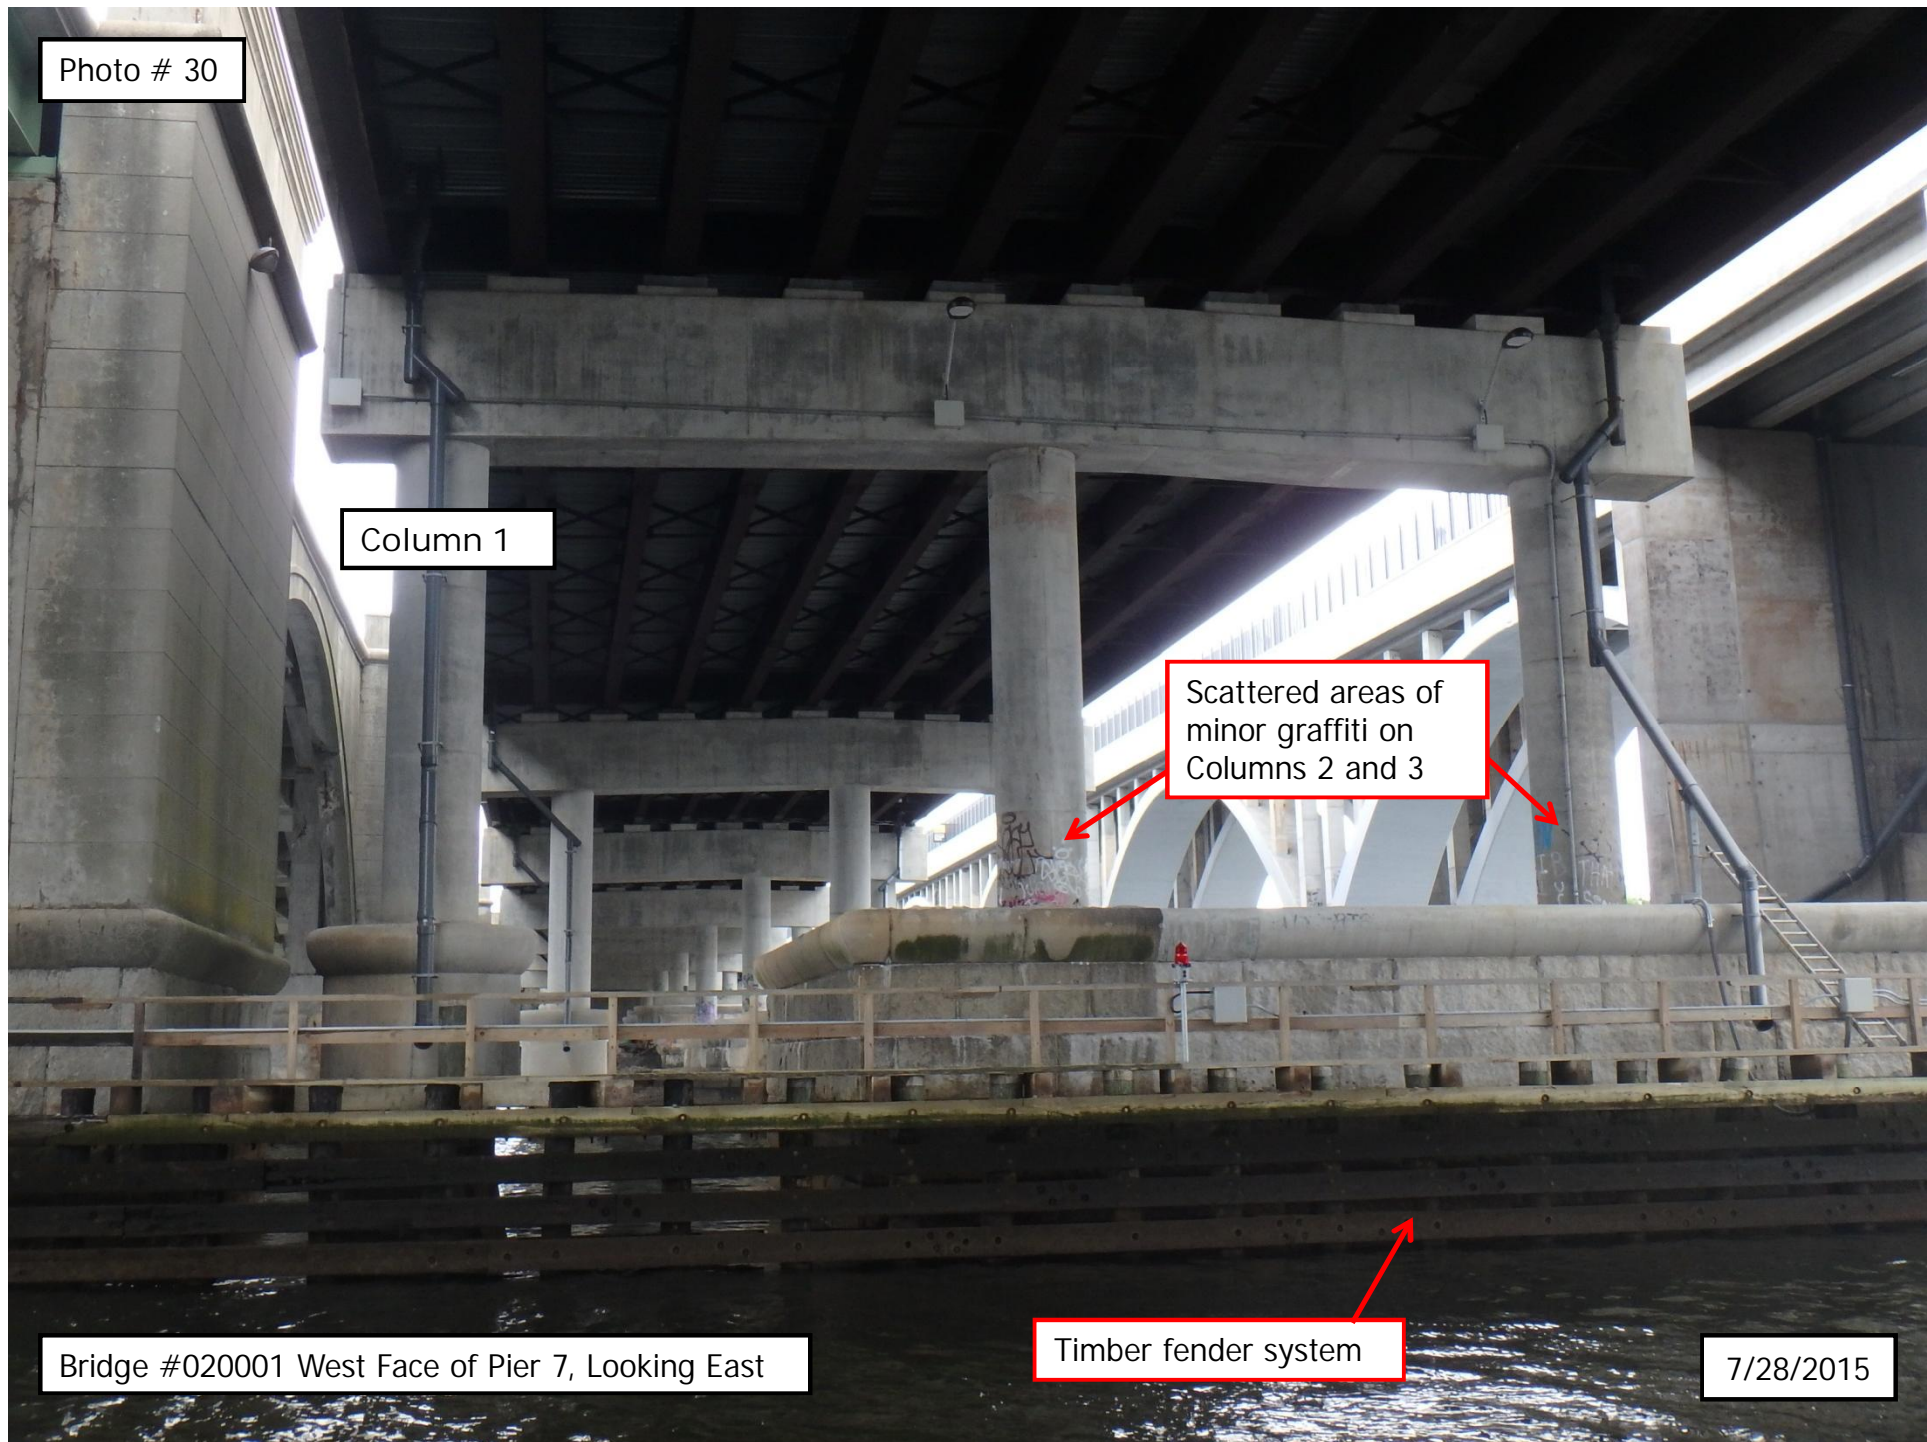
Photo # 30

Scattered areas of
minor graffiti on
Columns 2 and 3

Bridge #020001 West Face of Pier 7, Looking East

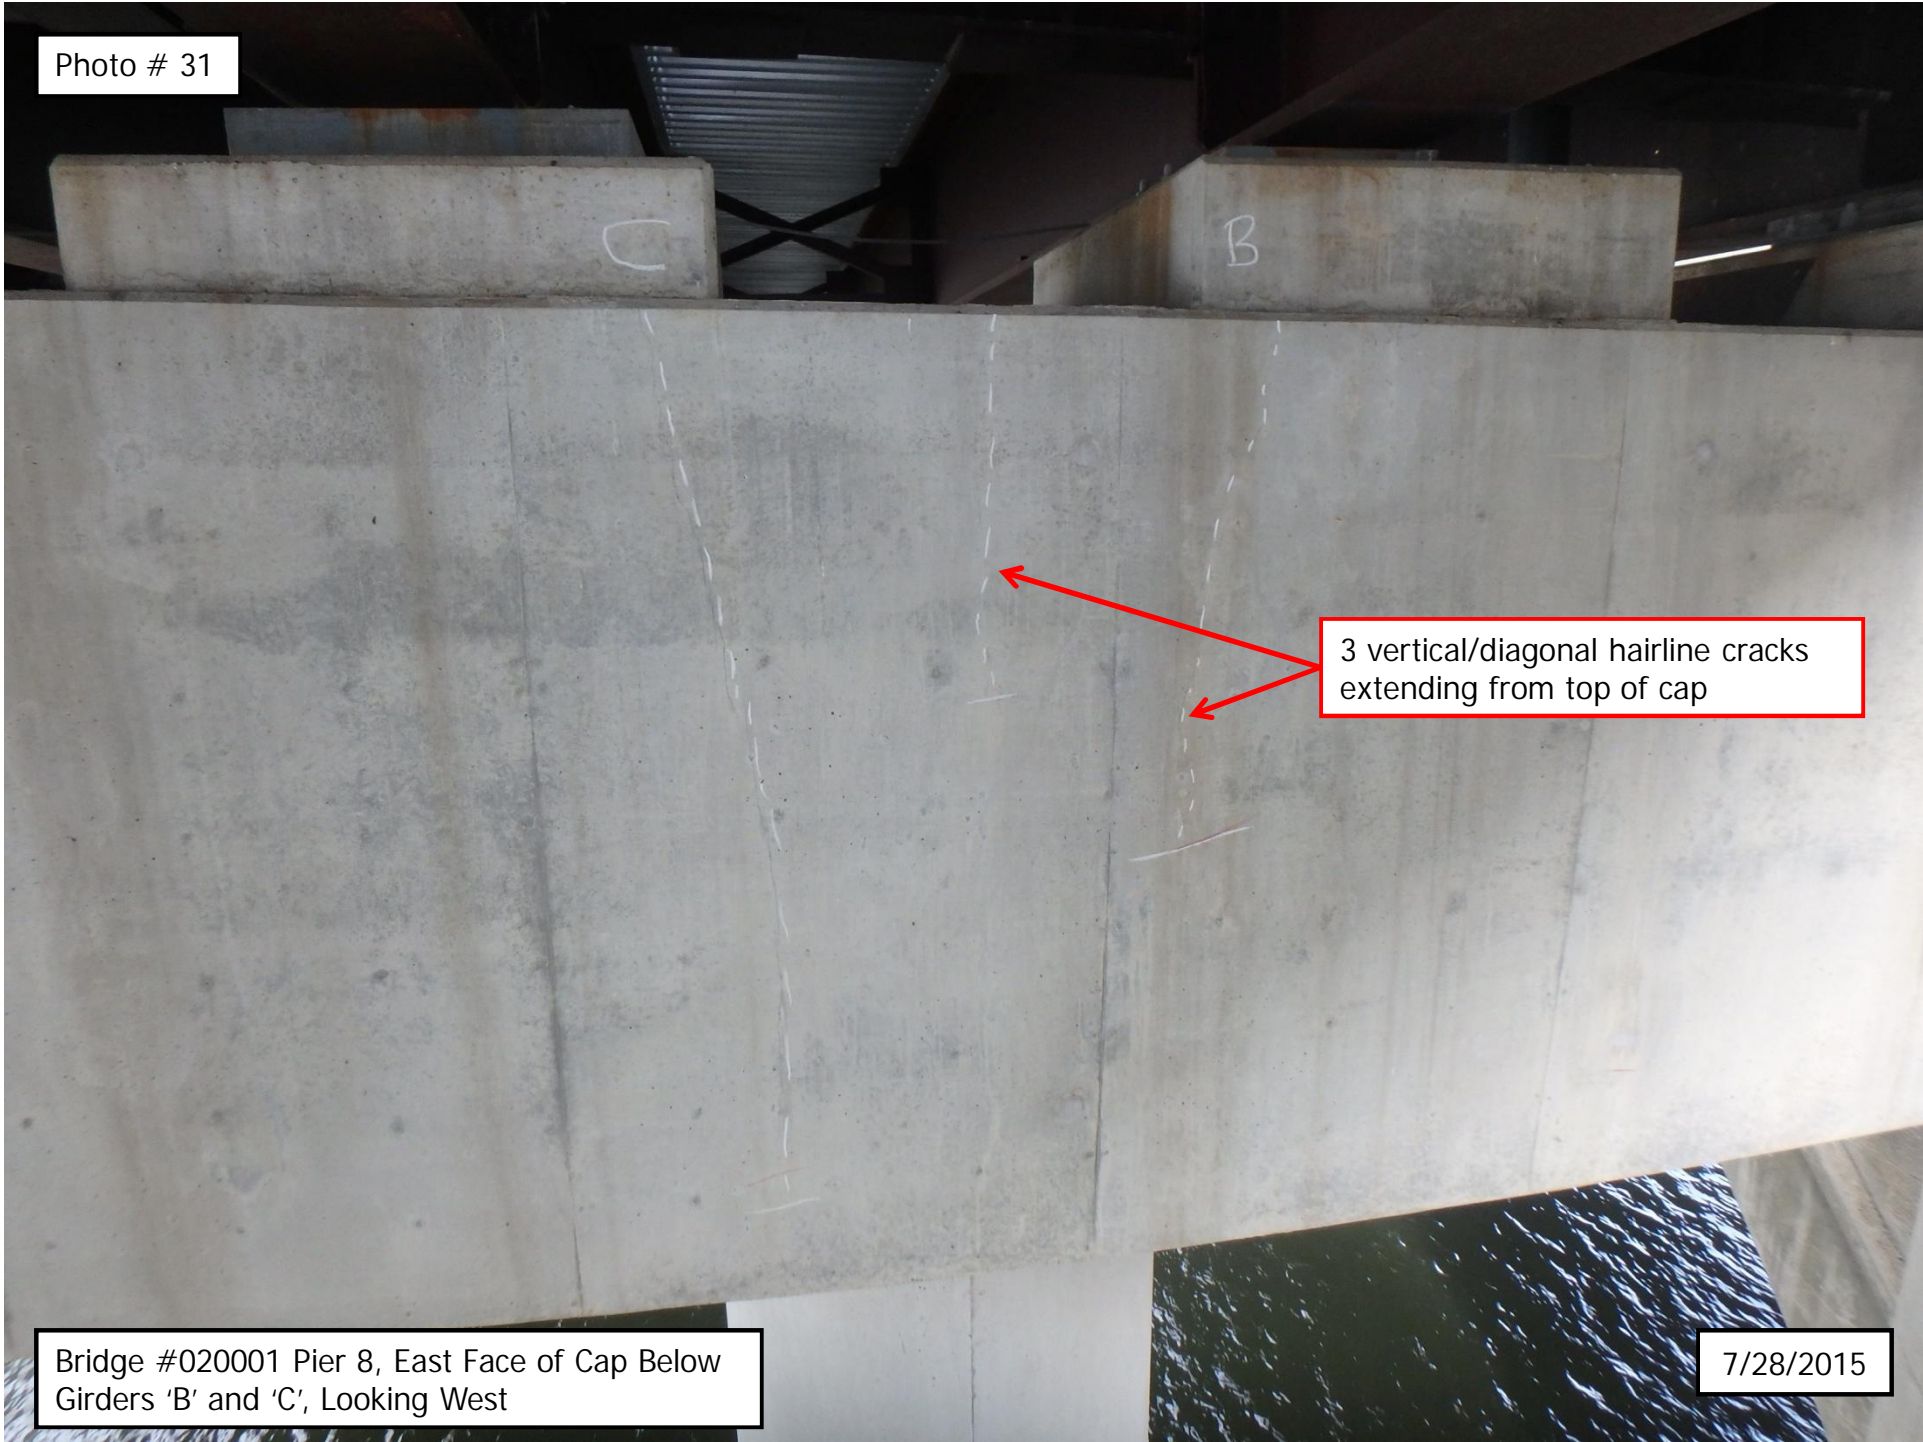
Photo # 31

3 vertical/diagonal hairline cracks extending from top of cap

Bridge #020001 Pier 8, East Face of Cap Below Girders 'B' and 'C', Looking West

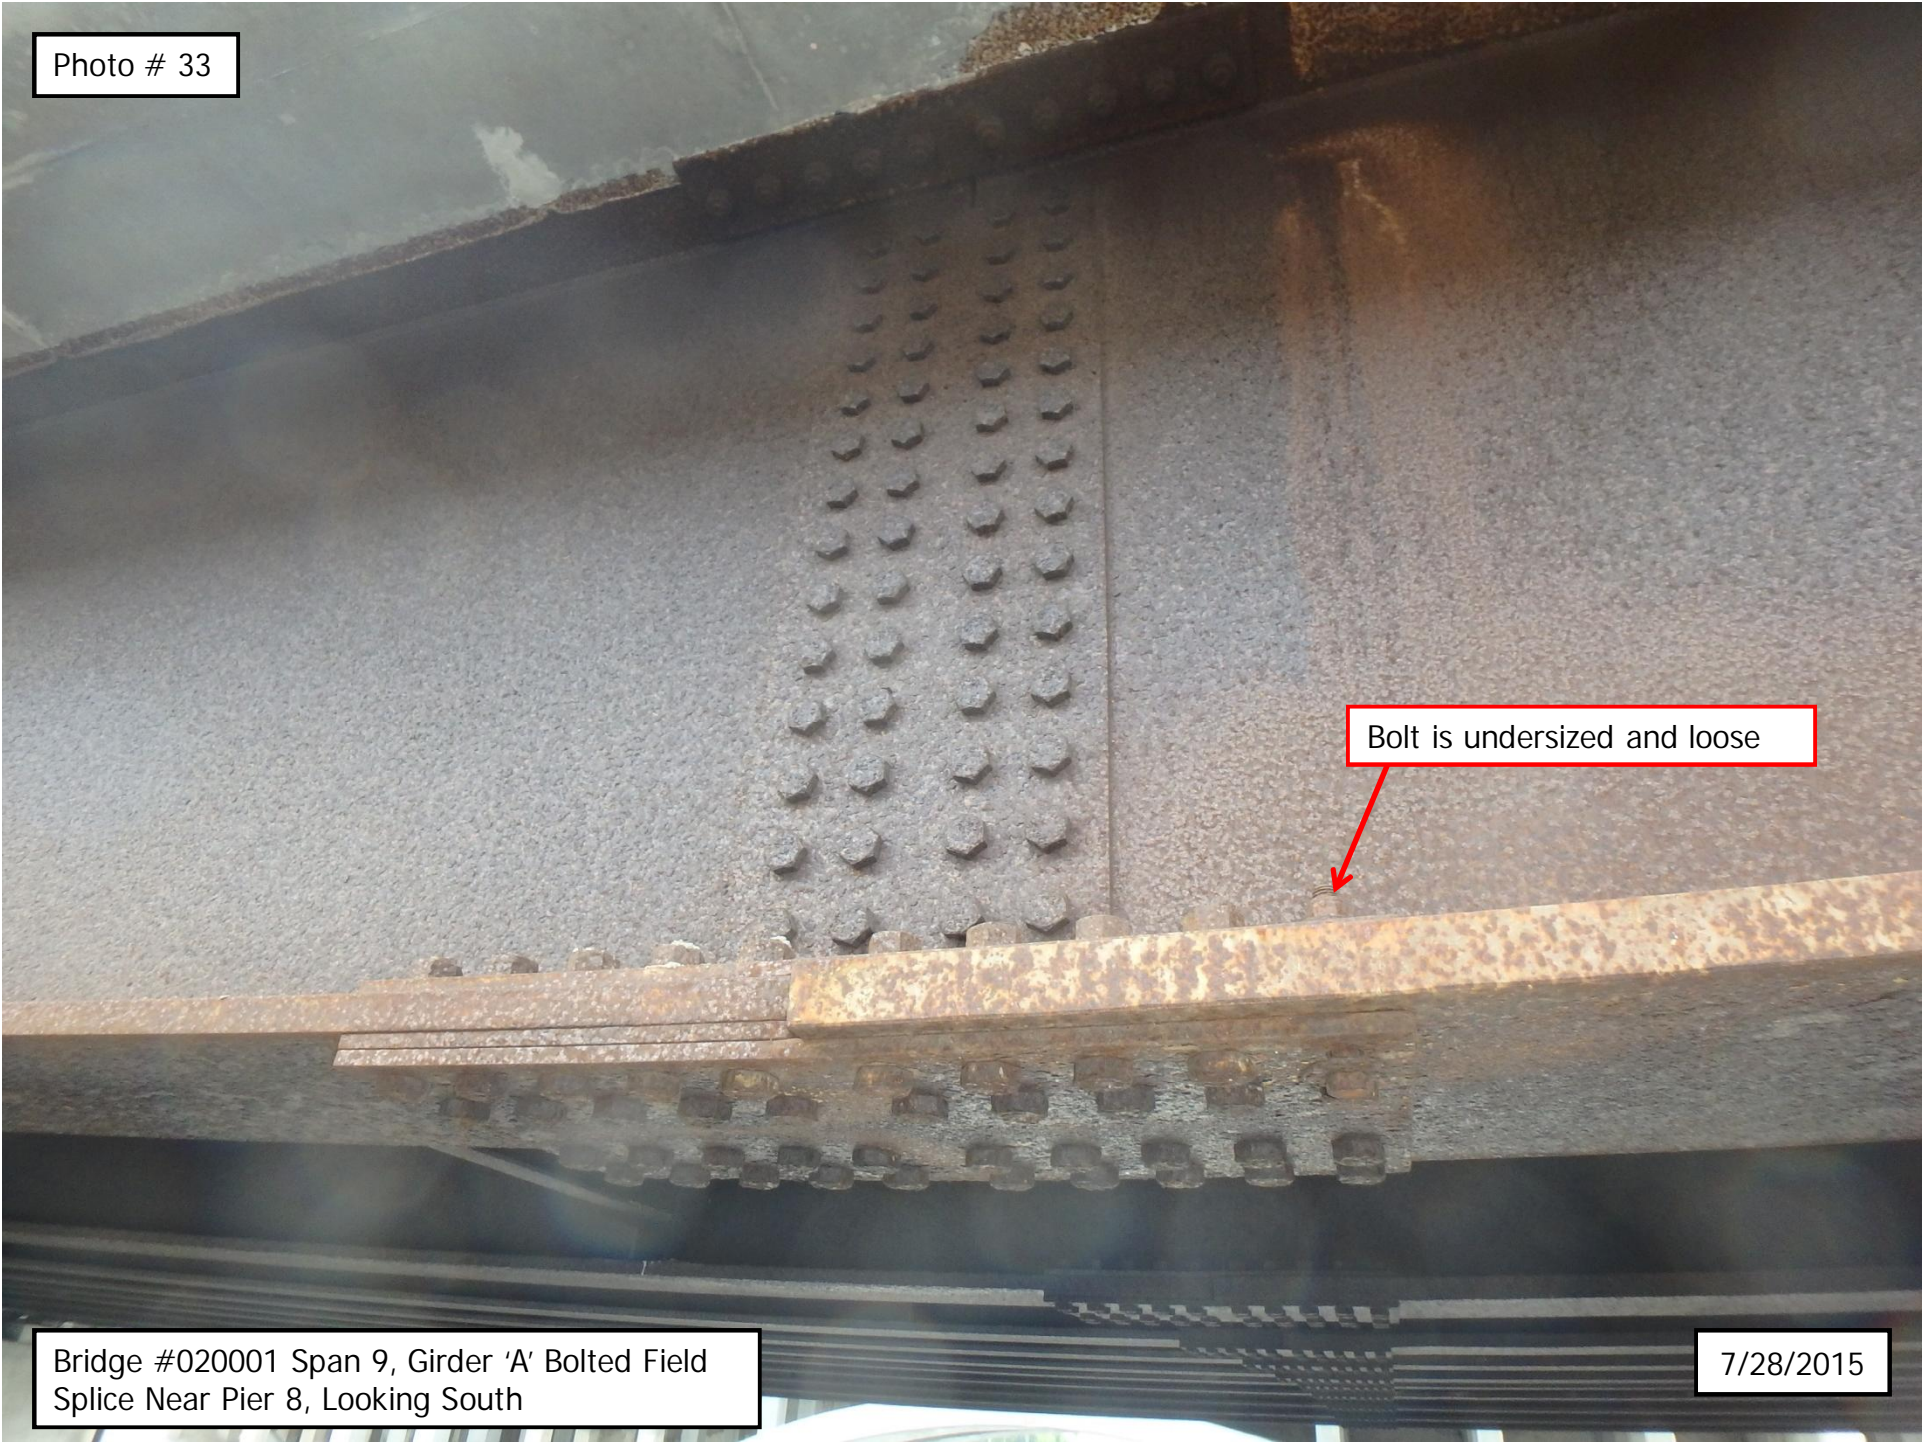
Photo # 33

Bolt is undersized and loose

Bridge #020001 Span 9, Girder 'A' Bolted Field Splice Near Pier 8, Looking South

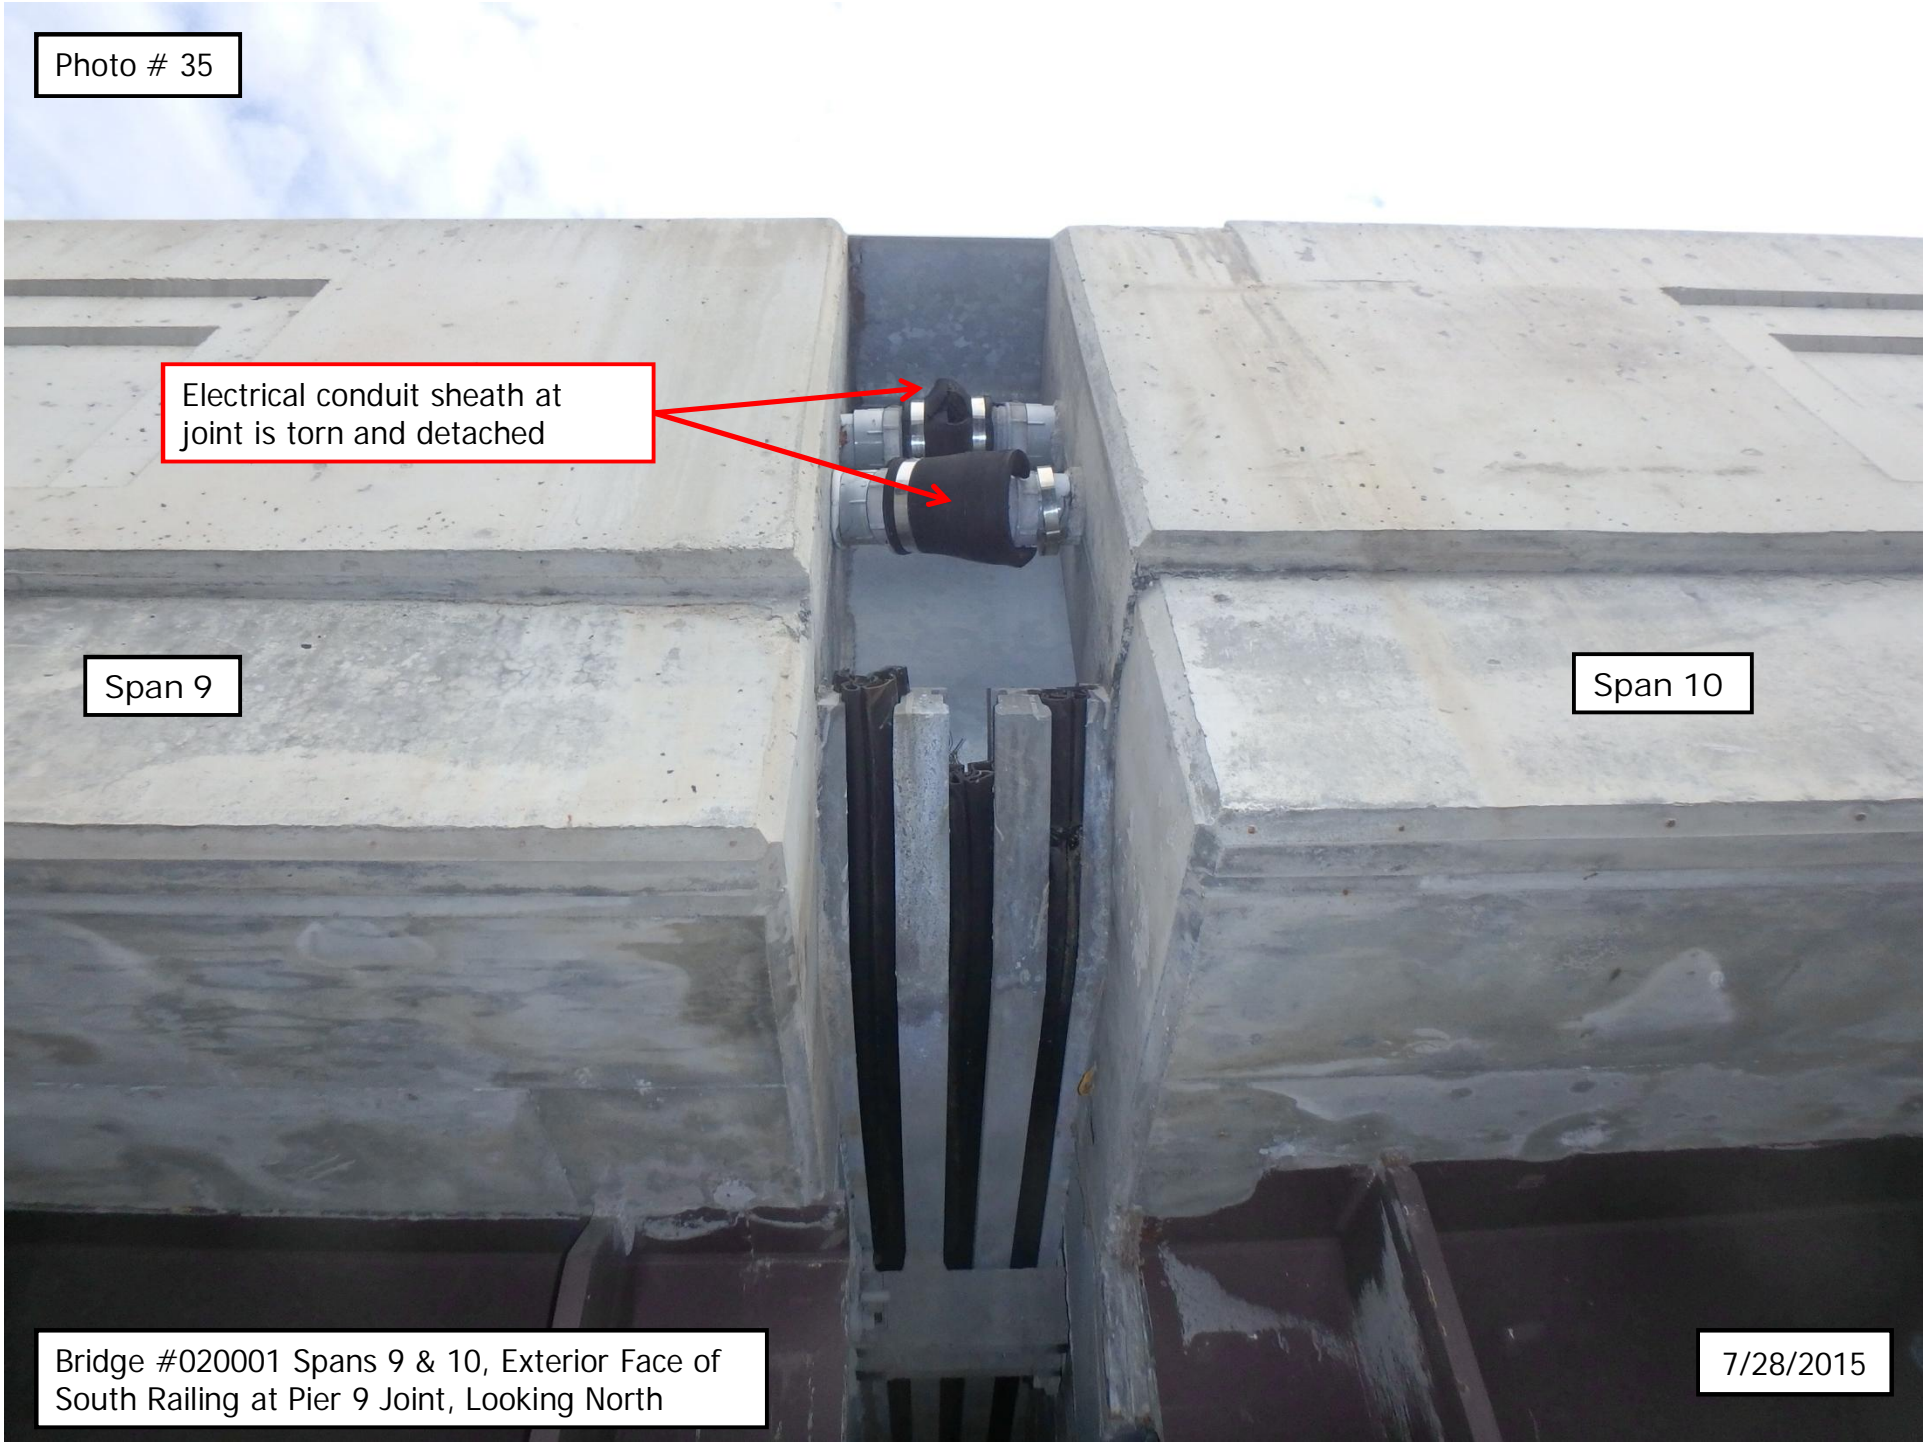
Photo # 35

Electrical conduit sheath at joint is torn and detached

Bridge #020001 Spans 9 & 10, Exterior Face of South Railing at Pier 9 Joint, Looking North

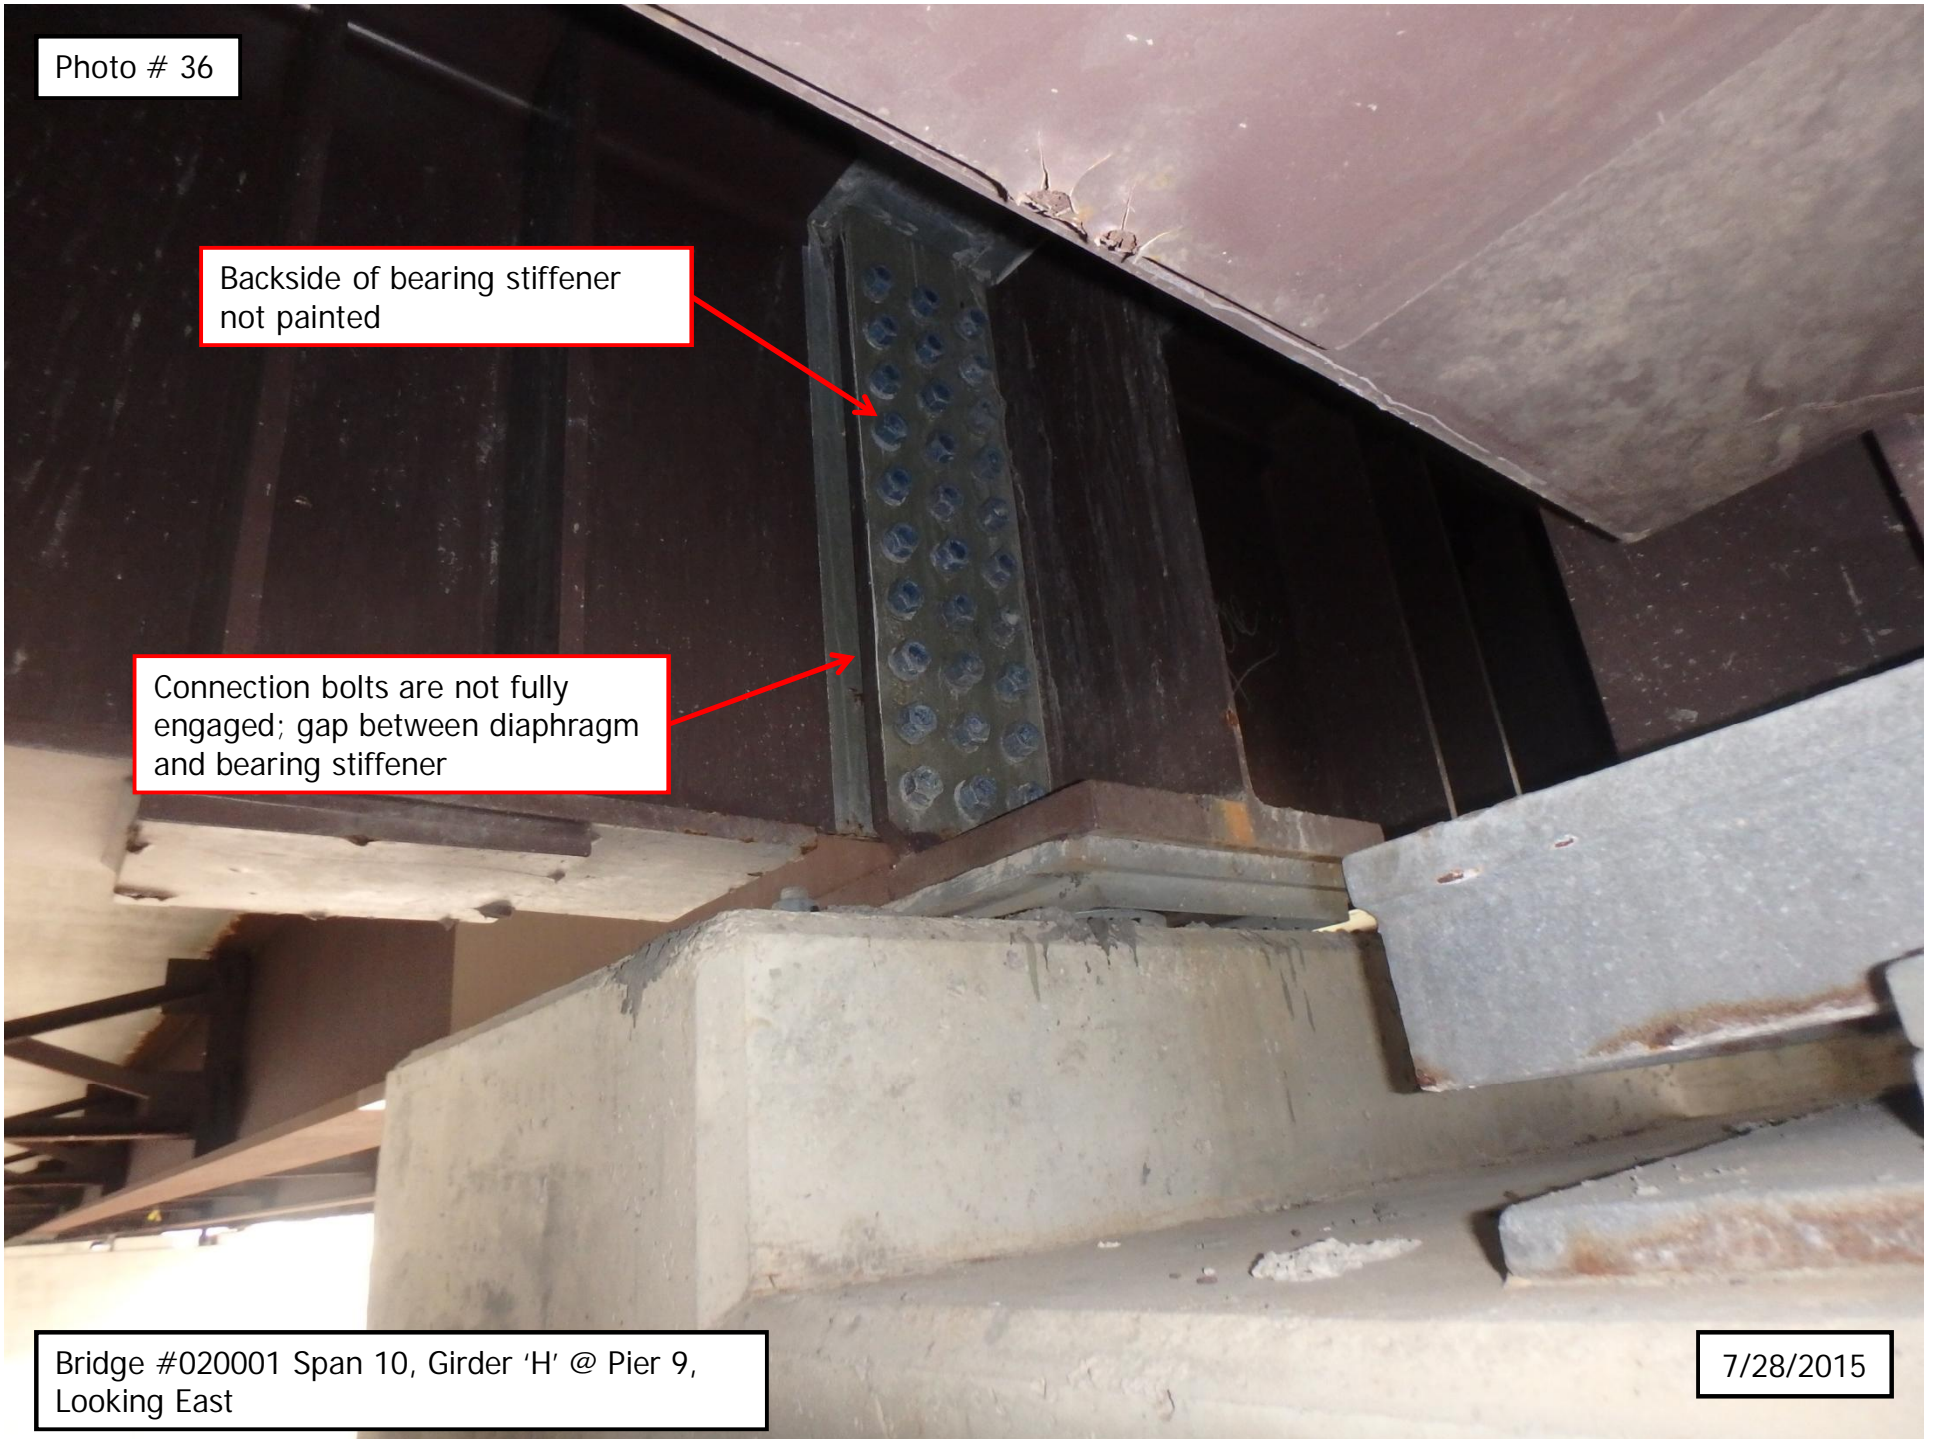
Photo # 36

Backside of bearing stiffener
not painted

Connection bolts are not fully
engaged; gap between diaphragm
and bearing stiffener

Bridge #020001 Span 10, Girder 'H' @ Pier 9,
Looking East

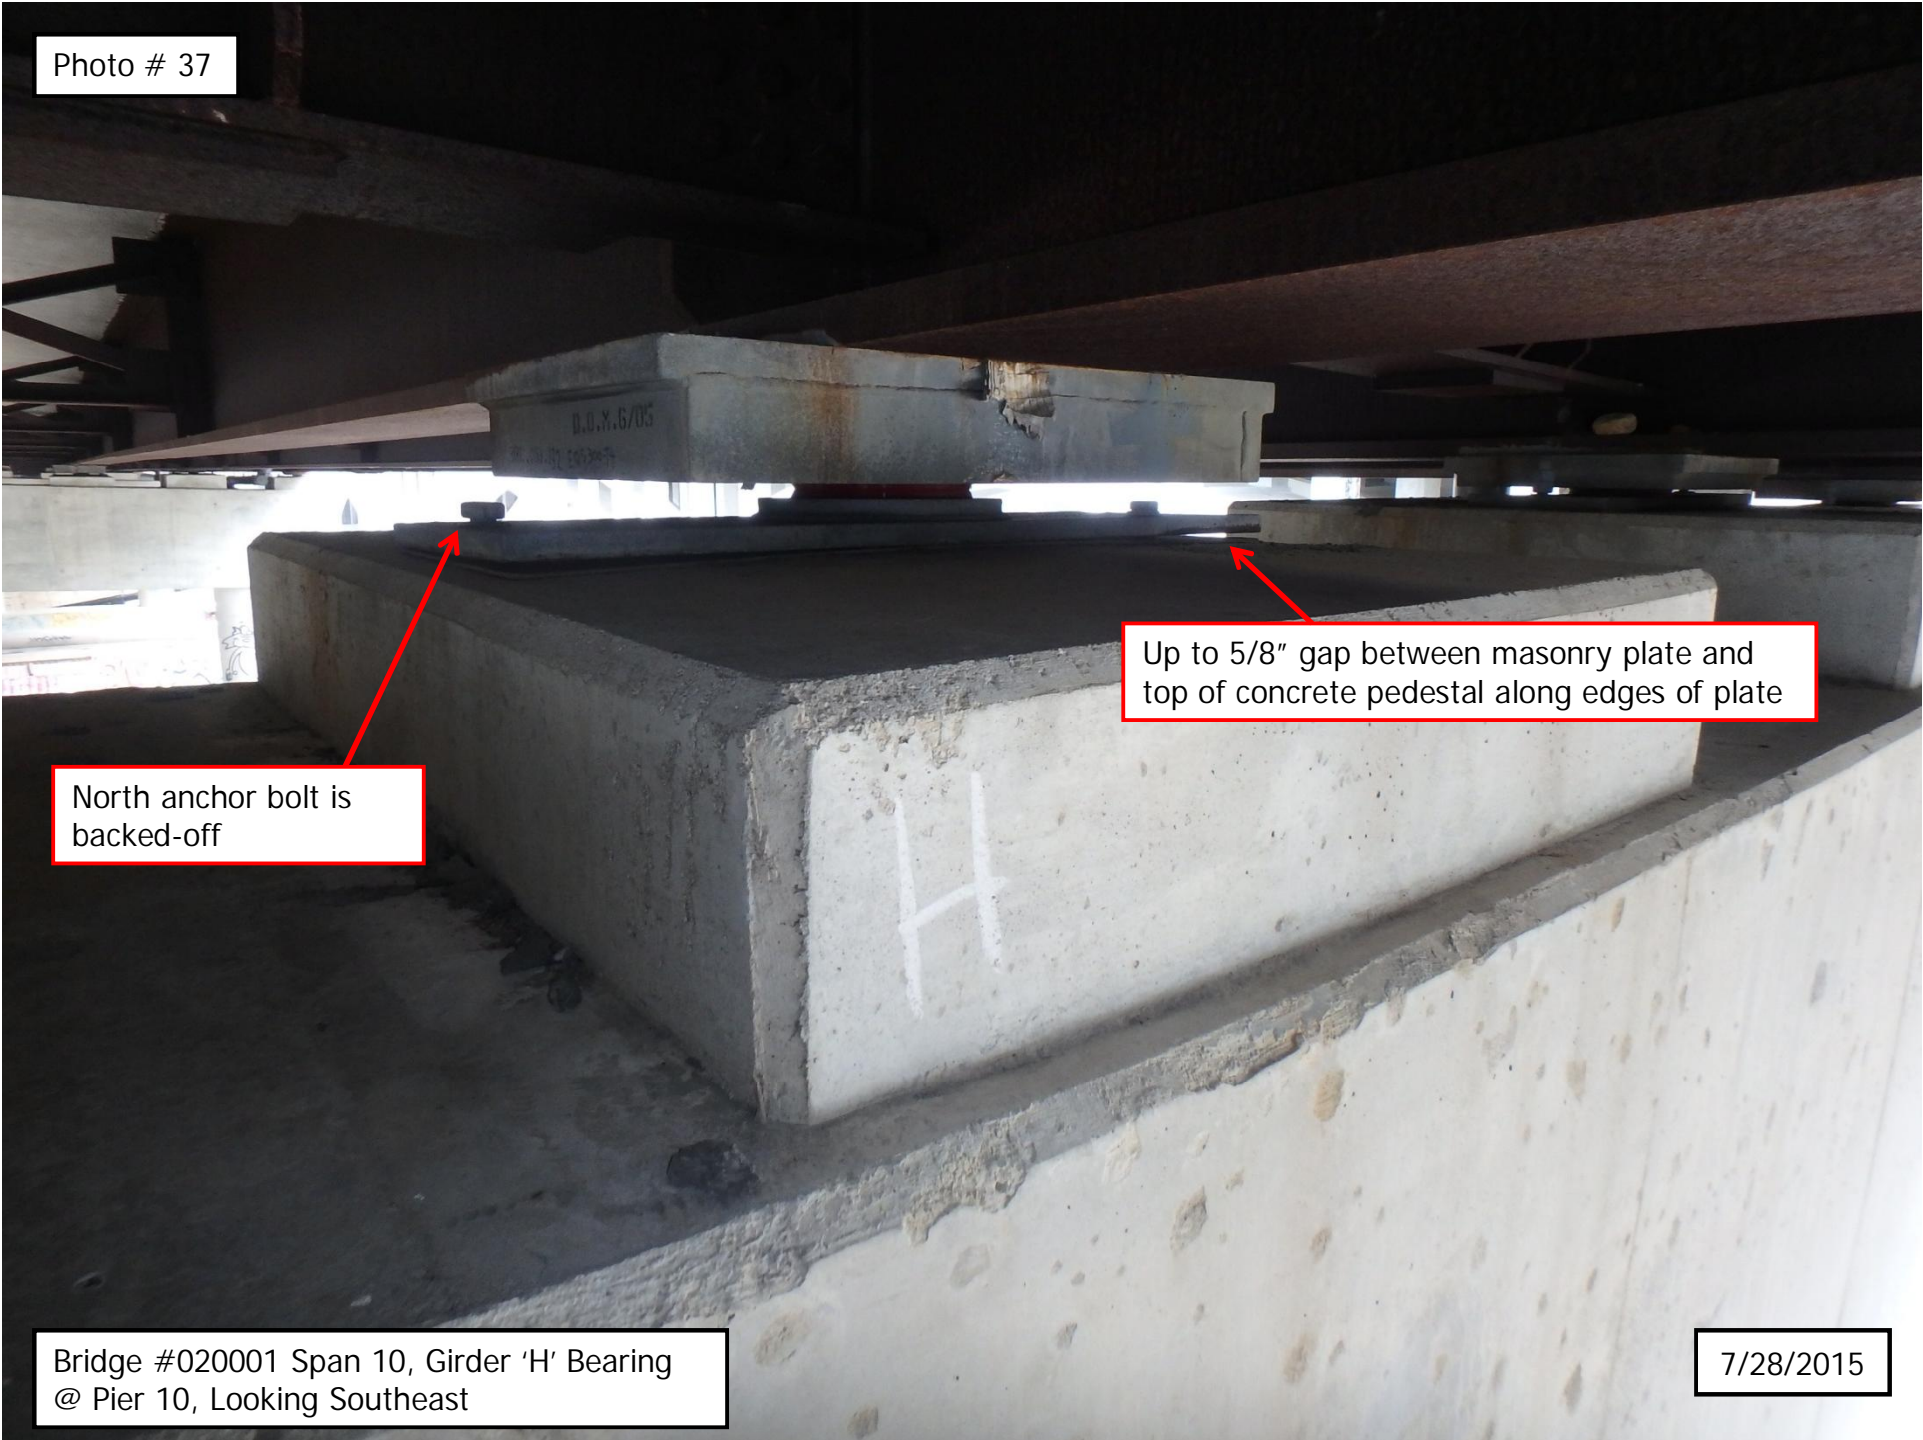
Photo # 37

North anchor bolt is backed-off

Up to 5/8" gap between masonry plate and top of concrete pedestal along edges of plate

Bridge #020001 Span 10, Girder 'H' Bearing @ Pier 10, Looking Southeast

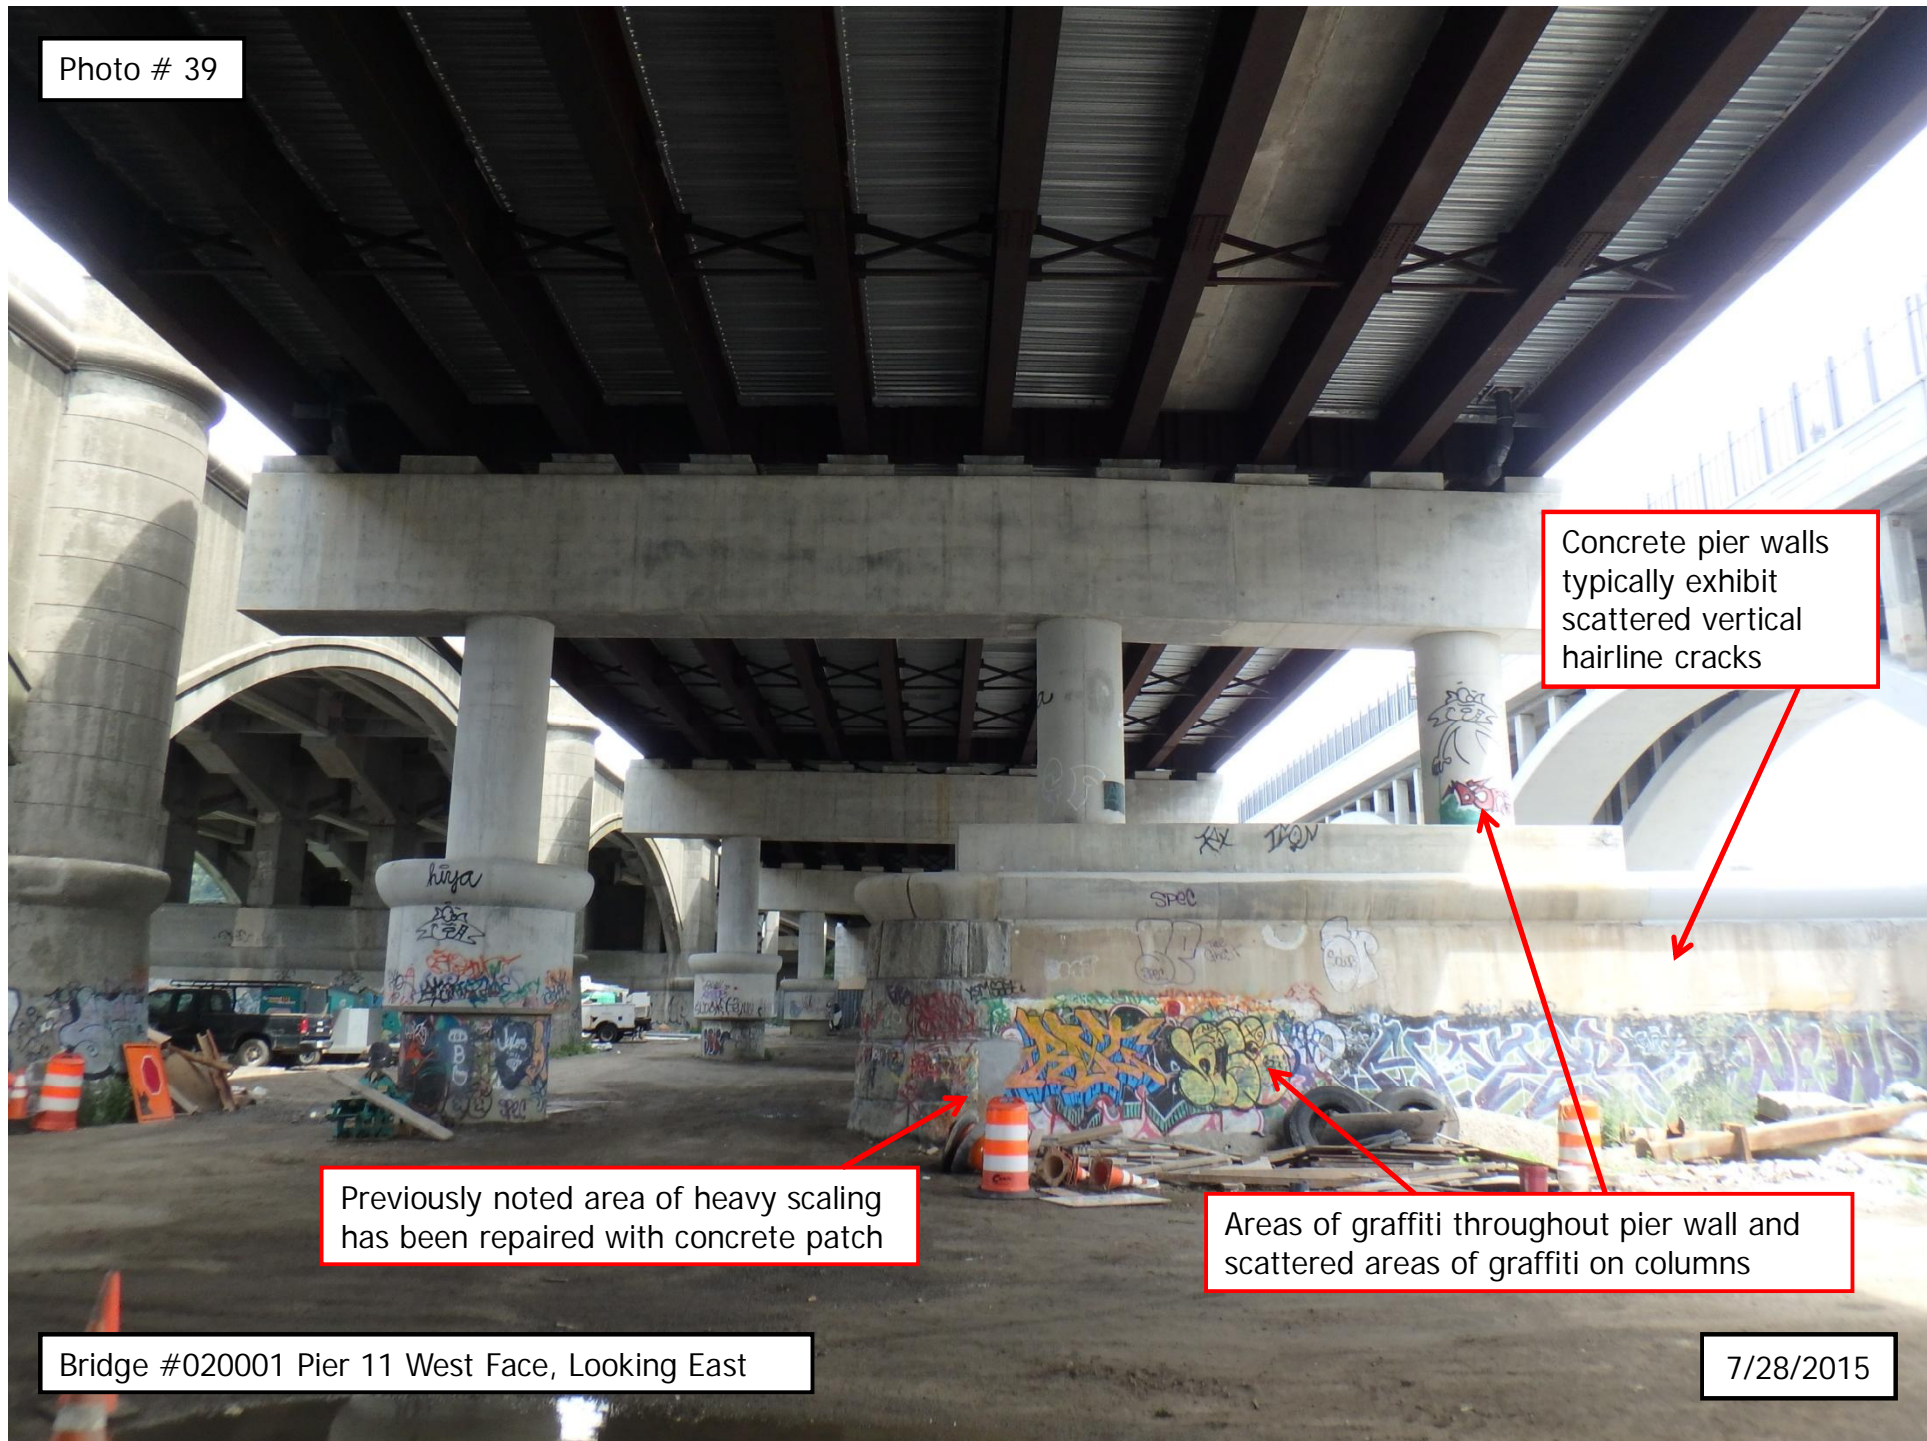
Photo # 39

Concrete pier walls typically exhibit scattered vertical hairline cracks

Previously noted area of heavy scaling has been repaired with concrete patch

Areas of graffiti throughout pier wall and scattered areas of graffiti on columns

Bridge #020001 Pier 11 West Face, Looking East

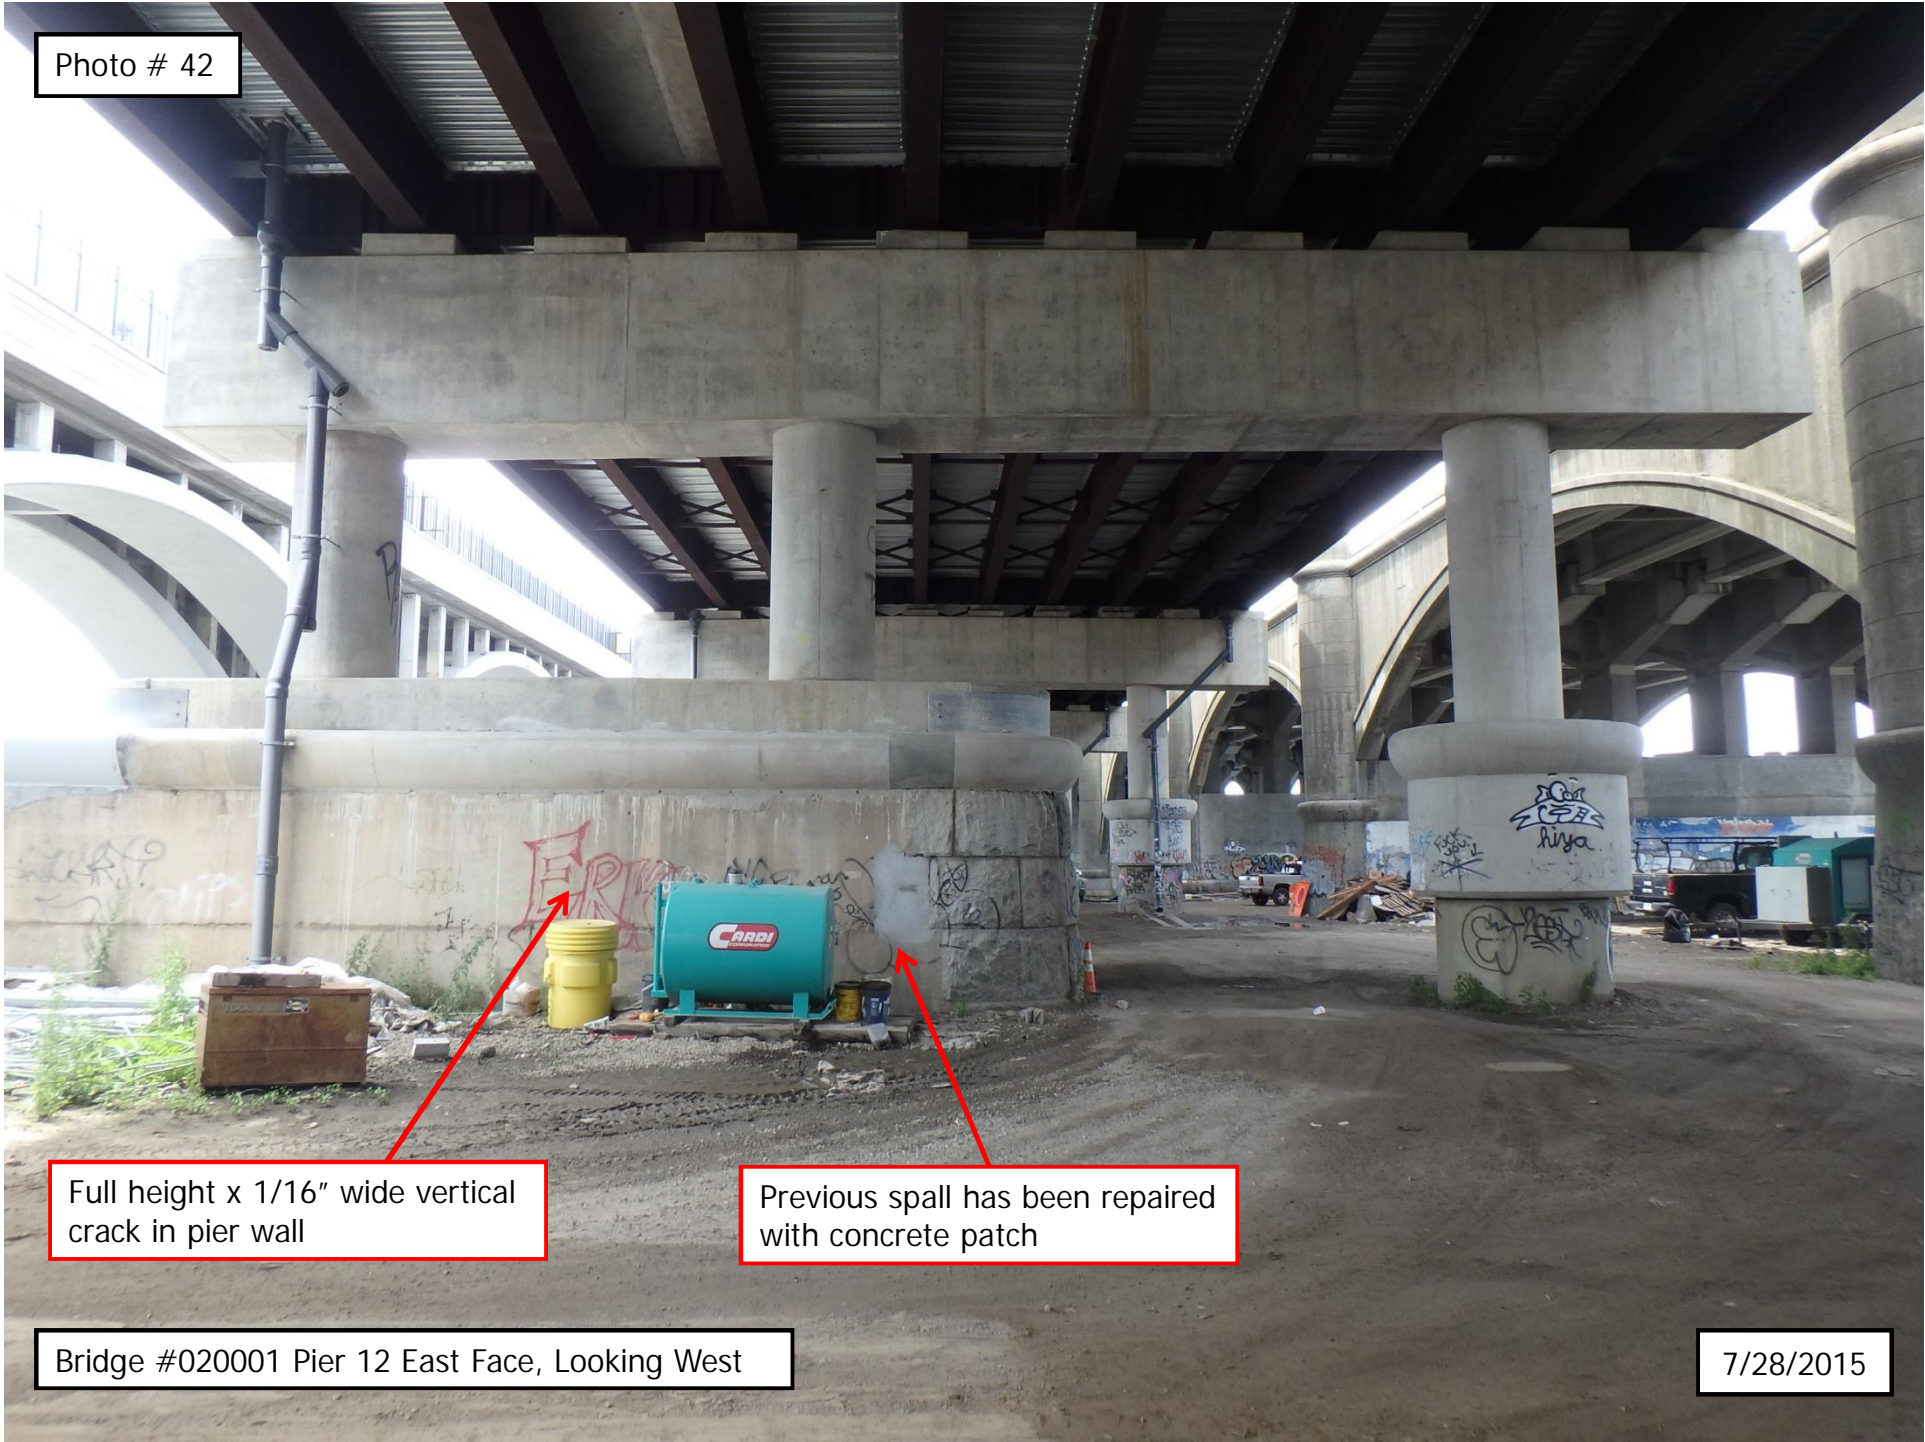
Photo # 42

Full height x 1/16" wide vertical crack in pier wall

Previous spall has been repaired with concrete patch

Bridge #020001 Pier 12 East Face, Looking West
