Bridge #020001 North Elevation, Looking South

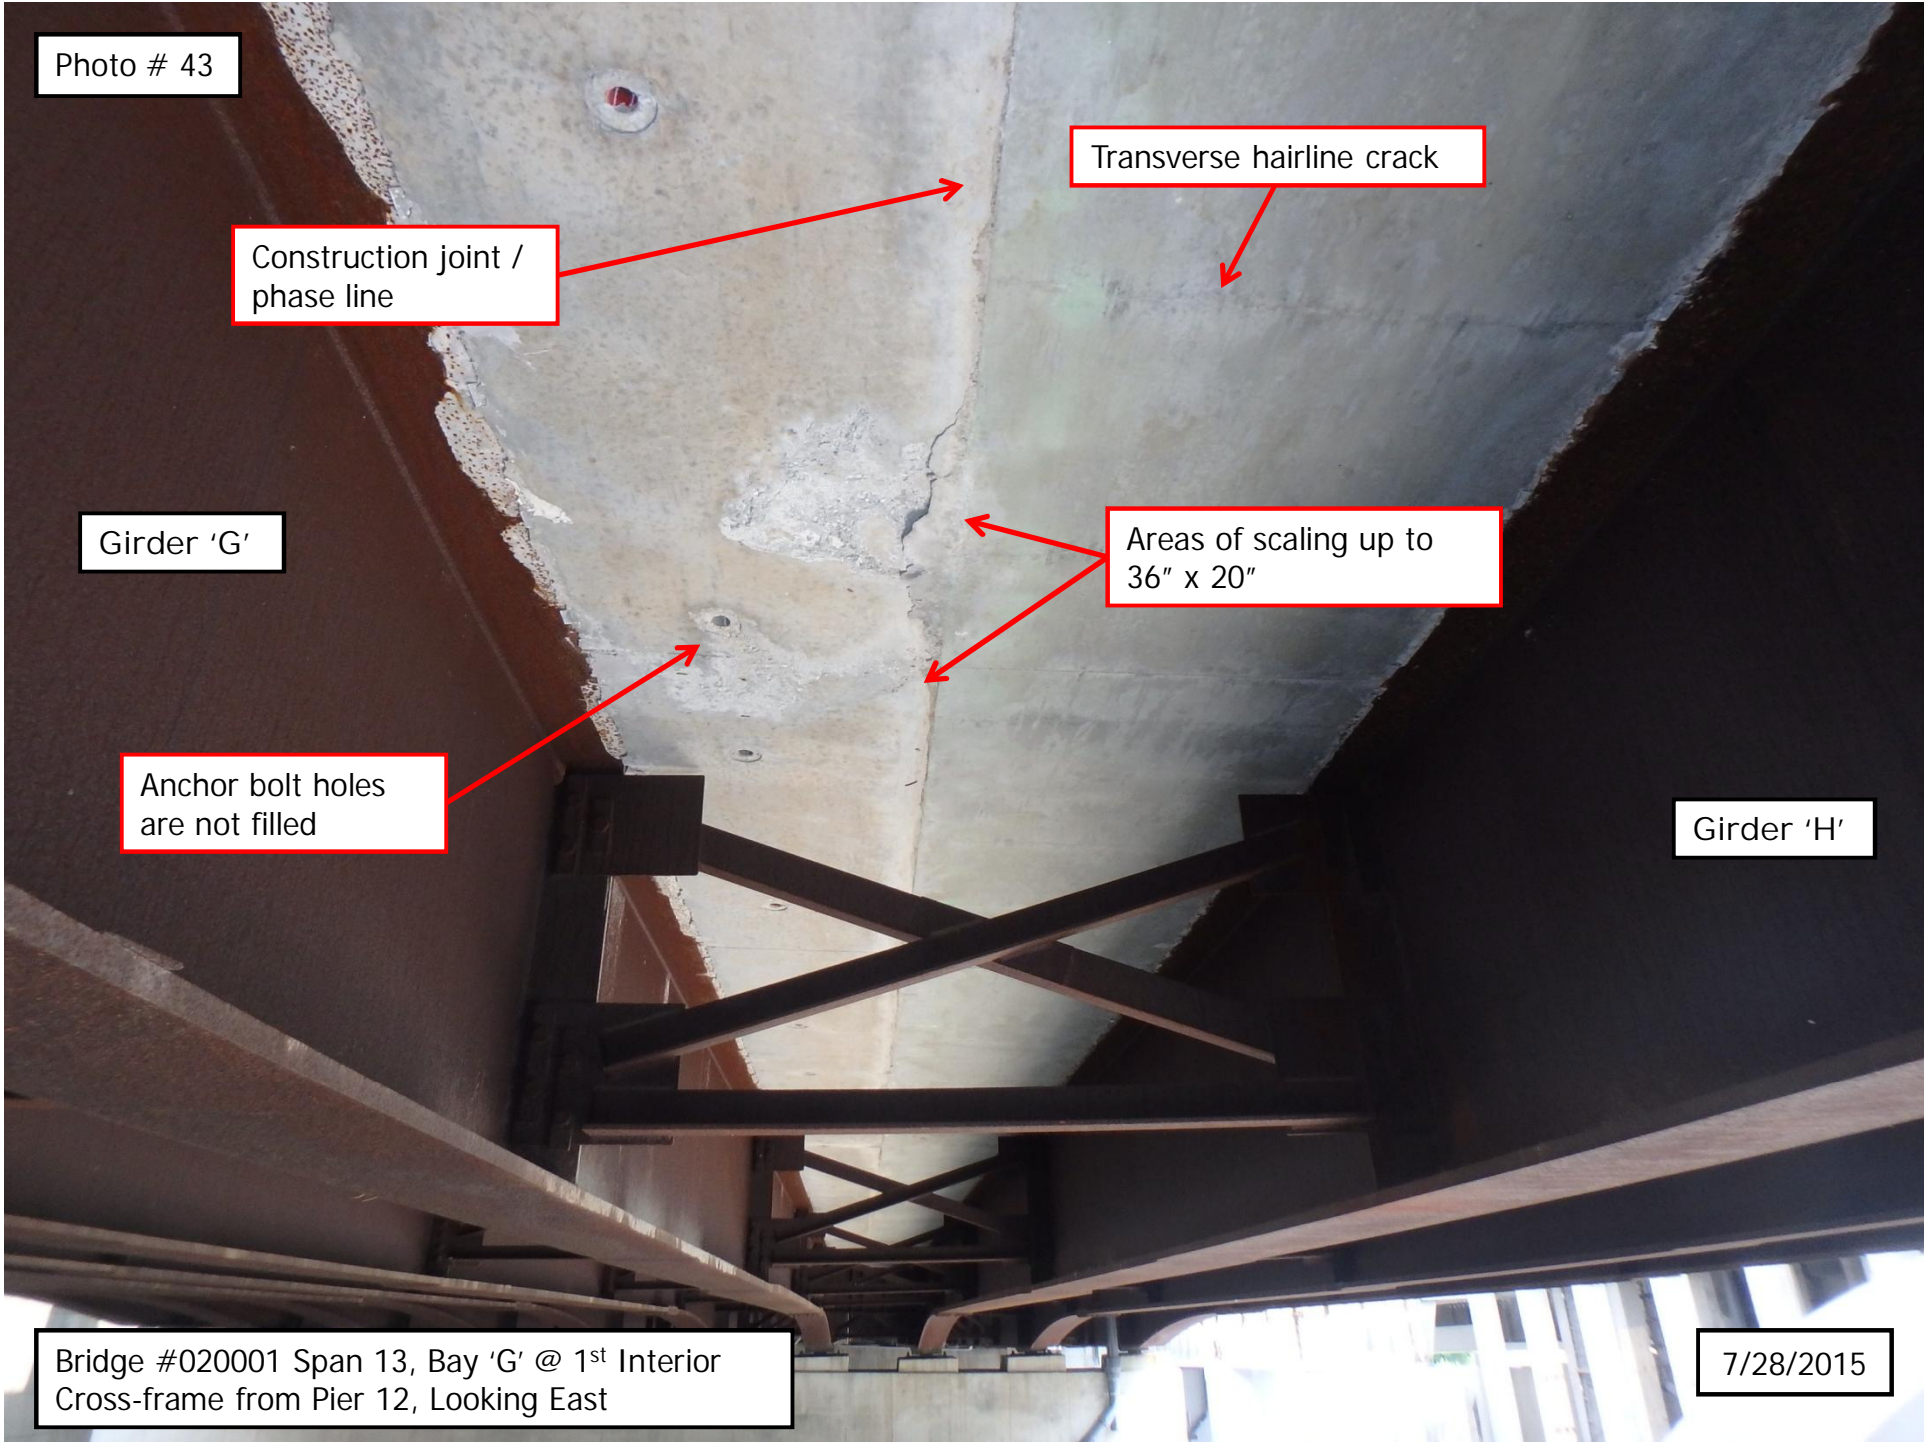
Photo # 43

Transverse hairline crack

Areas of scaling up to
36" x 20"

Anchor bolt holes
are not filled

Bridge #020001 Span 13, Bay 'G' @ 1st Interior
Cross-frame from Pier 12, Looking East

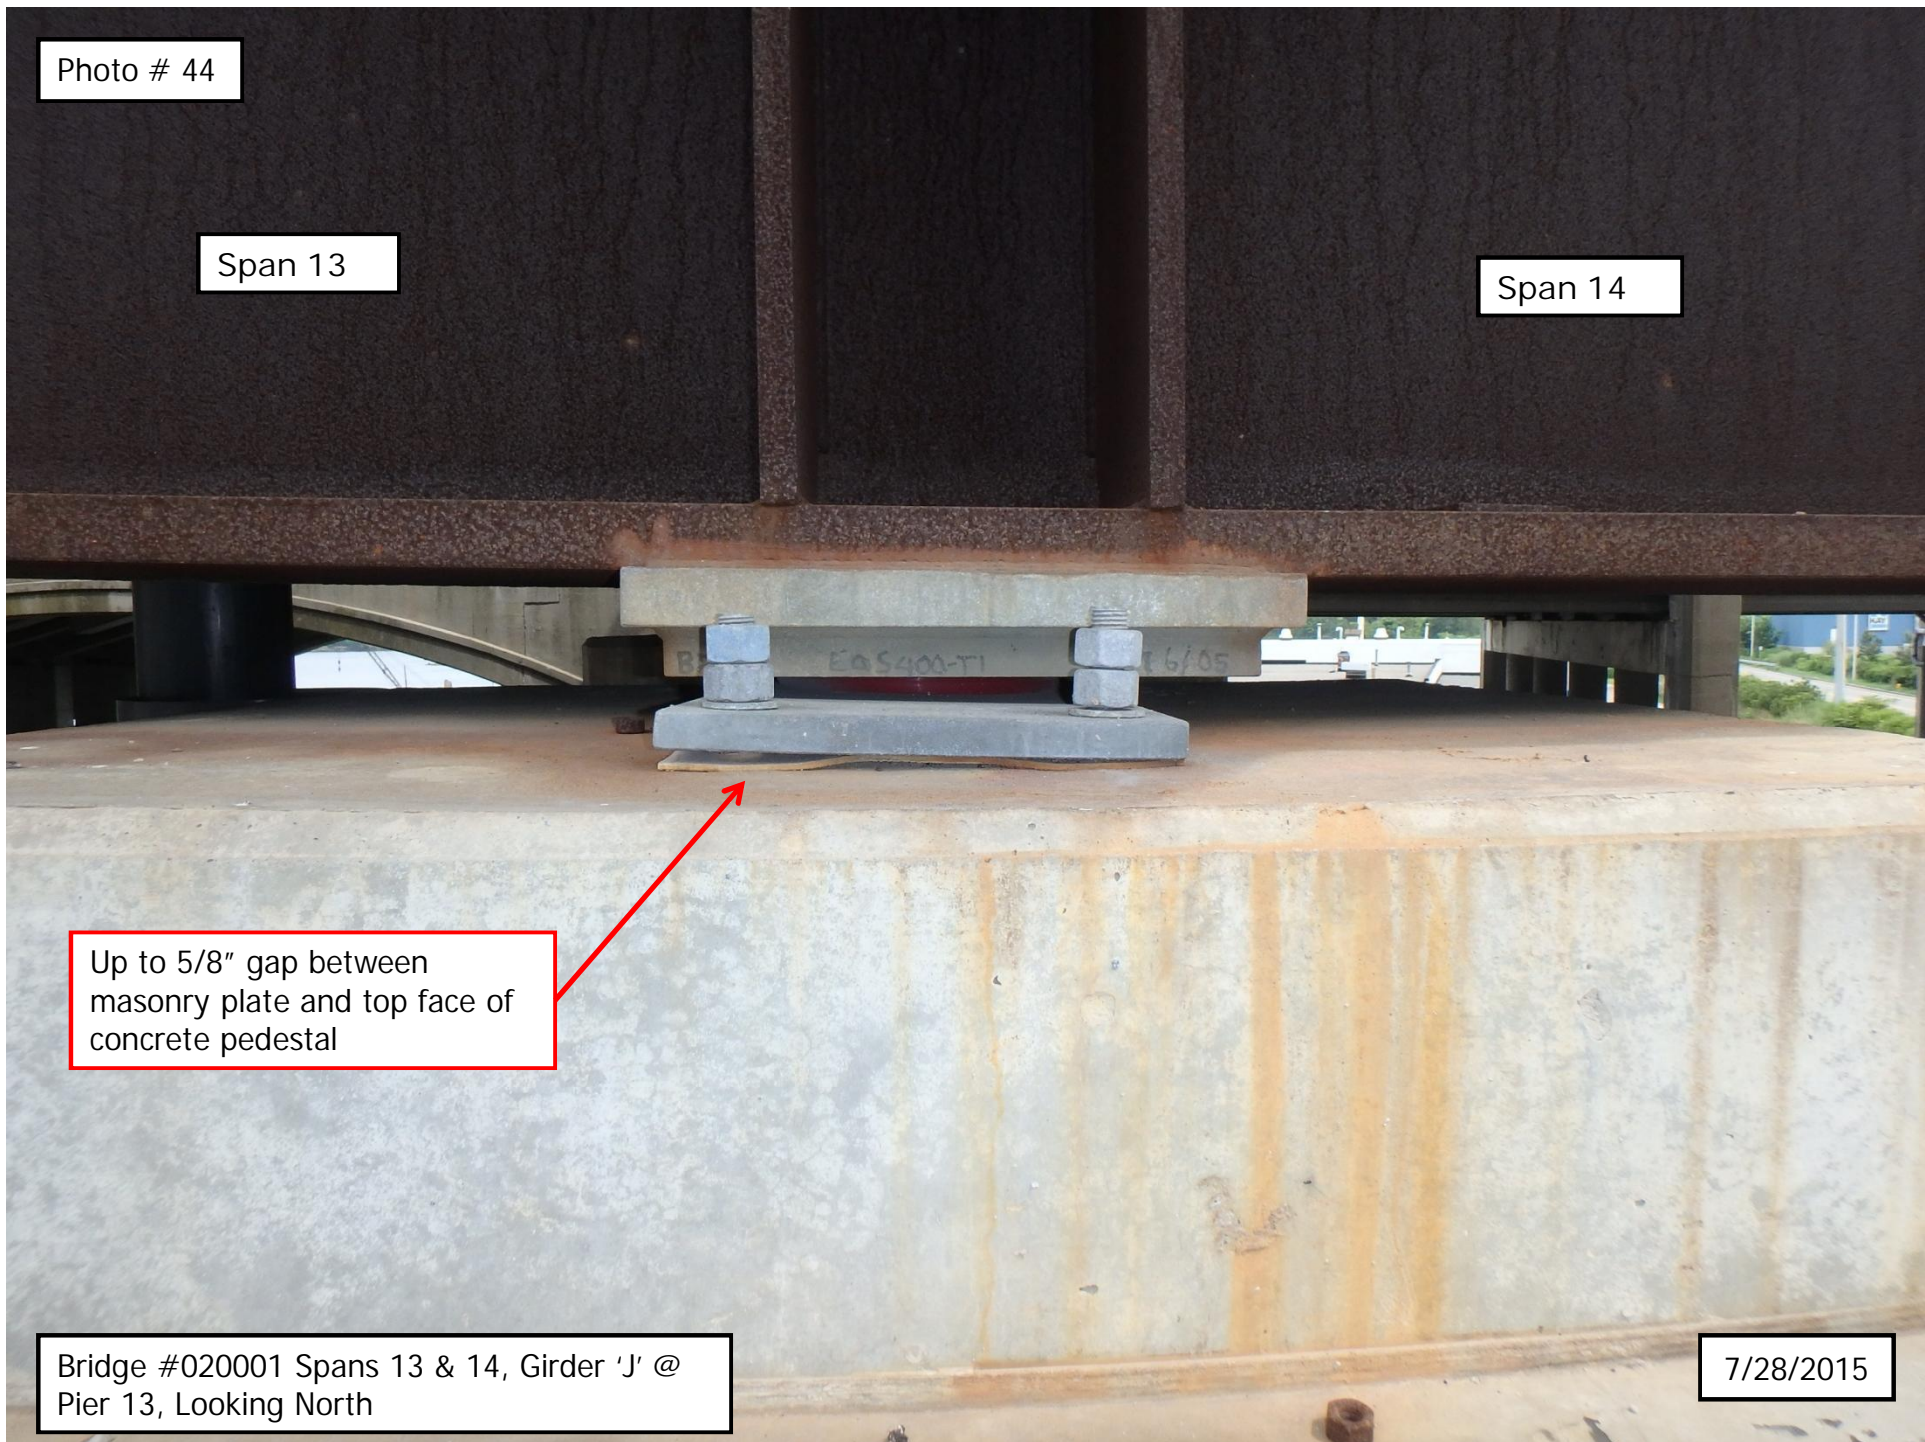
Photo # 44

Up to 5/8" gap between
masonry plate and top face of
concrete pedestal

Bridge #020001 Spans 13 & 14, Girder 'J' @
Pier 13, Looking North

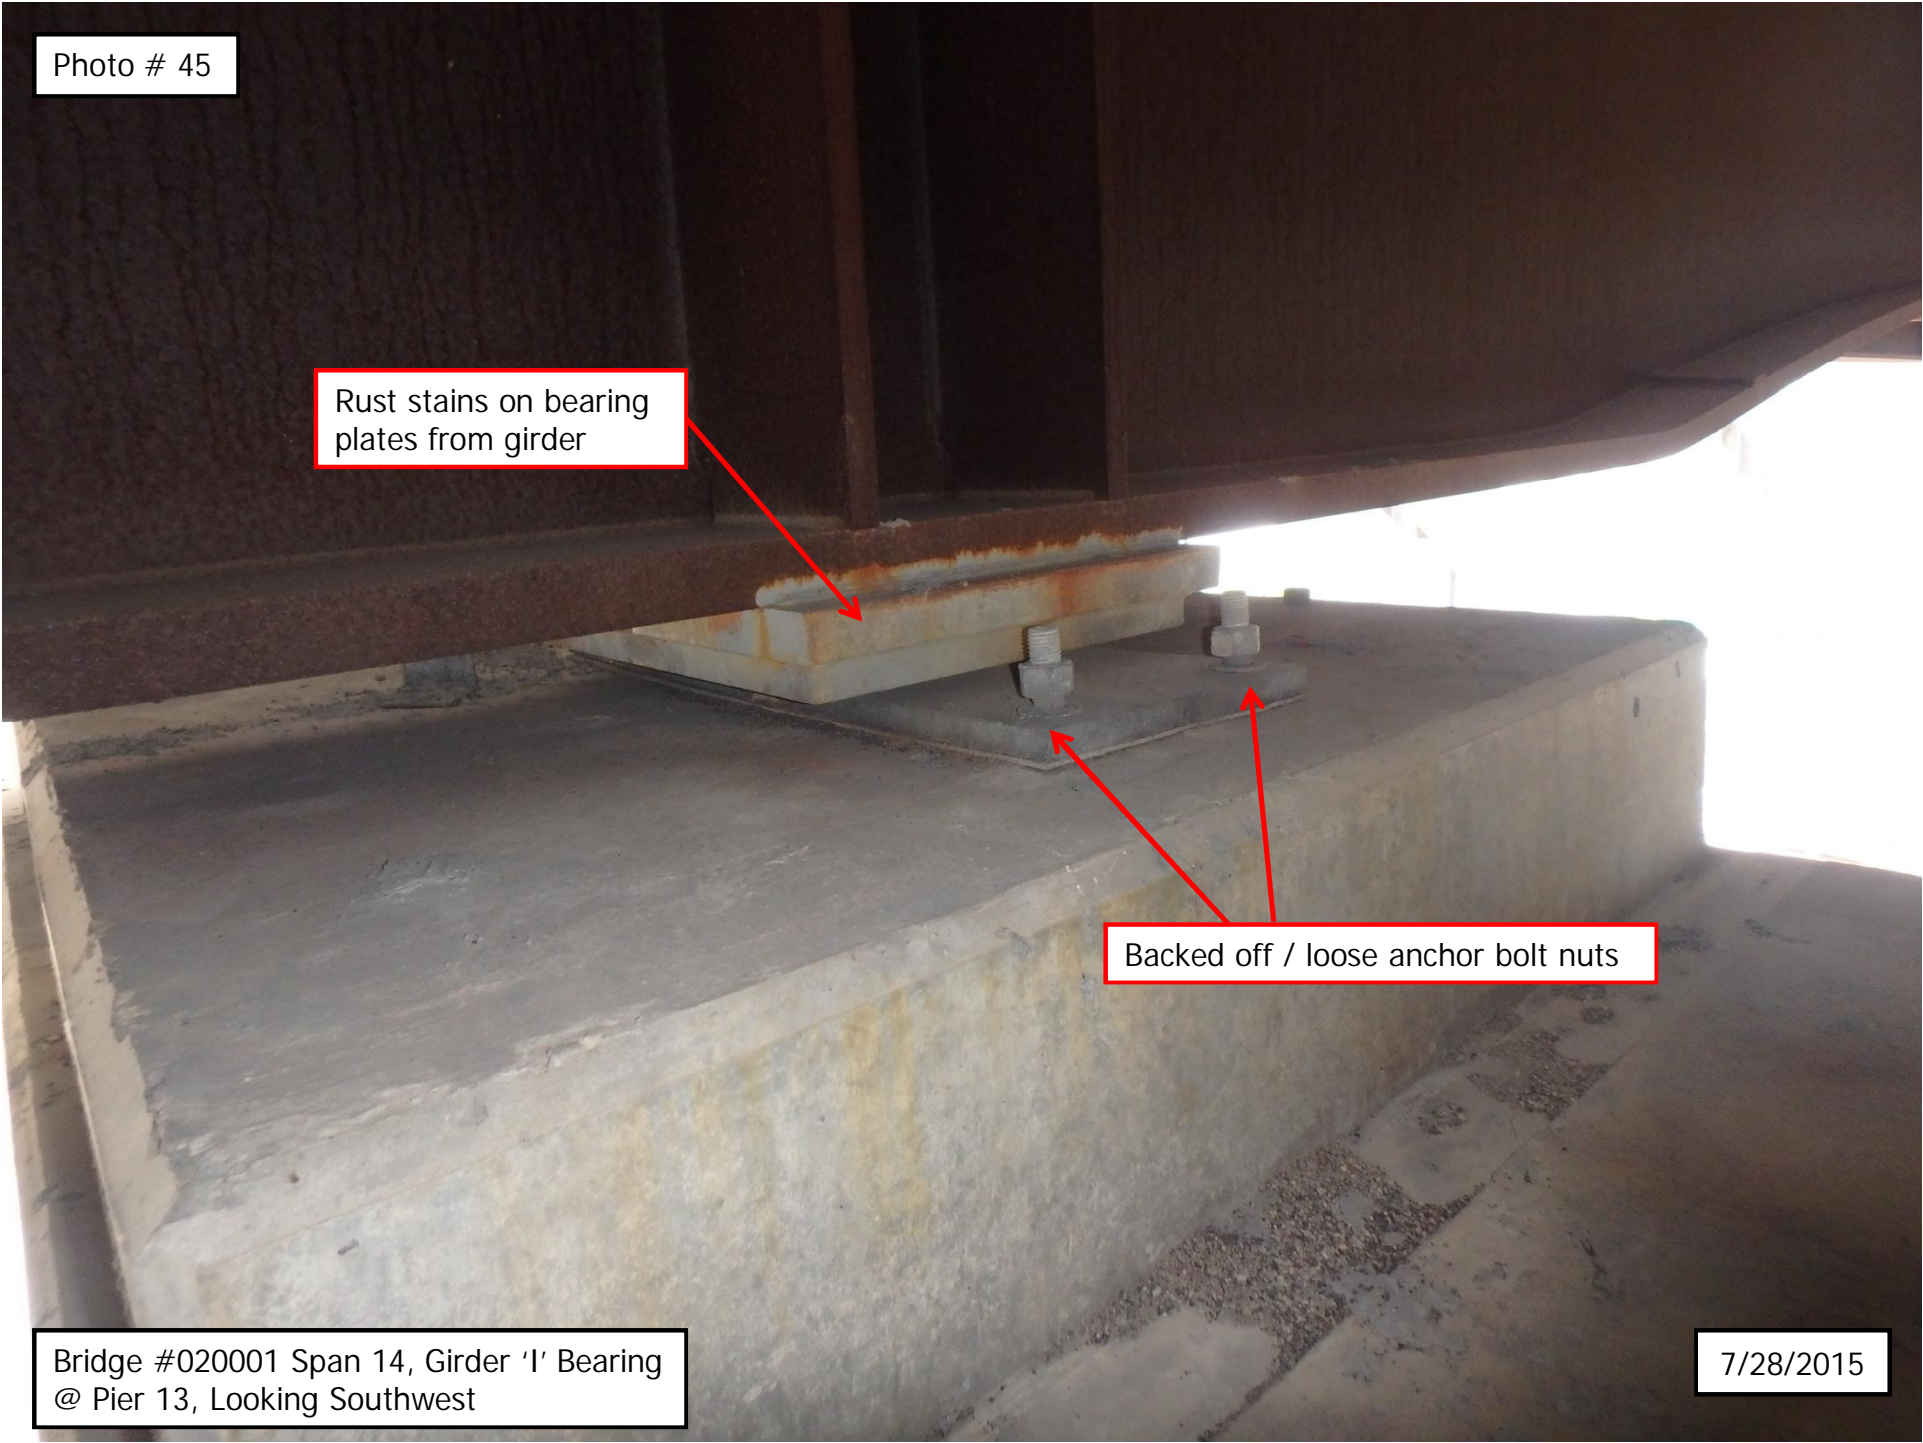
Photo # 45

Rust stains on bearing plates from girder

Backed off / loose anchor bolt nuts

Bridge #020001 Span 14, Girder 'I' Bearing @ Pier 13, Looking Southwest

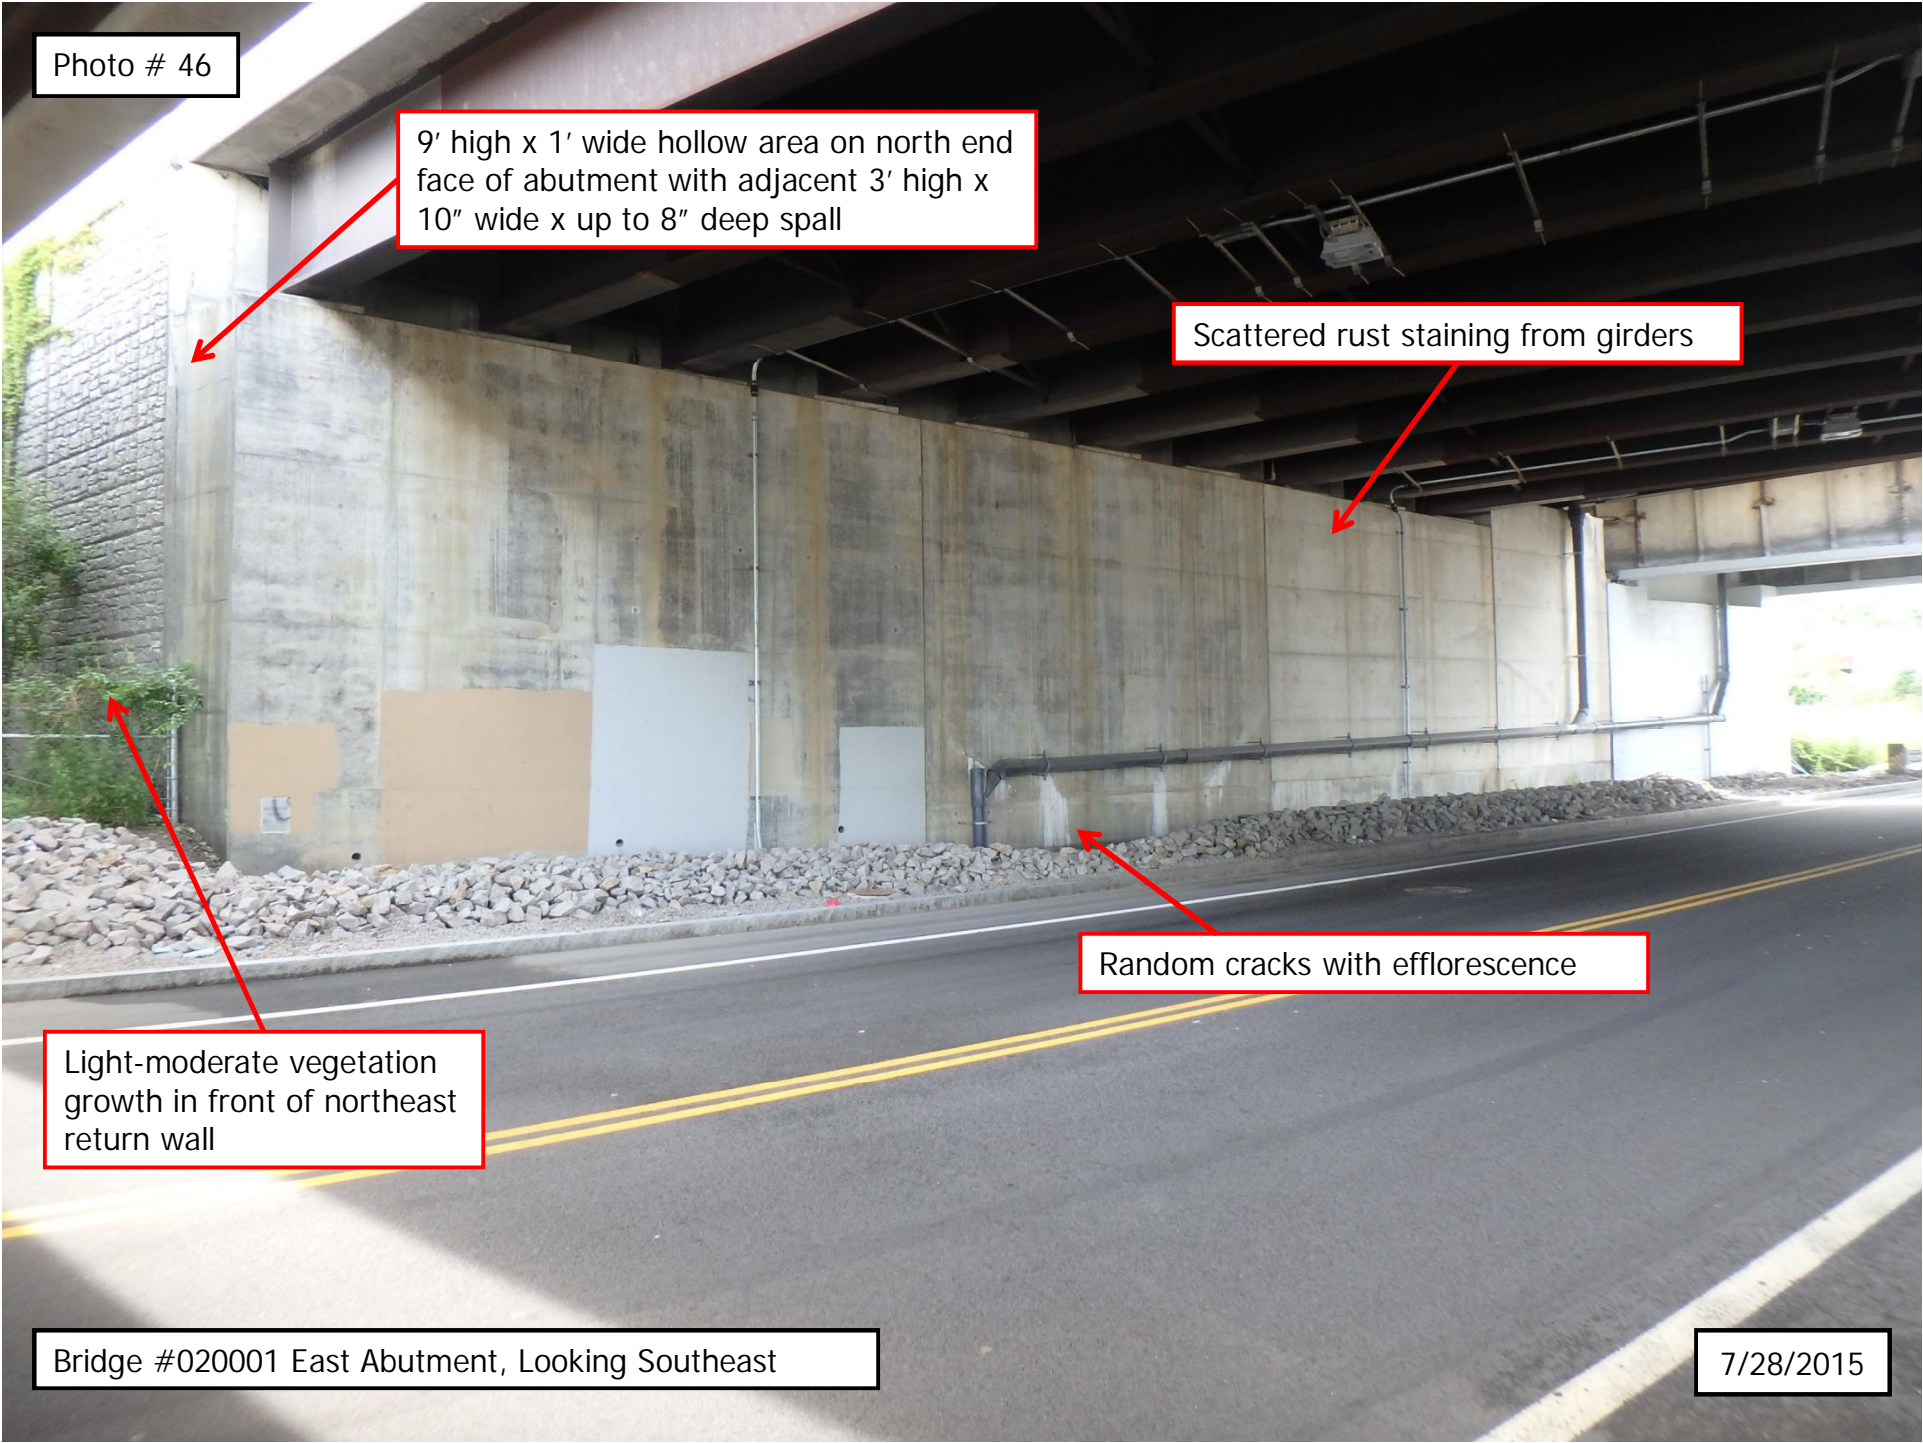
Photo # 46

9' high x 1' wide hollow area on north end face of abutment with adjacent 3' high x 10" wide x up to 8" deep spall

Scattered rust staining from girders

Random cracks with efflorescence

Light-moderate vegetation growth in front of northeast return wall

Bridge #020001 East Abutment, Looking Southeast

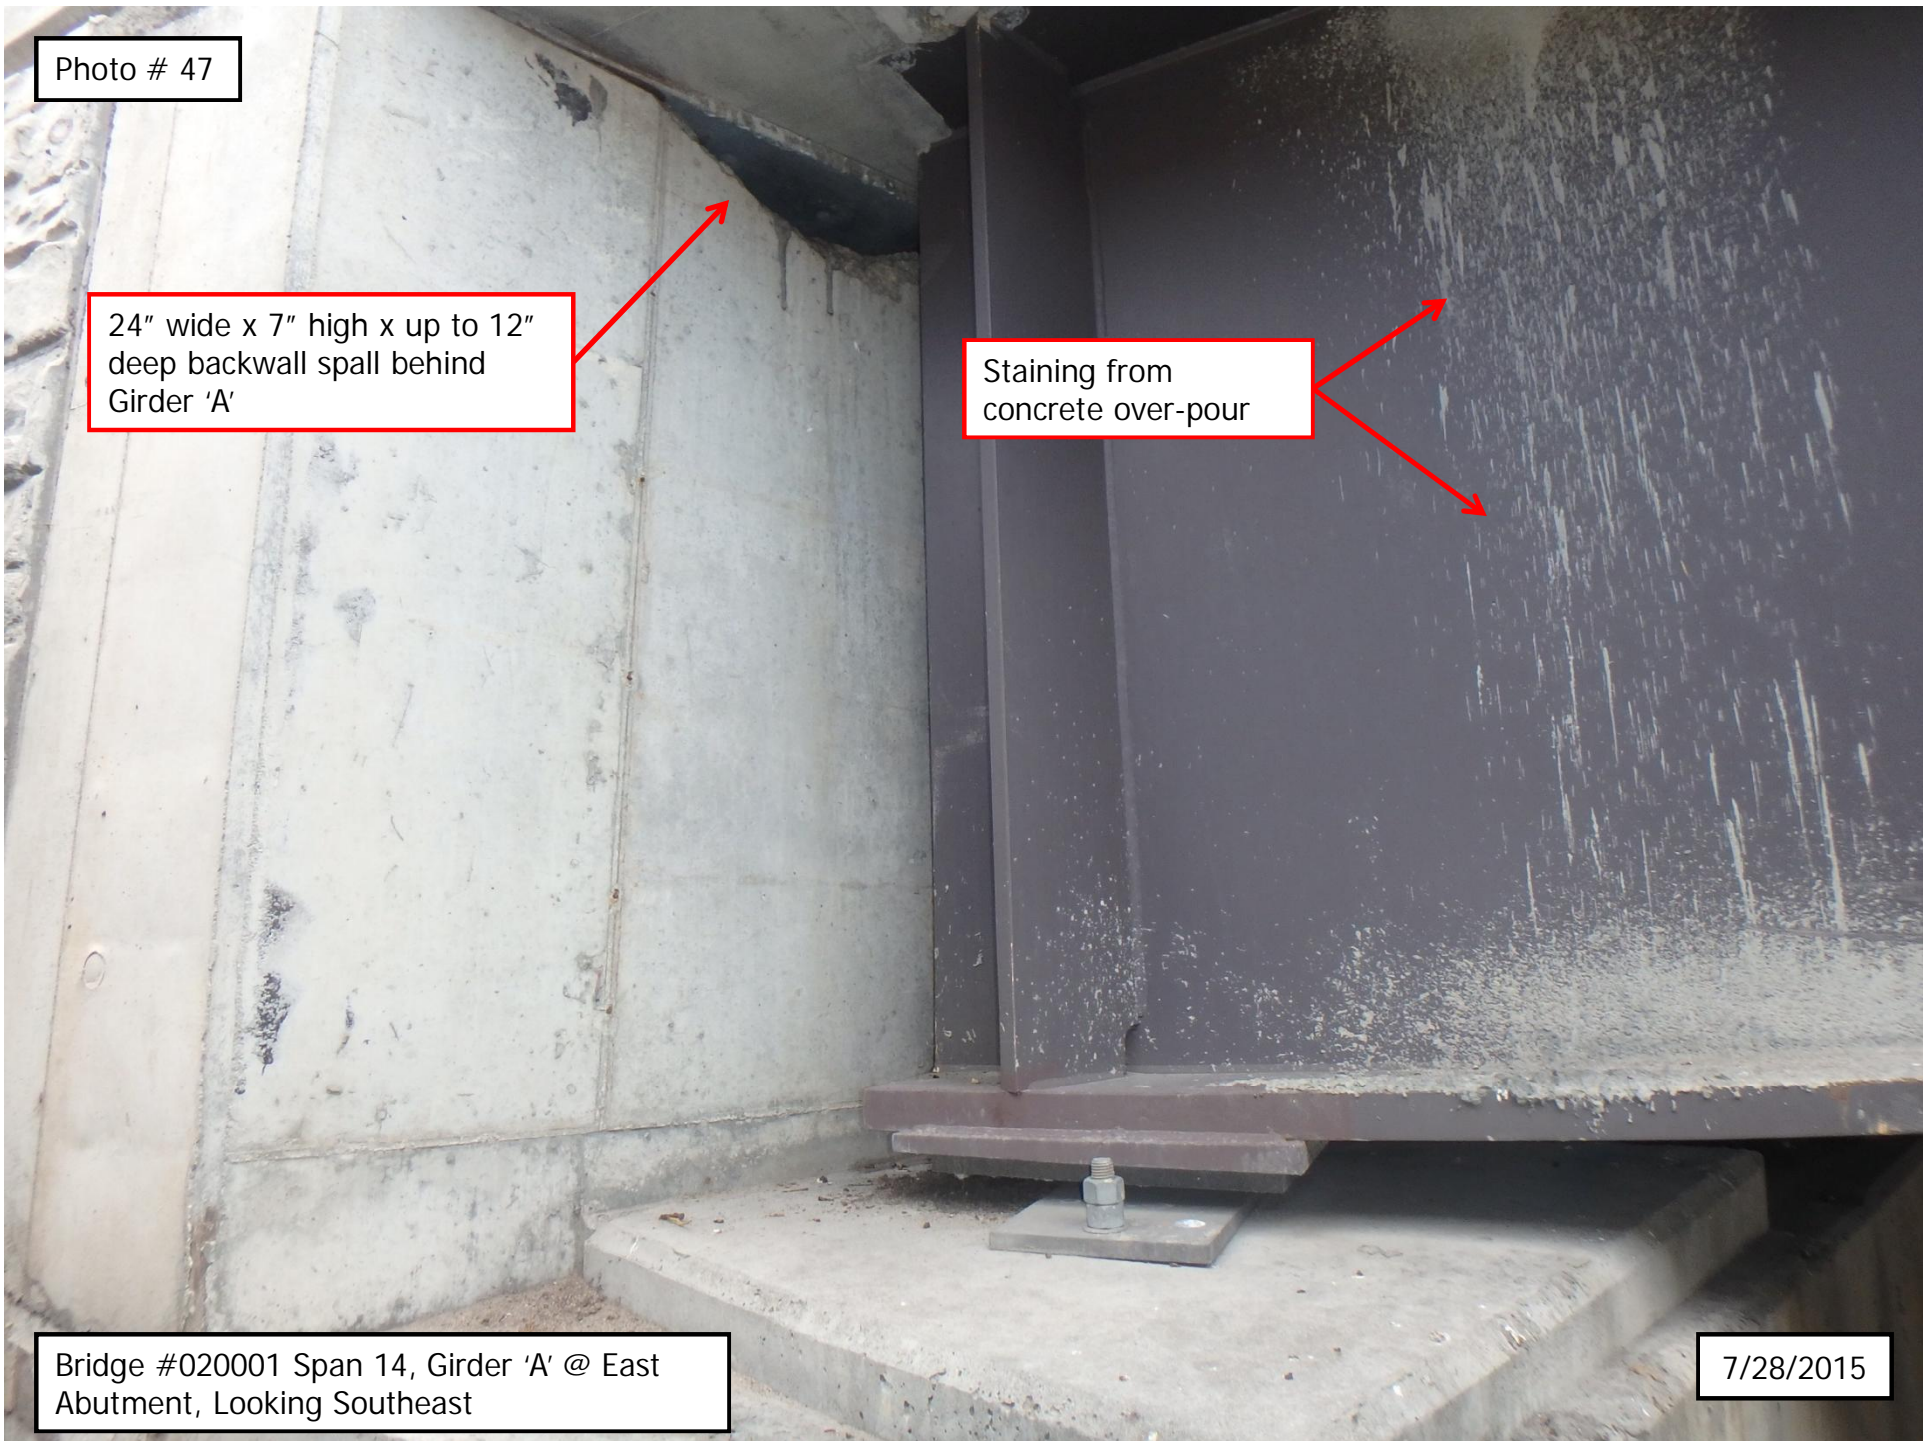
Photo # 47

24" wide x 7" high x up to 12" deep backwall spall behind Girder 'A'

Staining from concrete over-pour

Bridge #020001 Span 14, Girder 'A' @ East Abutment, Looking Southeast

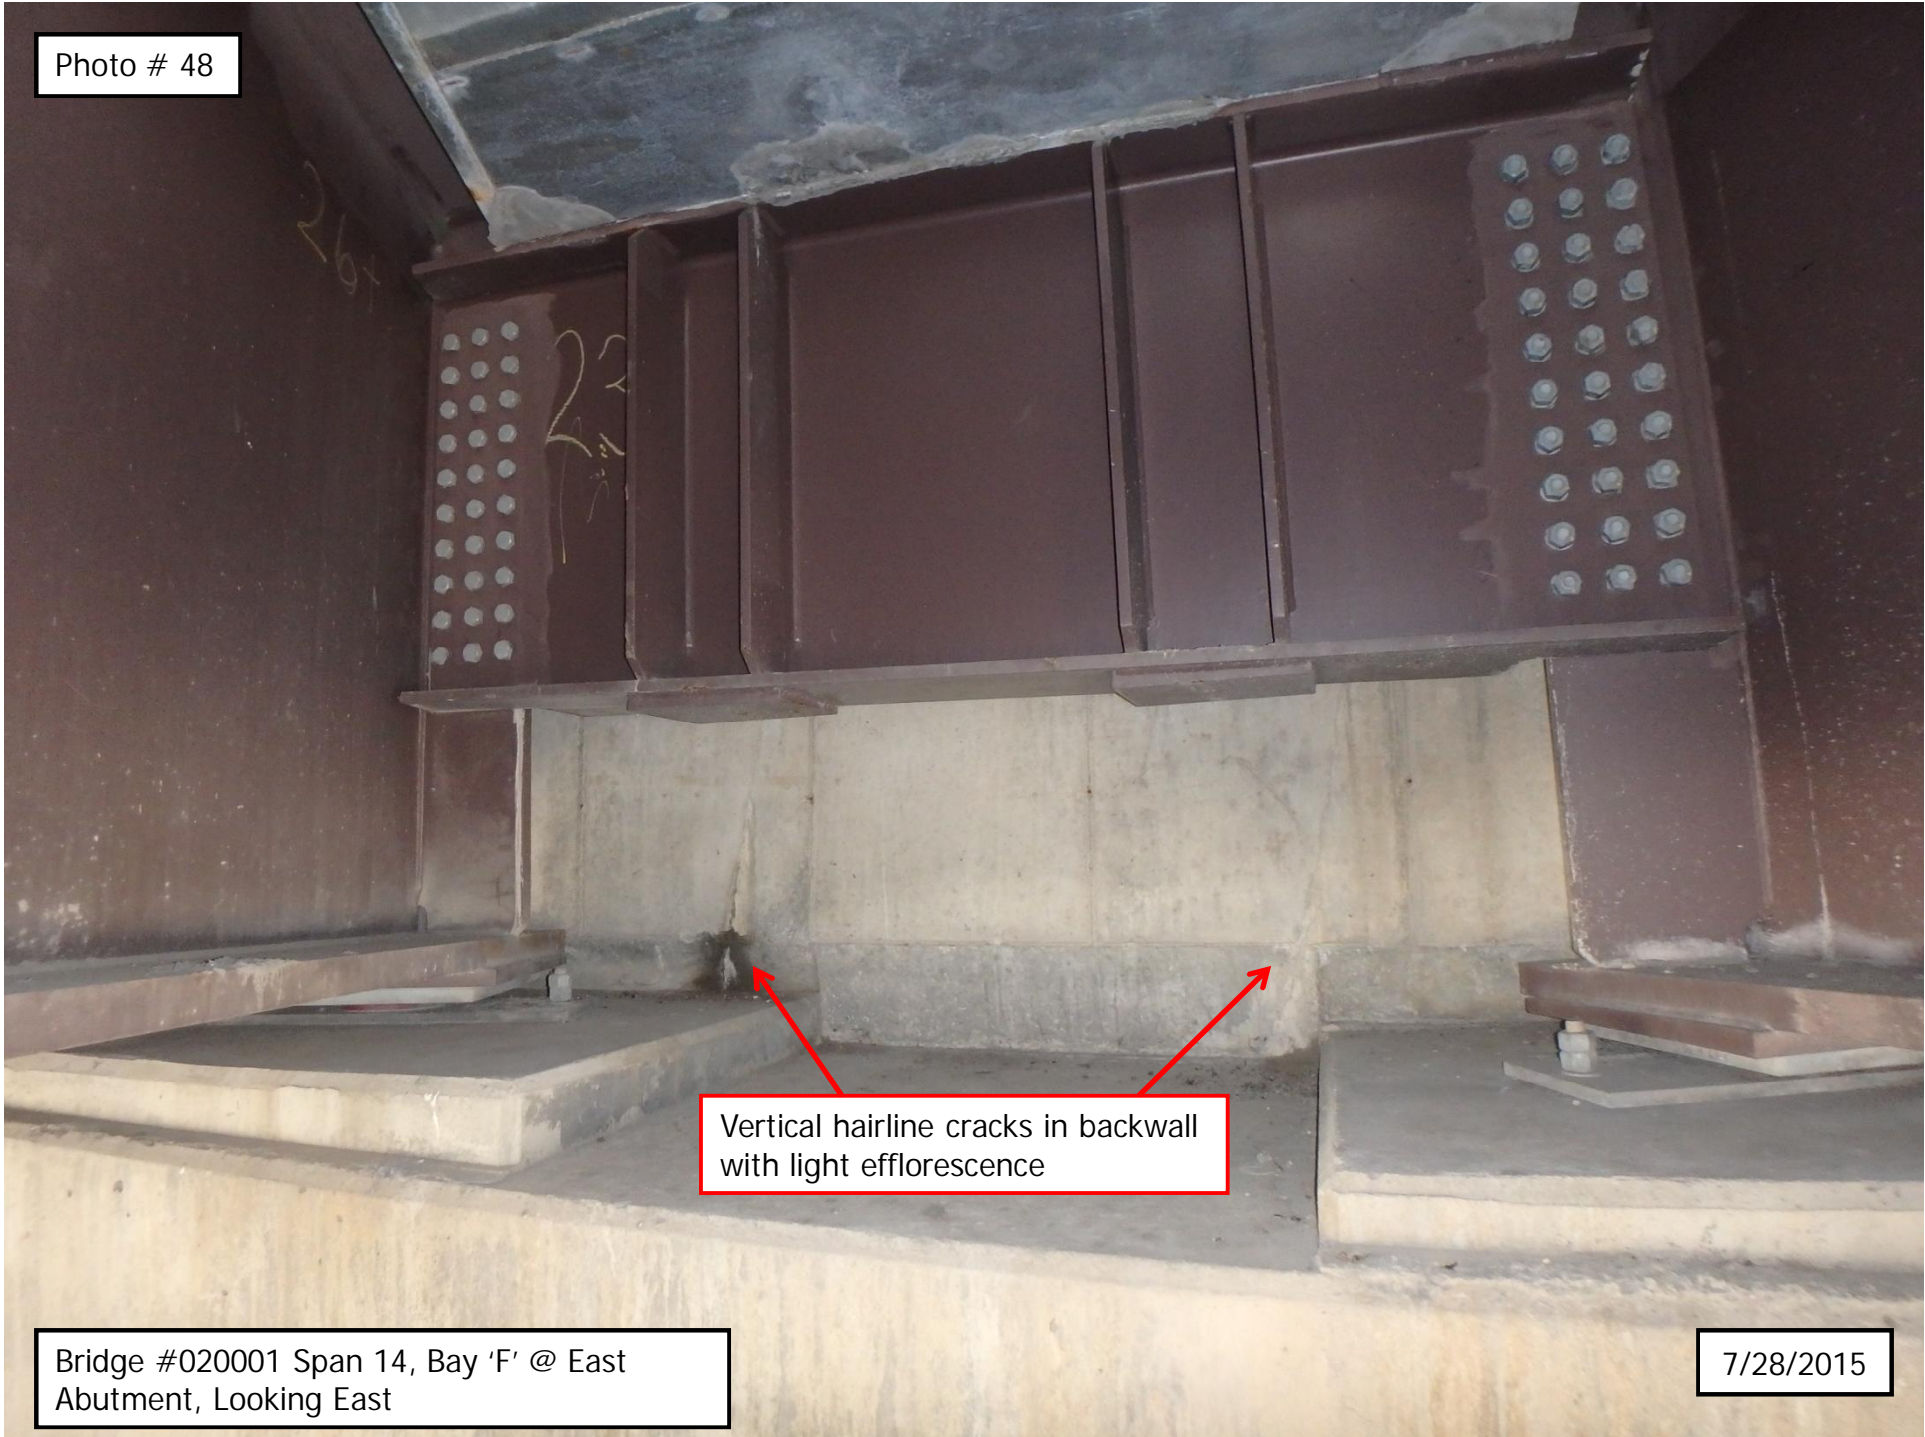
Photo # 48

Vertical hairline cracks in backwall with light efflorescence

Bridge #020001 Span 14, Bay 'F' @ East Abutment, Looking East
