Bridge: 020001
Photo: 1

South elevation at the main channel, looking north.

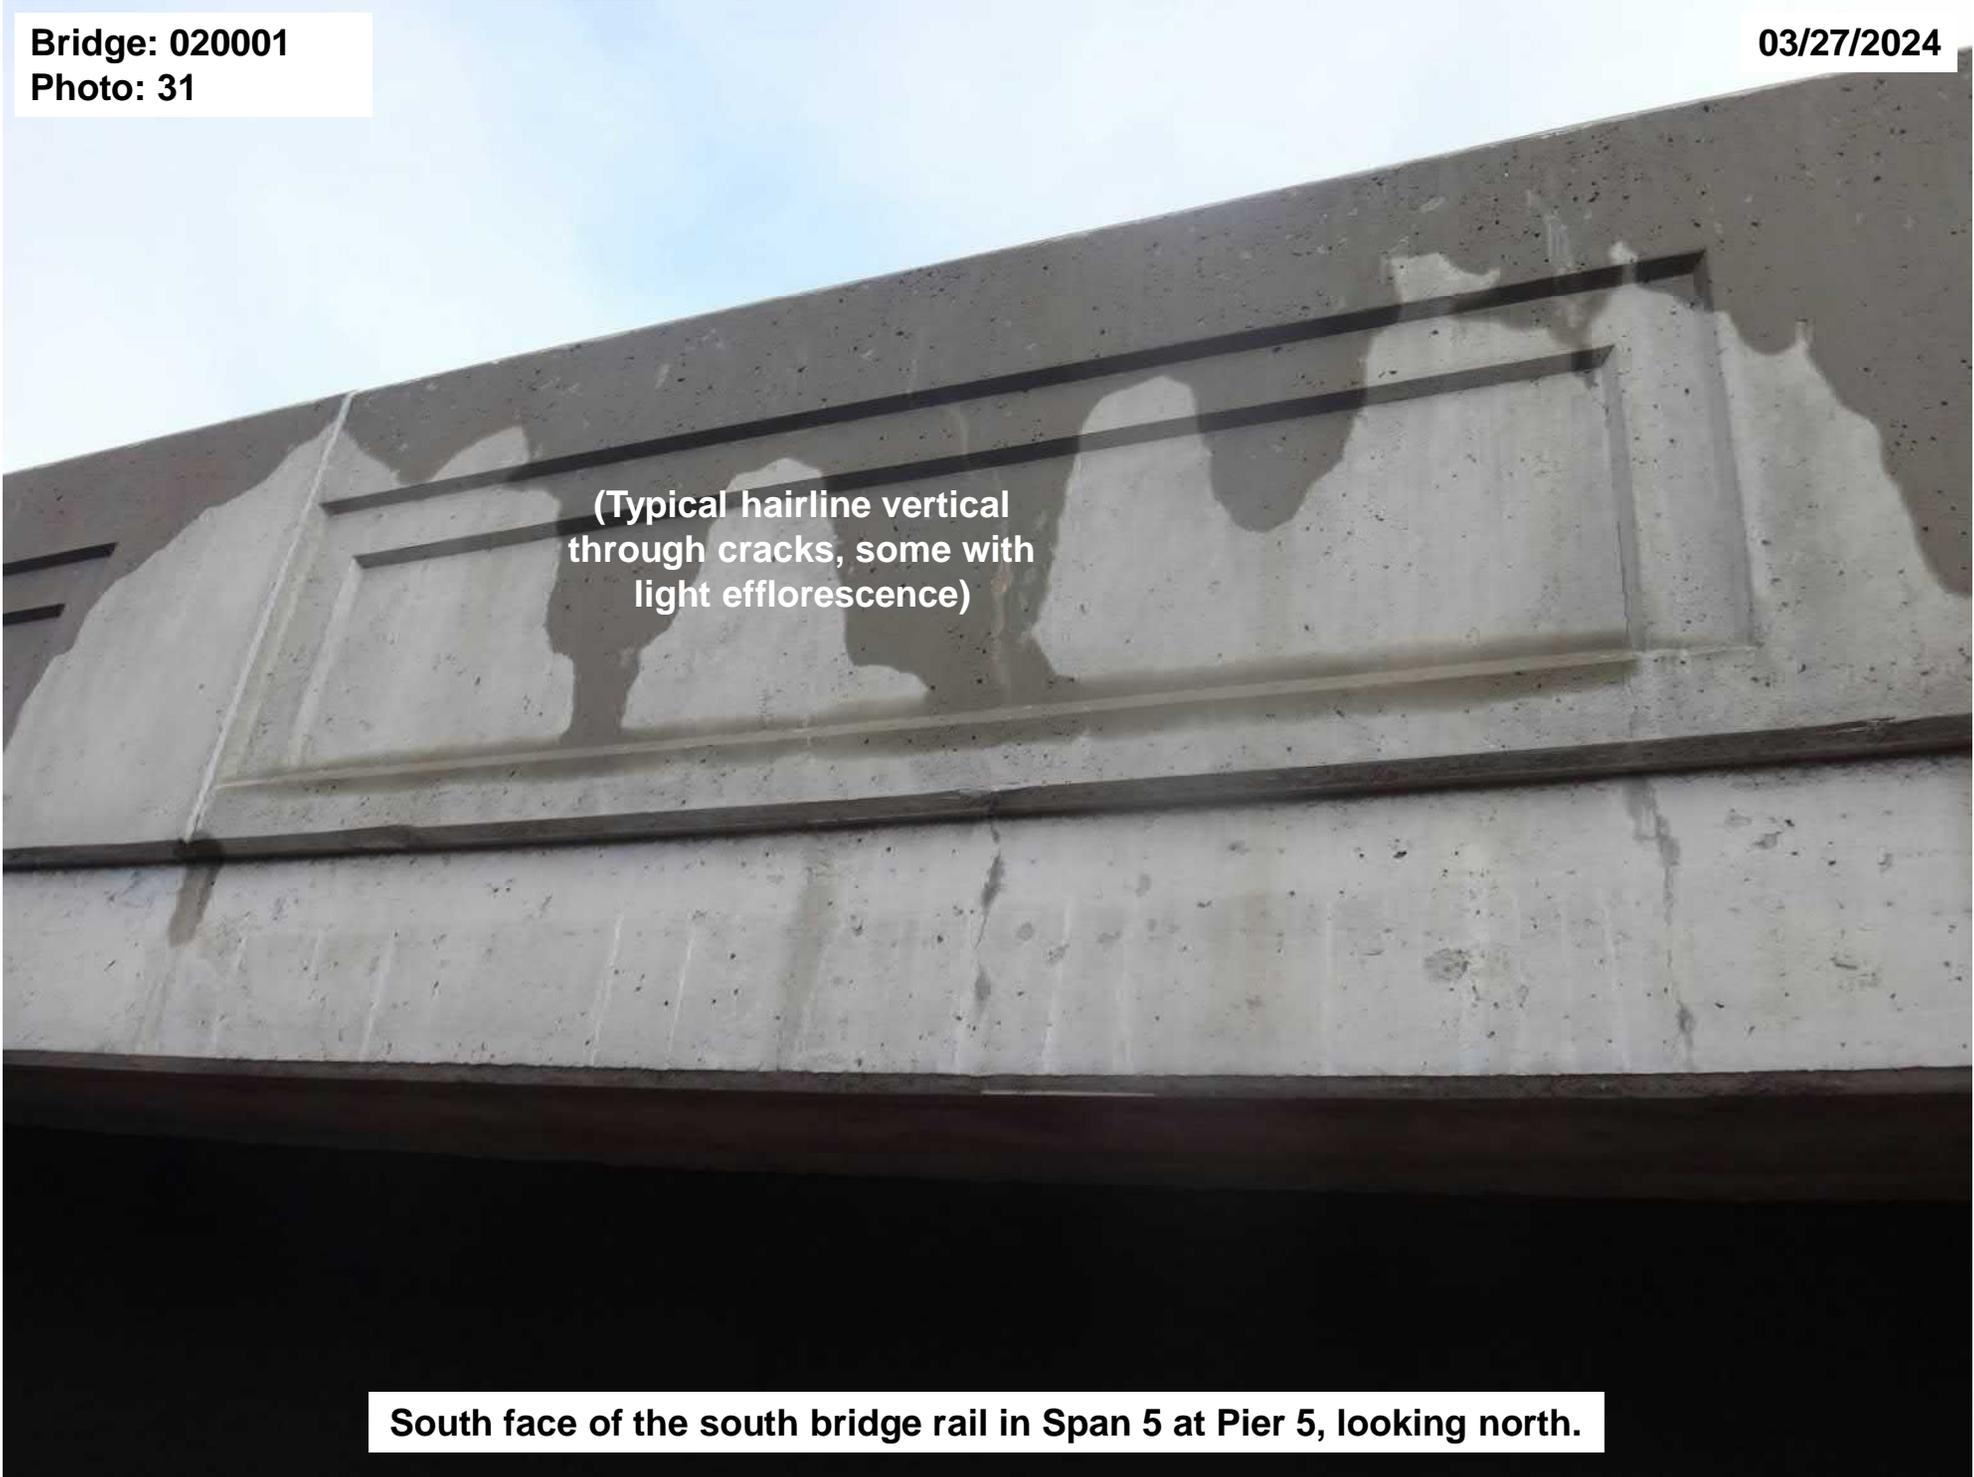
Bridge: 020001
Photo: 31

(Typical hairline vertical
through cracks, some with
light efflorescence)

South face of the south bridge rail in Span 5 at Pier 5, looking north.

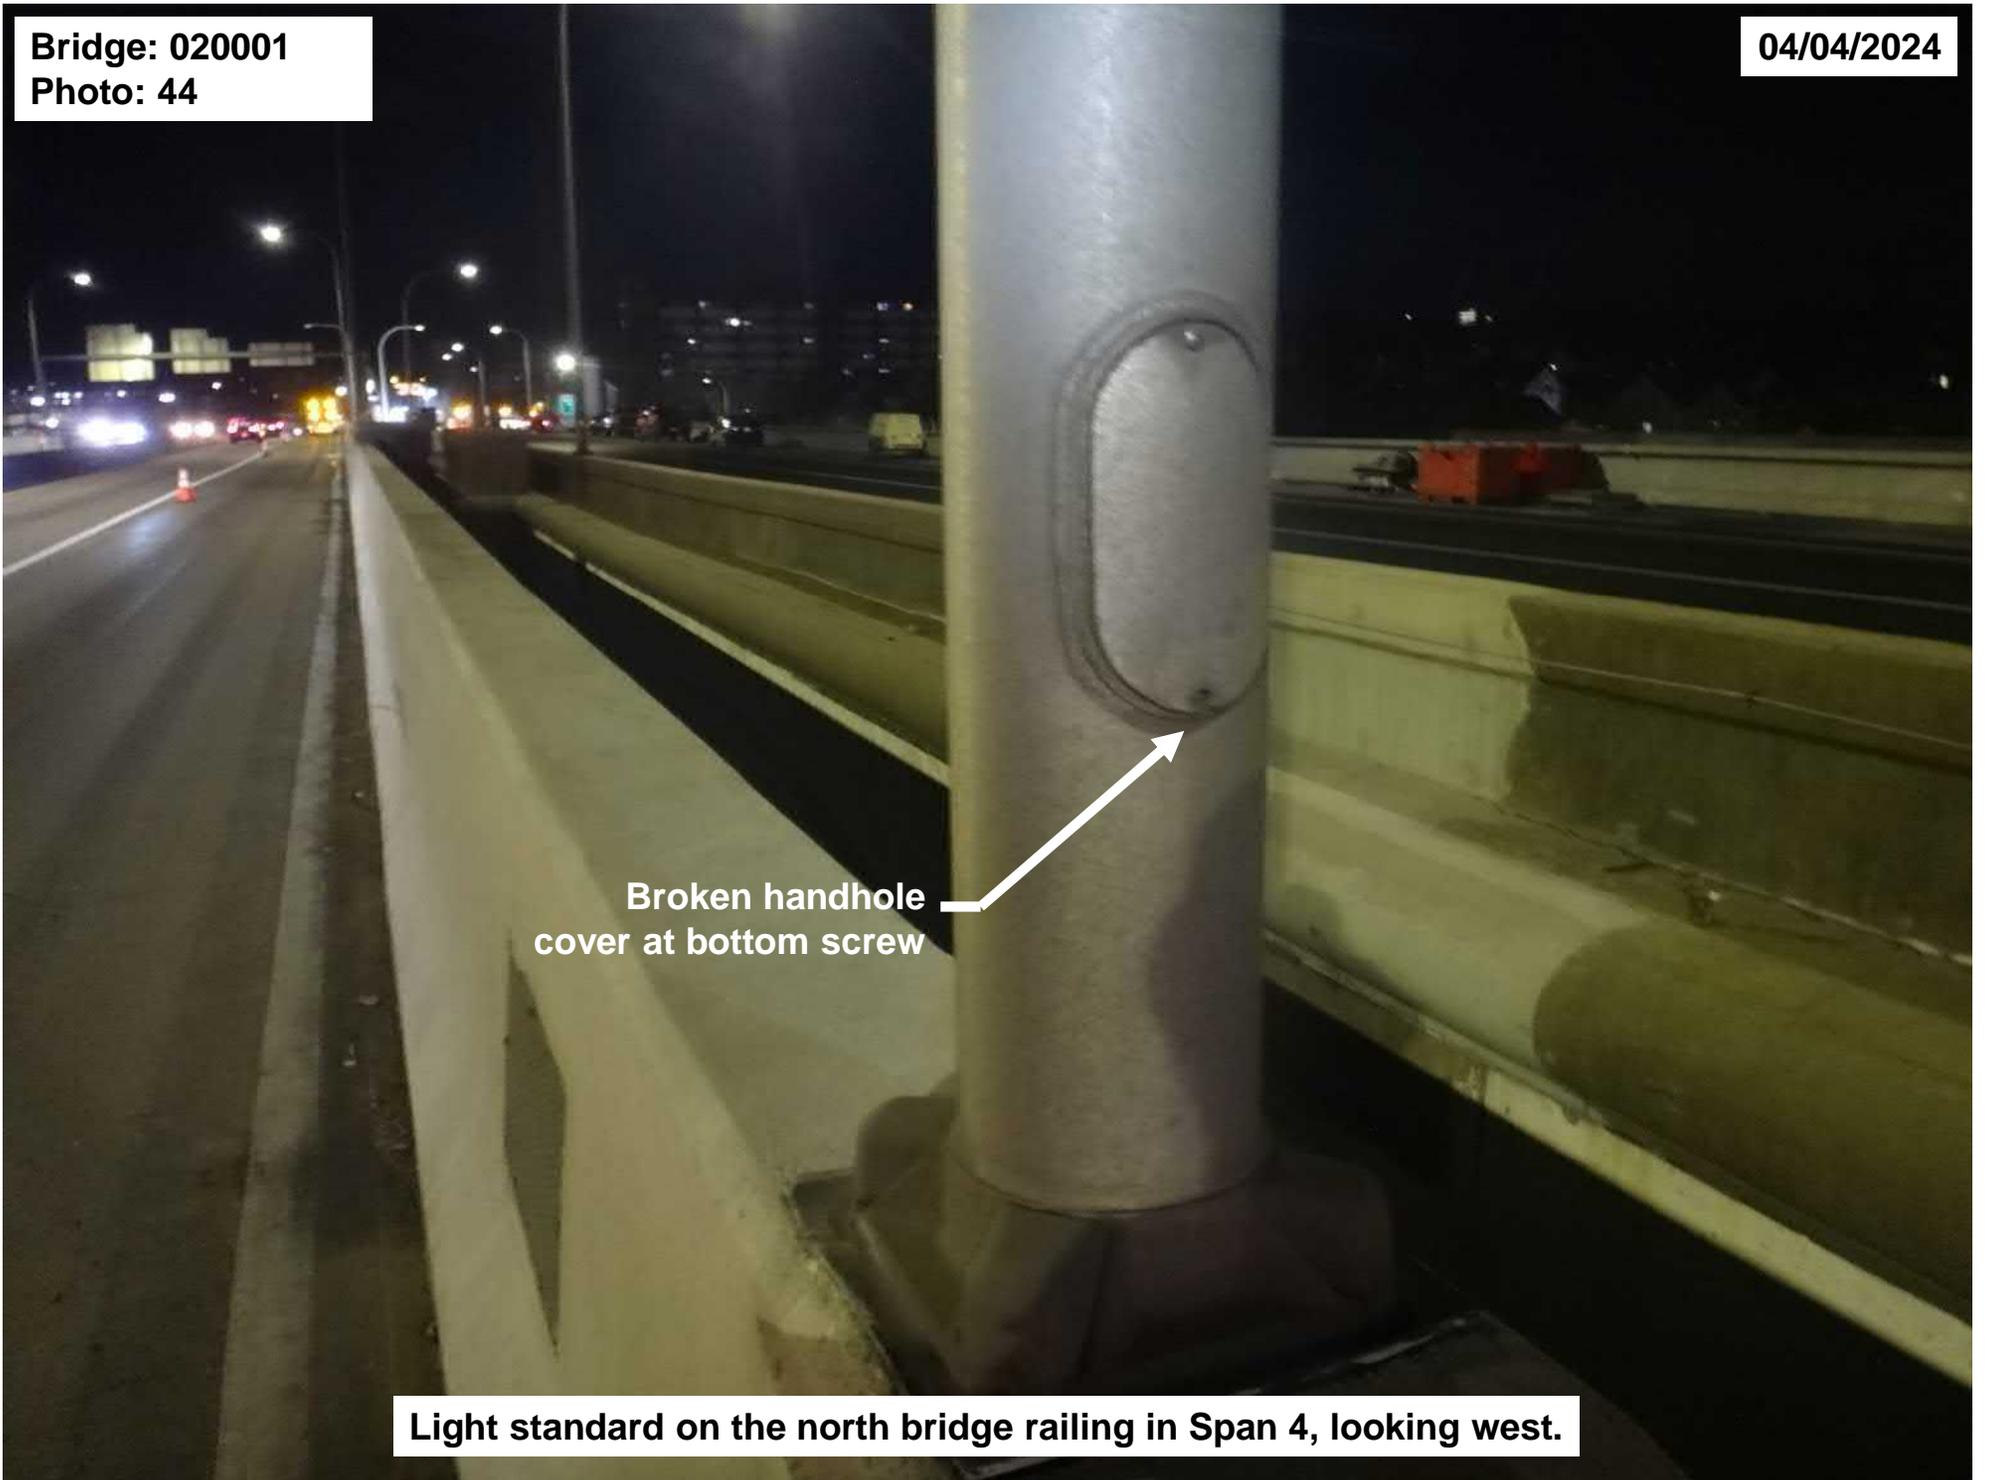
Broken handhole
cover at bottom screw

Light standard on the north bridge railing in Span 4, looking west.

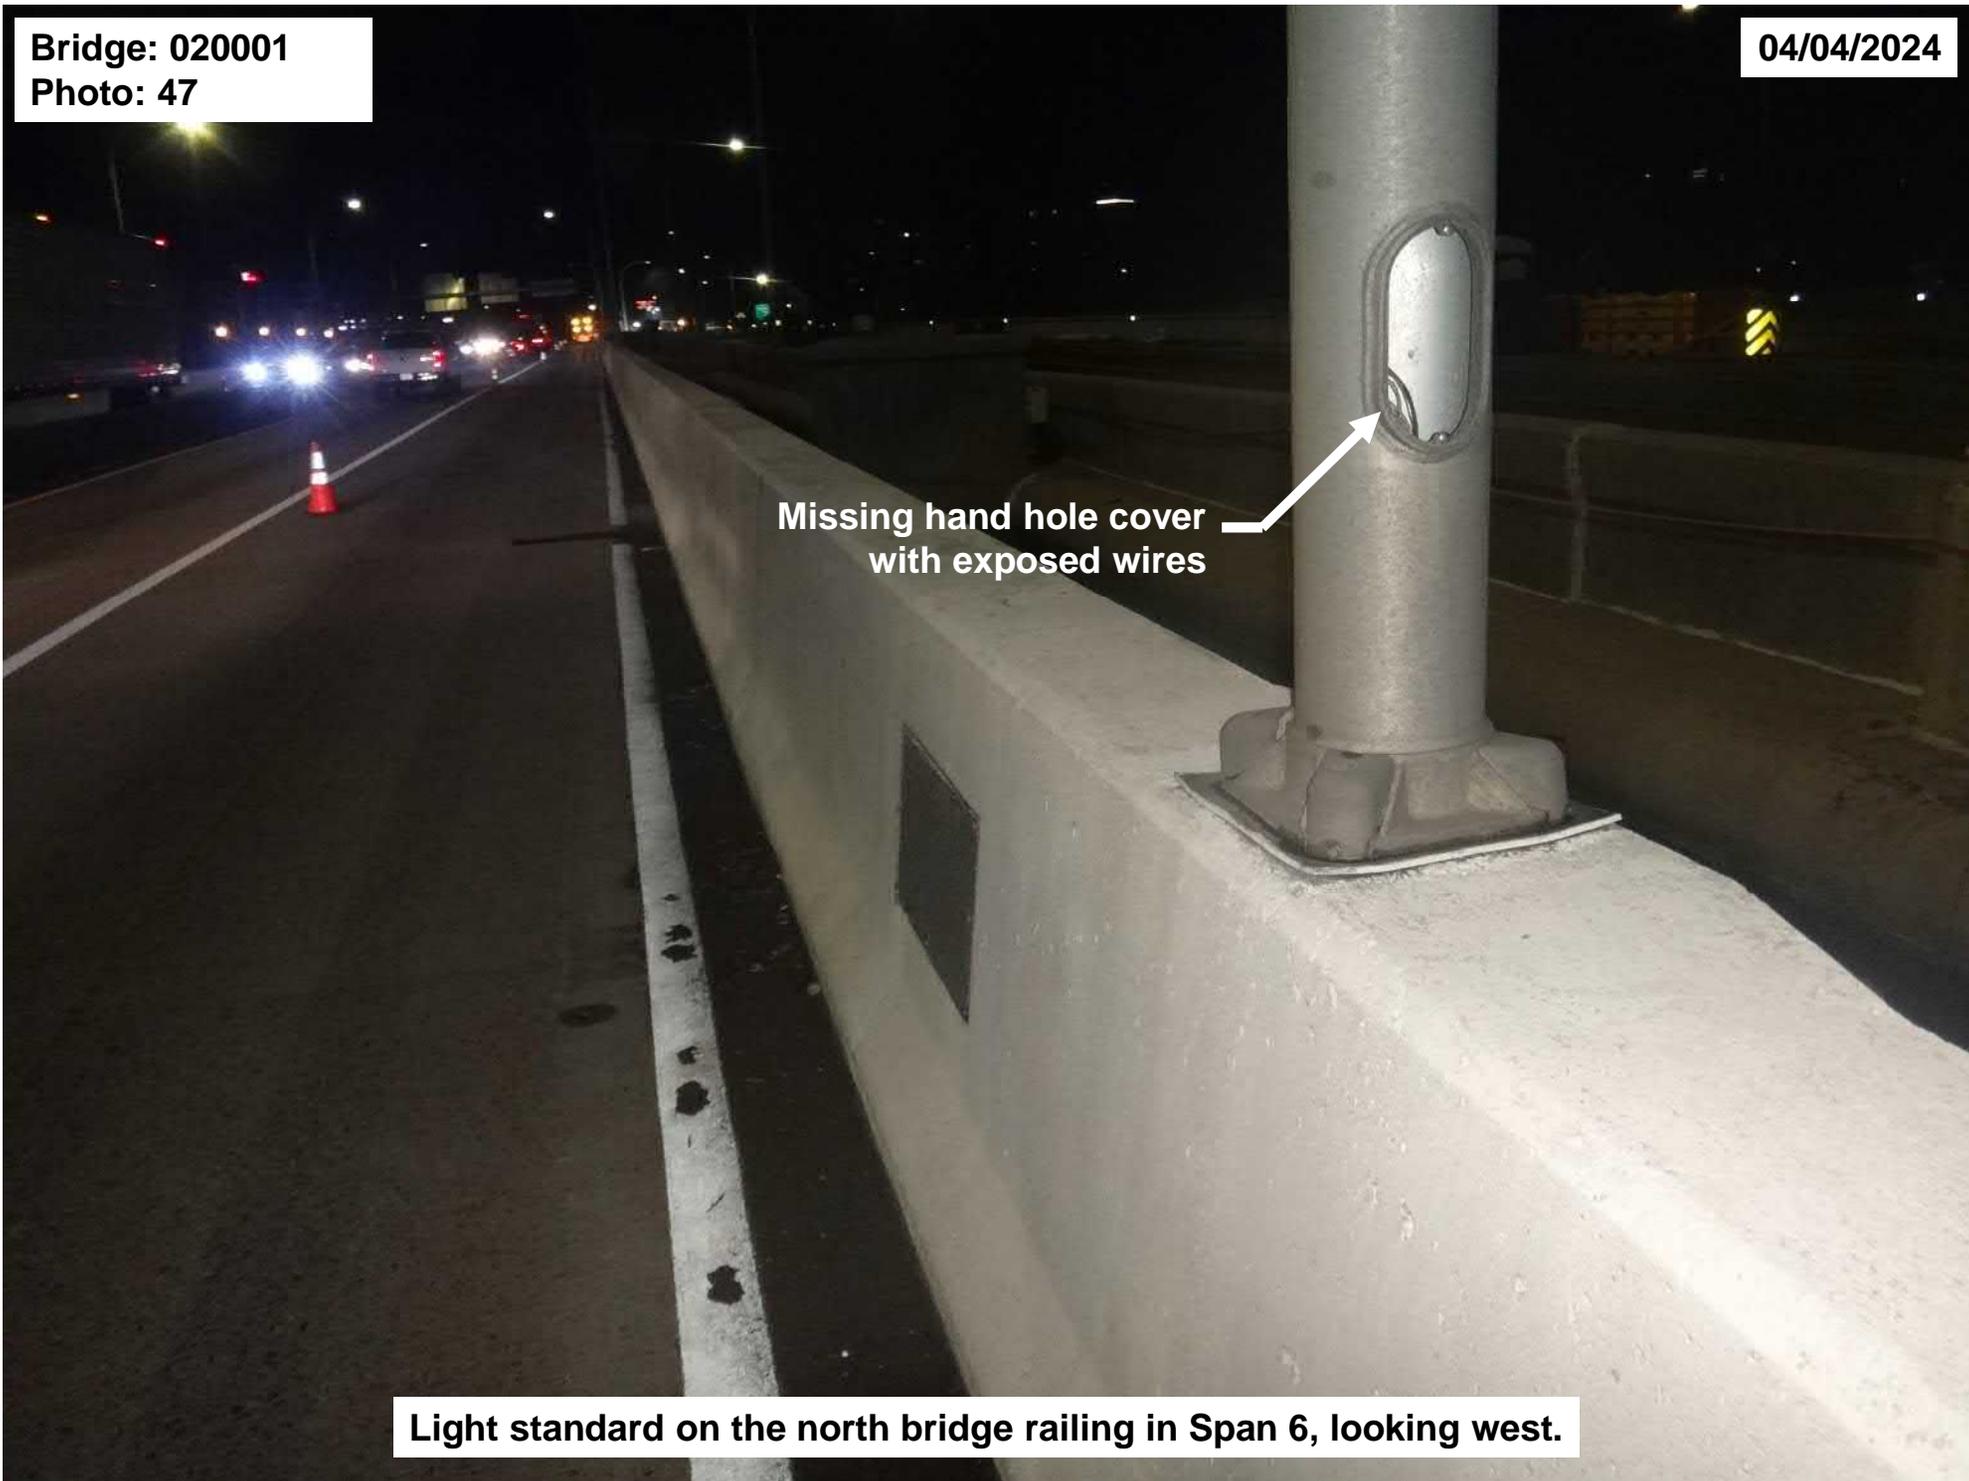
Bridge: 020001
Photo: 47

Missing hand hole cover
with exposed wires

Light standard on the north bridge railing in Span 6, looking west.

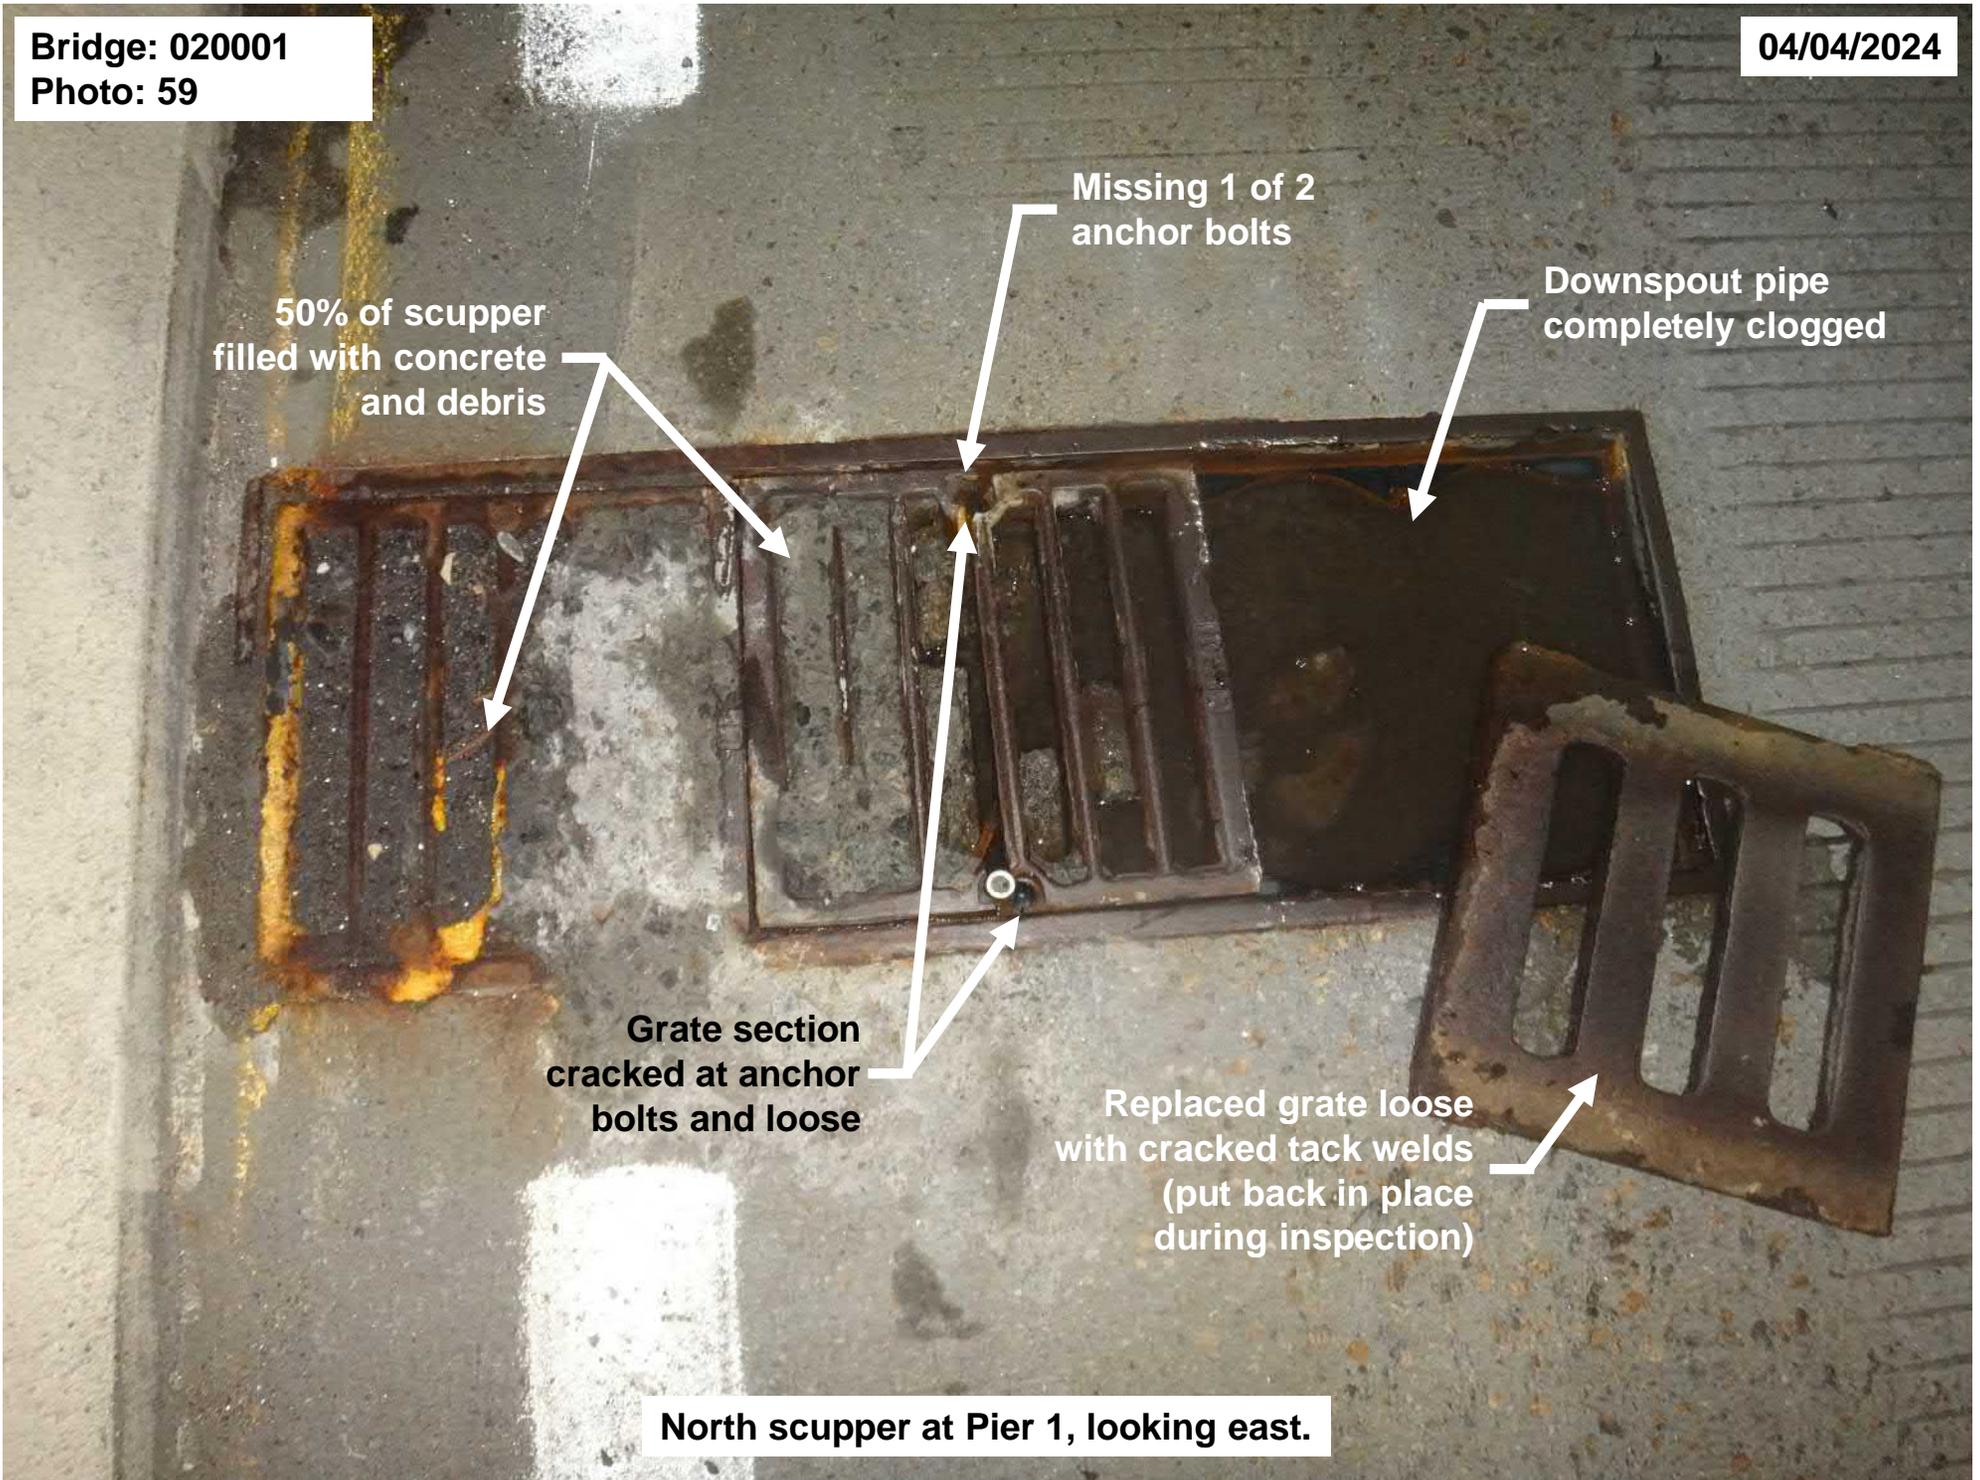
Grate section
cracked at anchor
bolts and loose

Replaced grate loose
with cracked tack welds
(put back in place
during inspection)

North scupper at Pier 1, looking east.

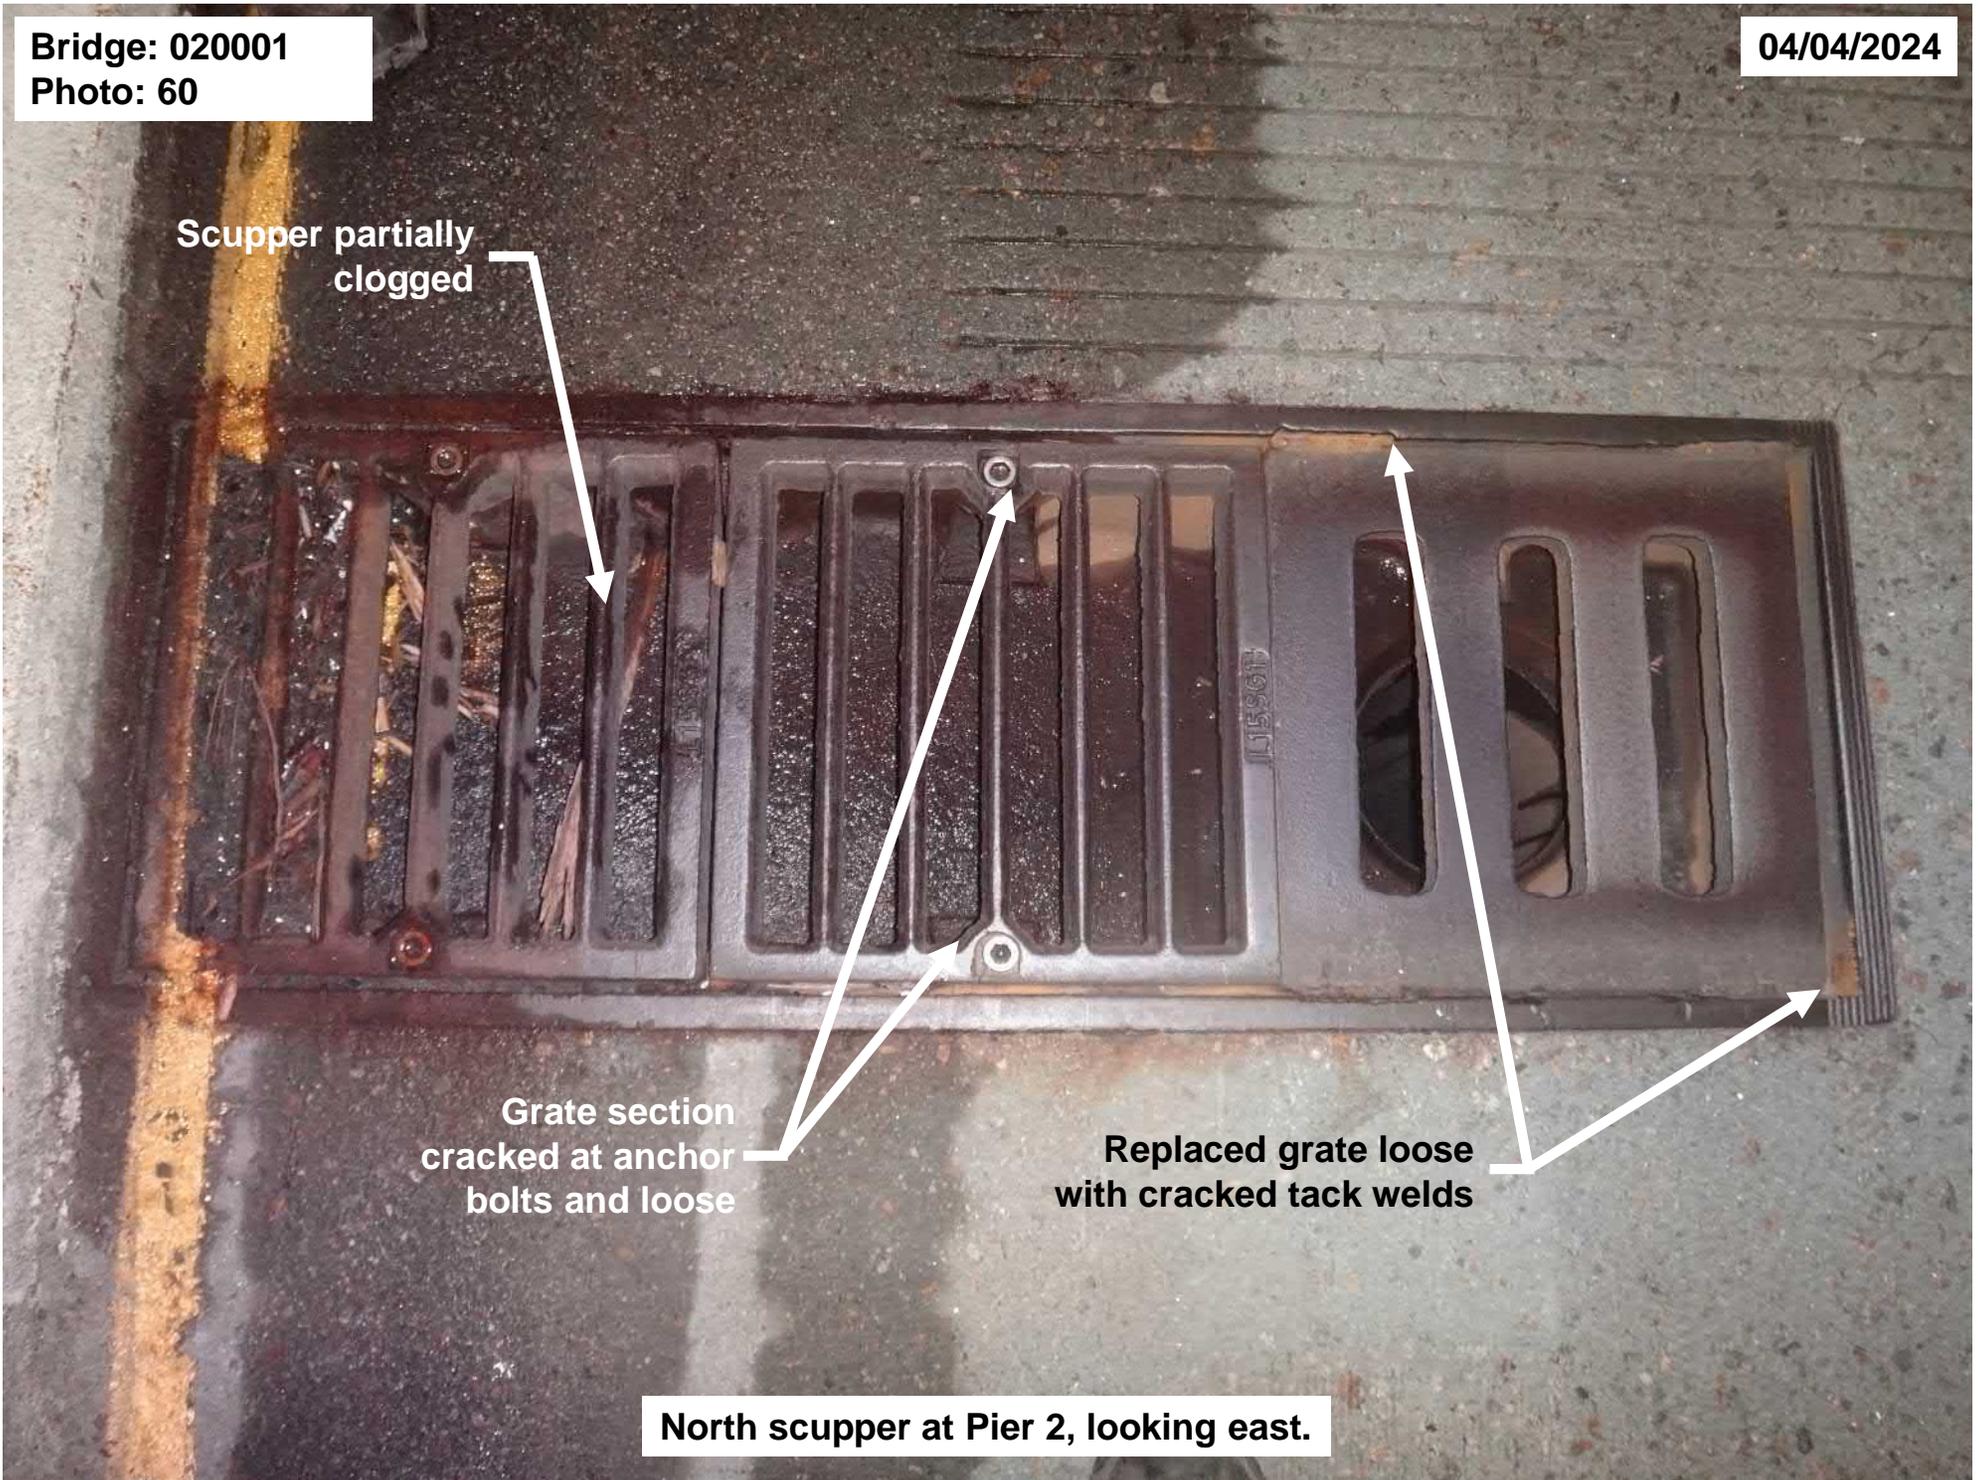
Bridge: 020001
Photo: 60

Grate section
cracked at anchor
bolts and loose

Replaced grate loose
with cracked tack welds

North scupper at Pier 2, looking east.

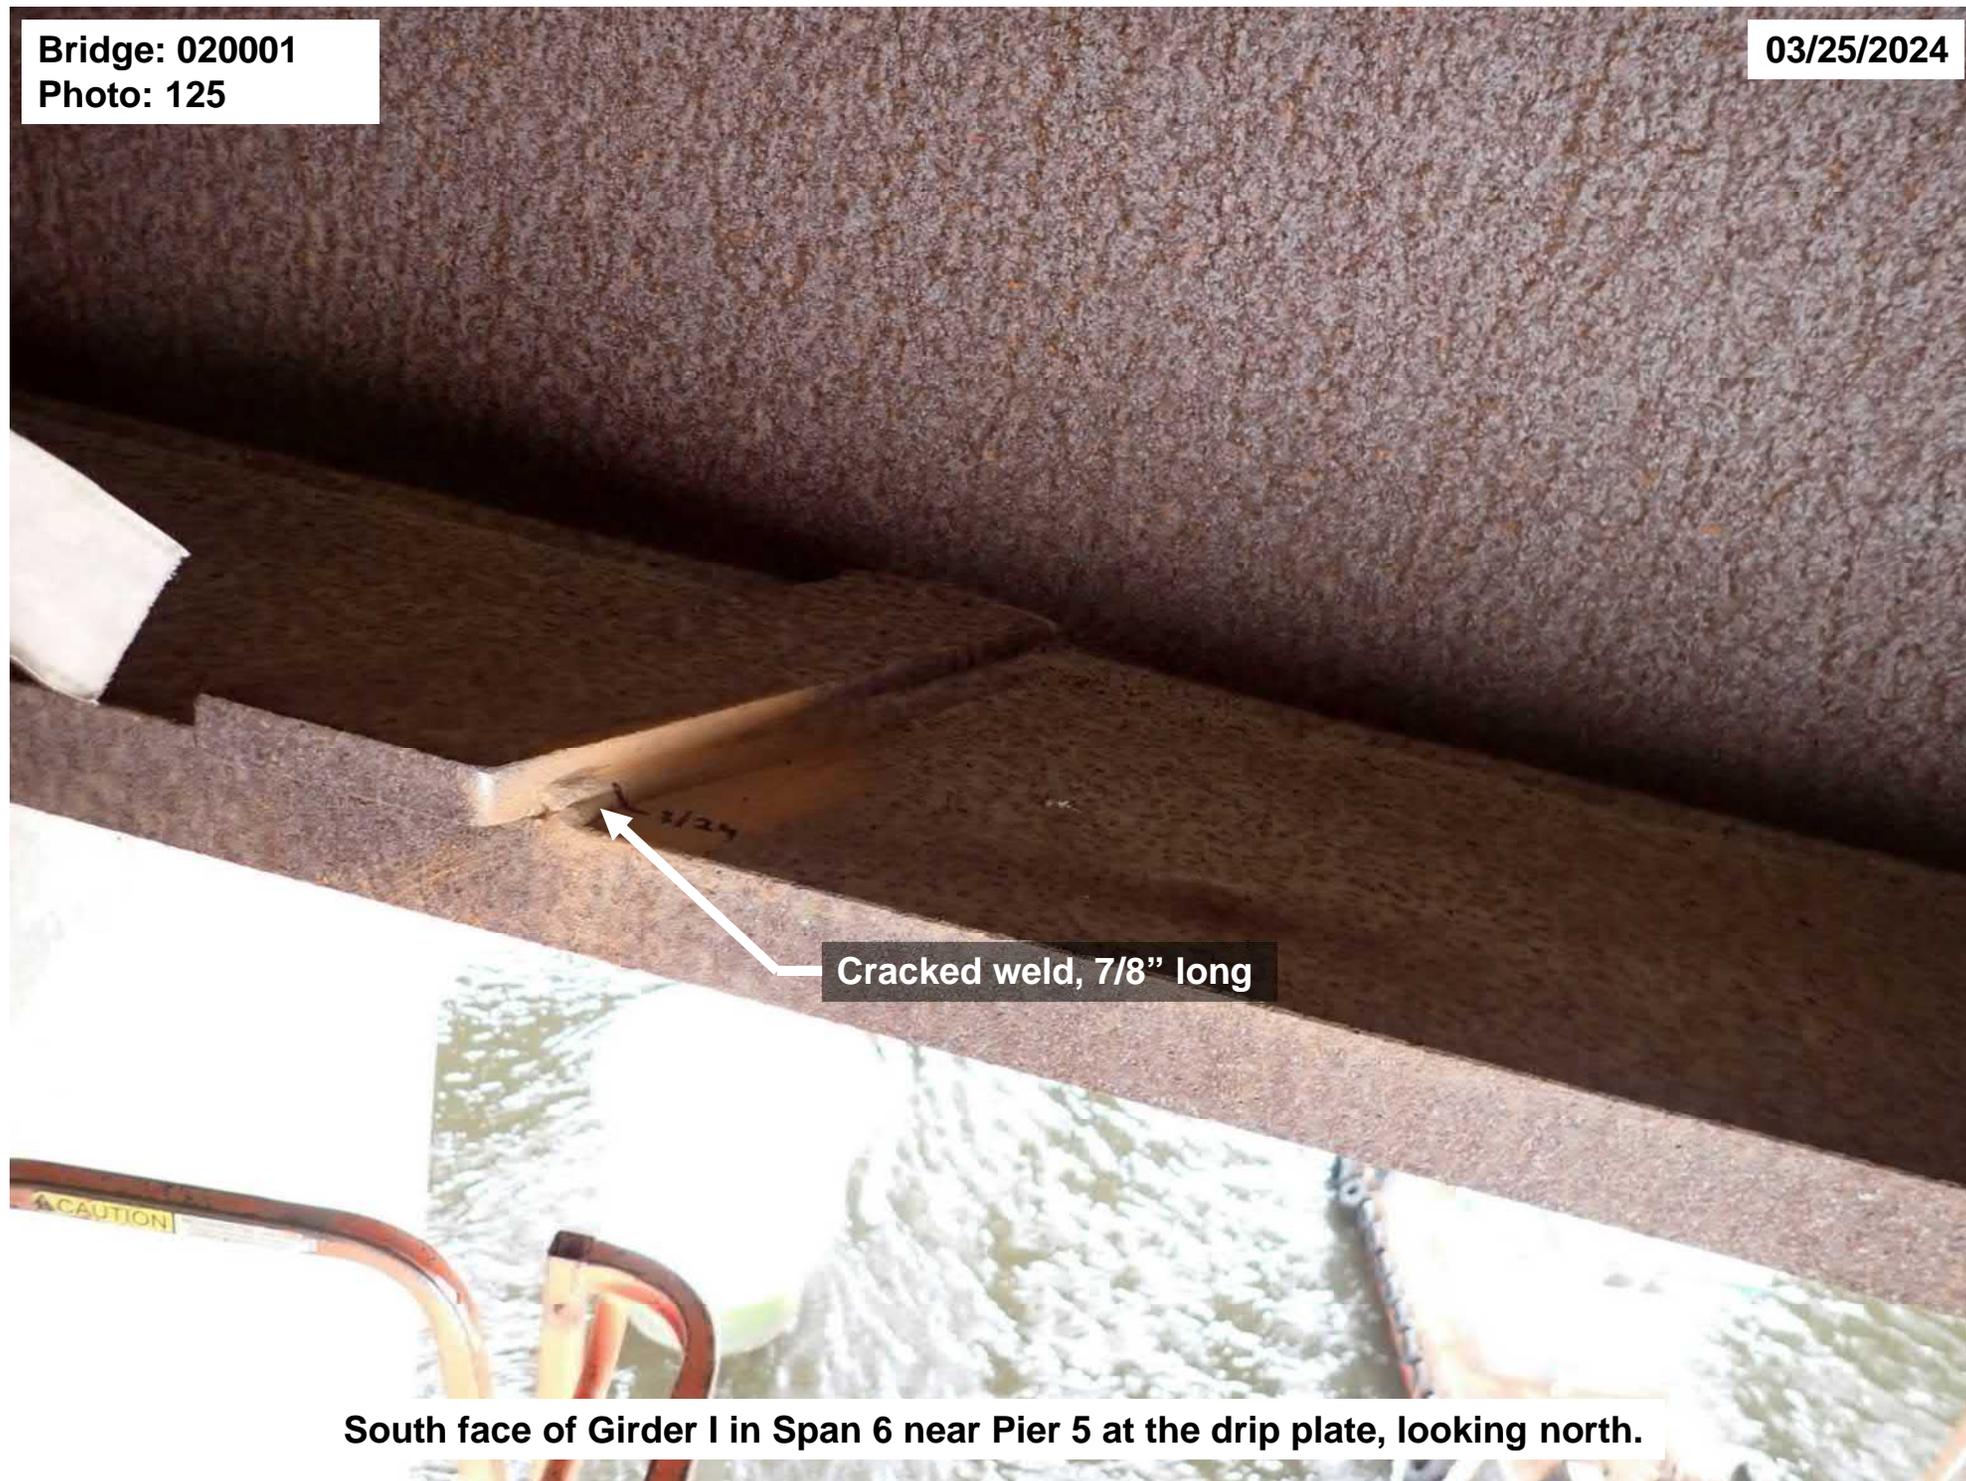
Bridge: 020001
Photo: 125

Cracked weld, 7/8" long

South face of Girder I in Span 6 near Pier 5 at the drip plate, looking north.

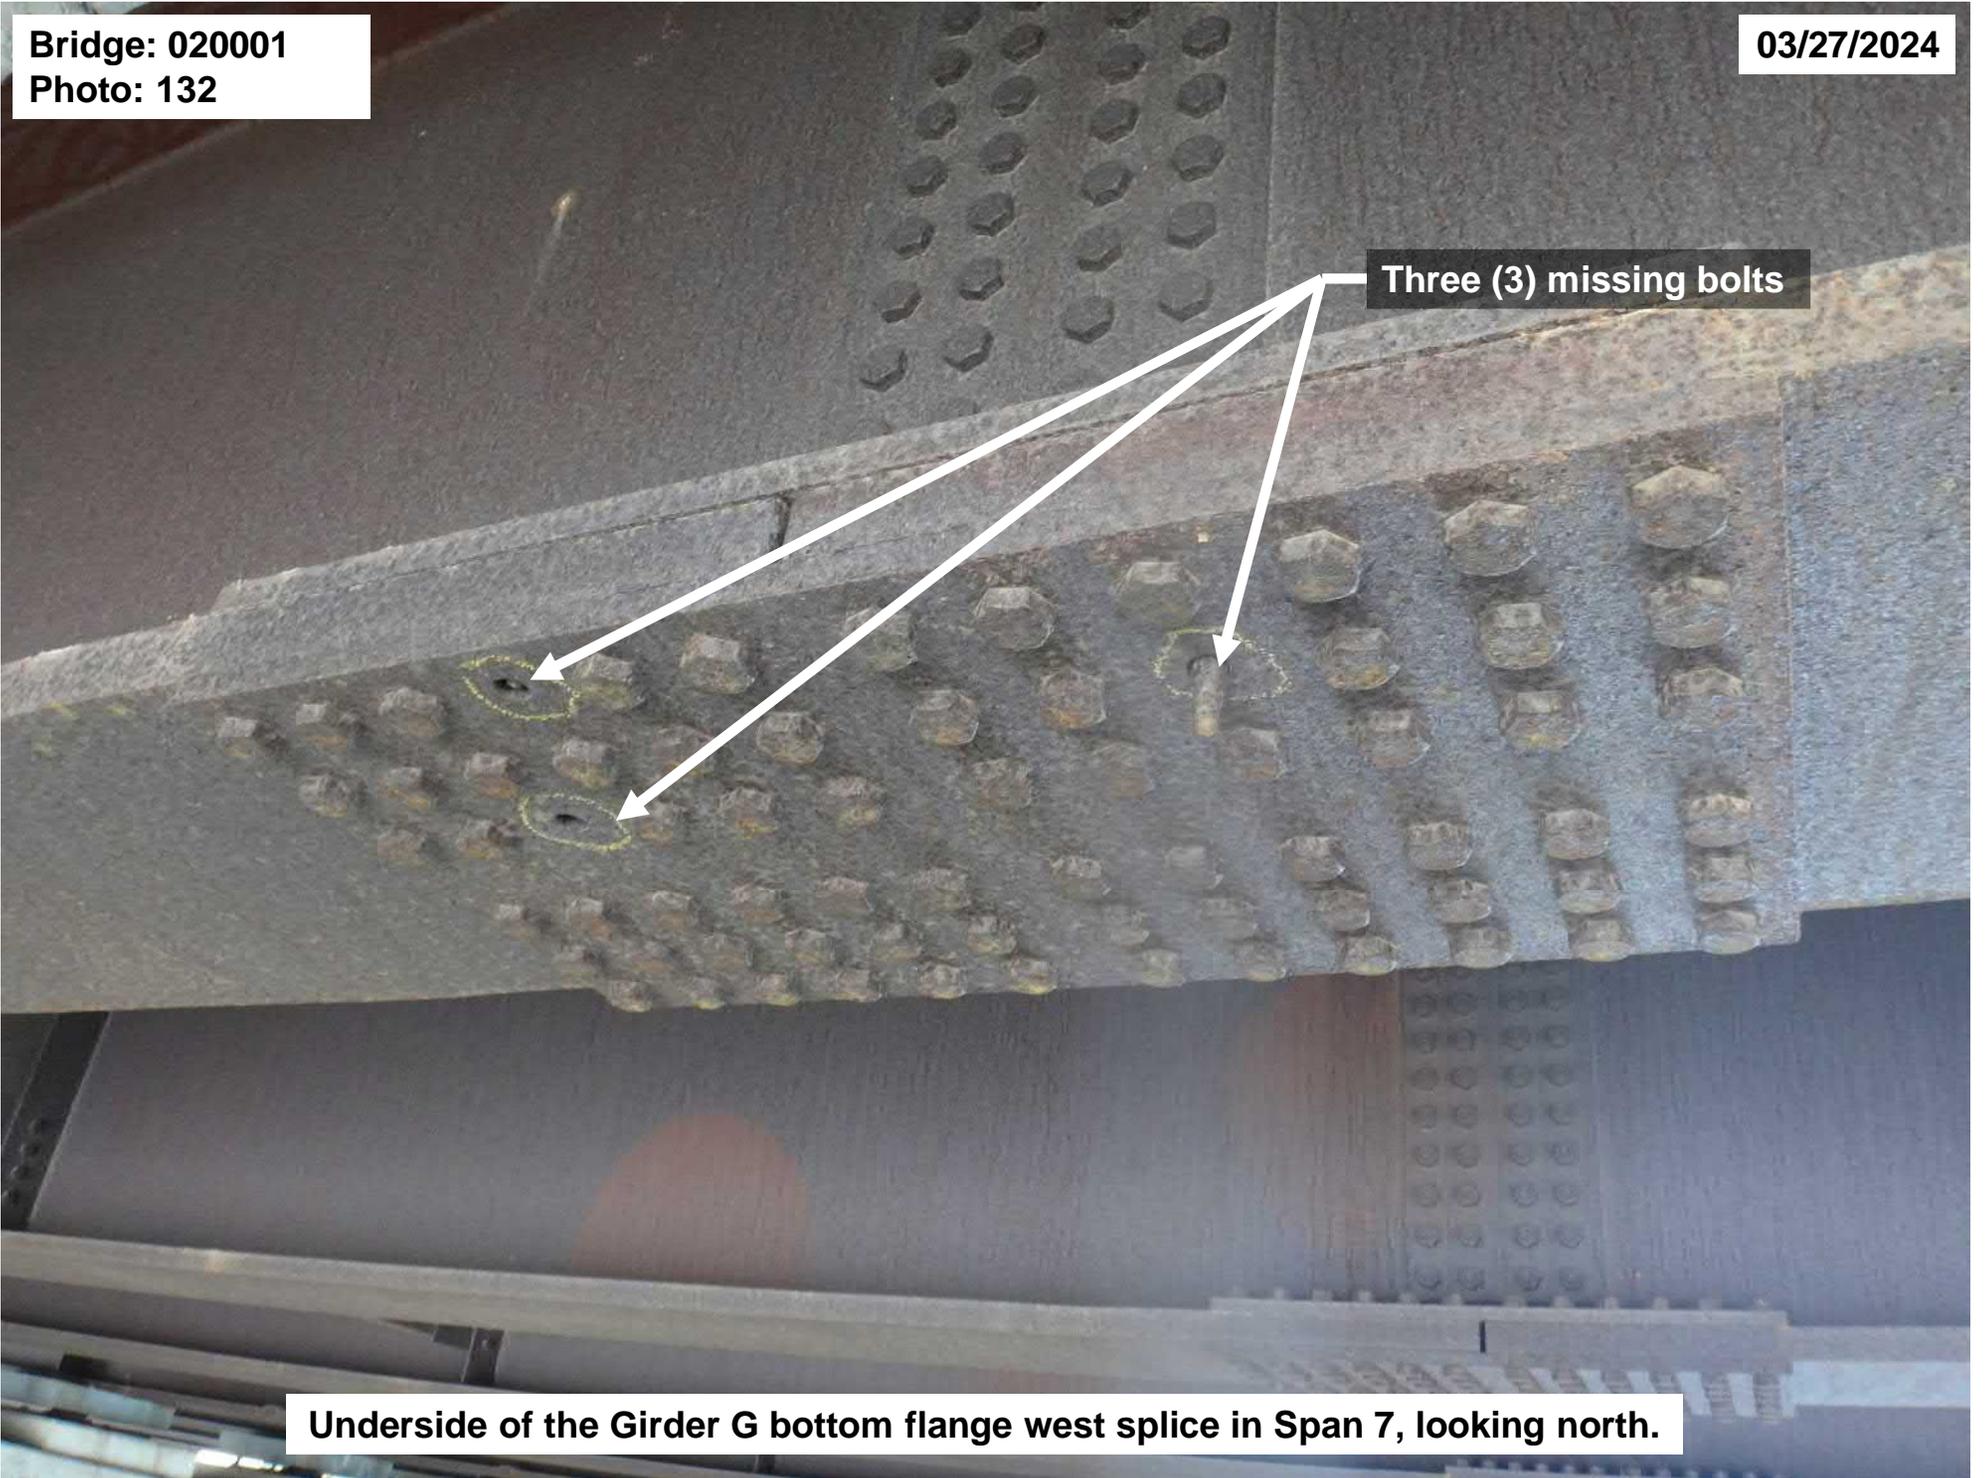
Three (3) missing bolts

Underside of the Girder G bottom flange west splice in Span 7, looking north.
