Bridge: 020001
Photo: 1

South elevation at the main channel, looking north.

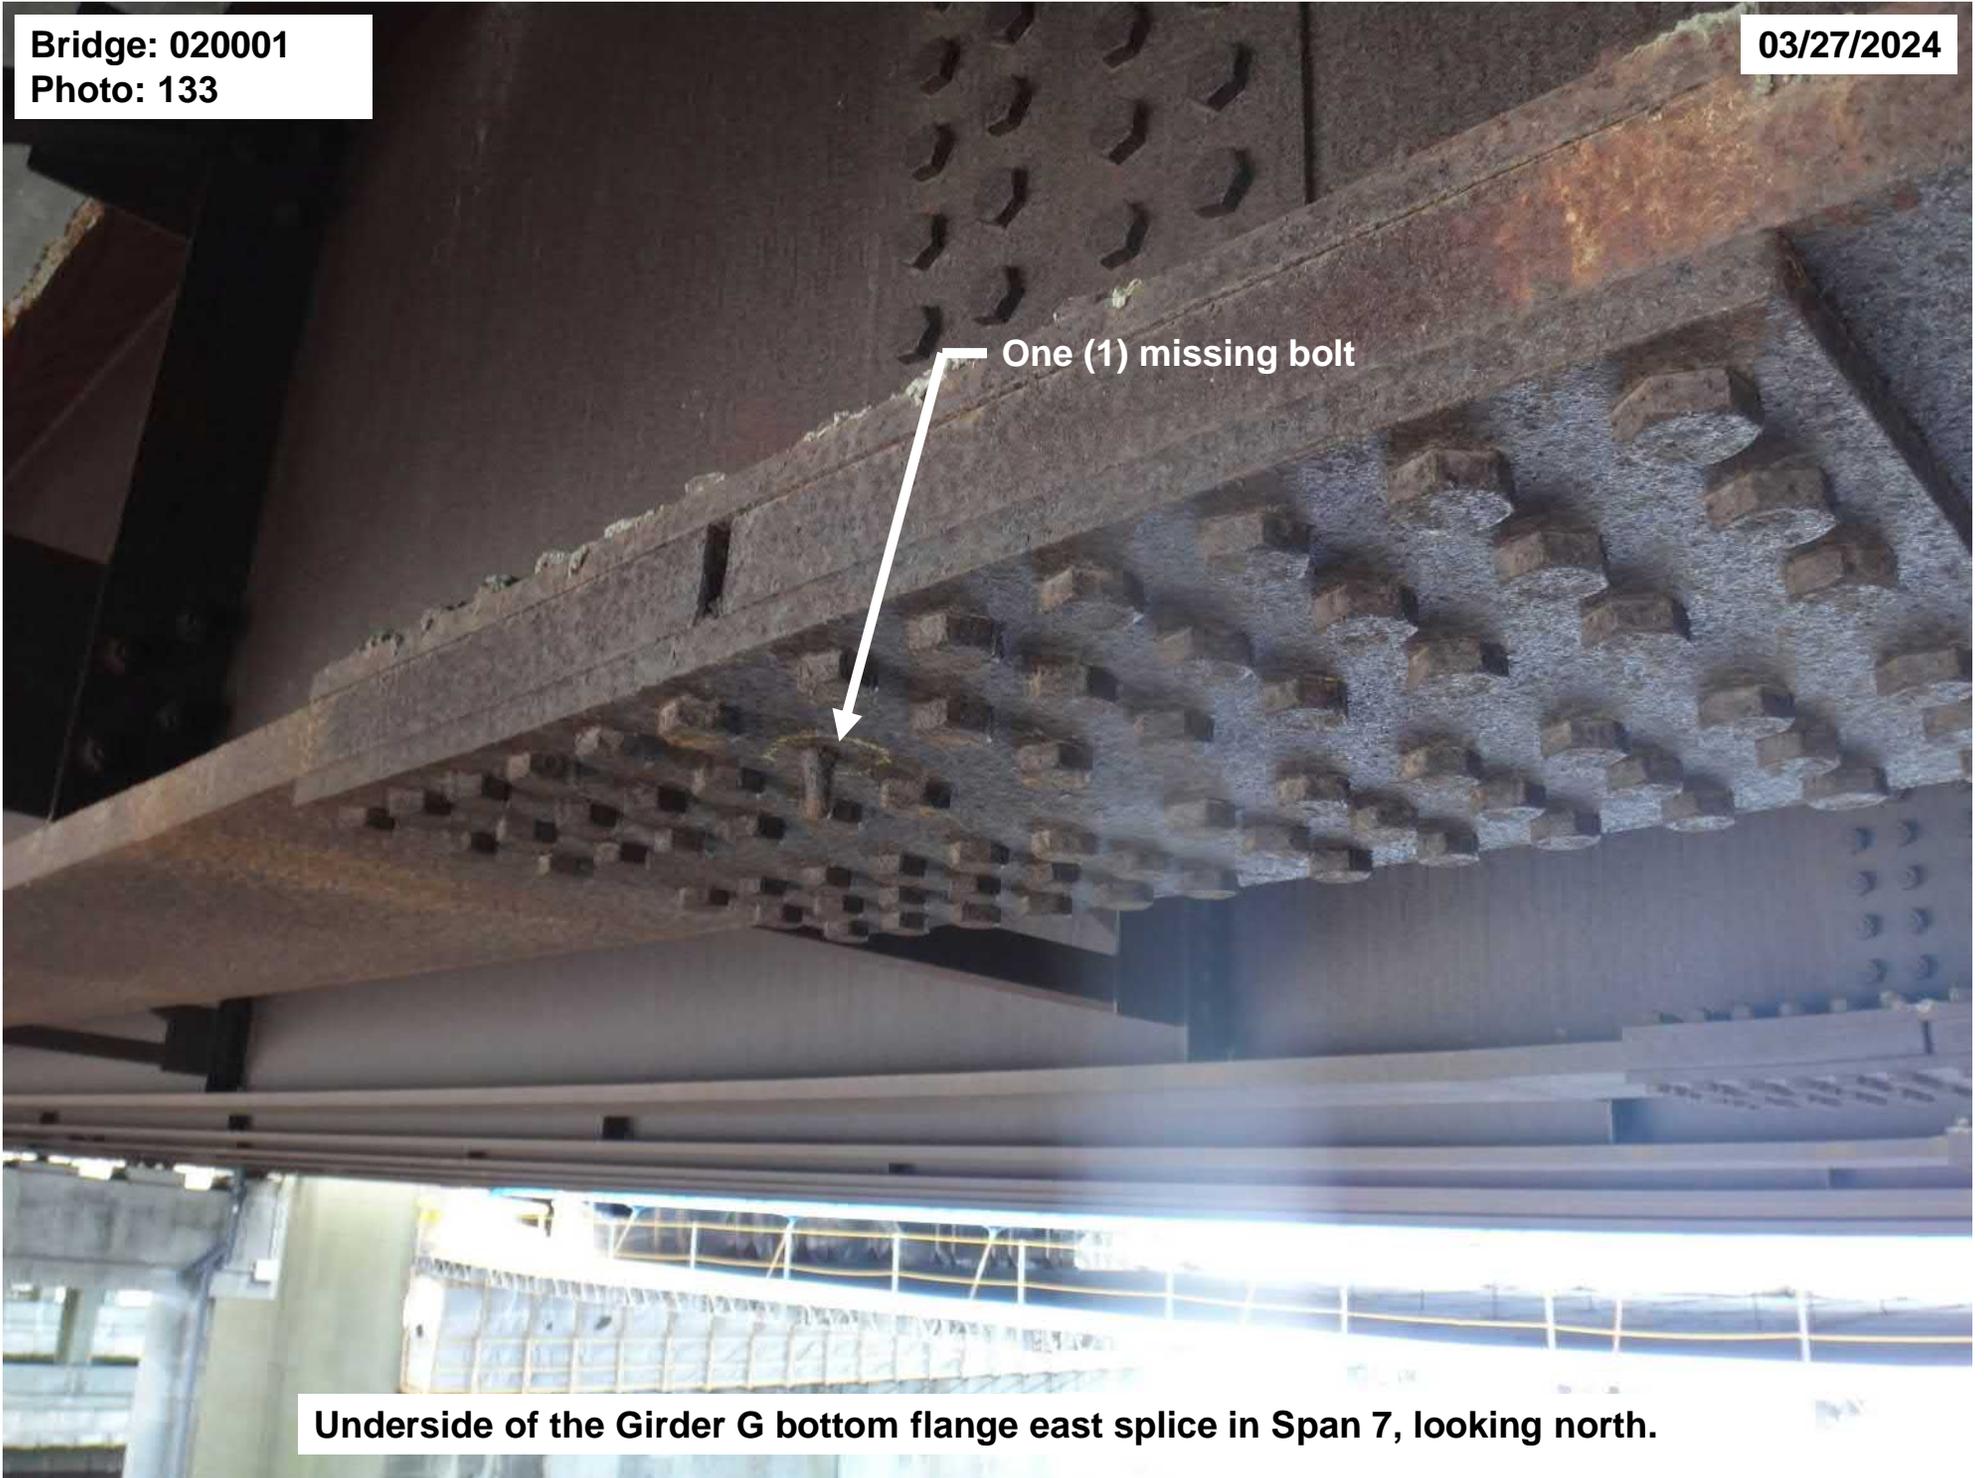
Bridge: 020001
Photo: 133

One (1) missing bolt

Underside of the Girder G bottom flange east splice in Span 7, looking north.

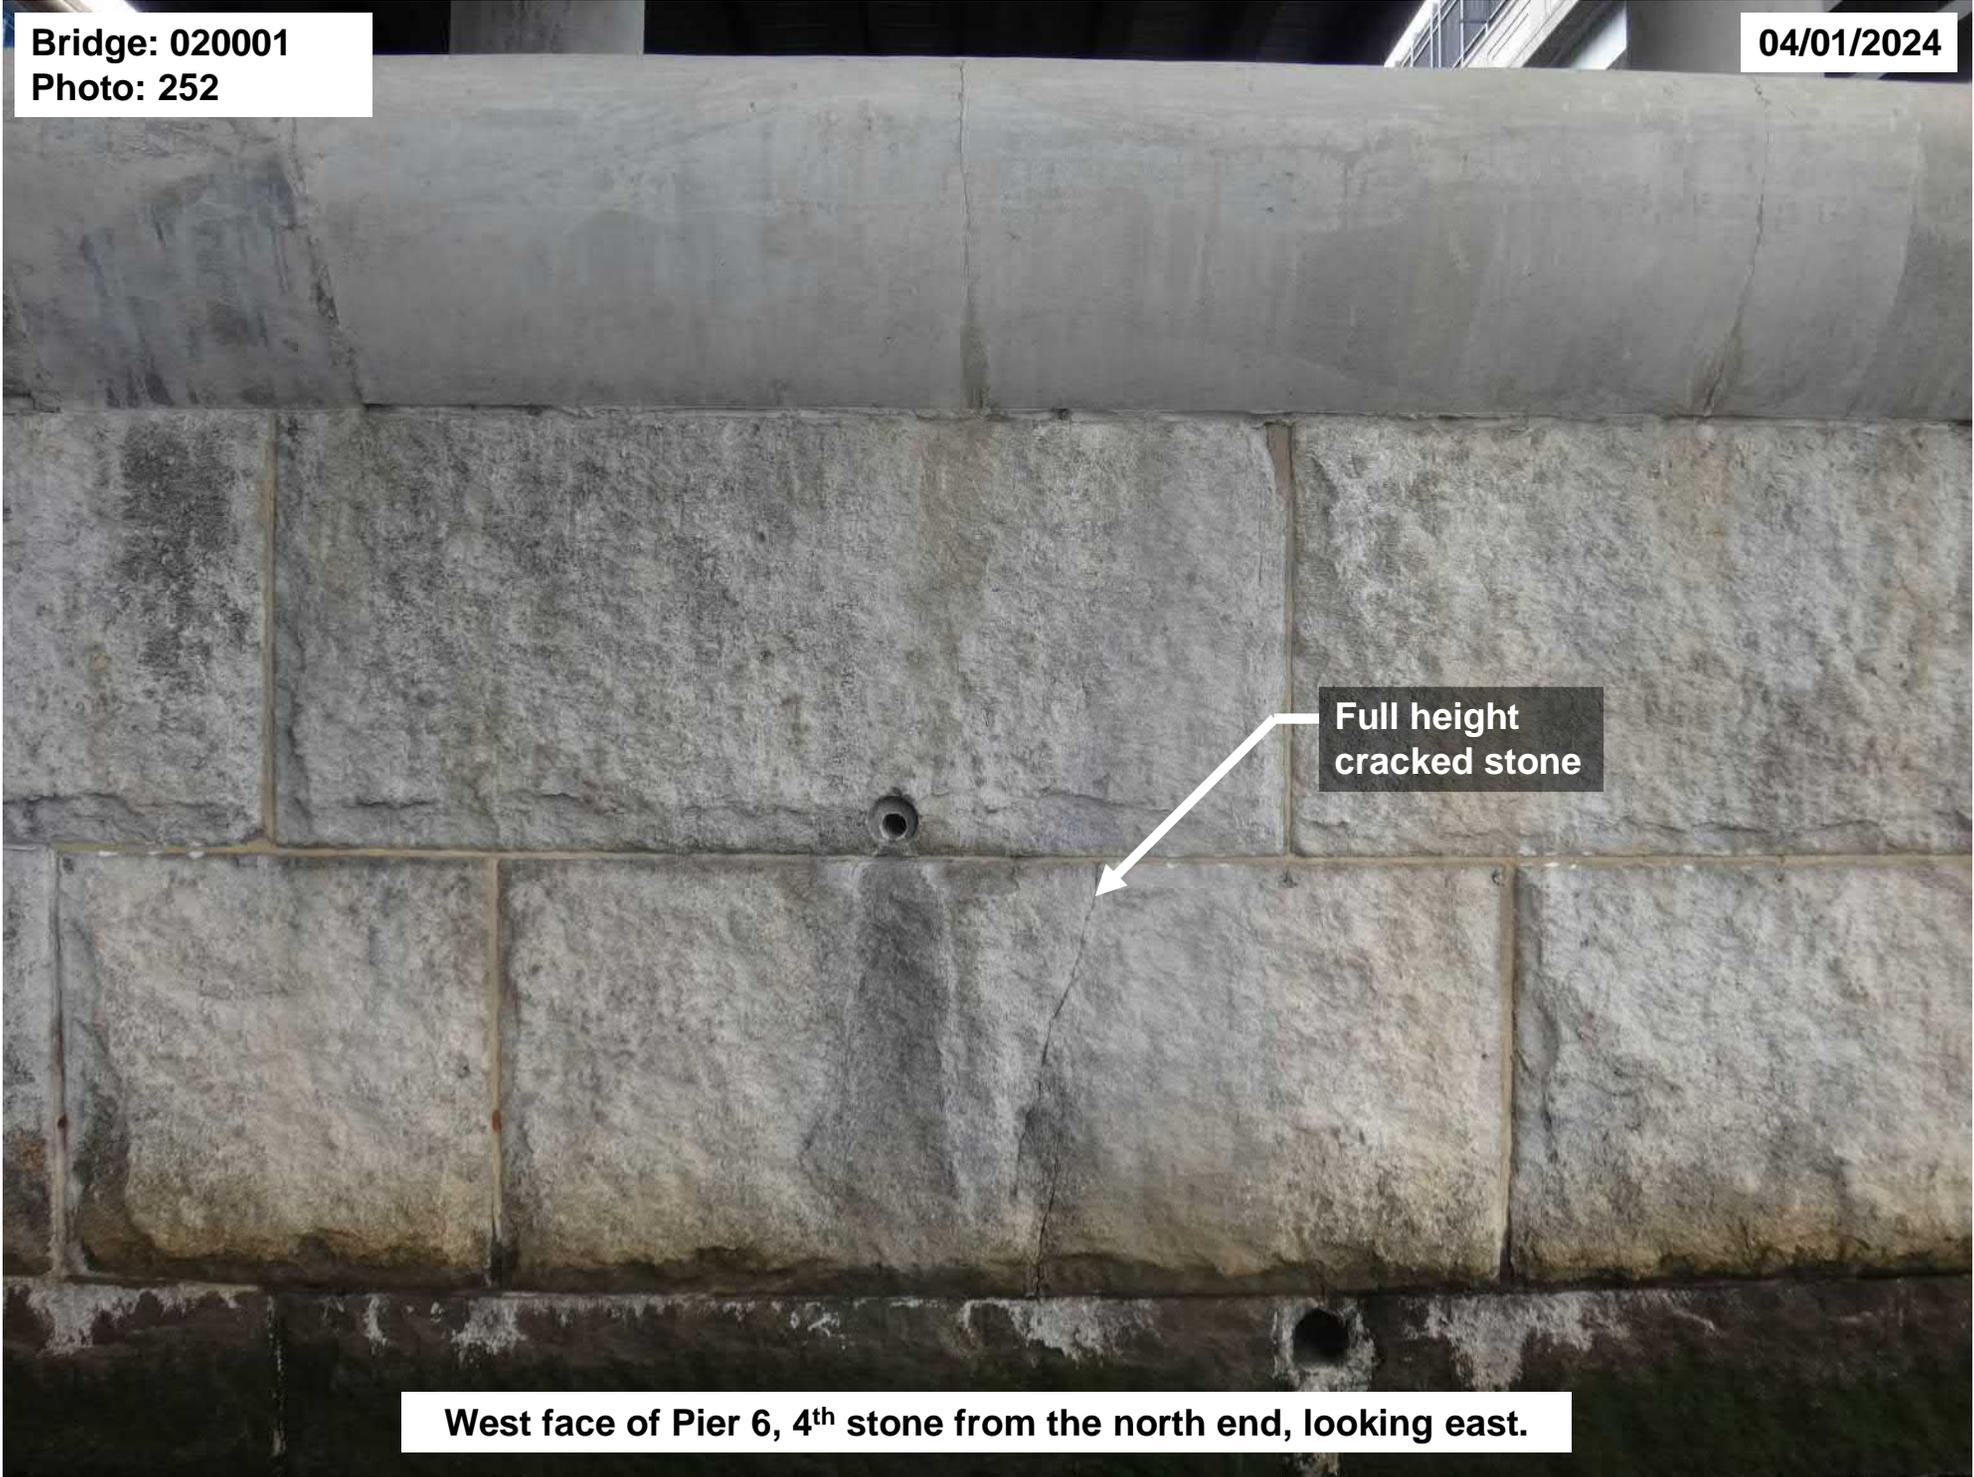
Bridge: 020001
Photo: 252

Full height
cracked stone

West face of Pier 6, 4th stone from the north end, looking east.

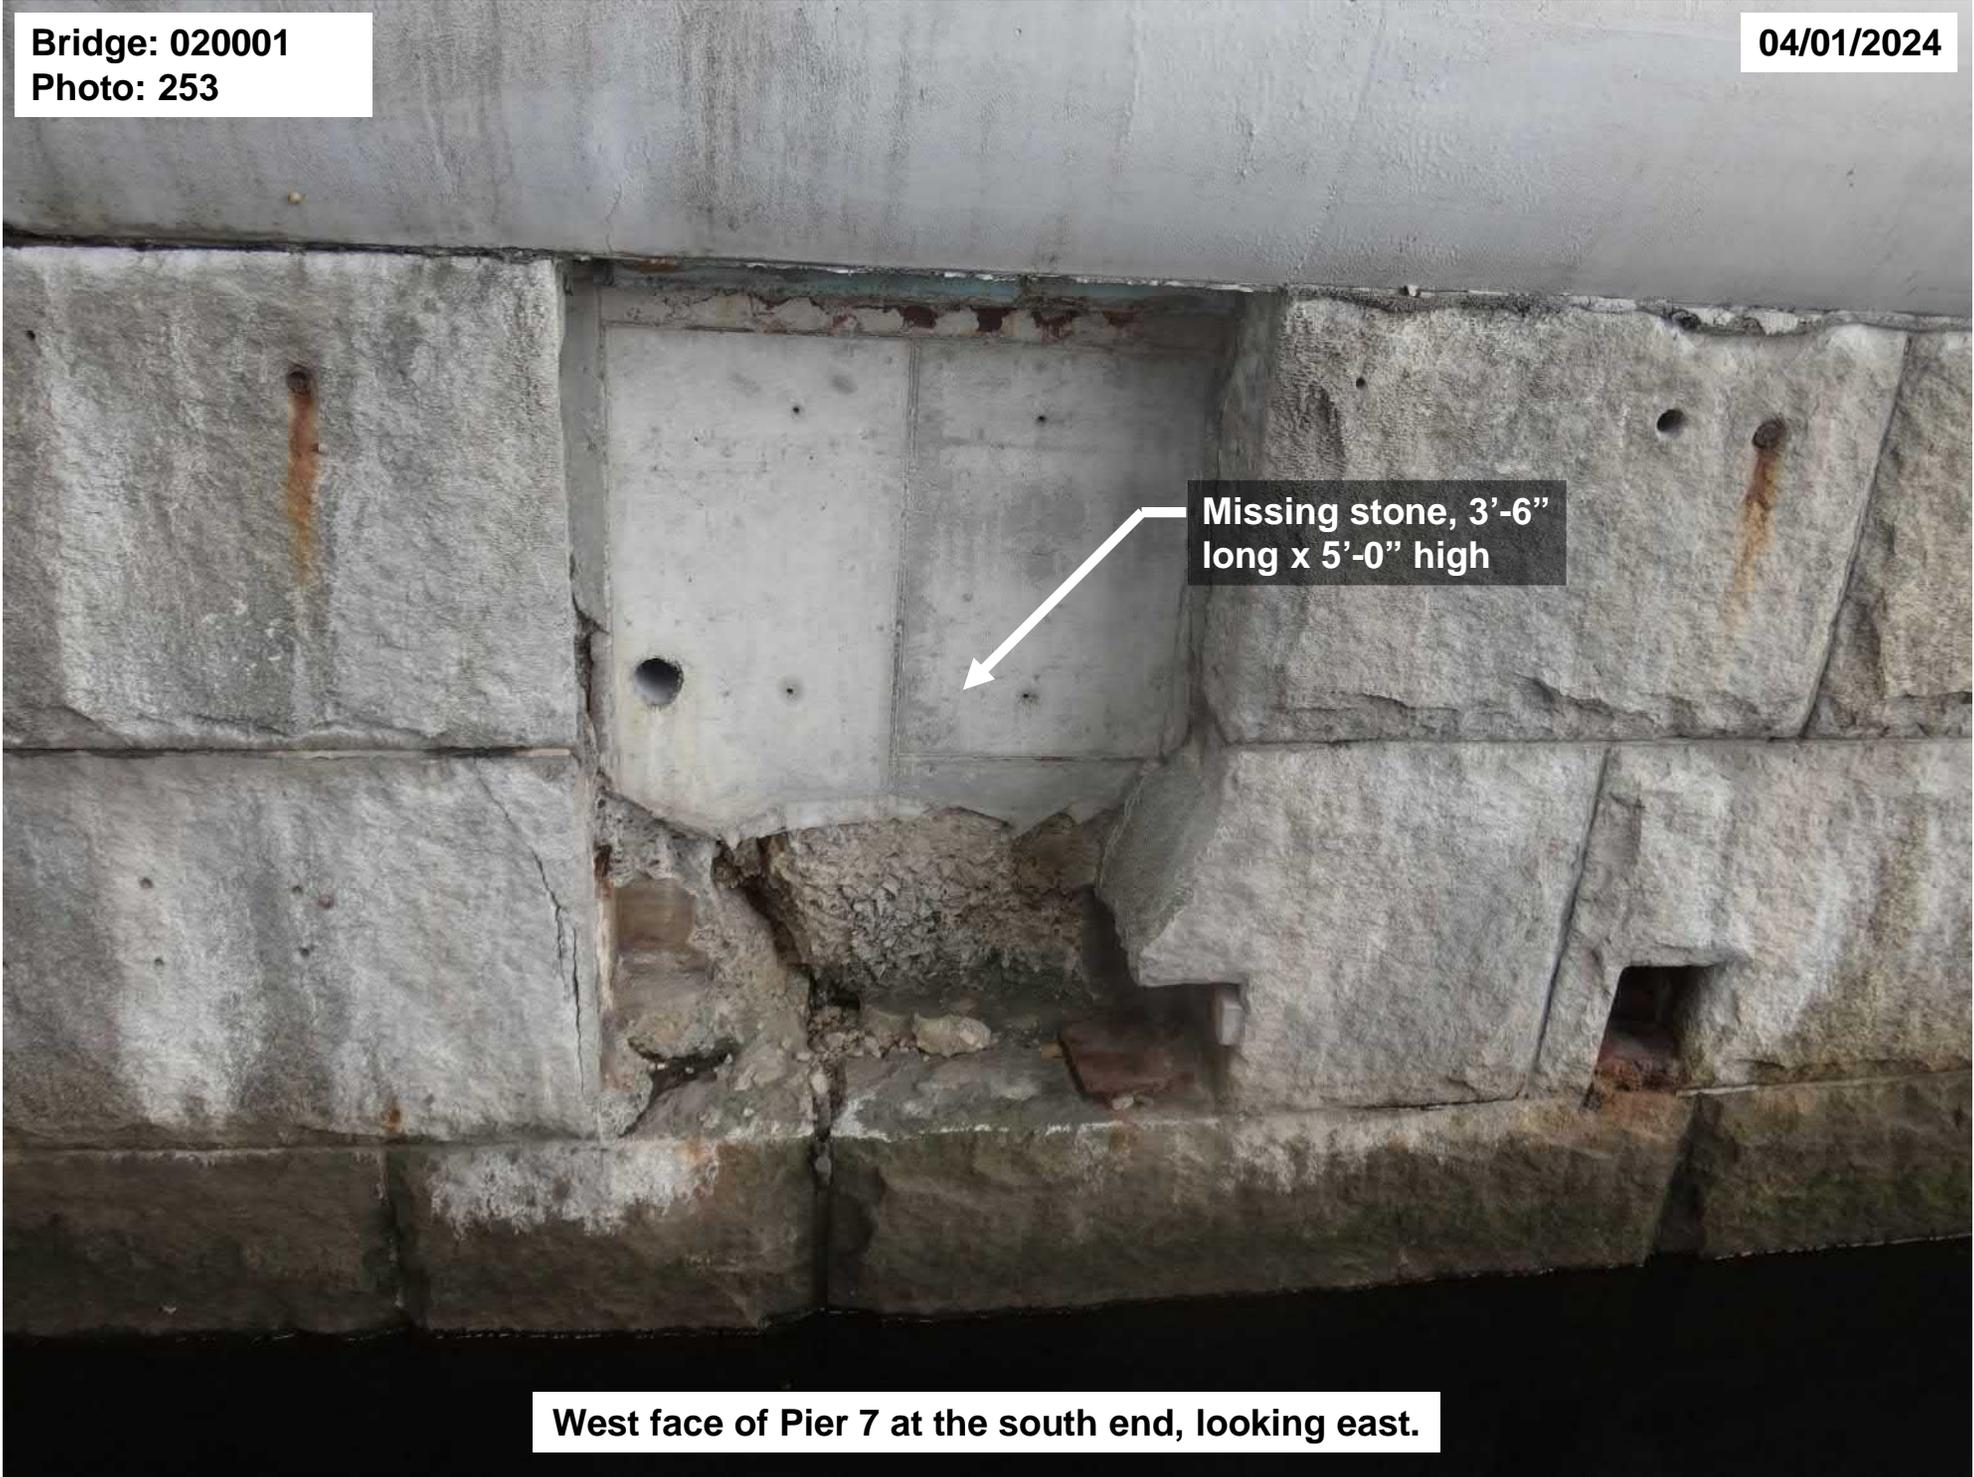
Bridge: 020001
Photo: 253

Missing stone, 3'-6"
long x 5'-0" high

West face of Pier 7 at the south end, looking east.

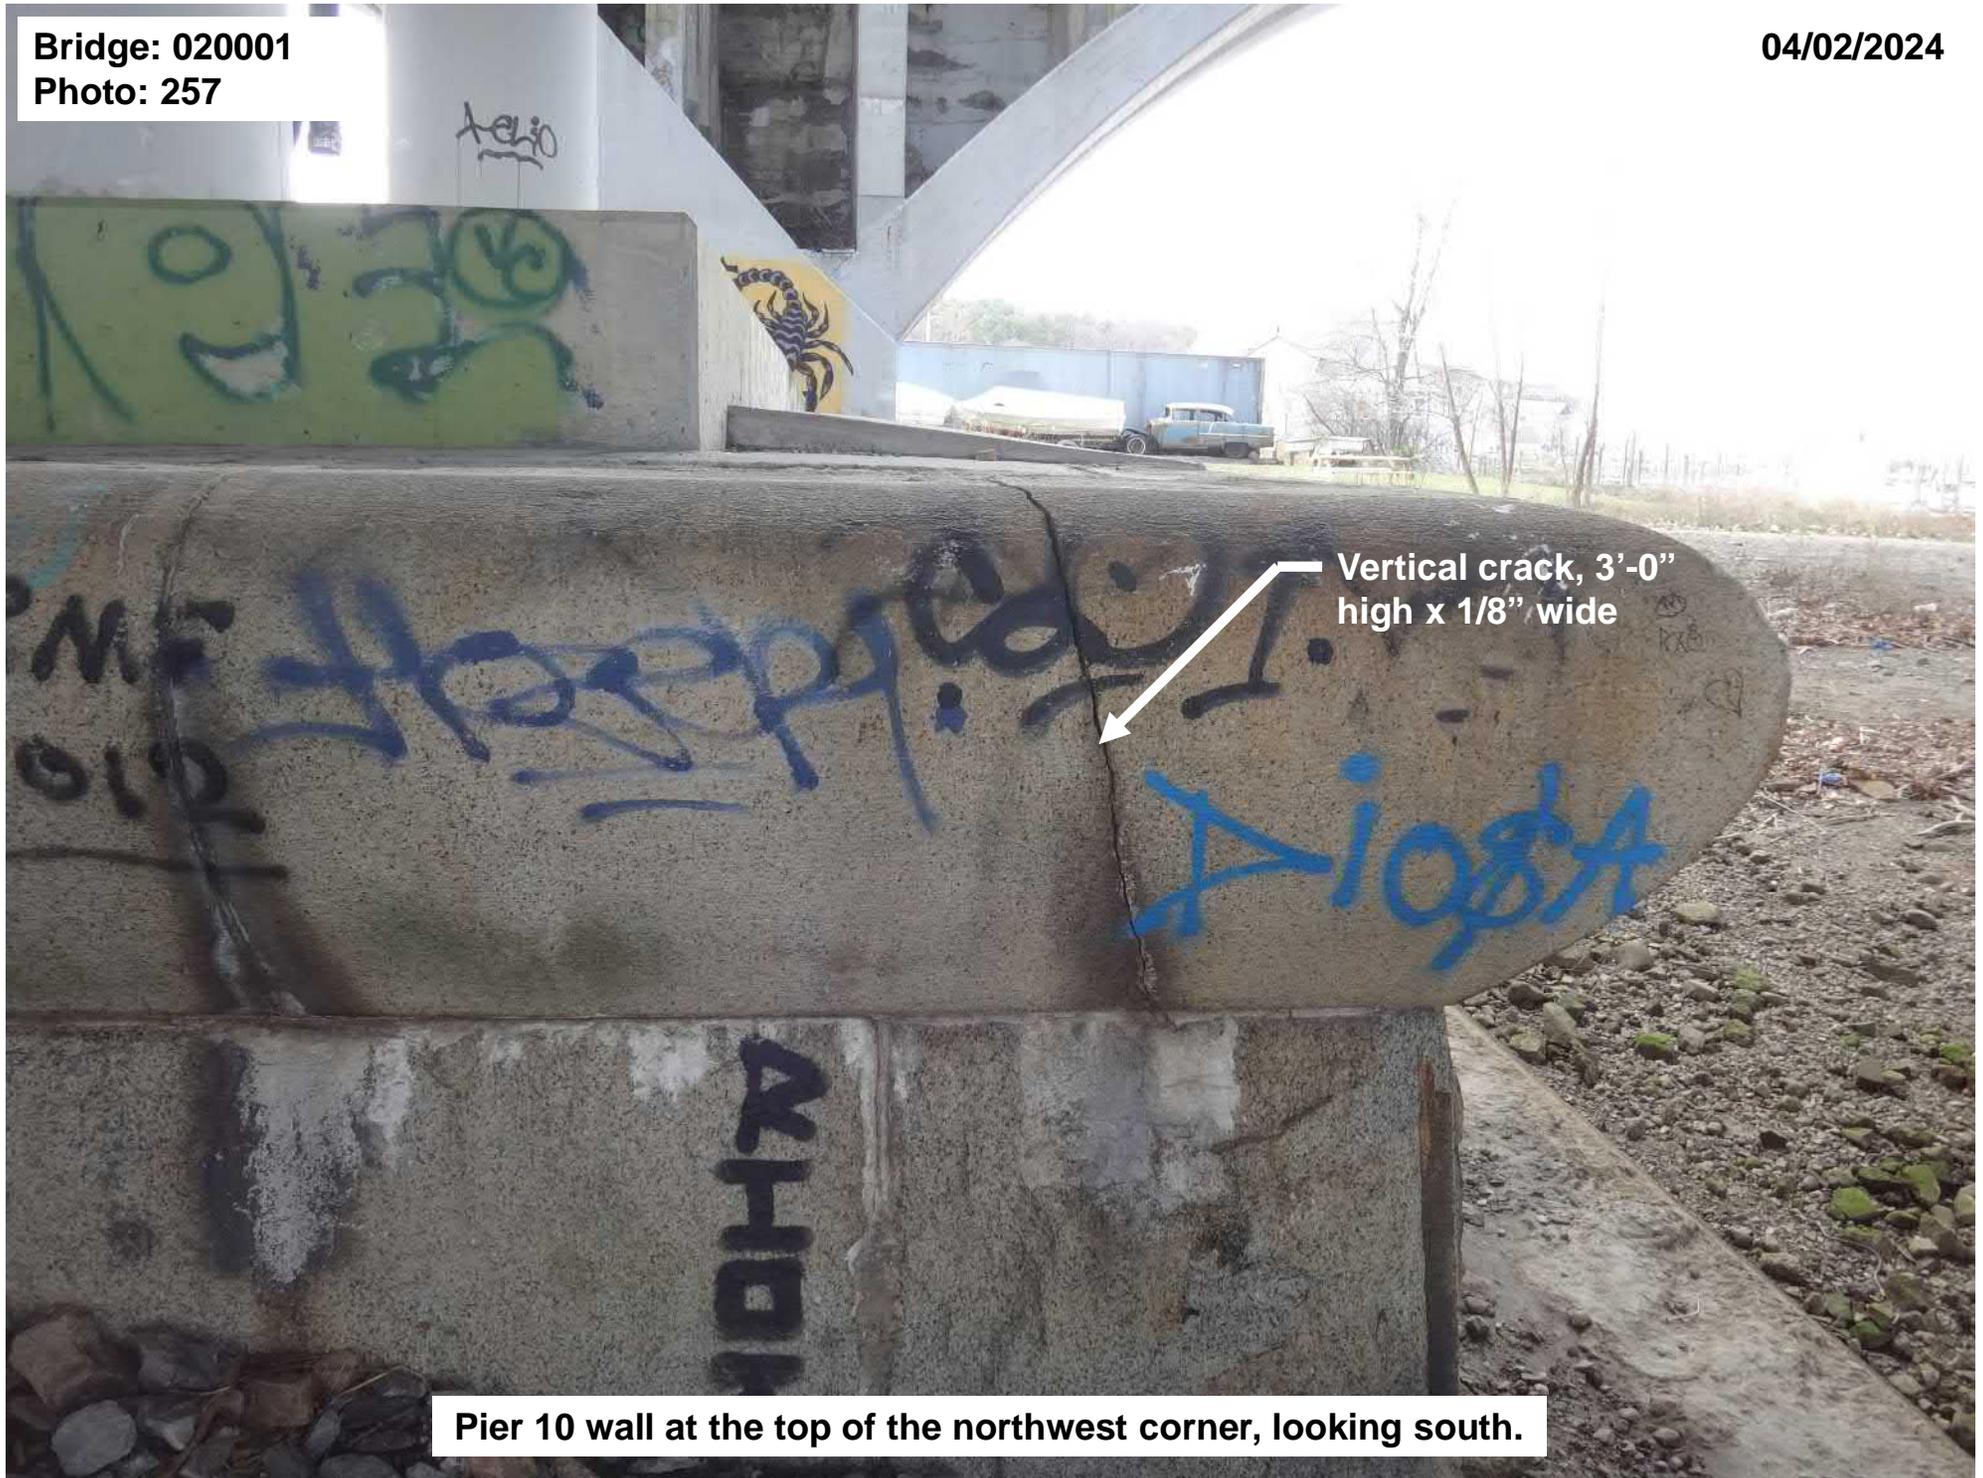
Bridge: 020001
Photo: 257

Vertical crack, 3'-0"
high x 1/8" wide

Pier 10 wall at the top of the northwest corner, looking south.

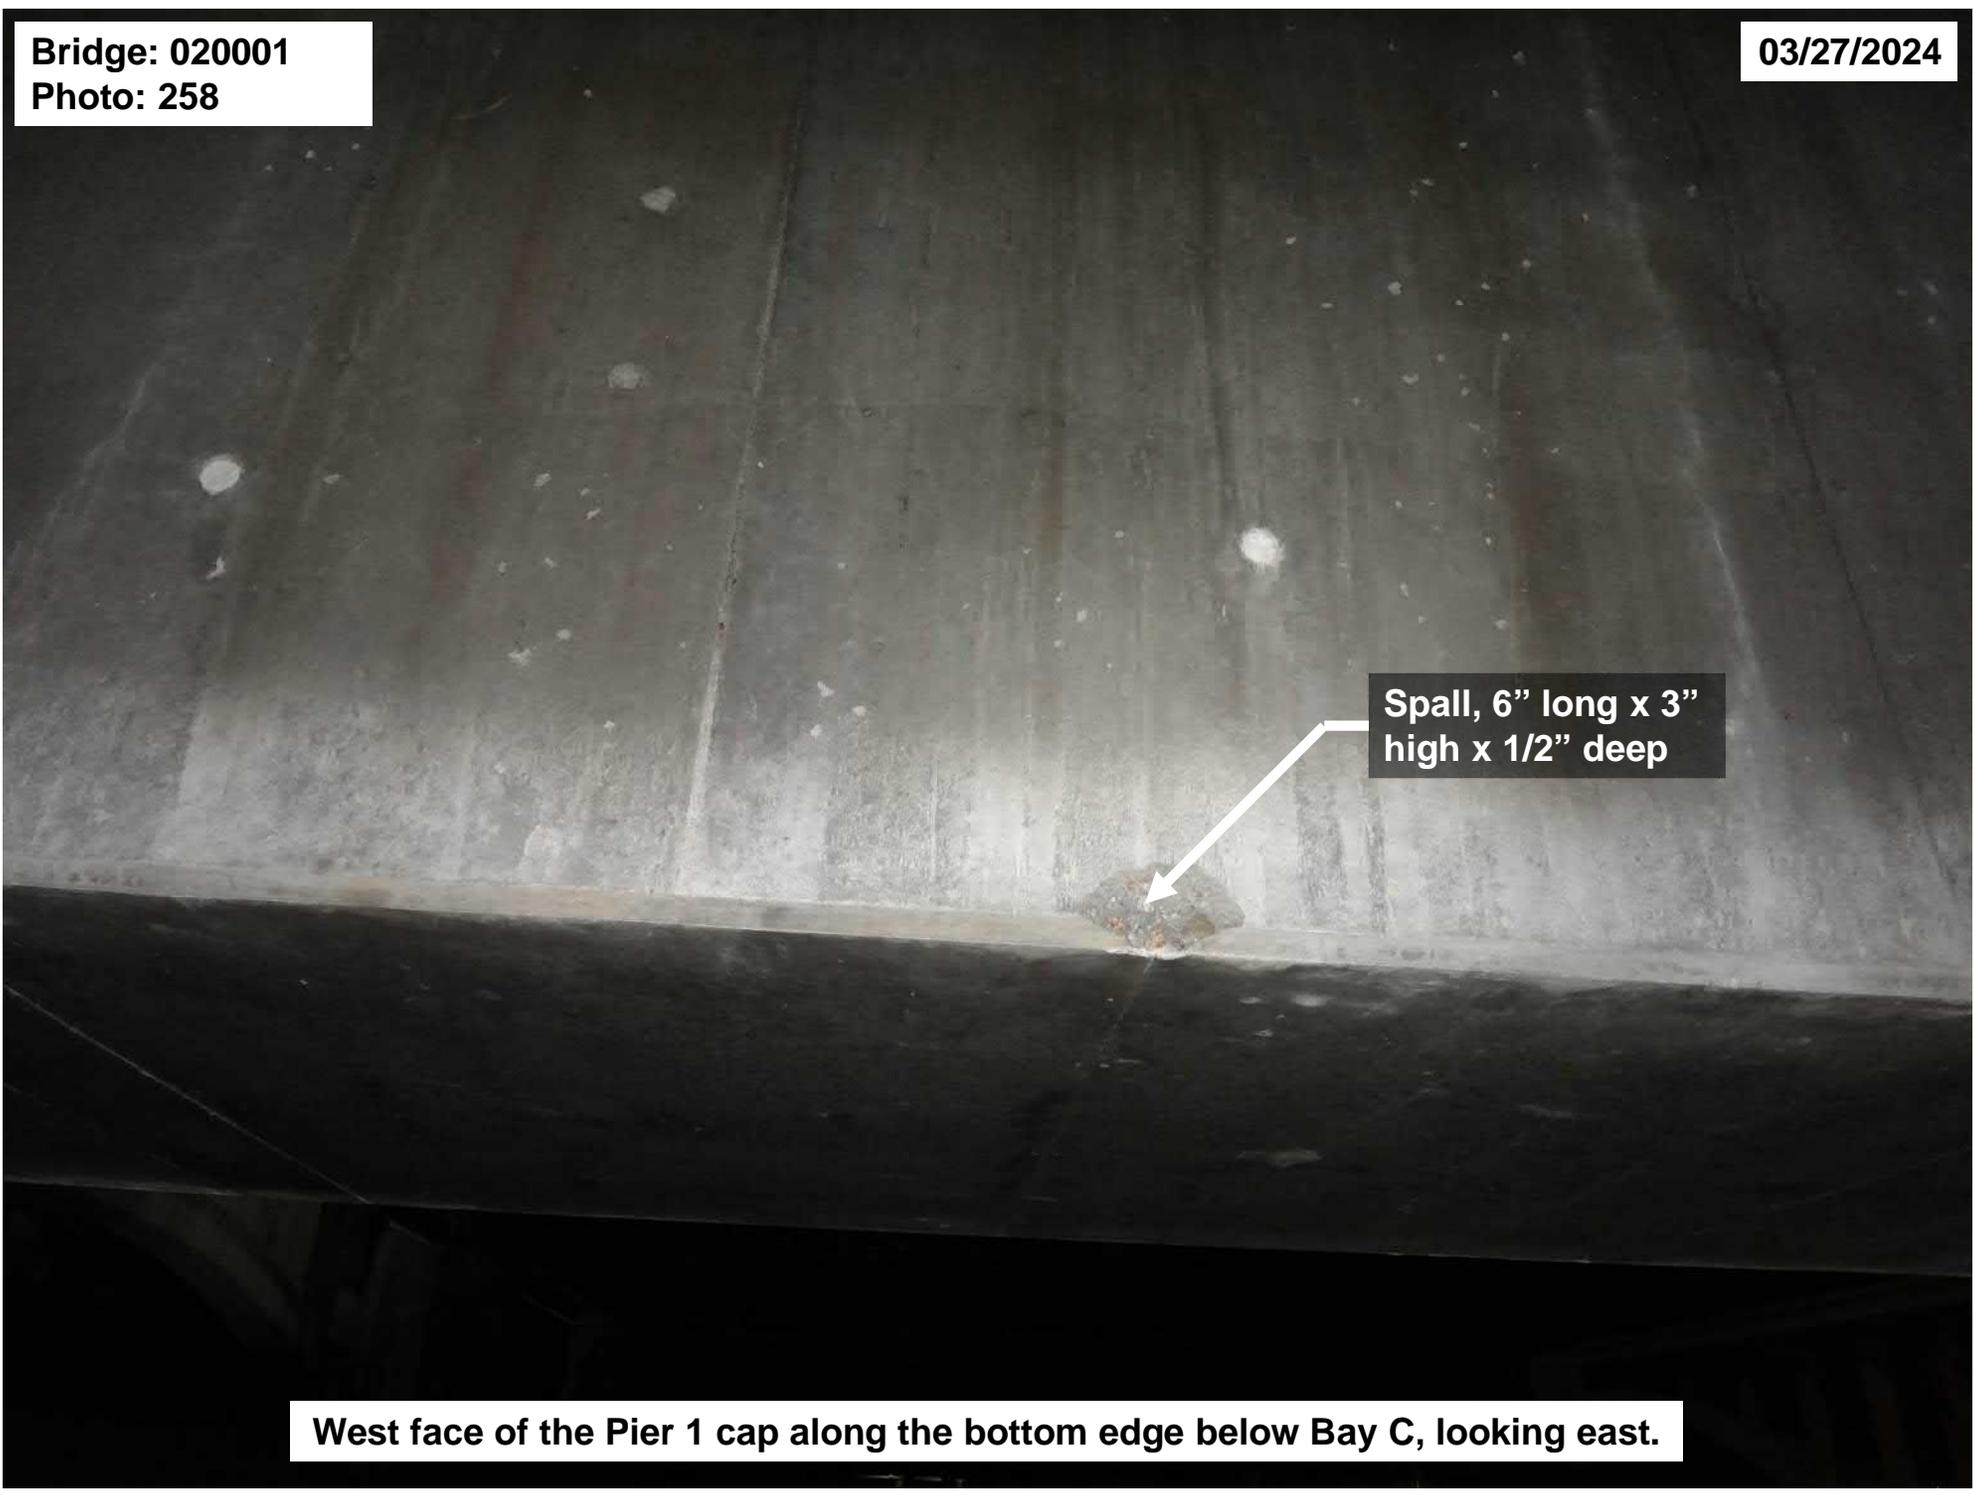
Bridge: 020001
Photo: 258

Spall, 6" long x 3"
high x 1/2" deep

West face of the Pier 1 cap along the bottom edge below Bay C, looking east.

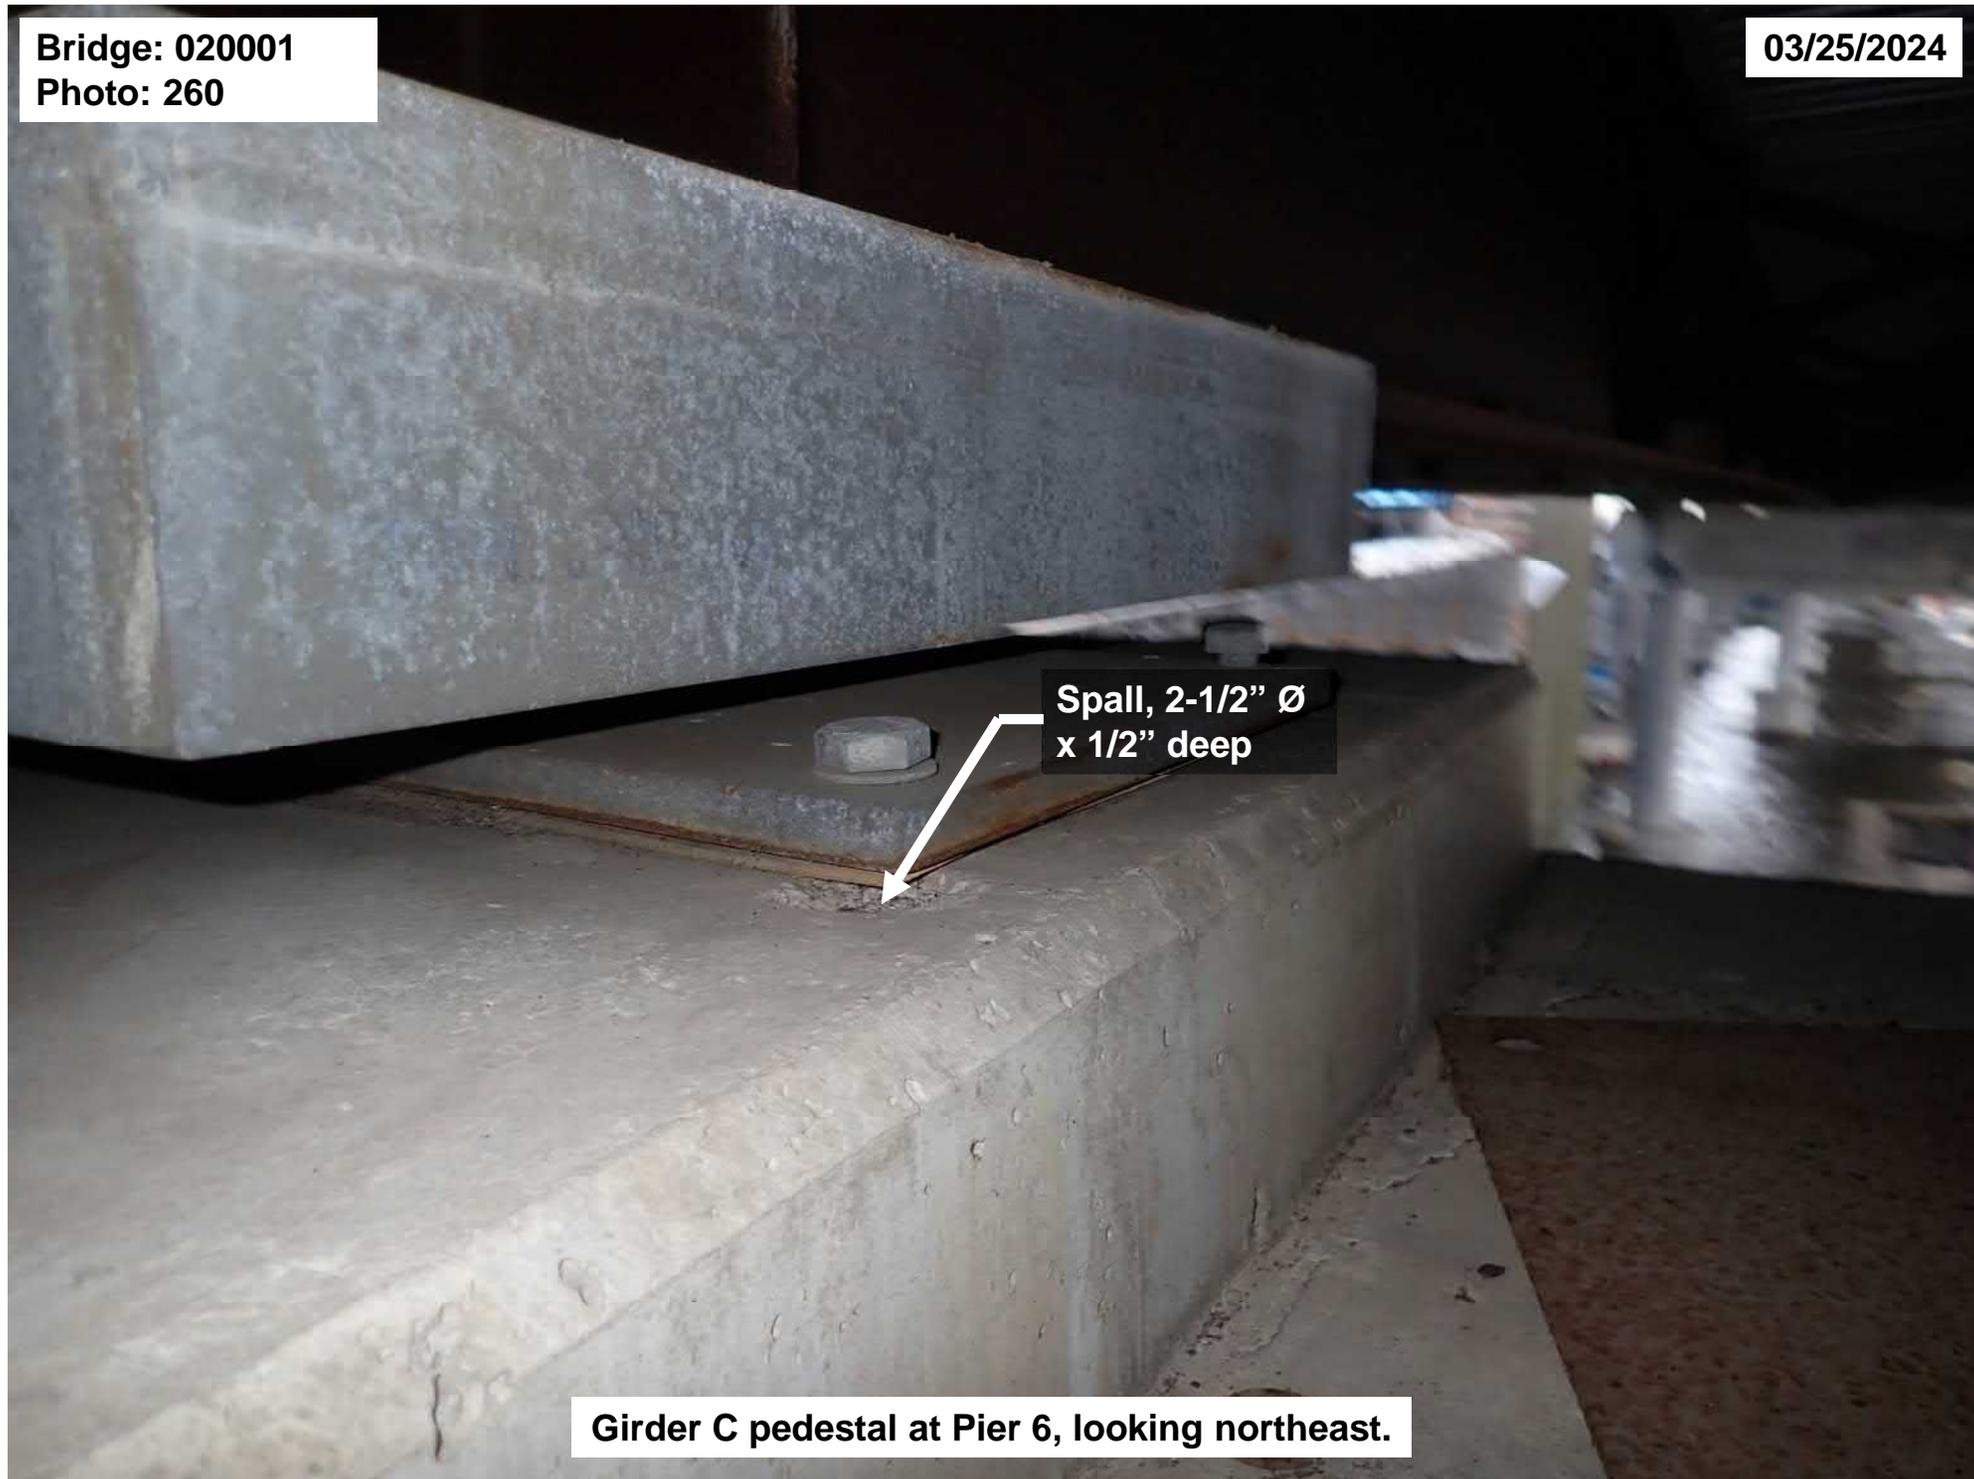
Bridge: 020001
Photo: 260

Spall, 2-1/2" Ø
x 1/2" deep

Girder C pedestal at Pier 6, looking northeast.

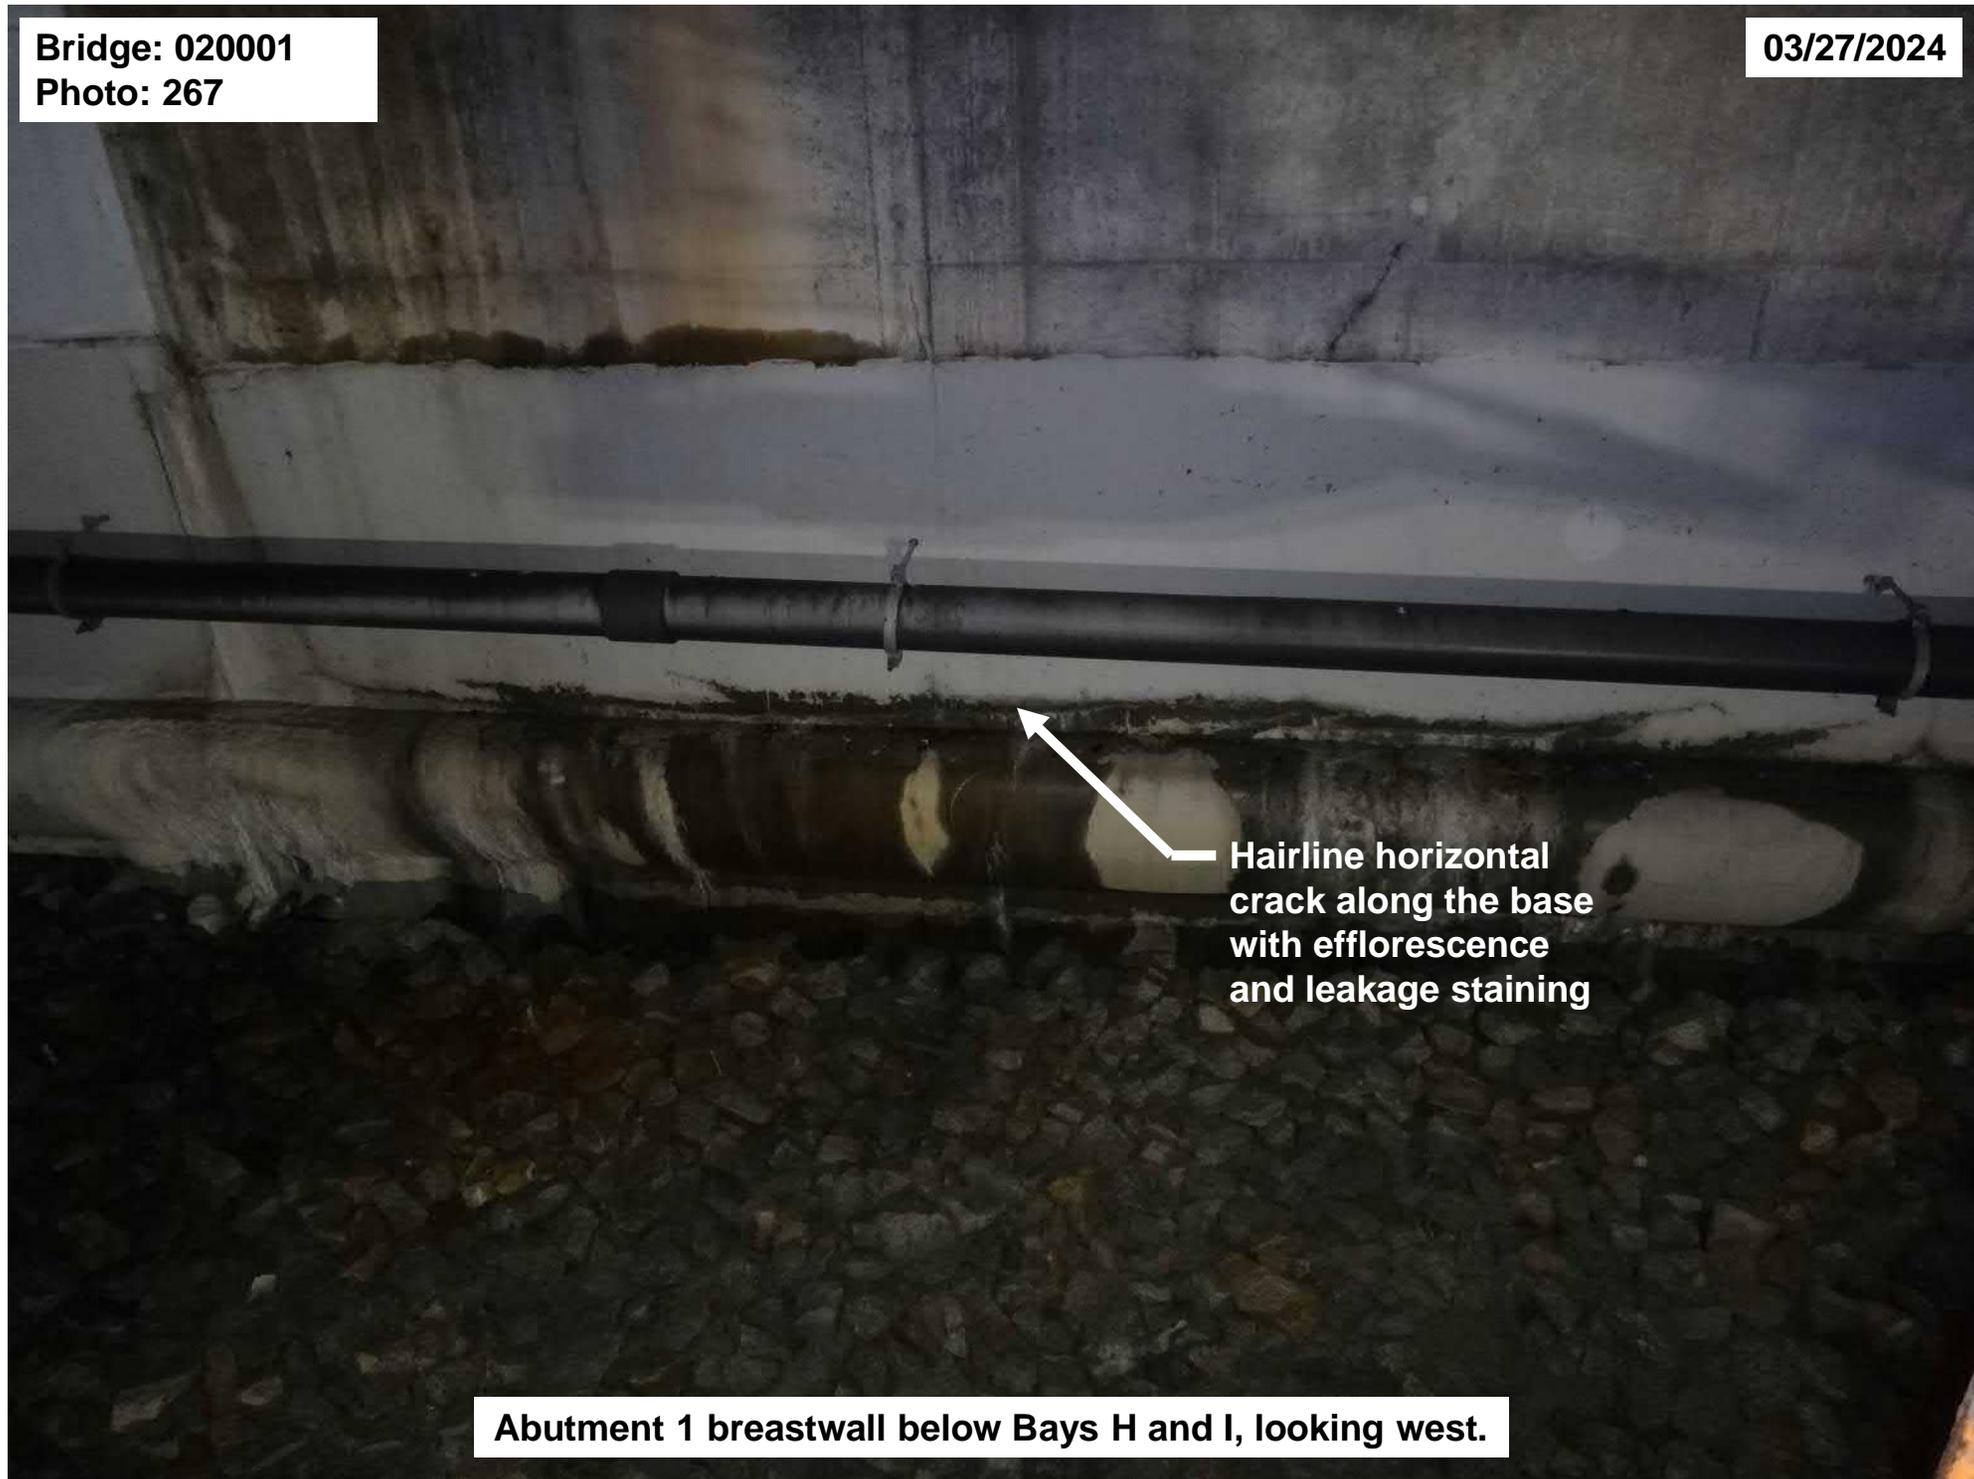
Bridge: 020001
Photo: 267

Hairline horizontal
crack along the base
with efflorescence
and leakage staining

Abutment 1 breastwall below Bays H and I, looking west.
