Bridge #020001 West Approach Bituminous Wearing Surface Looking Northeast

7/23/2019

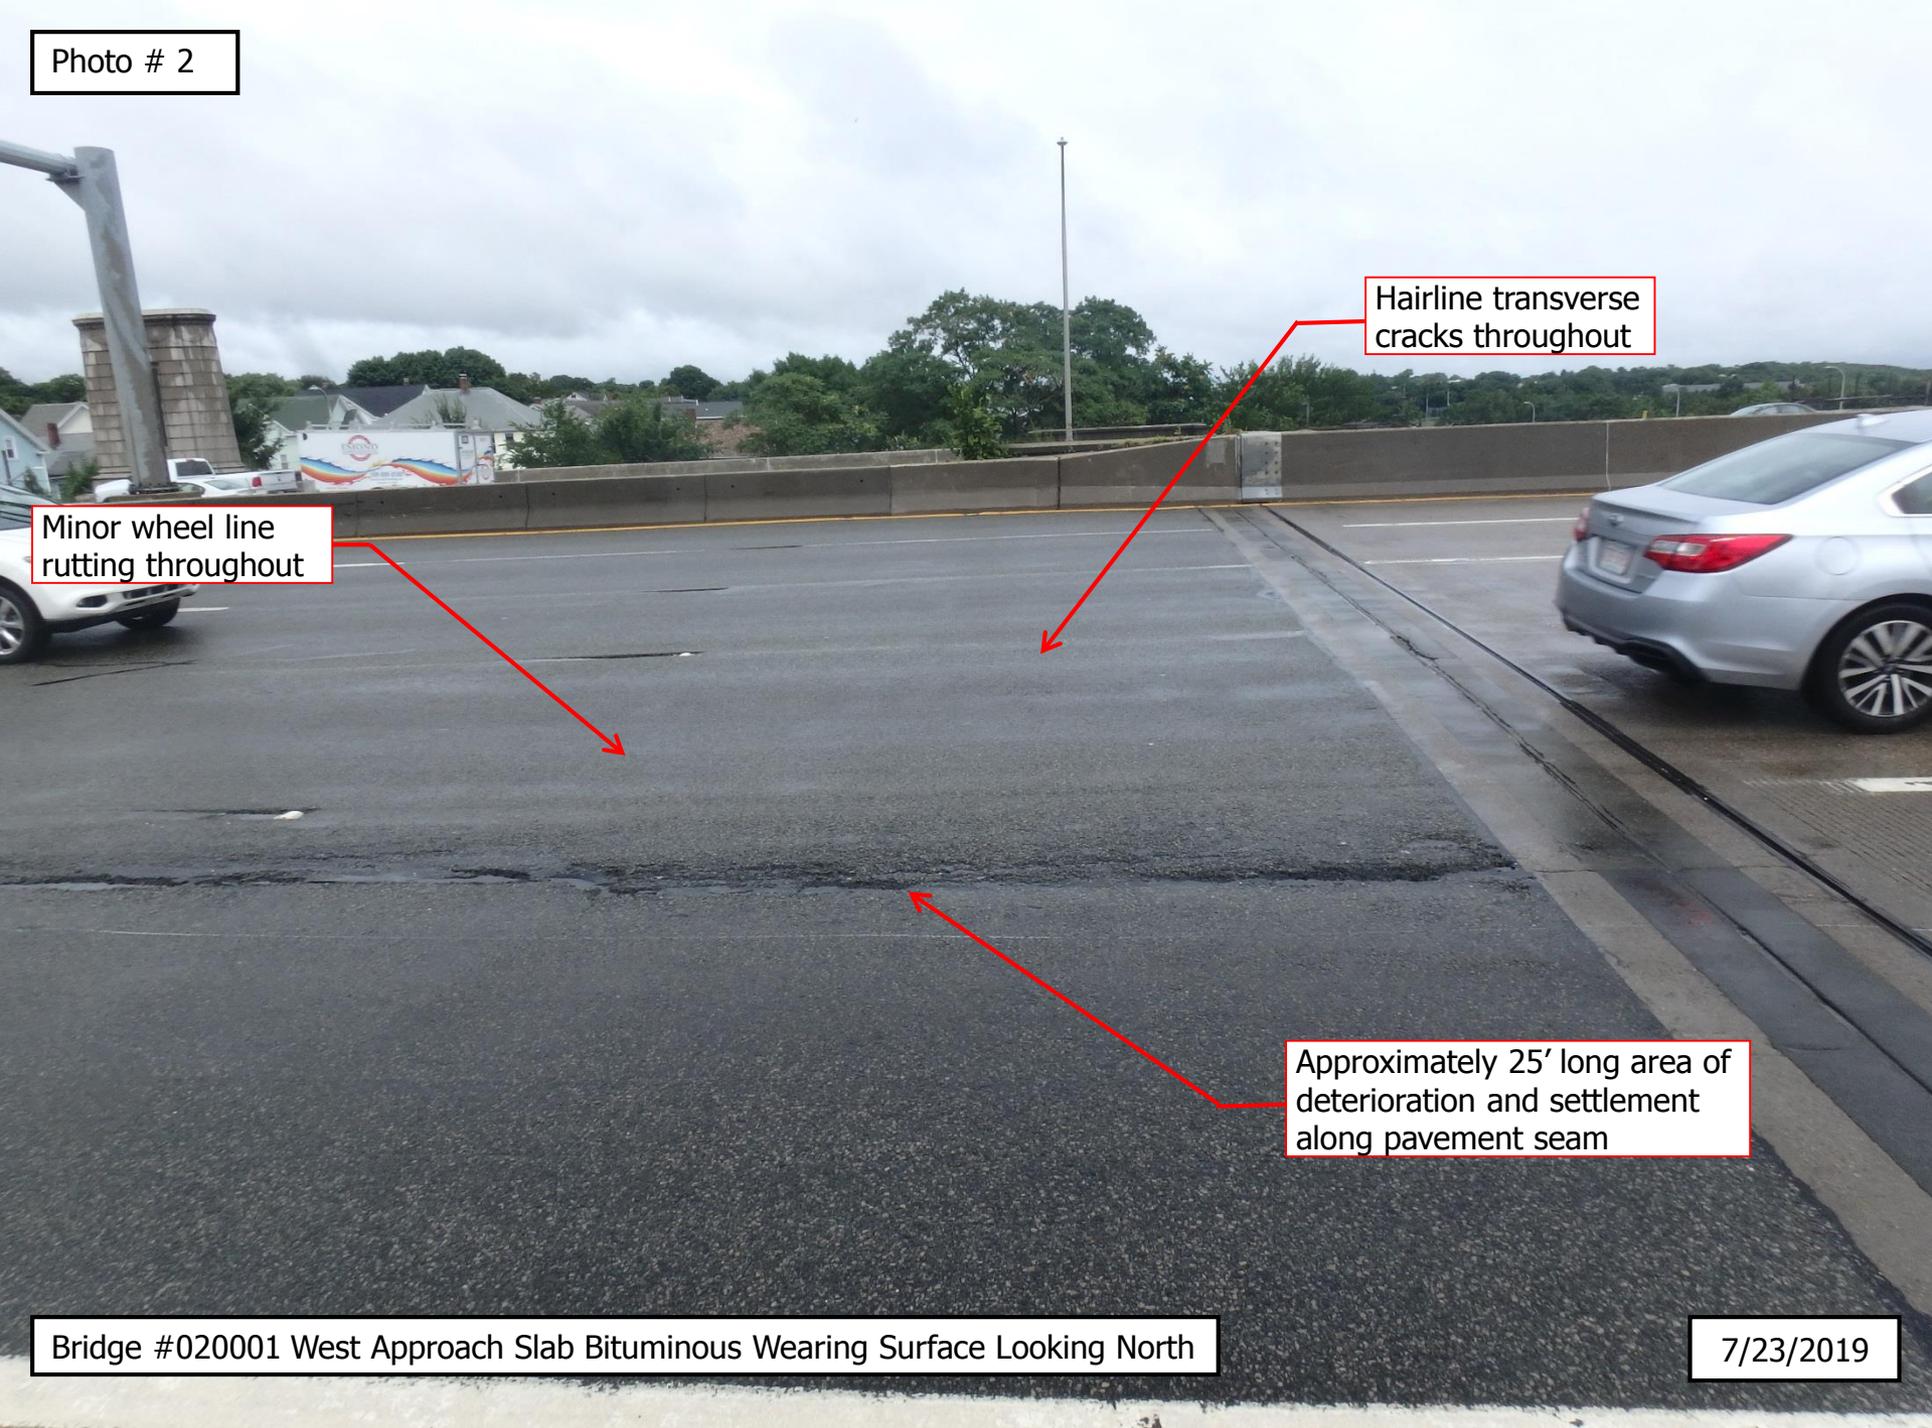
Minor wheel line rutting throughout

Hairline transverse cracks throughout

Approximately 25' long area of deterioration and settlement along pavement seam

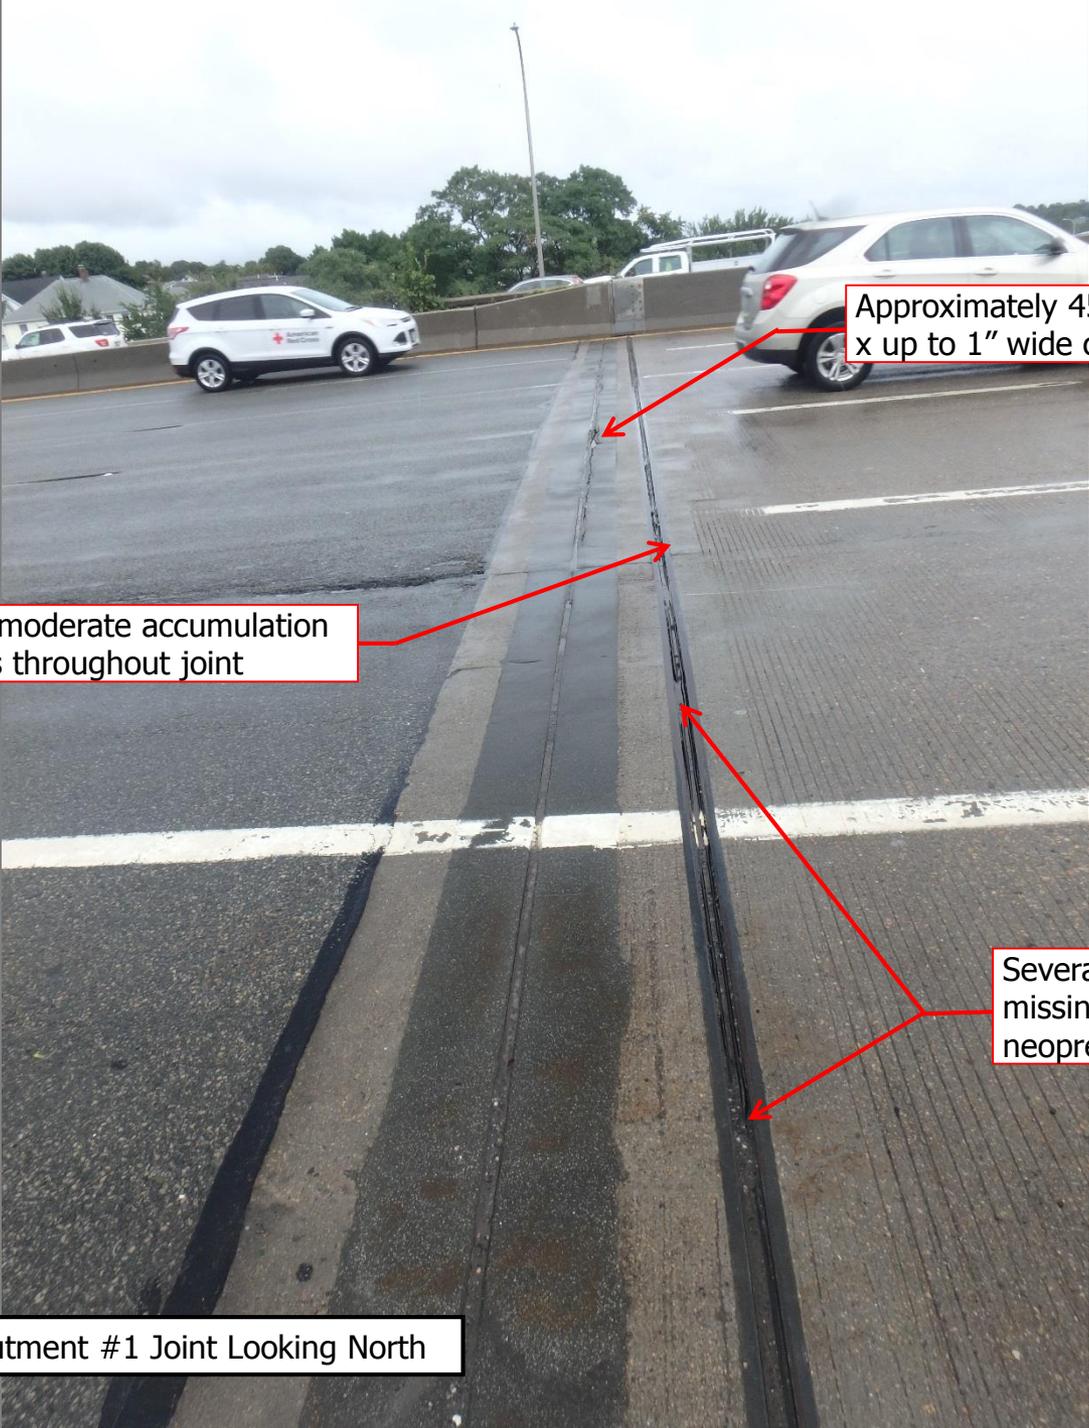
Photo # 3

Approximately 45' long
x up to 1" wide crack

Light to moderate accumulation
of debris throughout joint

Several locations of ripped,
missing and depressed
neoprene seal throughout joint

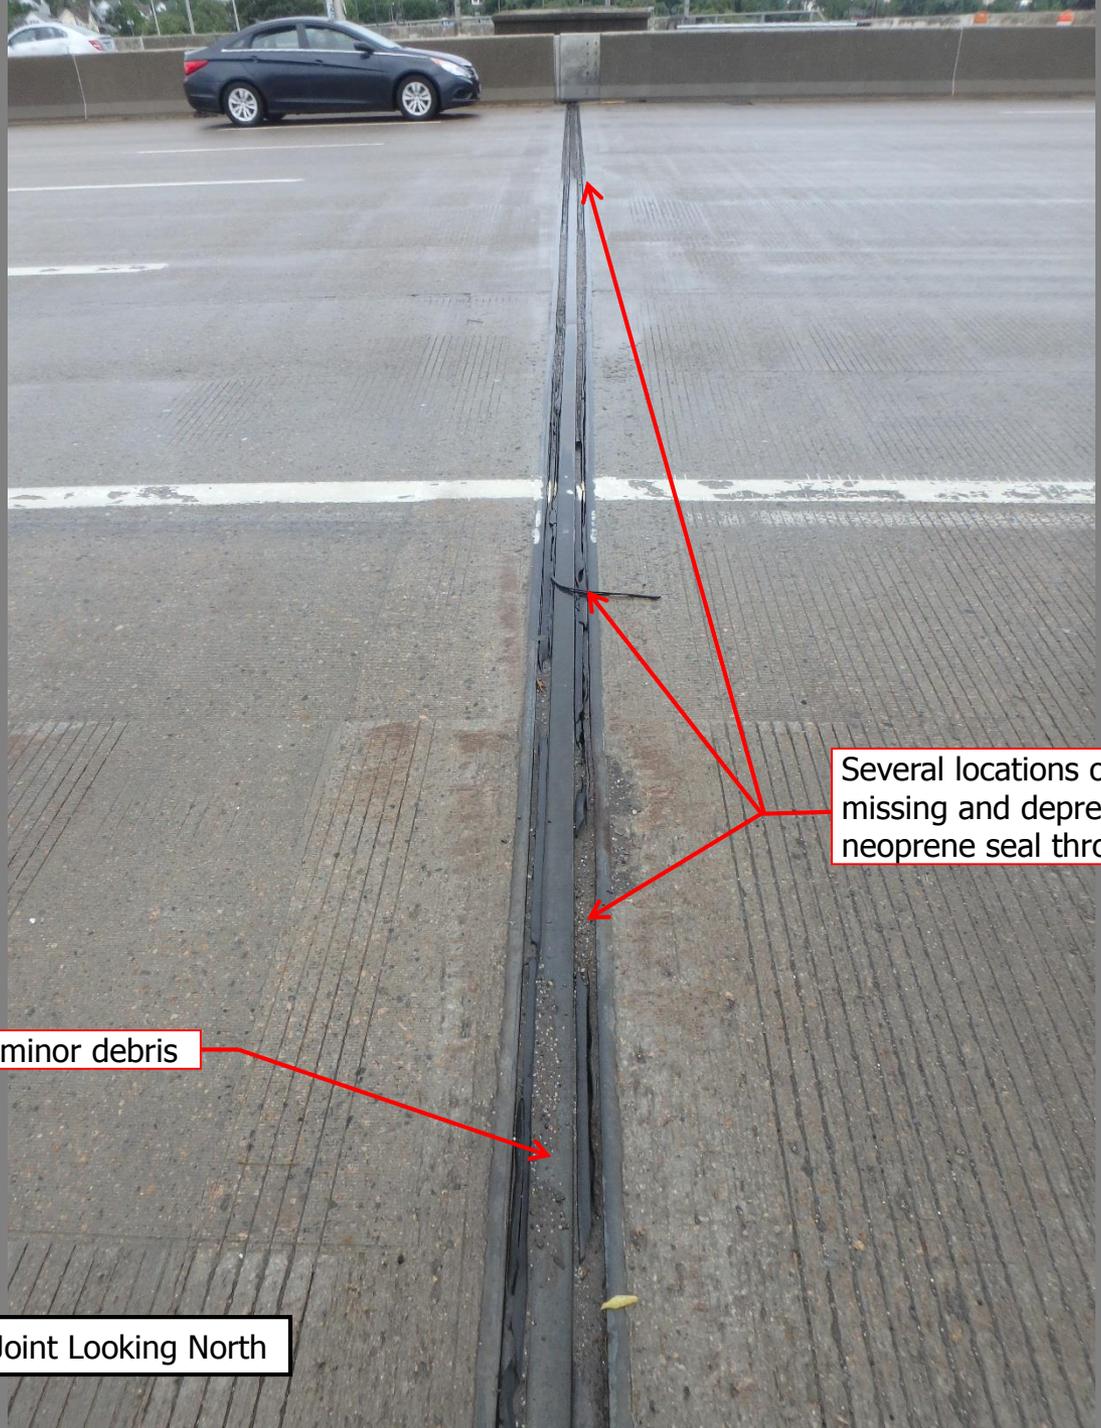
Photo # 9

Several locations of ripped, missing and depressed neoprene seal throughout joint

Areas of minor debris

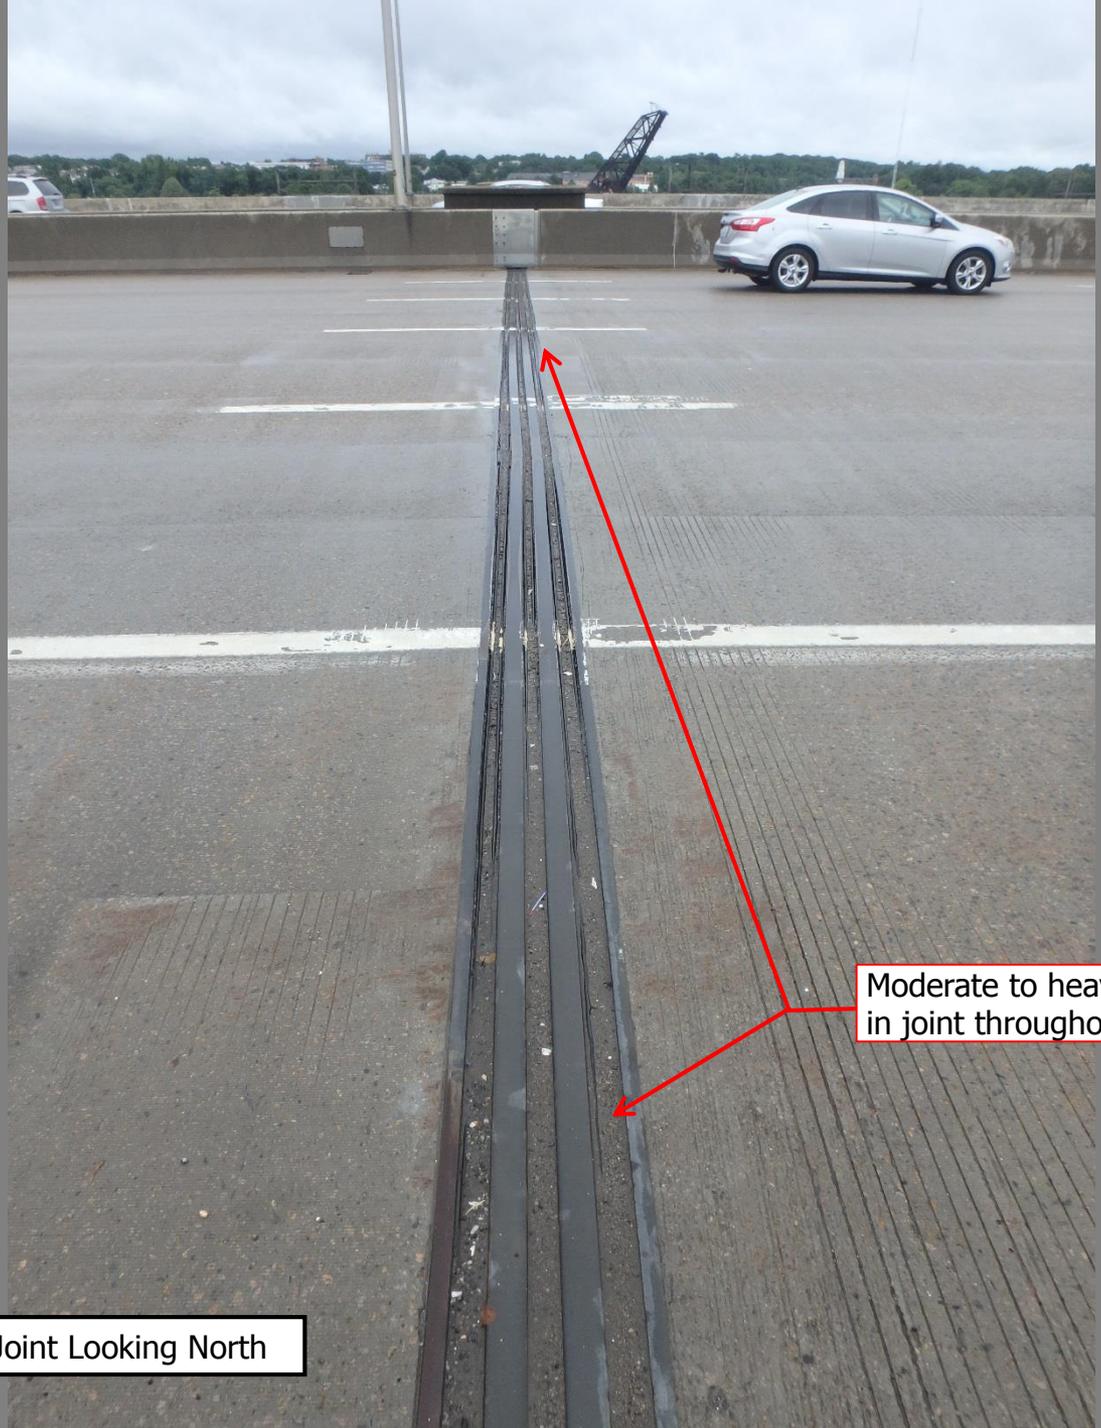
Photo # 10

Moderate to heavy debris in joint throughout

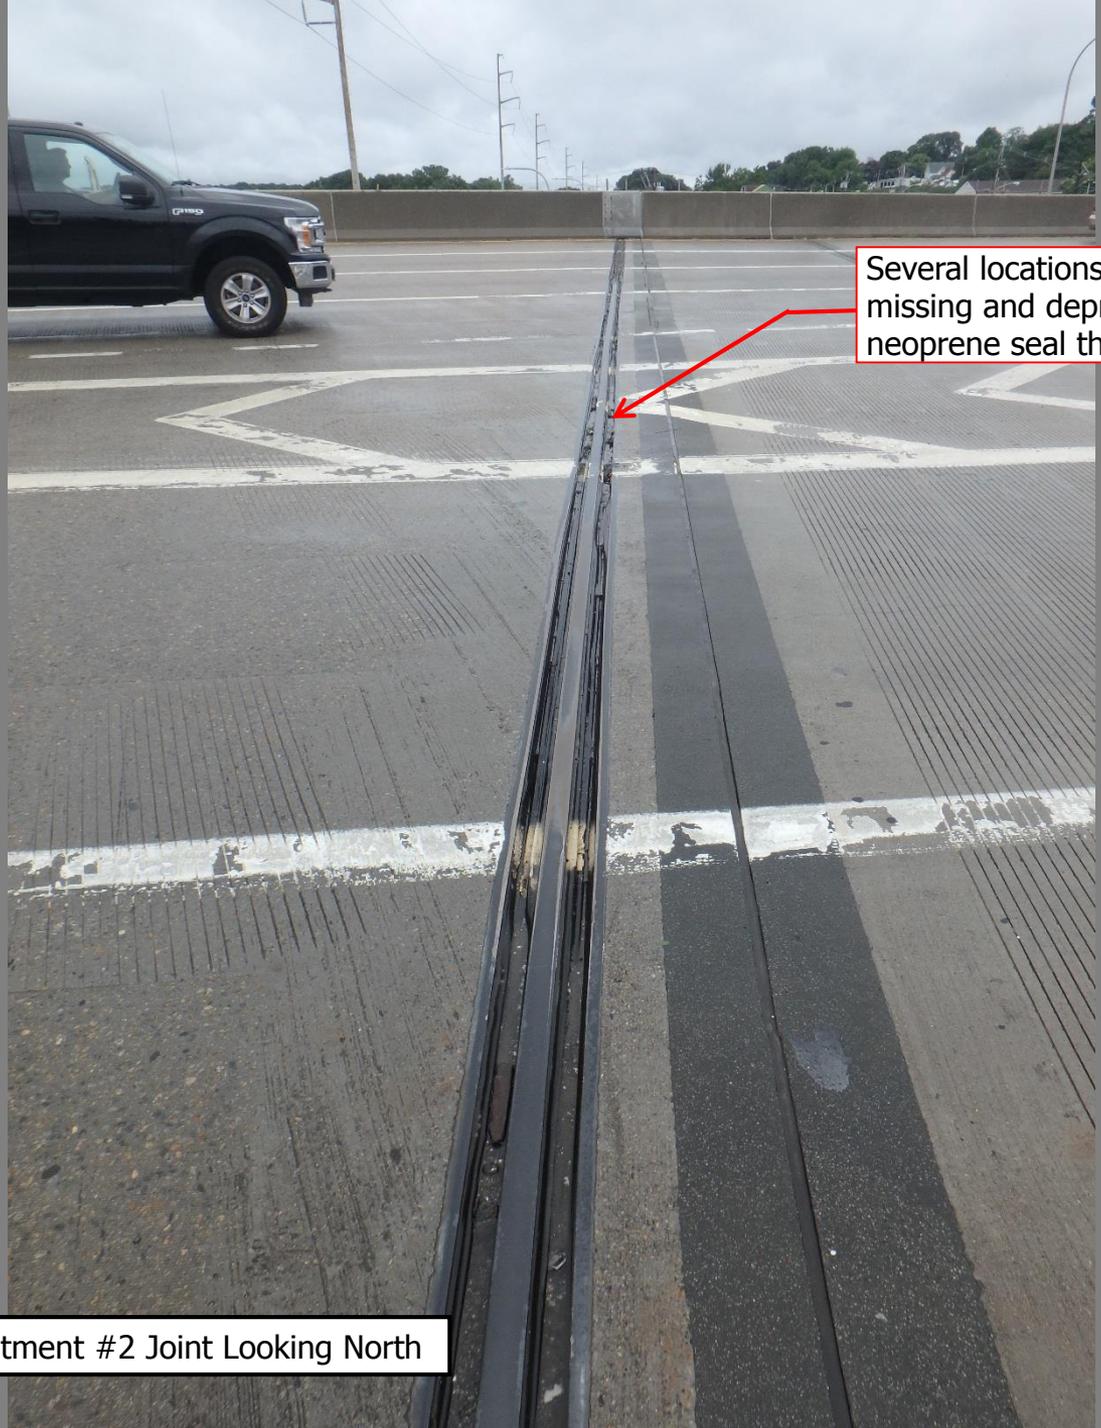
Photo # 13

Several locations of ripped, missing and depressed neoprene seal throughout joint

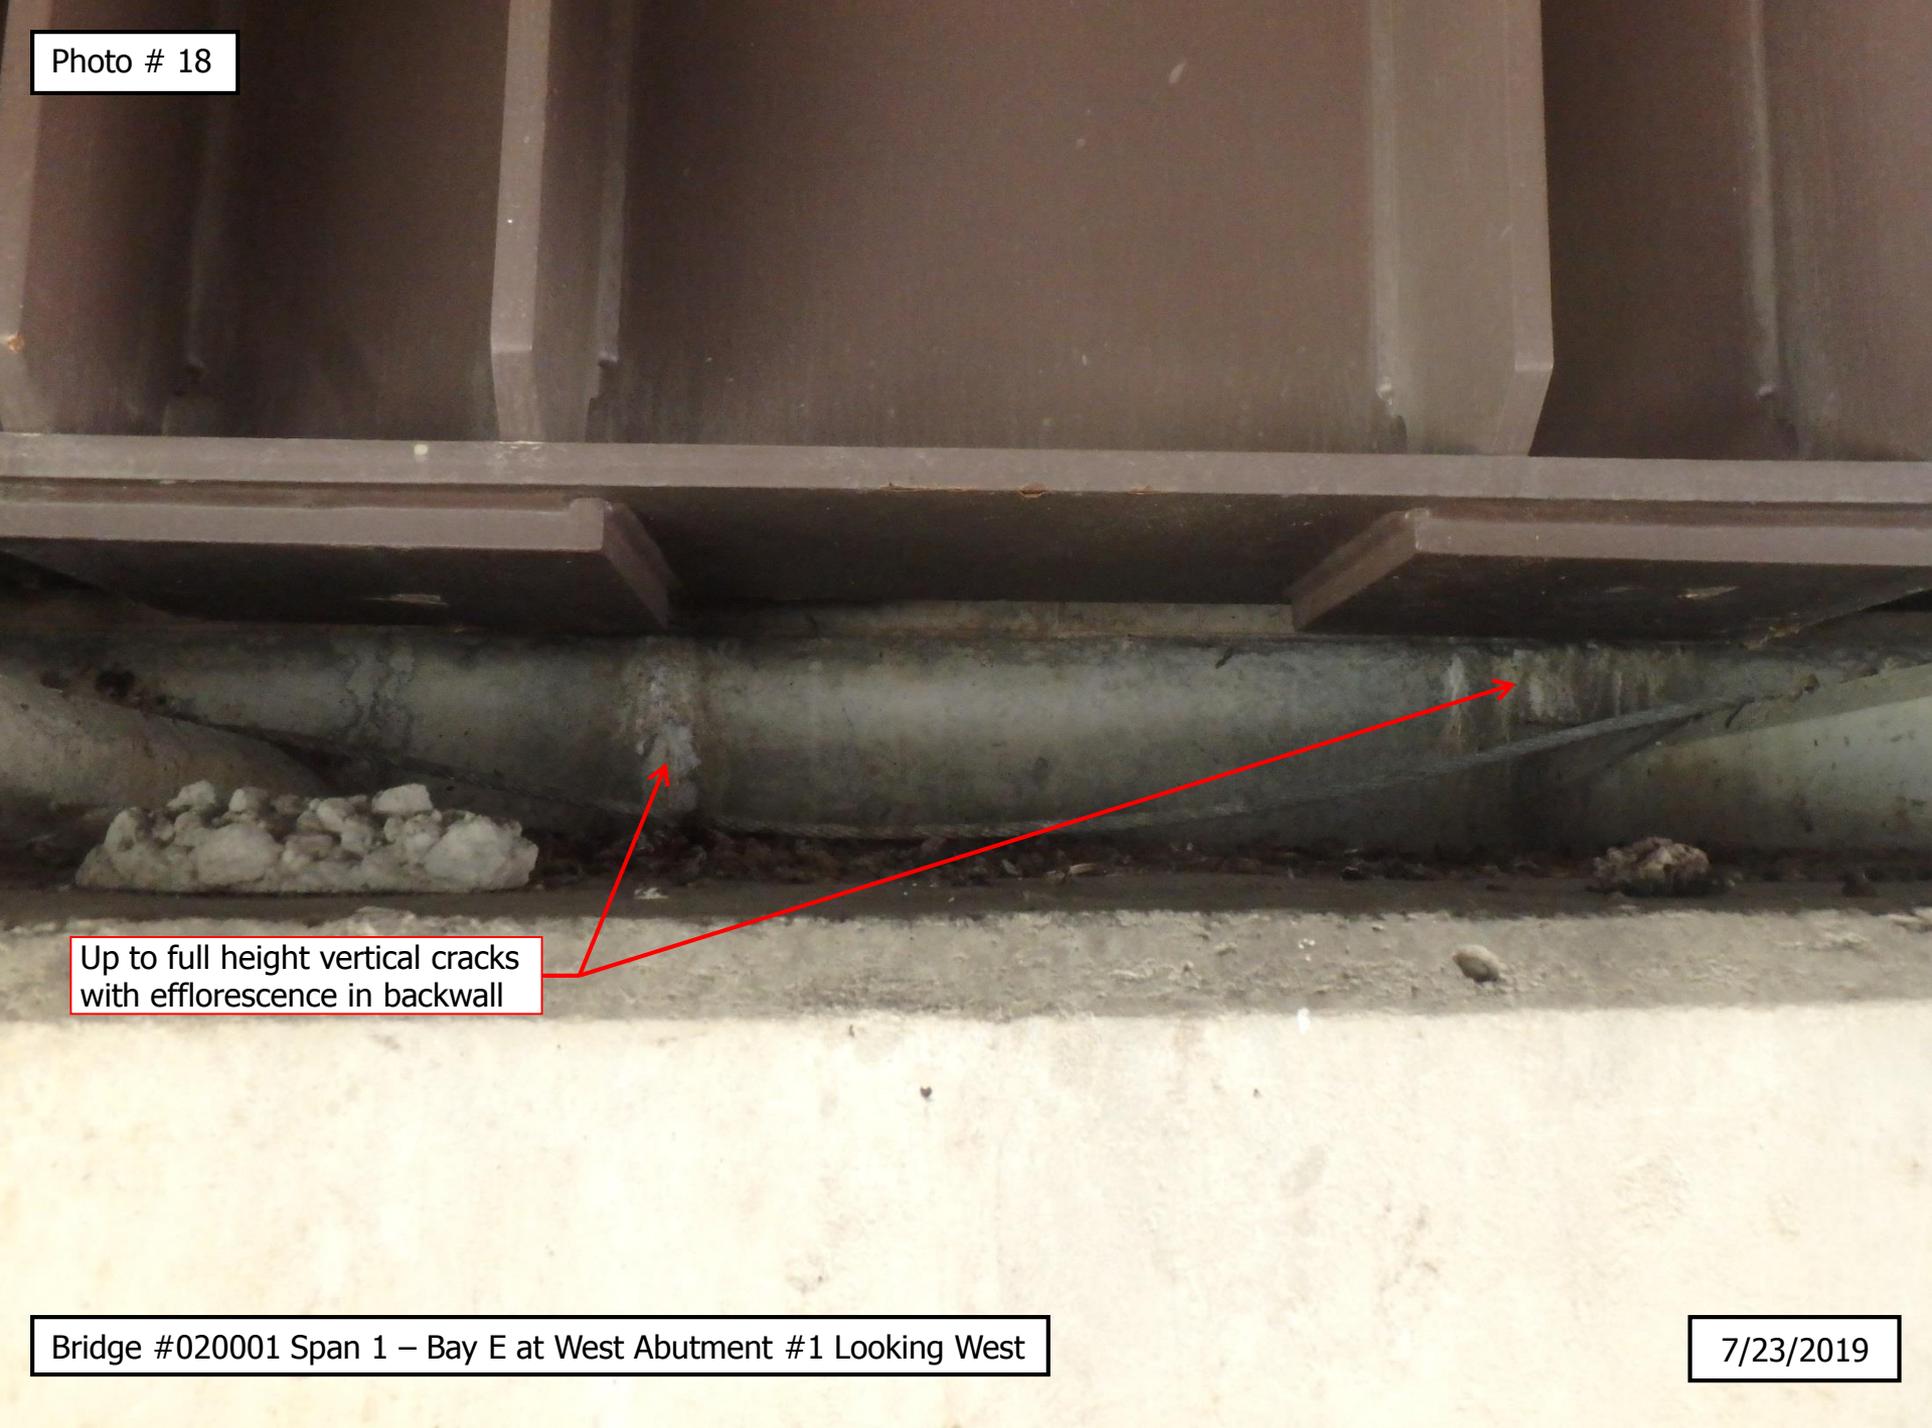
Photo # 18

Up to full height vertical cracks
with efflorescence in backwall

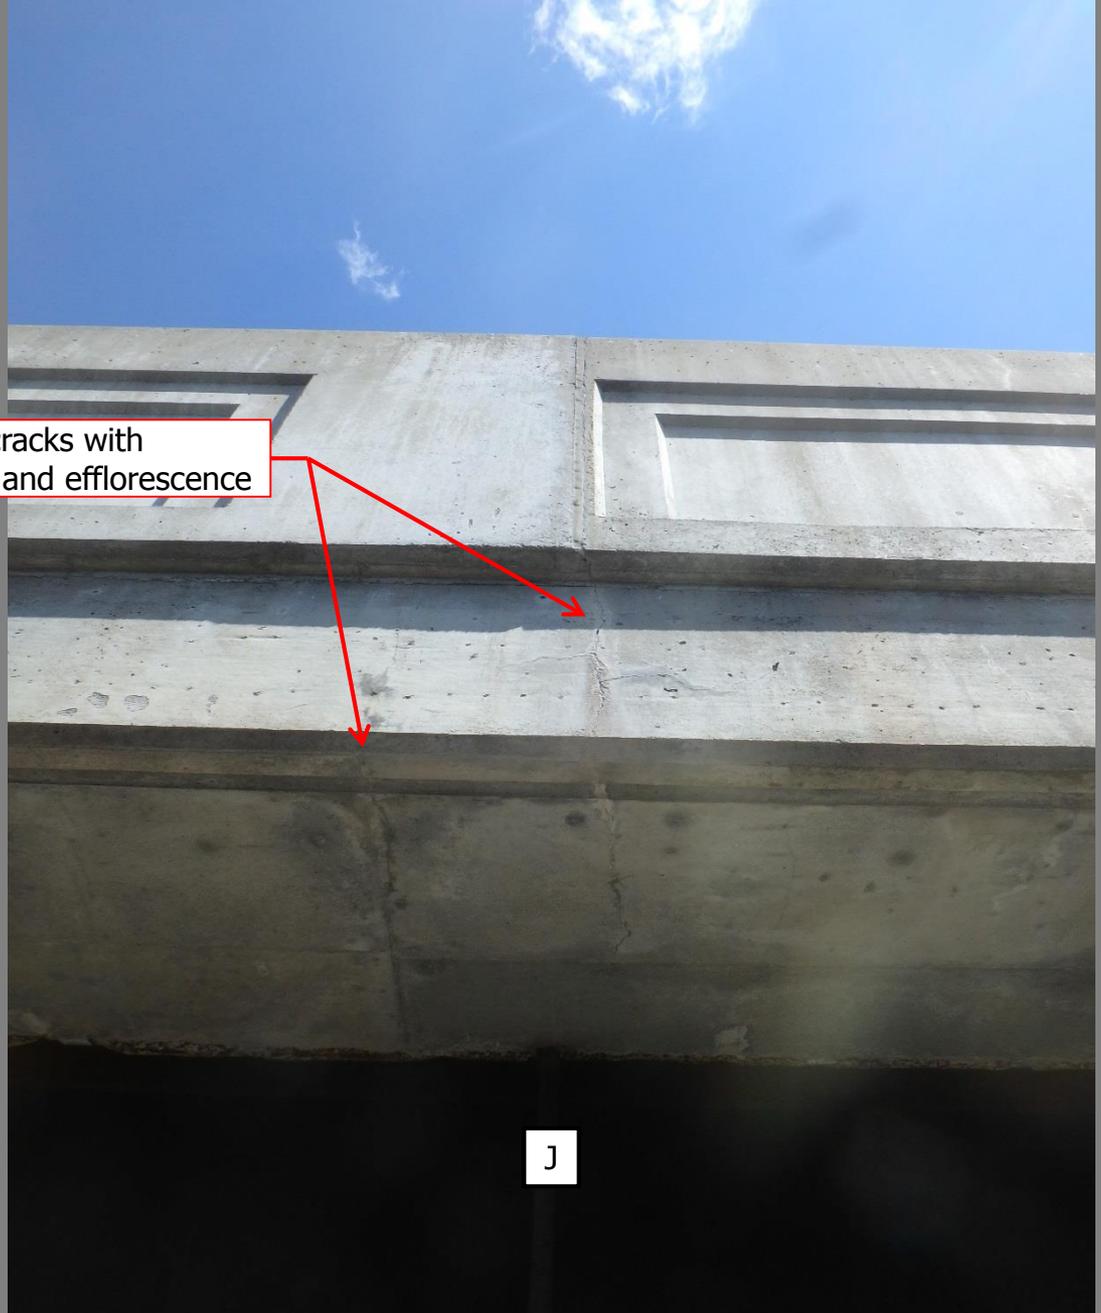
Hairline cracks with moisture and efflorescence

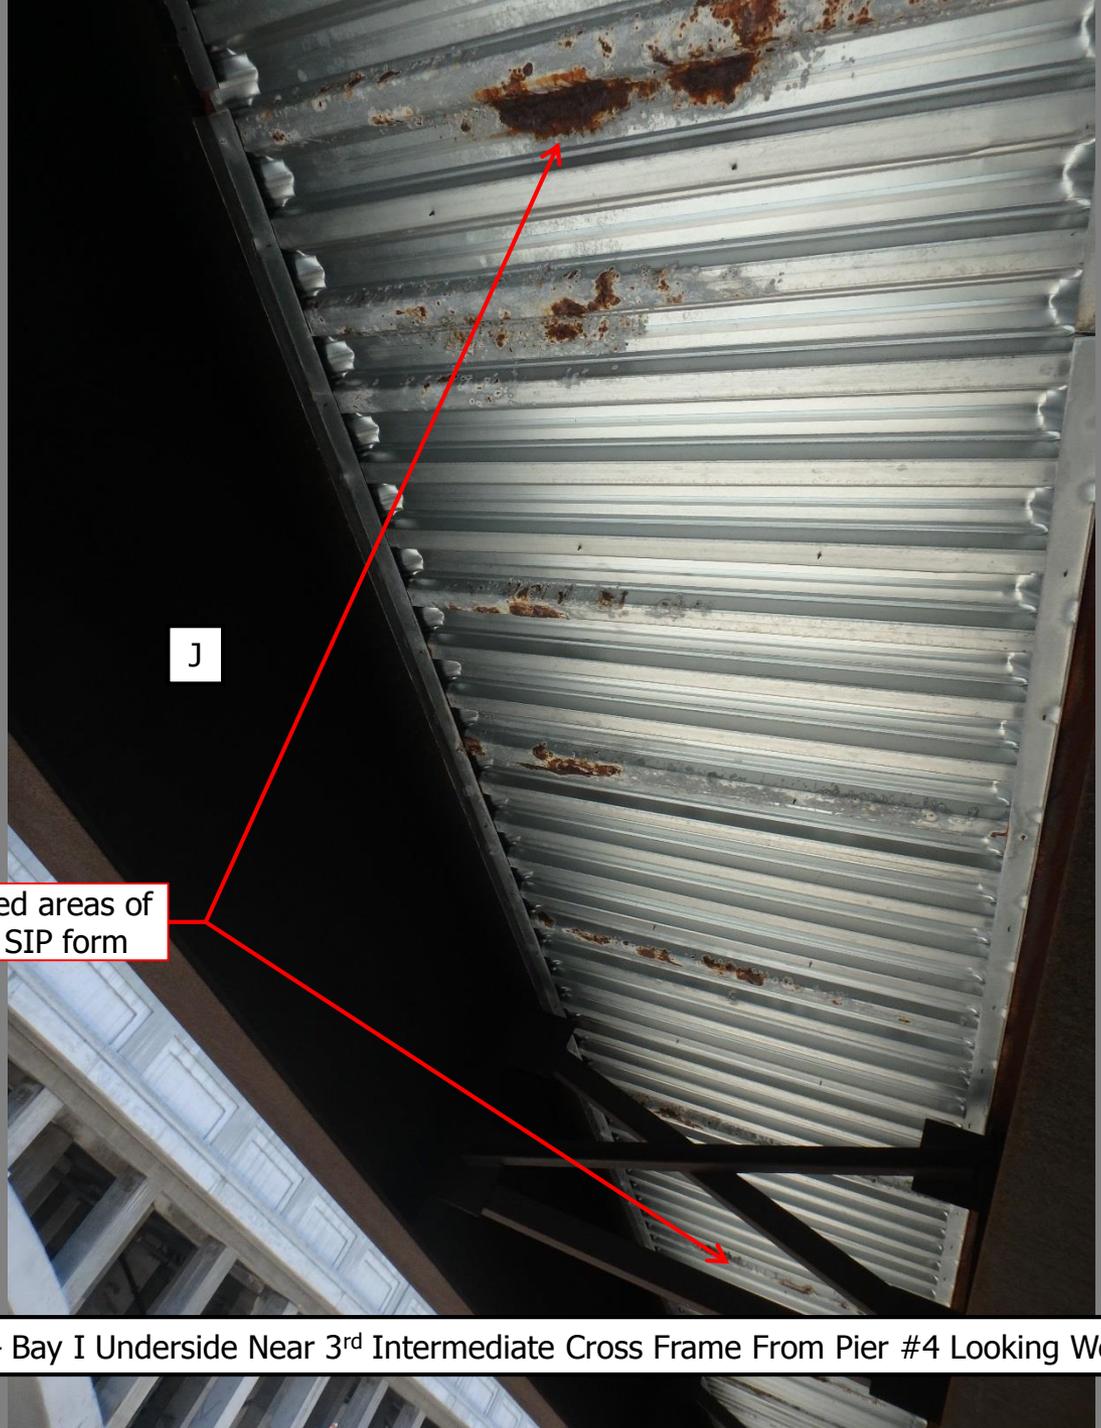
Photo # 29

Scattered areas of rust on SIP form

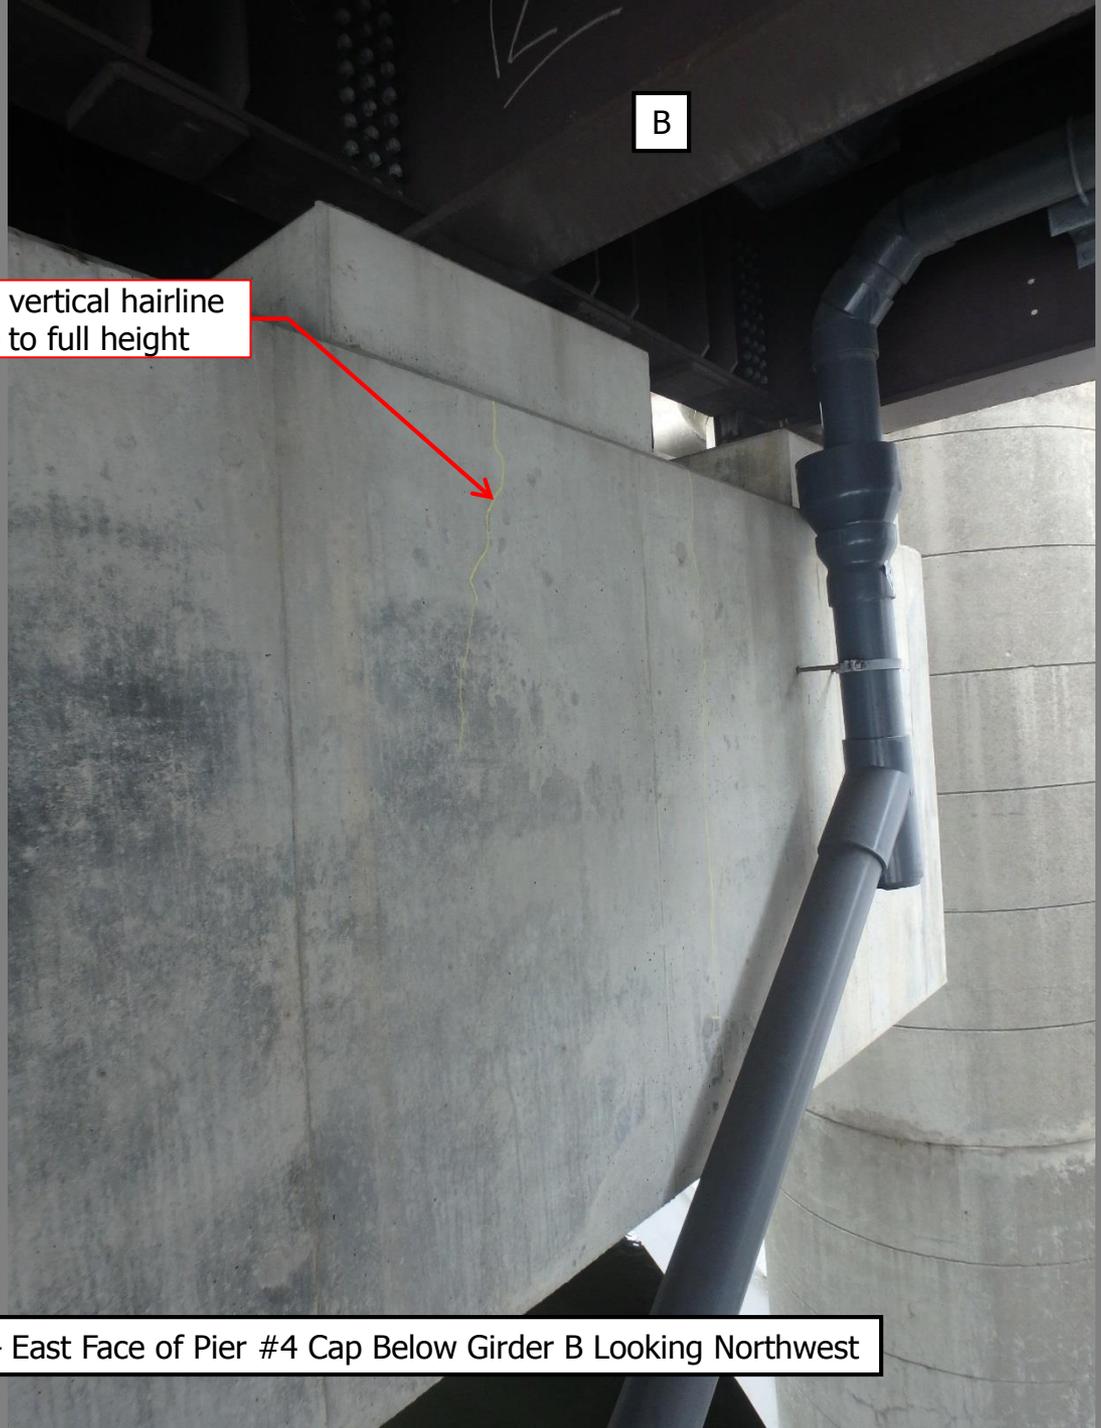
Scattered vertical hairline cracks up to full height

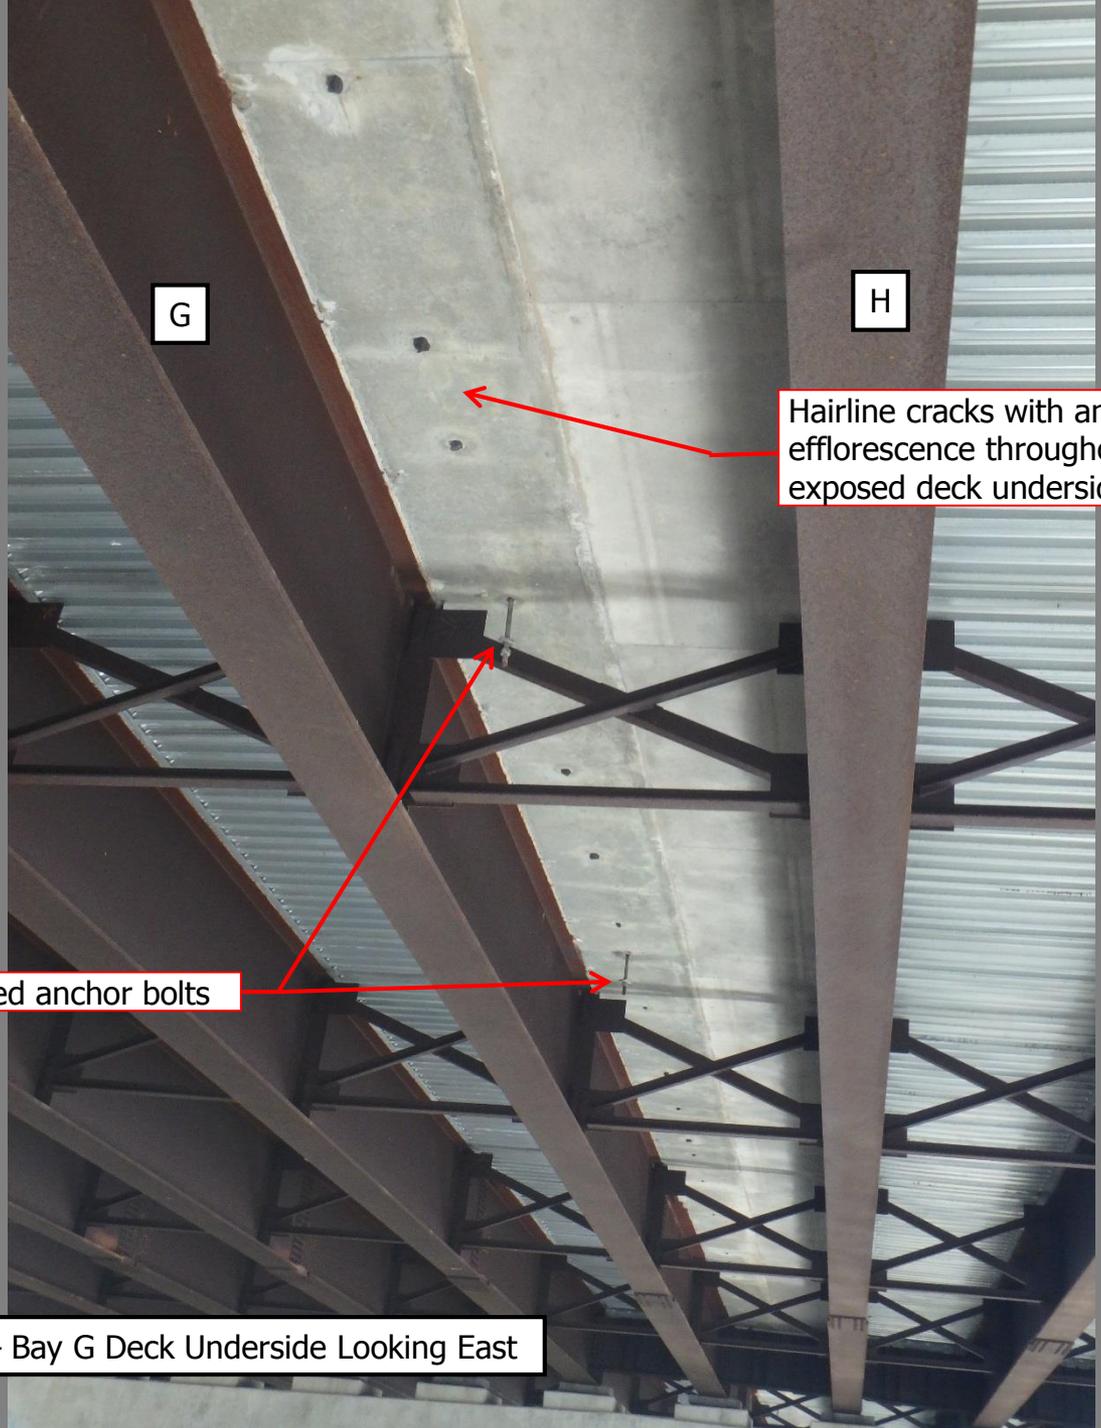
Photo # 42

Hairline cracks with and without efflorescence throughout exposed deck underside

Exposed anchor bolts

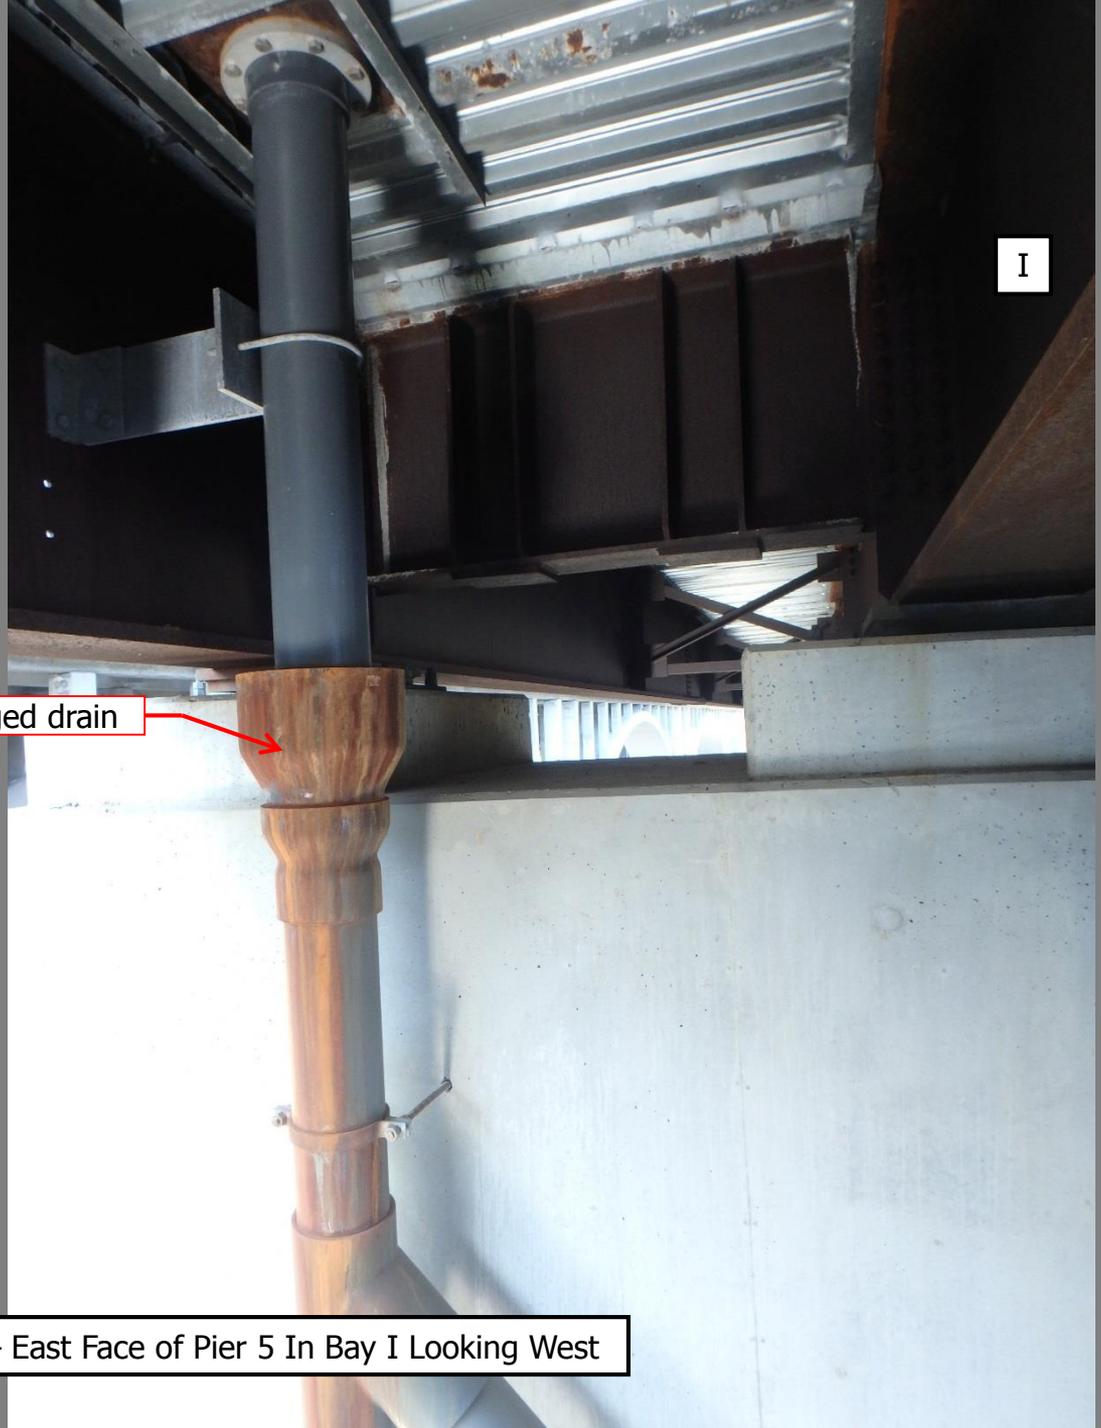
Photo # 44

Clogged drain

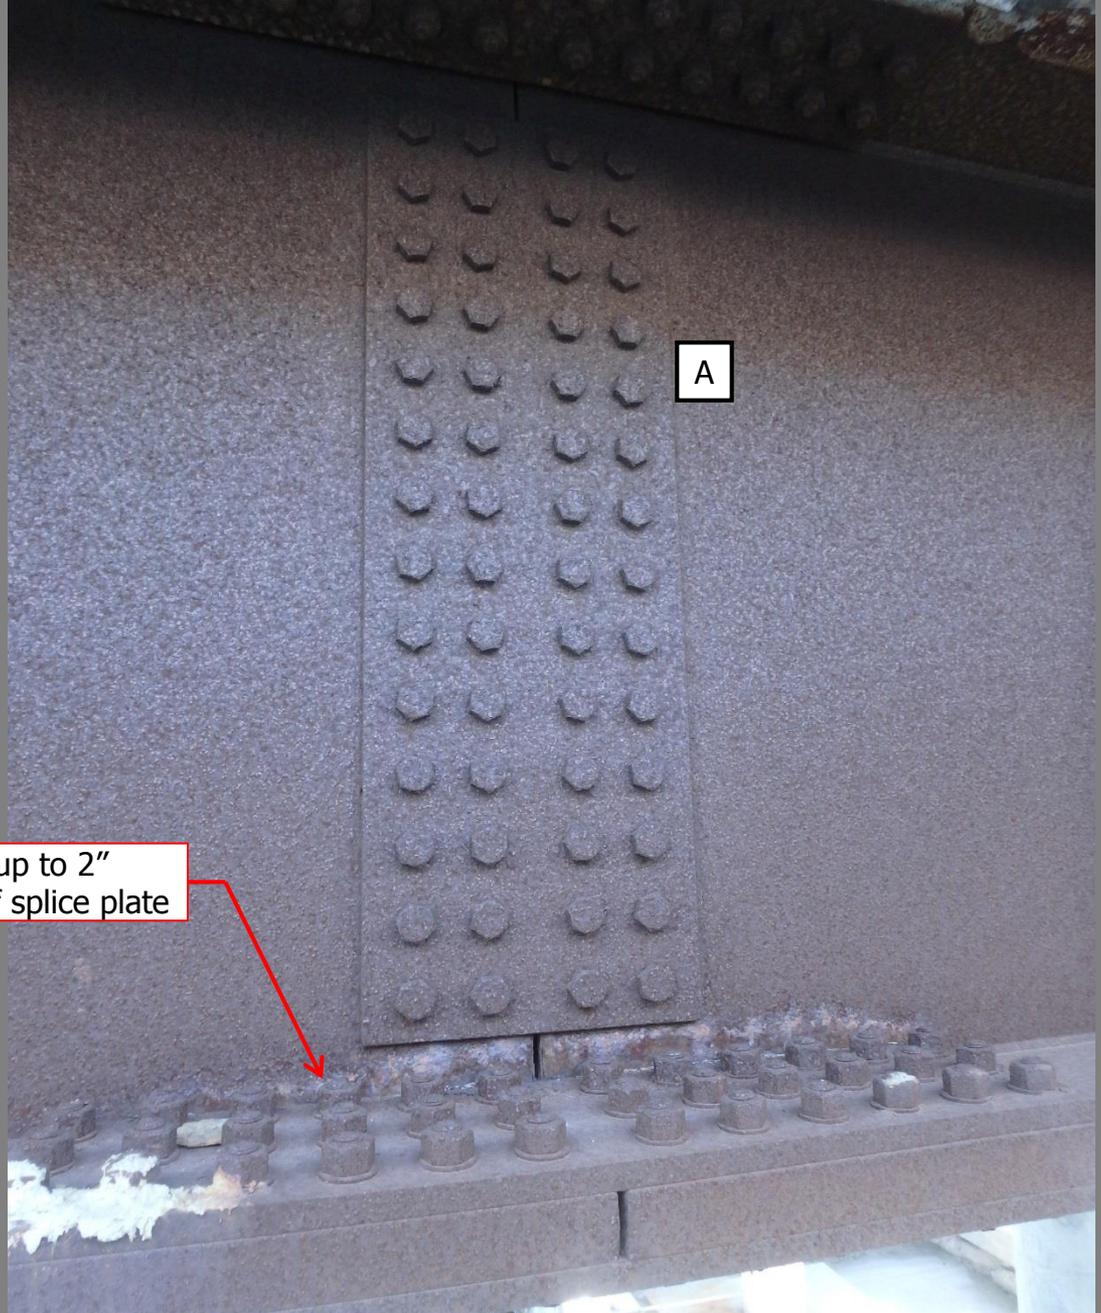
Minor laminar rust up to 2" high x full length of splice plate

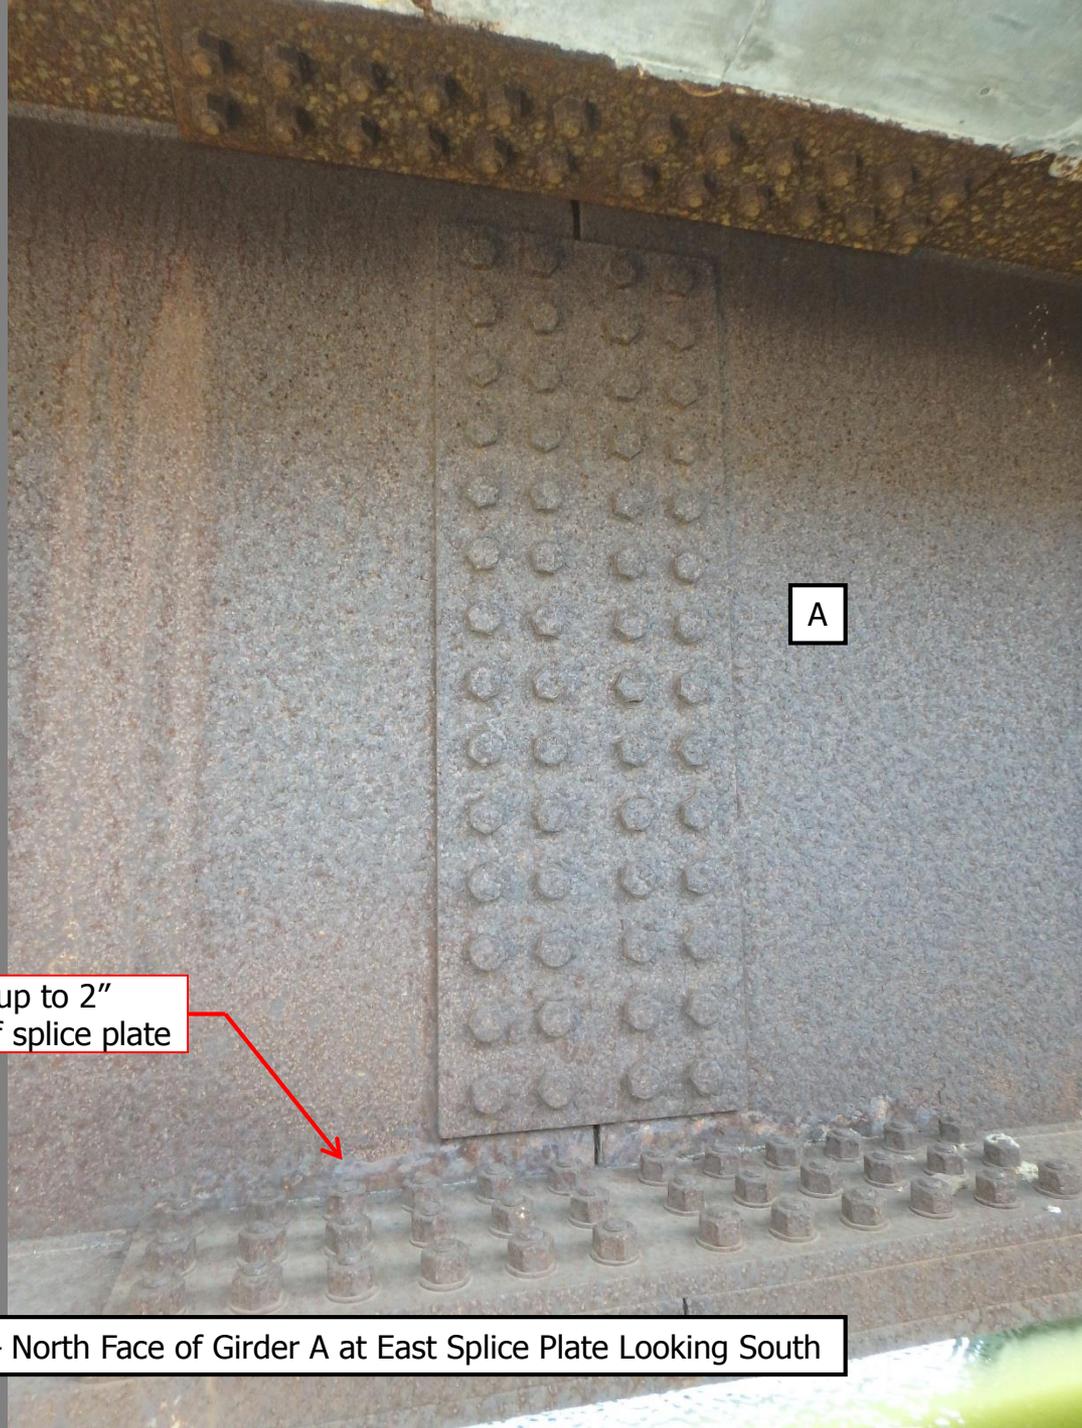
Minor laminar rust up to 2"
high x full length of splice plate
