Bridge #020001 West Approach Bituminous Wearing Surface Looking Northeast

7/23/2019

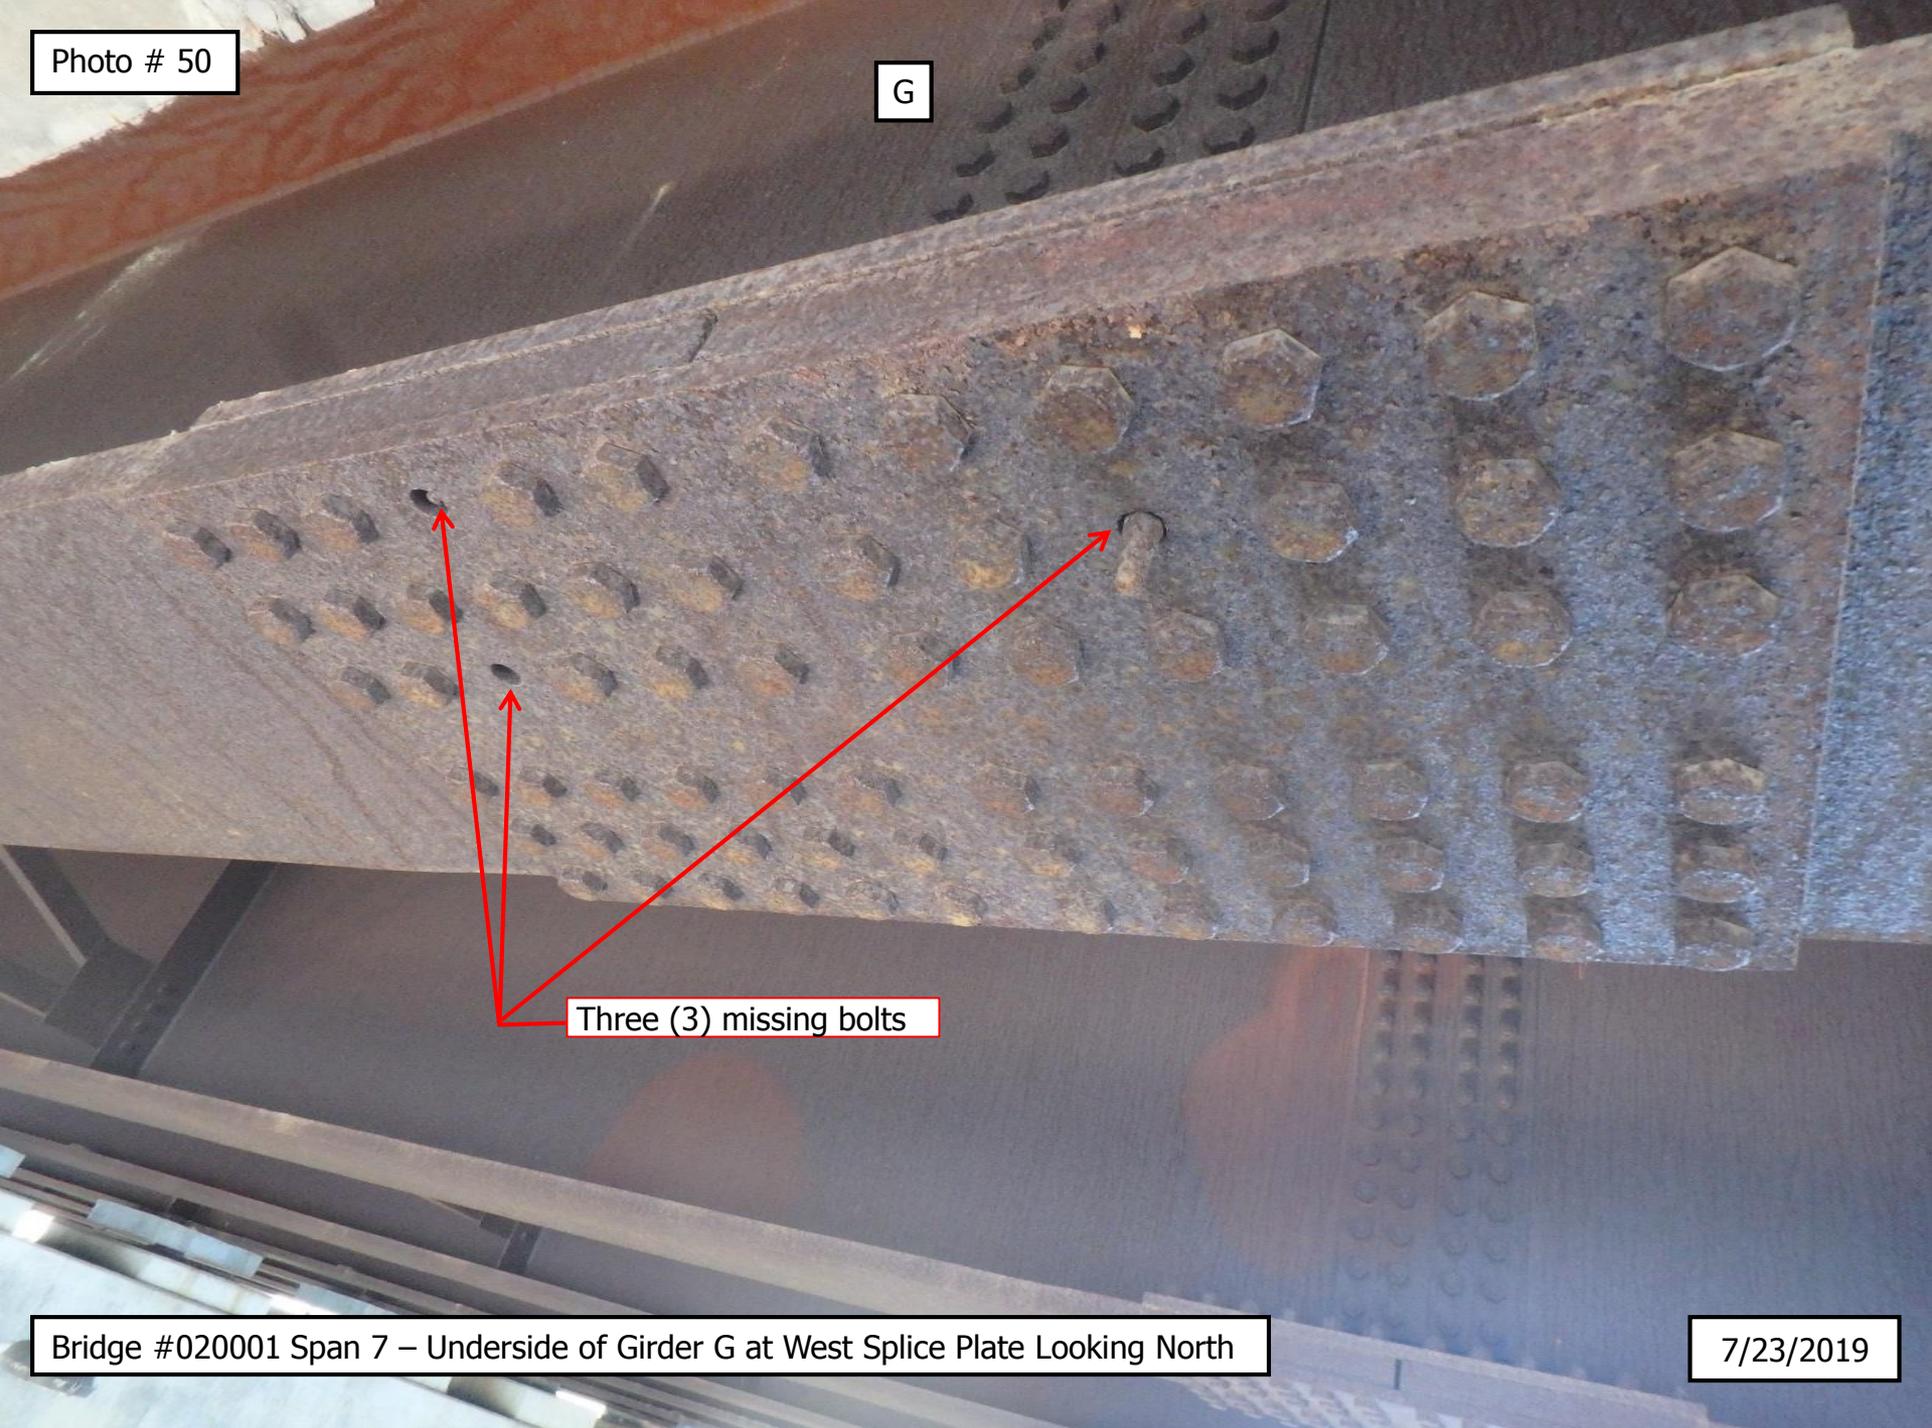
Three (3) missing bolts

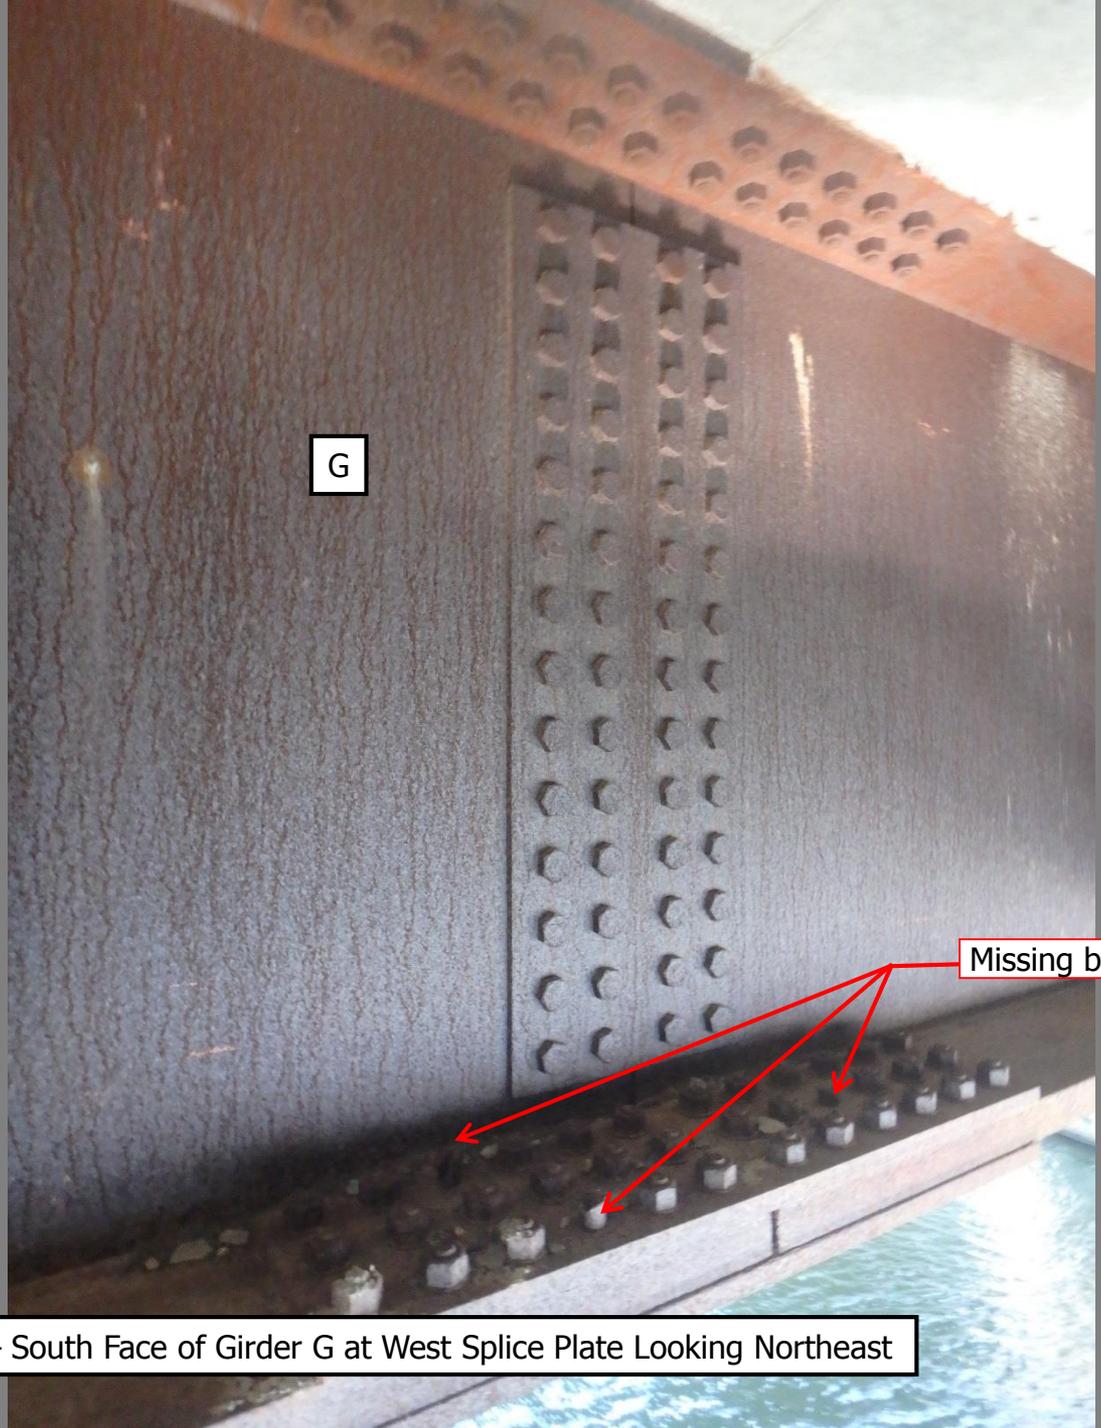
Missing bolts and nuts

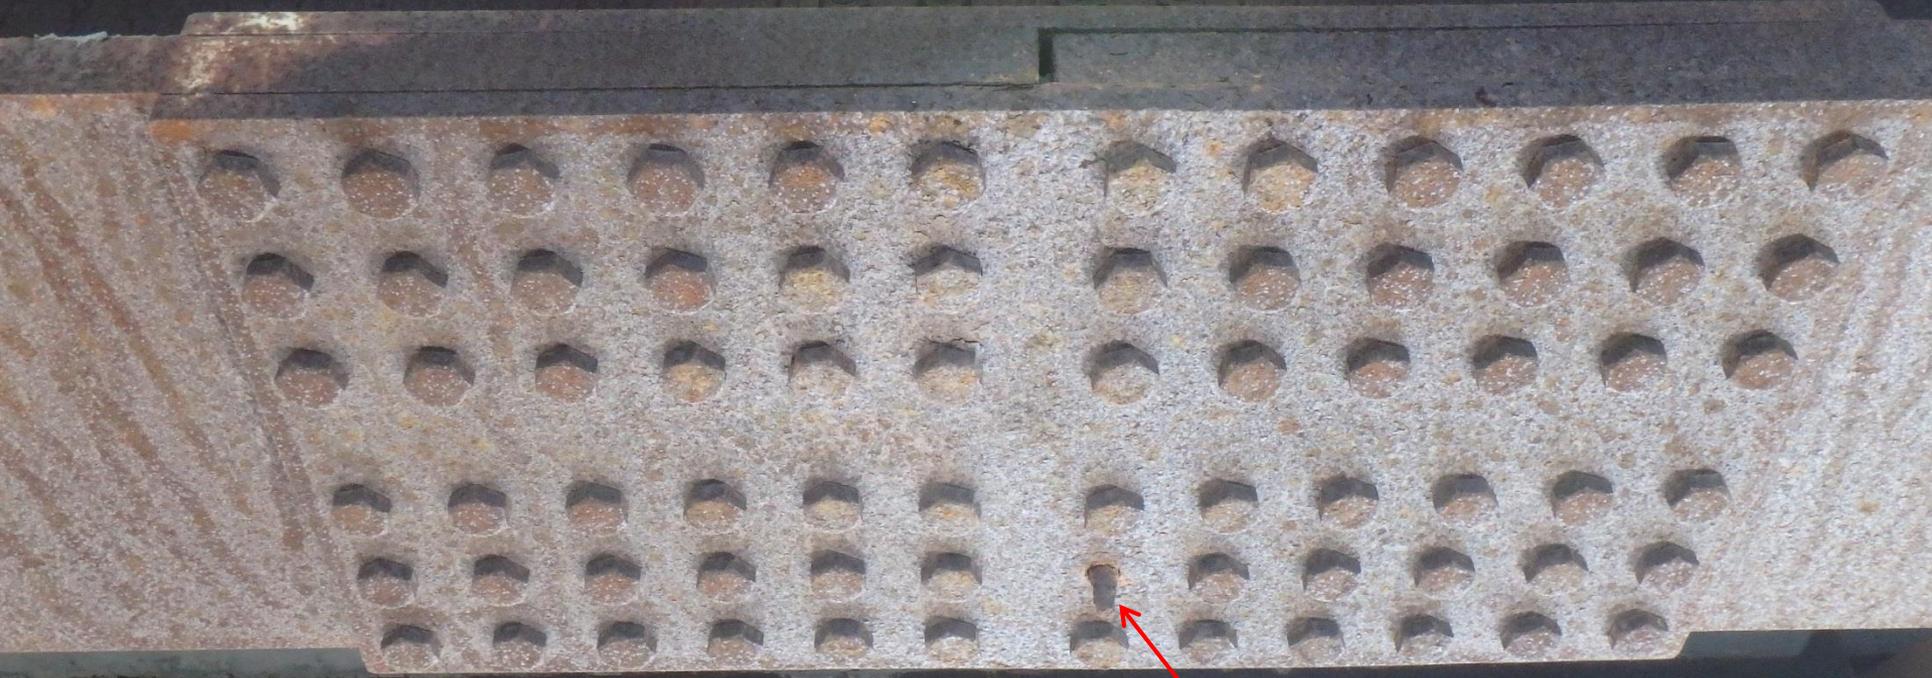
One (1) missing bolt

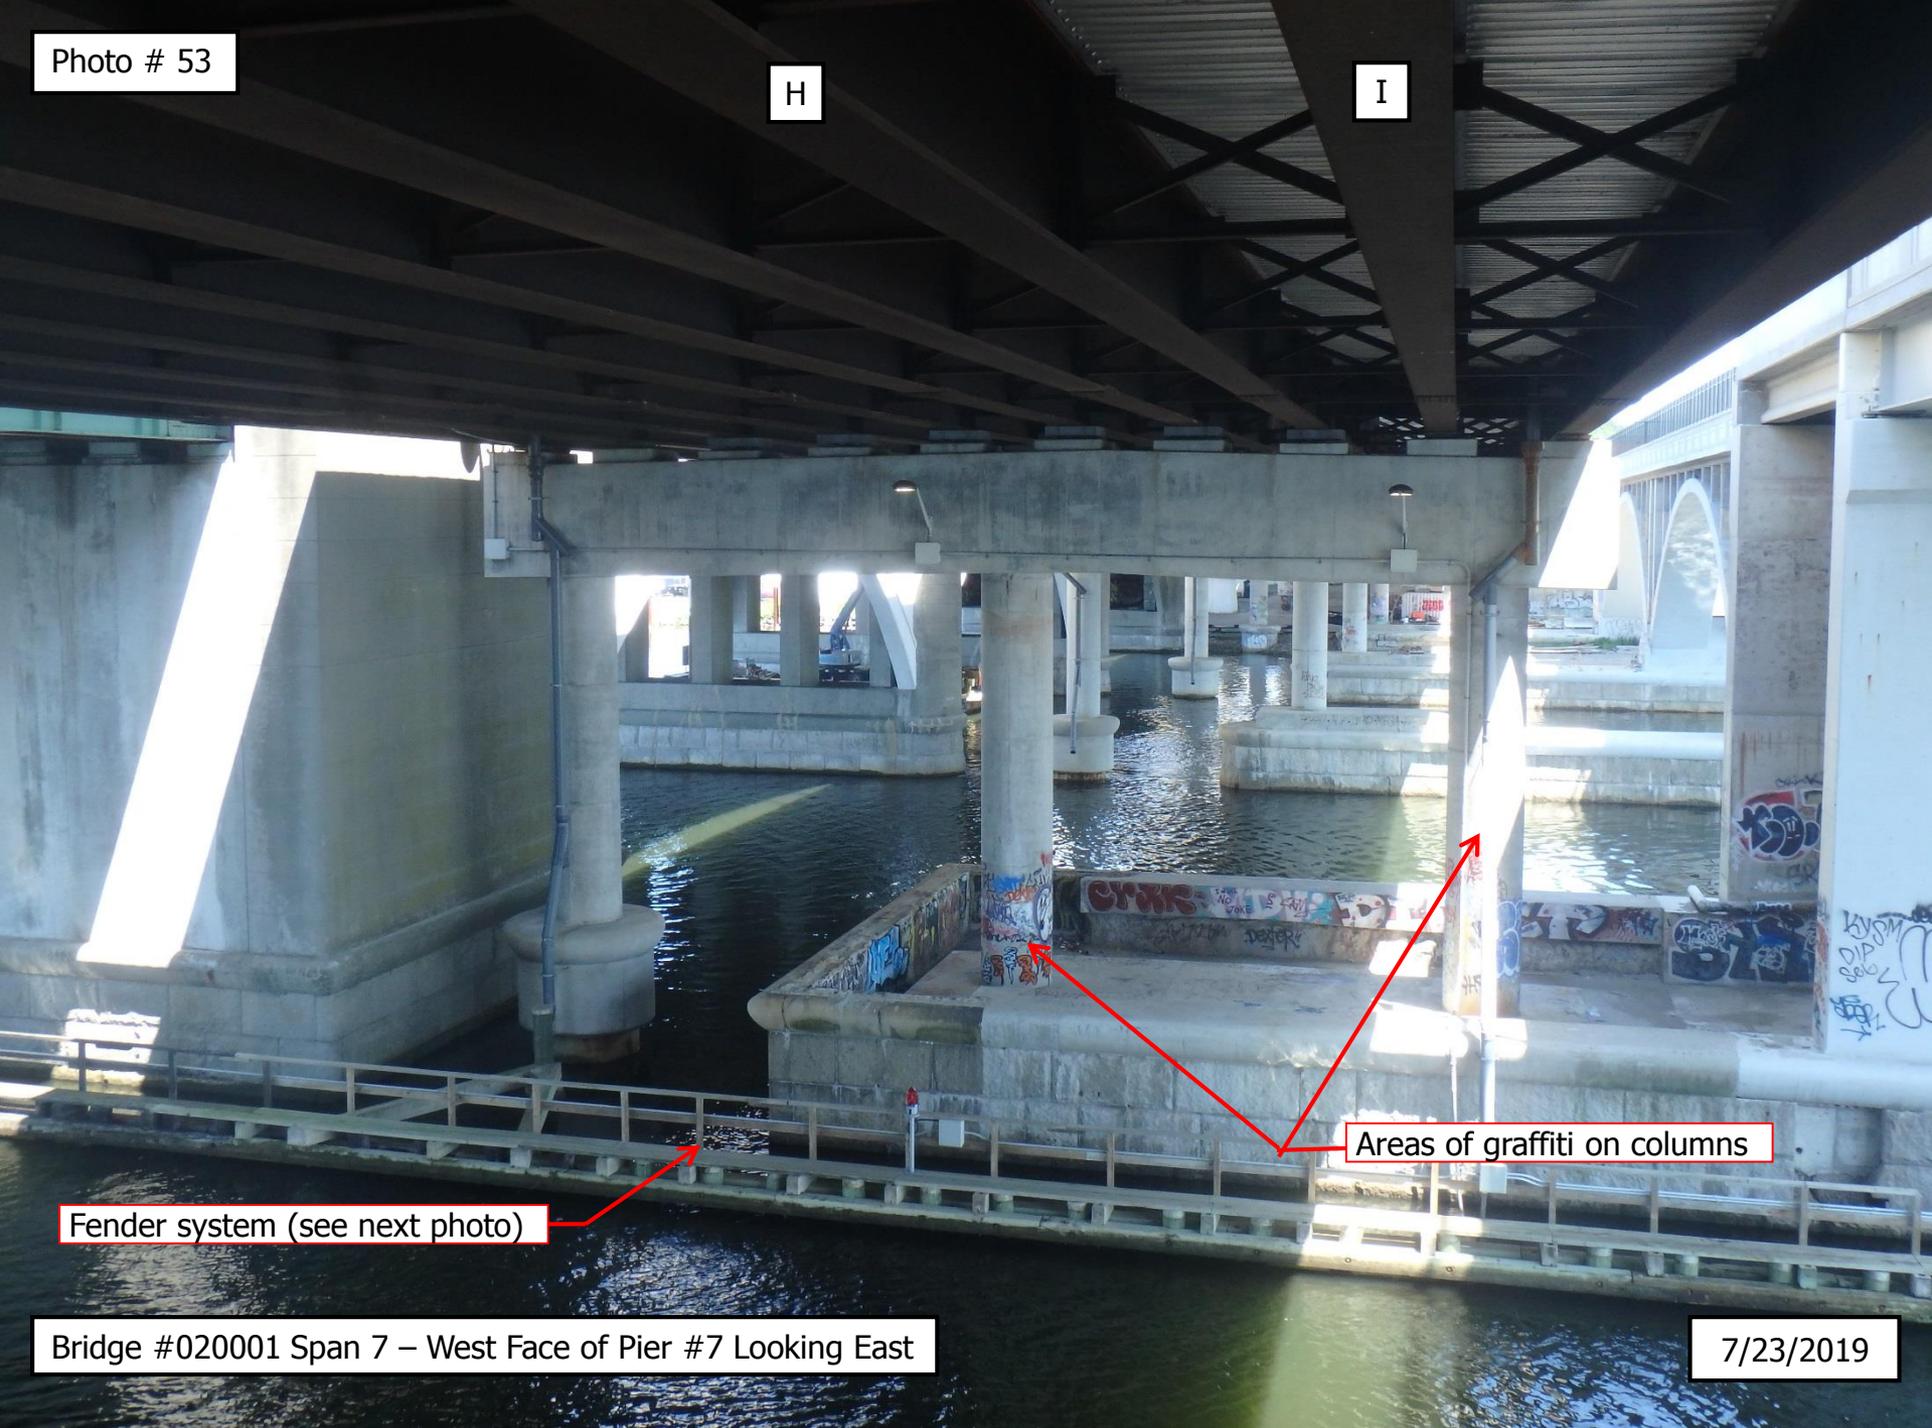
Fender system (see next photo)

Areas of graffiti on columns

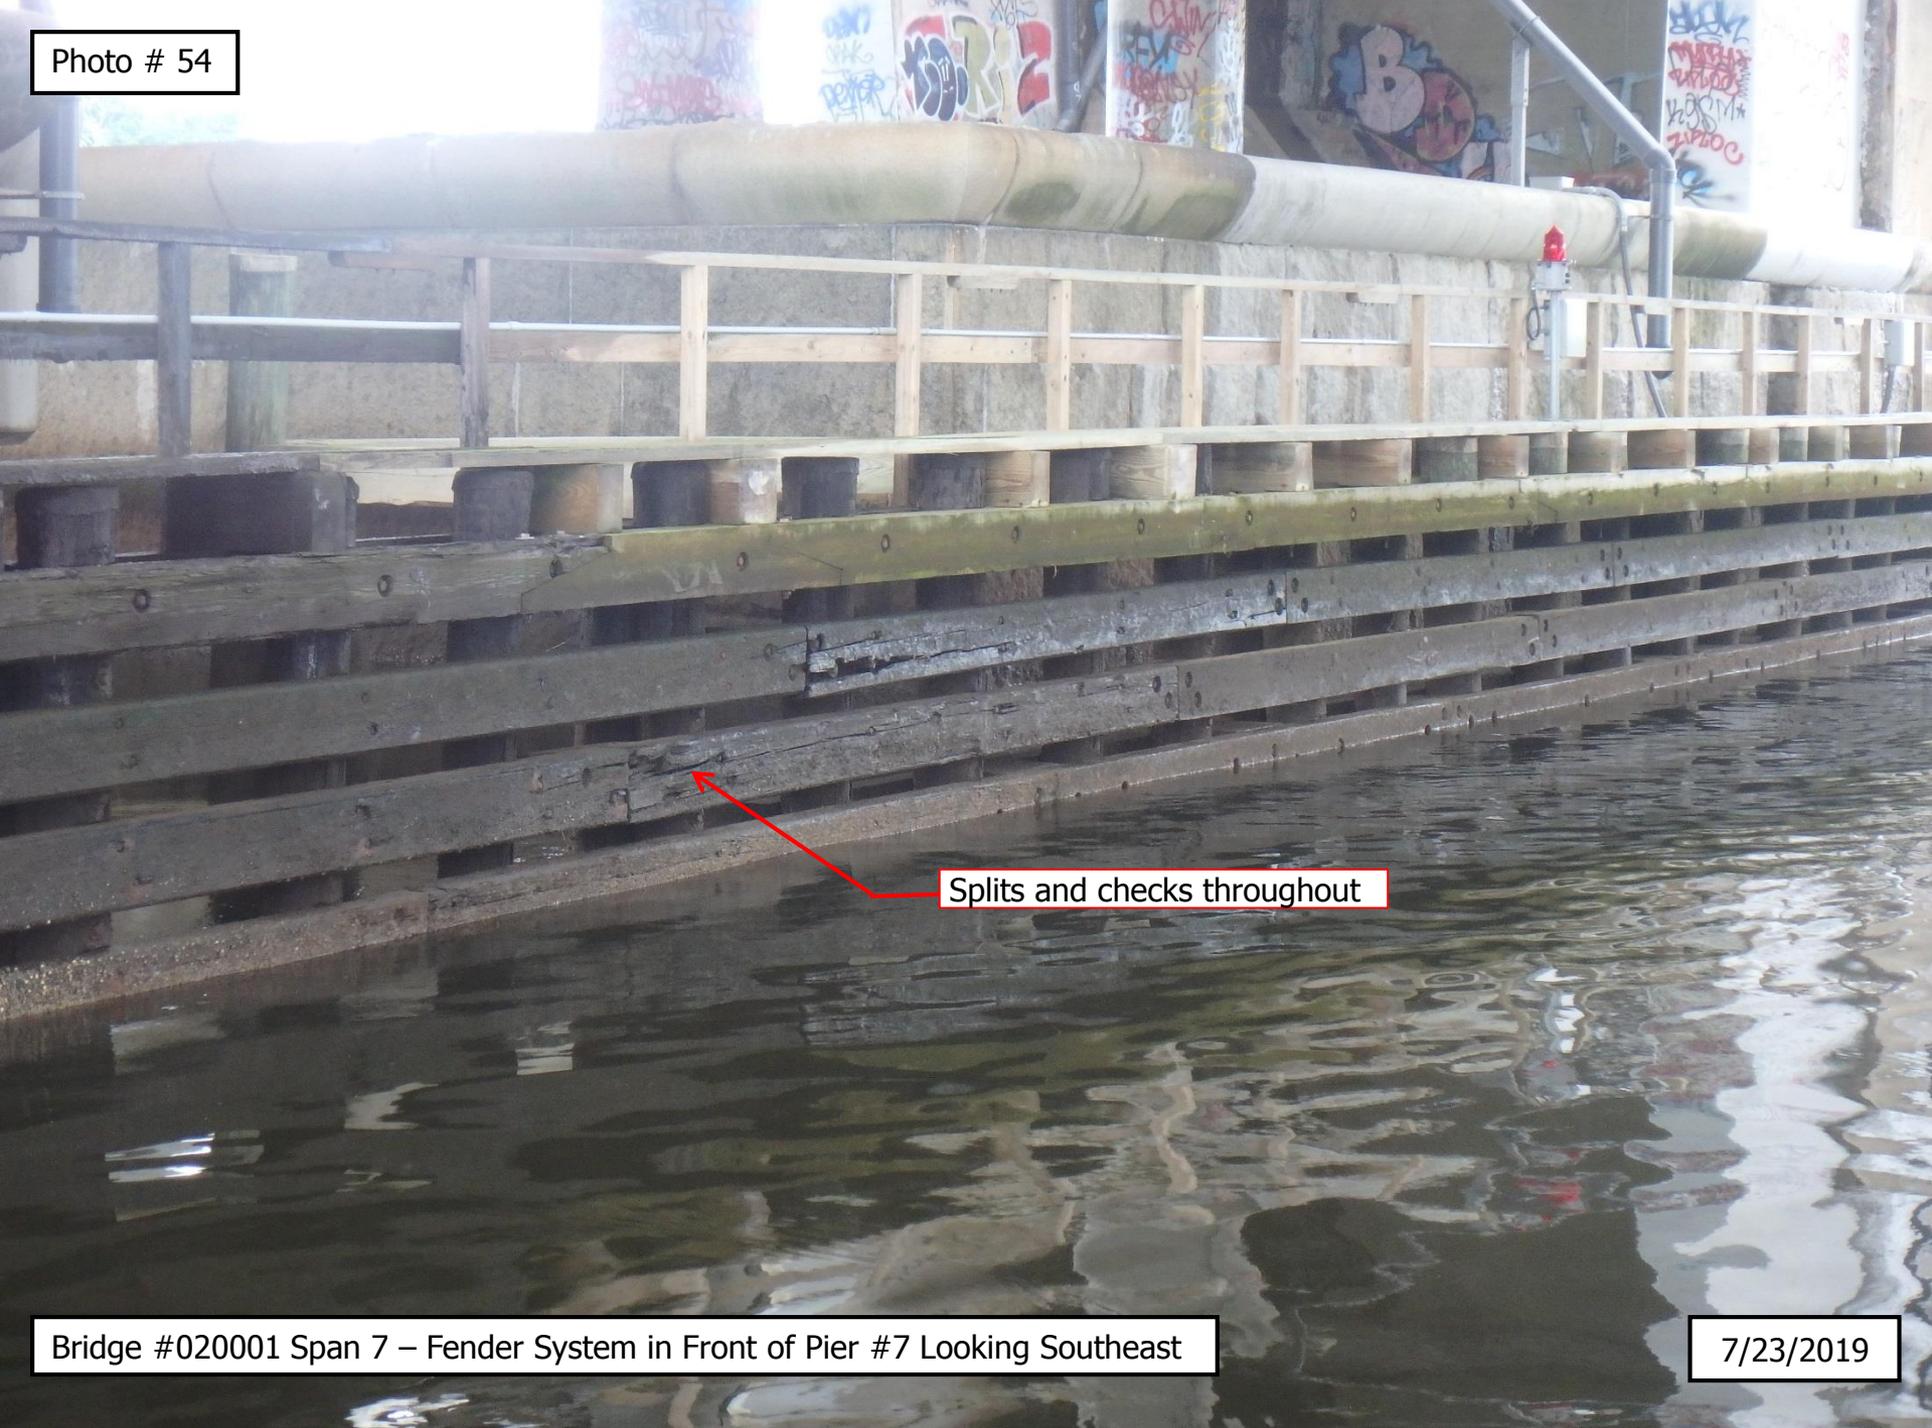
Splits and checks throughout

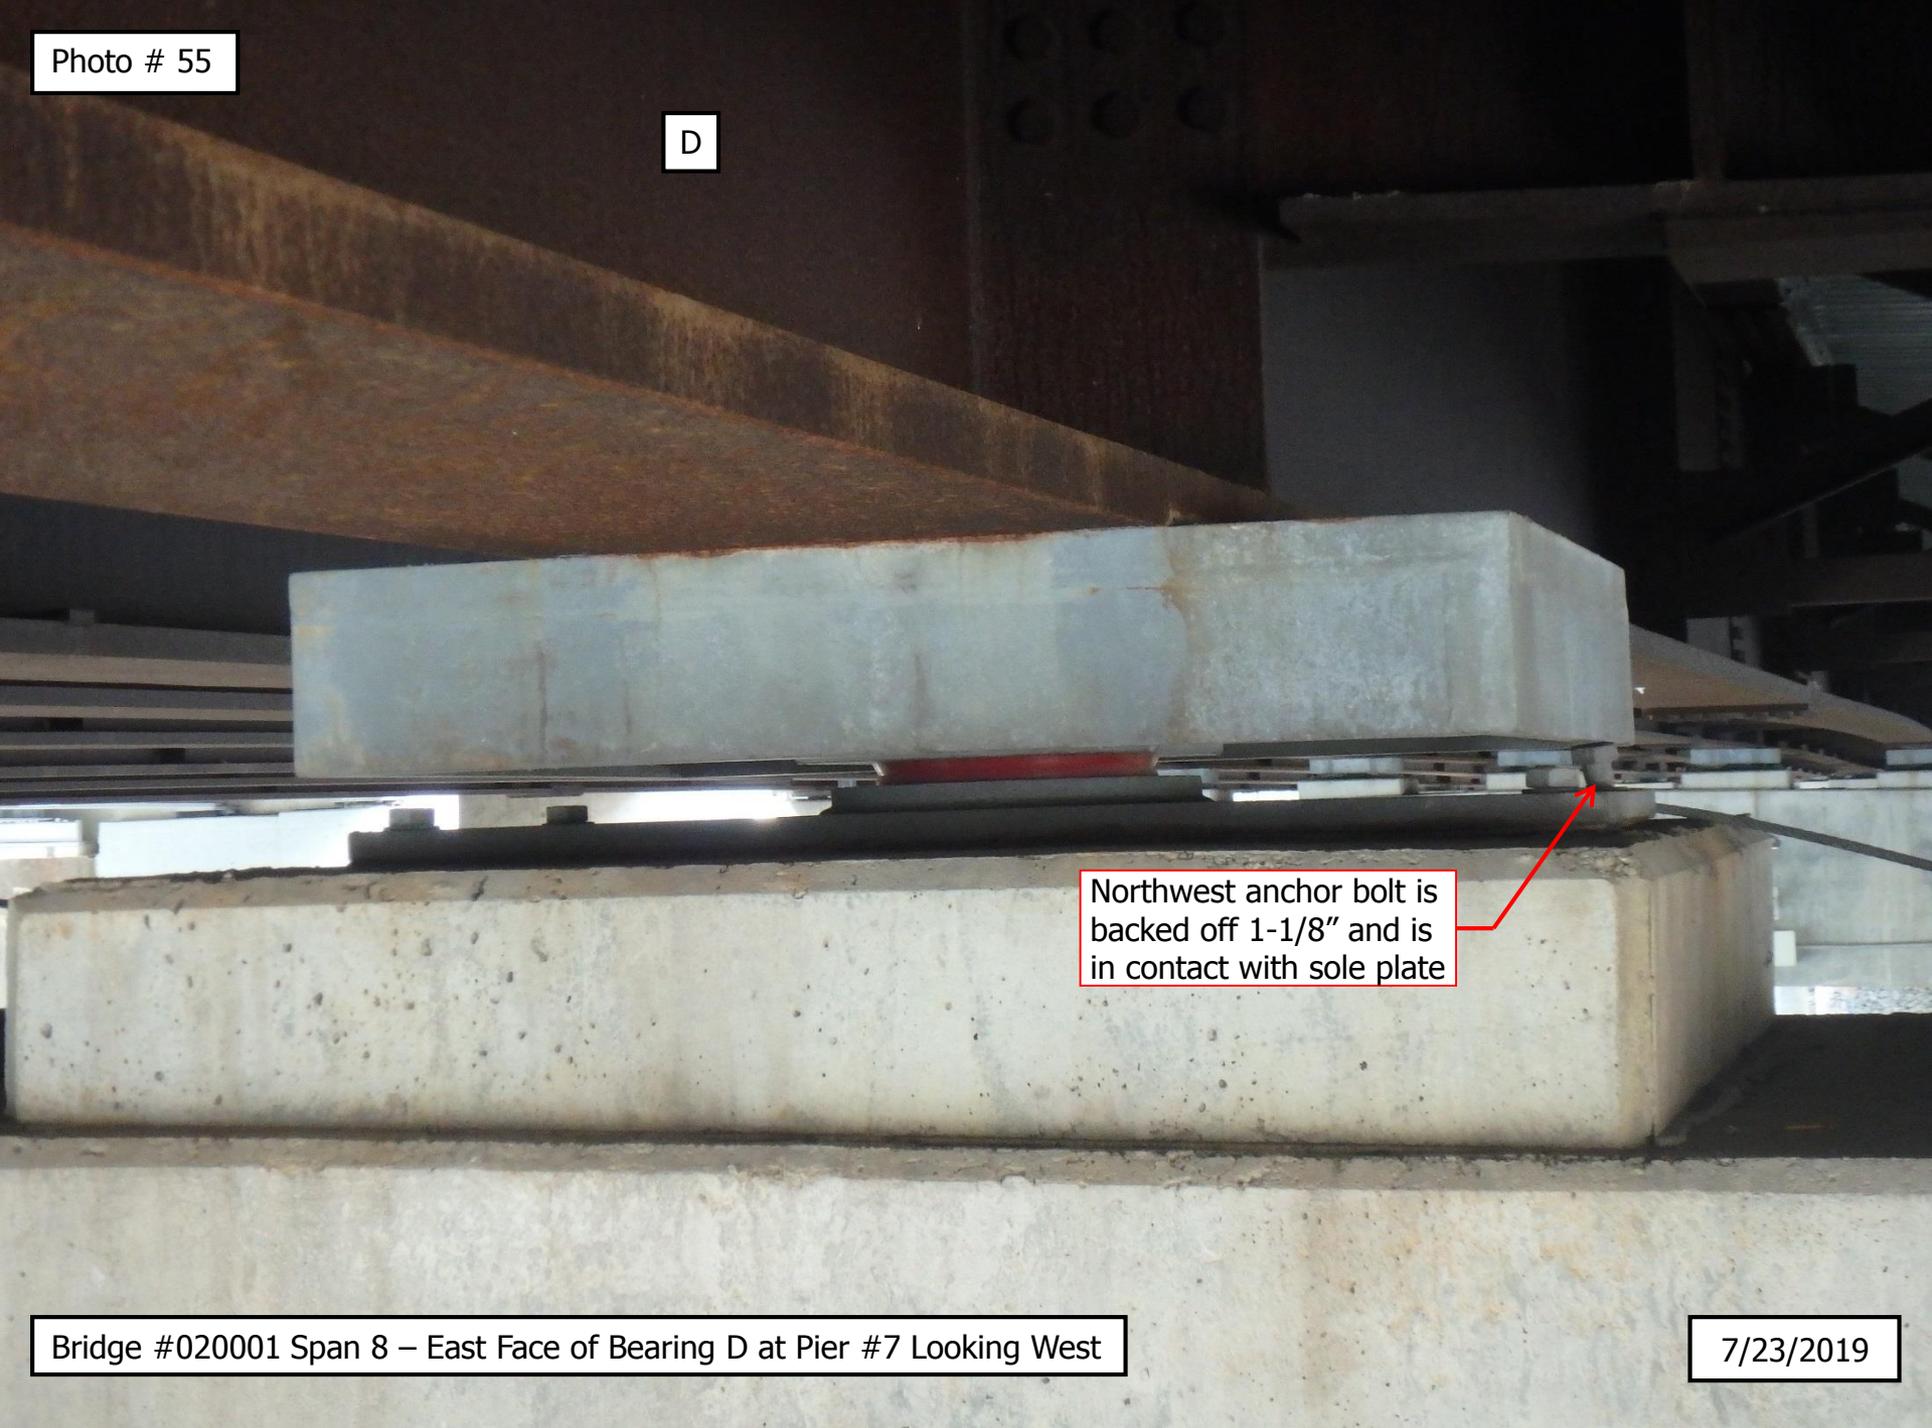
Northwest anchor bolt is backed off 1-1/8" and is in contact with sole plate

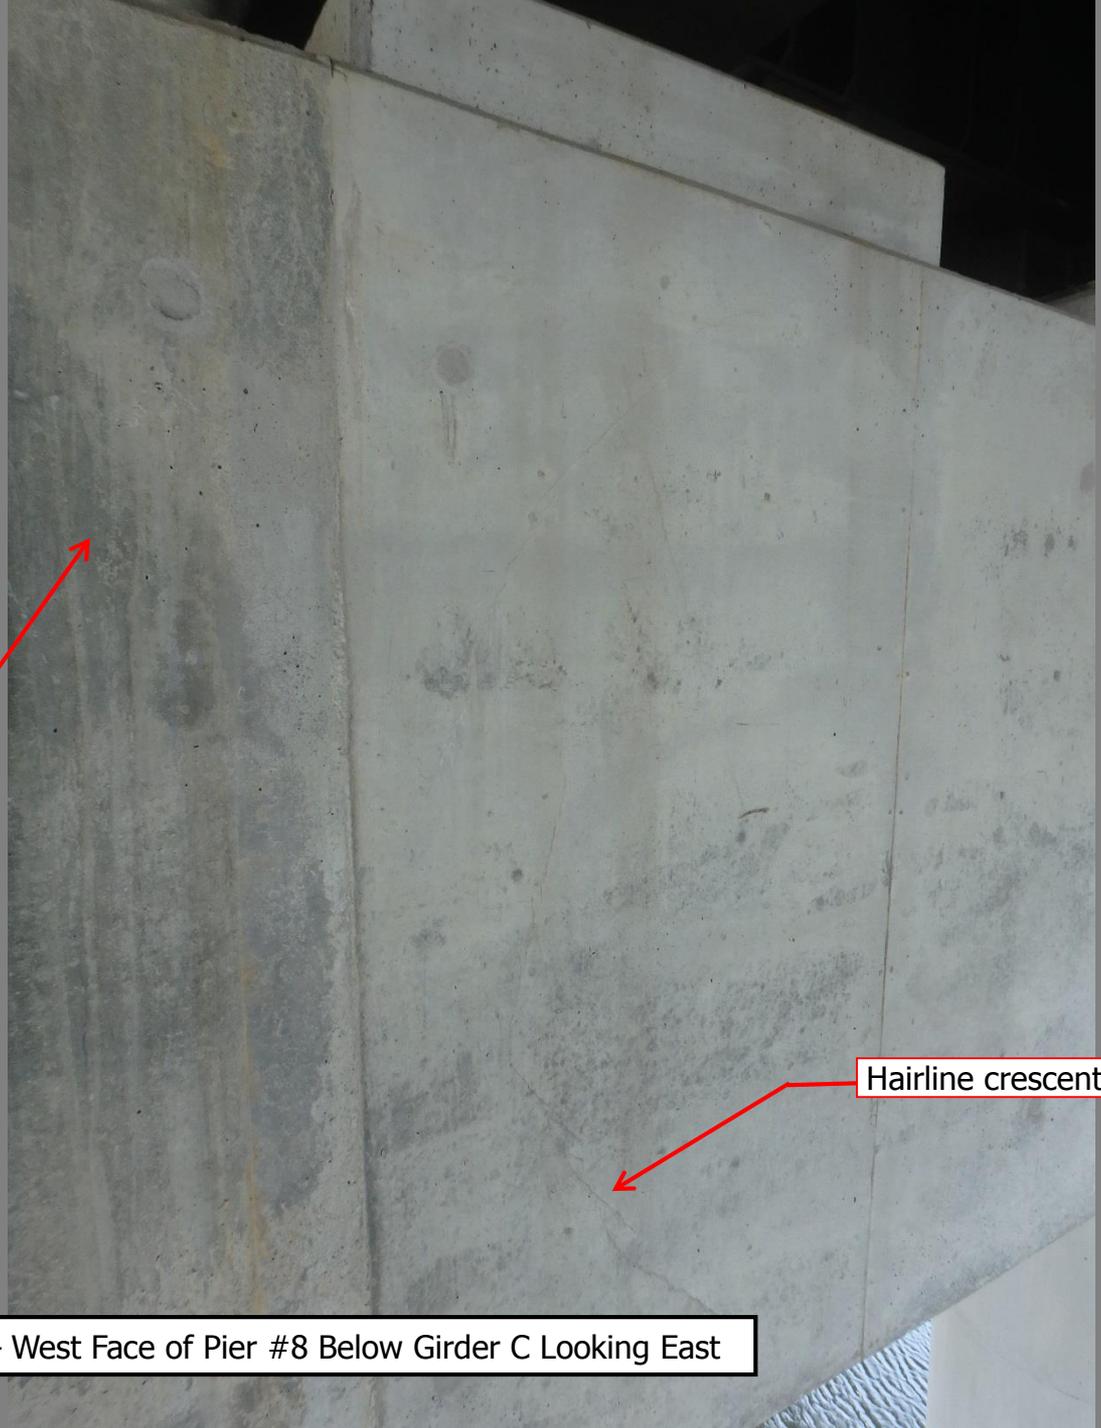
Efflorescence and moisture staining

Hairline crescent shaped cracks

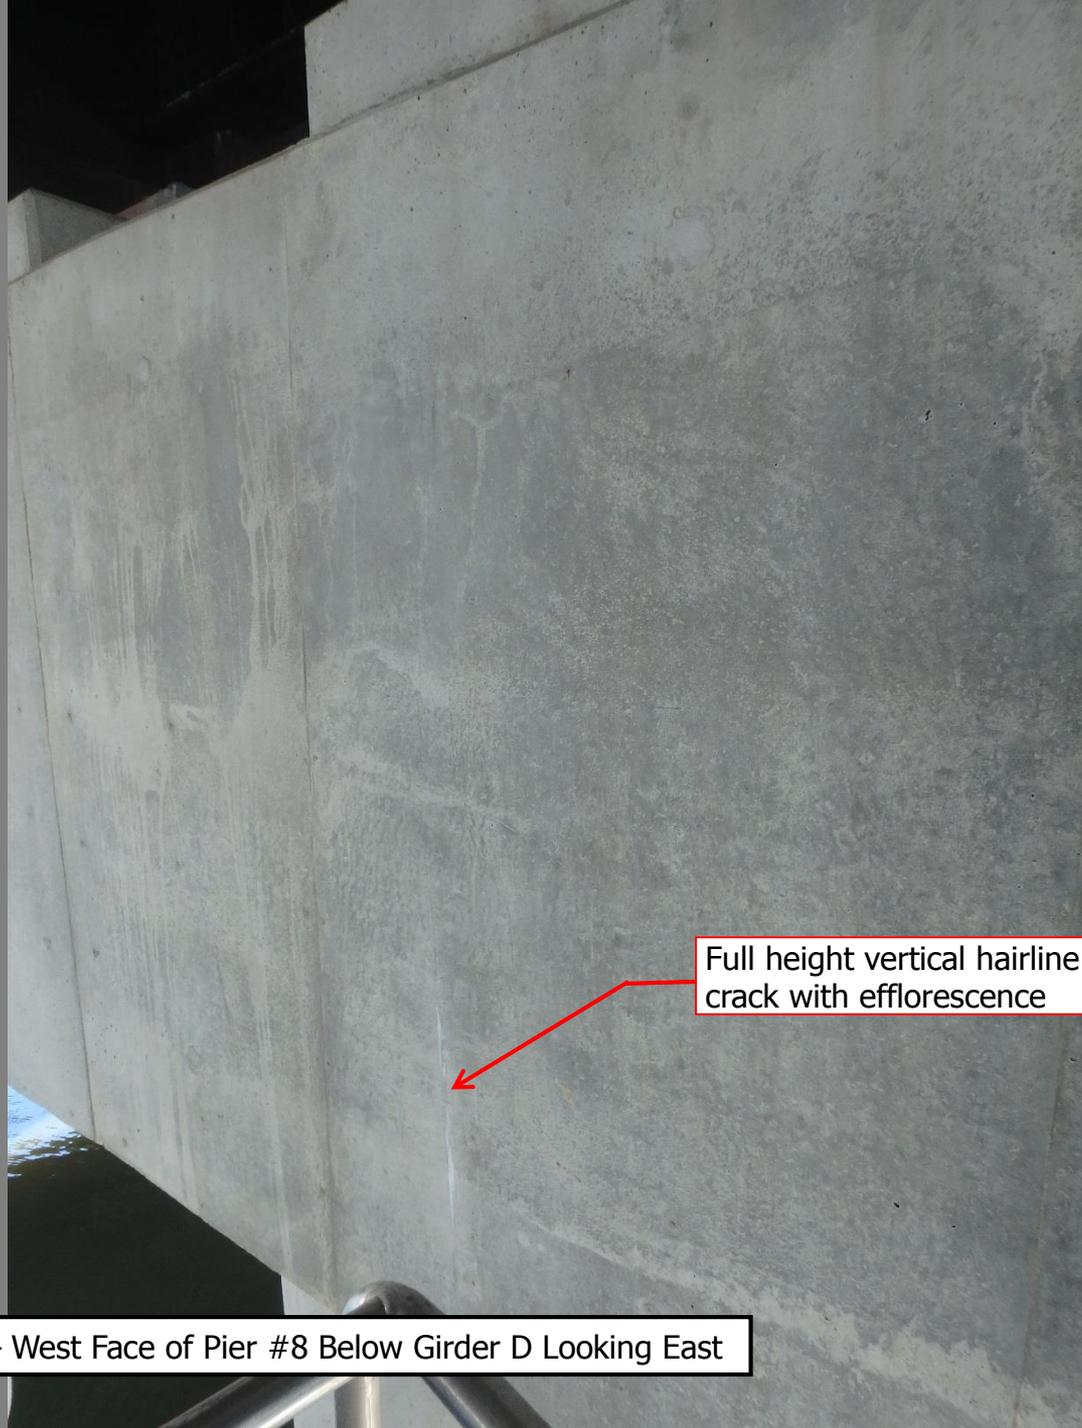
Full height vertical hairline
crack with efflorescence

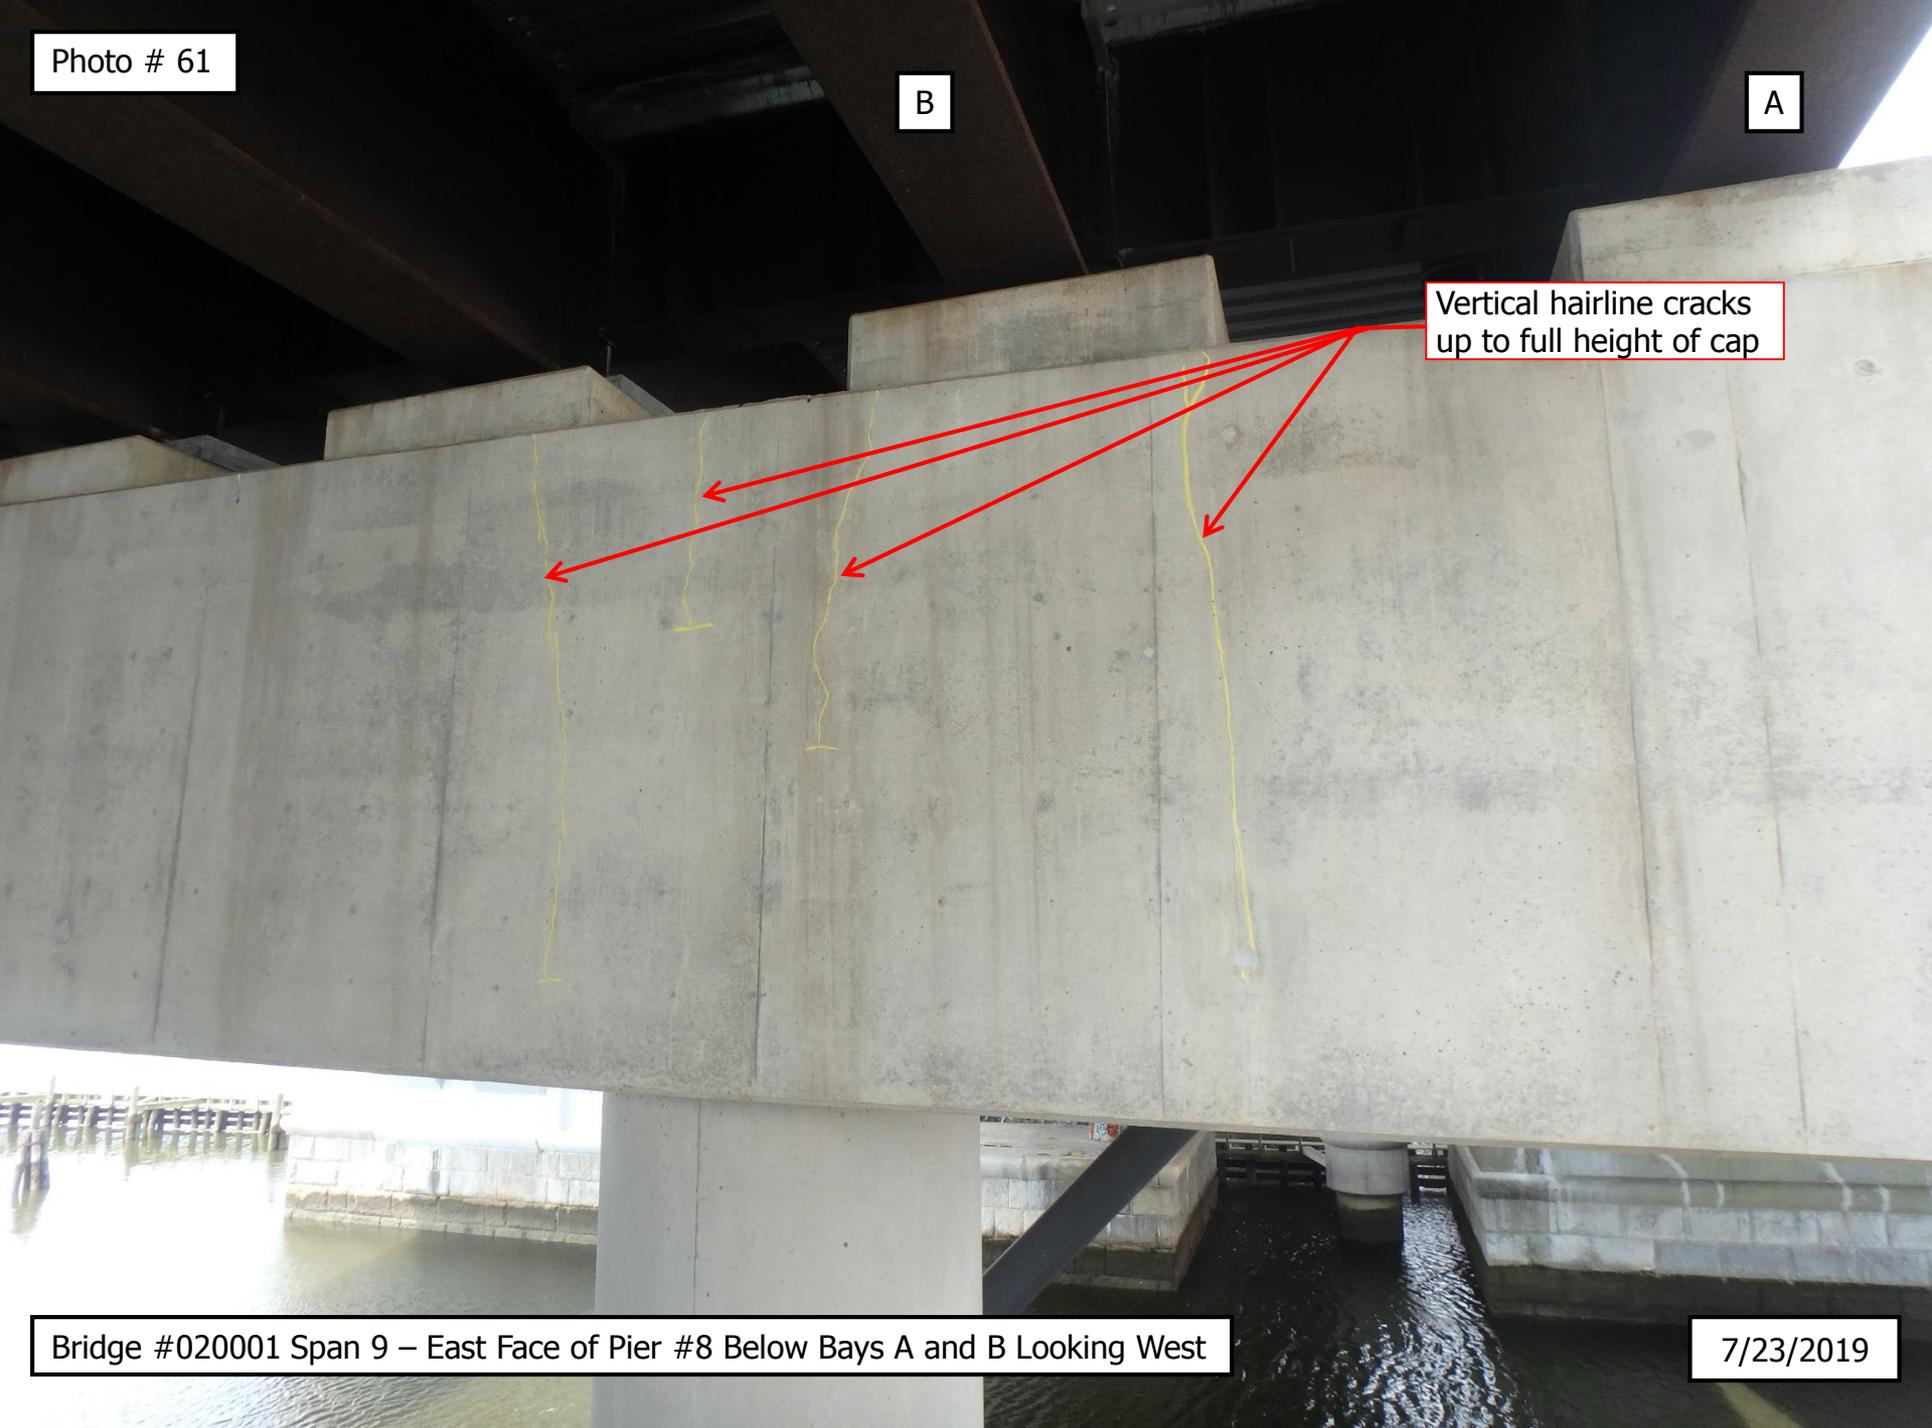
Vertical hairline cracks
up to full height of cap

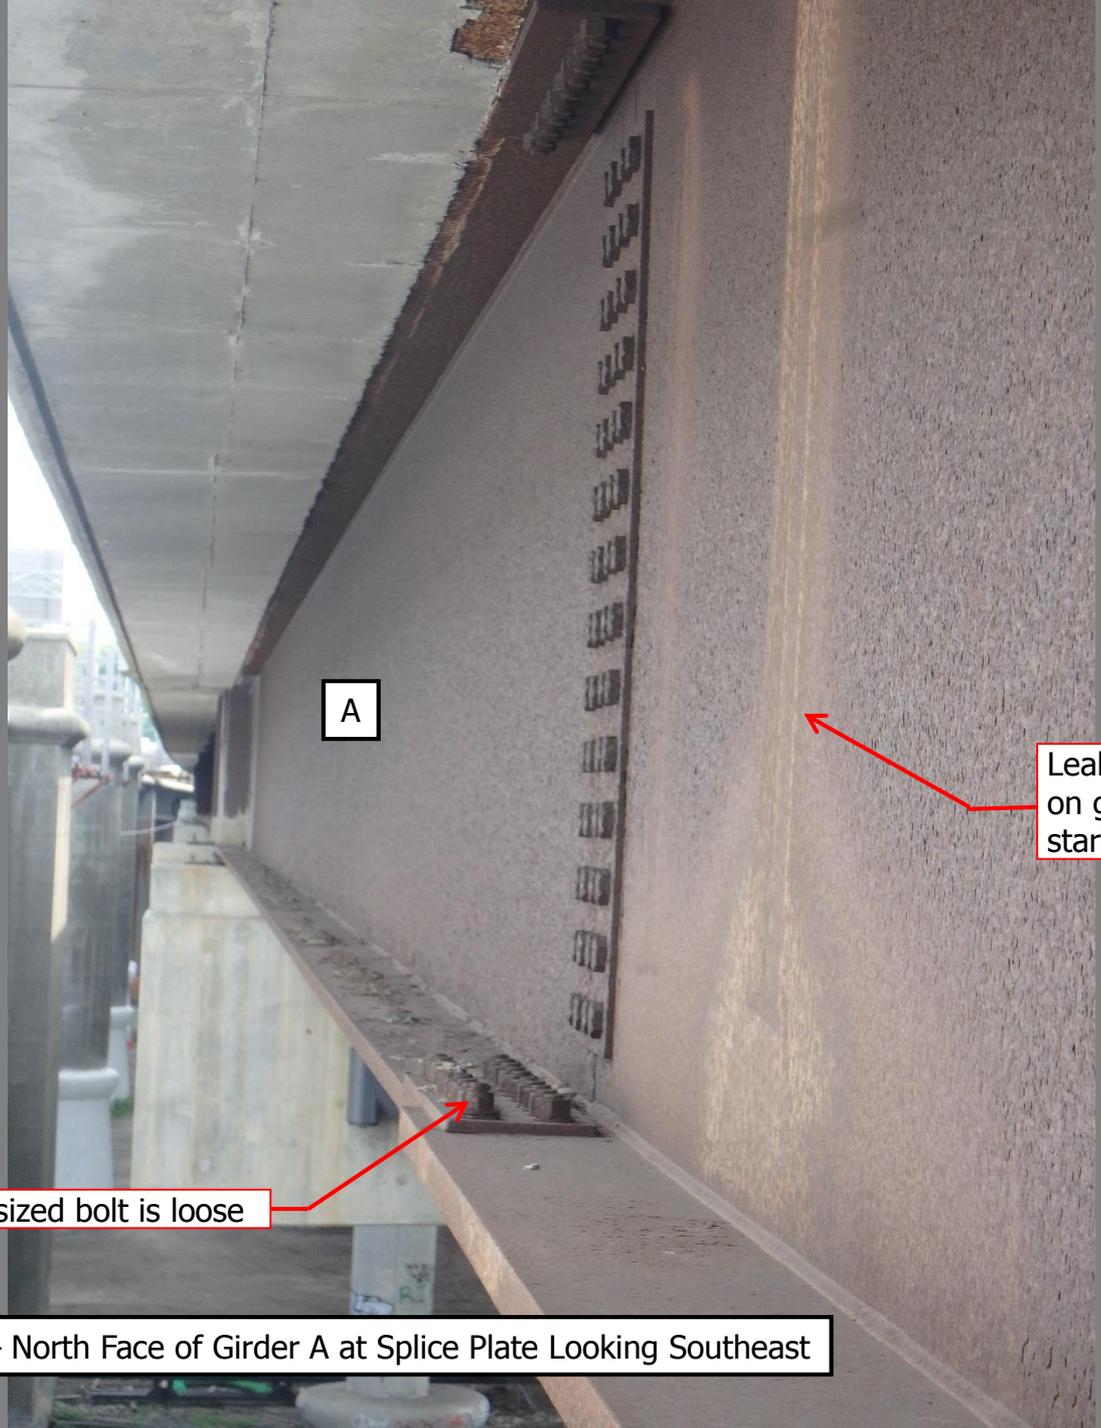
Leakage from deck underside on girder is causing rust to start flaking up to full height

Undersized bolt is loose
