Bridge #020001 West Approach Bituminous Wearing Surface Looking Northeast

7/23/2019

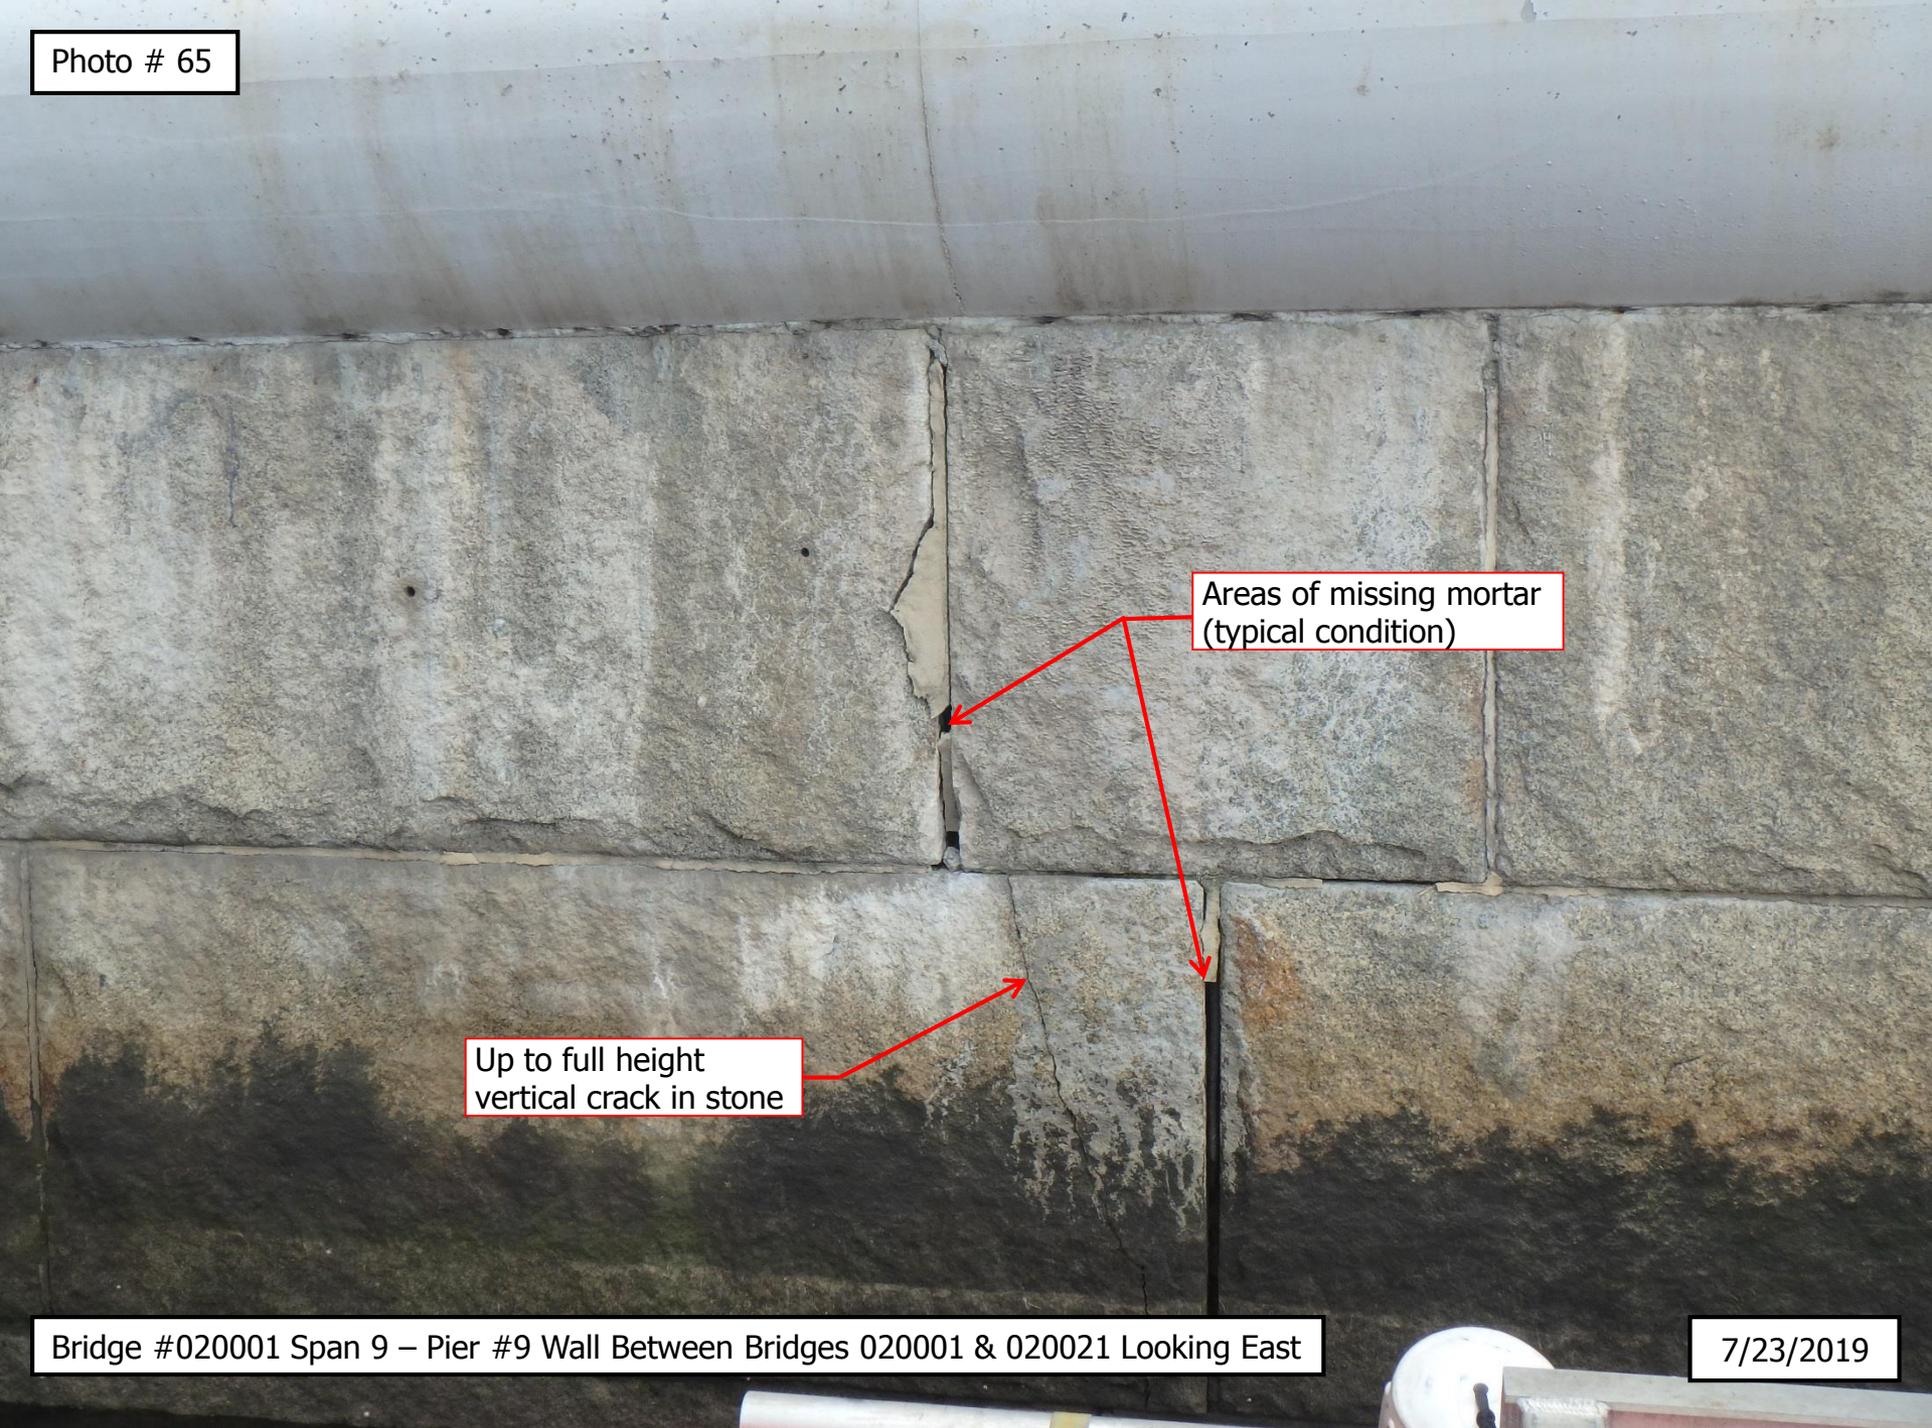
Areas of missing mortar
(typical condition)

Up to full height
vertical crack in stone

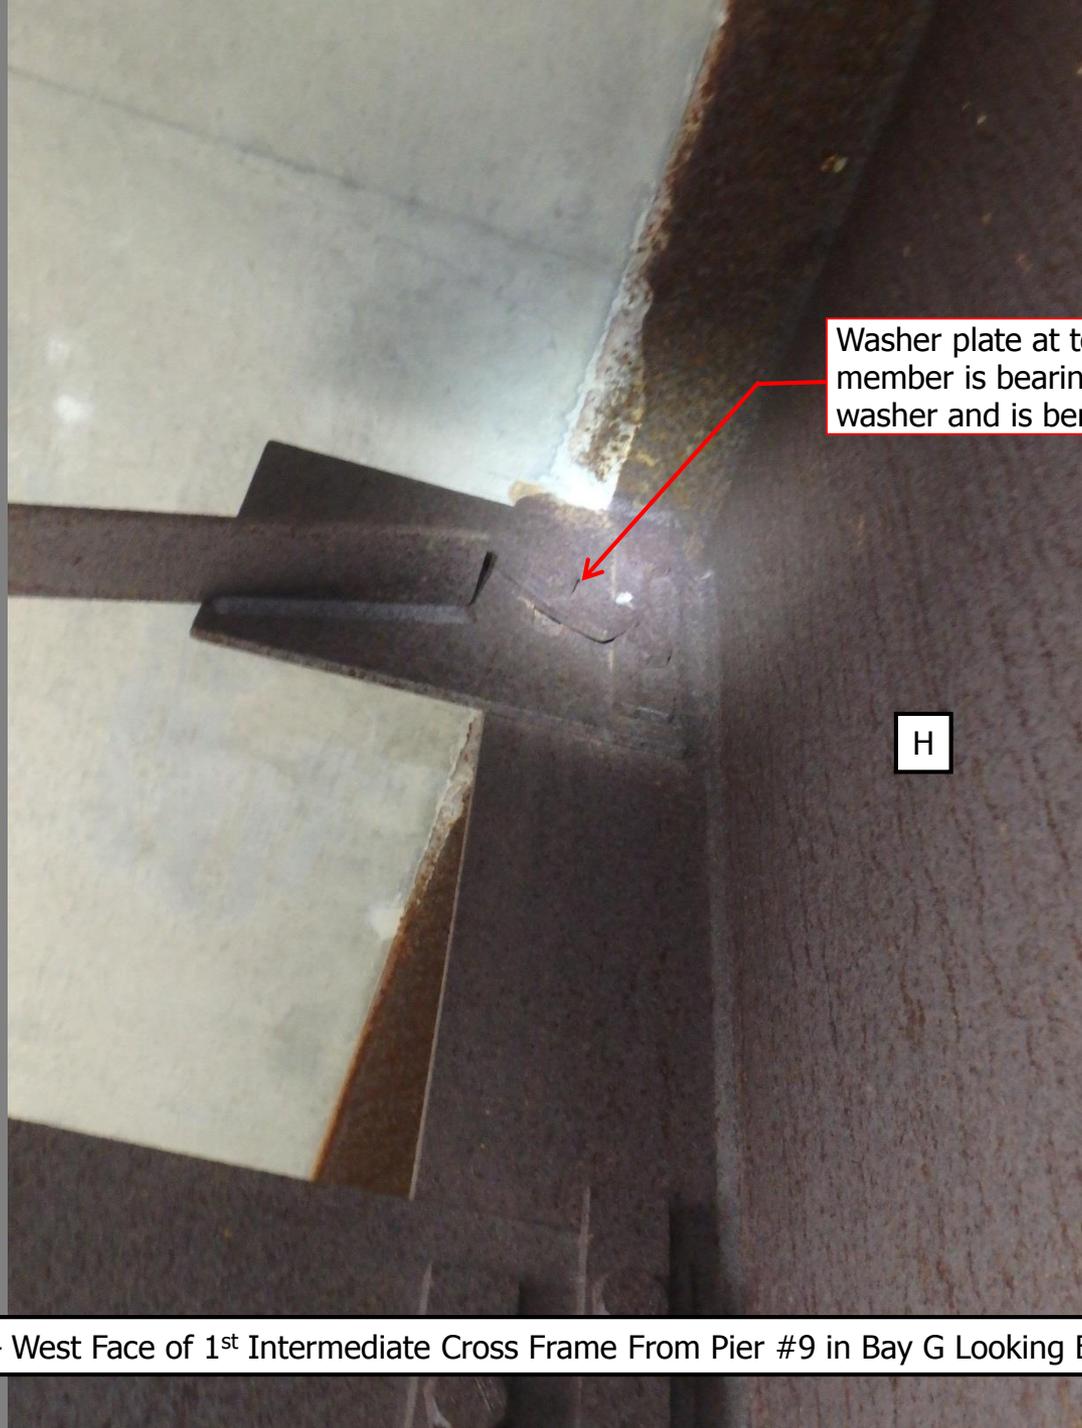
Washer plate at top cross member is bearing on adjacent washer and is bent slightly

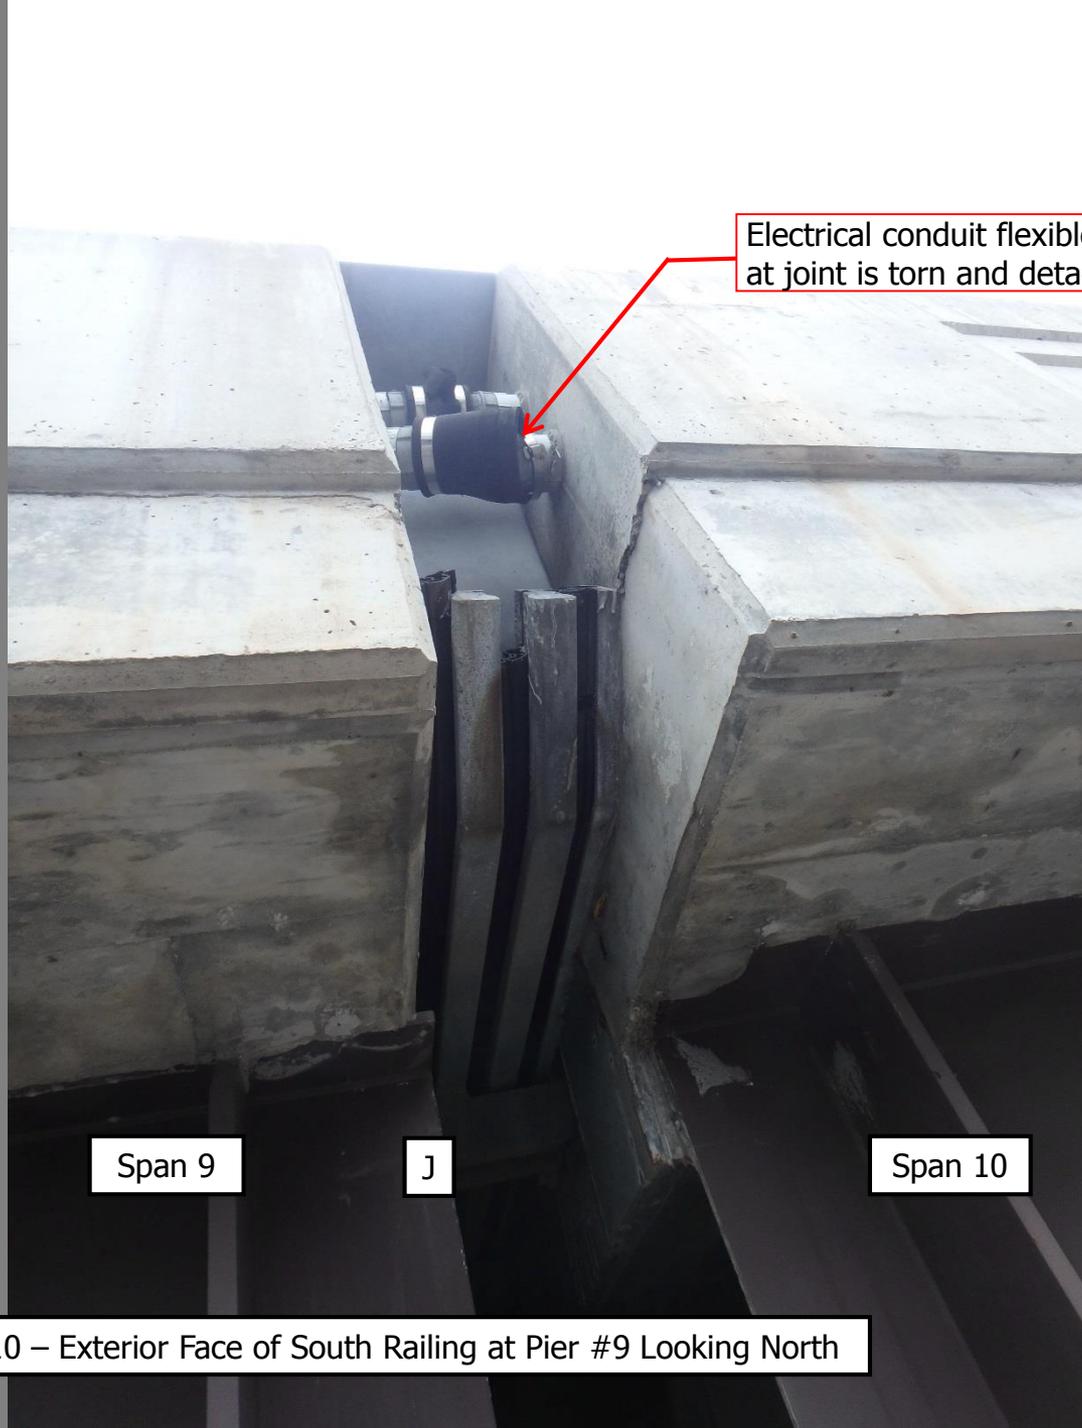
Electrical conduit flexible coupling at joint is torn and detached

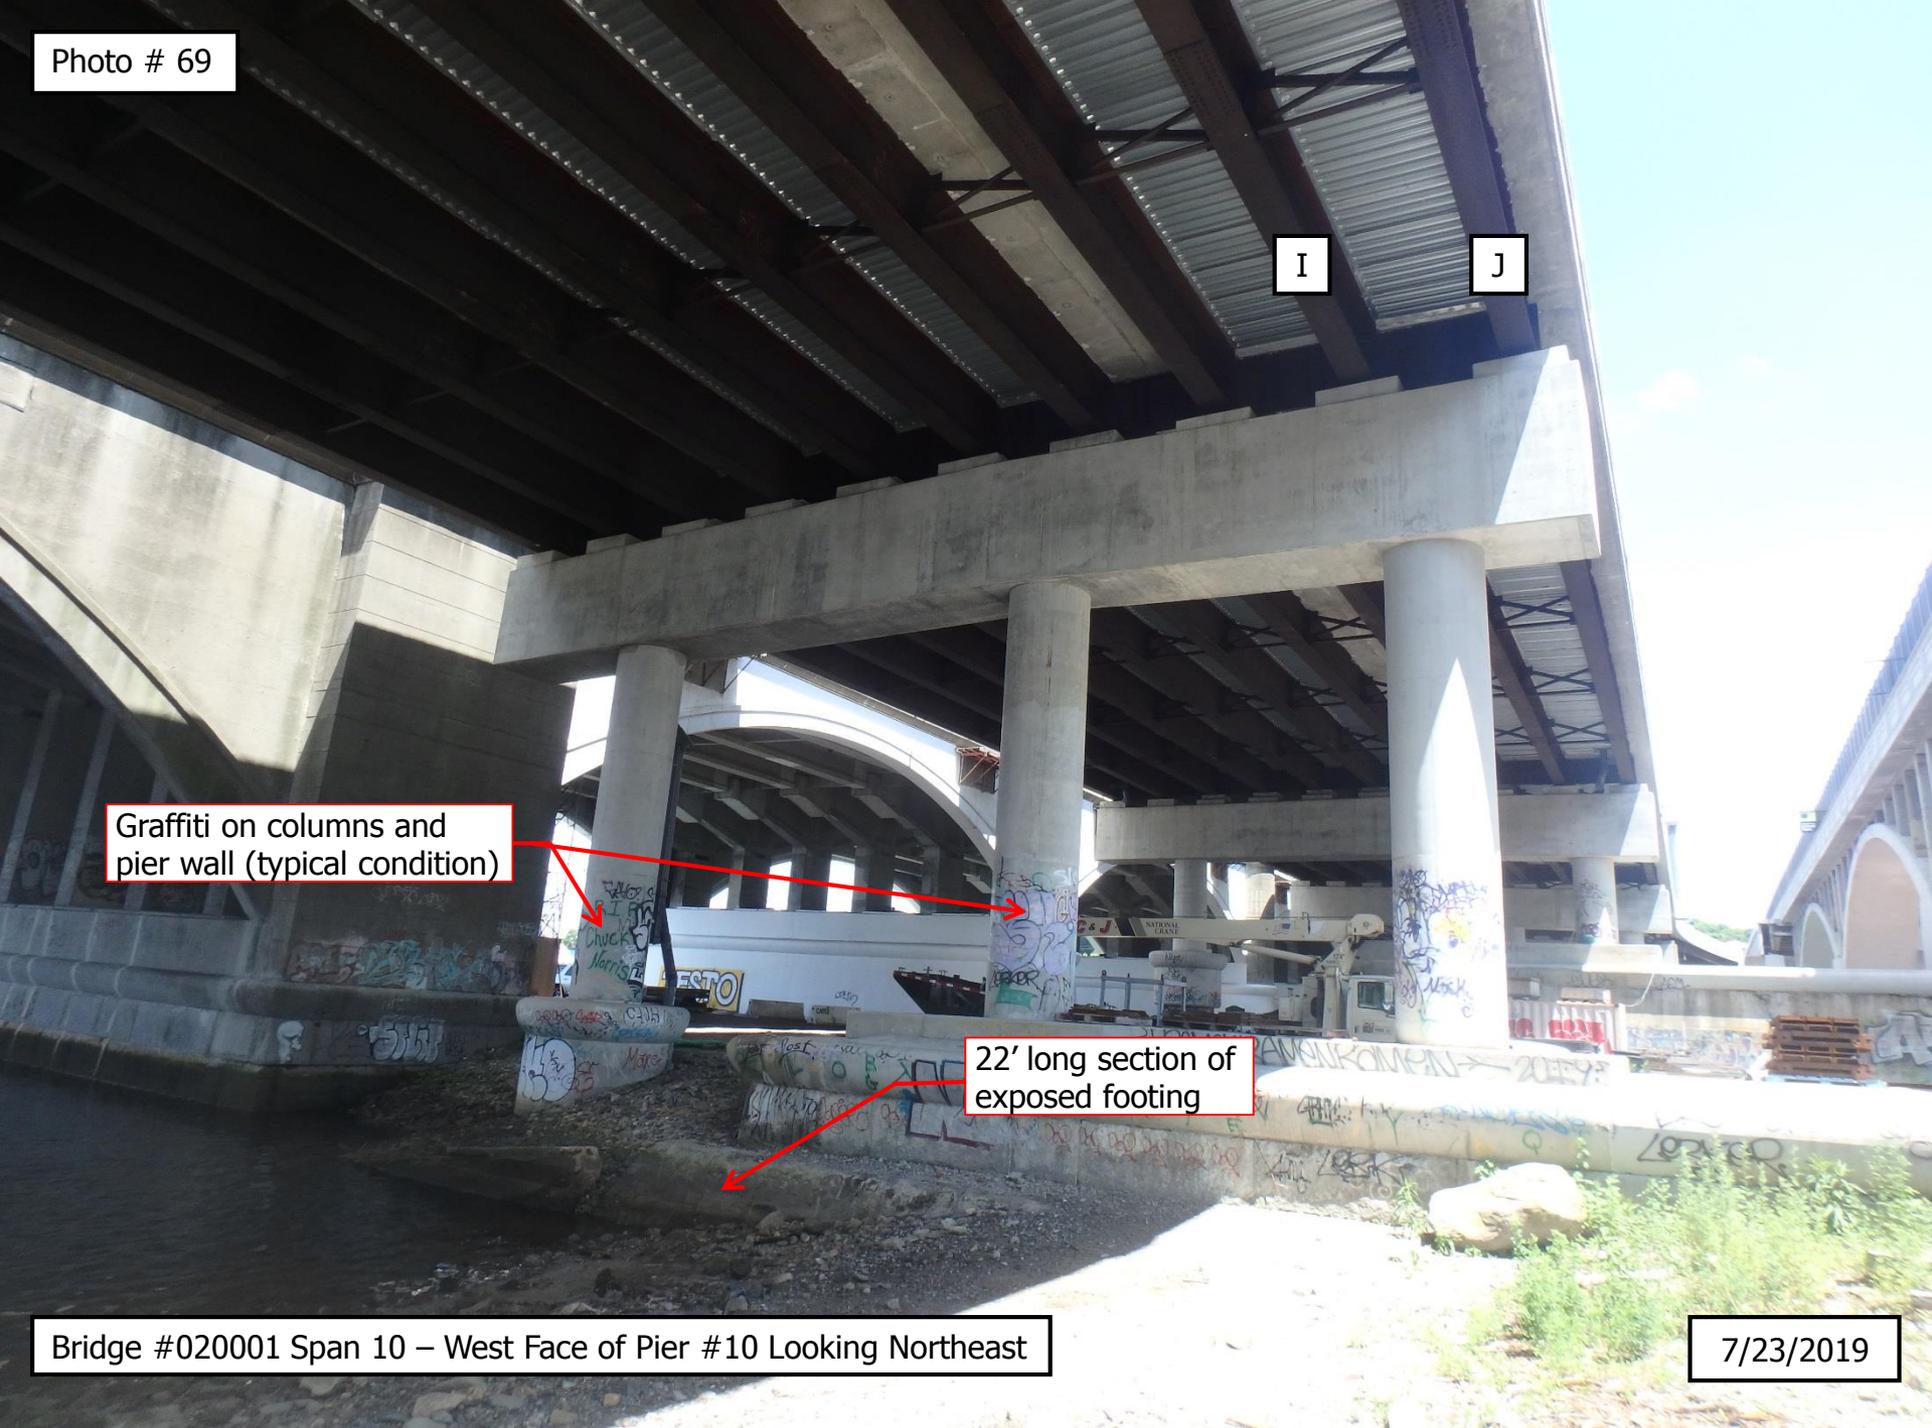
Graffiti on columns and pier wall (typical condition)

22' long section of exposed footing

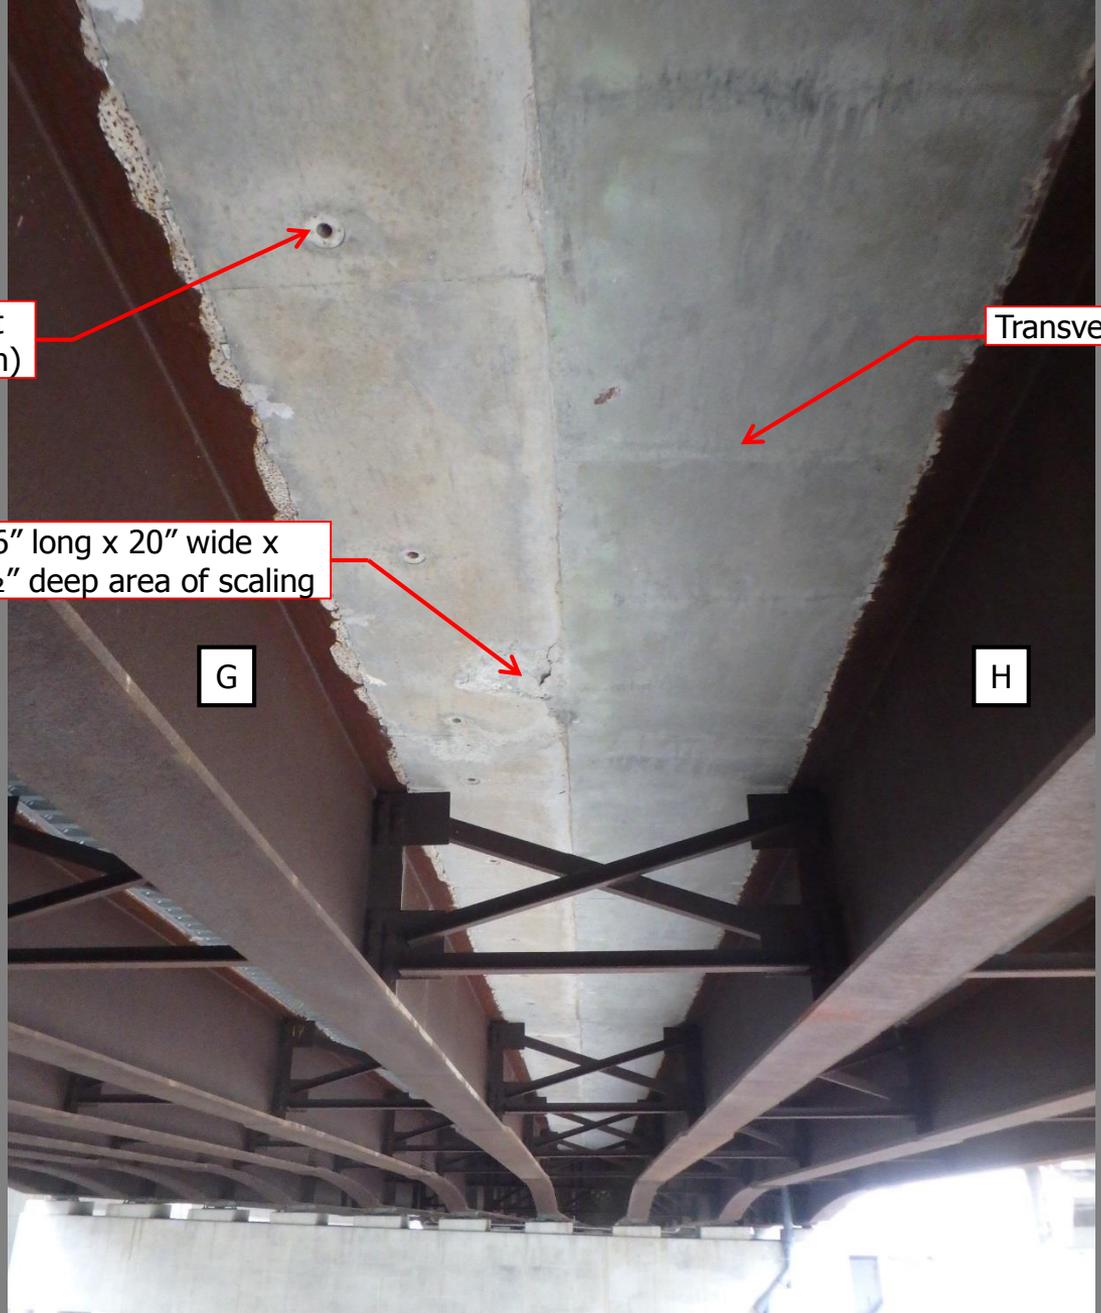
Anchor bolt holes are not patched (typical condition)

Transverse hairline cracks

36" long x 20" wide x 1/2" deep area of scaling

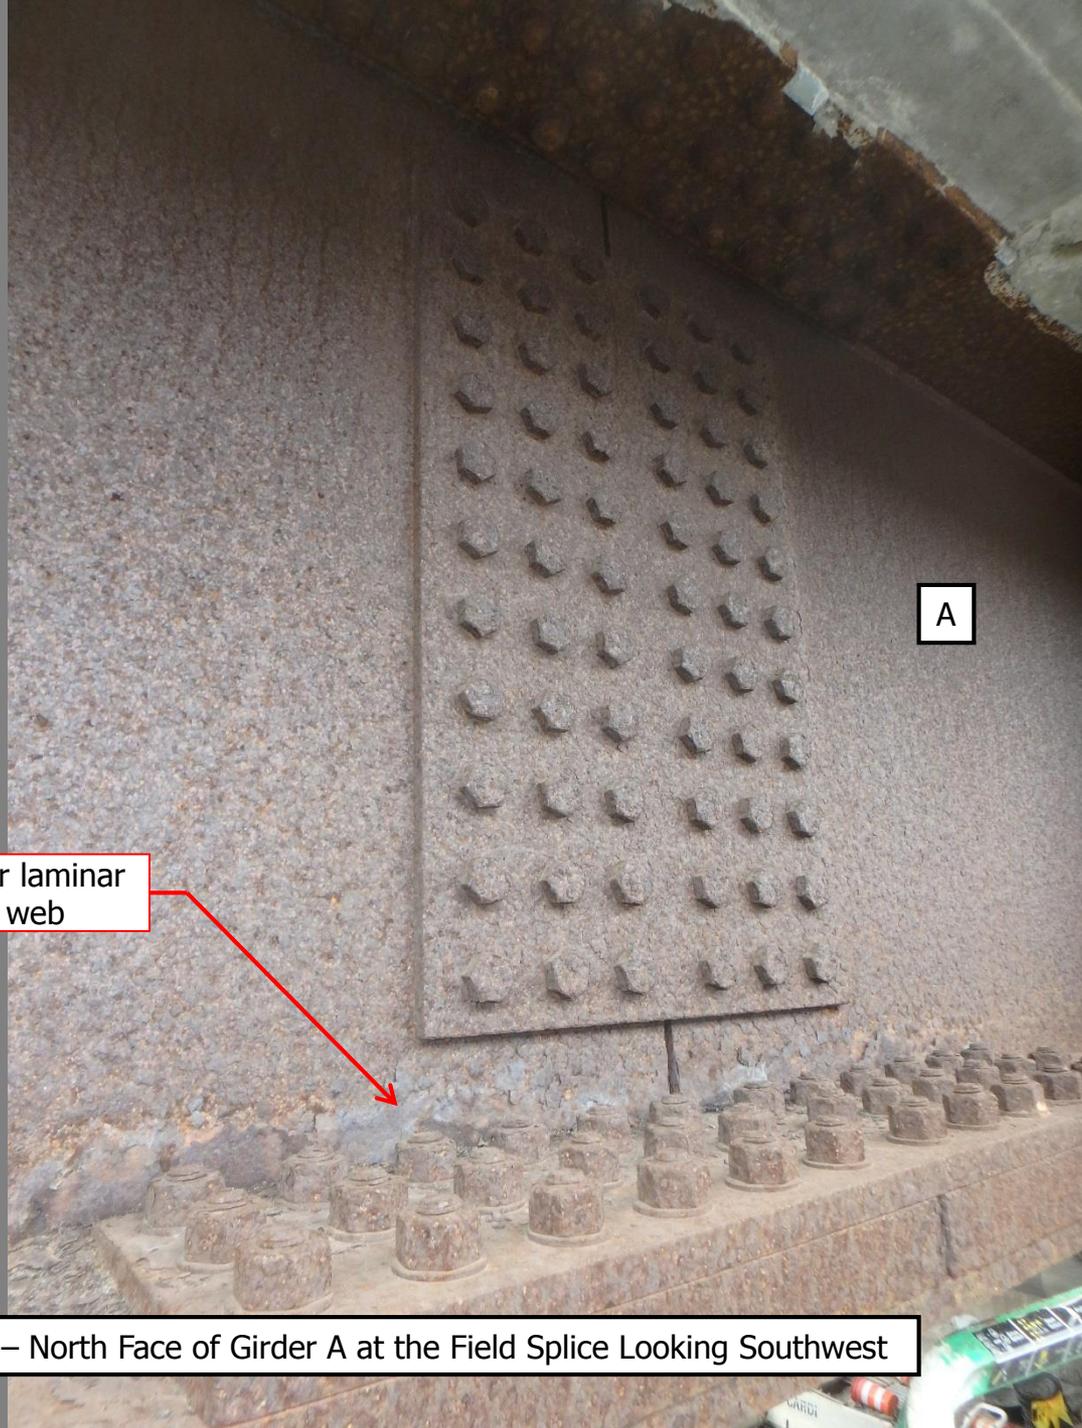
3" high x 36" long minor laminar
rusting along bottom of web

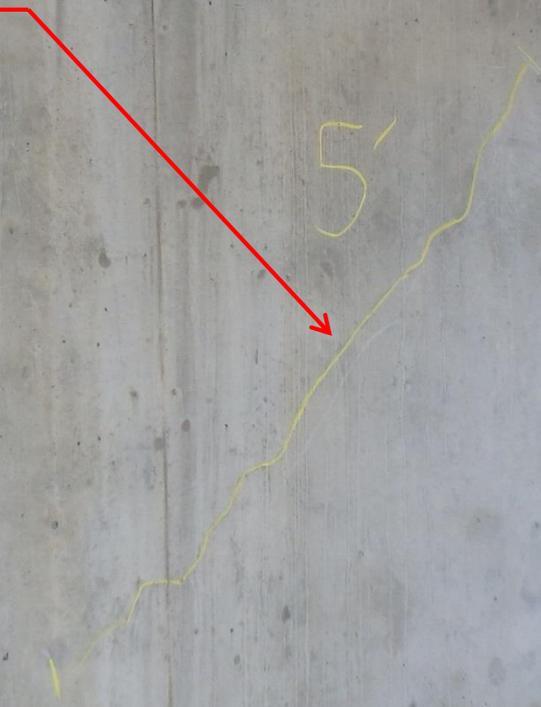
5' long diagonal hairline crack

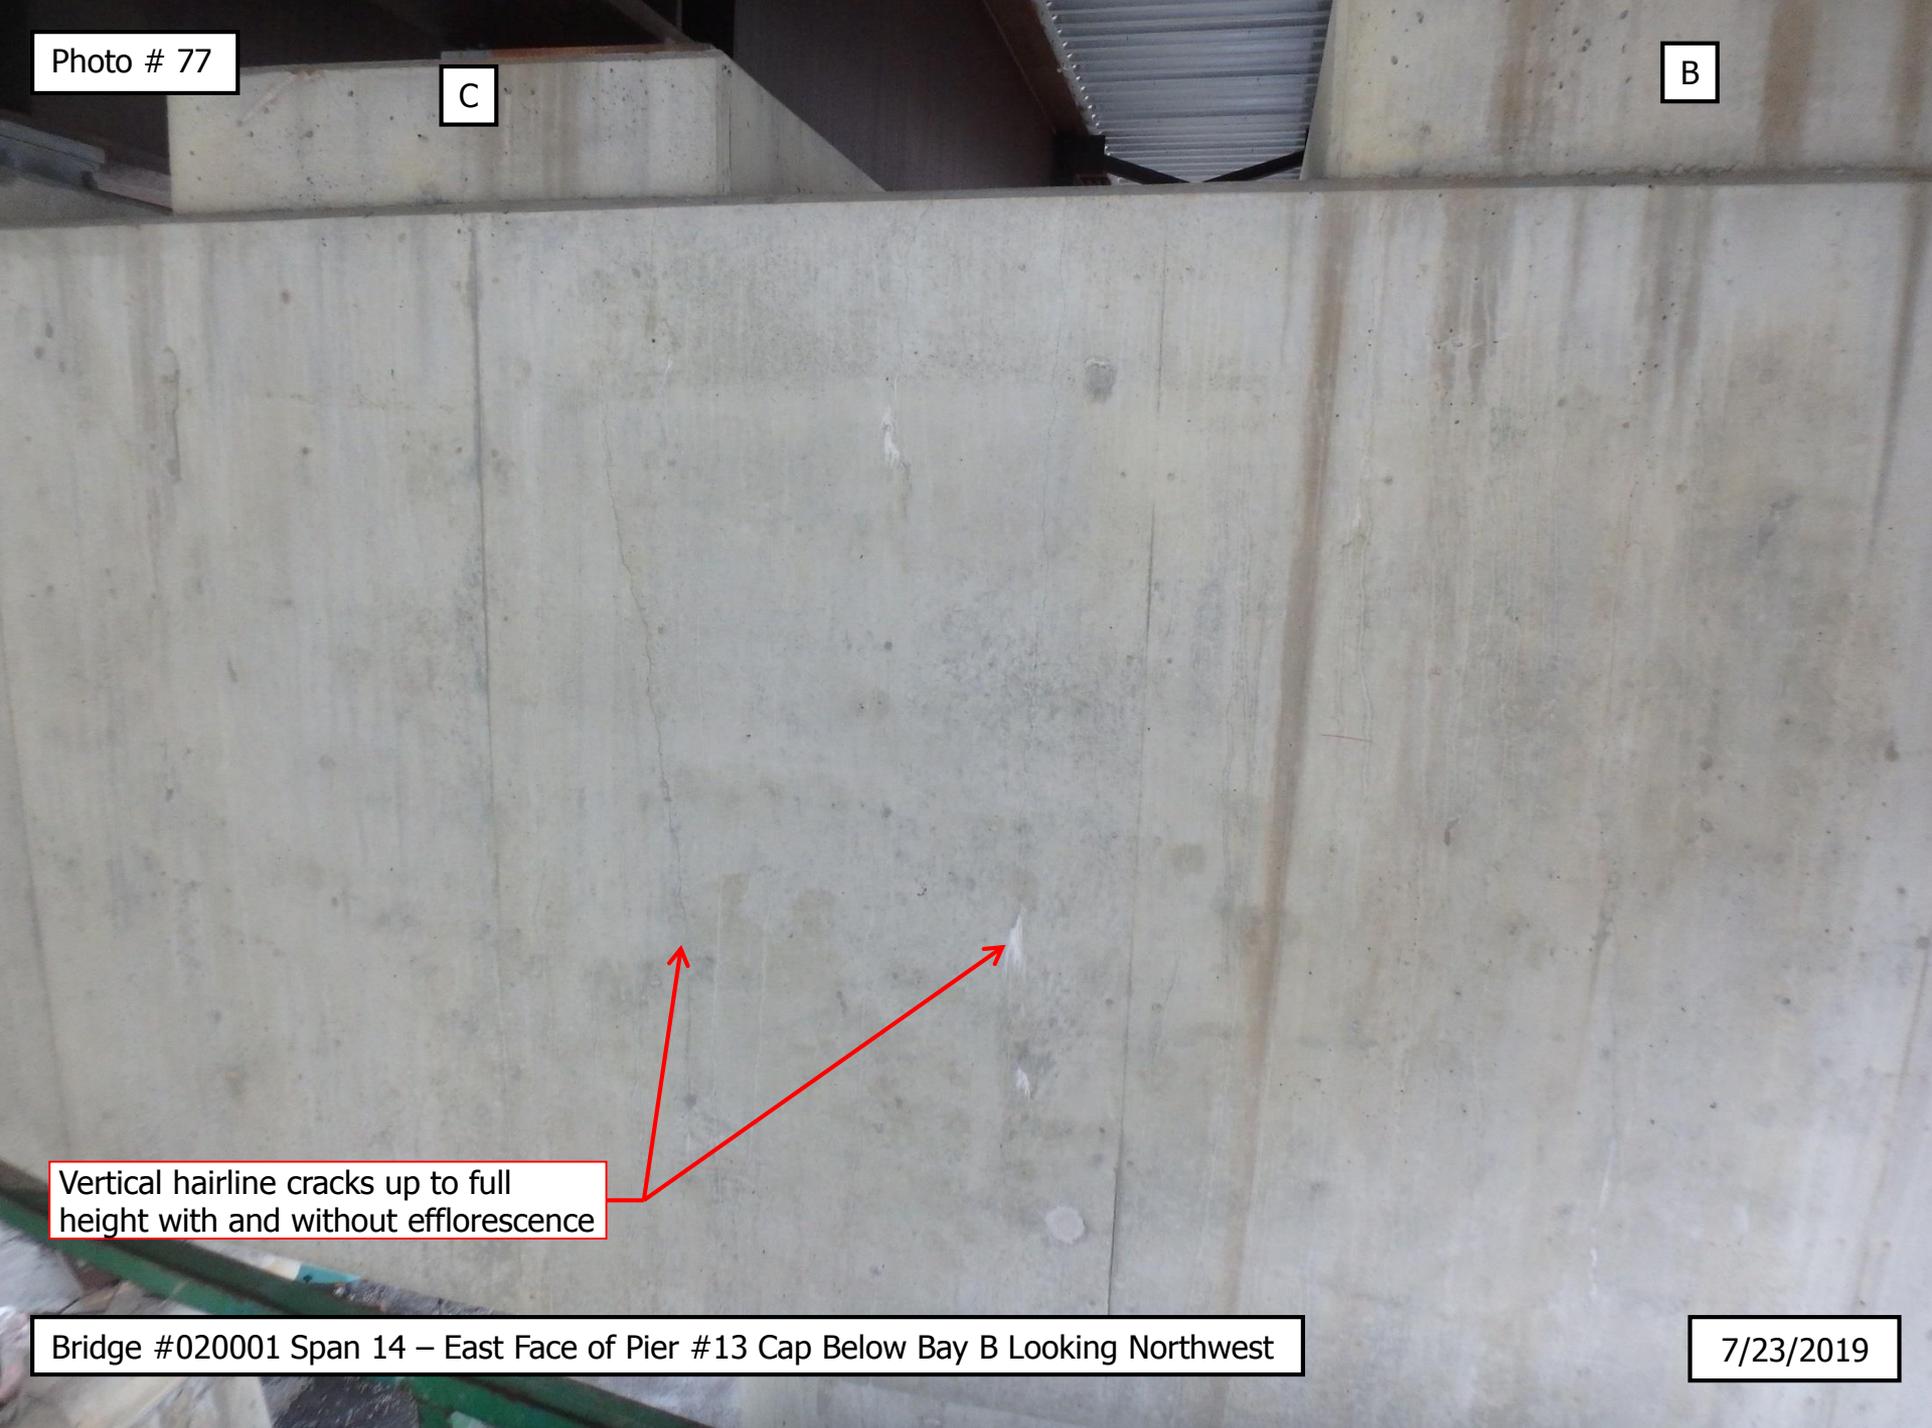
Vertical hairline cracks up to full height with and without efflorescence

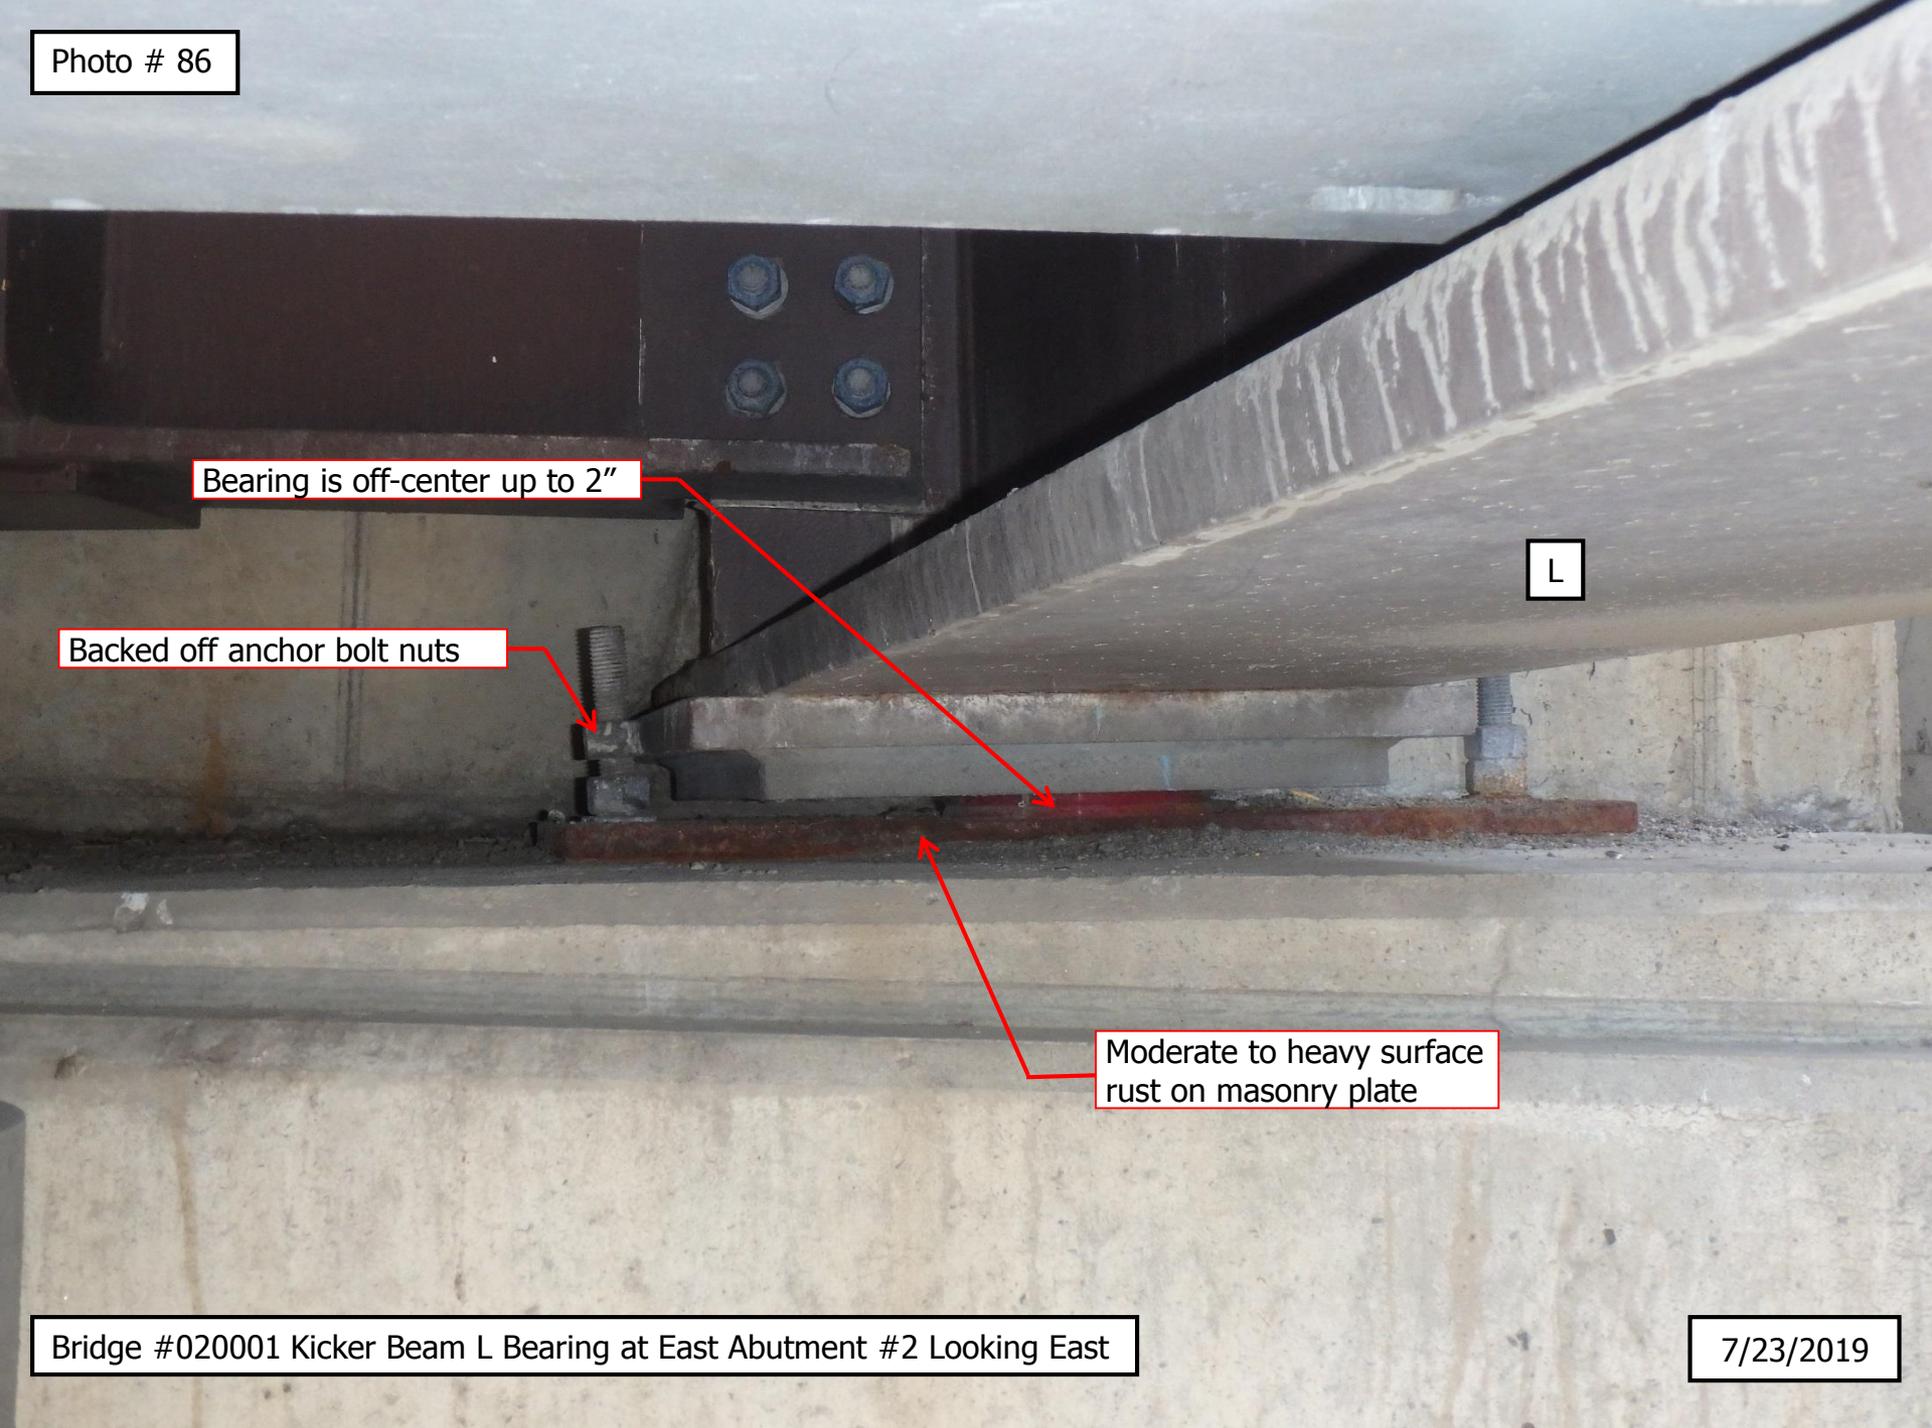
Bearing is off-center up to 2"

Backed off anchor bolt nuts

Moderate to heavy surface rust on masonry plate

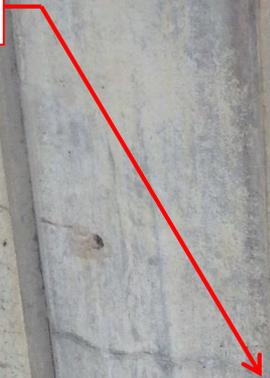
Horizontal hairline crack up to 30" long with active moisture
