End of
Bridge

West Approach

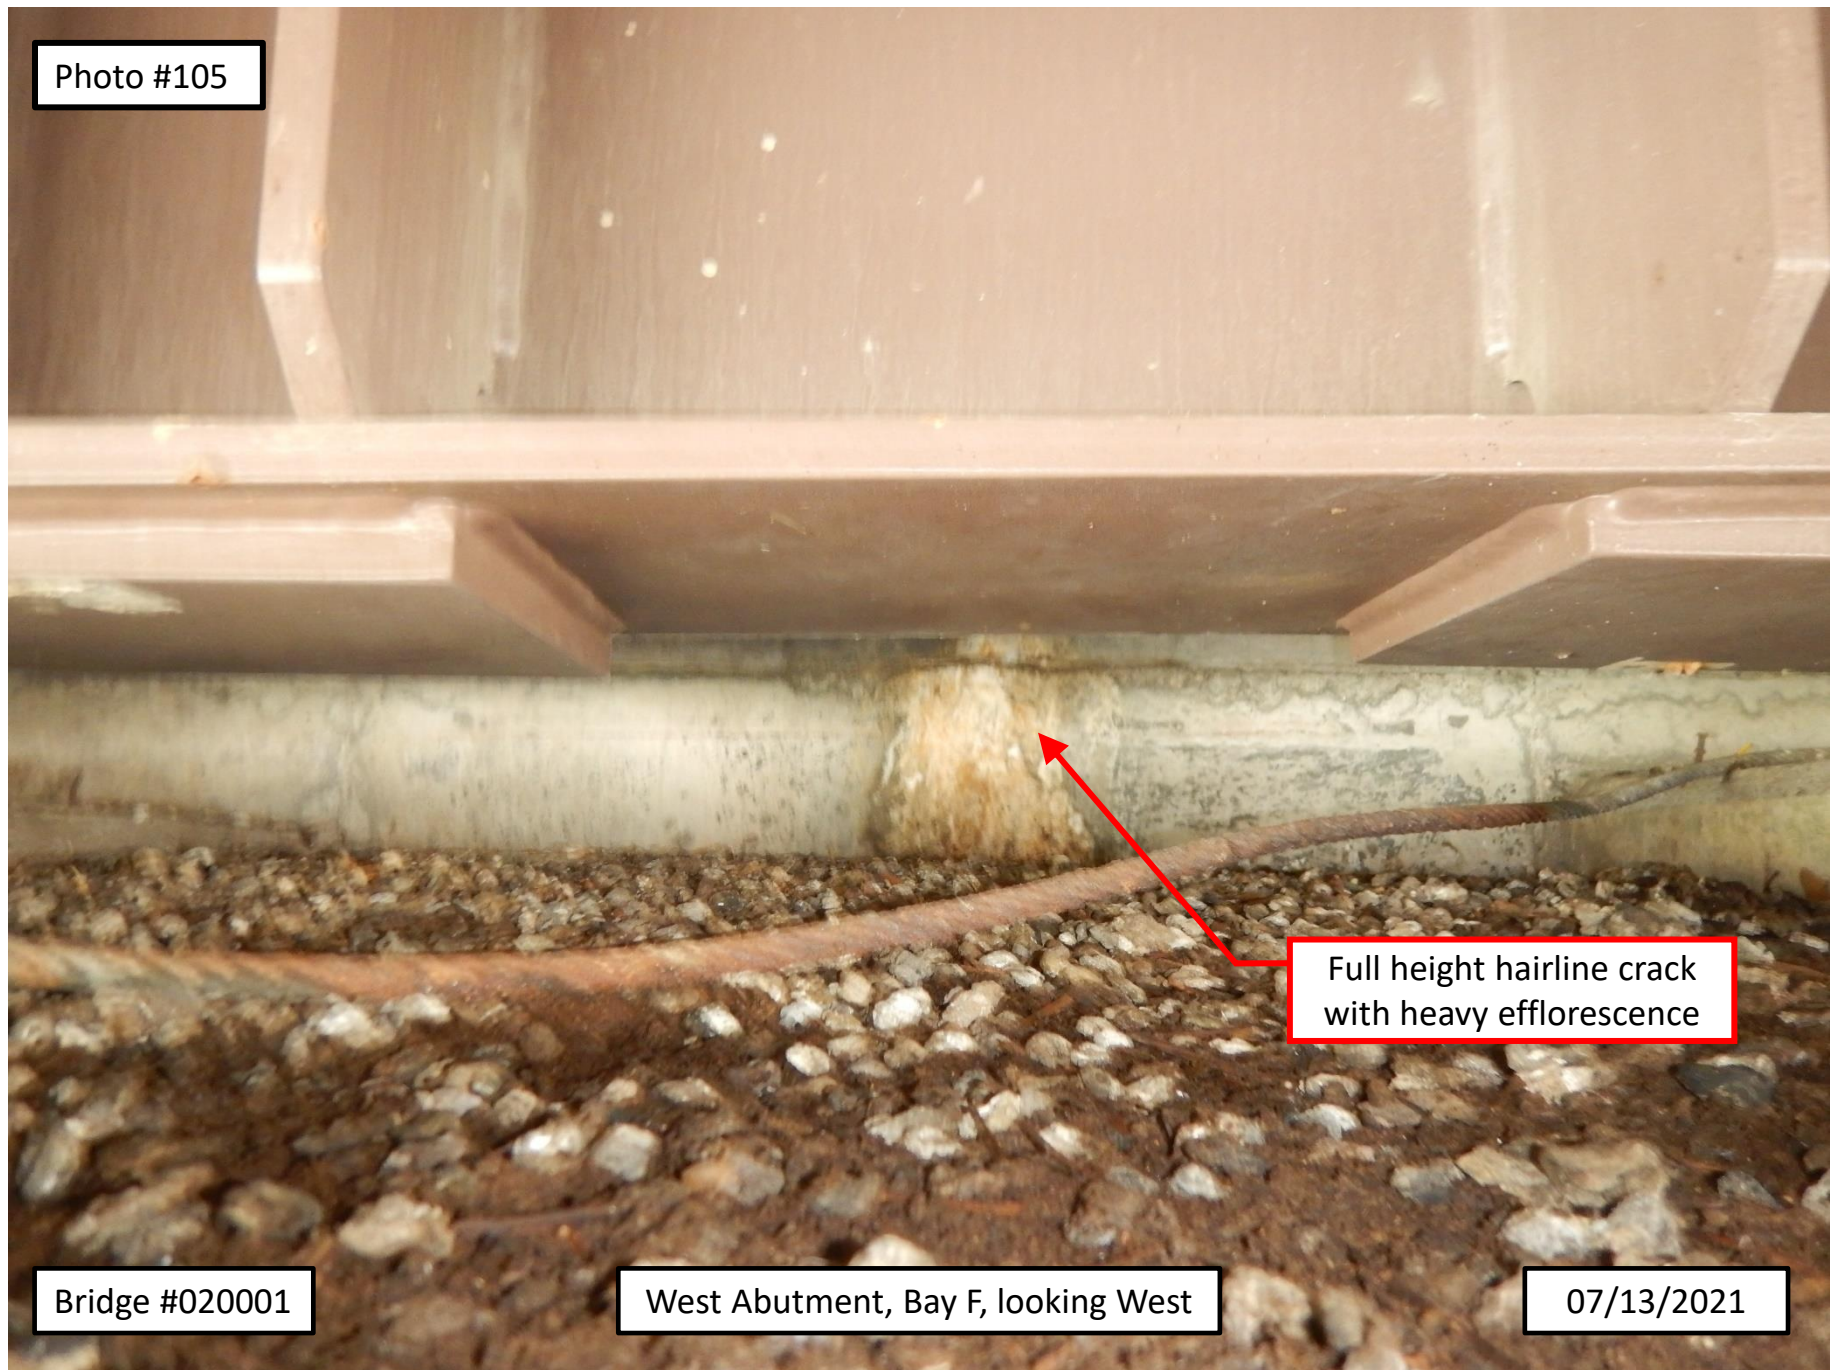
Full height hairline crack
with heavy efflorescence
