Minor to moderate wheel line rutting with areas of cracking throughout

Separation crack with potholes has been patched since the previous inspection

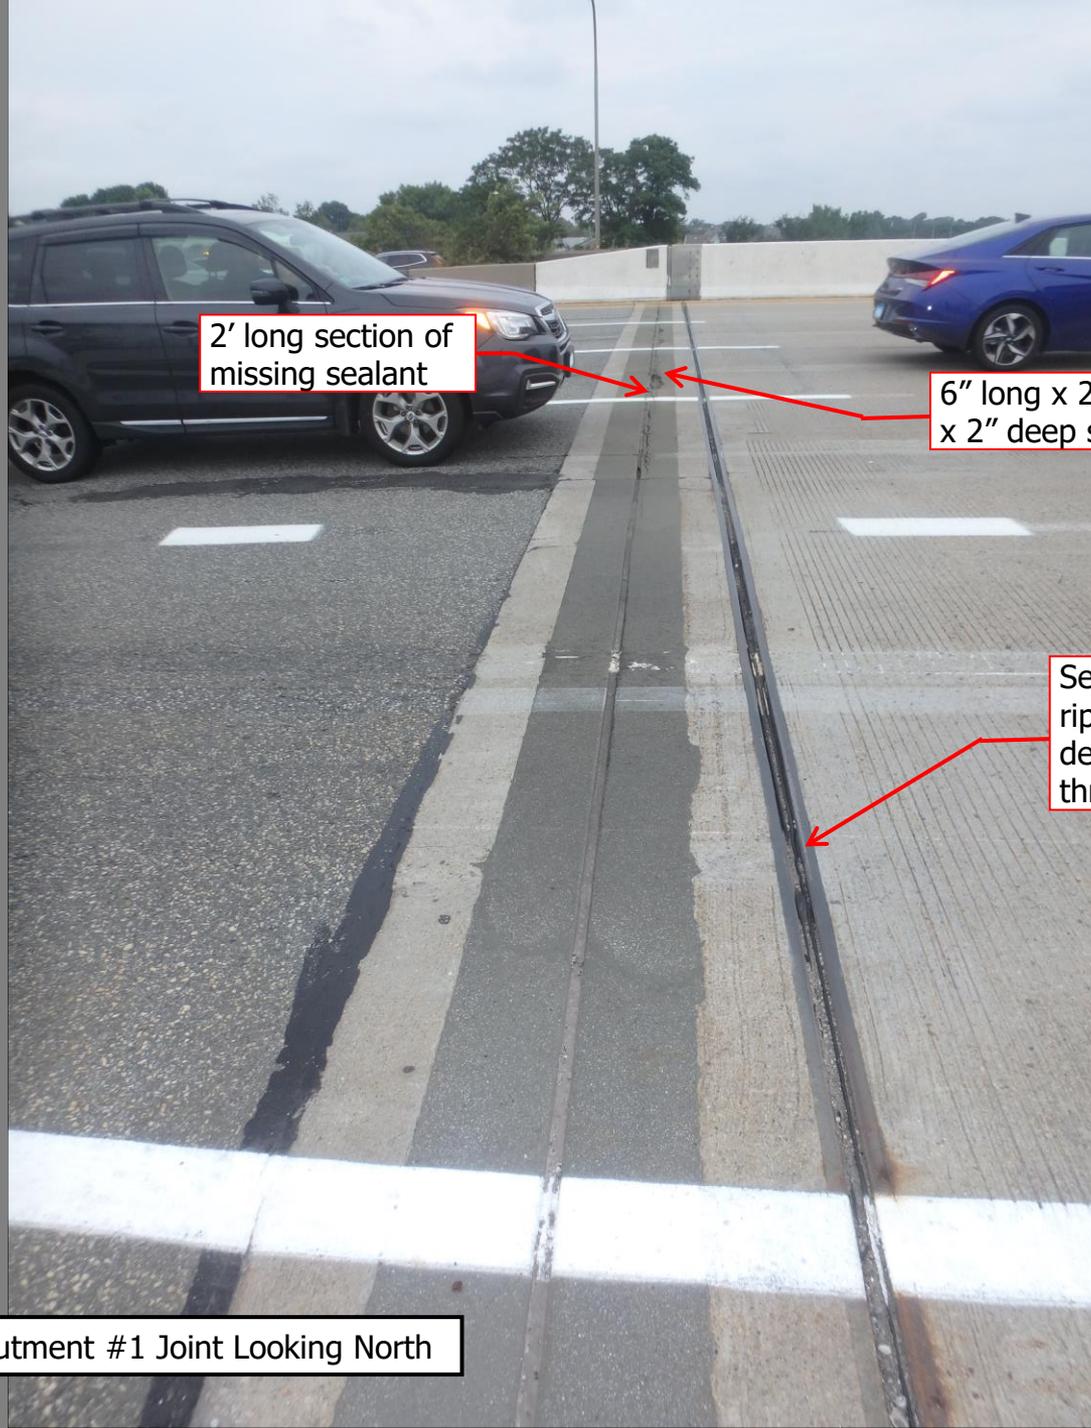
2' long section of missing sealant

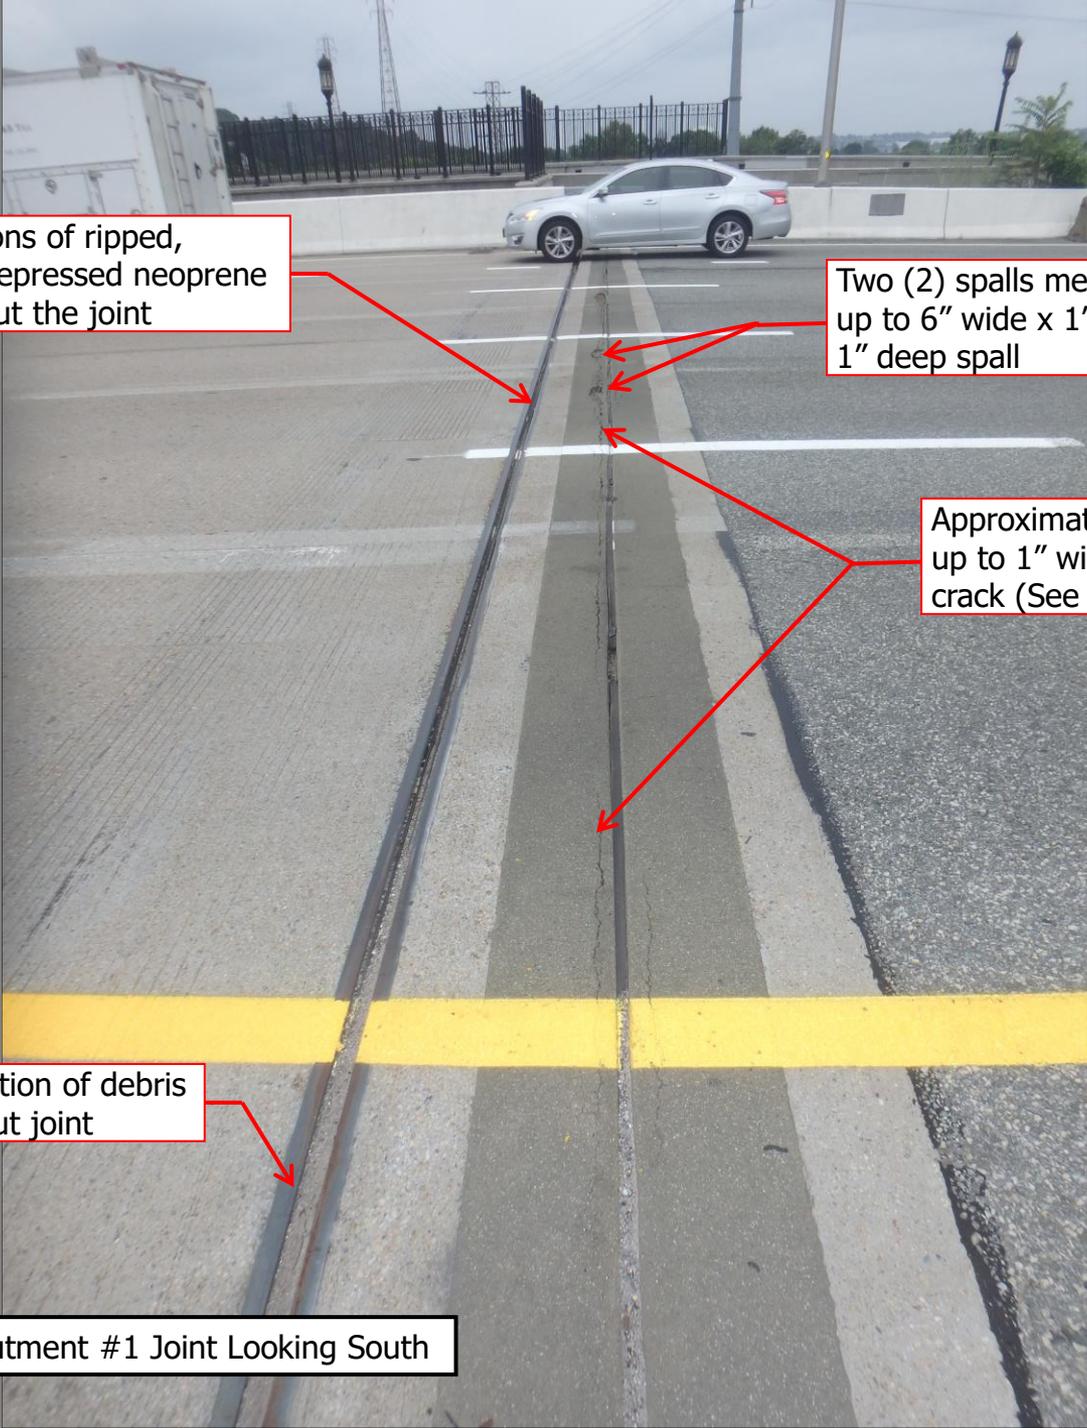
Bridge #020001 West Abutment #1 Joint Looking South

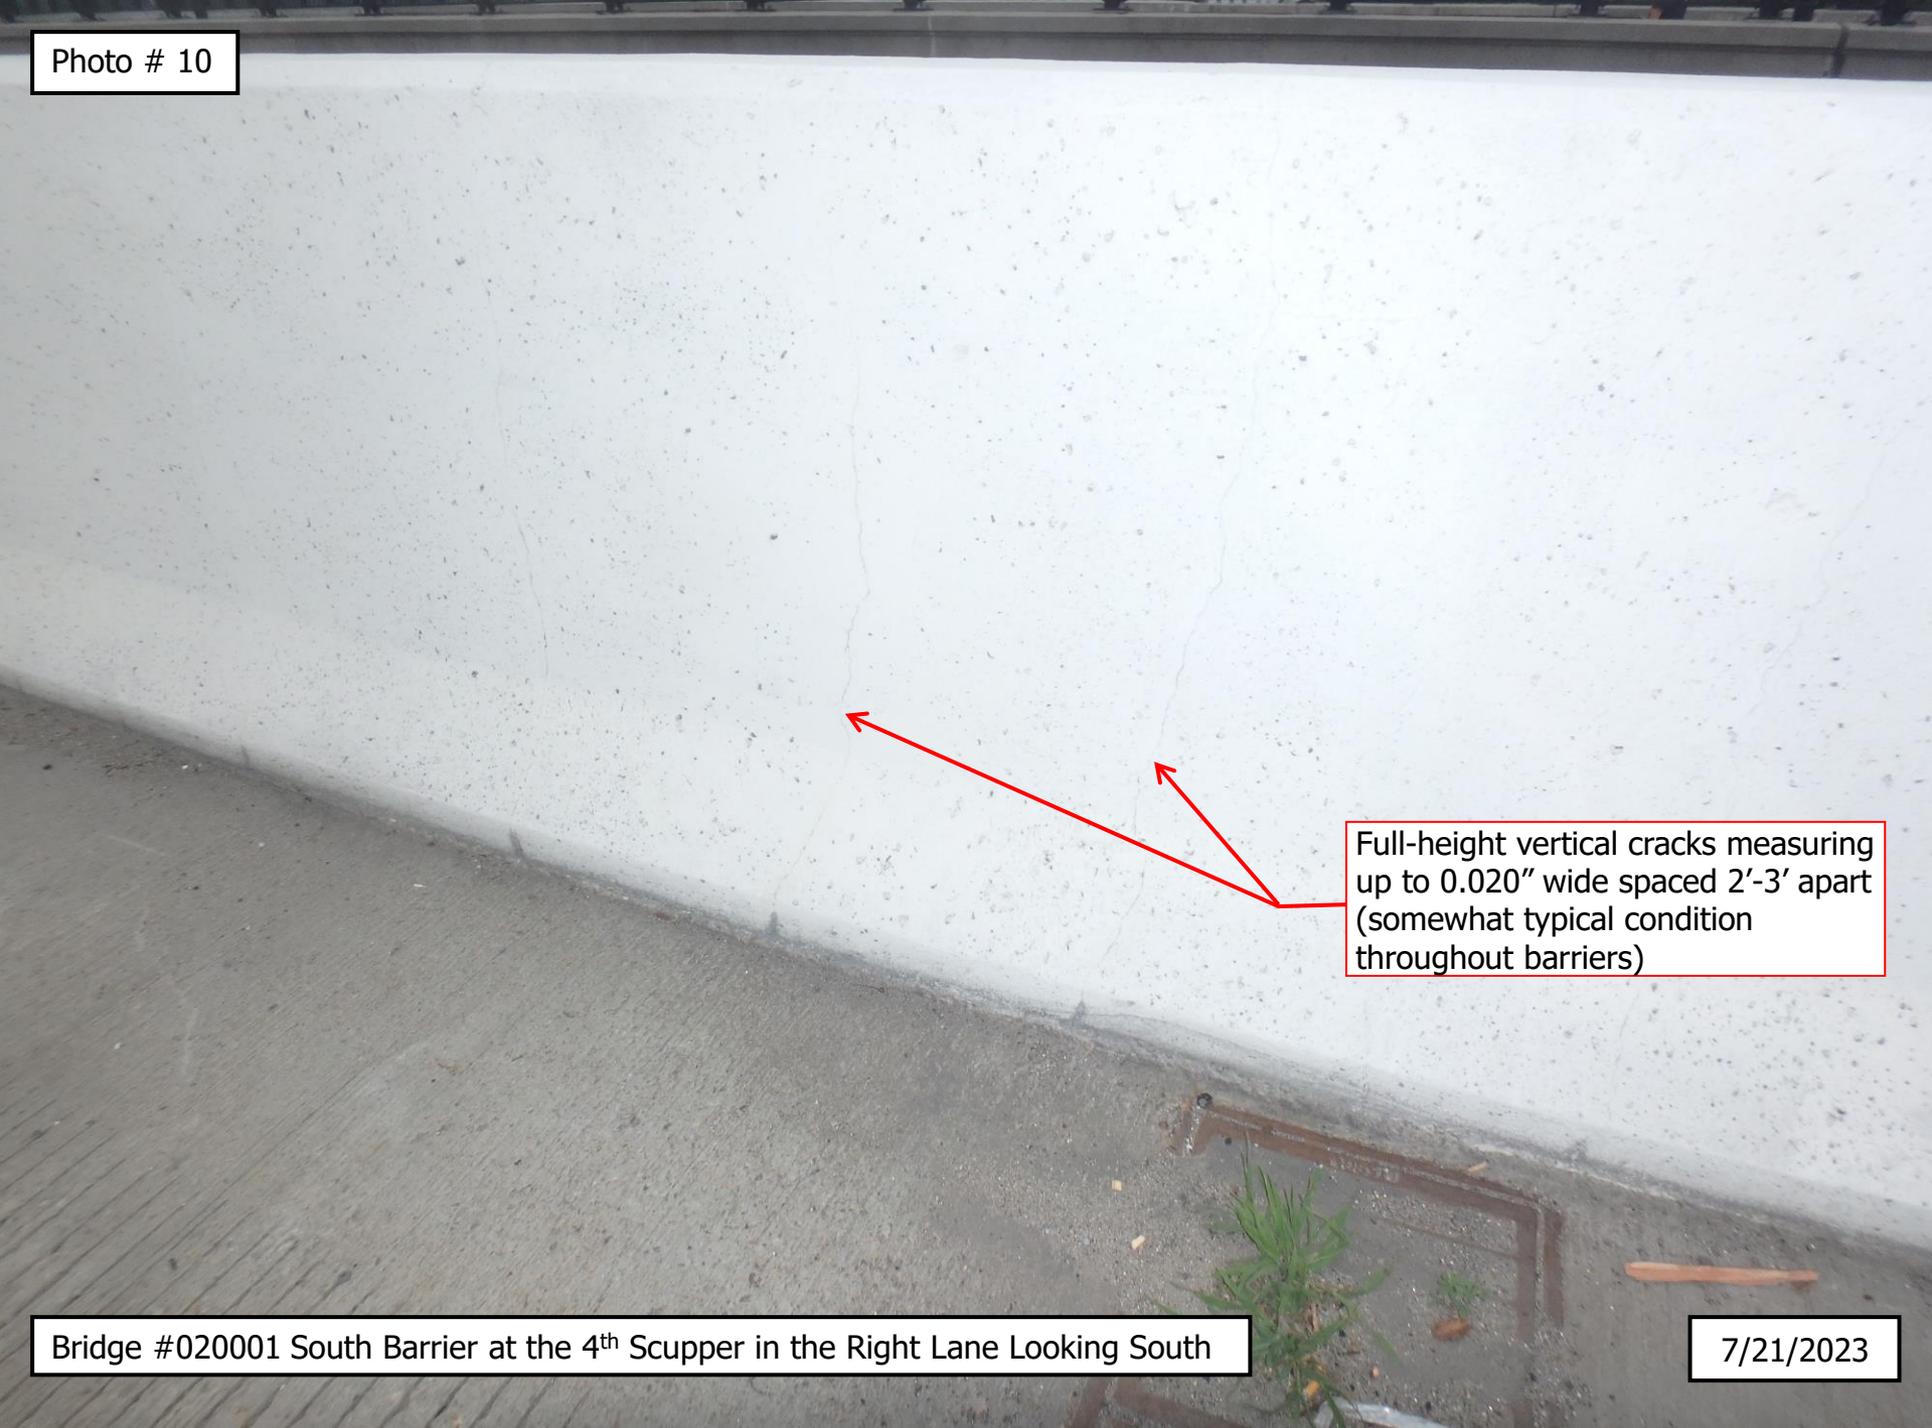
Full-height vertical cracks measuring up to 0.020" wide spaced 2'-3' apart (somewhat typical condition throughout barriers)

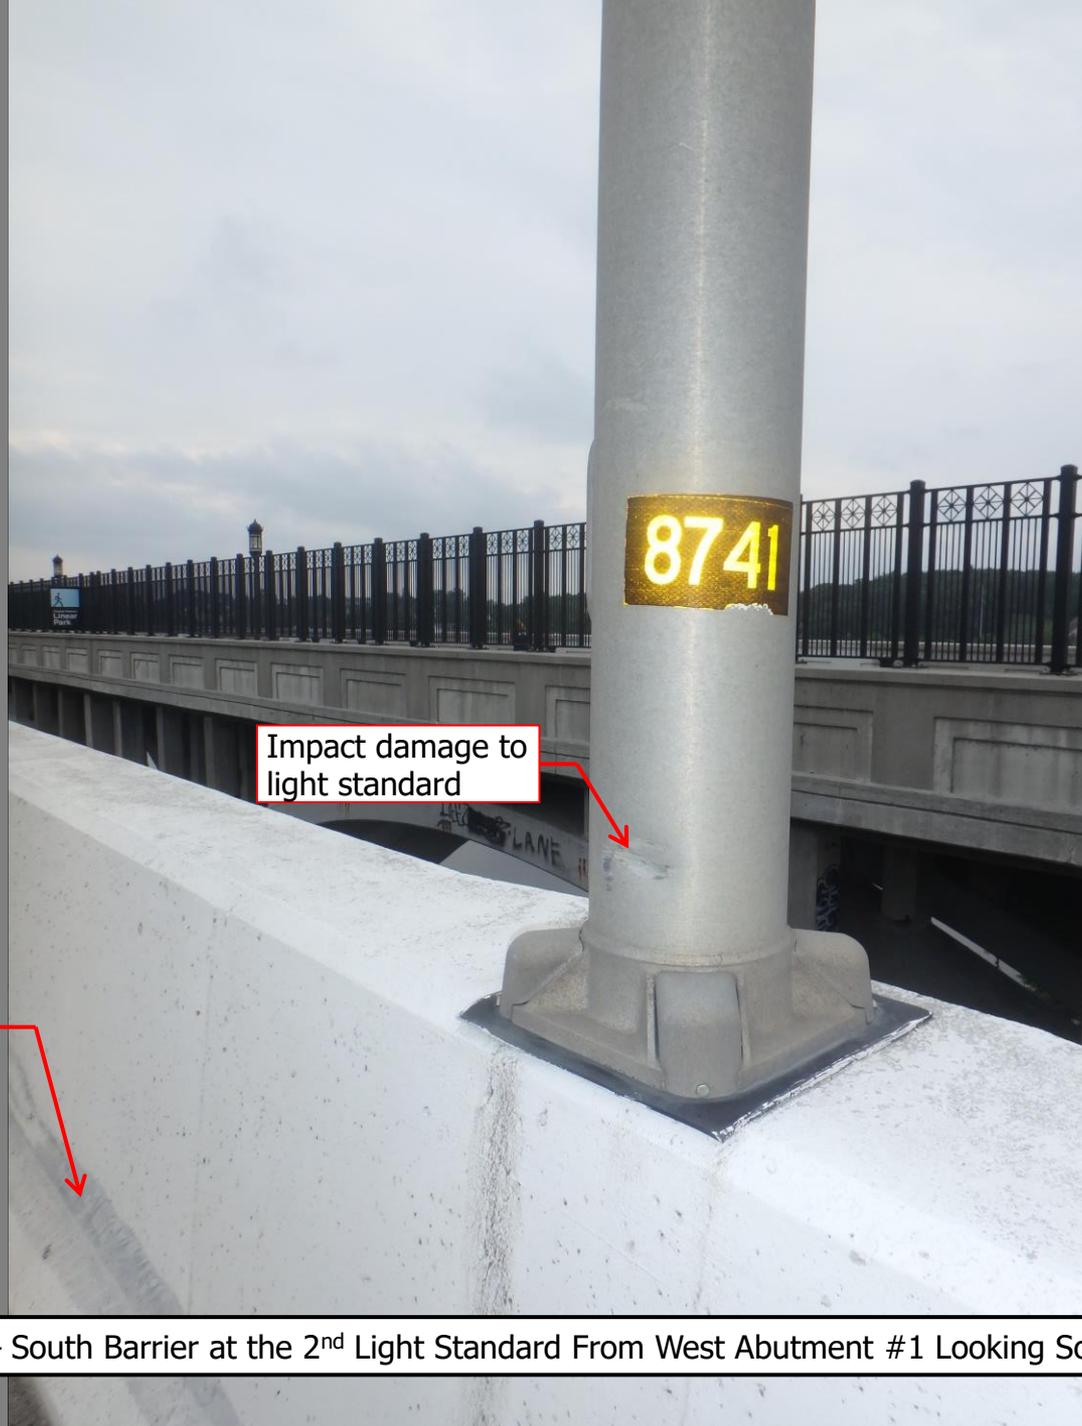
Impact damage to
light standard

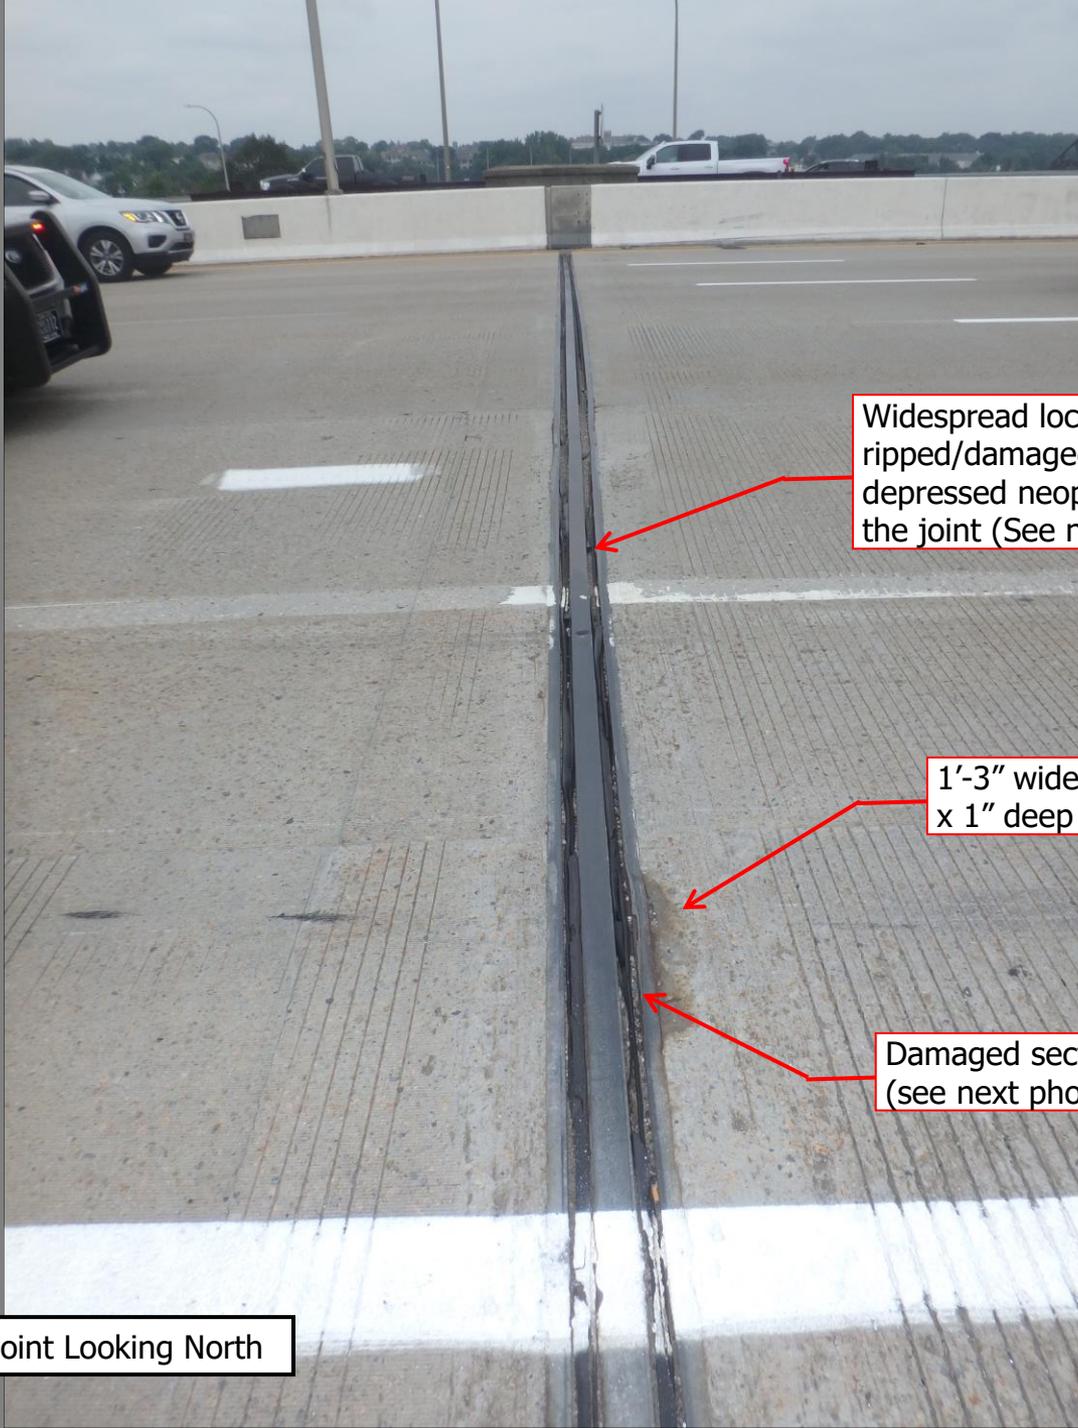
Widespread locations of ripped/damaged, missing and depressed neoprene seal throughout the joint (See next photo)

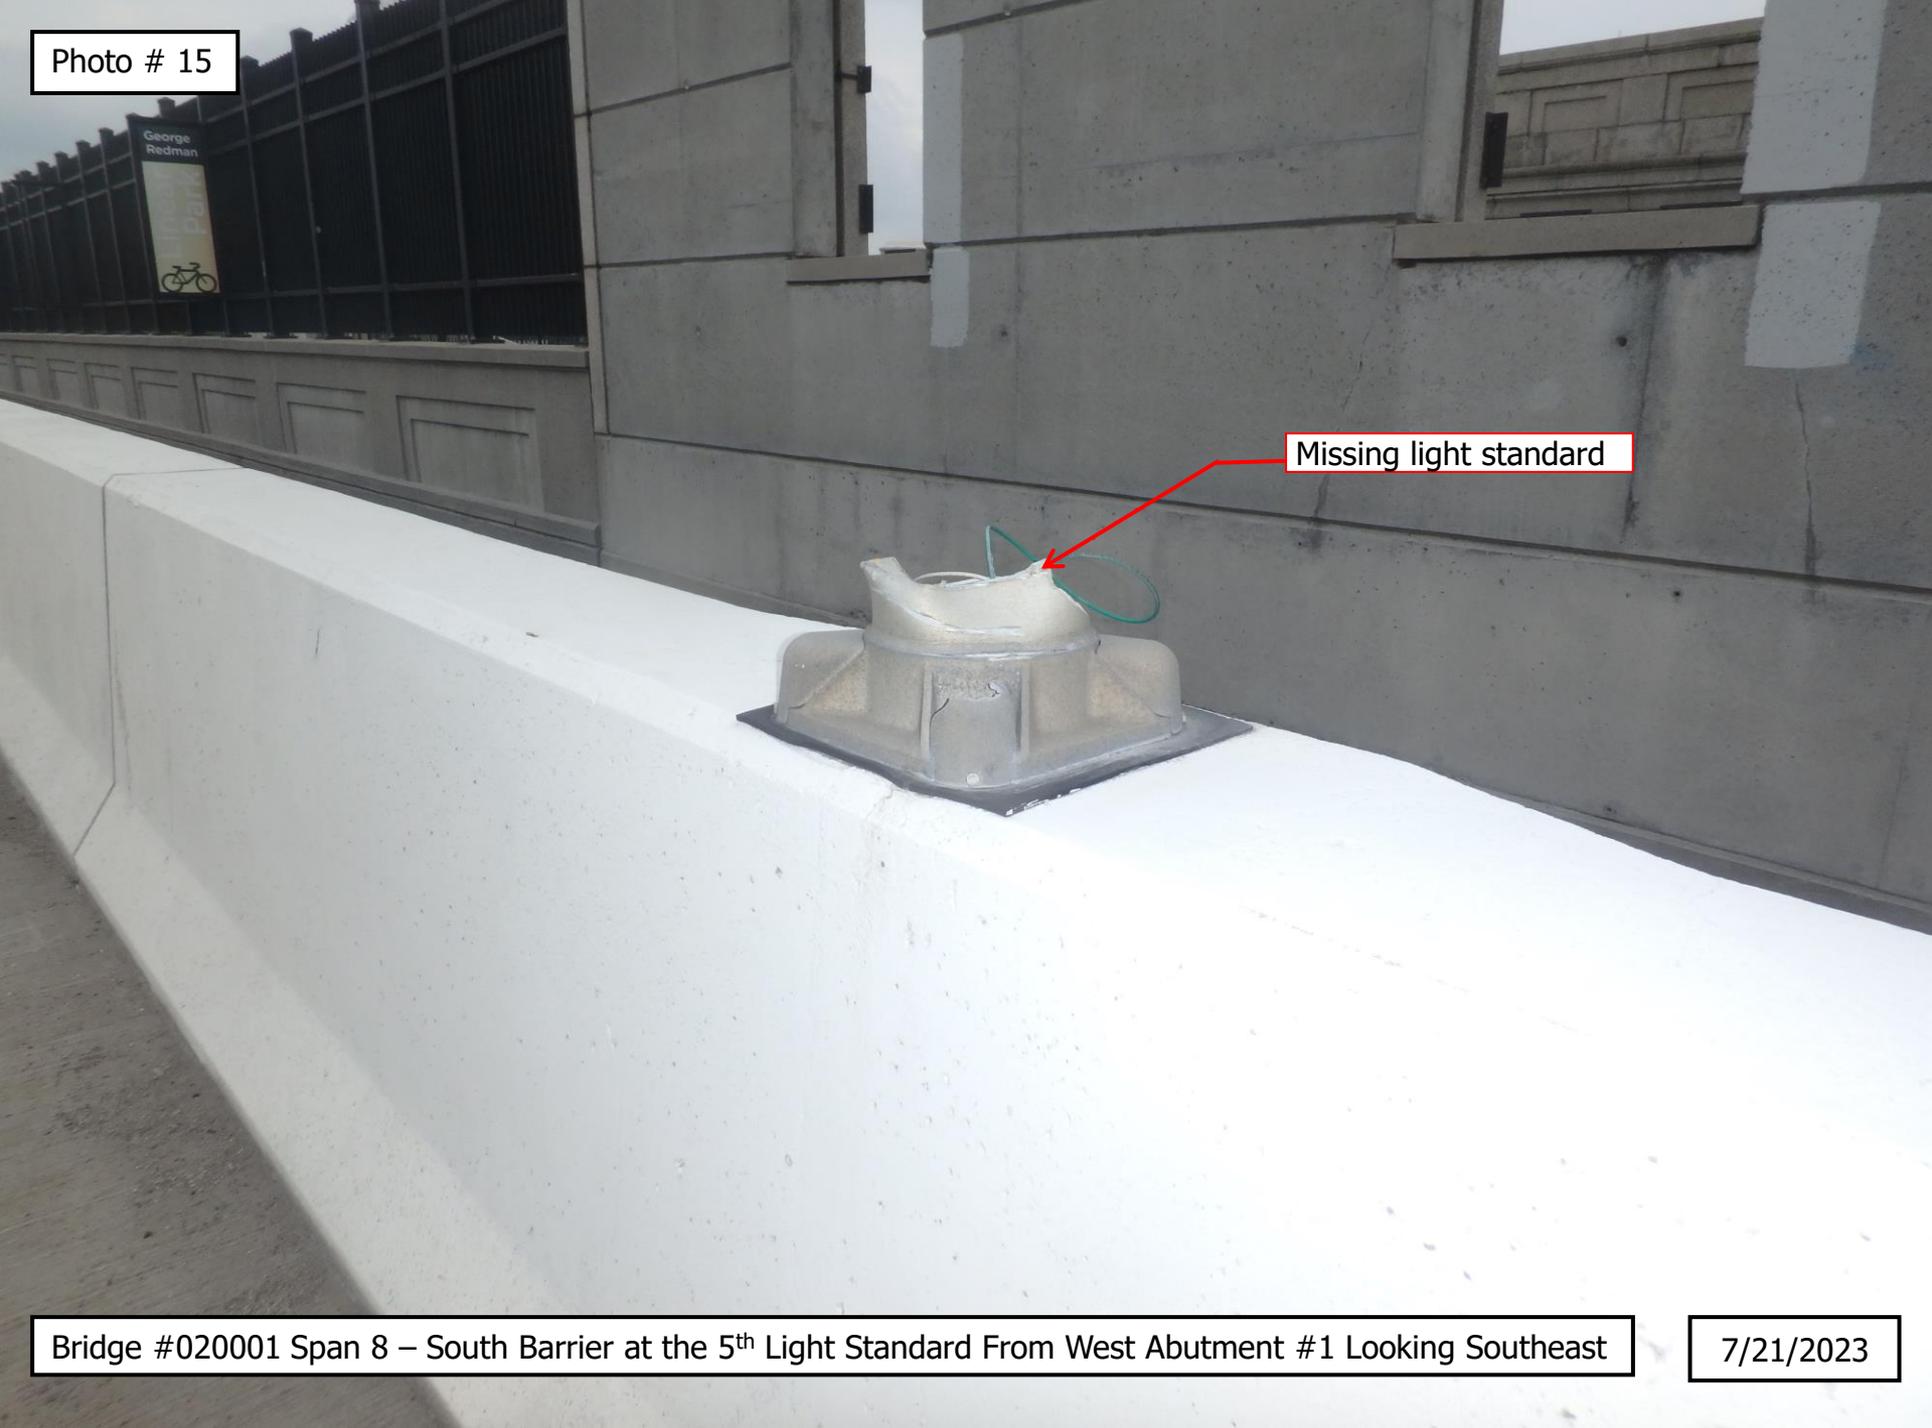
Missing light standard

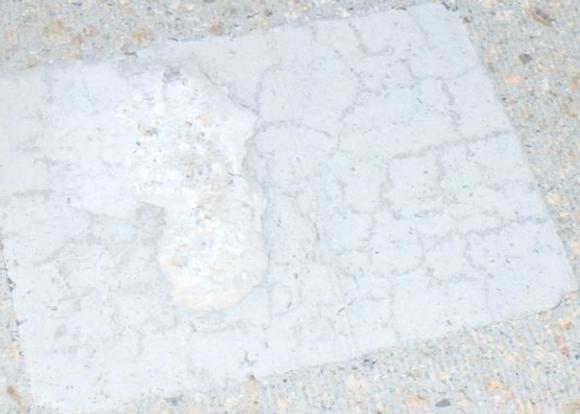
Bridge #020001 Top of Deck in Span 11 – Left Travel Lane Looking East

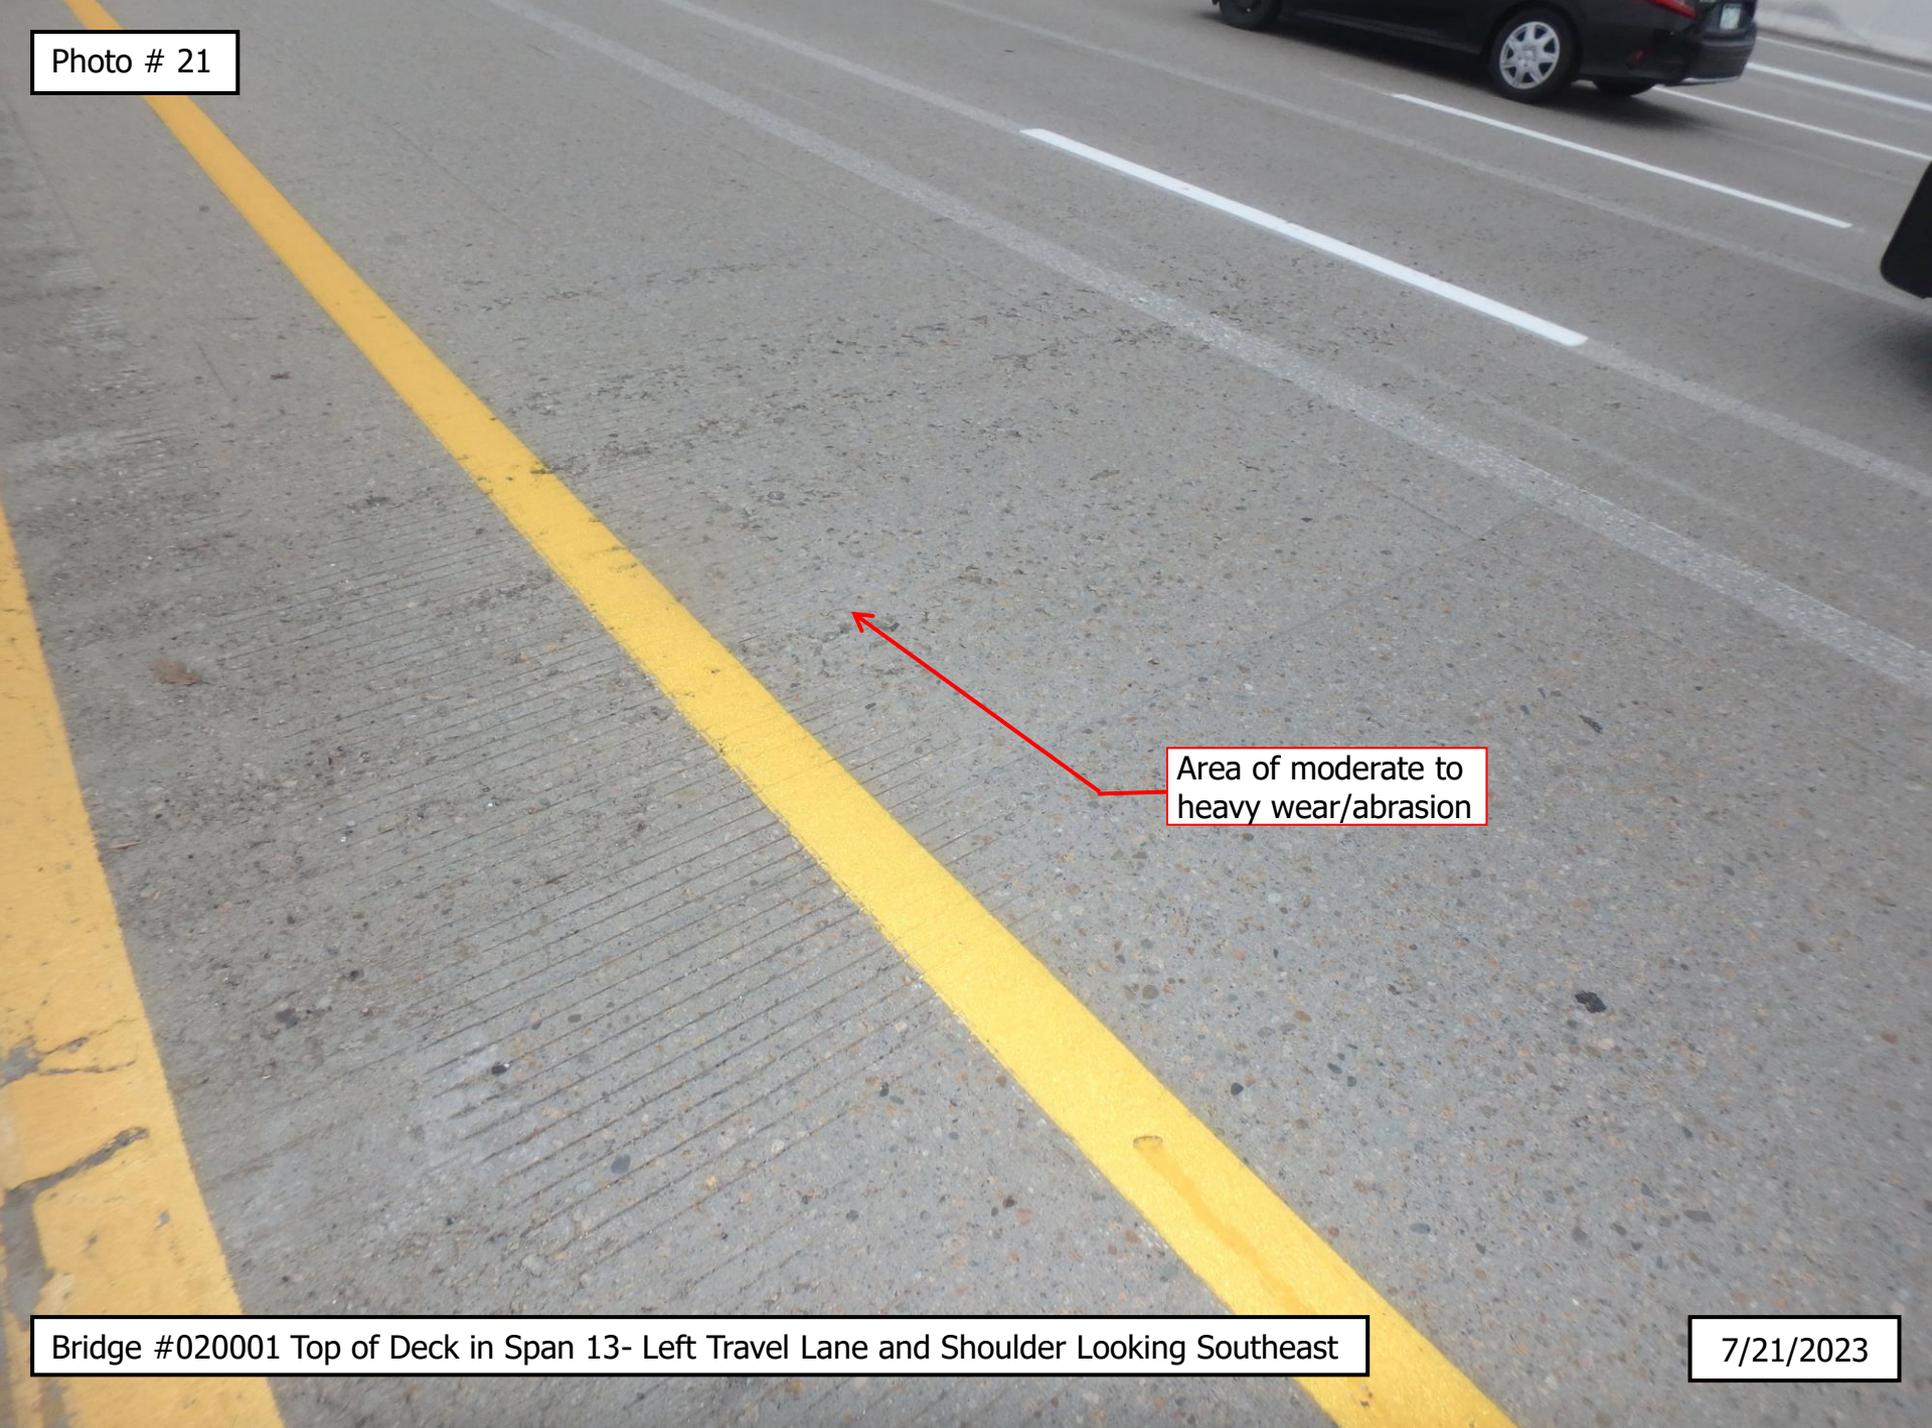
Area of moderate to heavy wear/abrasion

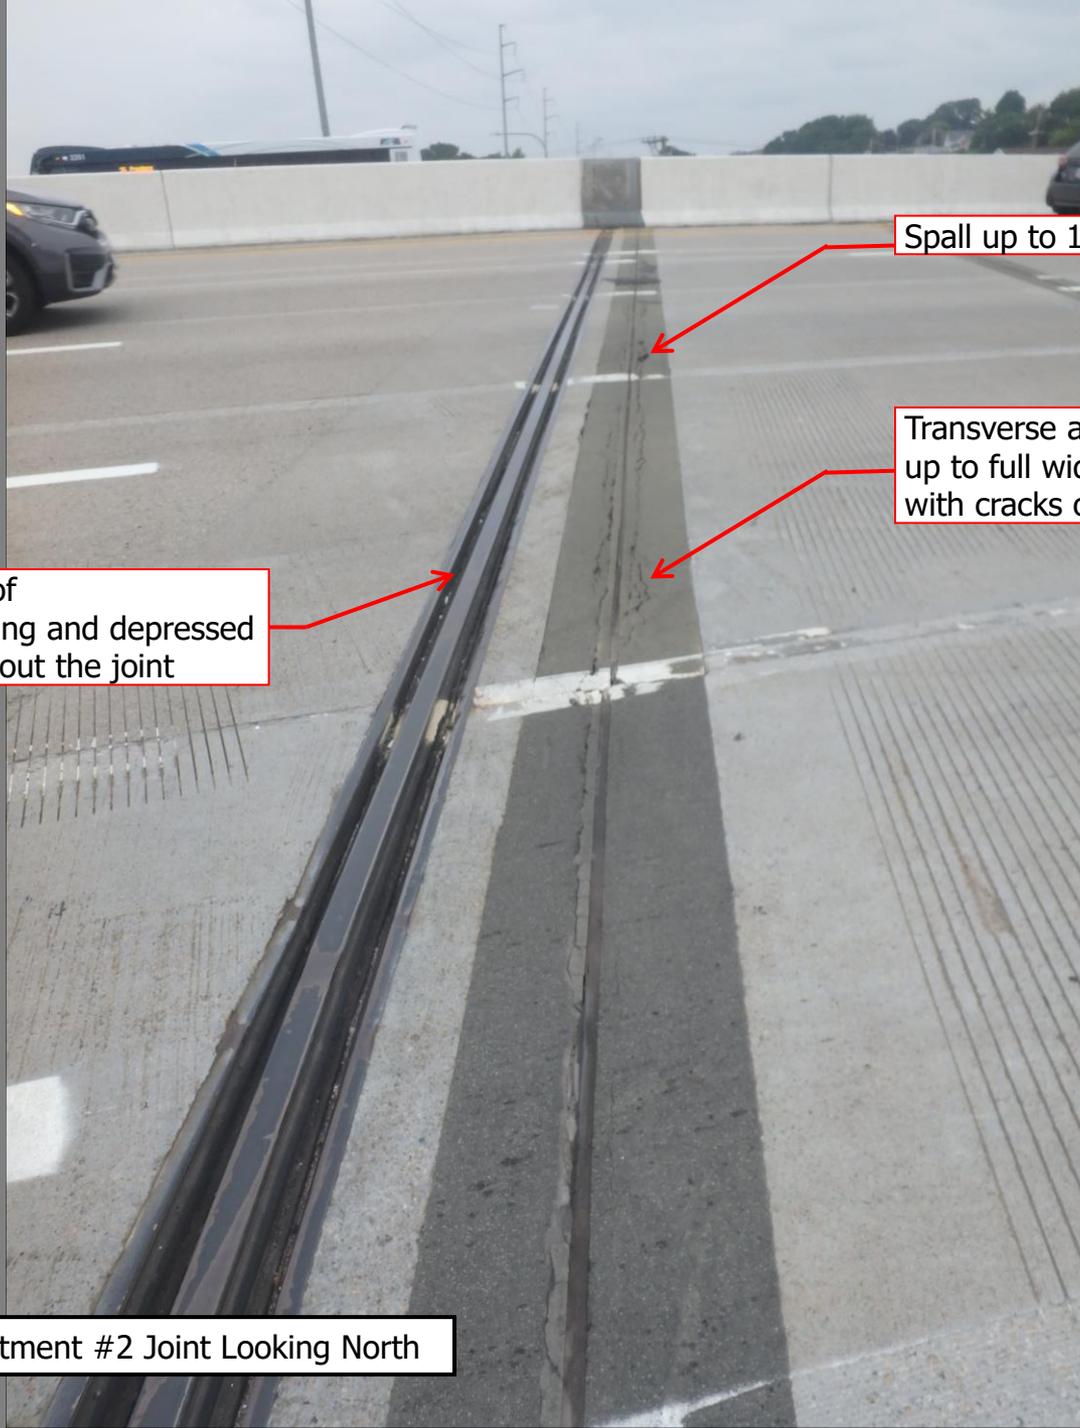
Widespread locations of ripped/damaged, missing and depressed neoprene seal throughout the joint

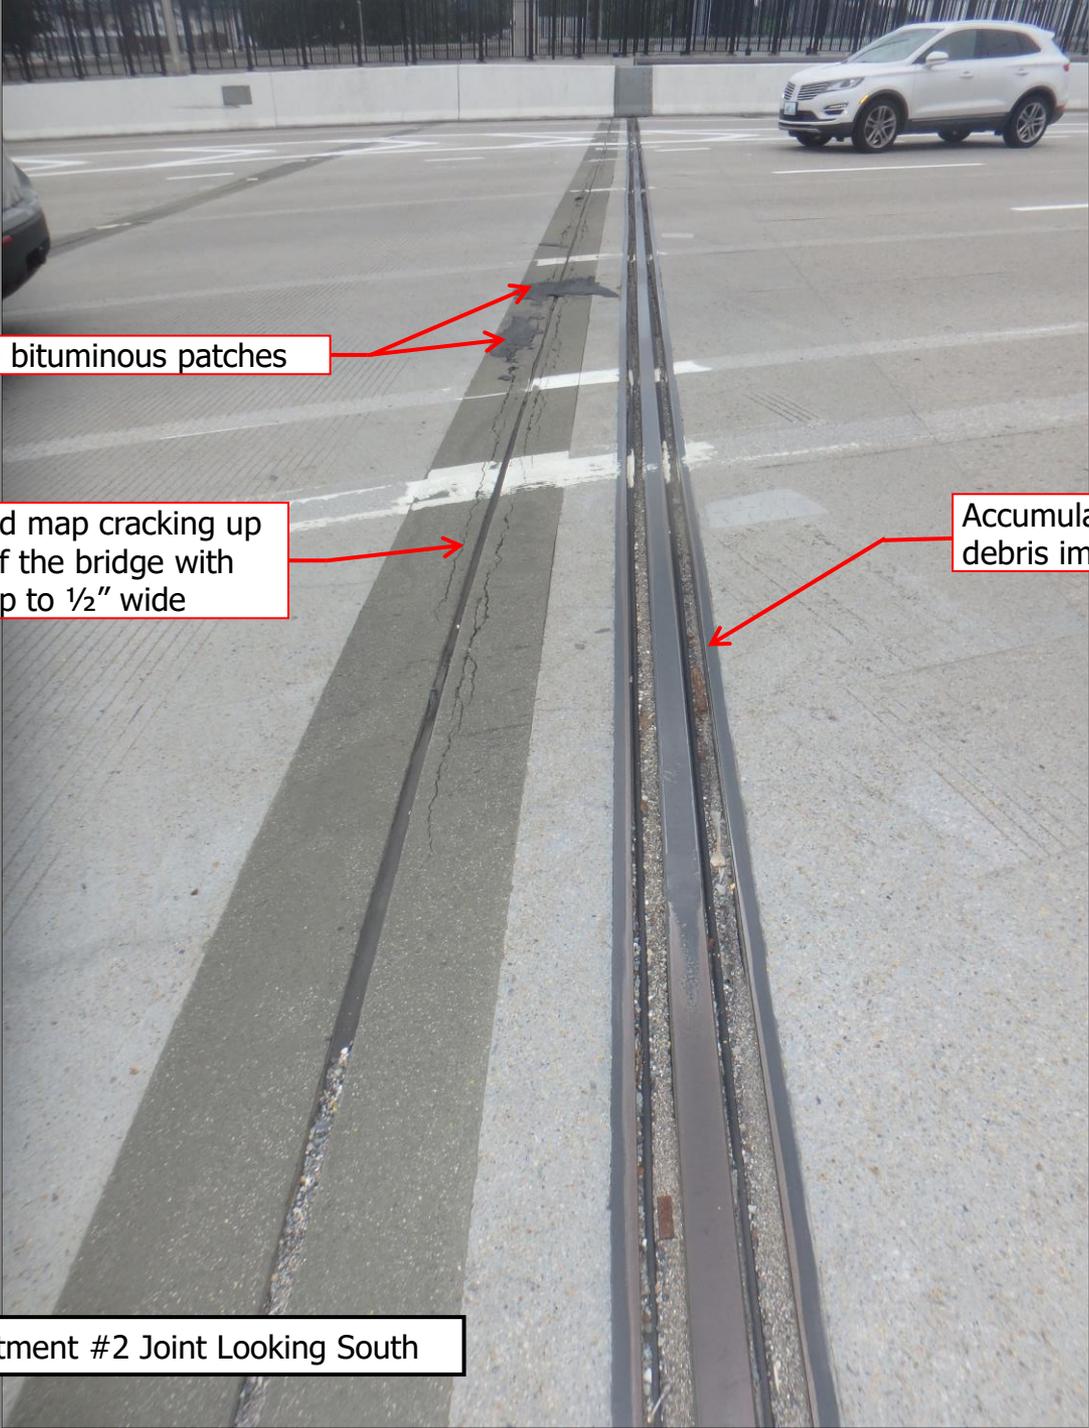
Two (2) bituminous patches

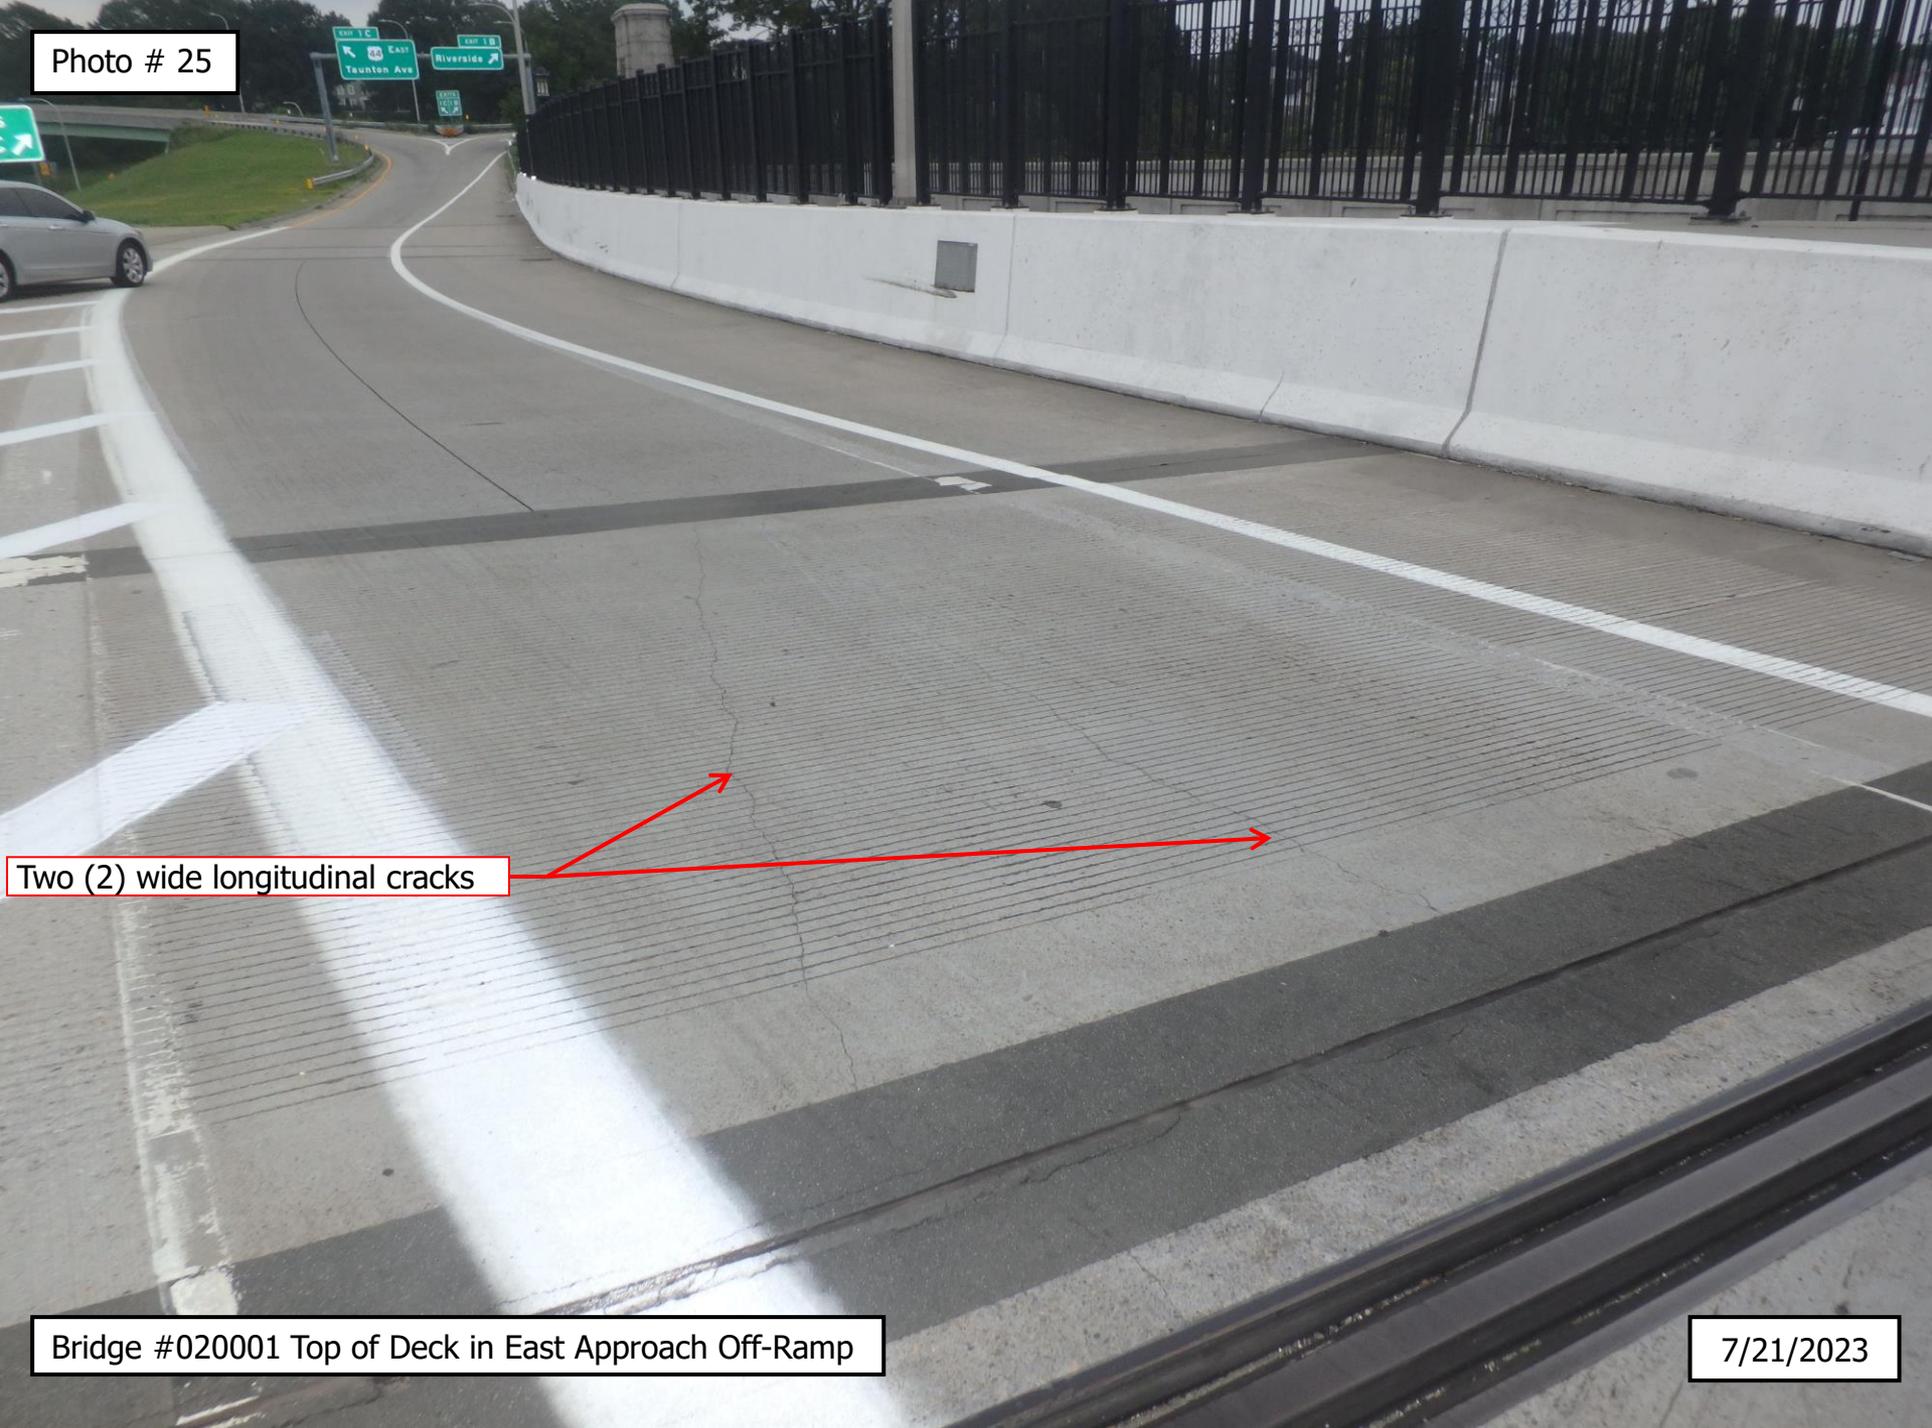
Two (2) wide longitudinal cracks

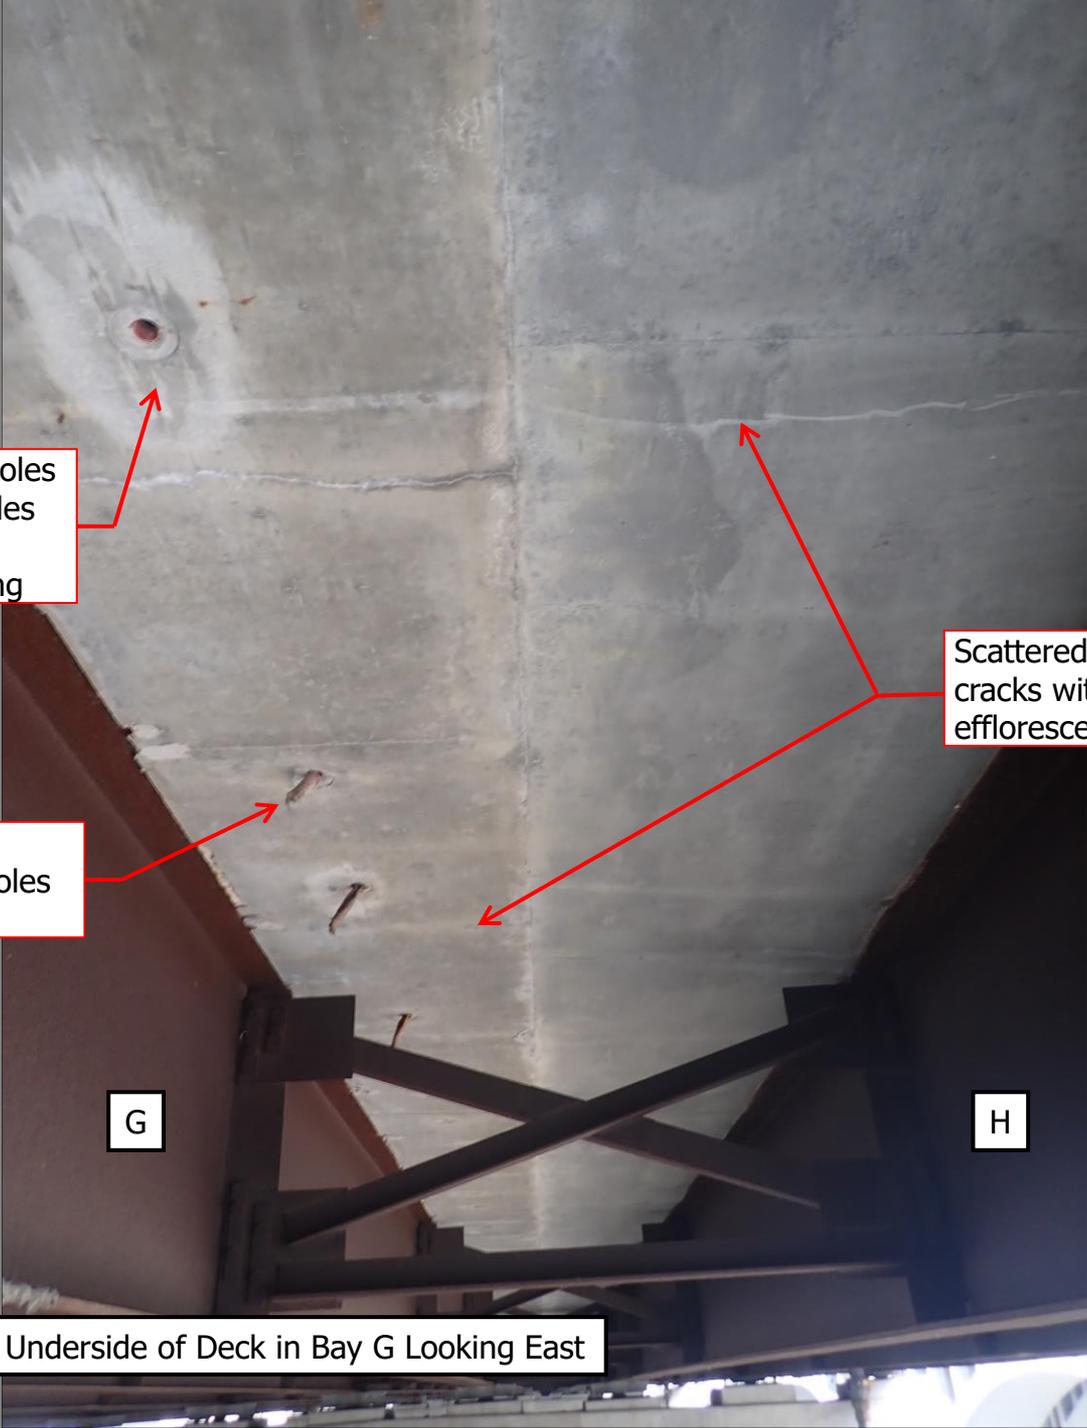
Evenly spaced anchor bolt holes throughout Bay G. Some holes were filled others were not. Some exhibit leakage staining
