Minor to moderate wheel line rutting with areas of cracking throughout

Separation crack with potholes has been patched since the previous inspection

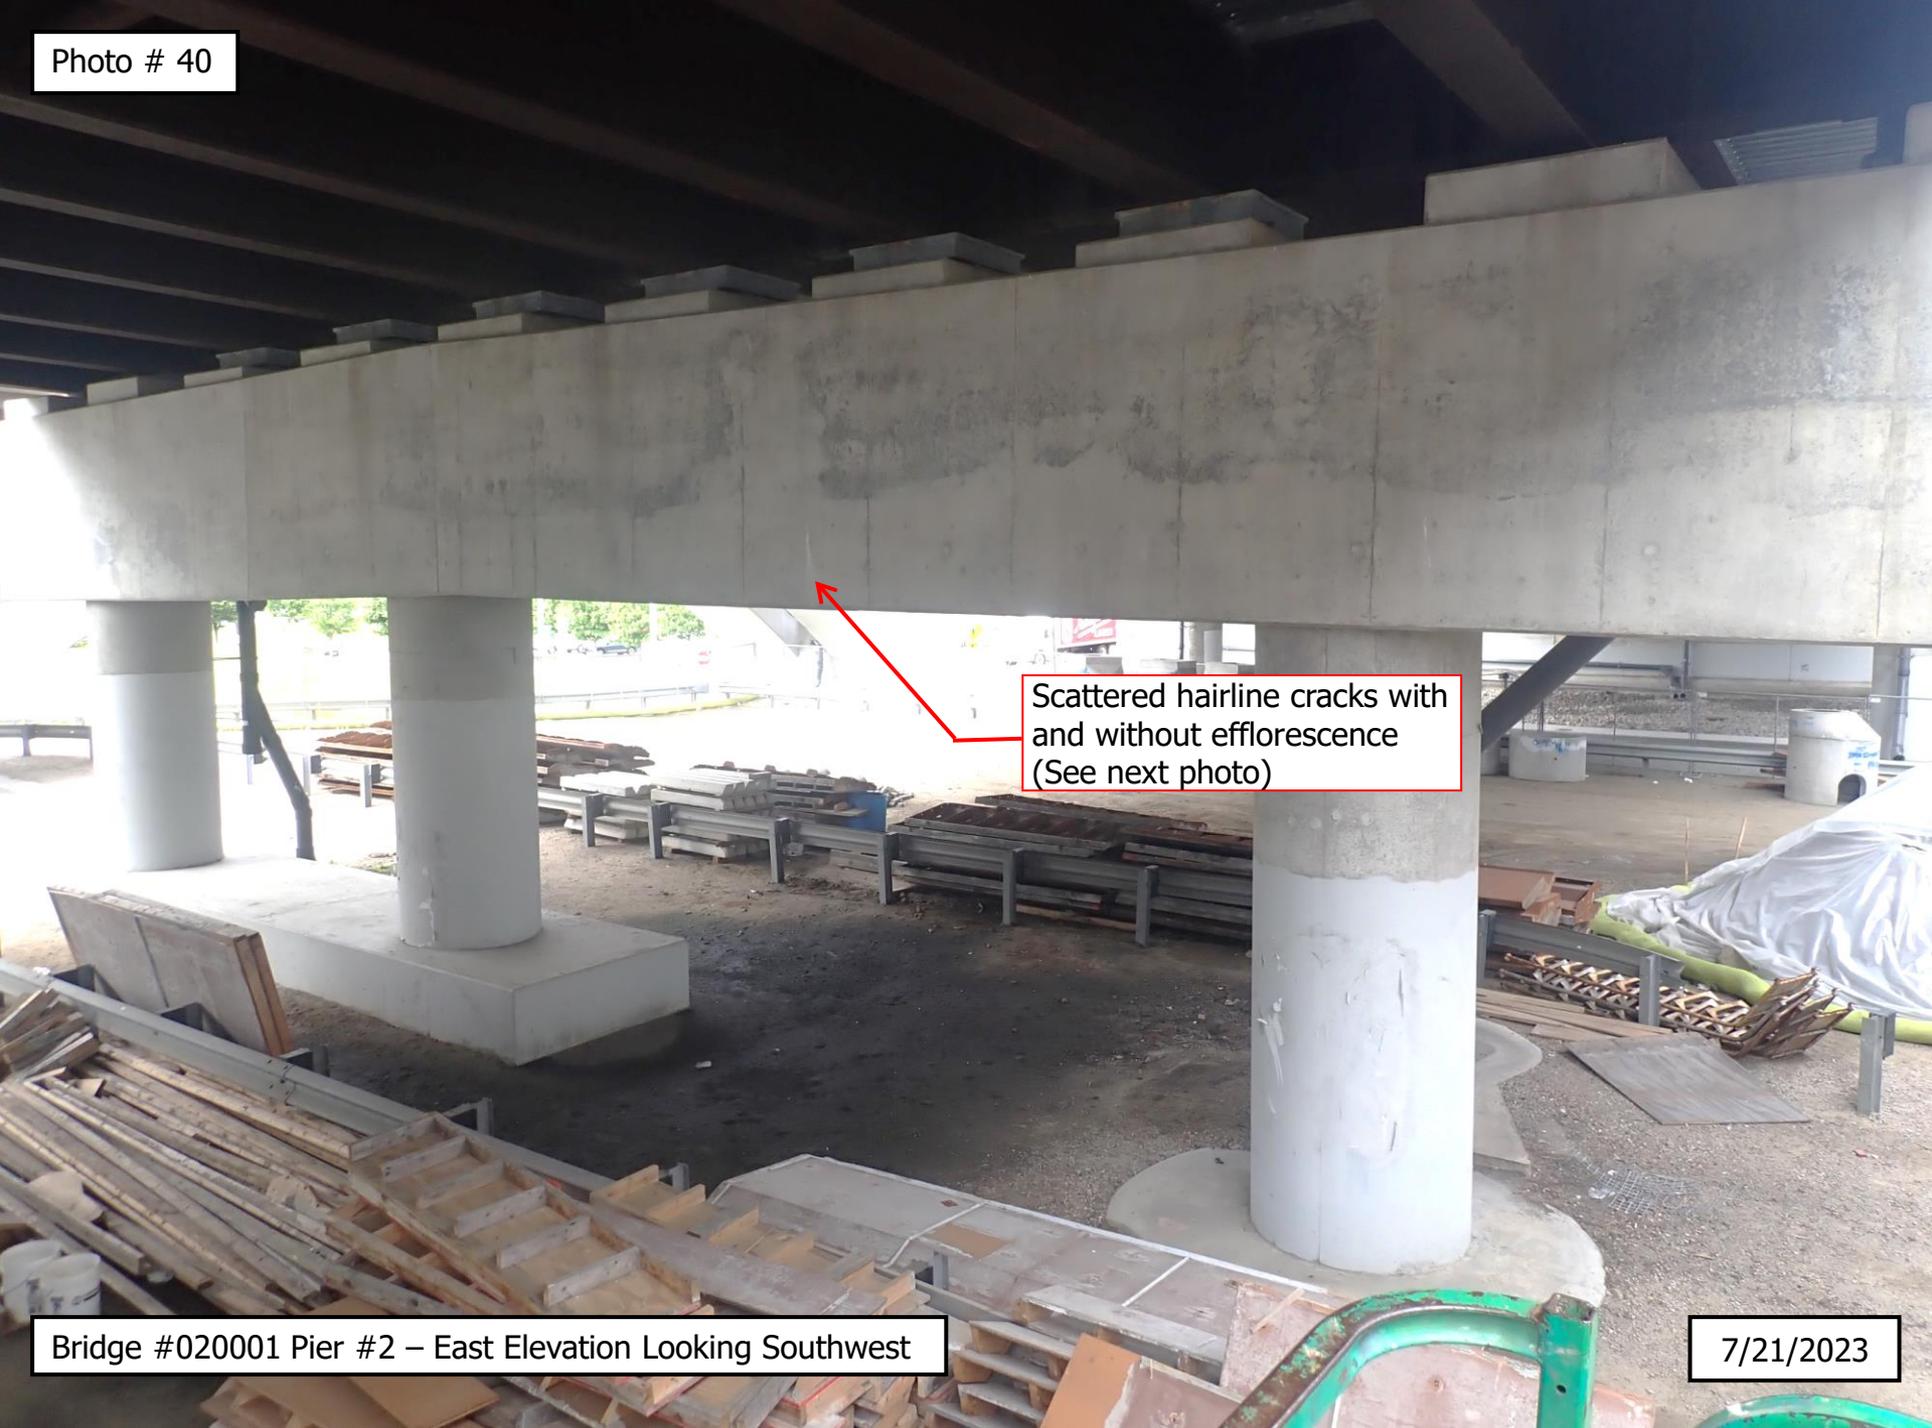
Scattered hairline cracks with
and without efflorescence
(See next photo)

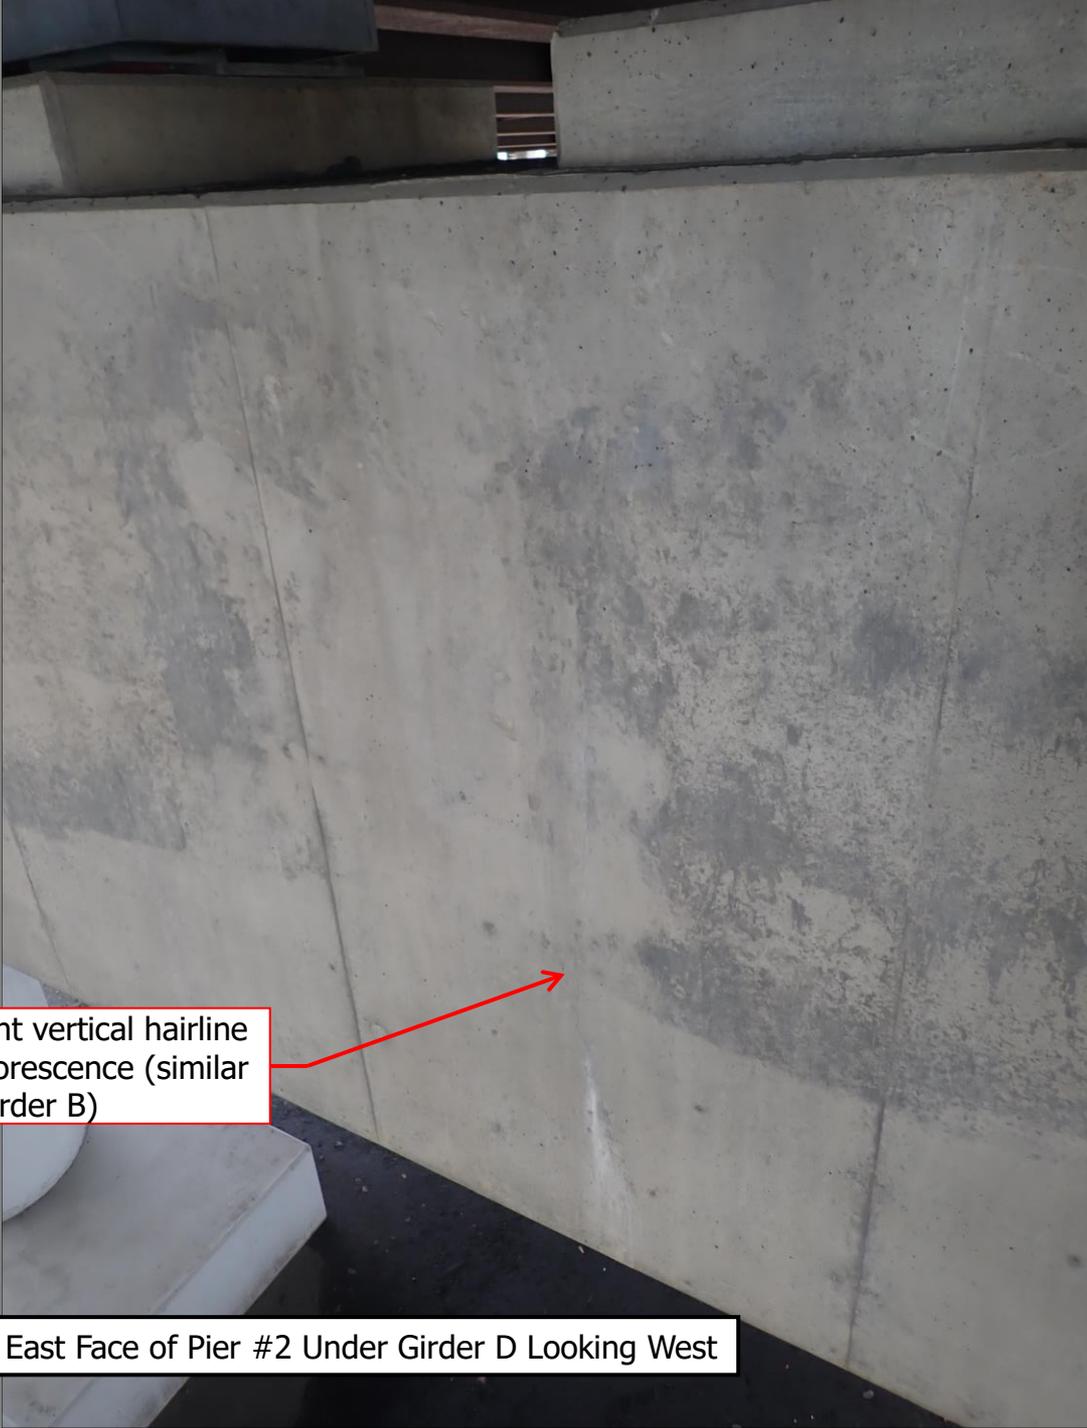
A photograph of a concrete pier showing a vertical crack with efflorescence. A red arrow points from the text box to the crack.

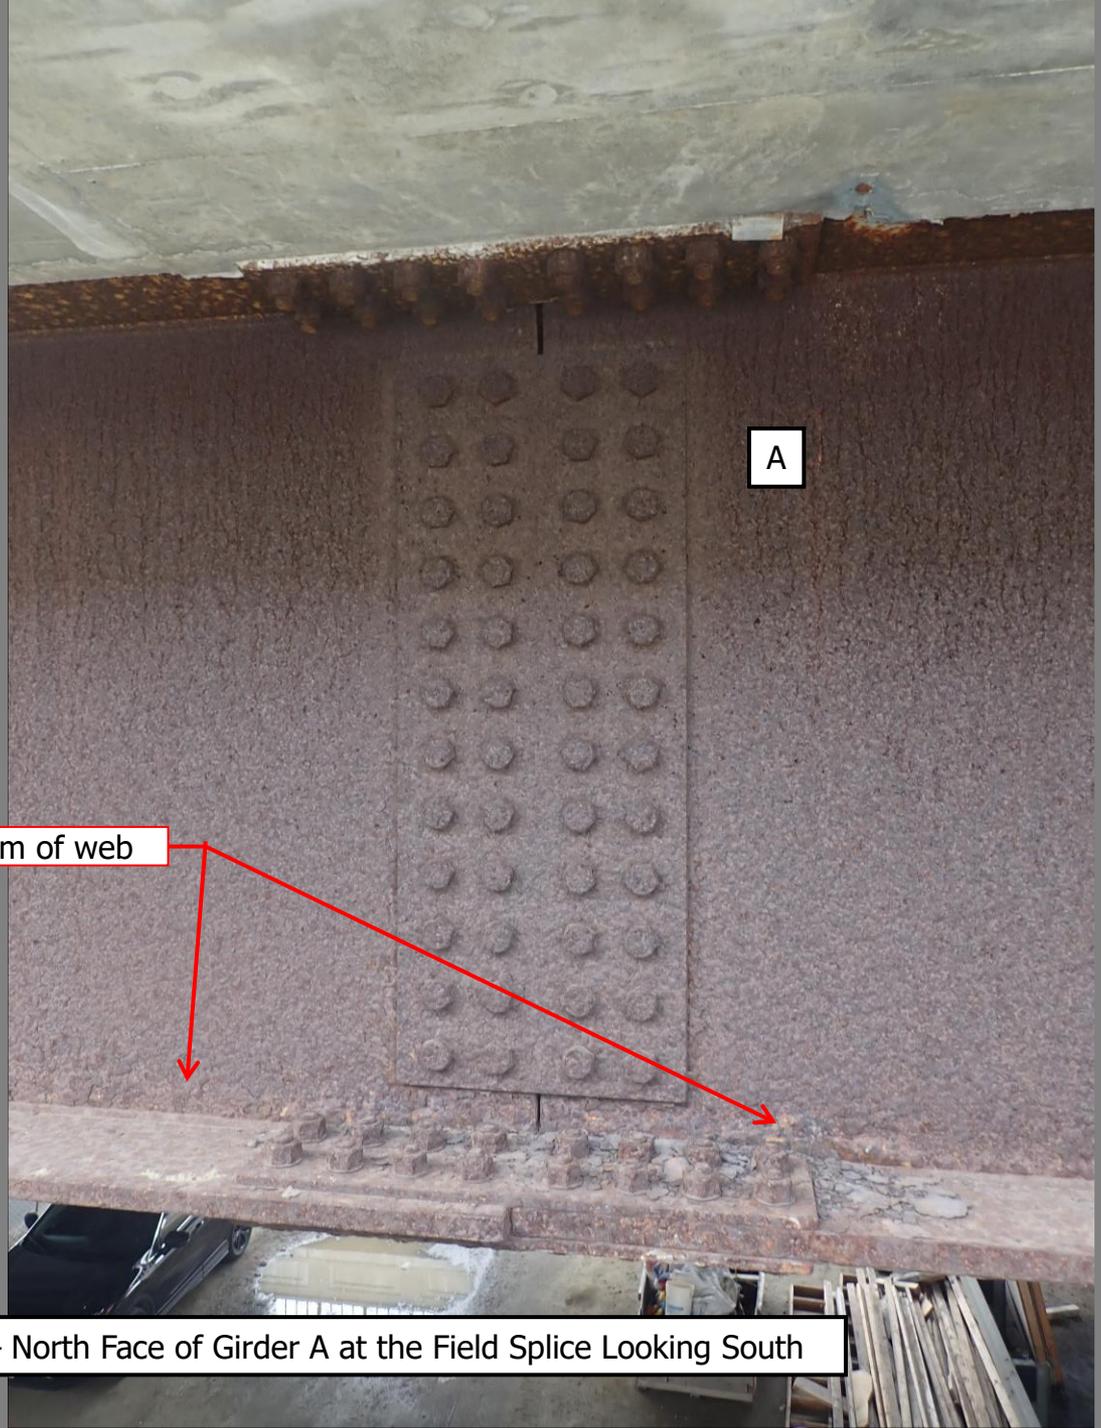
Laminar rust on bottom of web

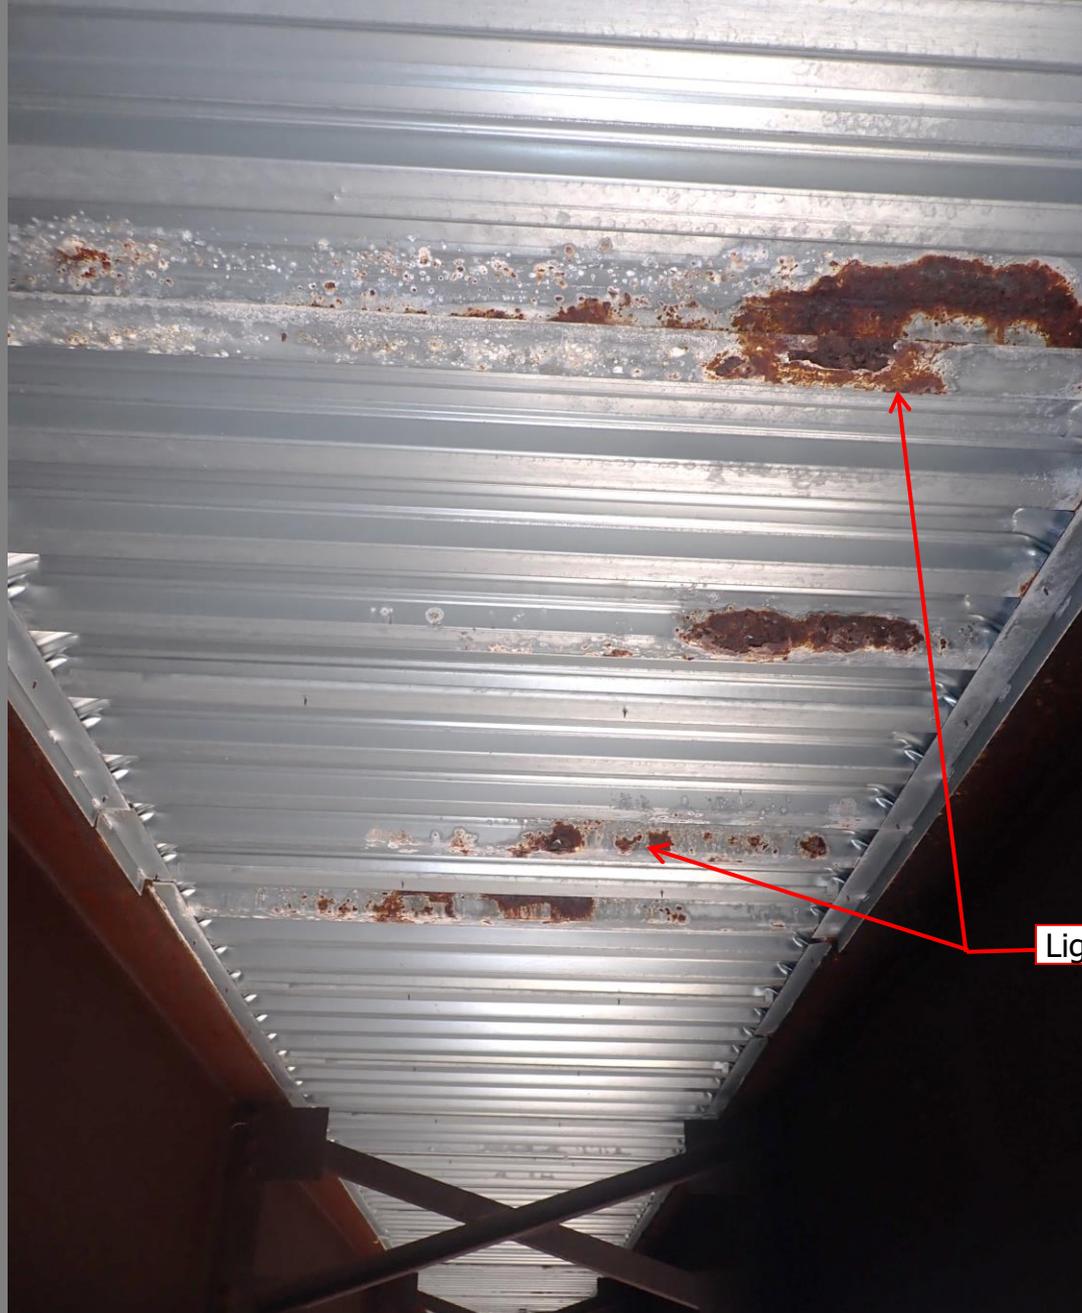
Light to heavy rust/corrosion

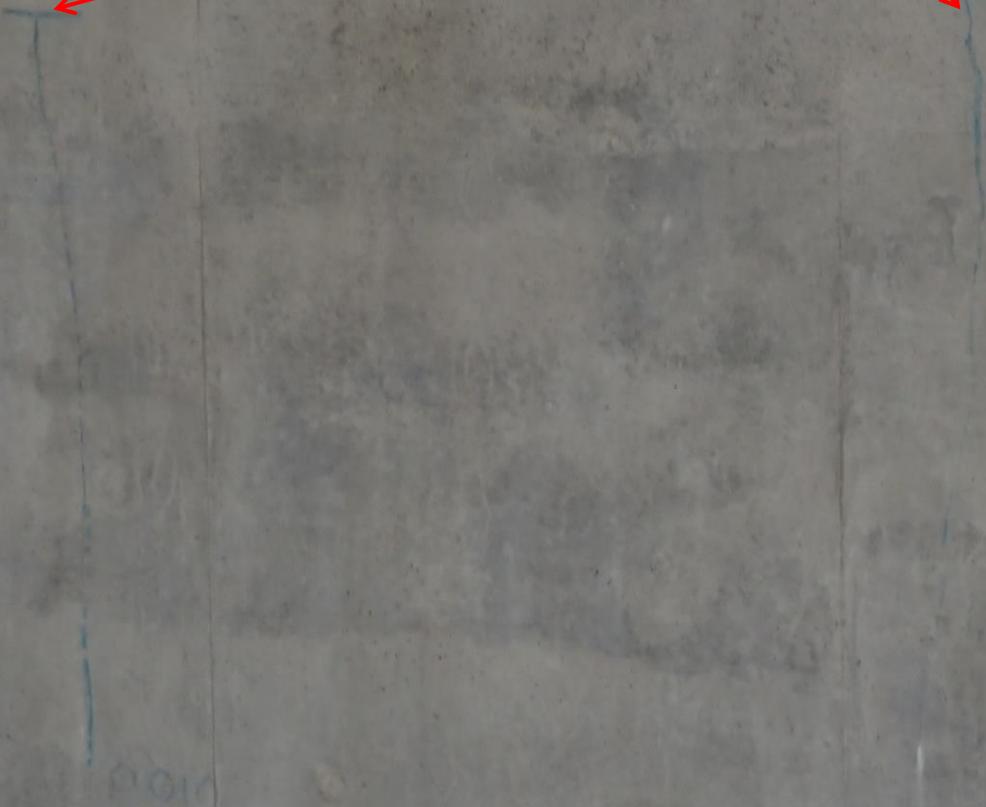
Bridge #020001 Span 3 – West Face of Pier #3 Below Girders E and F Looking East

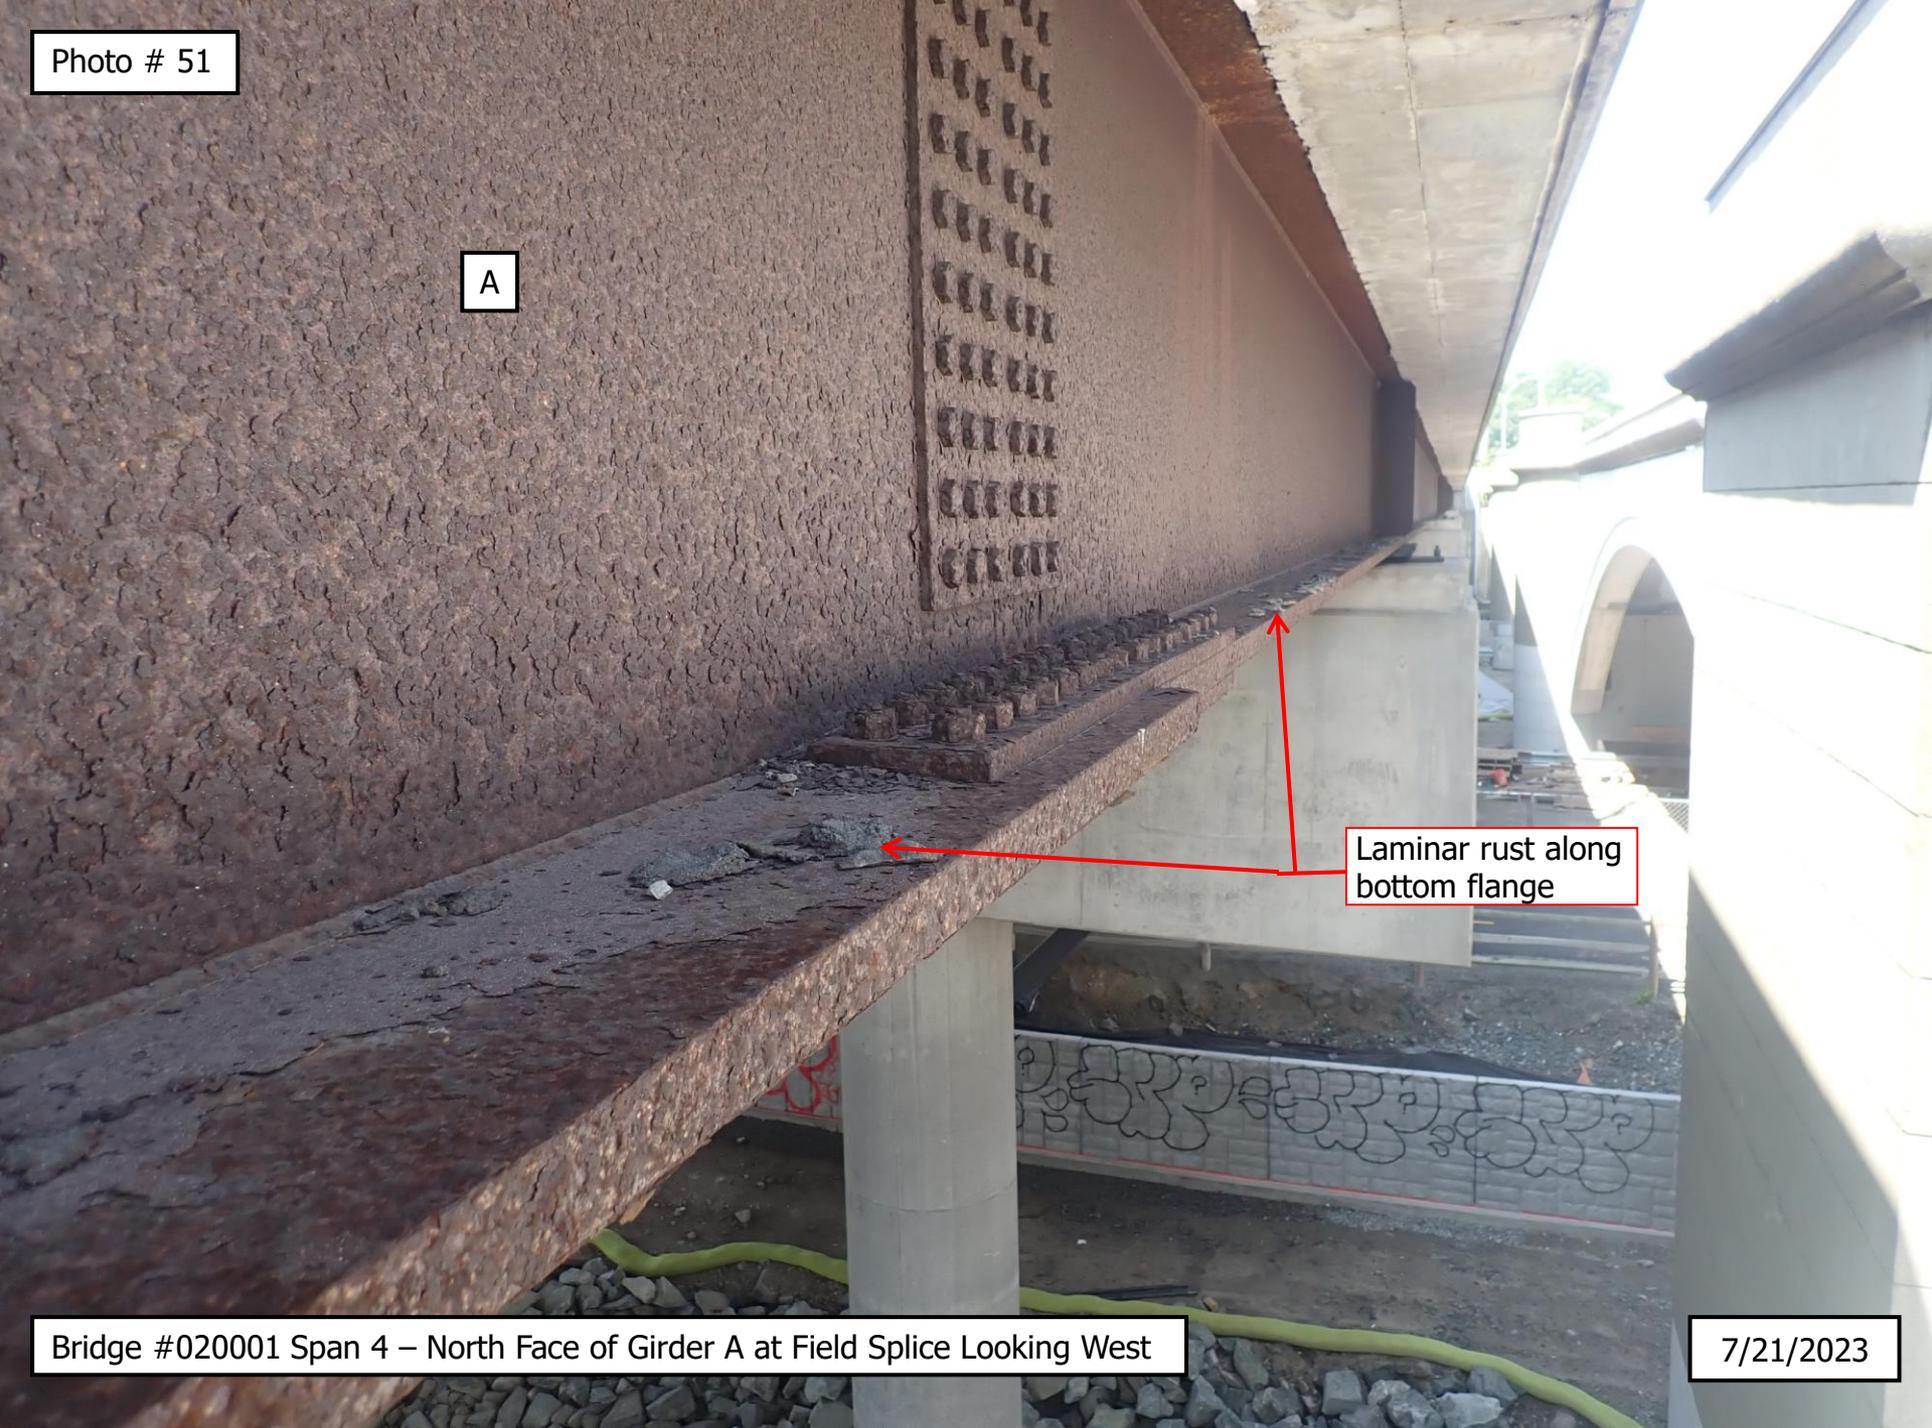
Laminar rust along bottom flange

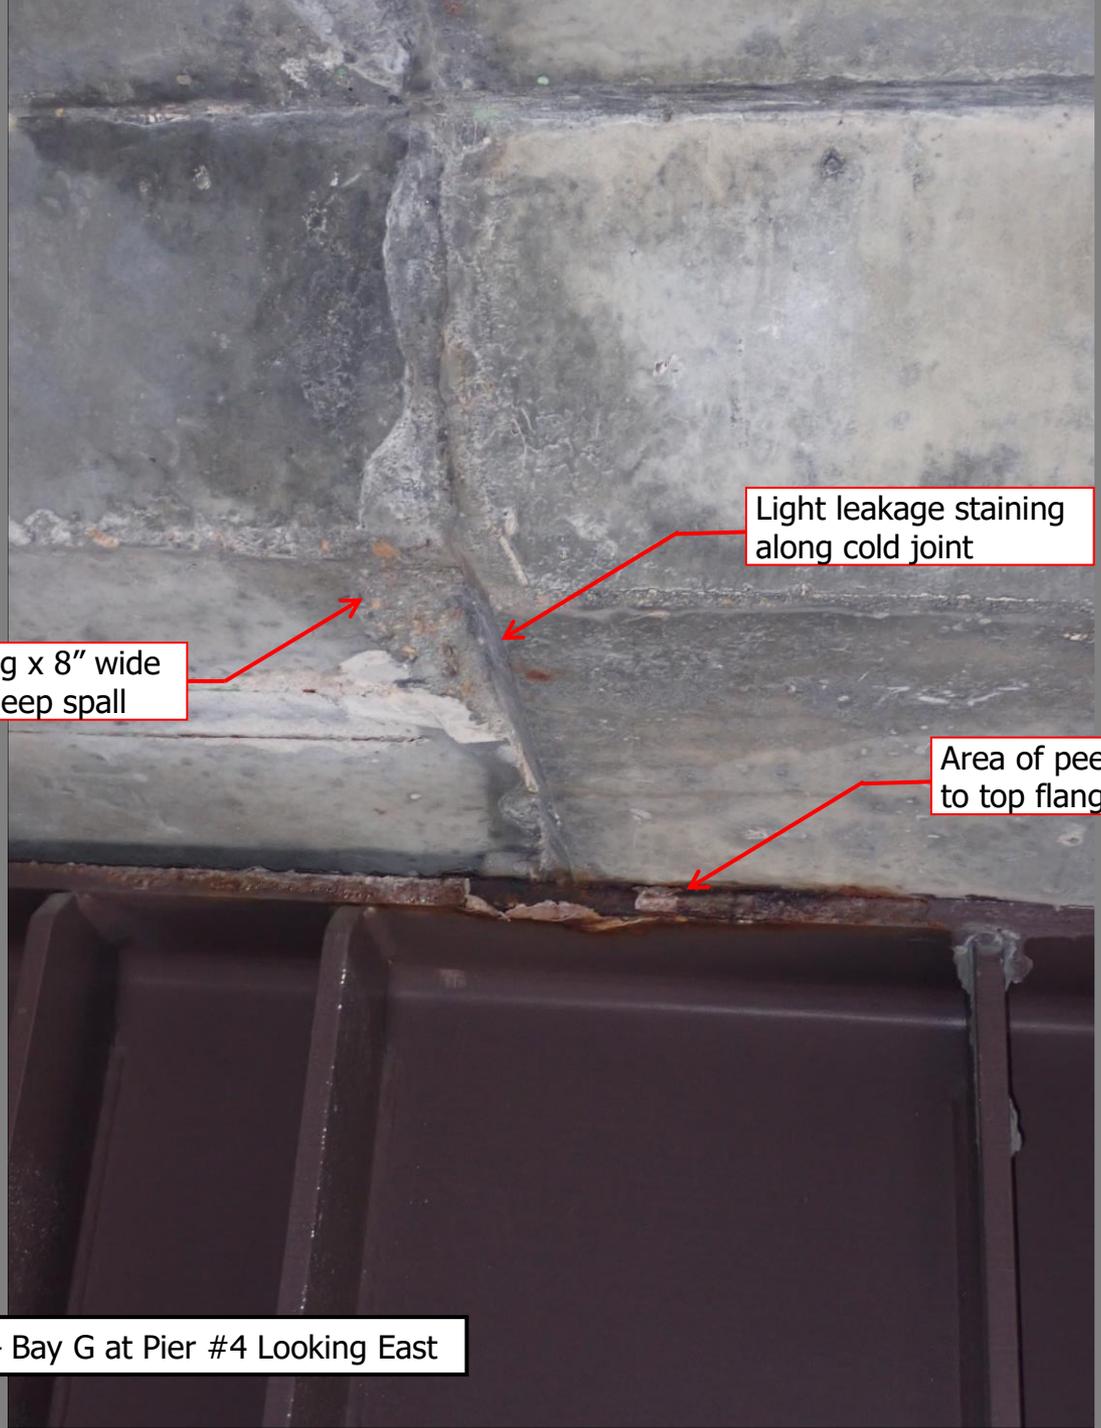
3" long x 8" wide
x 1" deep spall

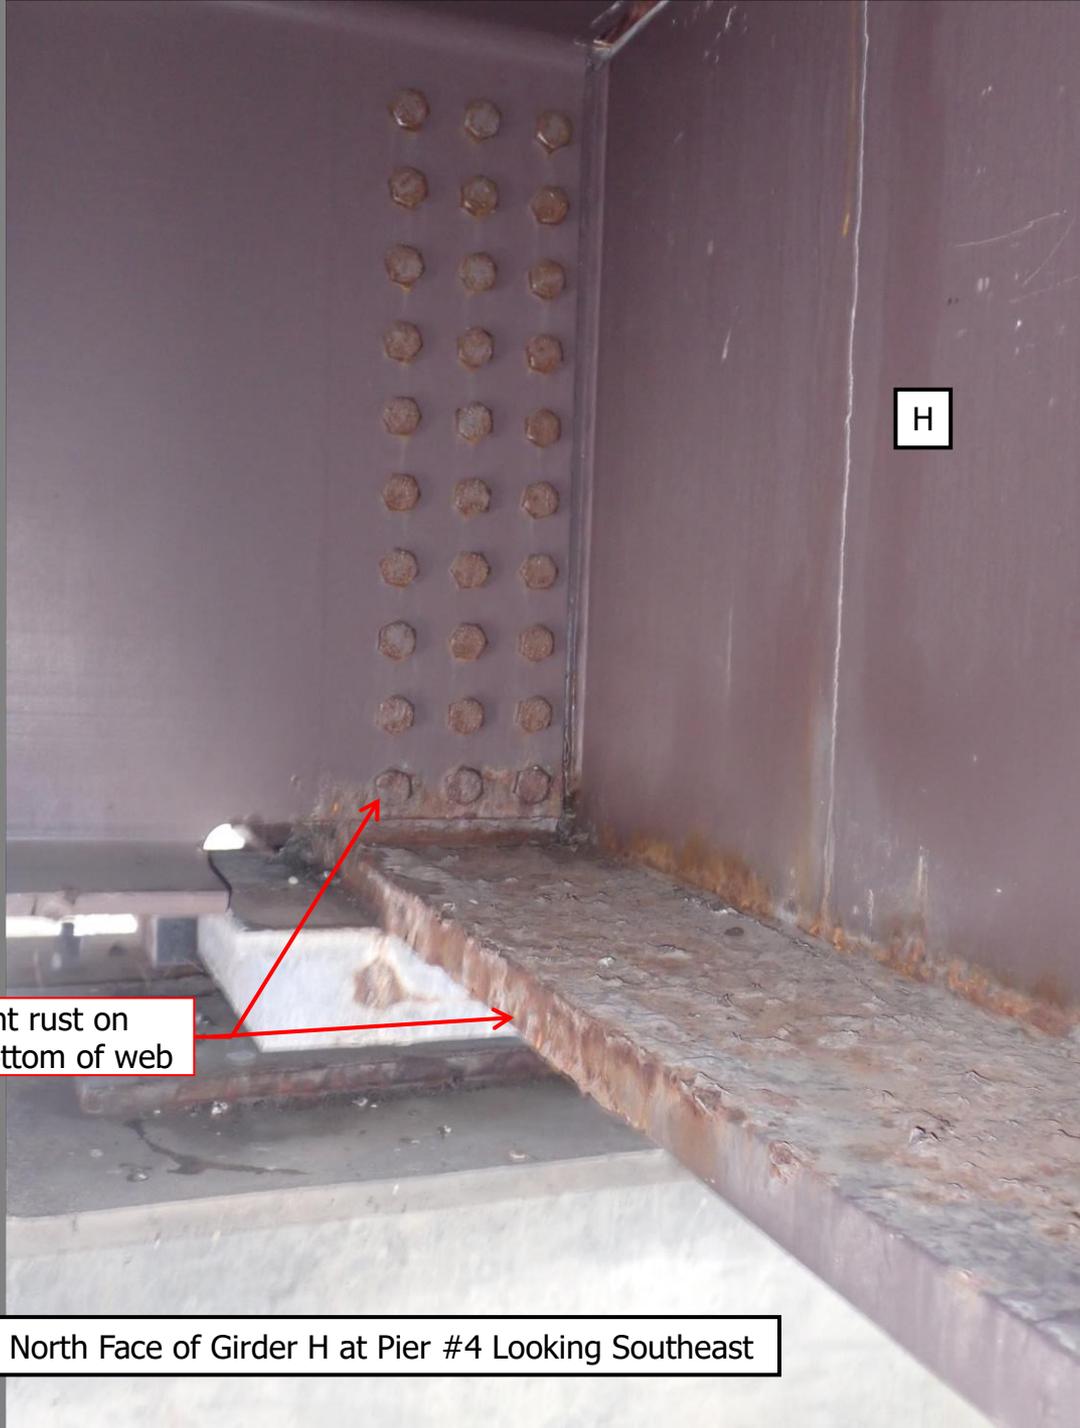
Peeling paint with light rust on
bottom flange and bottom of web

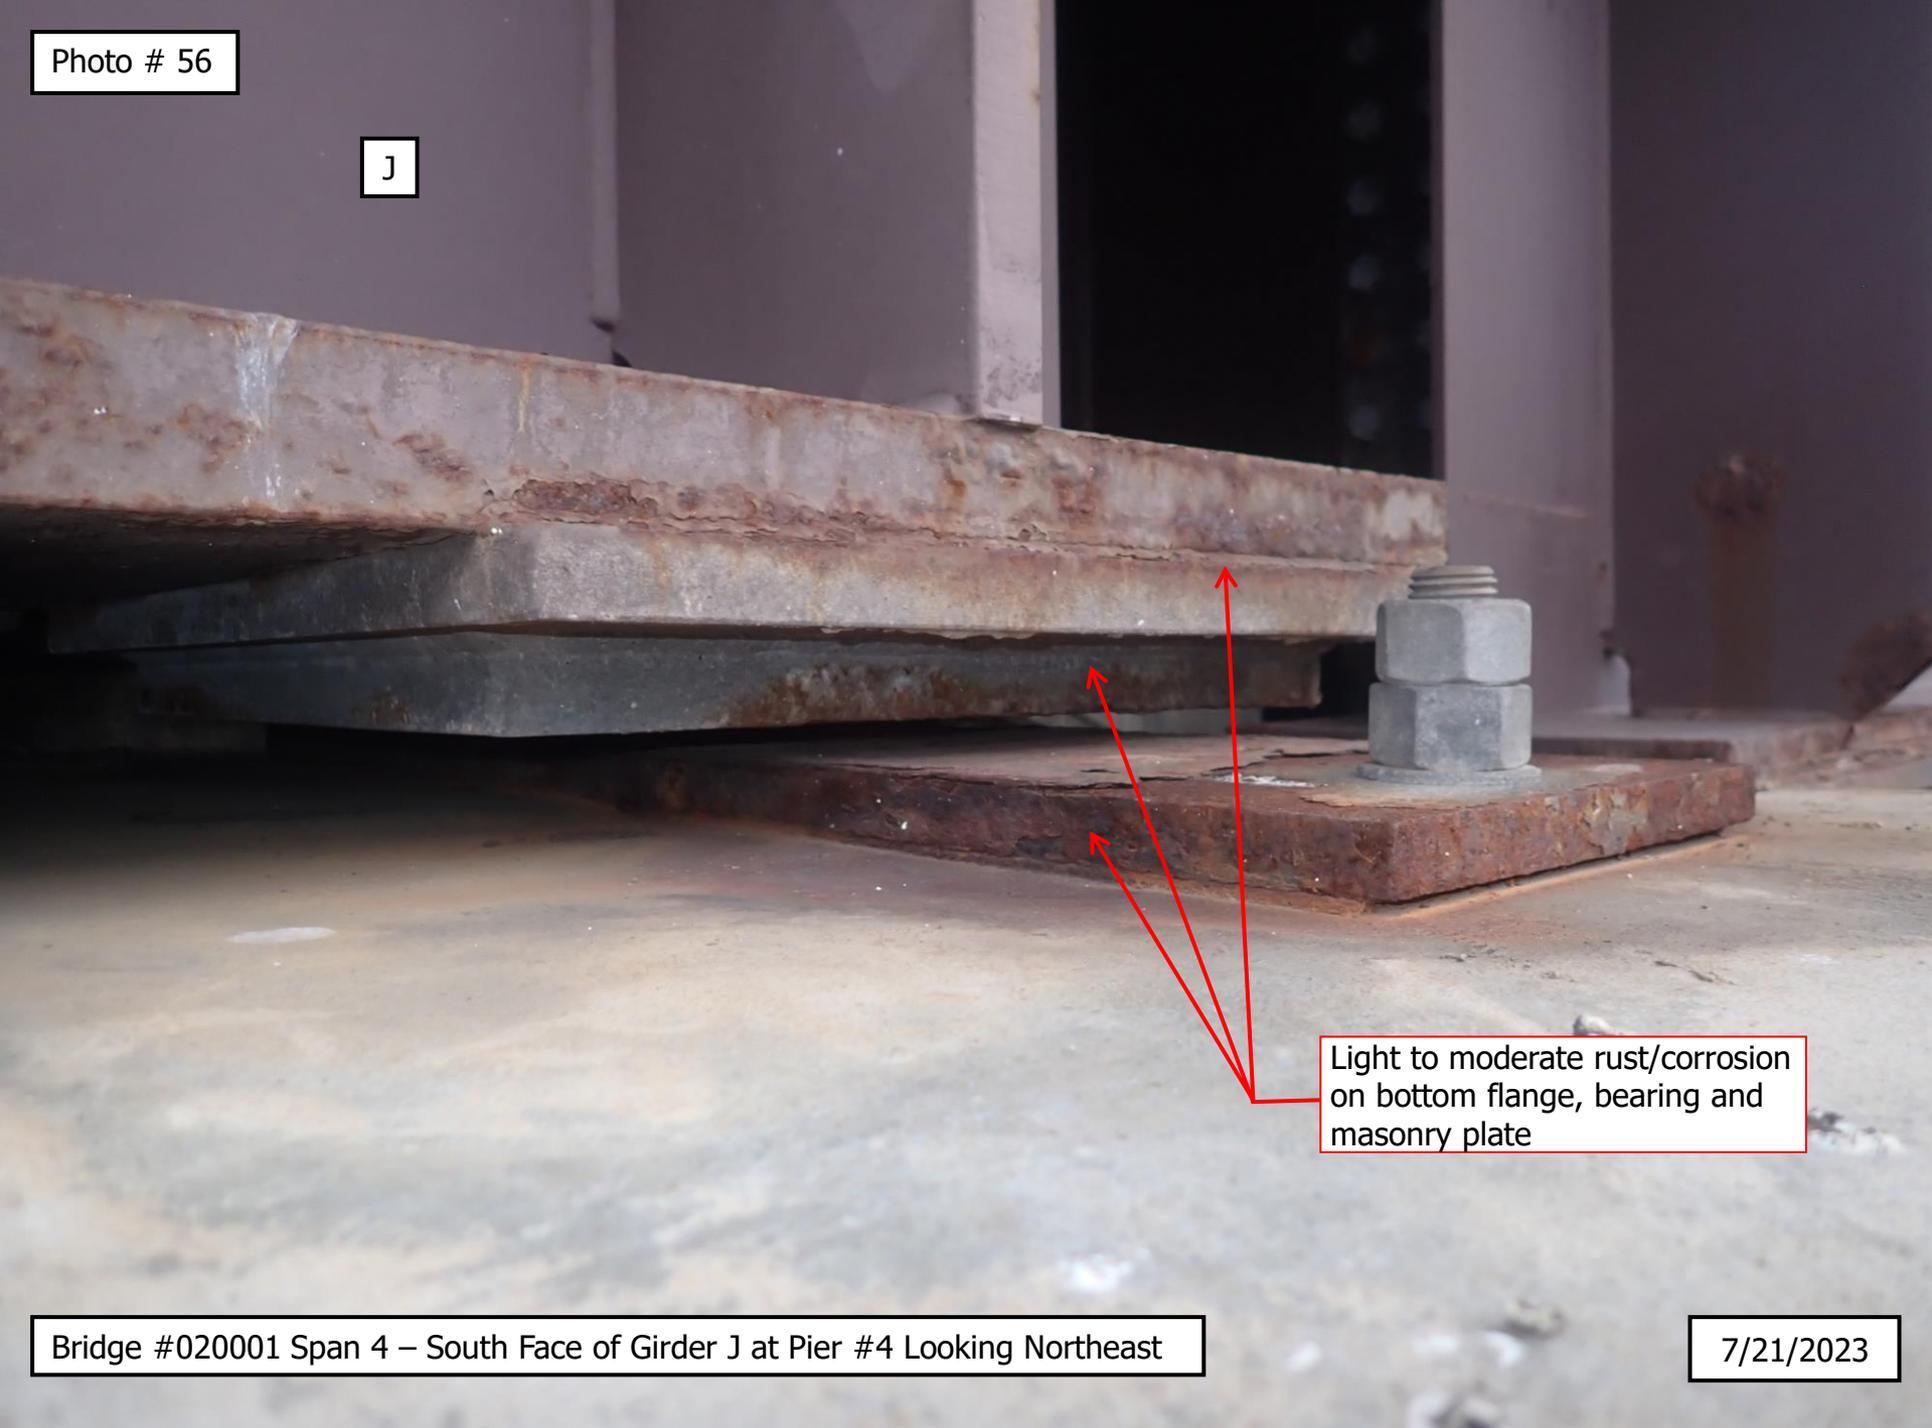
Light to moderate rust/corrosion
on bottom flange, bearing and
masonry plate

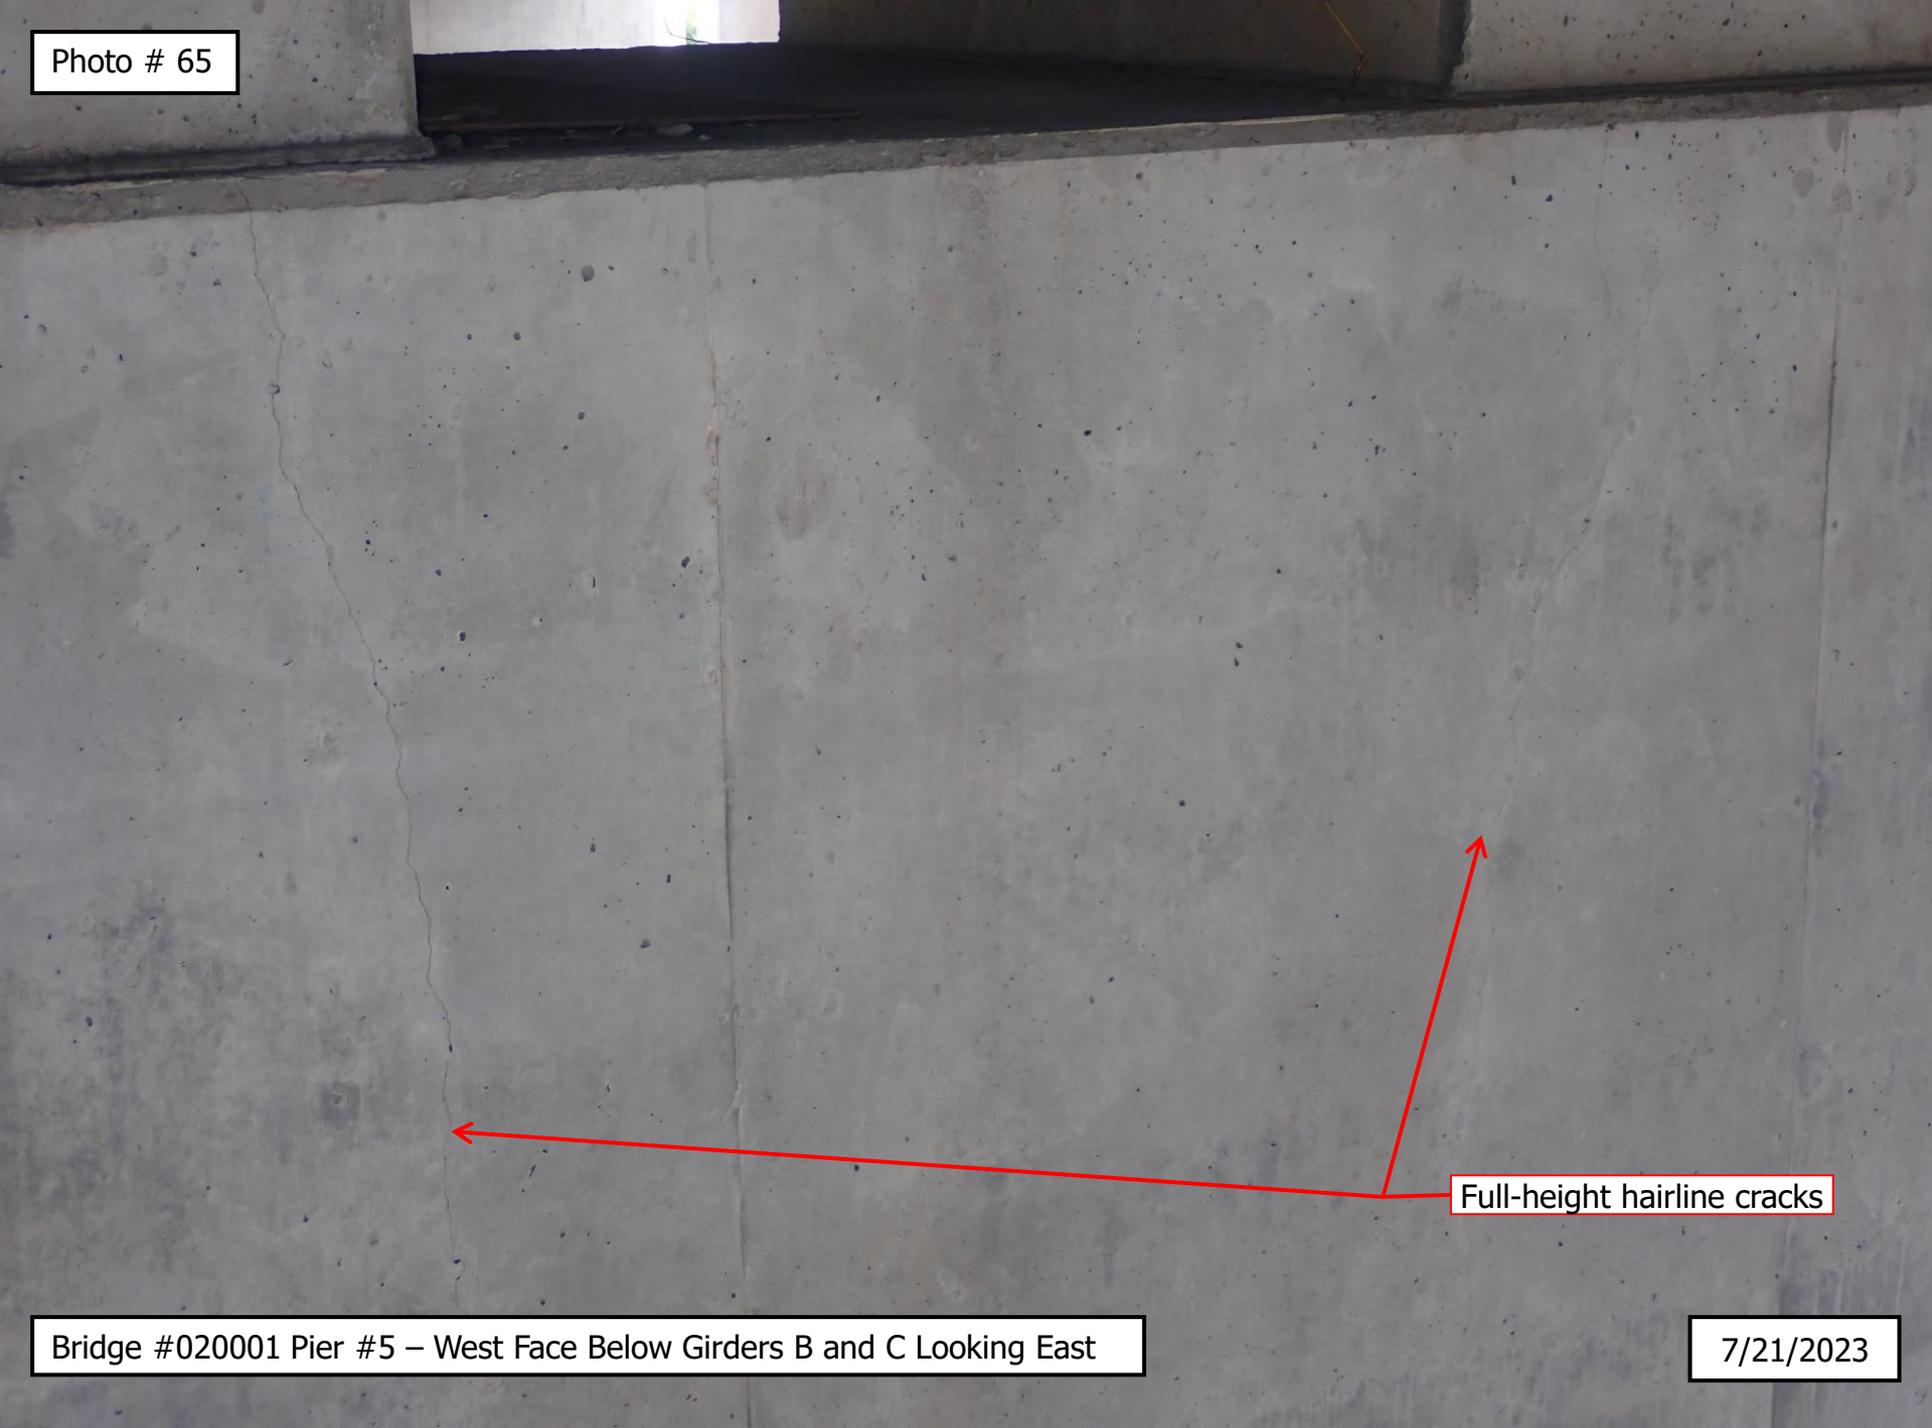
Full-height hairline cracks

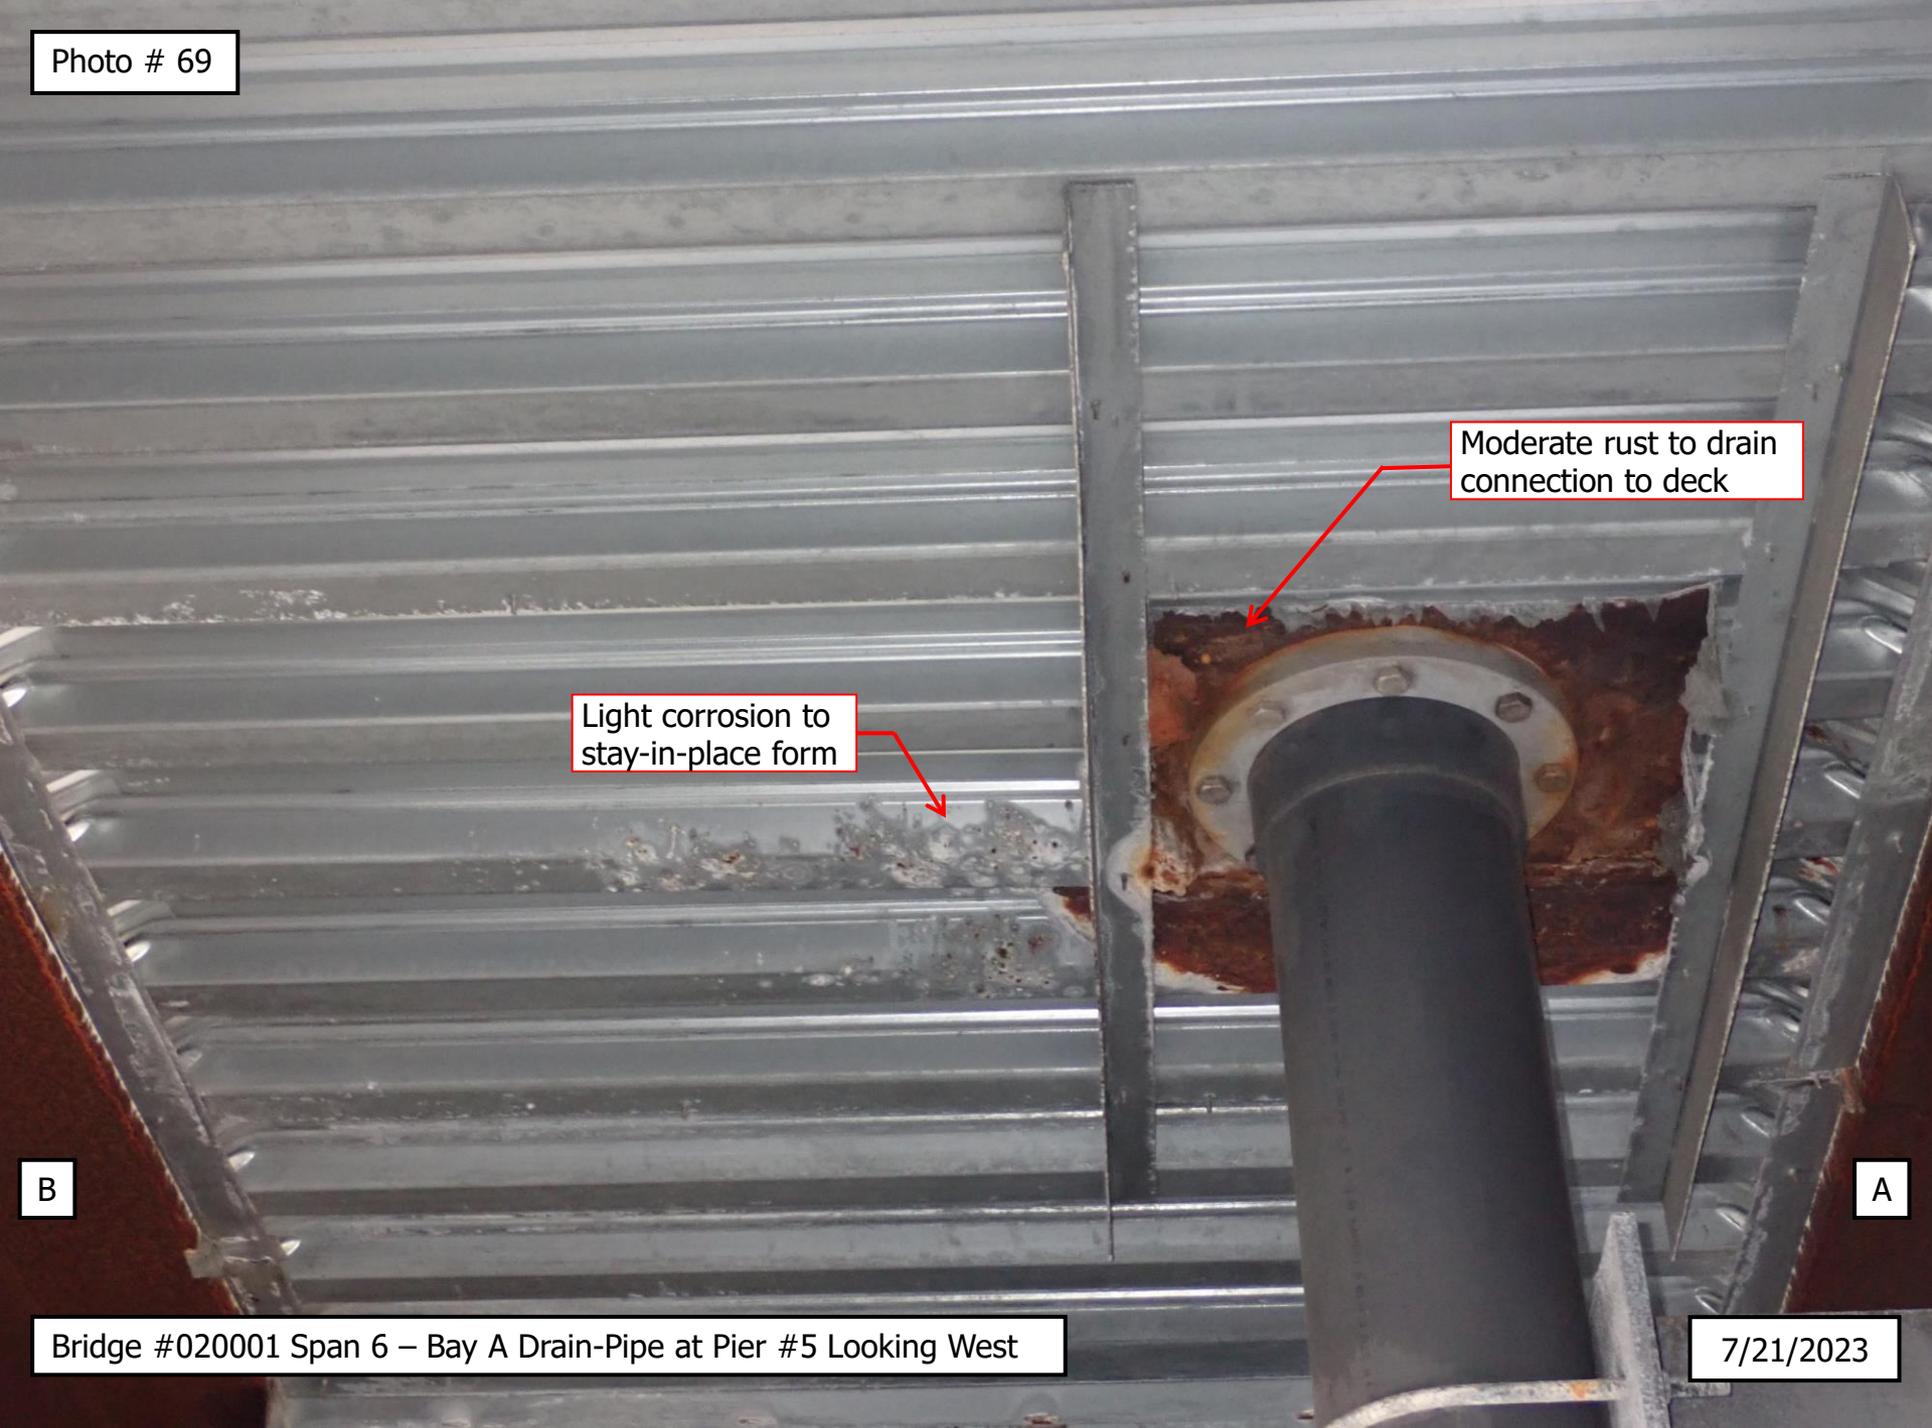
Moderate rust to drain connection to deck
