Minor to moderate wheel line rutting with areas of cracking throughout

Separation crack with potholes has been patched since the previous inspection

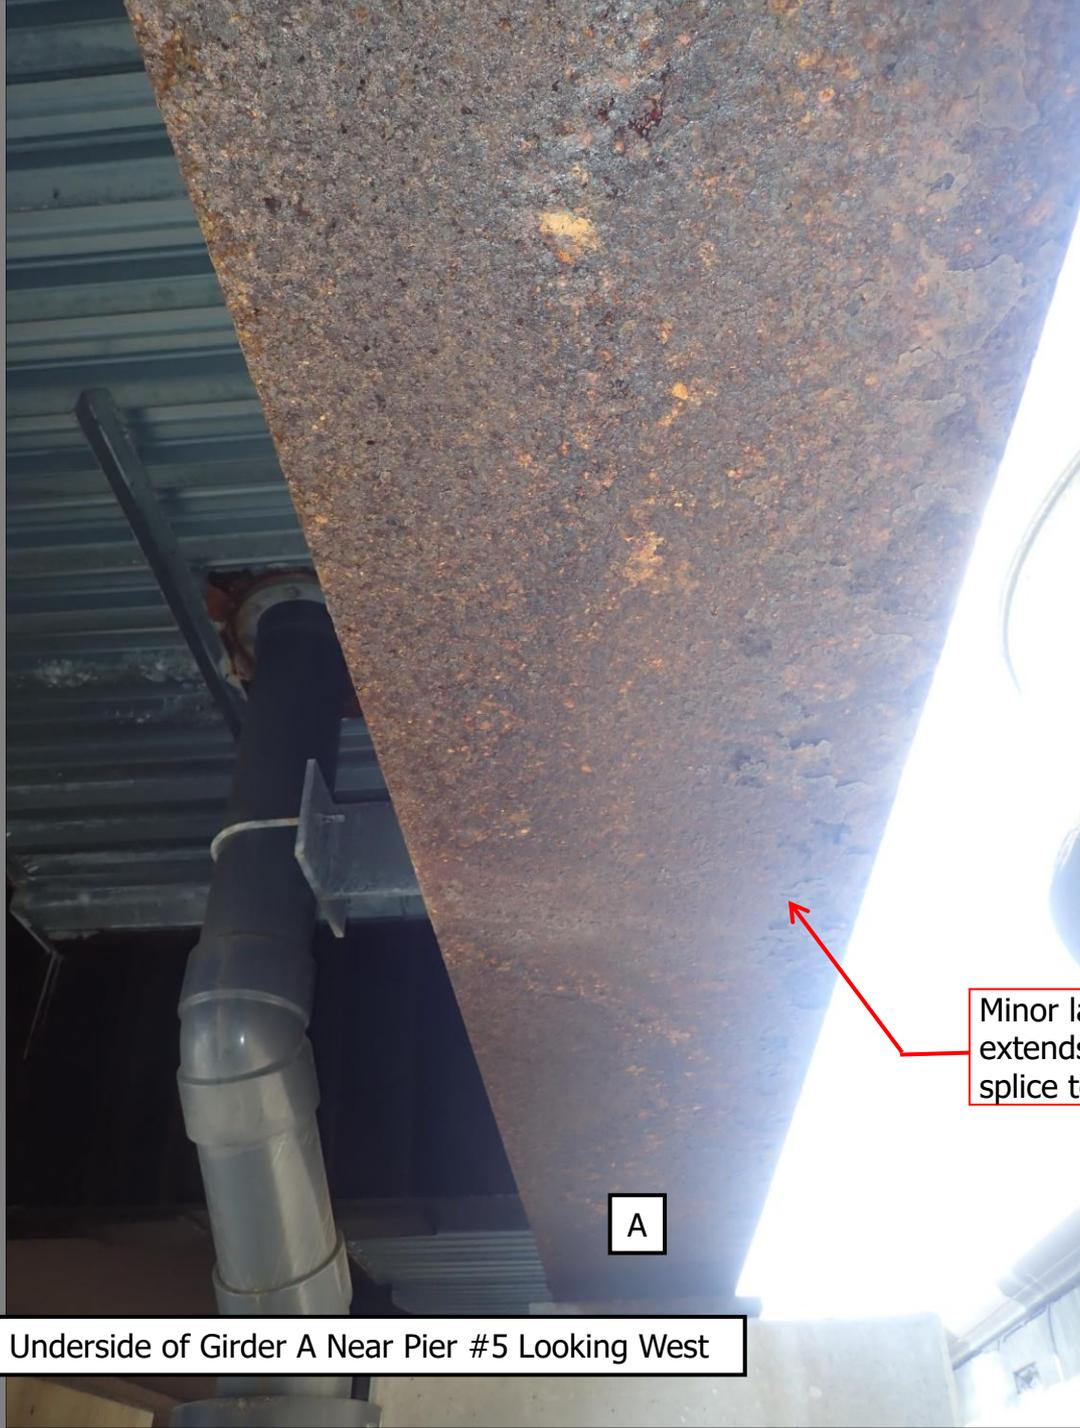
Minor laminar rust that extends from the field splice to the the pier

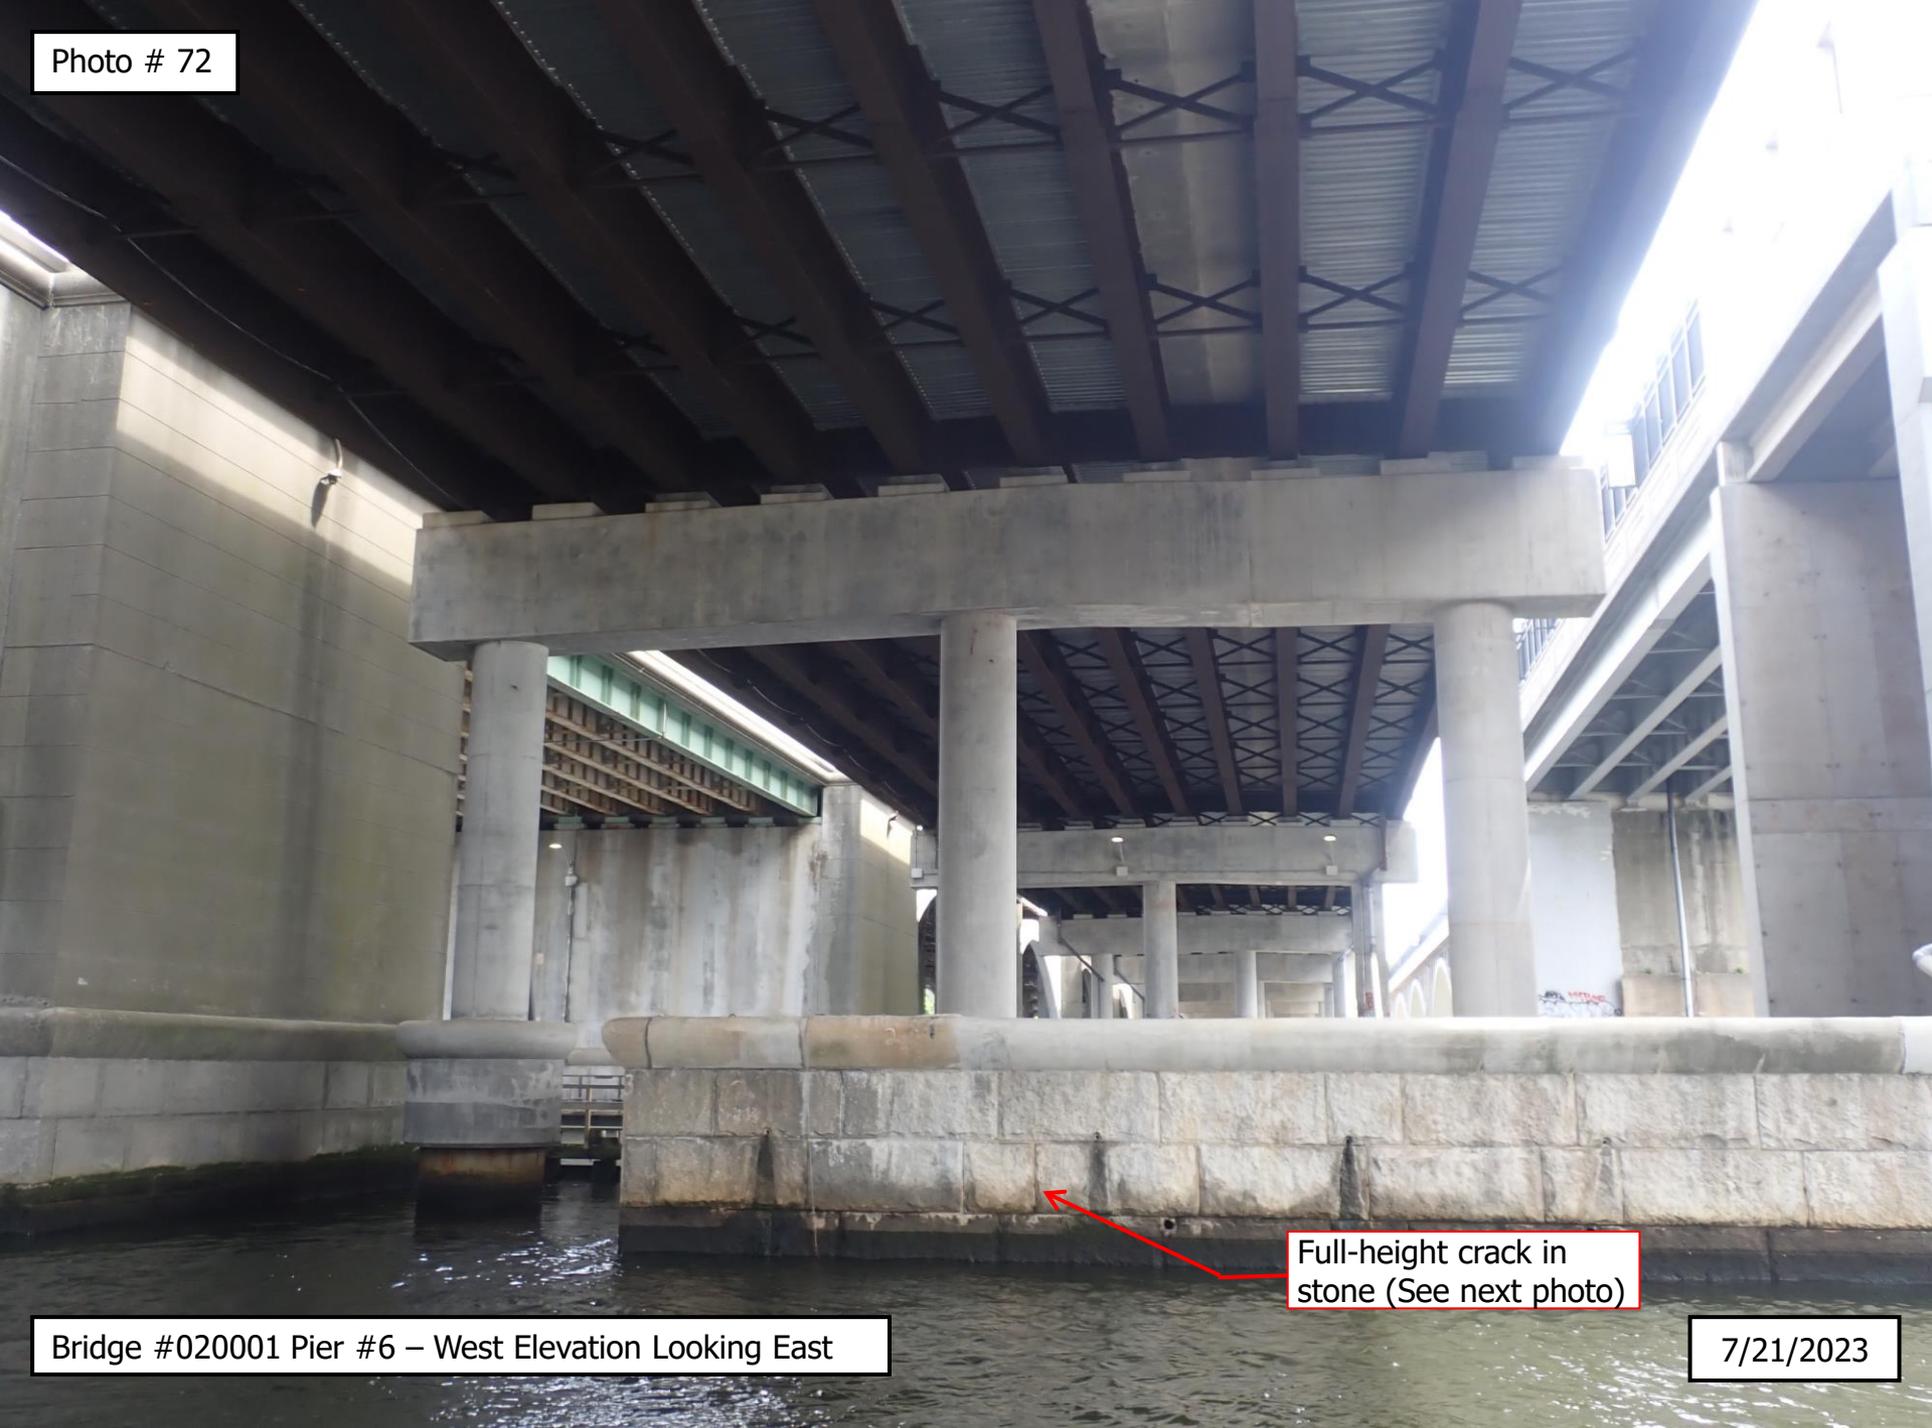
Full-height crack in
stone (See next photo)

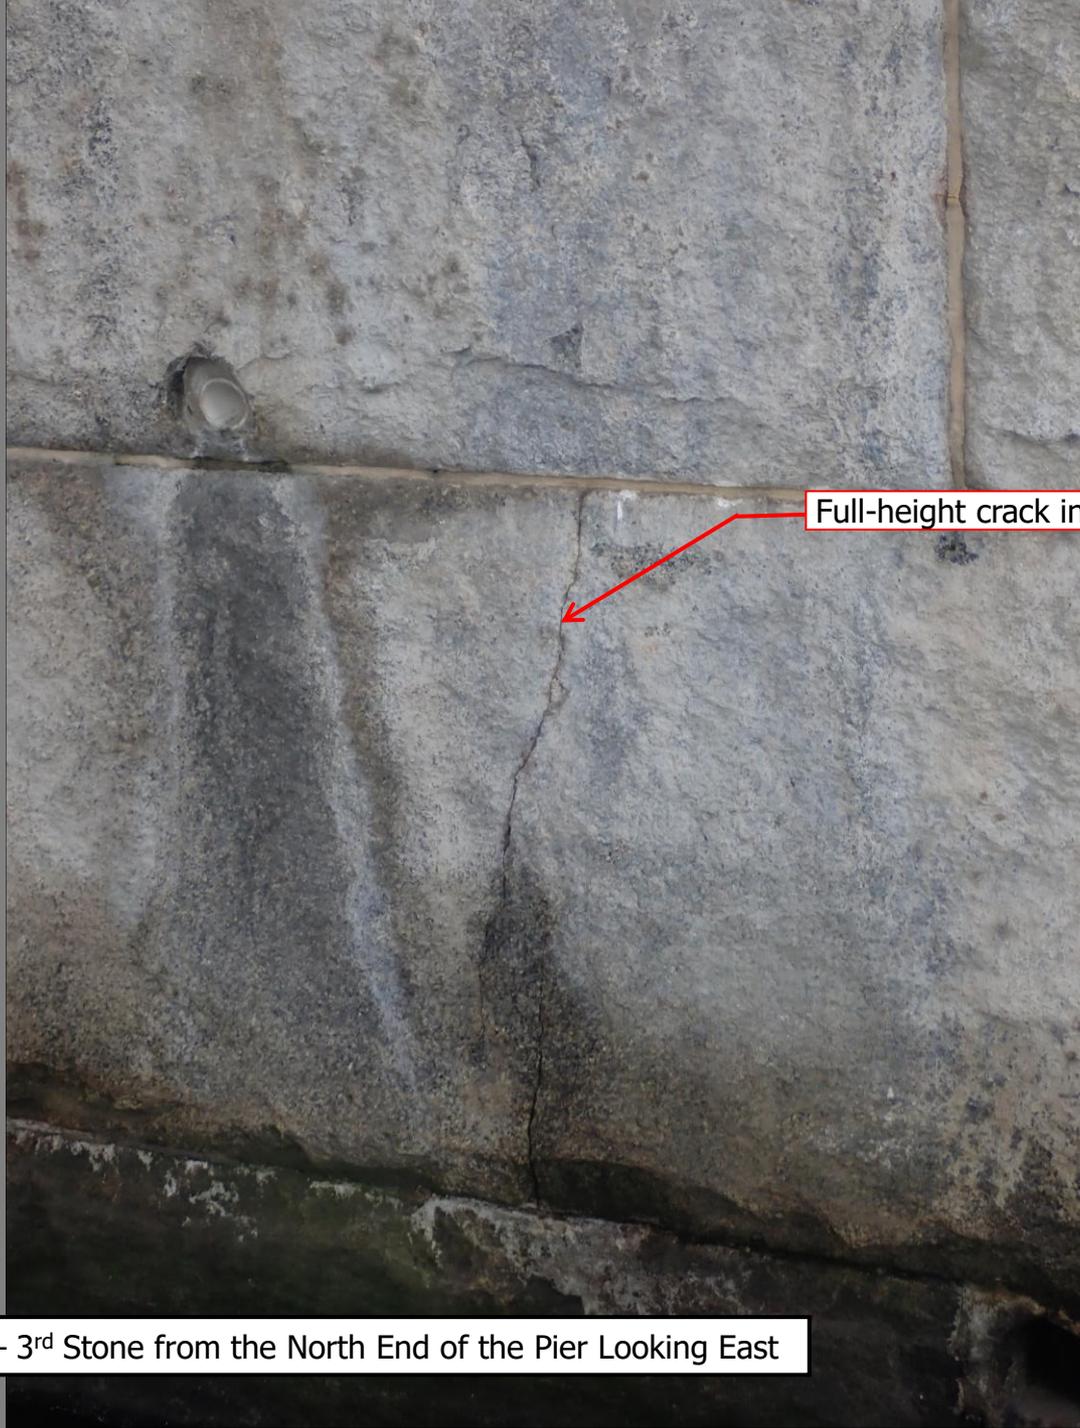
Full-height crack in stone

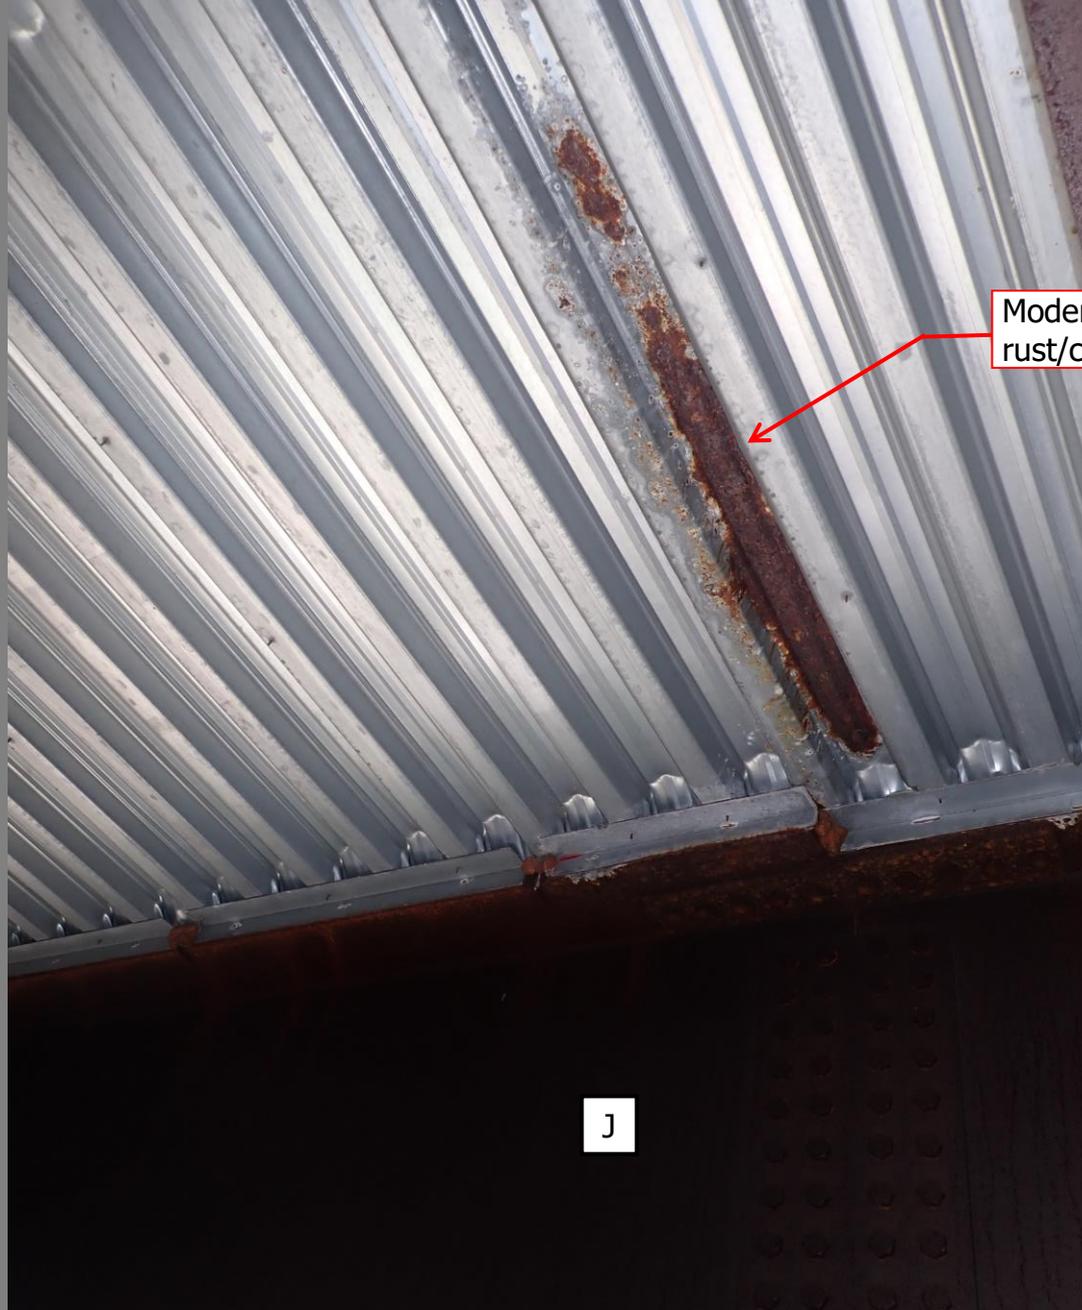
Moderate to heavy
rust/corrosion

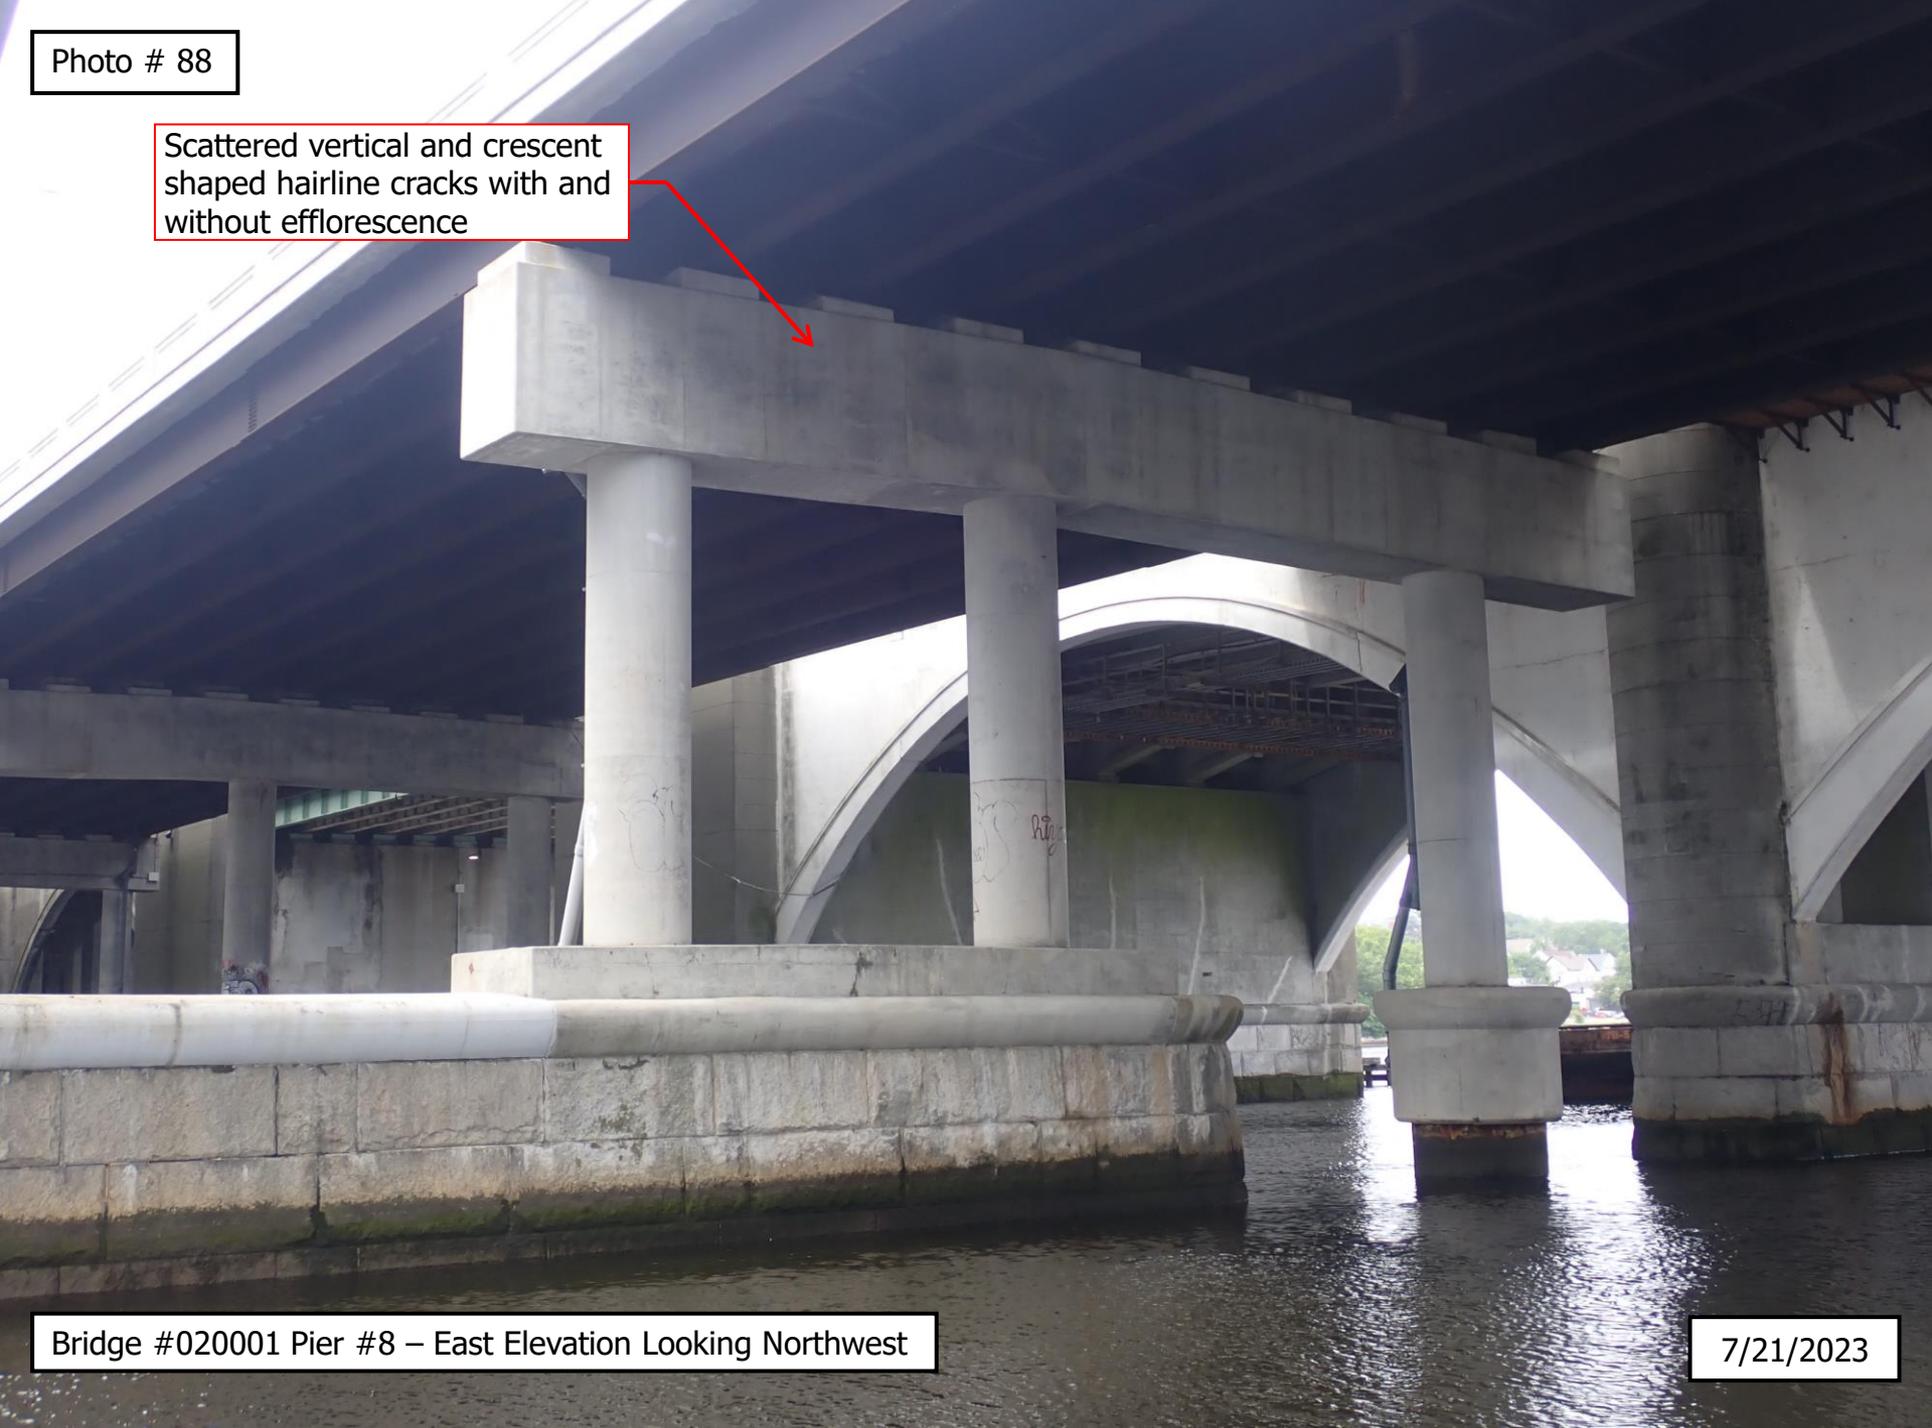
Bridge #020001 Pier #8 – East Elevation Looking Northwest

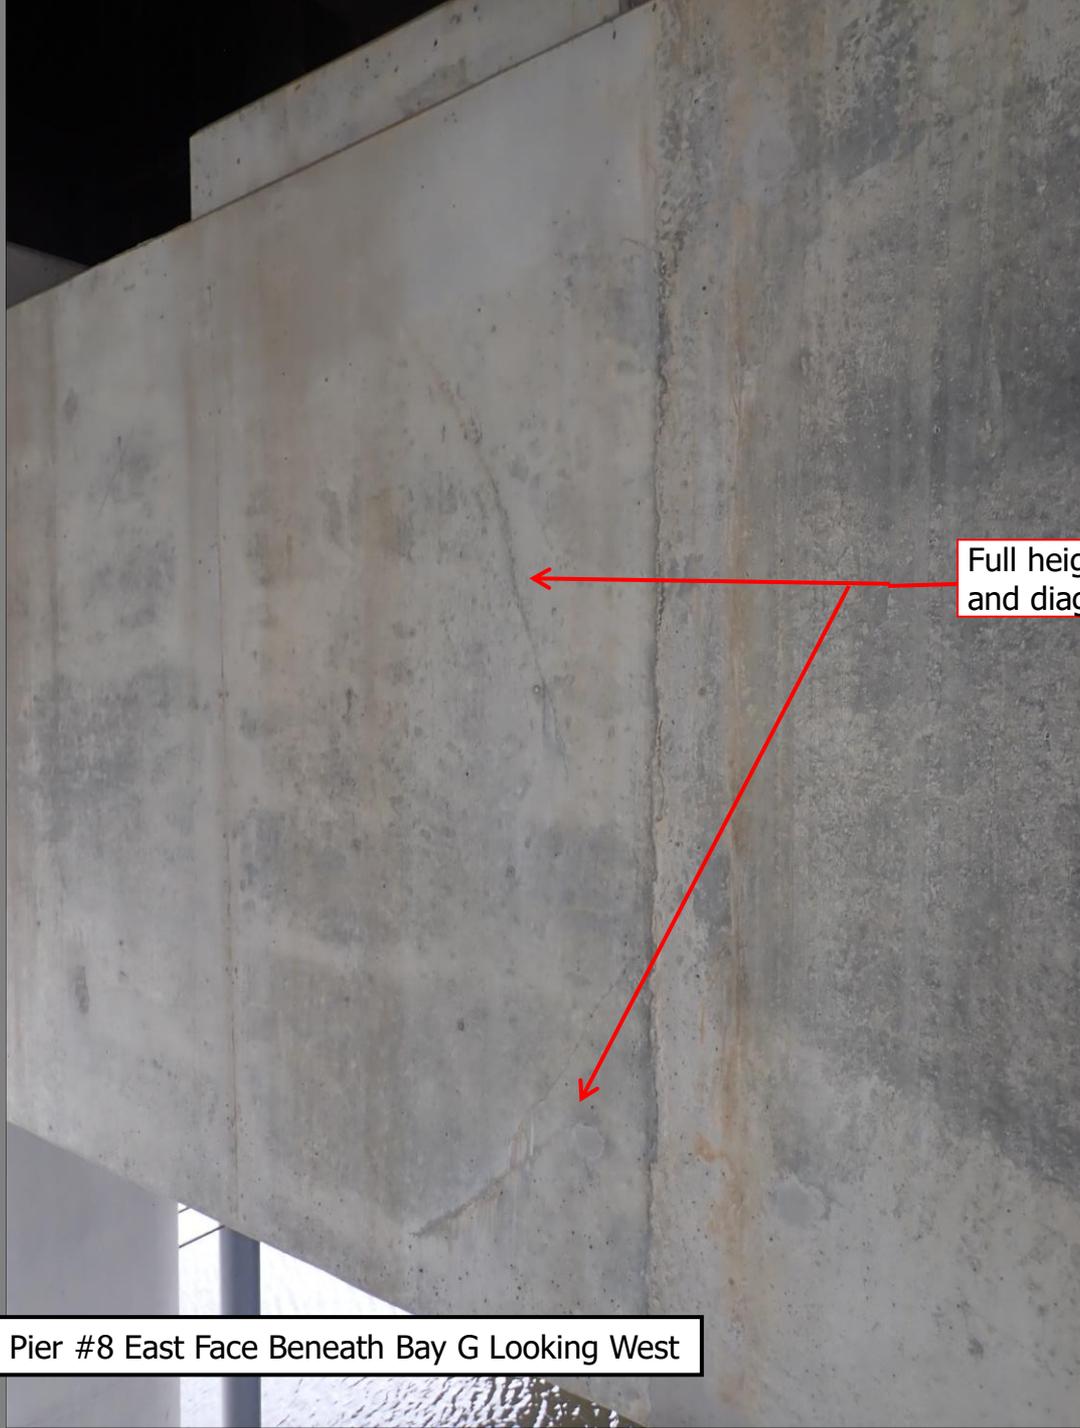
Full height crescent shaped
and diagonal hairline cracks

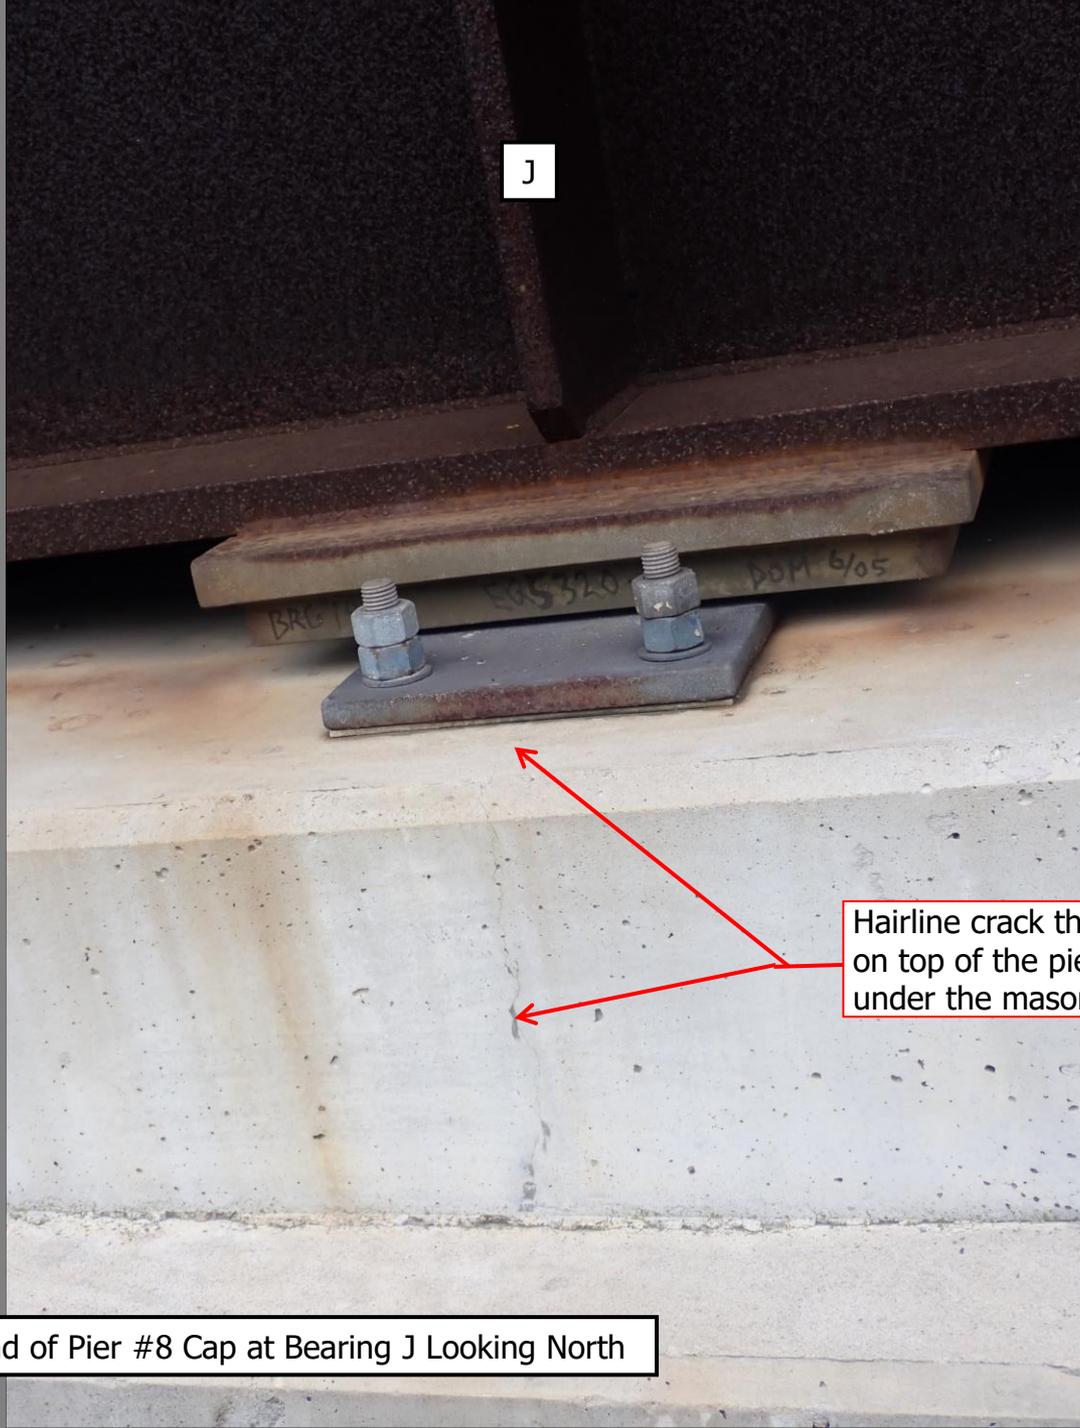
Hairline crack that extends on top of the pier cap and under the masonry plate

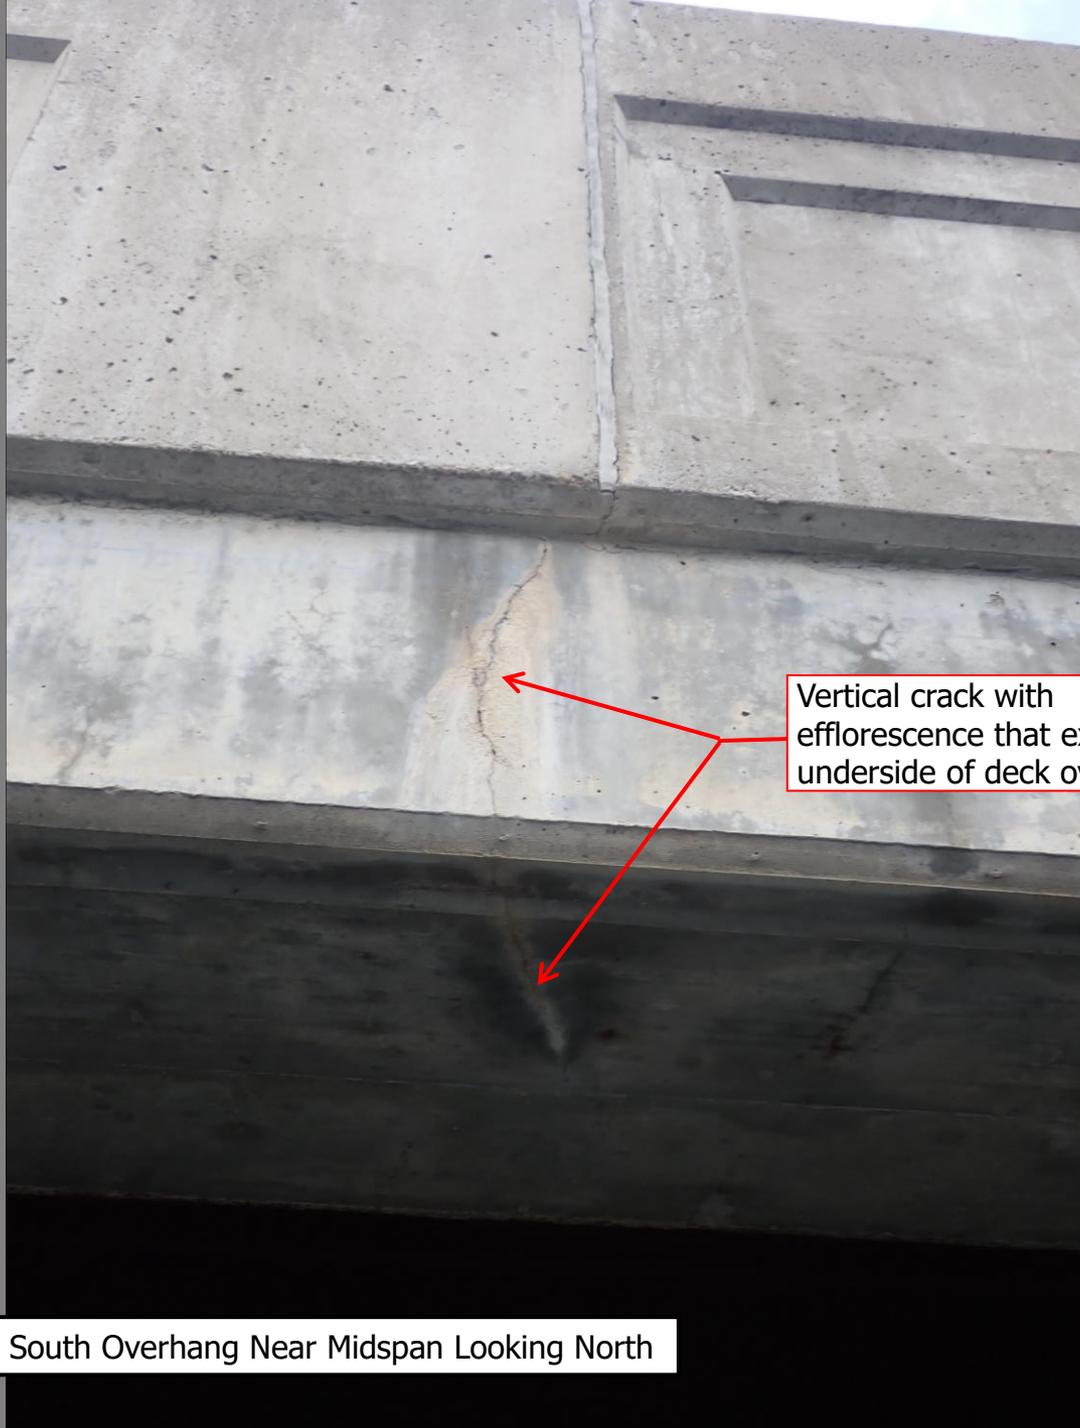
Vertical crack with efflorescence that extends on underside of deck overhang

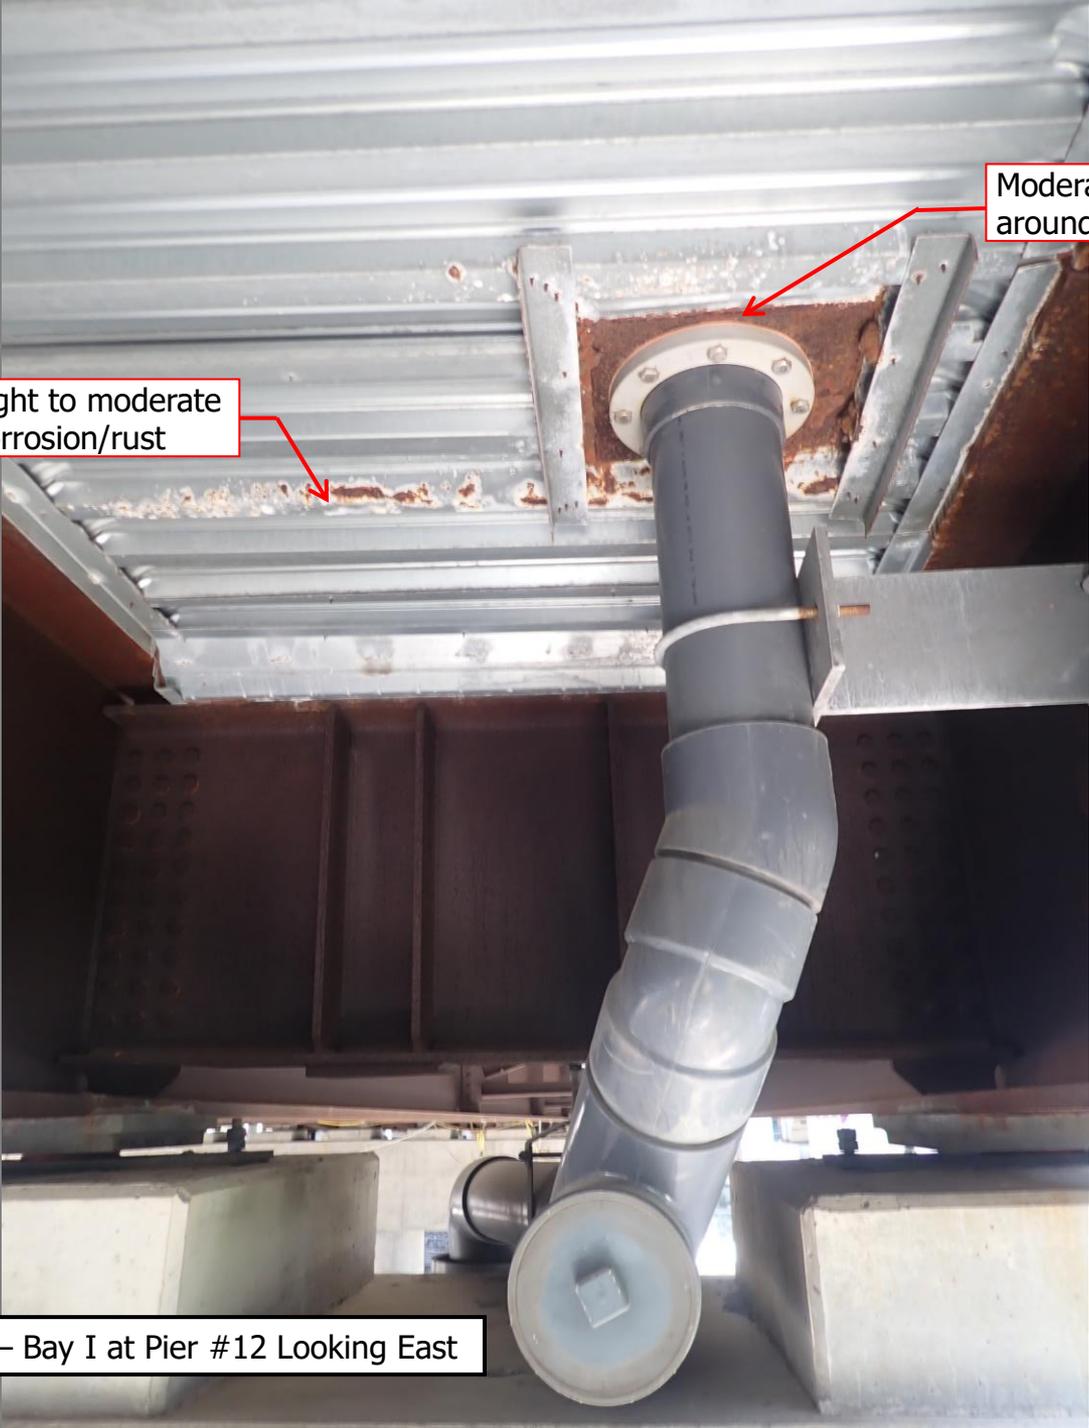
Moderate to heavy rust/corrosion around downspout

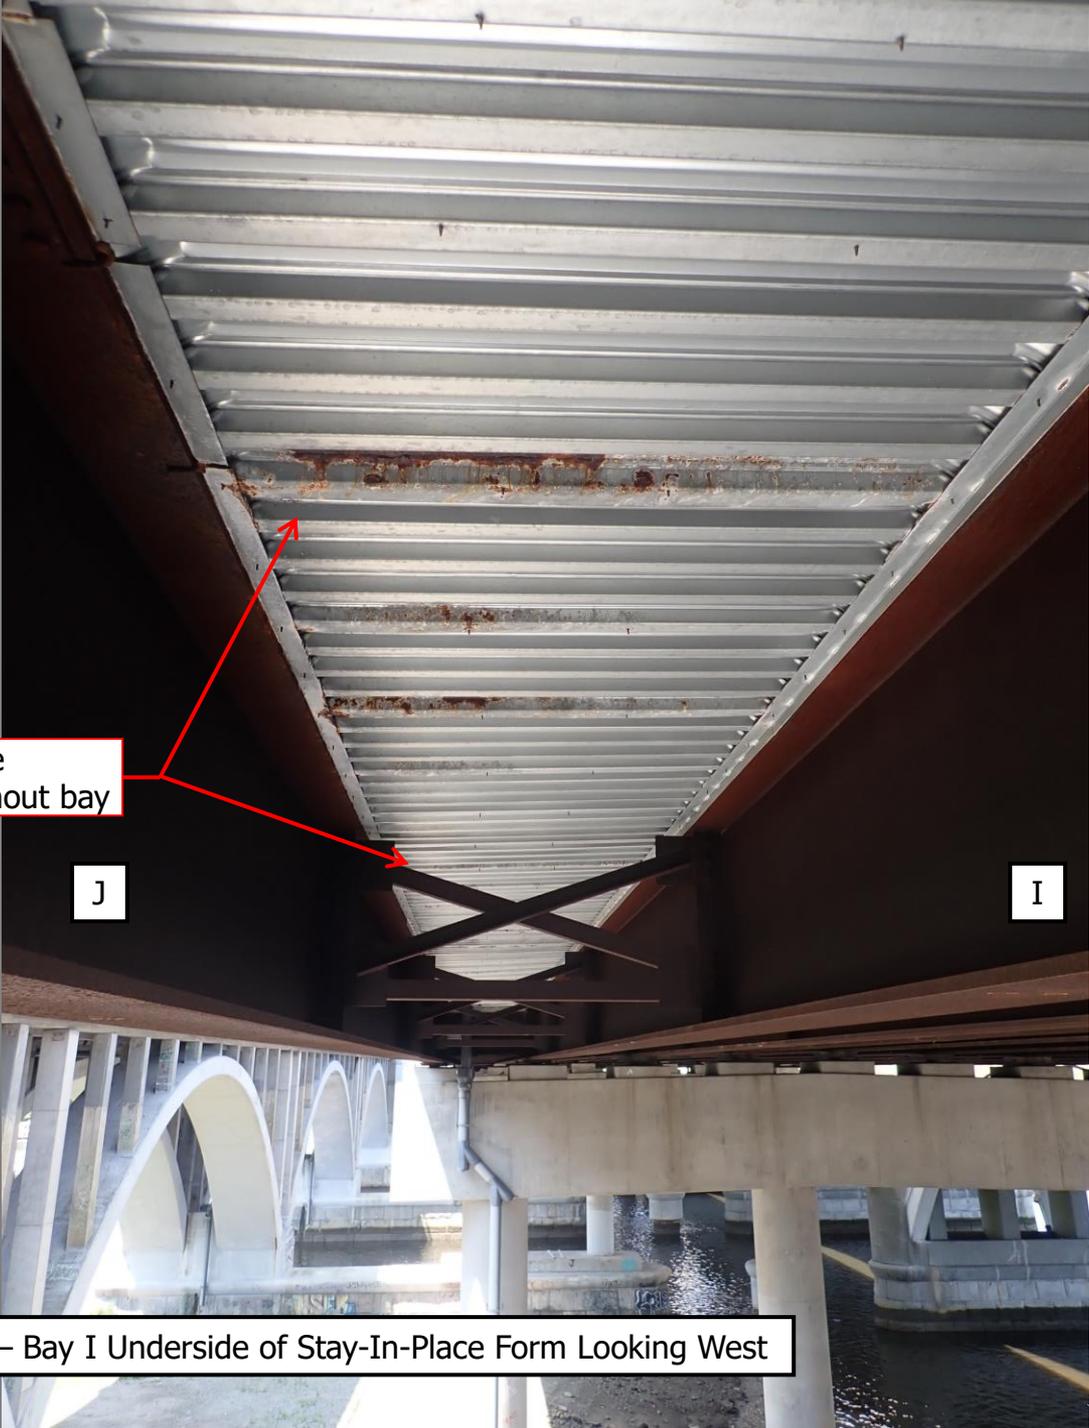
Isolated hairline cracks

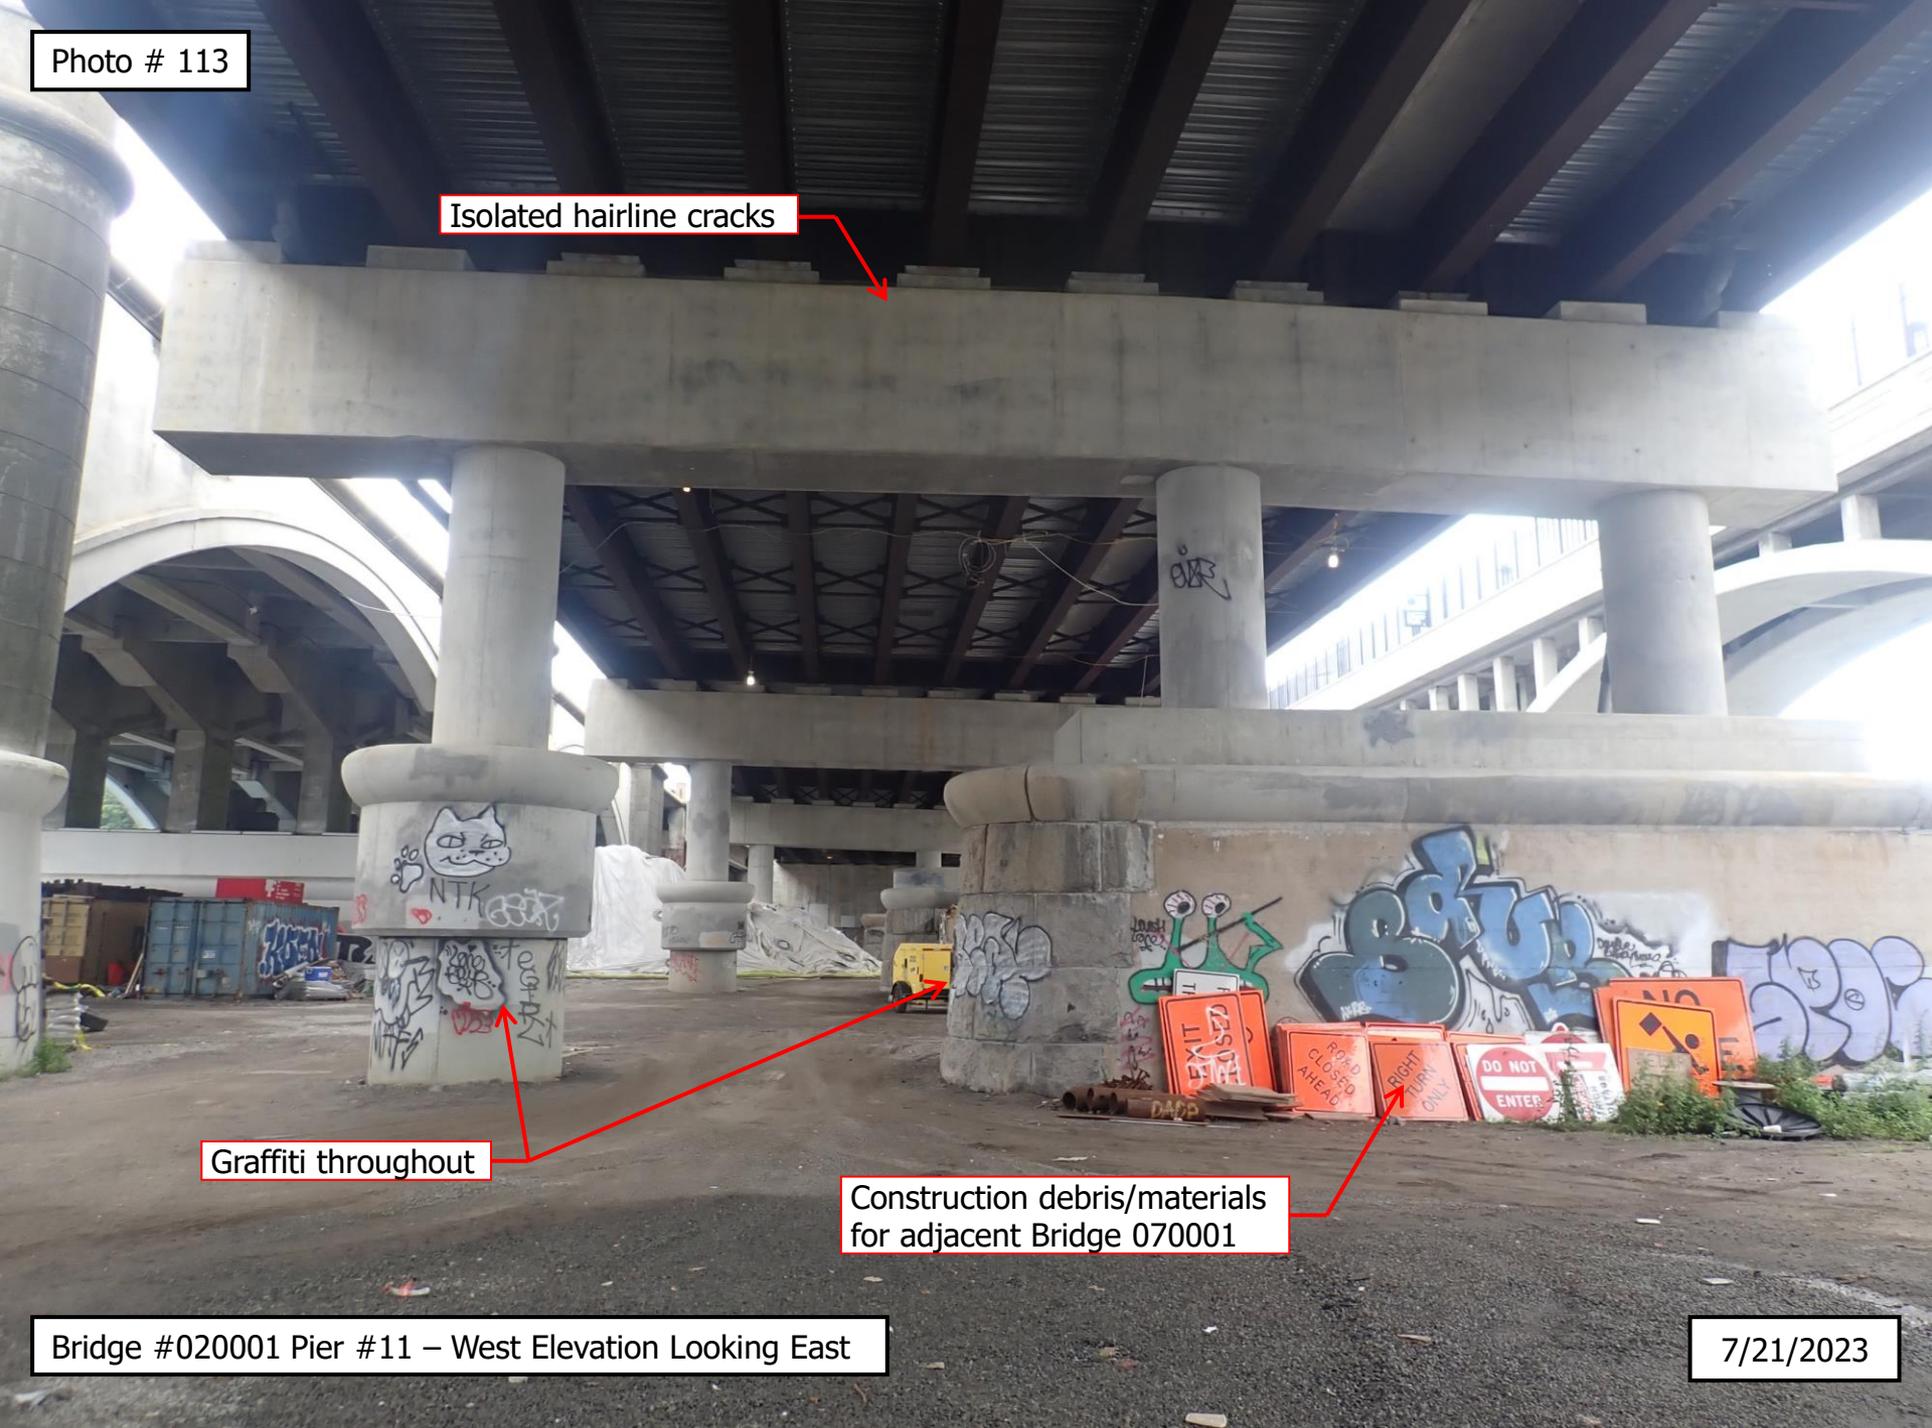
Construction debris/materials for adjacent Bridge 070001
