Minor to moderate wheel line rutting with areas of cracking throughout

Separation crack with potholes has been patched since the previous inspection

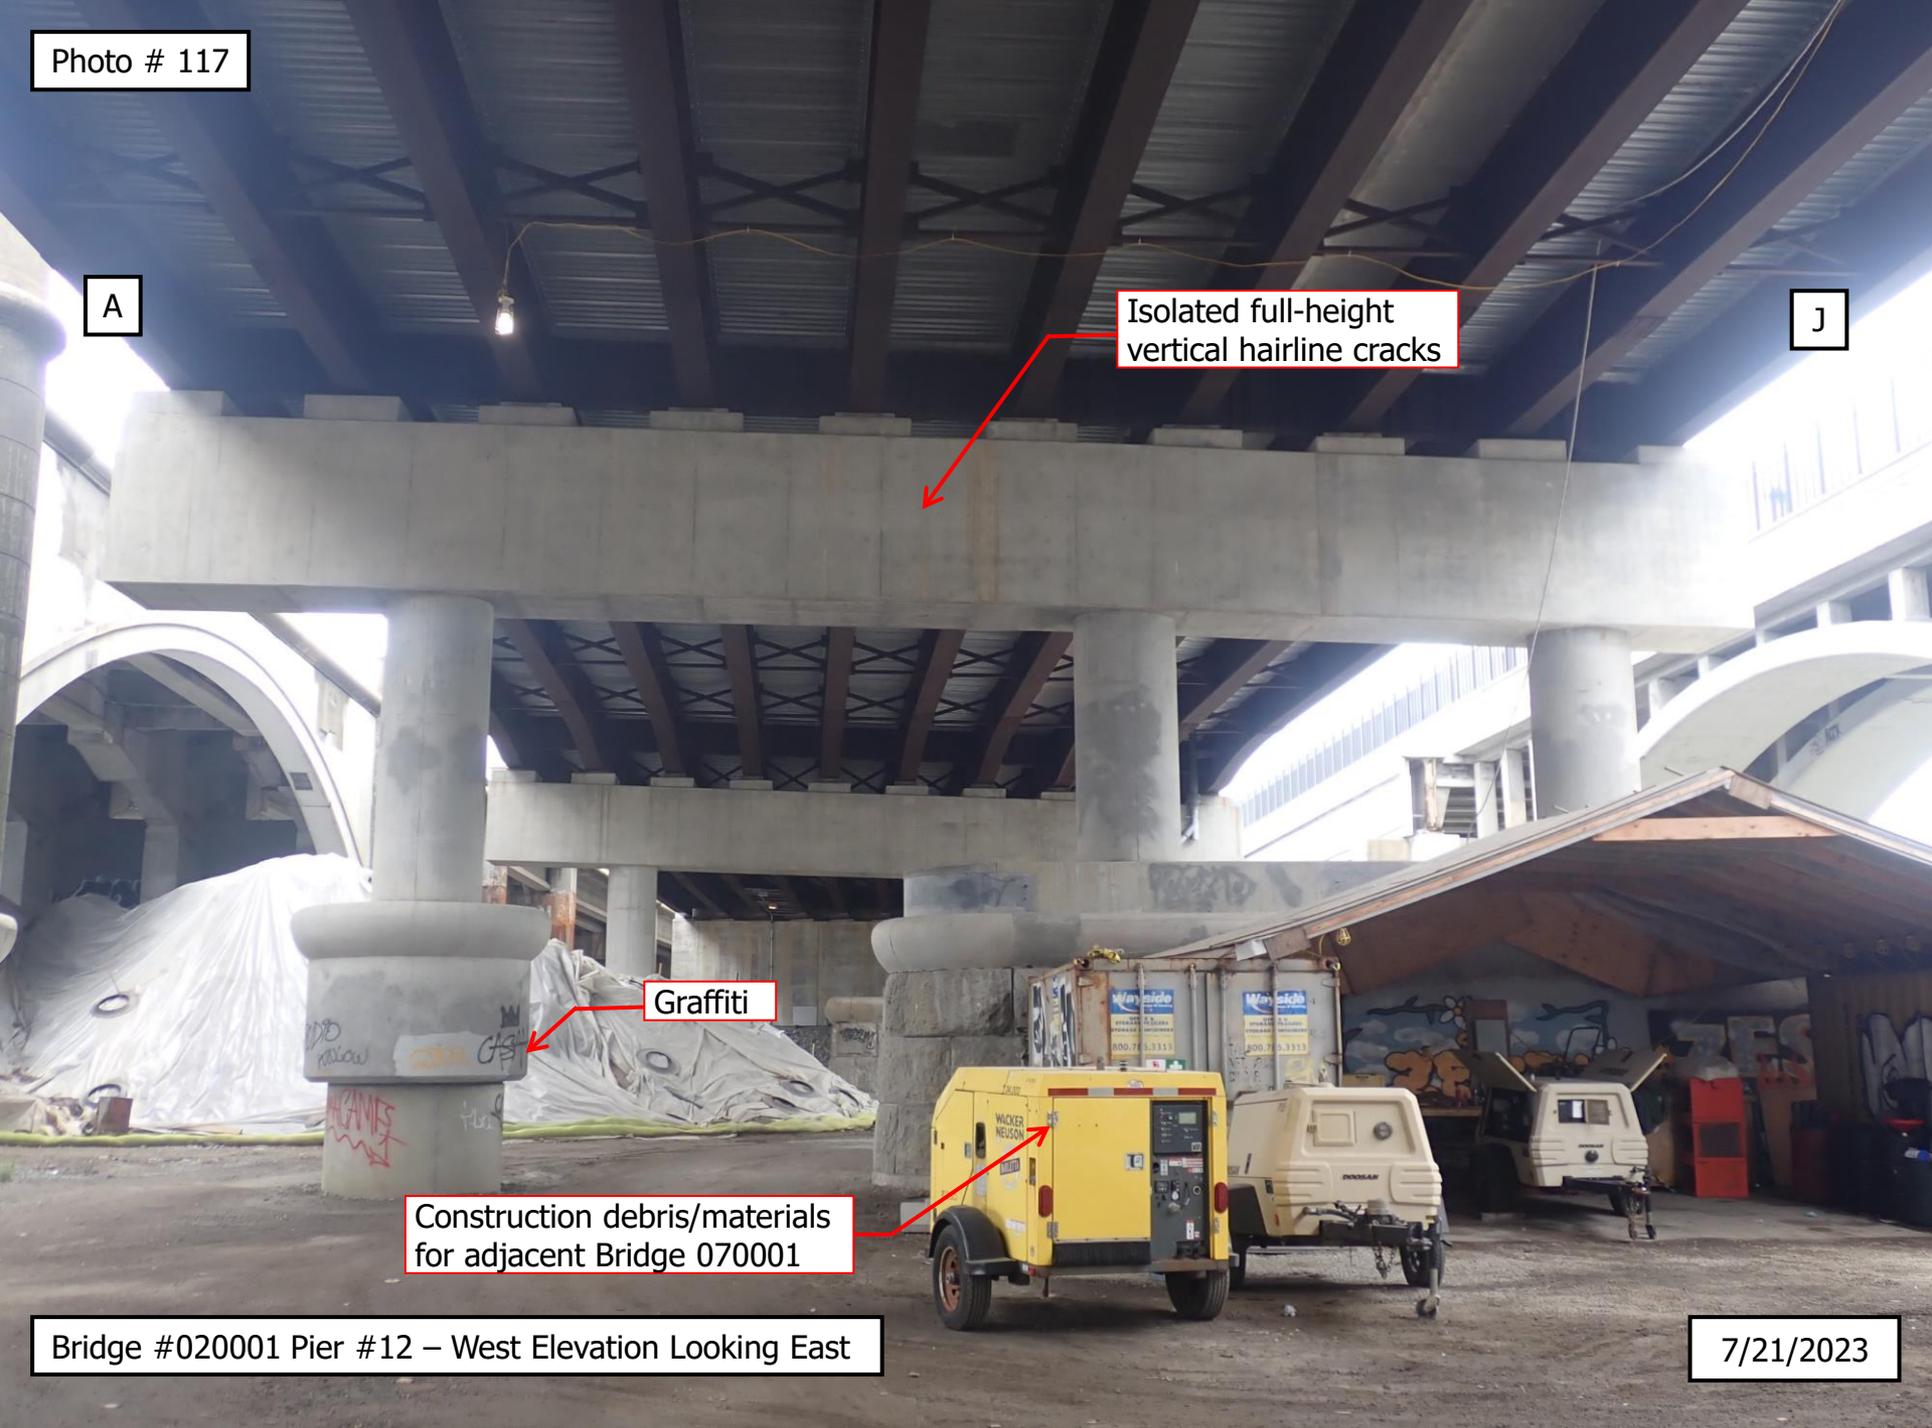
Construction debris/materials for adjacent Bridge 070001

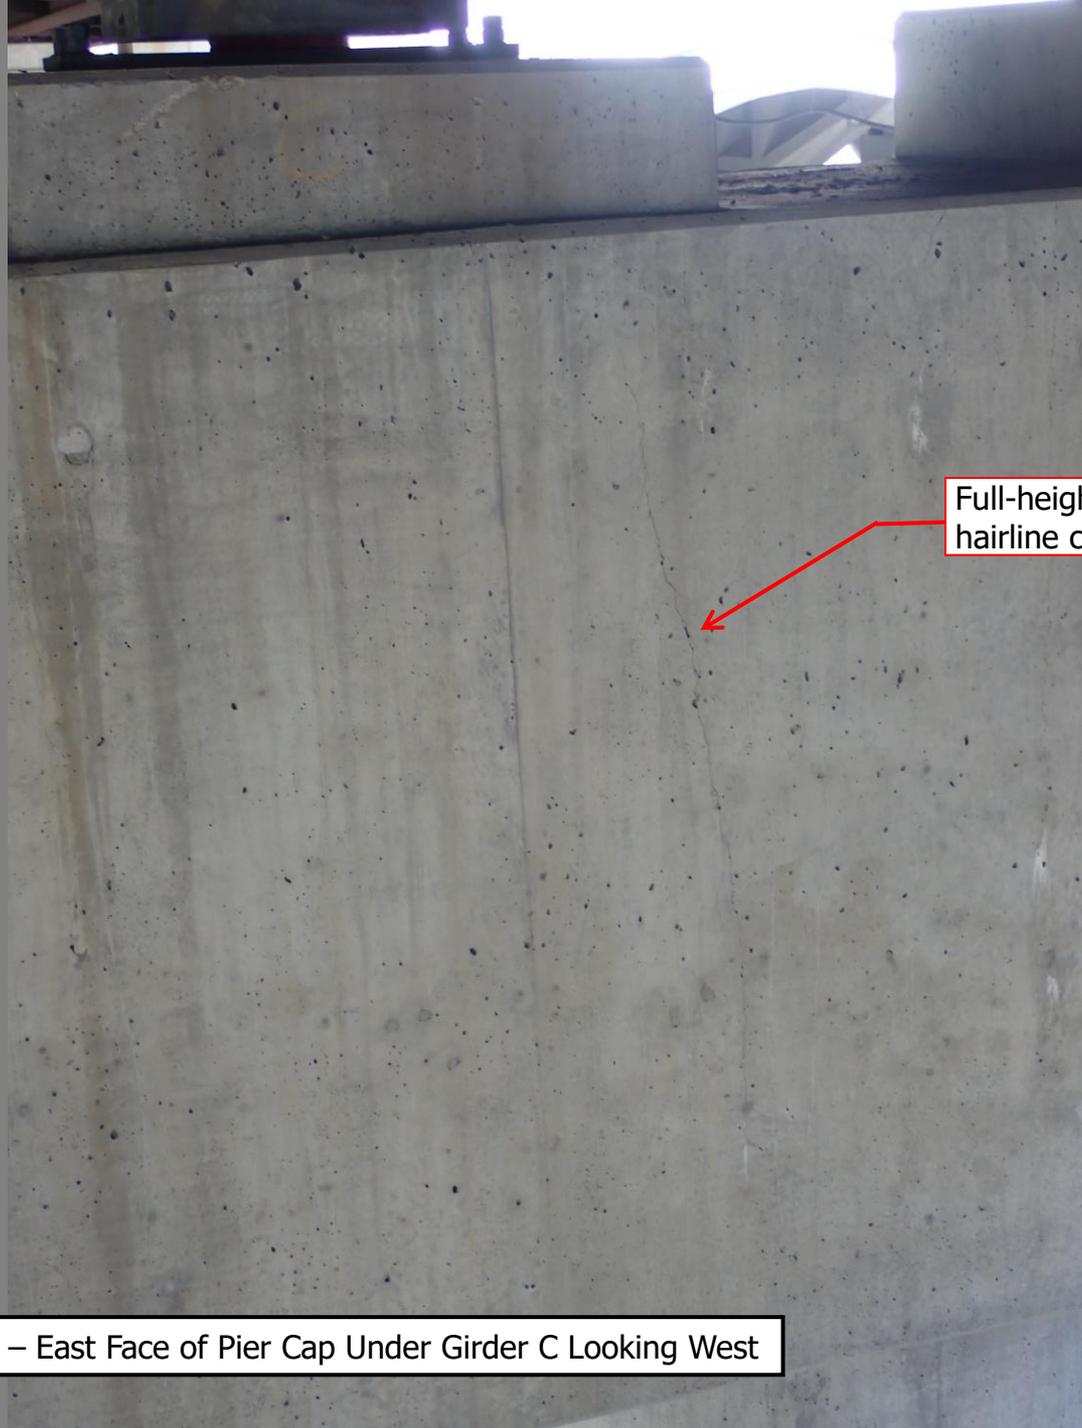
Full-height vertical
hairline crack
