WASHINGTON
BRIDGE
NO. 200

BRIDGE NO. 020001

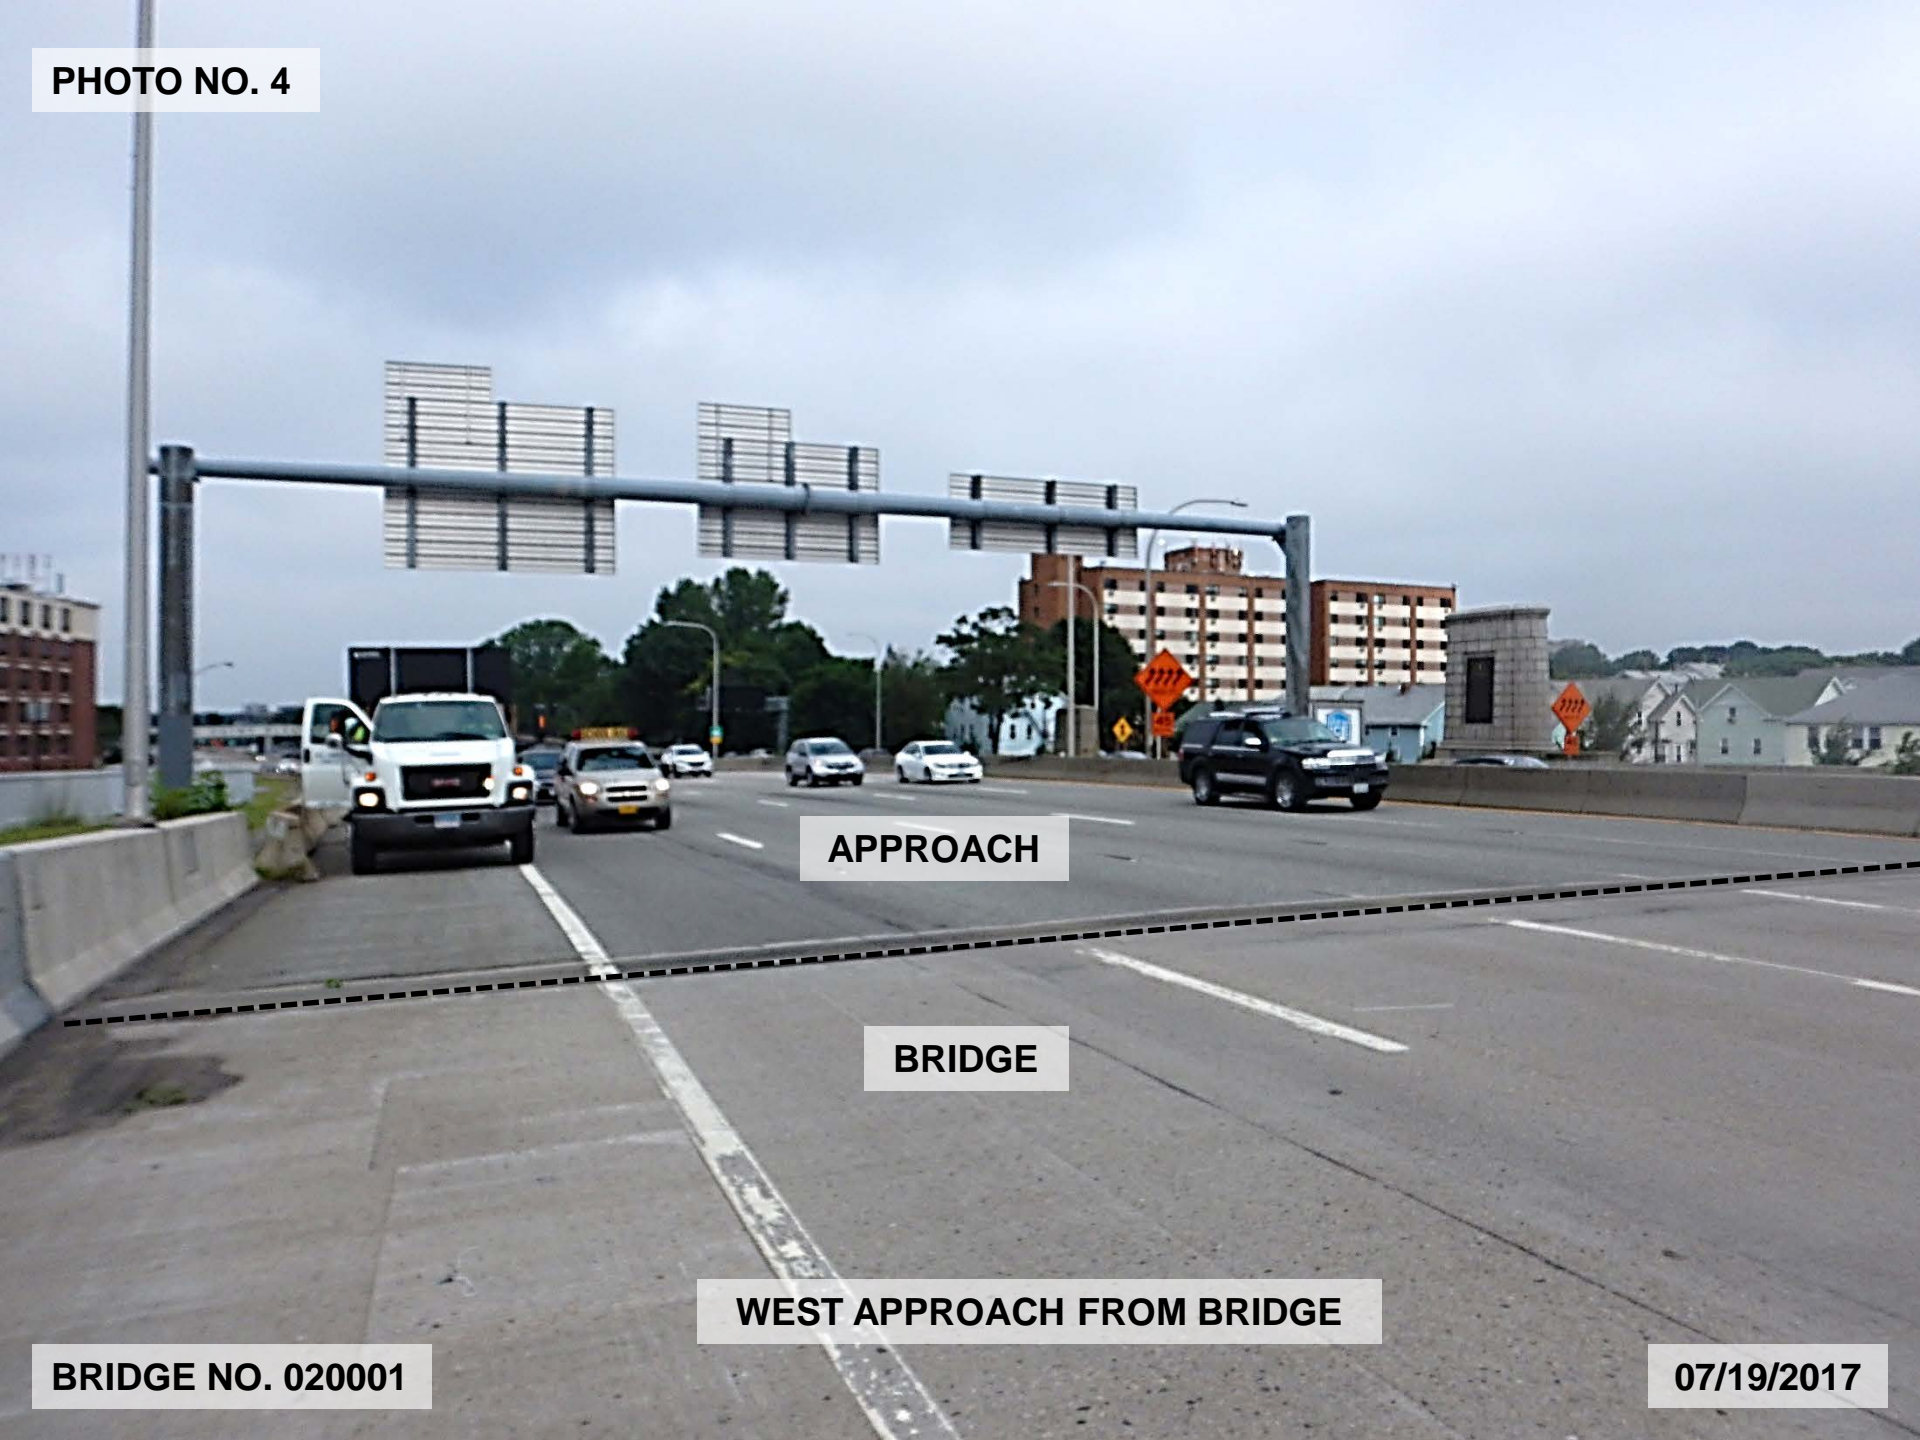
PHOTO NO. 4

WEST APPROACH FROM BRIDGE

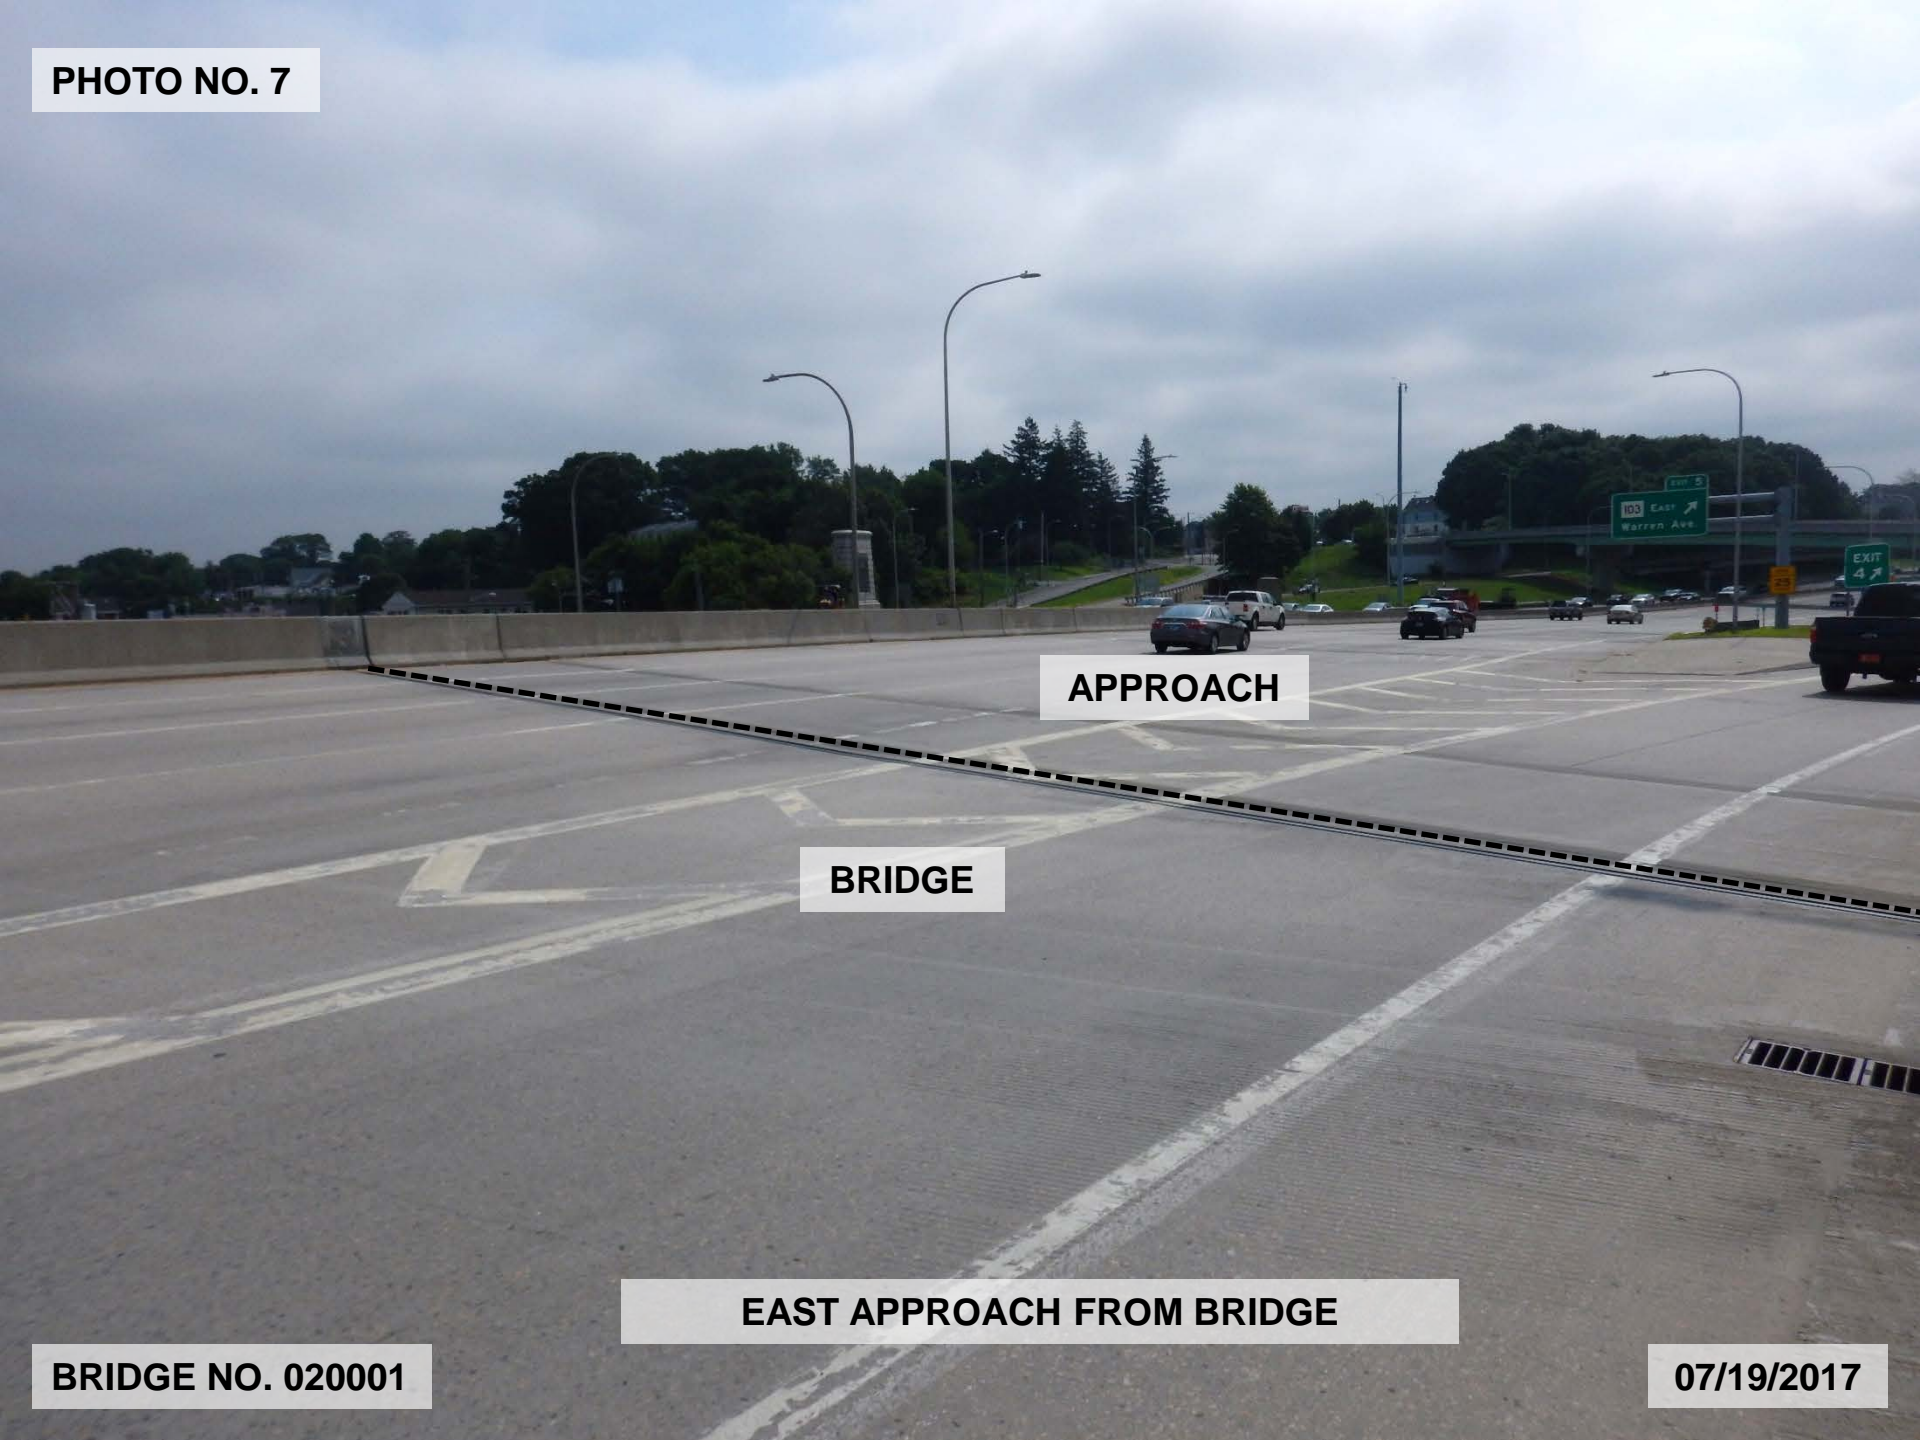
PHOTO NO. 7

EAST APPROACH FROM BRIDGE

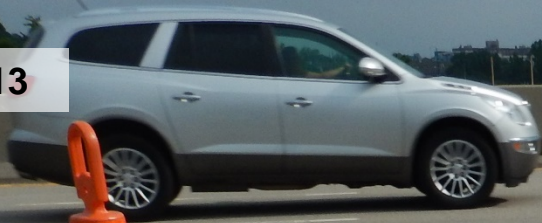
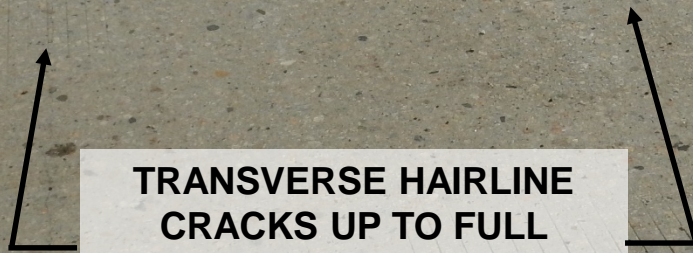
PHOTO NO. 13

LIGHT WEAR

**TRANSVERSE HAIRLINE
CRACKS UP TO FULL
LENGTH SPACED
APPROXIMATELY 2' TO 3'
APART**

**SPAN #1 WEARING
SURFACE, LOOKING NORTH**

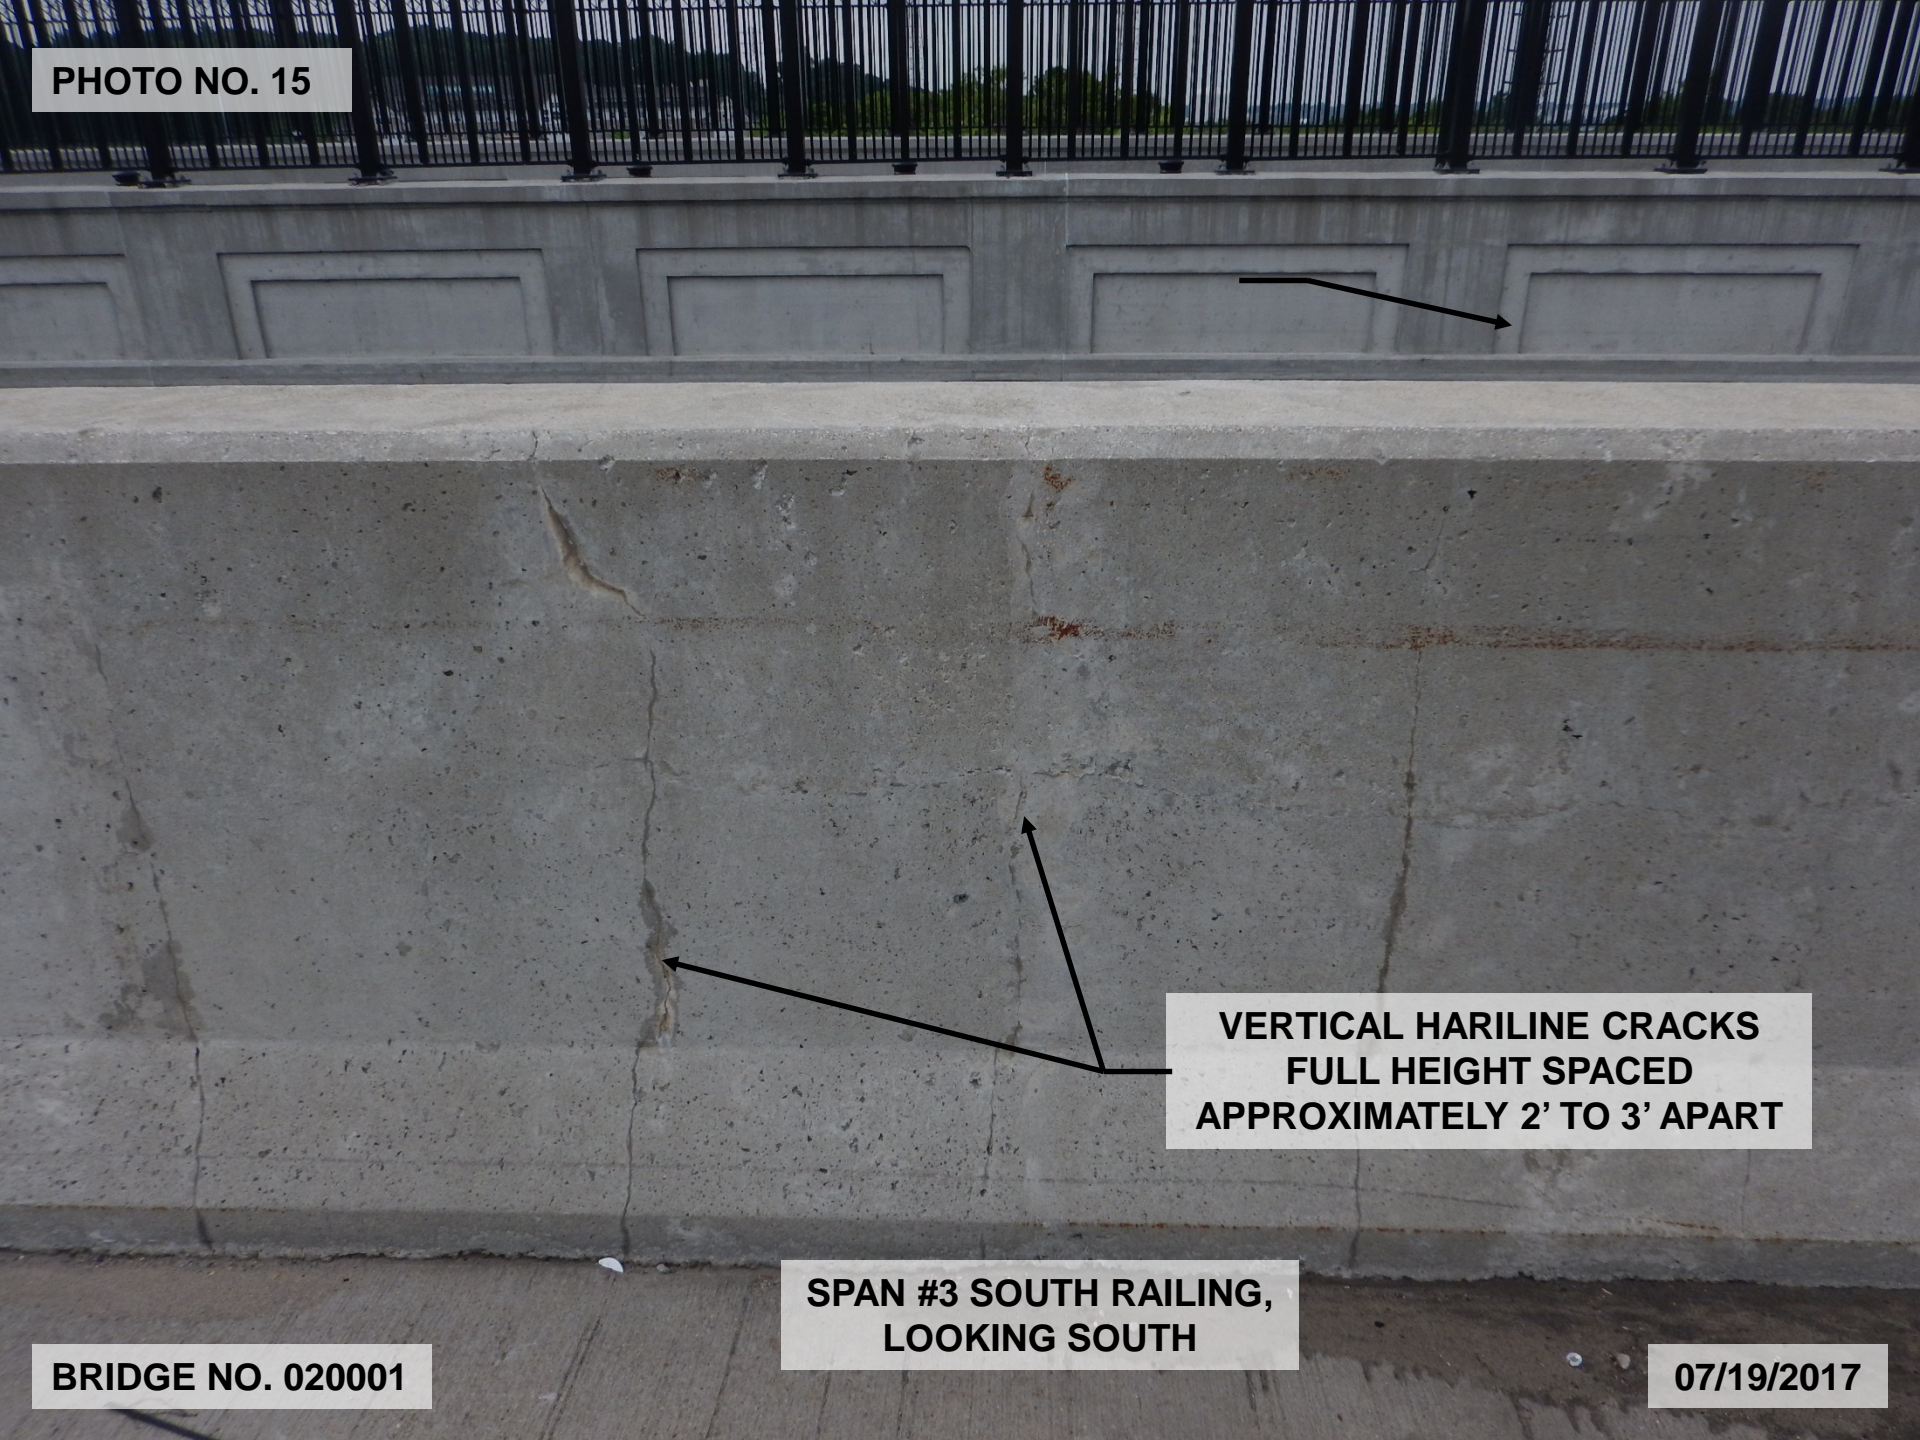
PHOTO NO. 15

VERTICAL HAIRLINE CRACKS
FULL HEIGHT SPACED
APPROXIMATELY 2' TO 3' APART

SPAN #3 SOUTH RAILING,
LOOKING SOUTH

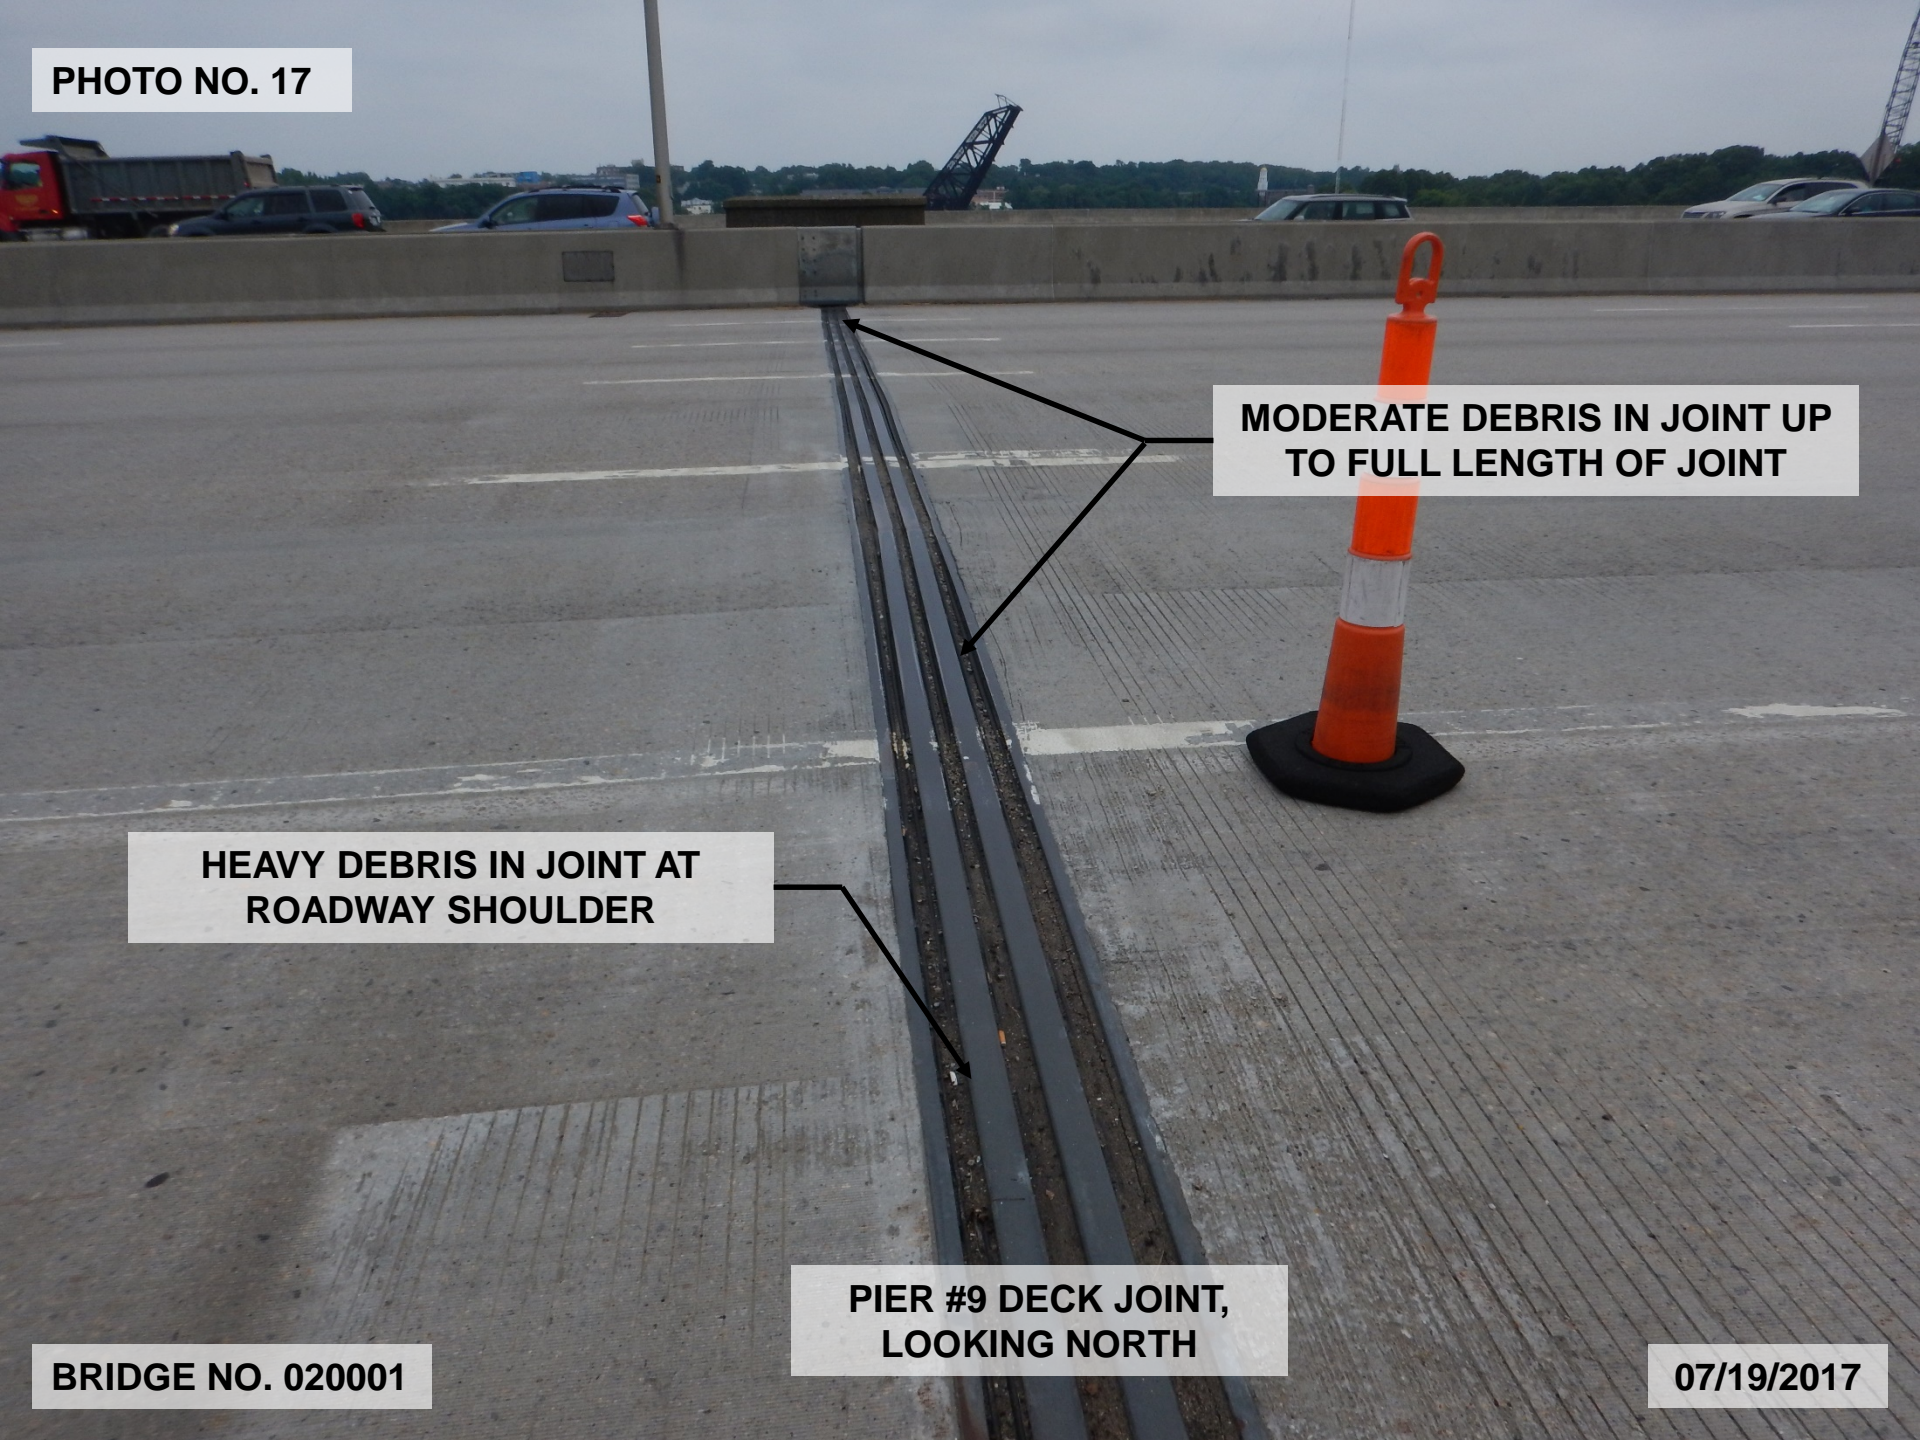
PHOTO NO. 17

**MODERATE DEBRIS IN JOINT UP
TO FULL LENGTH OF JOINT**

**HEAVY DEBRIS IN JOINT AT
ROADWAY SHOULDER**

**PIER #9 DECK JOINT,
LOOKING NORTH**

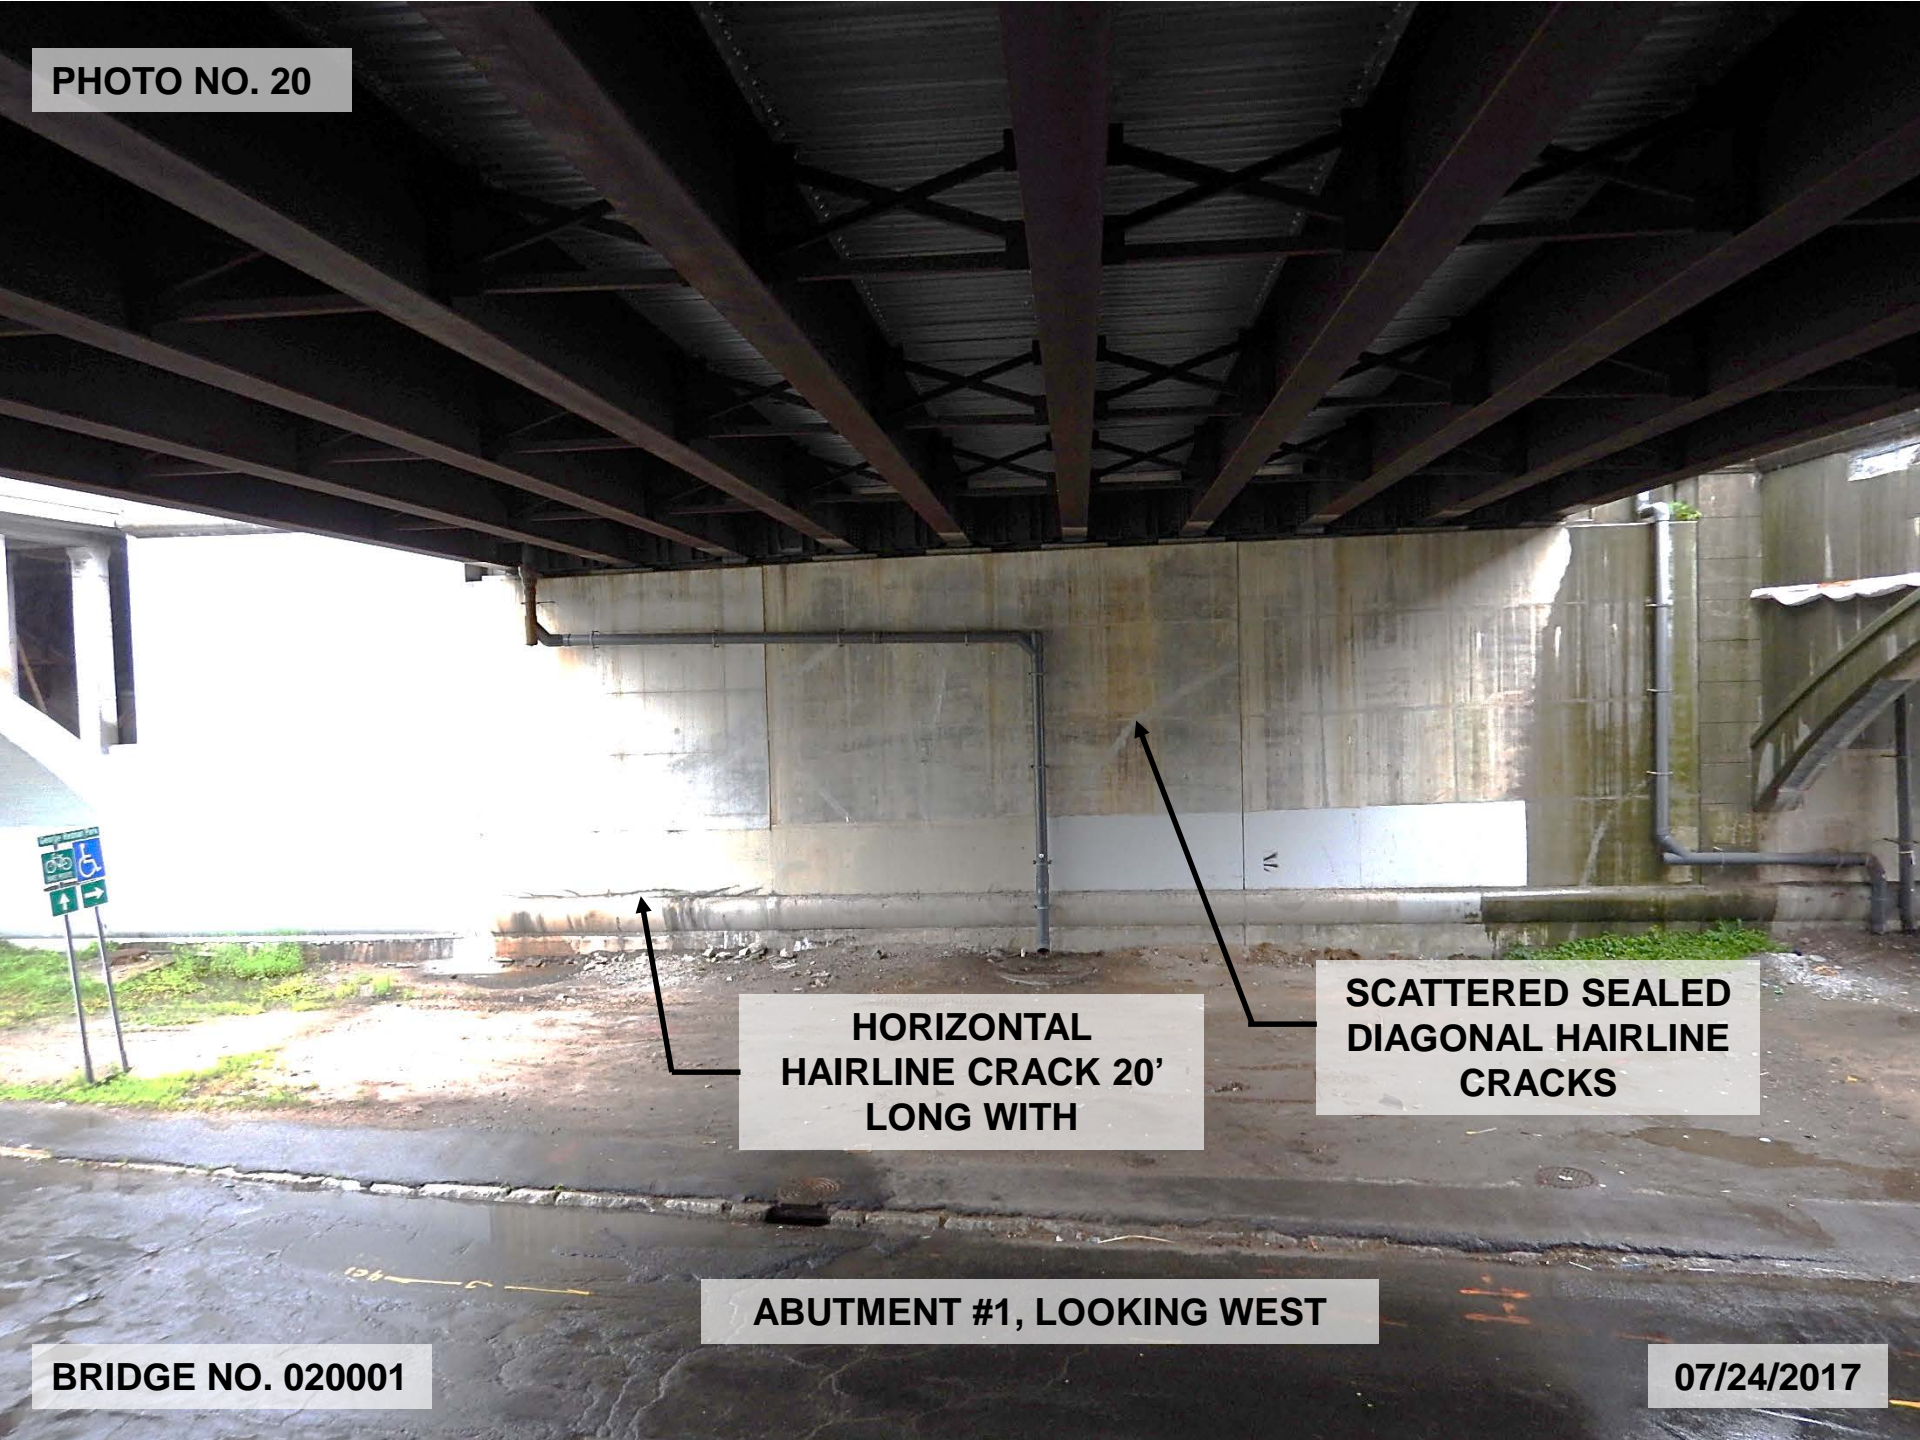
PHOTO NO. 20

HORIZONTAL
HAIRLINE CRACK 20'
LONG WITH

SCATTERED SEALED
DIAGONAL HAIRLINE
CRACKS

ABUTMENT #1, LOOKING WEST

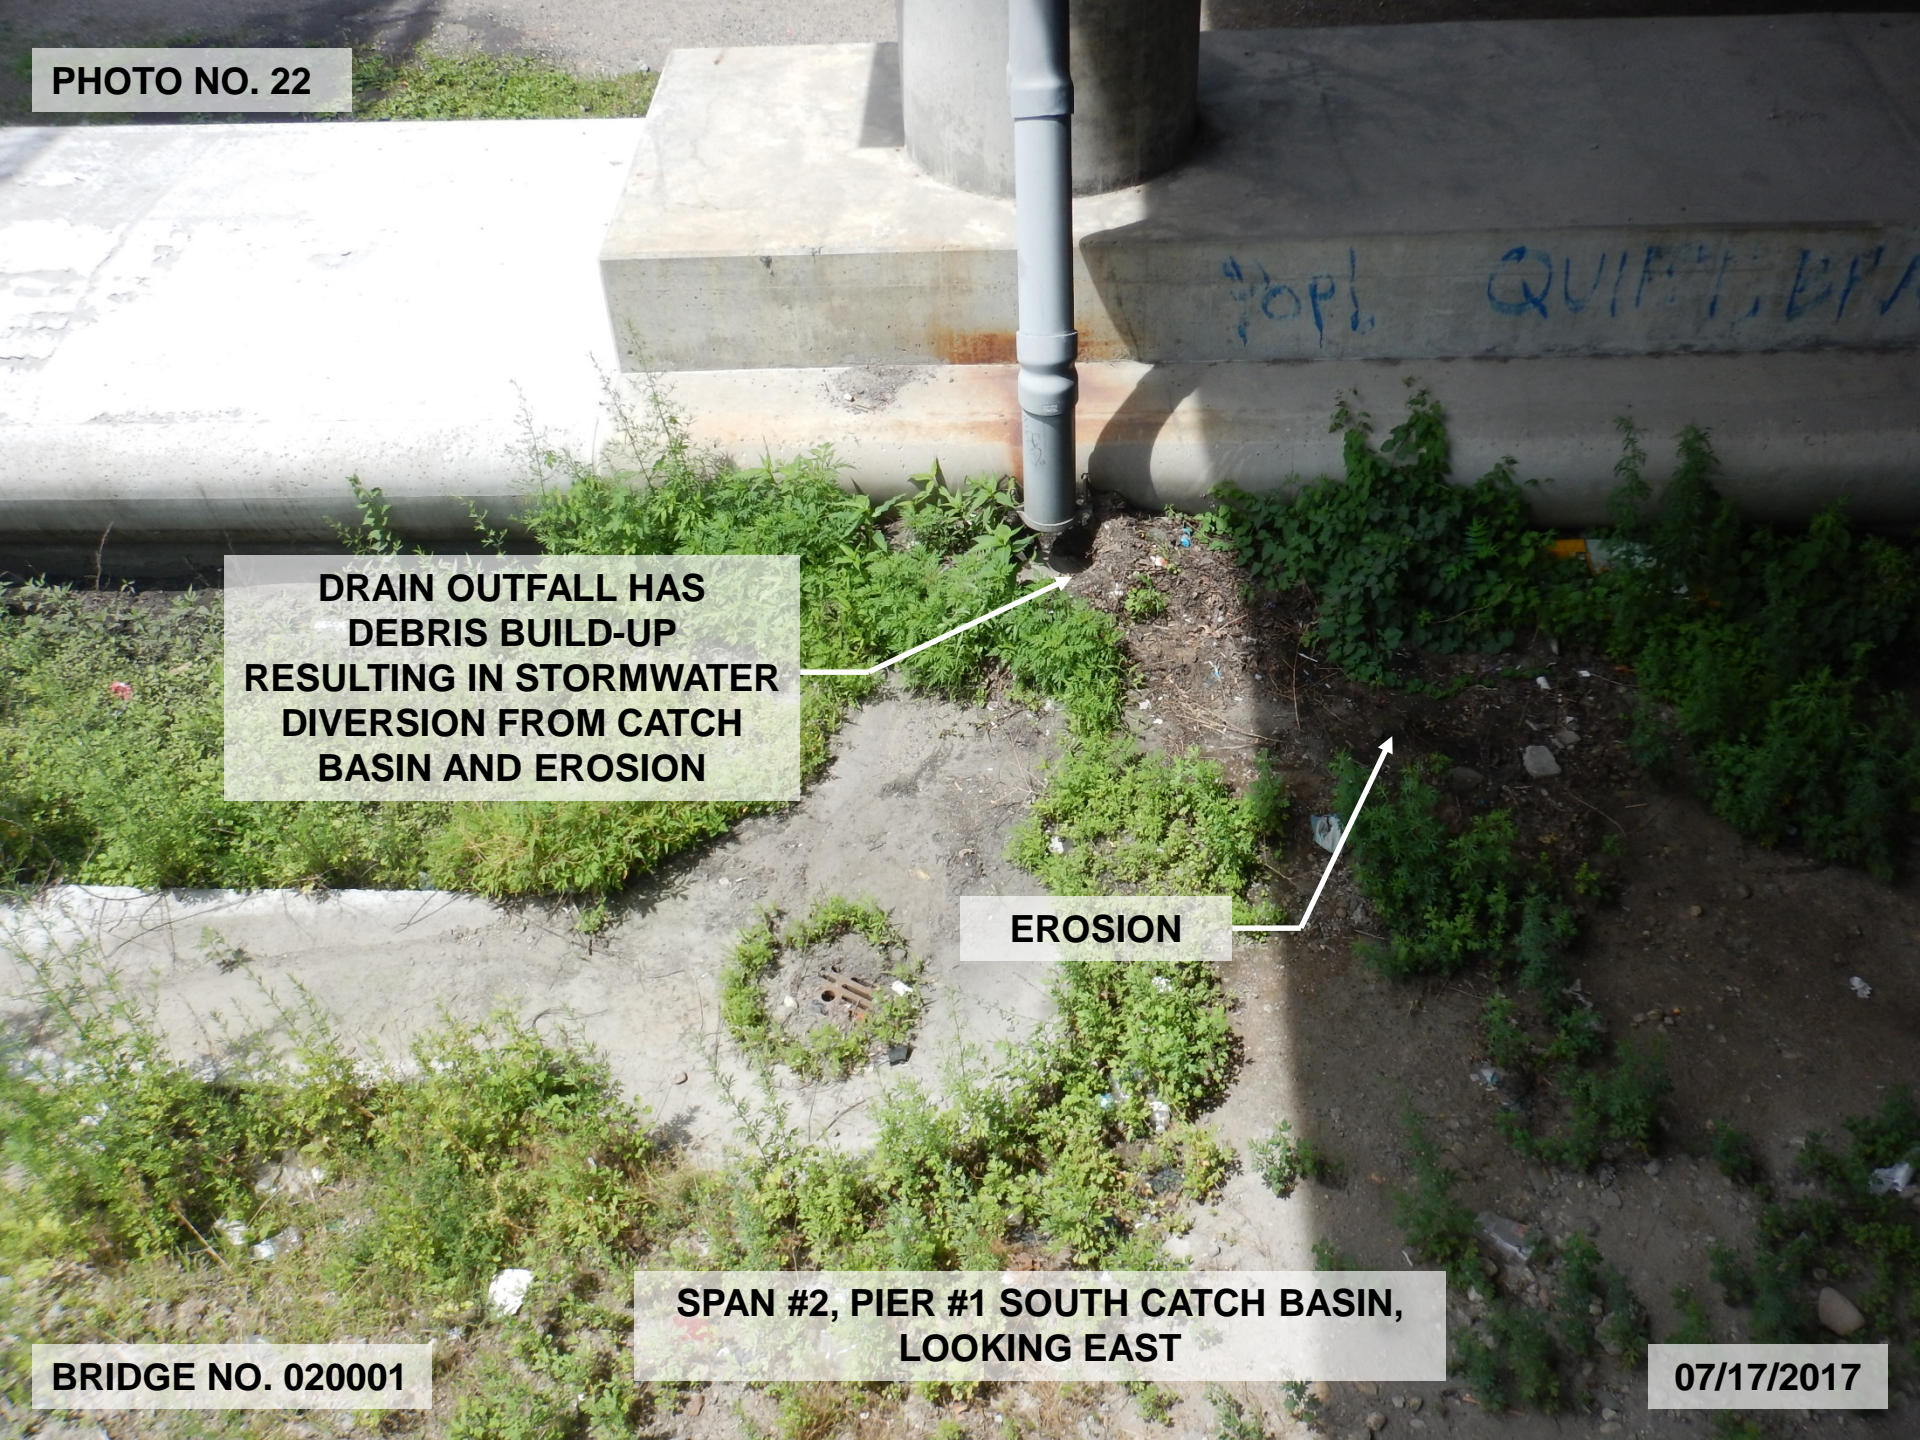
PHOTO NO. 23

SIGNS OF LEAKAGE
FROM ANCHOR BOLT
HOLE IN DECK
UNDERSIDE

LAMINAR RUST 14' LONG
AT TOP FACE OF BOTTOM
FLANGE CONTINUES TO
SECOND CROSS FRAME
FROM PIER #3

LAMINAR RUST 14' LONG
x 3" HIGH ON BOTTOM OF
NORTH WEB

LAMINAR RUST 4'
LONG UNDERSIDE OF
BOTTOM FLANGE

SPAN #3, BAY "G" NEAR SECOND CROSS
FRAME FROM PIER #3, LOOKING SOUTHWEST

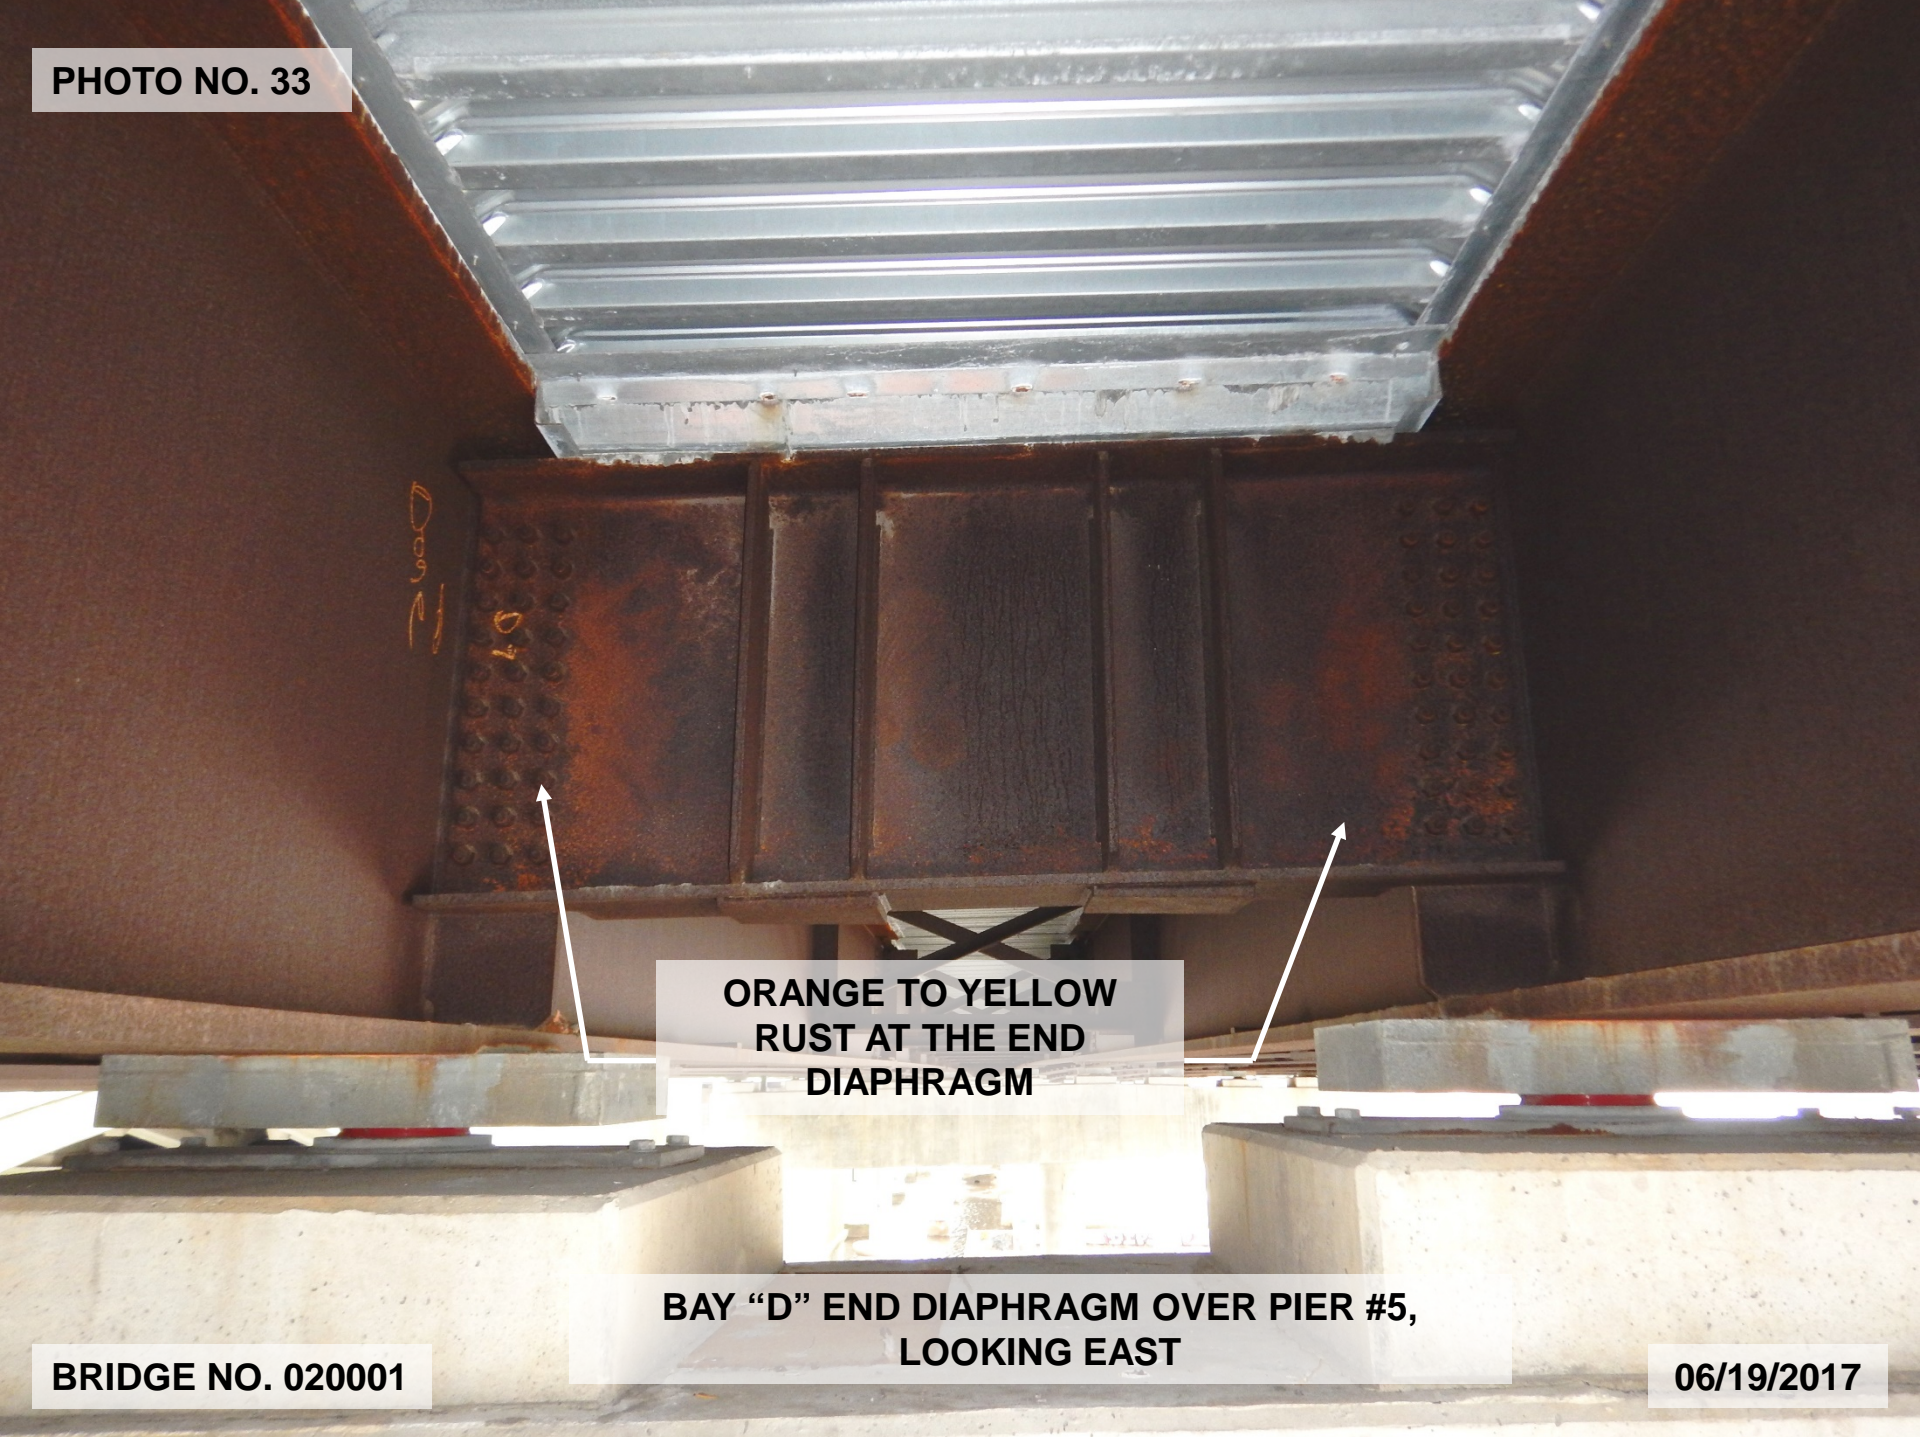
PHOTO NO. 33

ORANGE TO YELLOW
RUST AT THE END
DIAPHRAGM

BAY "D" END DIAPHRAGM OVER PIER #5,
LOOKING EAST

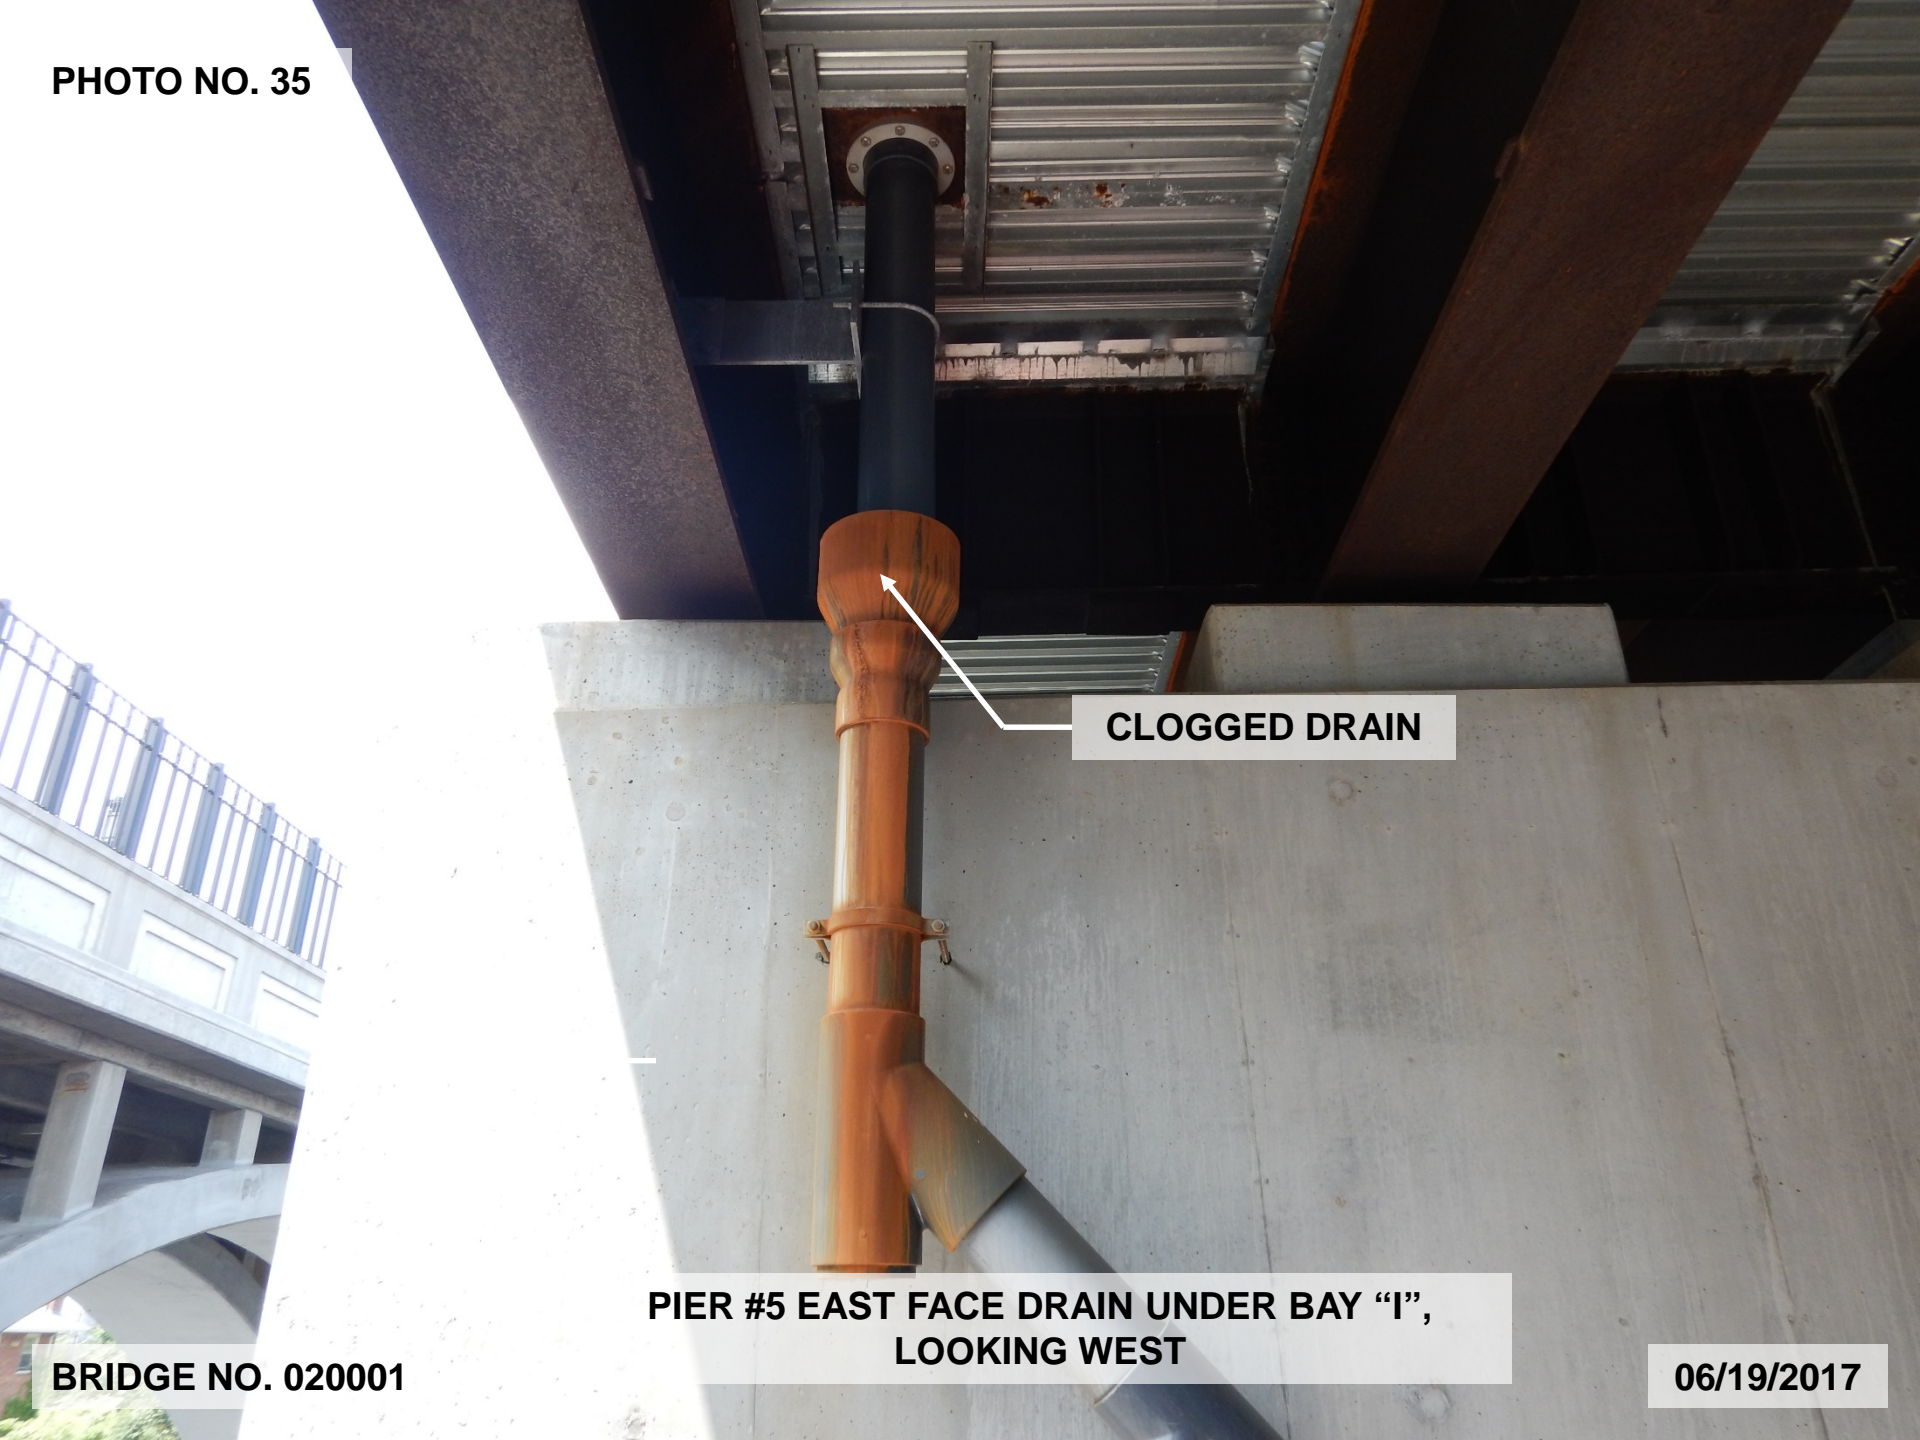
PHOTO NO. 35

CLOGGED DRAIN

**PIER #5 EAST FACE DRAIN UNDER BAY "I",
LOOKING WEST**
