WASHINGTON
BRIDGE
NO. 200

BRIDGE NO. 020001

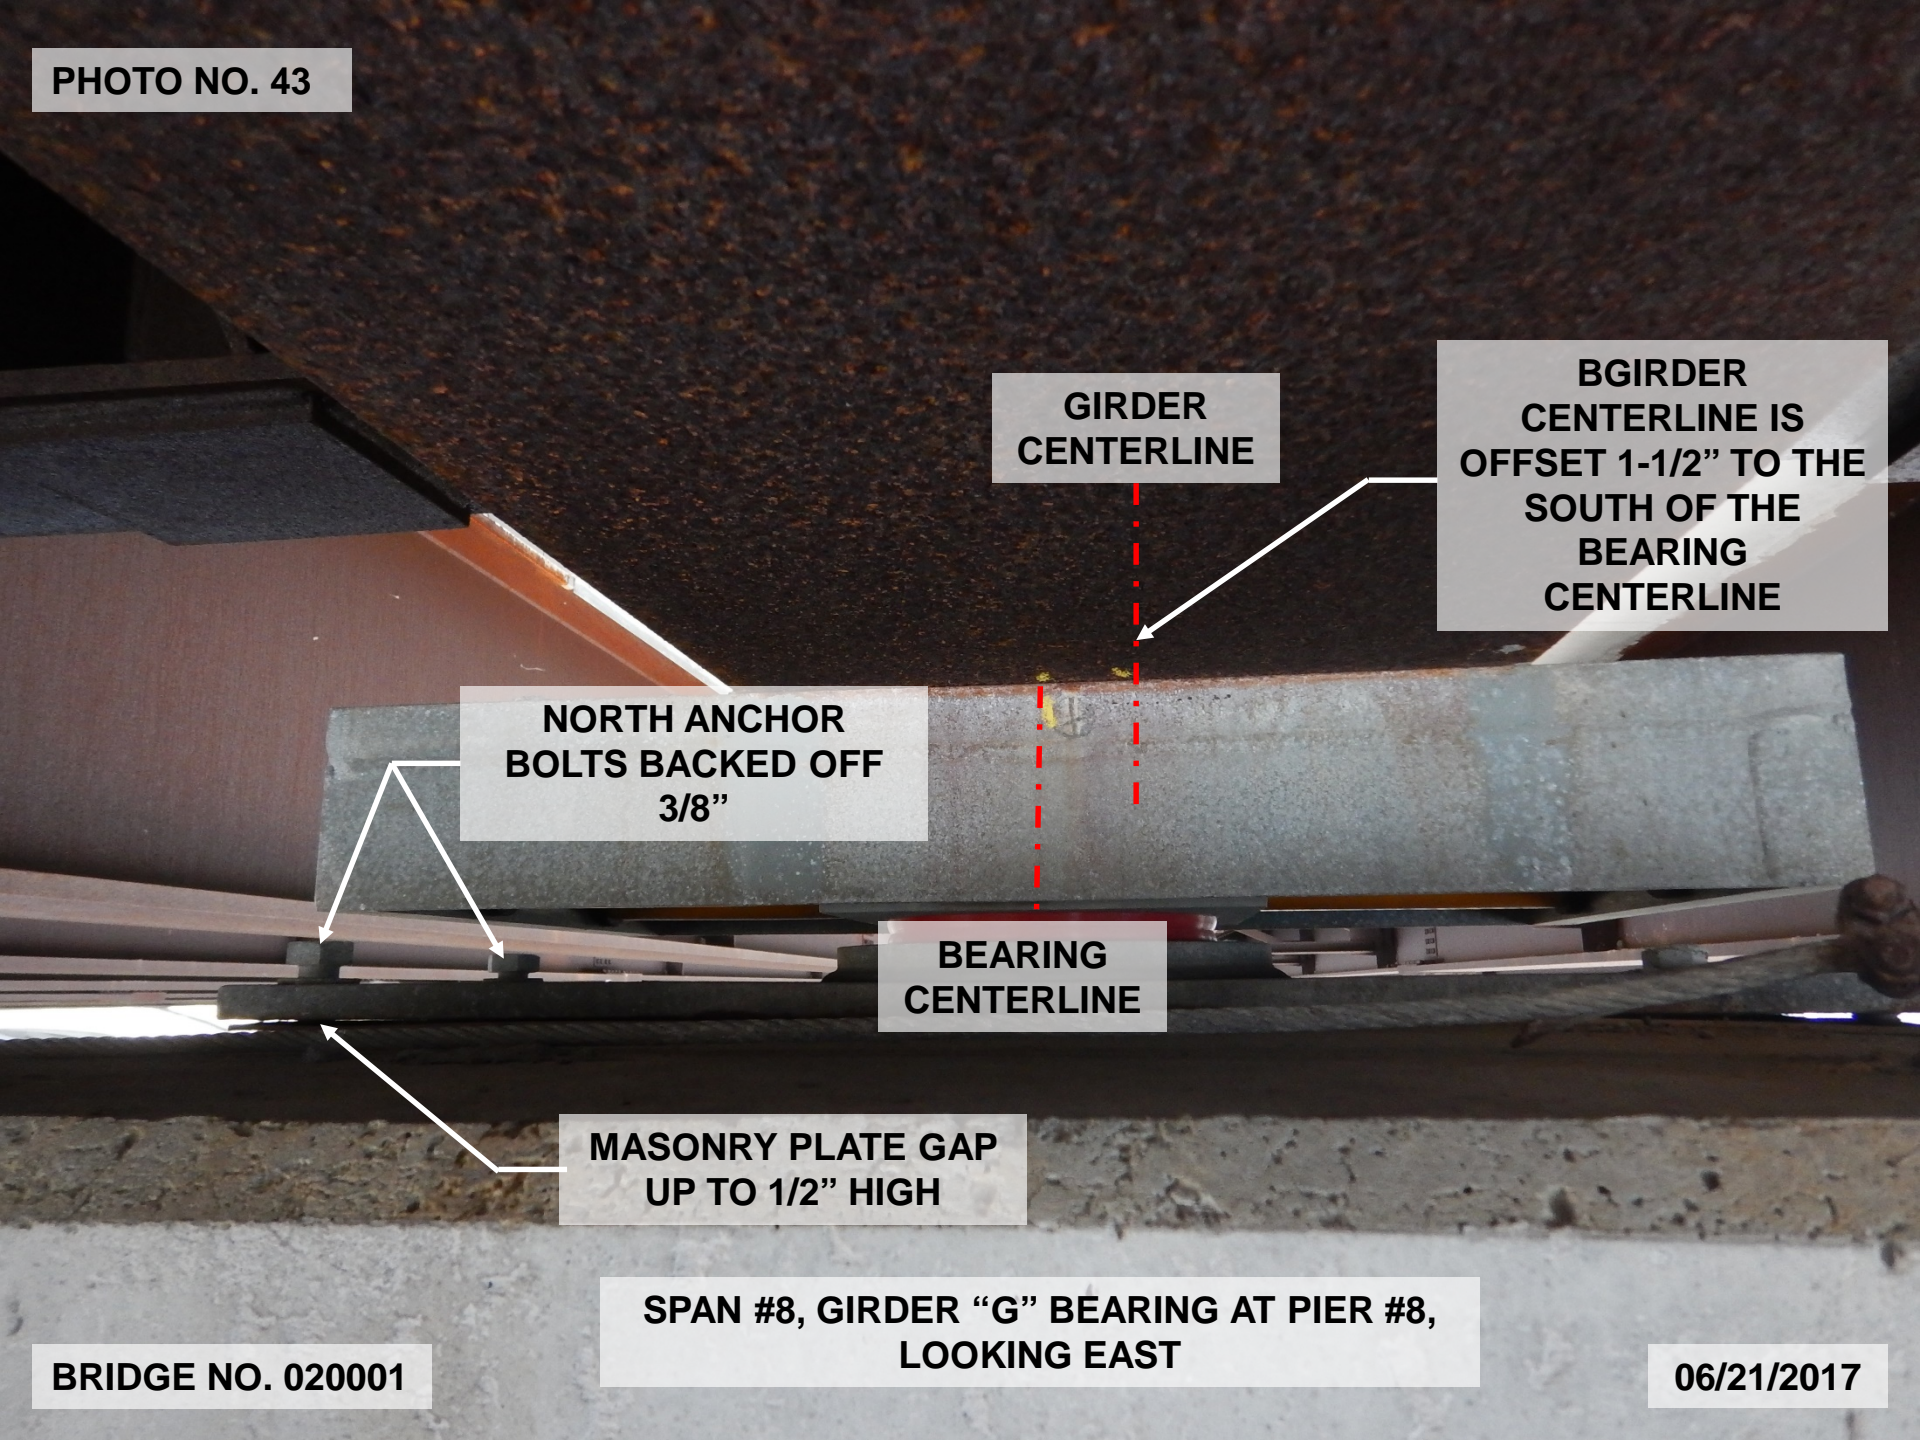
PHOTO NO. 43

BGIRDER
CENTERLINE IS
OFFSET 1-1/2" TO THE
SOUTH OF THE
BEARING
CENTERLINE

NORTH ANCHOR
BOLTS BACKED OFF
3/8"

MASONRY PLATE GAP
UP TO 1/2" HIGH

SPAN #8, GIRDER "G" BEARING AT PIER #8,
LOOKING EAST

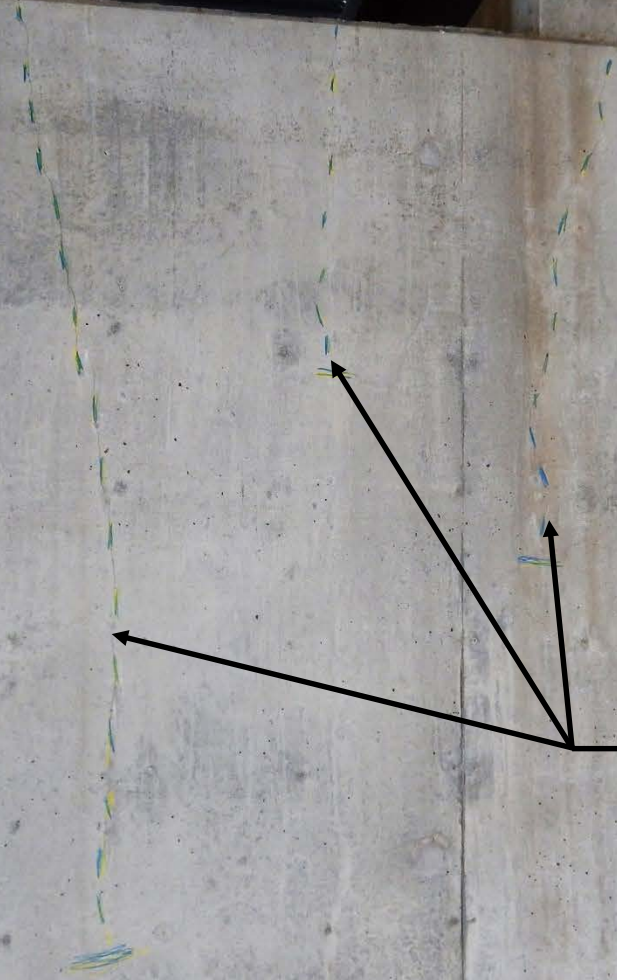
PHOTO NO. 44

3 VERTICAL/DIAGONAL
HAIRLINE CRACKS
EXTENDING FROM TOP
OF CAP

PIER #8, EAST FACE OF PIER CAP BELOW
GIRDERS "B" AND "C", LOOKING WEST

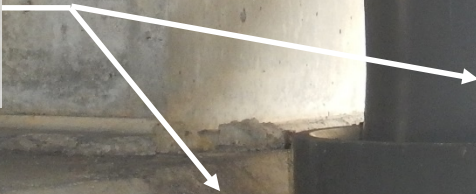
PHOTO NO. 54

**EVIDENCE OF WATER
SPLASHING ONTO
PIER FACE FROM
DRAIN PIPE**

**SPAN #12, BAY "A" AT PIER #11,
LOOKING NORTH**

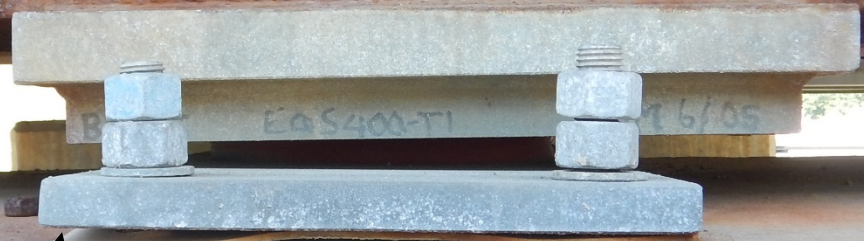
PHOTO NO. 58

GAP BETWEEN MASONRY PLATE AND
CONCRETE PEDESTAL UP TO 5/8" HIGH

GIRDER "J" AT PIER #13, LOOKING NORTH

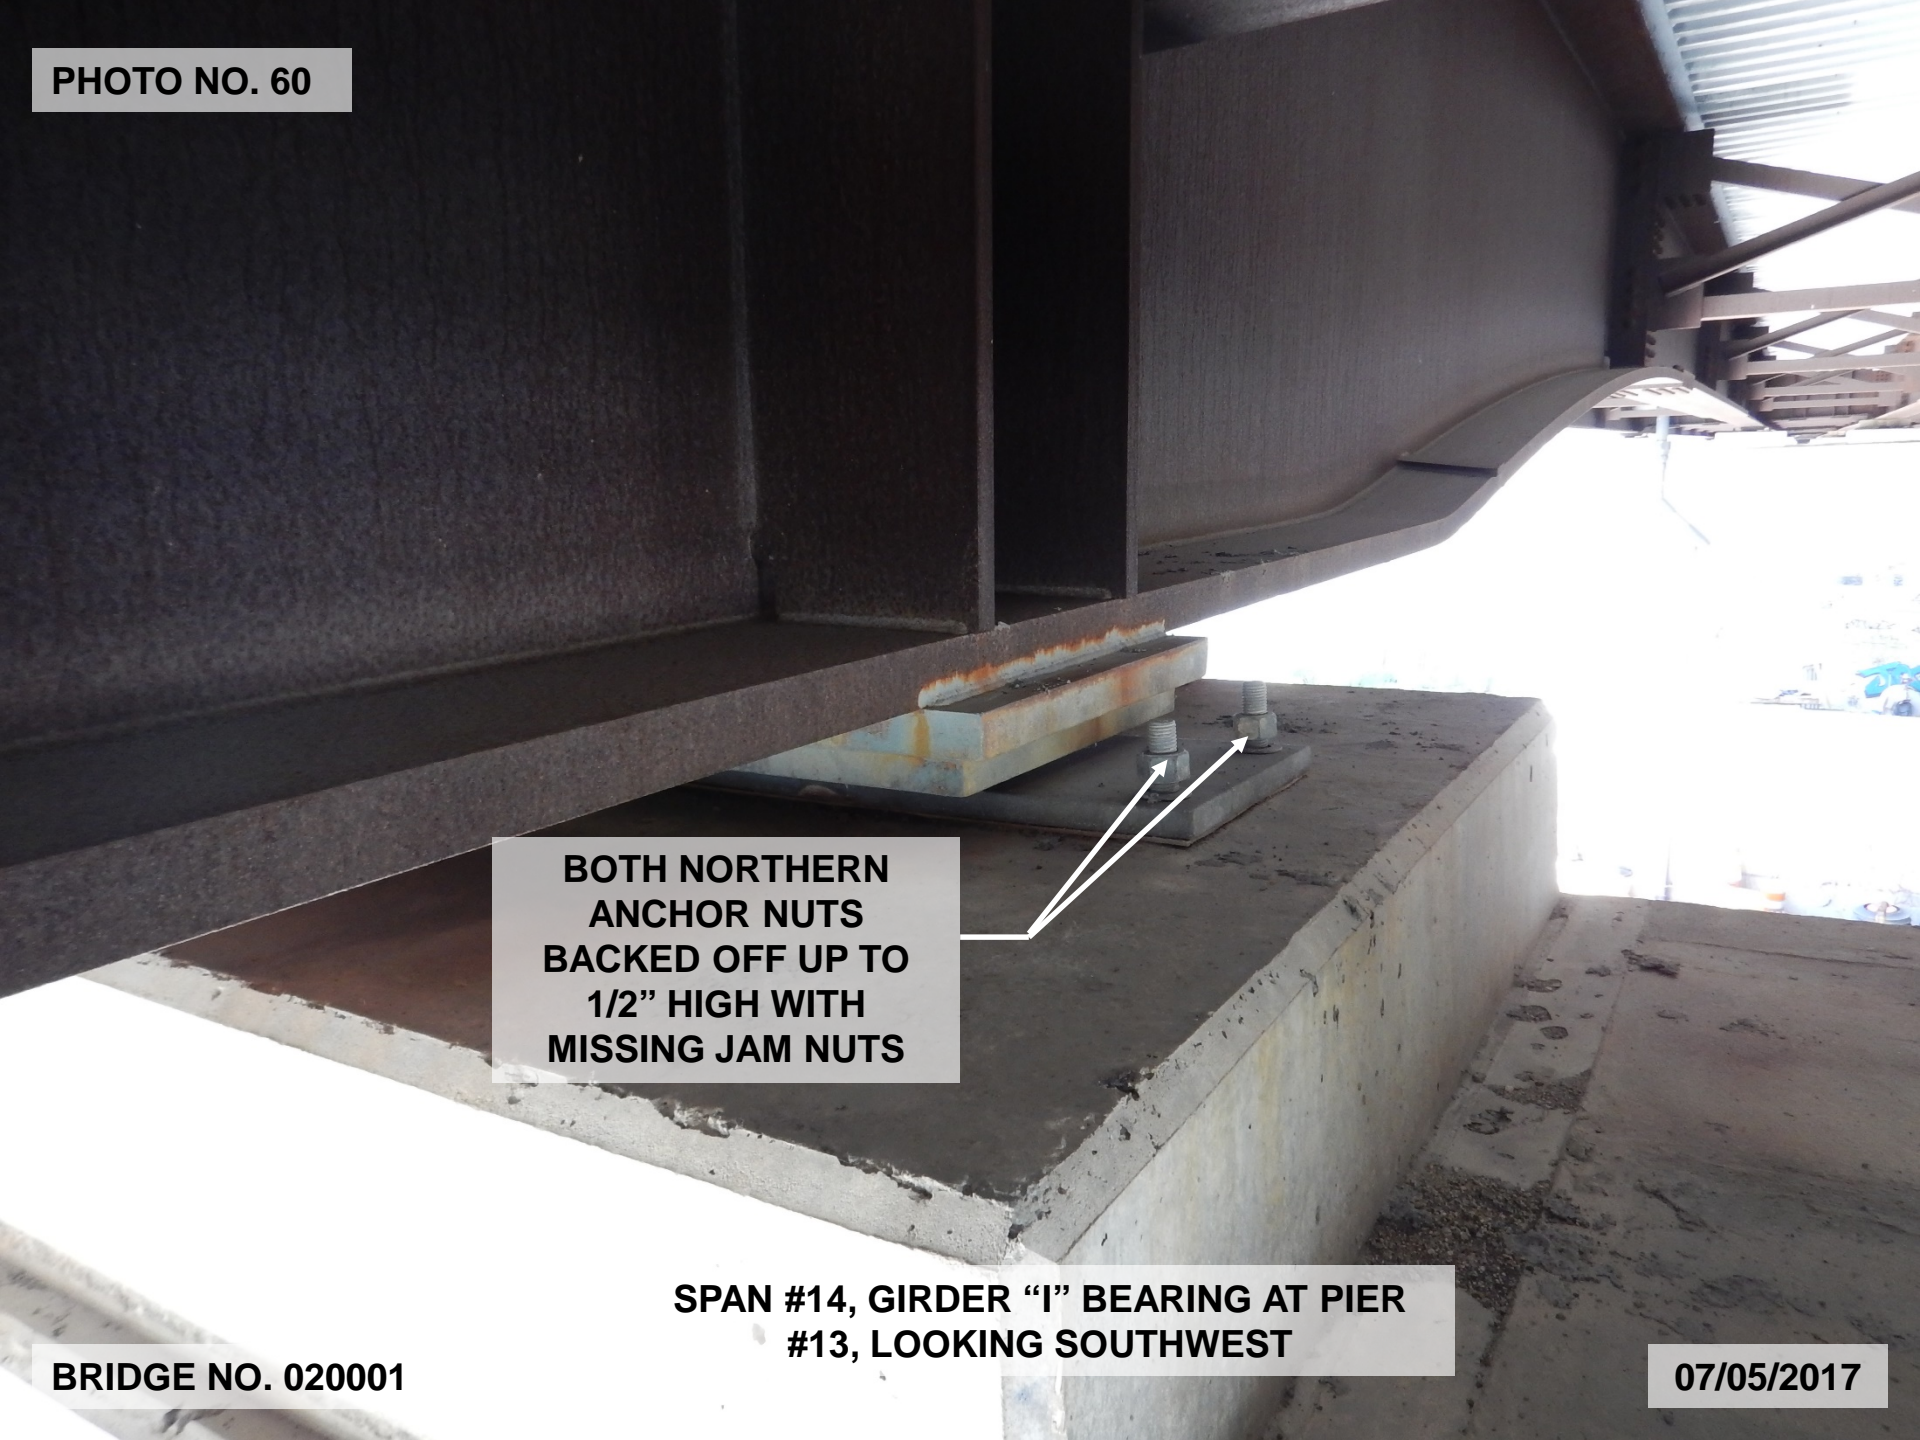
PHOTO NO. 60

**BOTH NORTHERN
ANCHOR NUTS
BACKED OFF UP TO
1/2" HIGH WITH
MISSING JAM NUTS**

**SPAN #14, GIRDER "I" BEARING AT PIER
#13, LOOKING SOUTHWEST**
