**Underwater Inspection of
Bridge Nos. 020001 & 020021
Washington Bridge South & Washington Bridge South
Pedestrian
Interstate 195 Eastbound & Bike Path/Pedestrian Bridge
Over
Seekonk River
In
East Providence, Rhode Island**

July 24, 2017

Underwater Inspection Report

Bridge Nos.: 020001 & 020021 Inspection Date: 7/24/2017
Bridge Names: Washington Bridge South & Washington Bridge South Pedestrian
Facility Carried: Interstate 195 Eastbound & Bike Path/Pedestrian
Feature Intersected: Seekonk River
City/Town: East Providence

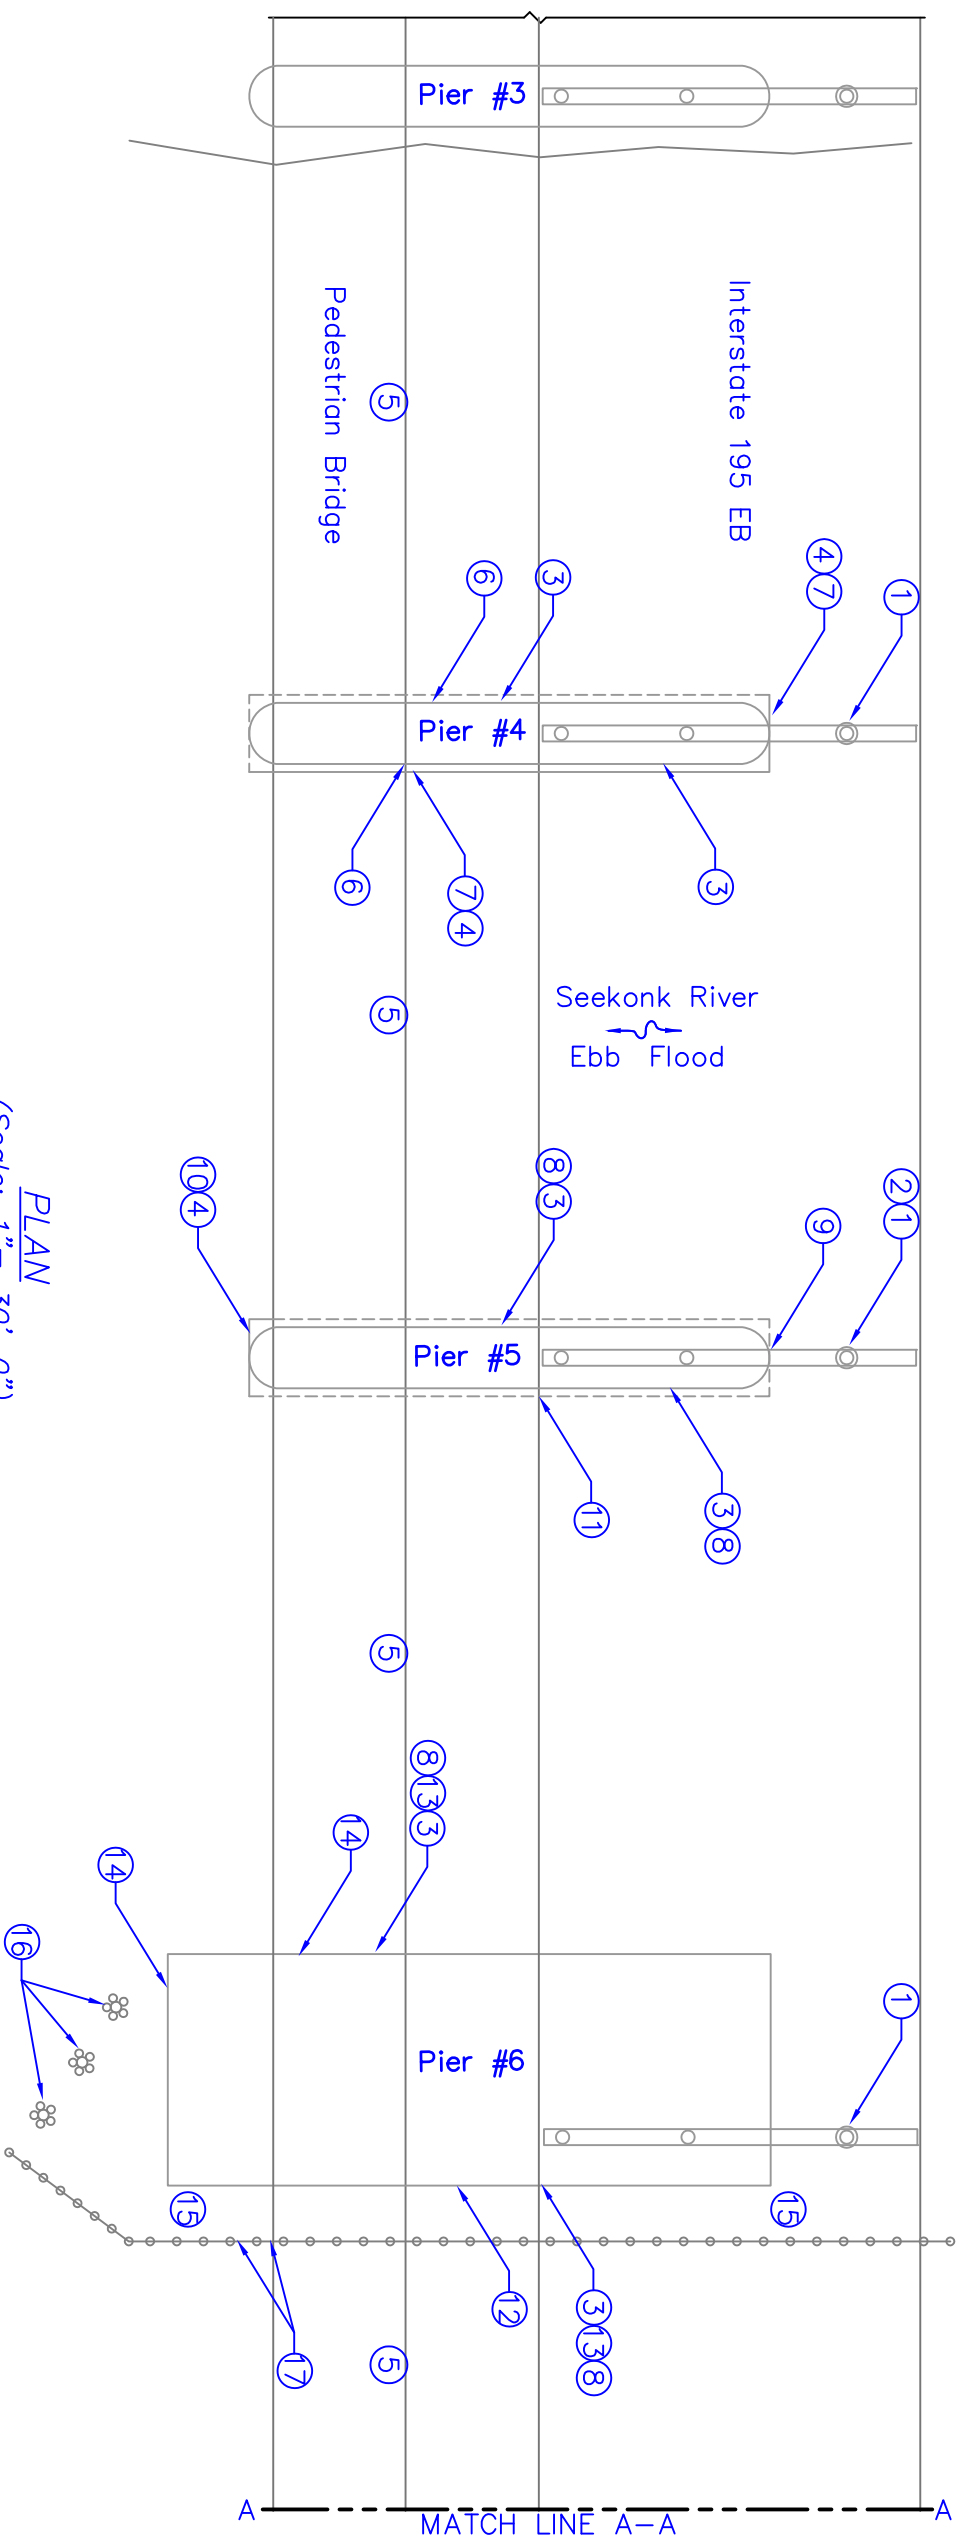
PLAN (PIER #4 TO PIER #6)

- ① At Piers #4 thru #6, the caisson pile at the north (upstream) end of the pier exhibits minor corrosion on the exposed portions of the steel casing. Also, there is a fiberglass wrap that extends 13-1/2' down from the underside of the concrete cap that exhibits no significant deficiencies.

- ② At Pier #5, the steel casing of the caisson pile exhibits a 1' high band of laminar corrosion with negligible section loss.
- ③ At Piers #4 thru #6 the granite stone masonry facade exhibits less than 5% deteriorated mortar with 3" to 6" of penetration between stones.

- ⑥ At Pier #4, there is a crack full height x 1/4" wide that extends onto the concrete step / pile cap near midspan of the west face and one cracked stone full height x 1/4" wide in the fourth stone course near the south end of the east face of the pier.

- ⑪ At Pier #5, there is rip rap up to 2' diameter intermittently along the full length of the east face of the pier.
- ⑫ At Pier #6, there is a missing granite stone 2' long x 2-1/2' high.

- ⑬ At Pier #6, there are isolated full-height cracked stones in the granite facade.
- ⑭ At Pier #6, there are voids at the concrete/granite interface up to 3' long x 6" high x 6" deep along the south and west faces of the pier.

- ⑯ The previously noted (2013) areas of splintering / section loss to the dolphin pile groups at the south (downstream) end of the fenders was not found and the piles appear to have been replaced.

- ⑰ The timber fender system members along the east side of Pier #6 exhibit minor checks and splits in the tidal zone and a fractured handrail in two locations with one broken post.

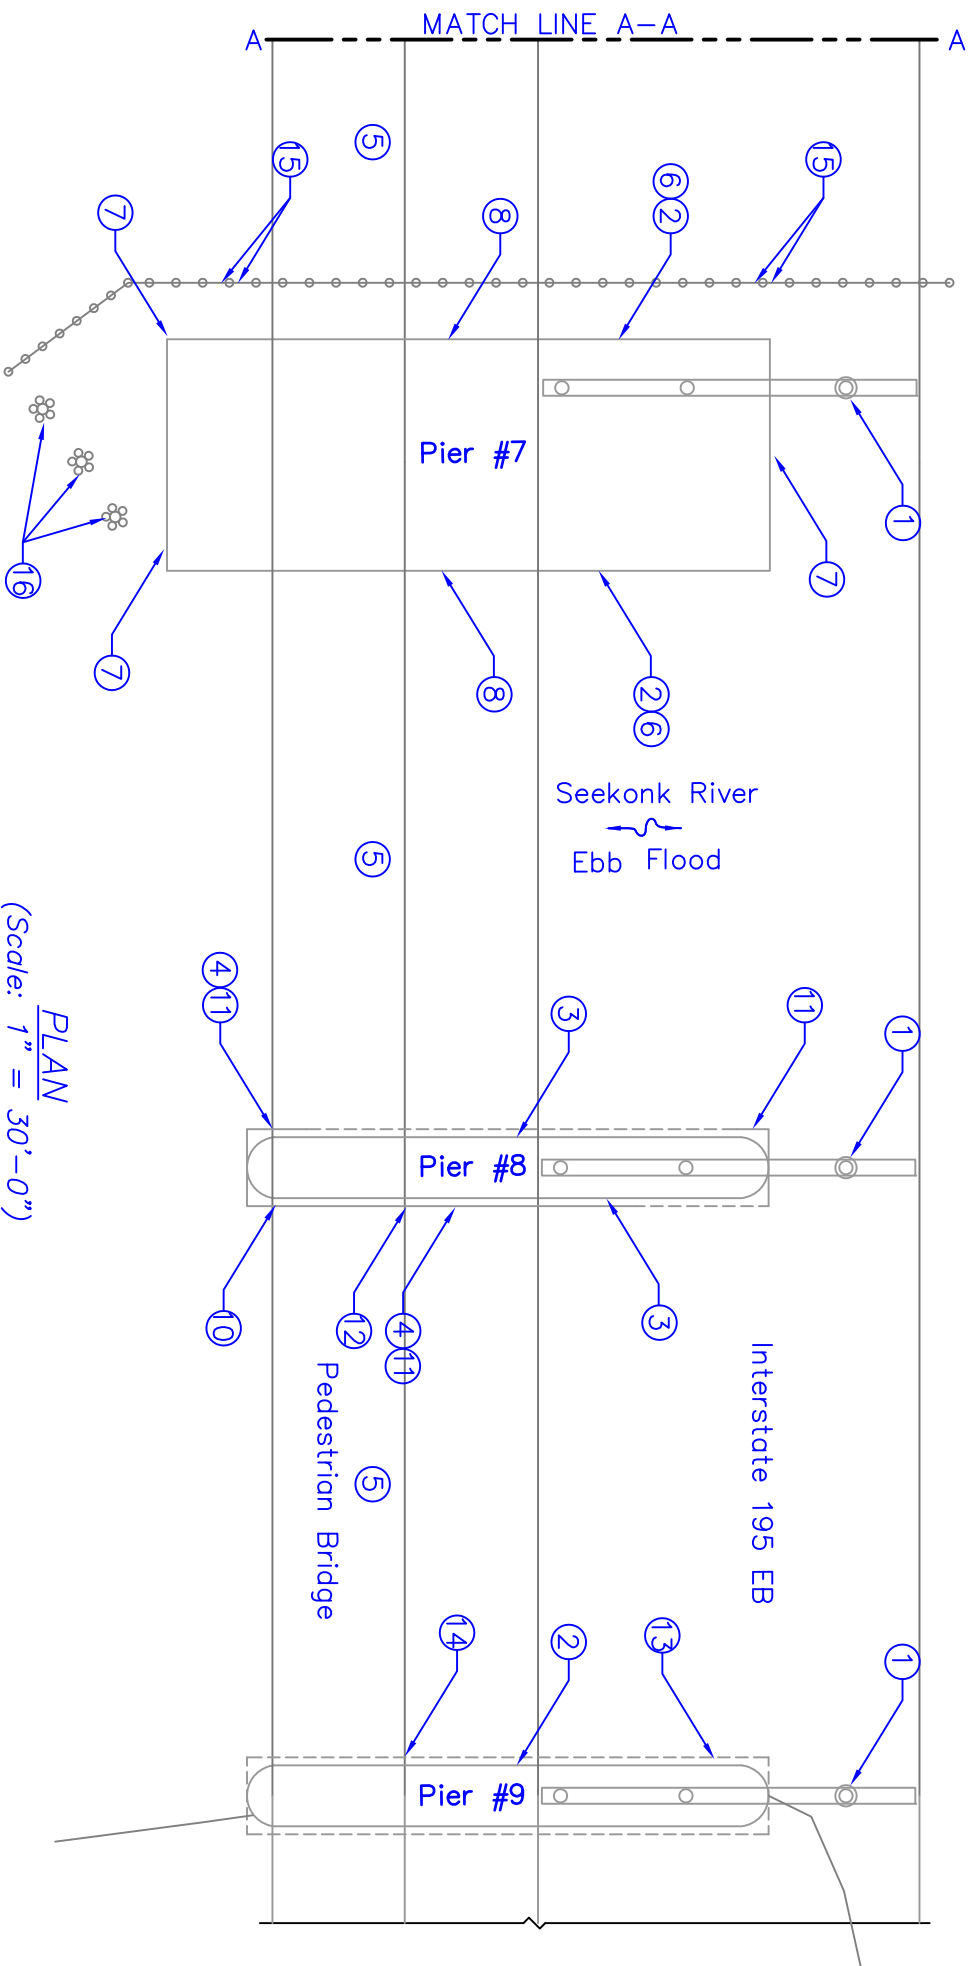
- ① At Piers #7 thru #9, the caisson pile at the north (upstream) end of the pier exhibits minor corrosion on the exposed portions of the steel casing. Also, there is a fiberglass wrap that extends 13-1/2' down from the underside of the concrete cap that exhibits no significant deficiencies.

- ② At Piers #7 and #9, the granite stone masonry facade exhibit less than 5% deteriorated mortar with between 3" to 6" of penetration between stones and isolated full-height cracked stones.

- ③ At Pier #8, the granite stone masonry facade exhibits 15% deteriorated mortar with up to 6" of penetration between stones and isolated full-height cracked stones.

- ⑧ At Pier #7, there are vertical cracks open between 1/8" and 1/4" wide that extend from the top of the pile cope down to the channel bottom near the midpoint of the pier stem on the west and east faces. The cracks have previously been partially sealed with epoxy and mortar.

- ⑨ At Pier #7, there is are missing granite stones 3-1/2' long x 5' high on the west face of the pier.
- ⑩ At Pier #8, there is a void in the concrete step / pile cap 18" long x 6" high x 2" deep at the south end of the east face of the pier.

- ⑫ At Pier #8, there is a vertical crack in the top two stone courses below the cap up to 1/2" wide.
- ⑬ At Pier #9, the previously noted (2013) exposure of the reinforced concrete step / pile cap 65' long x up to 0.5' vertically along the west face of the pier was not found.

- ⑭ At Pier #9, there is a crack through the first three stone courses x 1/2" wide near the south end of the west face of the pier.
- ⑮ The fender system members along the west side of Pier #7 exhibit minor checks and splits in the tidal zone and a missing section of handrail near the south end.

- ⑯ The previously noted (2013) areas of splintering / section loss to the dolphin pile groups at the south (downstream) end of the fenders was not found and the piles appear to have been replaced.

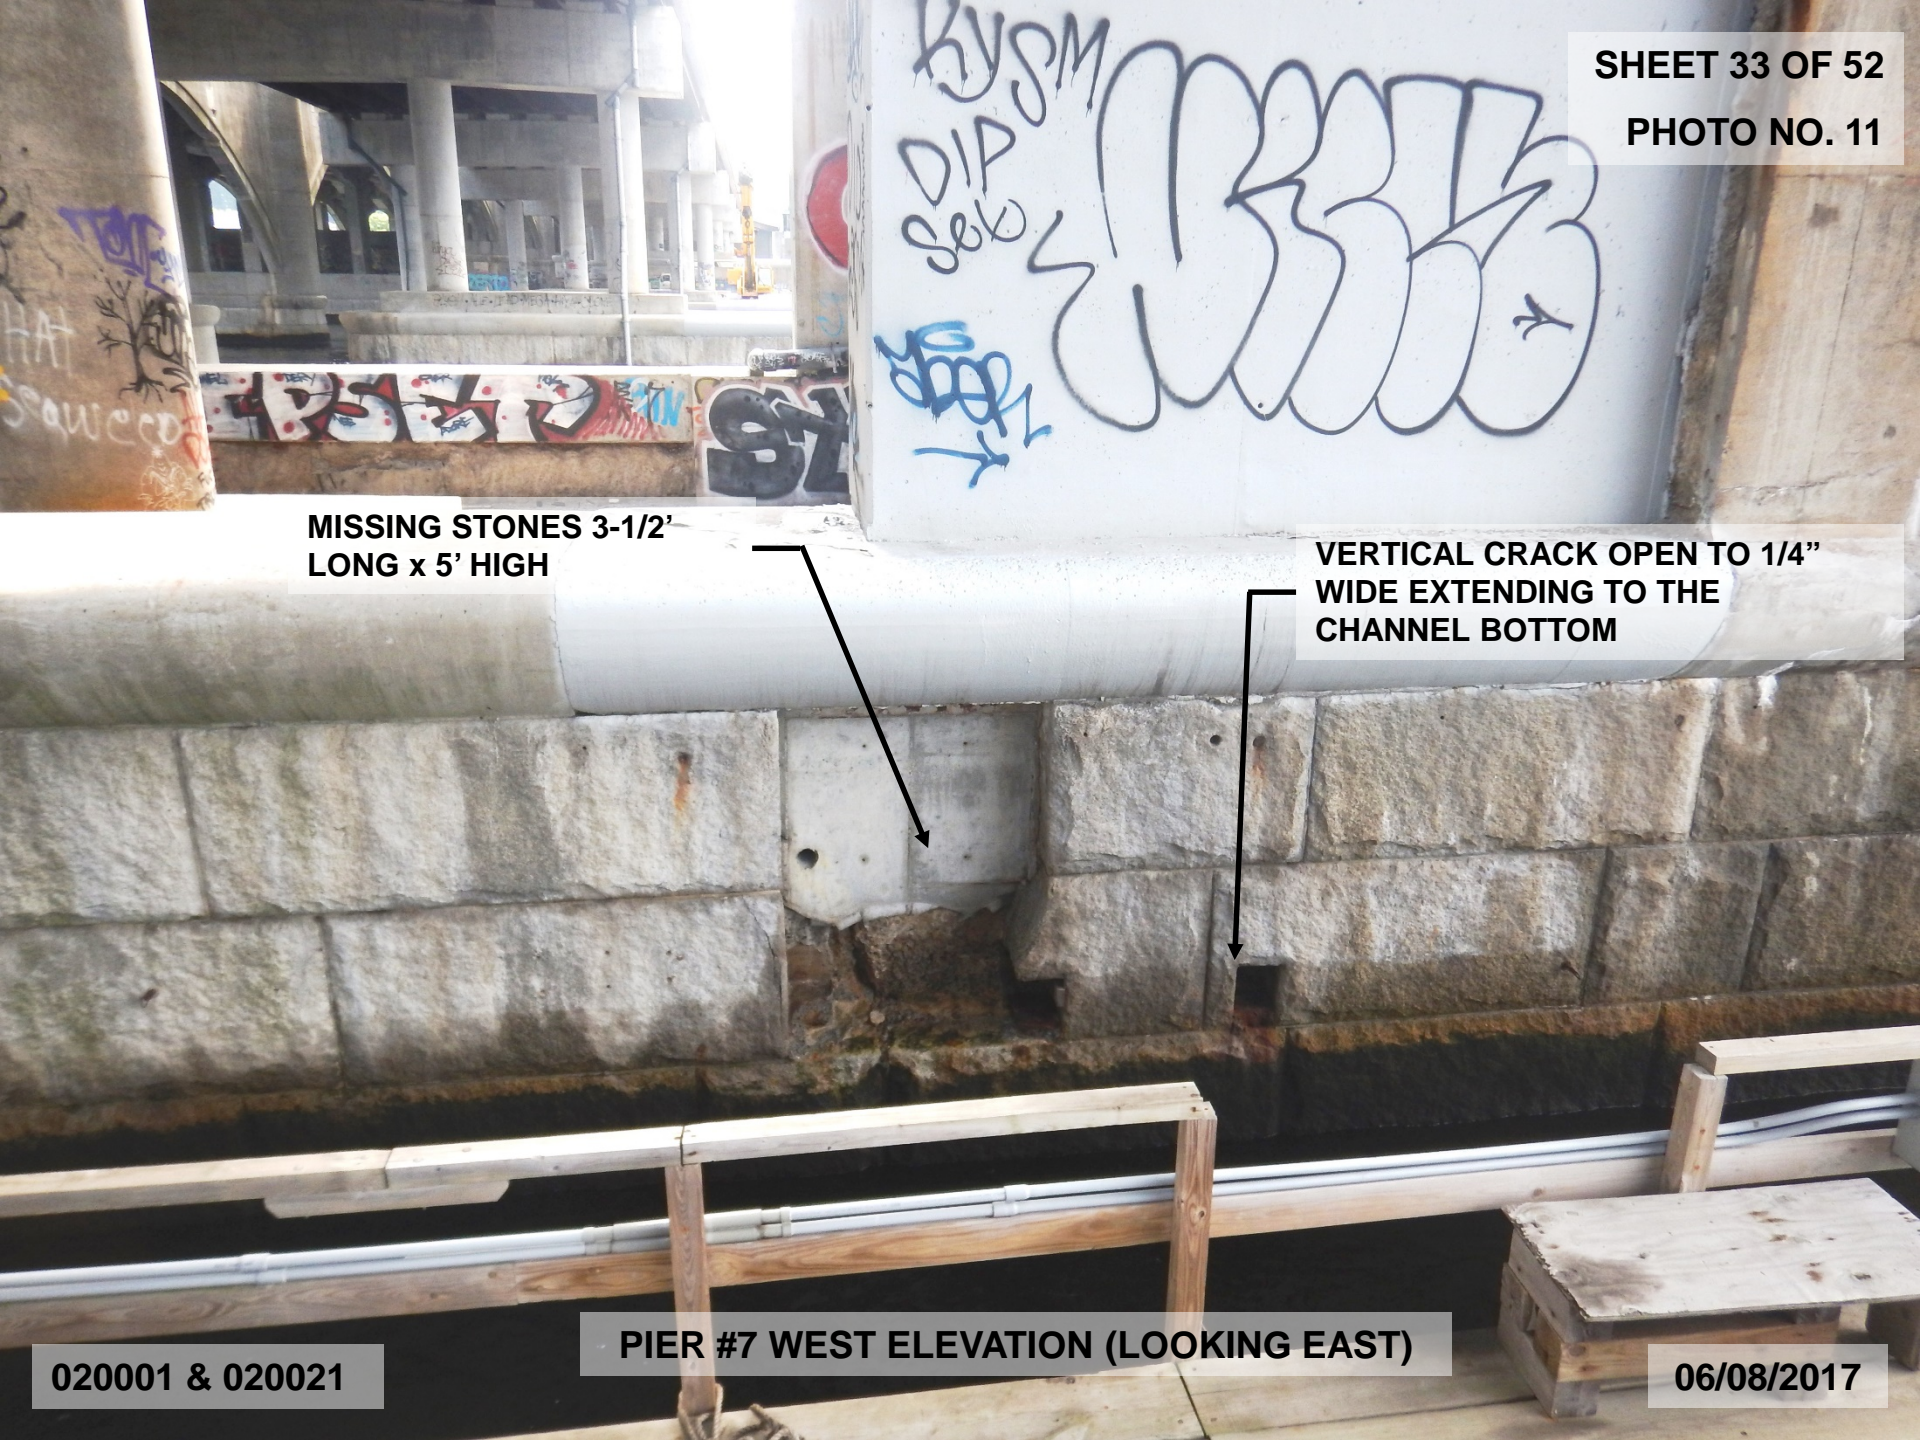
MISSING STONES 3-1/2'
LONG x 5' HIGH

VERTICAL CRACK OPEN TO 1/4"
WIDE EXTENDING TO THE
CHANNEL BOTTOM

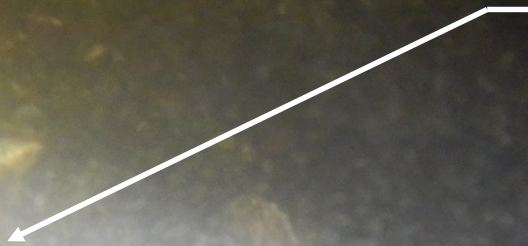
PIER #7 SOUTH ELEVATION (LOOKING NORTH)

AREA OF ABRASION 2' LONG
X 1' HIGH X UP TO 2" DEEP
LOCATED ON THE SOUTH
FACE OF THE PIER STEM

AREA OF ABRASION 12"
DIAMETER x 5" DEEP
LOCATED ON THE
SOUTHWEST CORNER OF
THE PIER STEM AT THE
CHANNEL BOTTOM

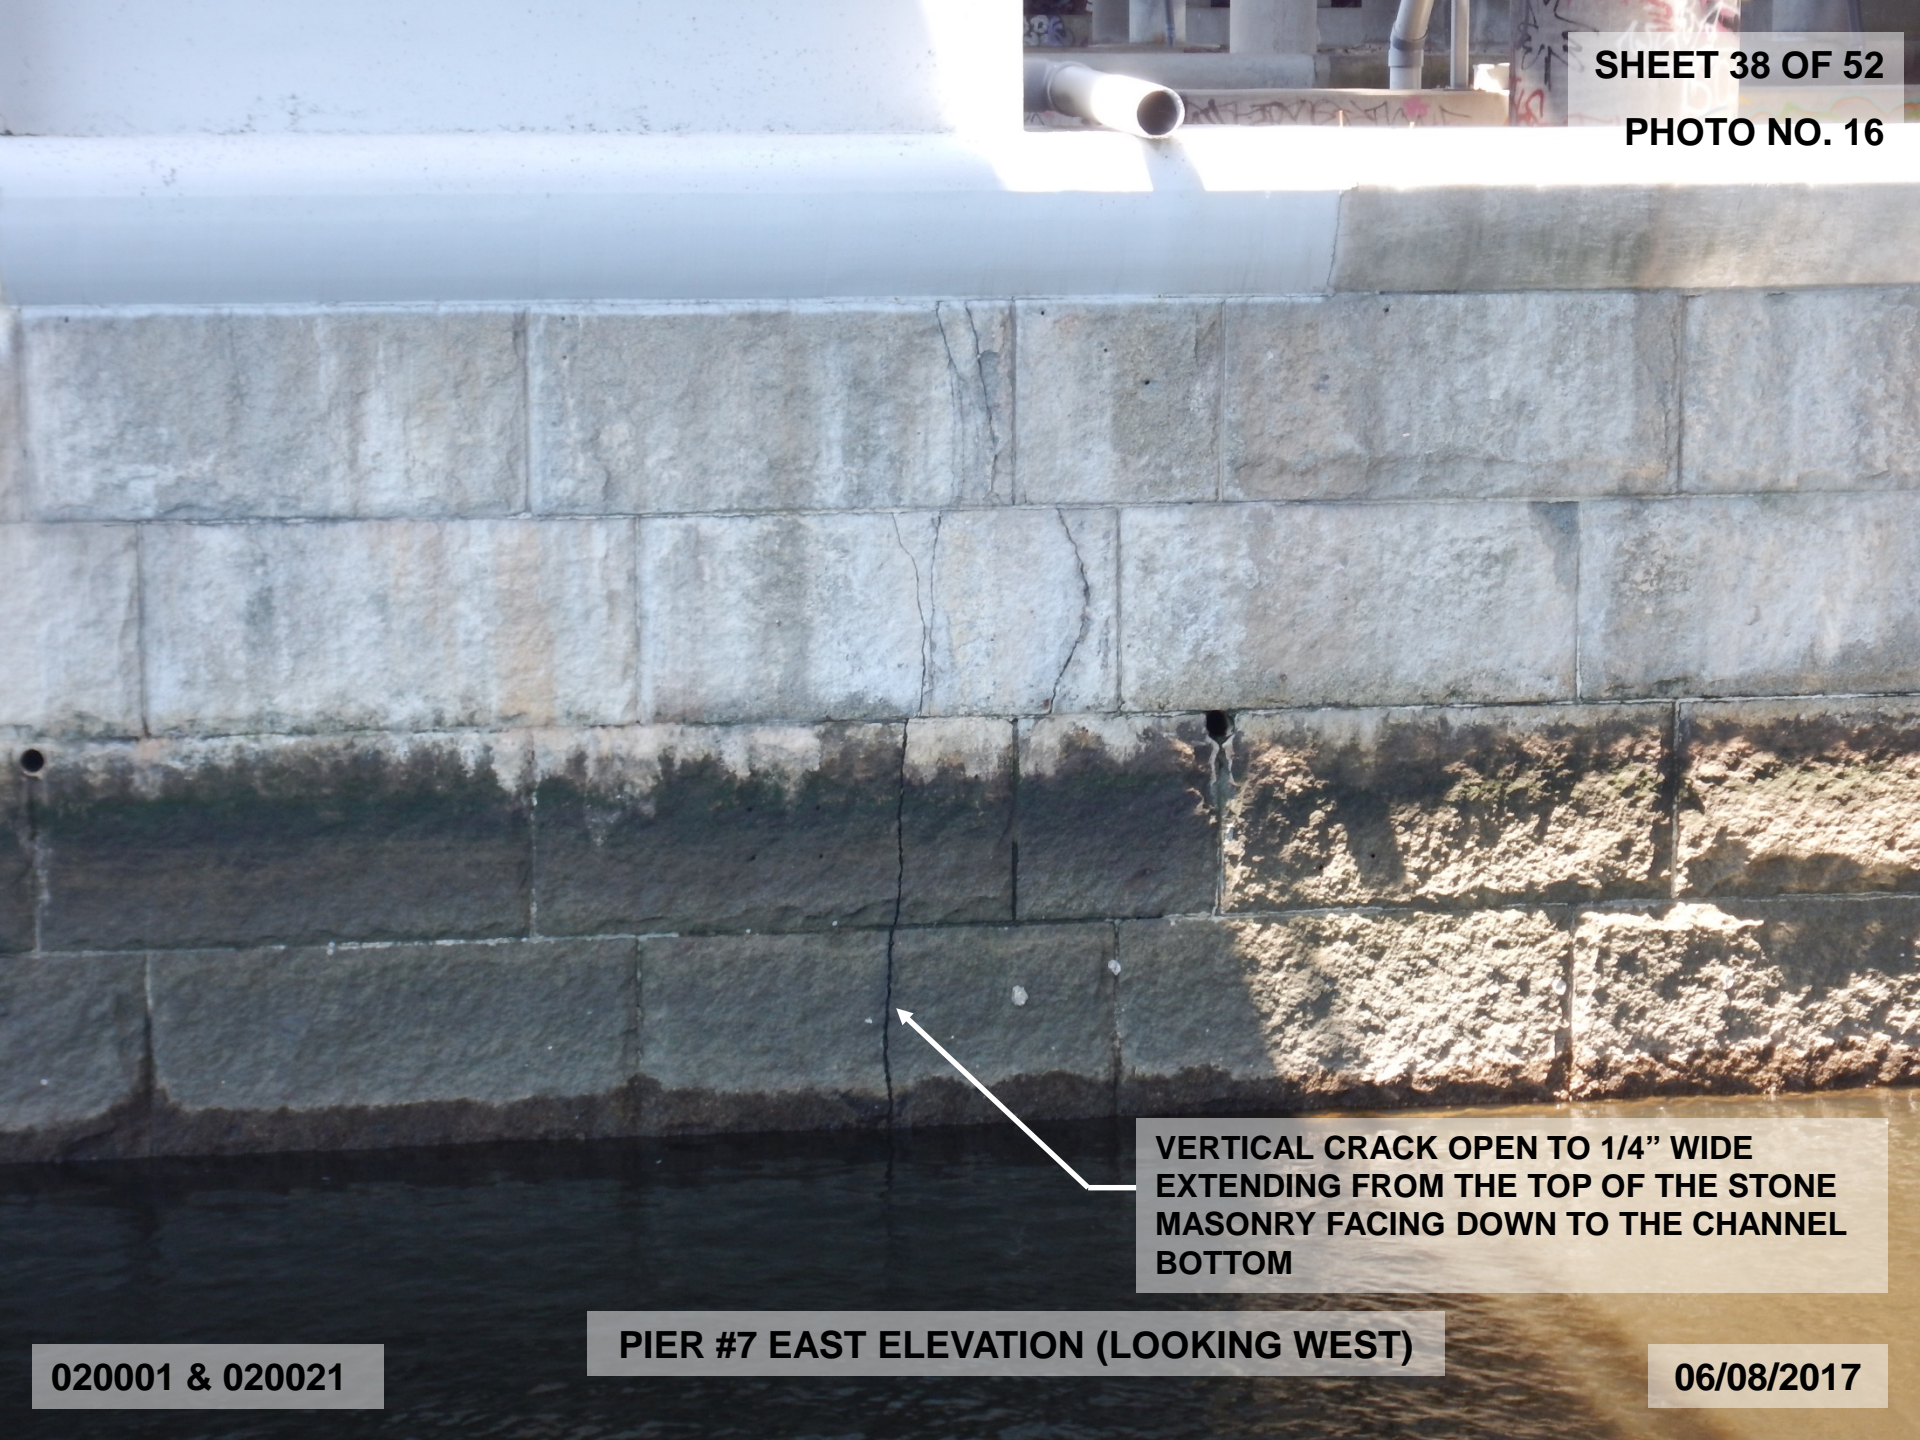
PIER #7 EAST ELEVATION (LOOKING WEST)

**STEEL ENCASED CAISSON
PILE WITH FIBERGLASS
JACKET IN THE TIDAL ZONE
WITH NO SIGNIFICANT
DEFICIENCIES**

**STONE MASONRY FACED PIER WALL WITH LESS
THAN 5% DETERIORATED MORTAR, 3" - 6"
PENETRATIONS BETWEEN STONES AND
ISOLATED FULL-HEIGHT CRACKED STONES**

**VERTICAL CRACK OPEN TO 1/4" WIDE EXTENDING
FROM THE TOP OF THE STONE MASONRY FACING
DOWN TO THE CHANNEL BOTTOM**

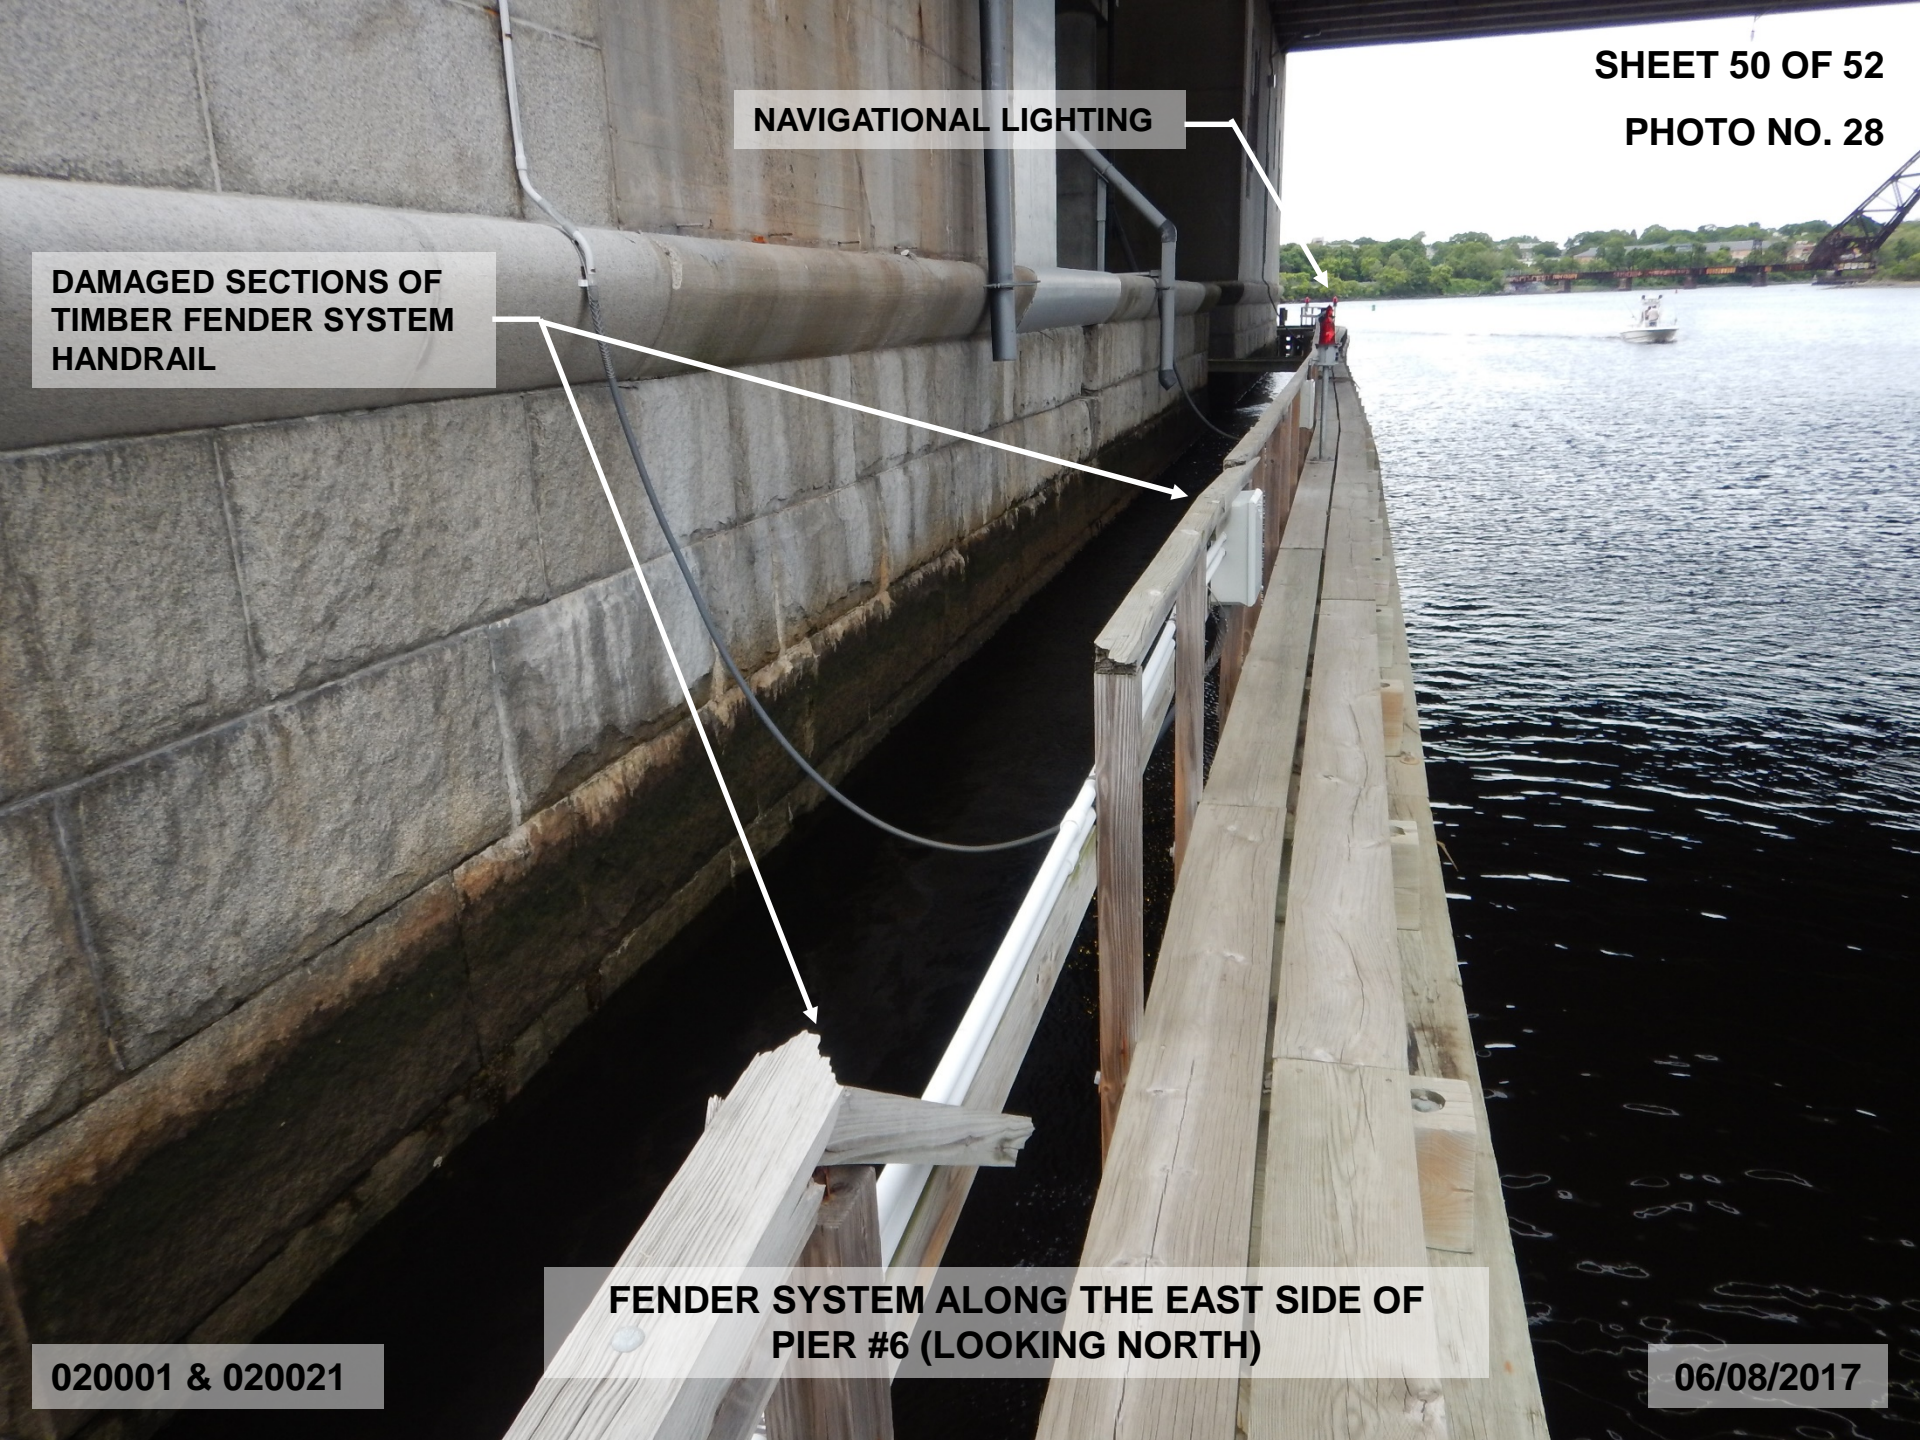
FENDER SYSTEM ALONG THE EAST SIDE OF
PIER #6 (LOOKING NORTH)

DAMAGED SECTIONS OF TIMBER
FENDER SYSTEM HANDRAIL

DAMAGED SECTIONS OF
TIMBER FENDER SYSTEM
HANDRAIL

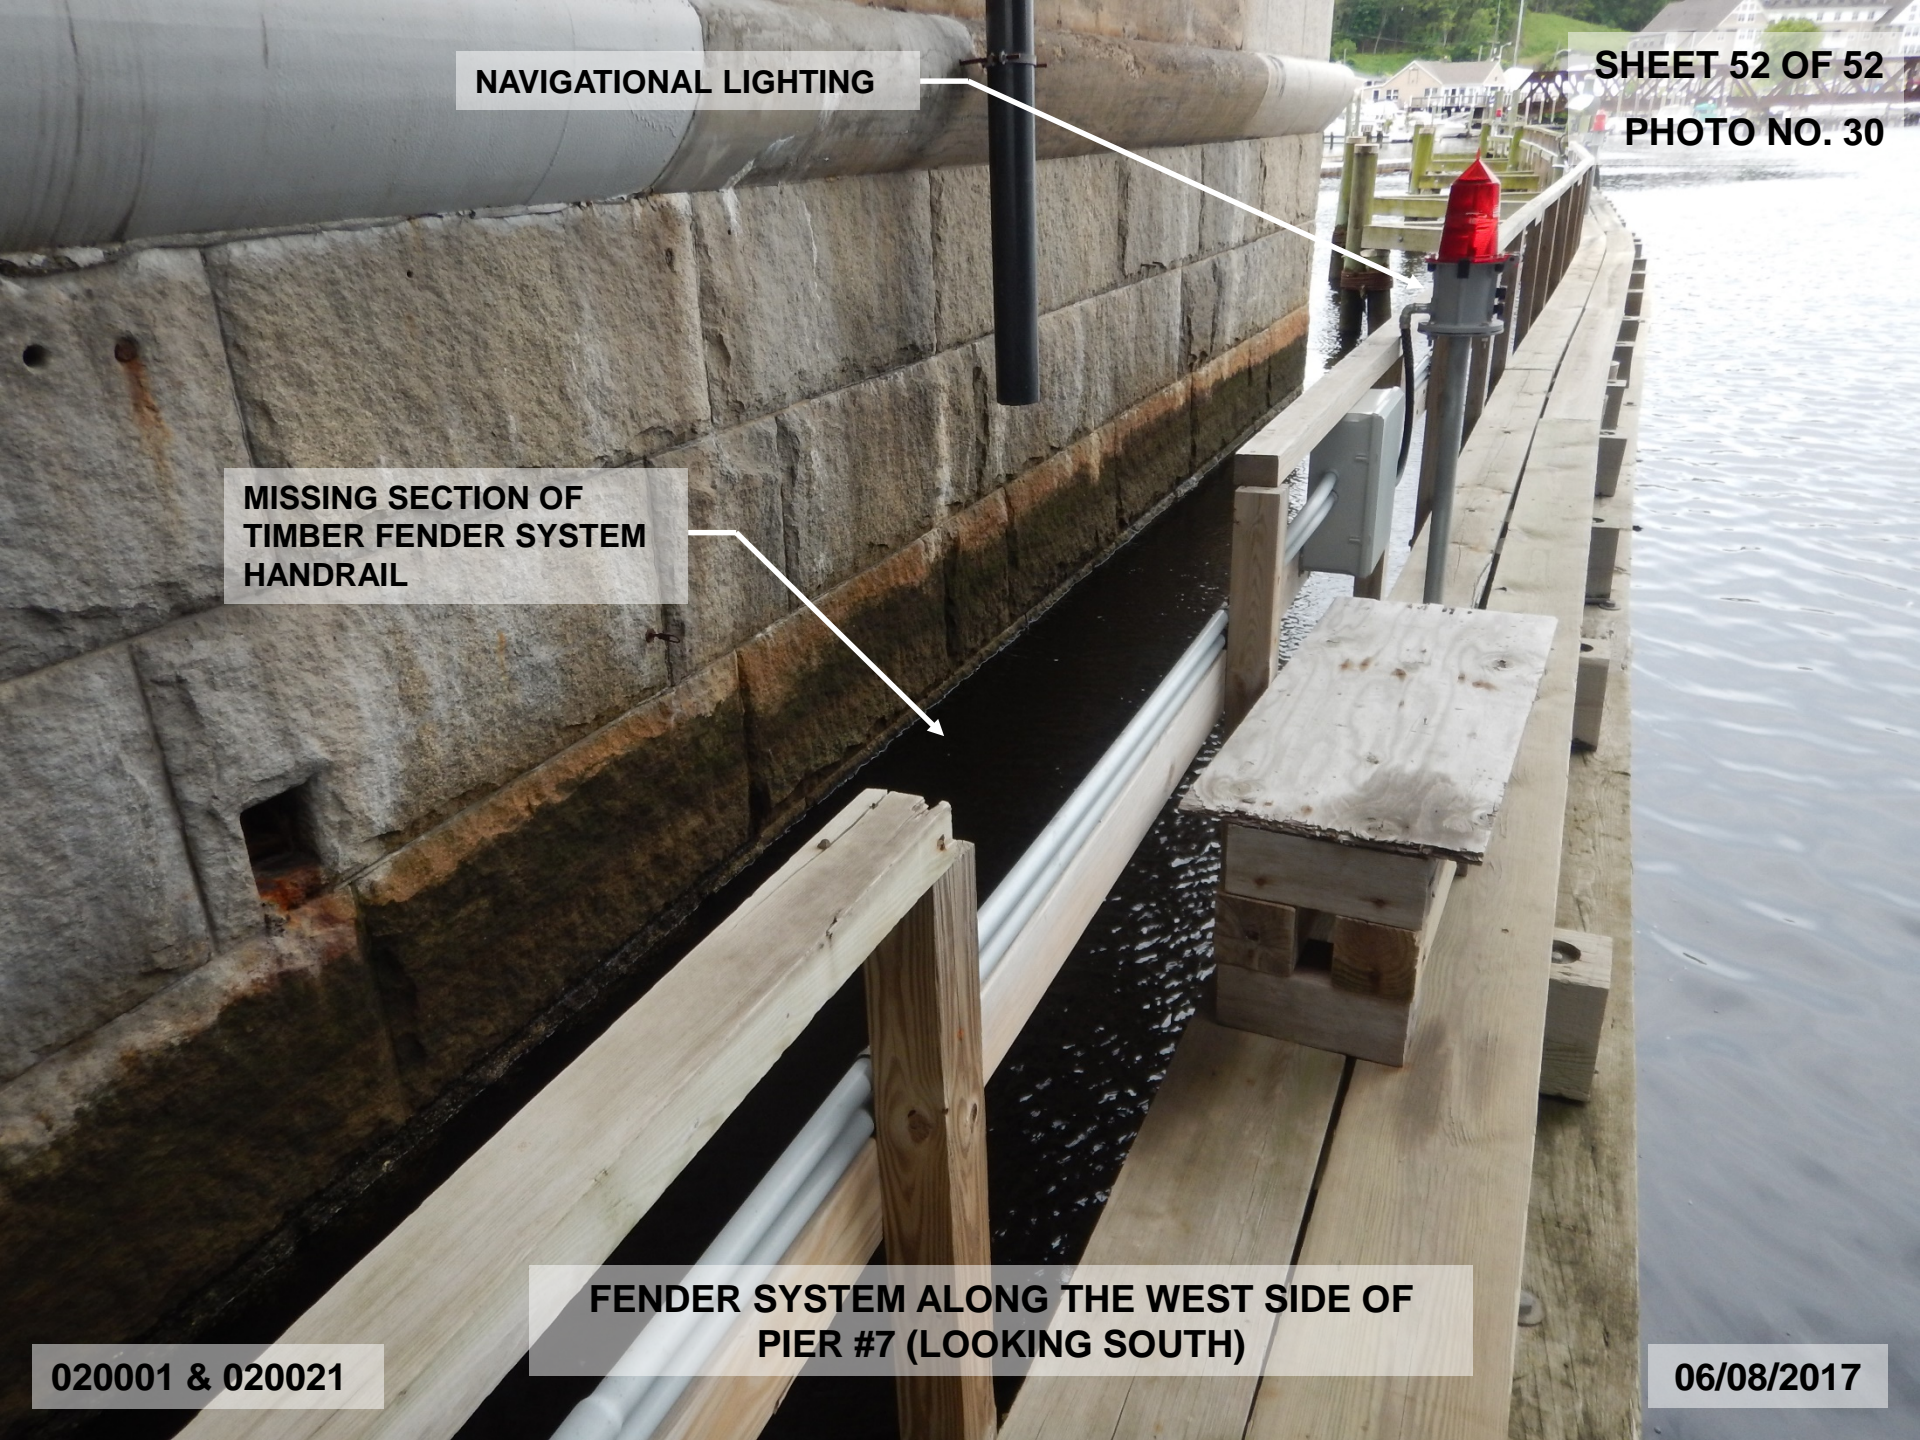
MISSING SECTION OF TIMBER
FENDER SYSTEM HANDRAIL

MISSING SECTION OF
TIMBER FENDER SYSTEM
HANDRAIL
