Engineering Disasters

These tragic episodes are a reminder of the importance that engineers have in ensuring the safety of the public and what can happen when engineering failures occur.

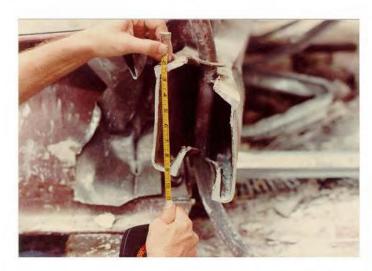
During a tea dance event in the hotel's atrium, the walkways suddenly collapsed, with the upper walkway falling onto the lower one and then both crashing to the ground below. The collapse was swift and catastrophic.

The disaster was caused by a design flaw in the construction of the walkways. The original design called for two walkways to be suspended from the ceiling, one above the other, with a set of steel rods connecting the two walkways. However, this design was later changed to a single set of rods, supporting both walkways. This change significantly increased the load on the connections. The connection between the walkways and the rods was inadequately designed and constructed. The walkways were suspended from a set of threaded rods and nuts, and this connection was not able to withstand the load placed on it.

After the incident, investigations revealed the design flaw and construction errors as the primary causes of the collapse. Engineers, architects, and contractors involved in the project faced legal repercussions, including civil lawsuits and professional consequences.

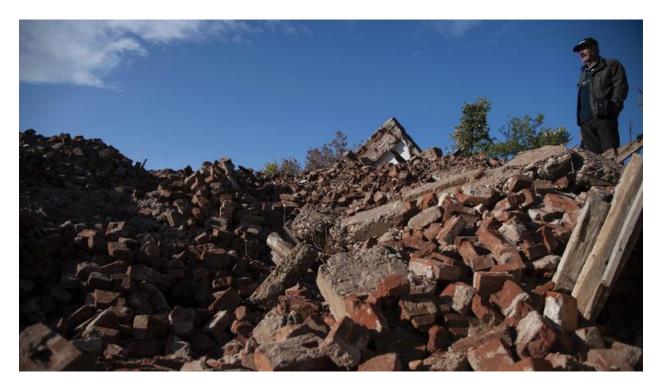
A strong earthquake led to the precast concrete floors of the school building collapsing, which was caused by poor ties with the walls. The earthquake caused extensive damage in the region.

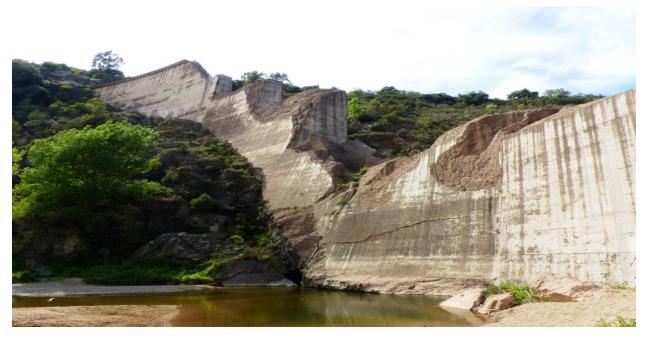
Remains of the dam

There were two main features of the rock mass the dam was built into proved to be the root cause of the dam failure due to seepage and were related to unfavorable rock structures which included a fault. Neither the fault nor the foliation had been recognized at the time of construction as there had been no geotechnical or geologic investigation of the area before the dam was constructed.

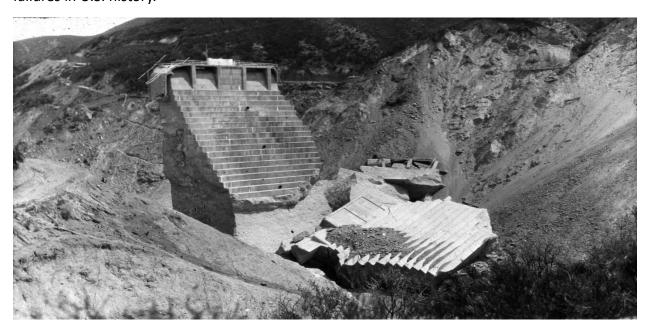
Inadequate geologic evaluations of an underlying thrust fault and a landslide, as well as poor dam operation and maintenance caused the under-seepage that led to the collapse of the dam. Today, geologists also believe the increased saturation and hydrostatic pressure from the dam further reduced the structural integrity of the underlying rock in the foundation and abutment contacts. As a result of this tragedy, the State of California created the board of registration for Civil Engineers in 1929.

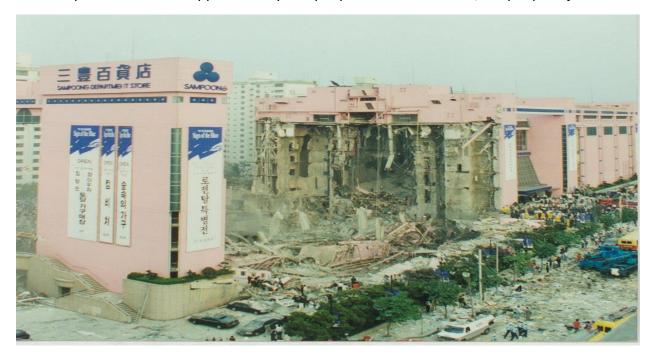
Once the investigation focused on structural failure, it was initially believed the building's poorly-laid foundation and the unstable ground that it was built on, both led to the failure. Investigation of the rubble revealed that a substandard concrete mix of cement and seawater and poorly-reinforced concrete was used for the ceilings and walls.

Further investigation indicated that the building was built incorrectly using what was called "flat slab construction". Reinforced concrete buildings are often built by using columns and beams, with the floor slab supported over the full length of the beams. "Flat slab construction" does not use beams but supports the floor slab directly on the columns. The area of floor around the columns must be reinforced in order to carry the load; if the columns are too narrow, they can punch through the slab.

Examination of the building showed the concrete columns installed were only 24 inches in diameter, which was much smaller than the required 31-inch column diameter indicated in the plans. To compound this issue, the number of steel reinforcement bars embedded into the concrete was 8, not the required 16, which gave the building only half its needed strength. Steel reinforcements intended to strengthen the concrete floor were placed 4 inches from the top instead of 5 inches which further decreased the strength of the structure.

Fire shields were installed around all escalators to prevent the spread of fire from floor to floor, but to install them, the support columns were cut, further reducing their diameter. The reduced diameter concentrated the load on a smaller area of the slab, leading to an eventual puncturing of it. Those factors, along with the addition of a fifth floor including restaurants and heavy restaurant equipment, all contributed to the building's eventual failure. The original building design would have been more than twice as strong as needed to remain erect. As it is, the flawed structure managed to stand for almost five years.

Investigators pinpointed the direct cause of the collapse, known as the "trigger" or tipping point, for the building. It was revealed that two years before the collapse, the building's three rooftop air-conditioning units had been moved because of noise complaints from neighbors on the east side of the building. The building's managers admitted noticing cracks in the roof during the move, but instead of lifting them with a crane, the units were put on rollers and dragged across the roof, further destabilizing the surface.

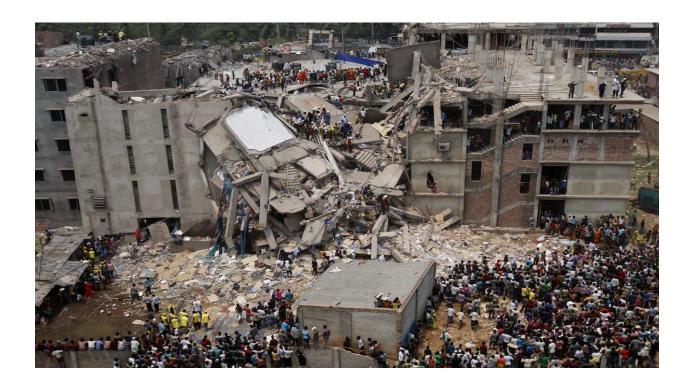
Parts of the building were built without proper city permits. The 5th to 8th floors were added to the building without load-bearing walls. The garment factory's heavy equipment was more than the building structure could sustain. The foundation was weak and was built on soft, swampy ground.

These poor conditions were magnified due to the inferior quality of materials used in the building's construction, as well as shoddy building design and poor building practices.

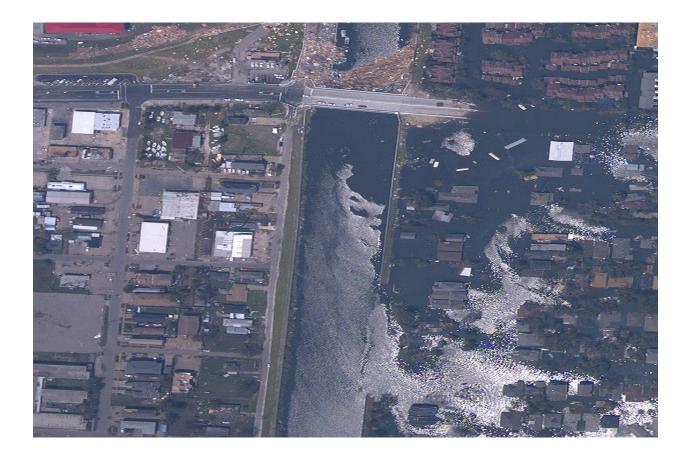
The primary mechanisms of failure at the 17th Street Canal, London Avenue Canal and Industrial Canal (east side north) were improper design of the canal floodwalls. The failure mechanism for the Industrial Canal (east side south and west side) was overtopping of levees and floodwalls by the hurricane storm surge. The primary mechanism of failure for levees protecting eastern New Orleans was the existence of sand in 10 percent of the levee locations instead of compacted clay. The primary mechanism of failure for the levees protecting St. Bernard Parish was overtopping due to improper maintenance of the Mississippi River Gulf Outlet.

With the exception of four foundation design failures, all of the major breaches were caused by overtopping and subsequent erosion. There was significant levee overtopping and erosion that caused overtopping and subsequent wide-spread flooding, particularly in Orleans East. The levee-floodwall designs for the 17th Street and London Avenue Outfall Canals and the northeast breach of the IHNC were inadequate due to steel sheet-pilings driven to depths that were too shallow. In four cases the structures failed catastrophically prior to water reaching design elevations. A significant number of structures that were subjected to water levels beyond their

design limits performed well. Typically, in the case of floodwalls, they represented more conservative design assumptions and, for levees, use of higher quality, less erodible materials. In the aftermath of these failures, the U.S. Army Corps of Engineers instituted widespread repairs and additions to the flood control system in and around New Orleans at a cost of over \$100 billion.

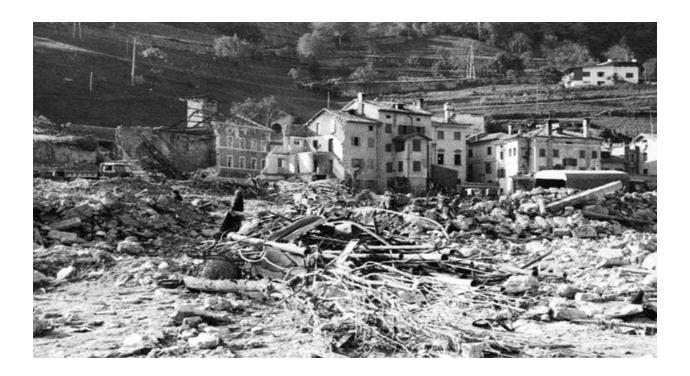
Filling of the reservoir began in February 1960 and in October the lake was already 550 feet deep. Soon afterward, the first fissures were noted on the slopes of Mount Toc and November 4, when a landslide with over 700.000 cubic yards of rock occurred and slid into the reservoir. Alarmed, technicians decided to slightly reduce the rate the reservoir was filled. This strategy was successful until mid-1963 when, between April and May, the depth of the reservoir was rapidly increased from 640 feet to 750 feet. By mid-July, the reservoir depth was 780 feet.

On October 9th, the entire slope of Mt. Toc collapsed. Within 25 seconds estimated and 240 to 270 million cubic yards of rock and forest plunged into the reservoir, filling the 1,300 feet deep gorge behind the dam. The wave generated by the impact of the landslide traveled 460 feet up on the opposite shore, reaching some buildings of the village of Erto. At the moment of the impact the reservoir contained 115 million cubic yards of water. The landslide pushed part of the water out of the lake, producing a wave with a maximum height of 860 feet.

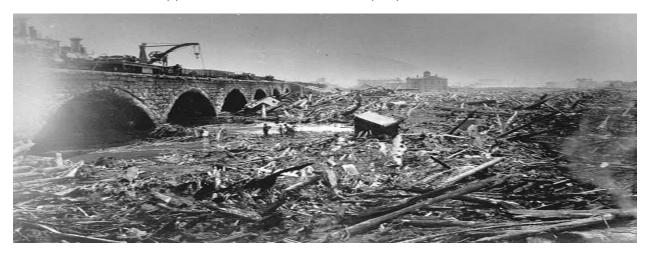
Between 2:50 and 2:55 p.m. the South Fork Dam breached. A Lidar analysis of the Conemaugh Lake basin reveals that it contained over 14 million cubic yards of water at the moment the dam collapsed.

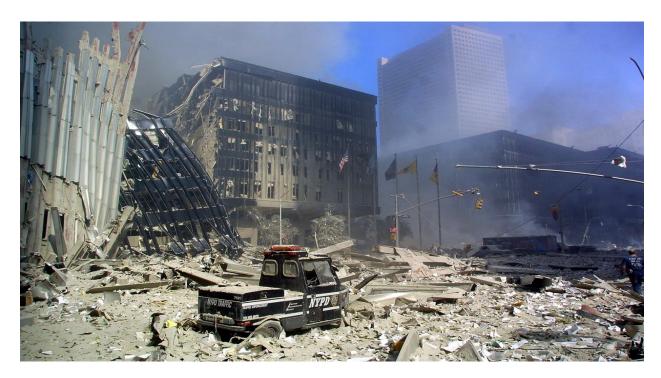
The North Tower was struck between the 93rd and 100th floors; at least six core building columns were severed while others sustained heavy damage. The South Tower was struck by the plane (impact load) between the 78th and 85th floors, and the damage to the core was much more severe. The plane was traveling more than 100 mph faster (542MPH) than the one that struck the North Tower, and it struck the tower on its south face. It penetrated the building core from its short side rather than the middle, as in the case of the North Tower. This caused at least 10 core columns to be severed, including one of the corner columns. It was noted that the corner core columns carried 20 percent of the weight of the tower. Throughout the eight floors of the impact of the North Tower and seven floors of the impact area of the South Tower the core's steel was stripped of its Sprayed-on fire resistive membrane (SFRM). This exposed the resulting unprotected steel on those floors to the fires initiated by the 10,000 gallons of jet fuel and sustained by the combustible contents, such as carpets, cubicles, furniture, and finishings. The jet fuel was atomized and did not burn for more than 30 minutes. The resulting fires were due to the combustibles on the floors themselves. The core columns, now without protection, would be exposed to significant heat for one hour and 42 minutes in the North Tower and 55 minutes within the South Tower.

The National Institute of Standards and Technology (NIST) determined the fires to be the main cause of the collapses, finding that sagging floors pulled inward on the perimeter columns, causing them to bow and then buckle. Once the upper section of the building began to move downward, a total progressive collapse of the towers occurred.
