Bridge: 020001
Photo: 1

South elevation at the main channel, looking north.

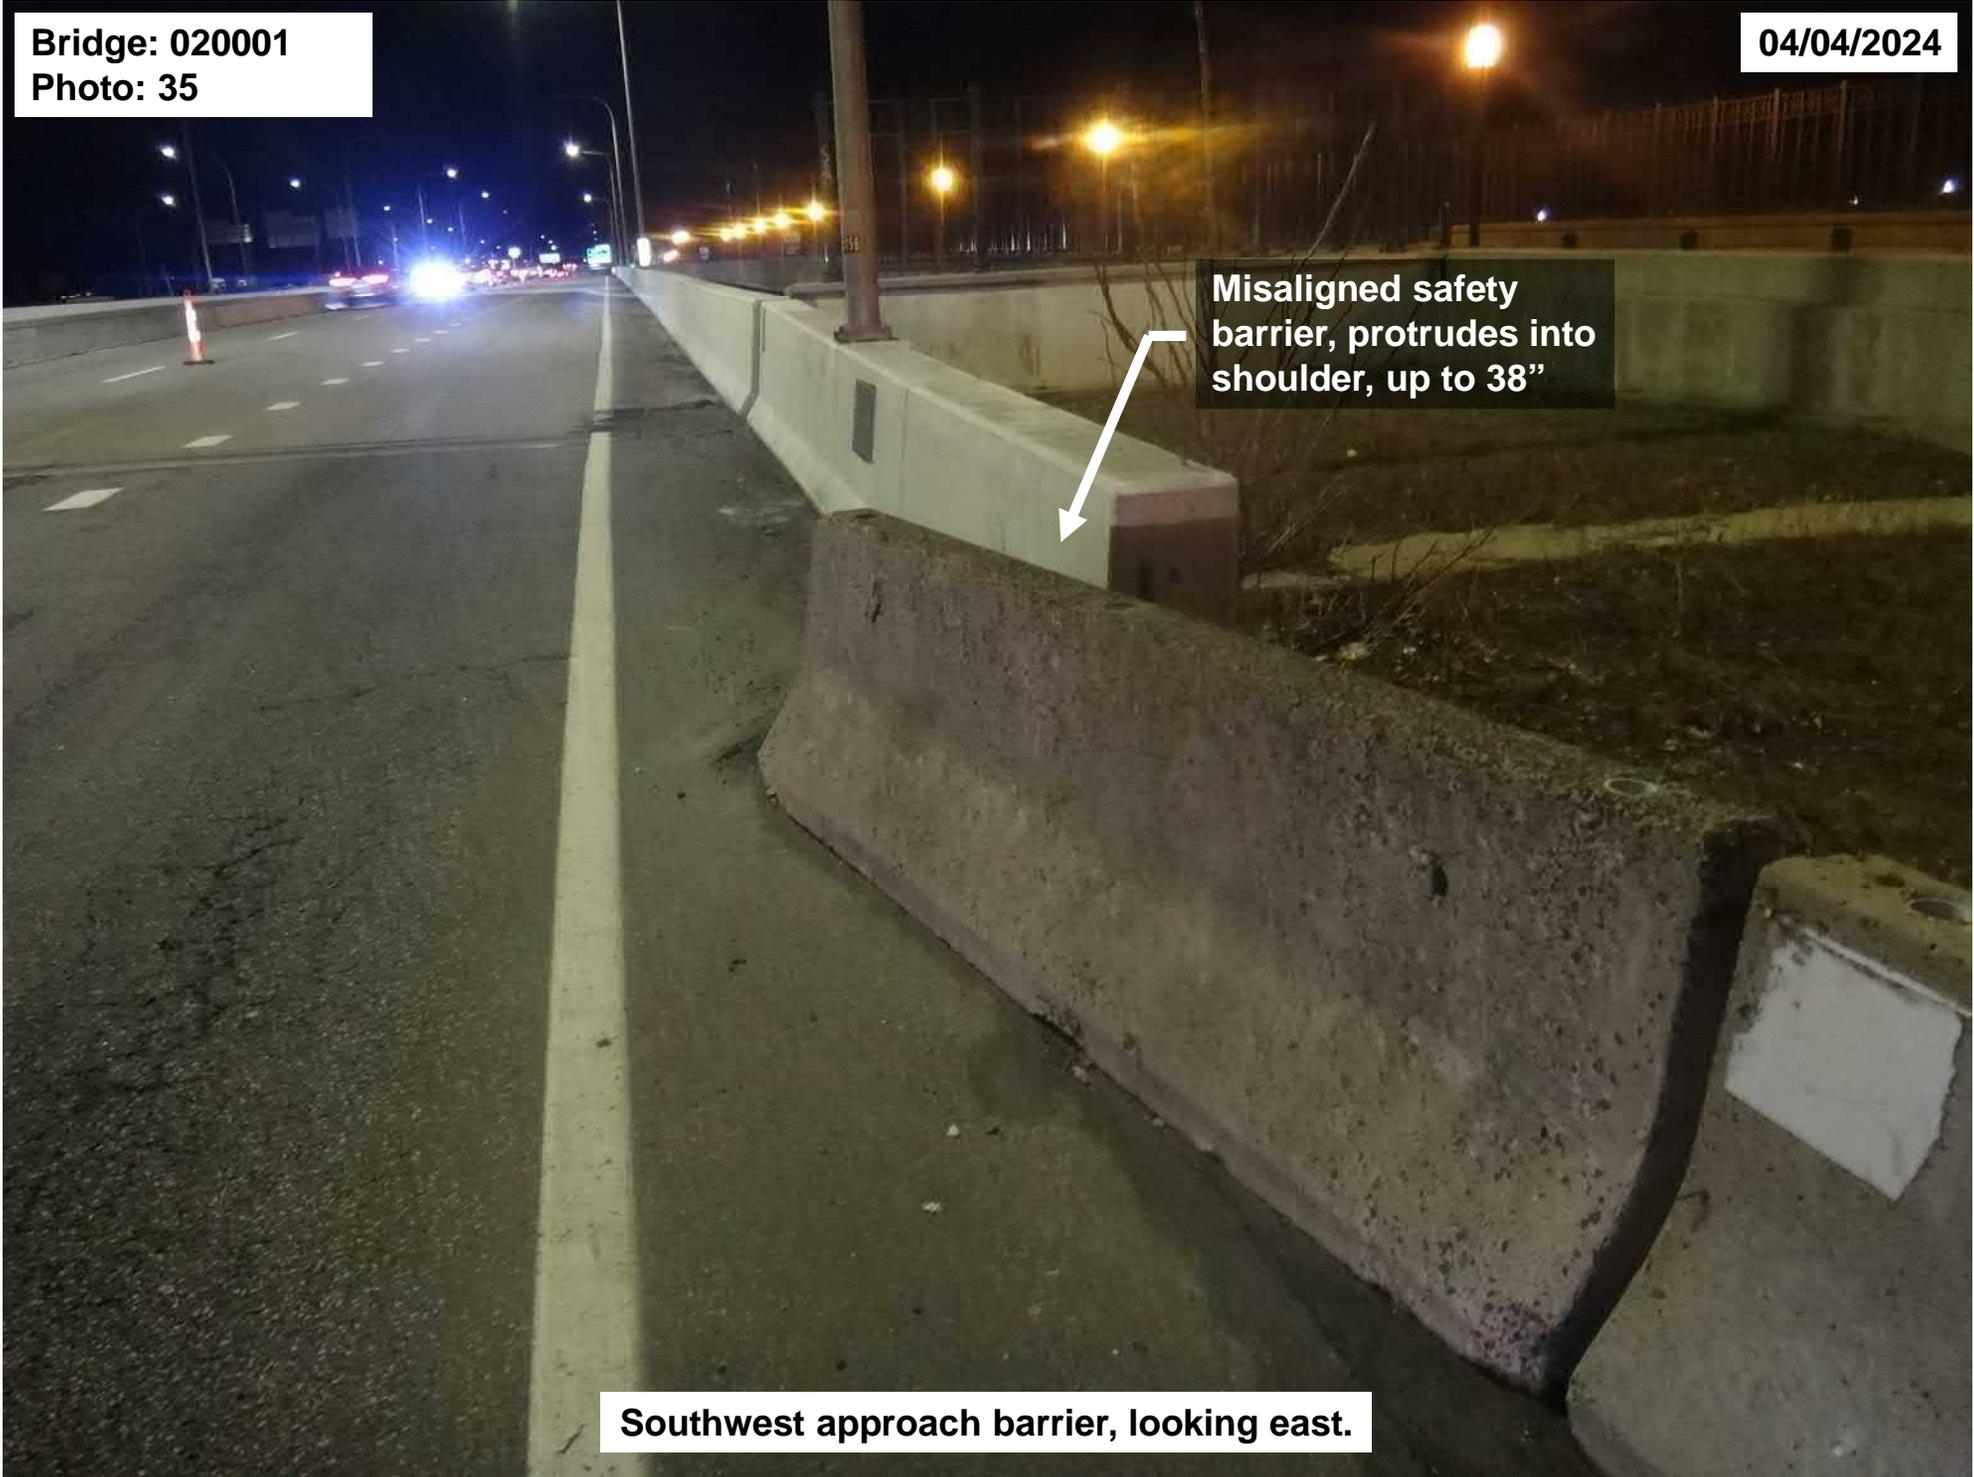
Misaligned safety barrier, protrudes into shoulder, up to 38"

Southwest approach barrier, looking east.

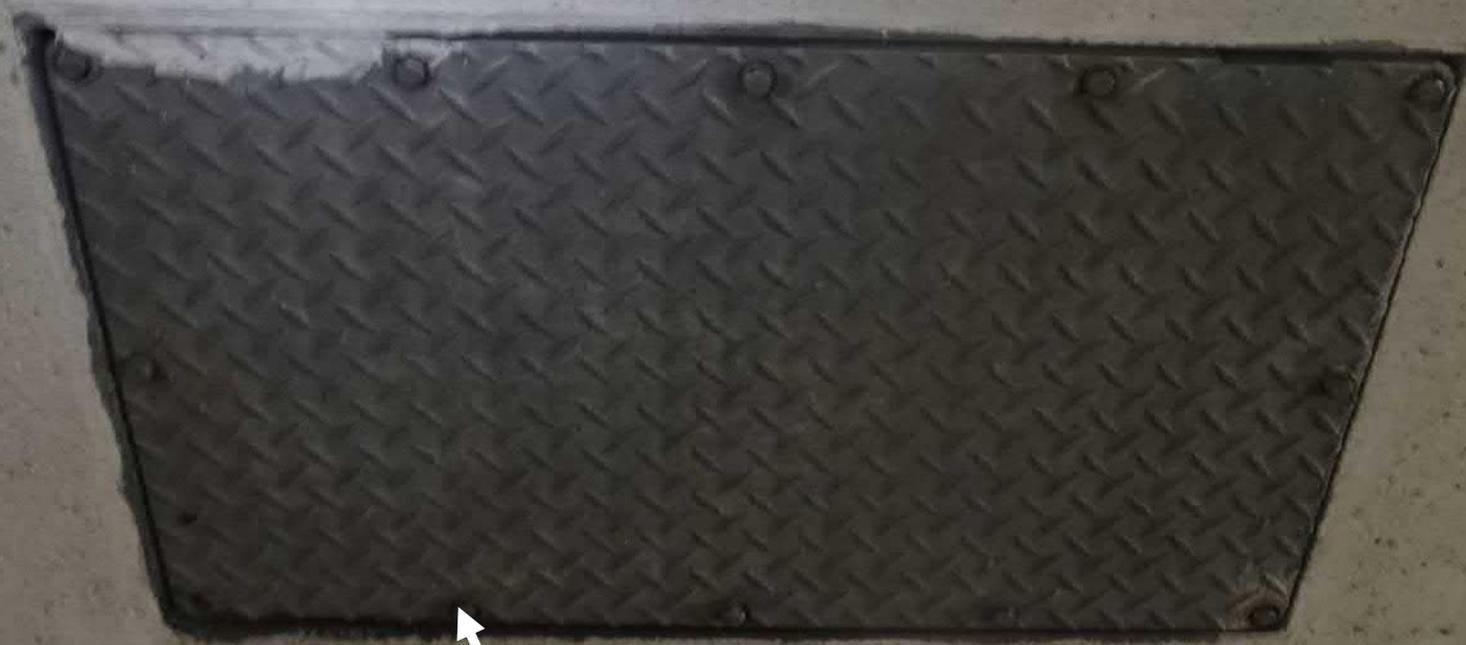
Bridge: 020001
Photo: 37

— One (1) missing bolt

Junction box in Span 4 on the north bridge railing, looking north.

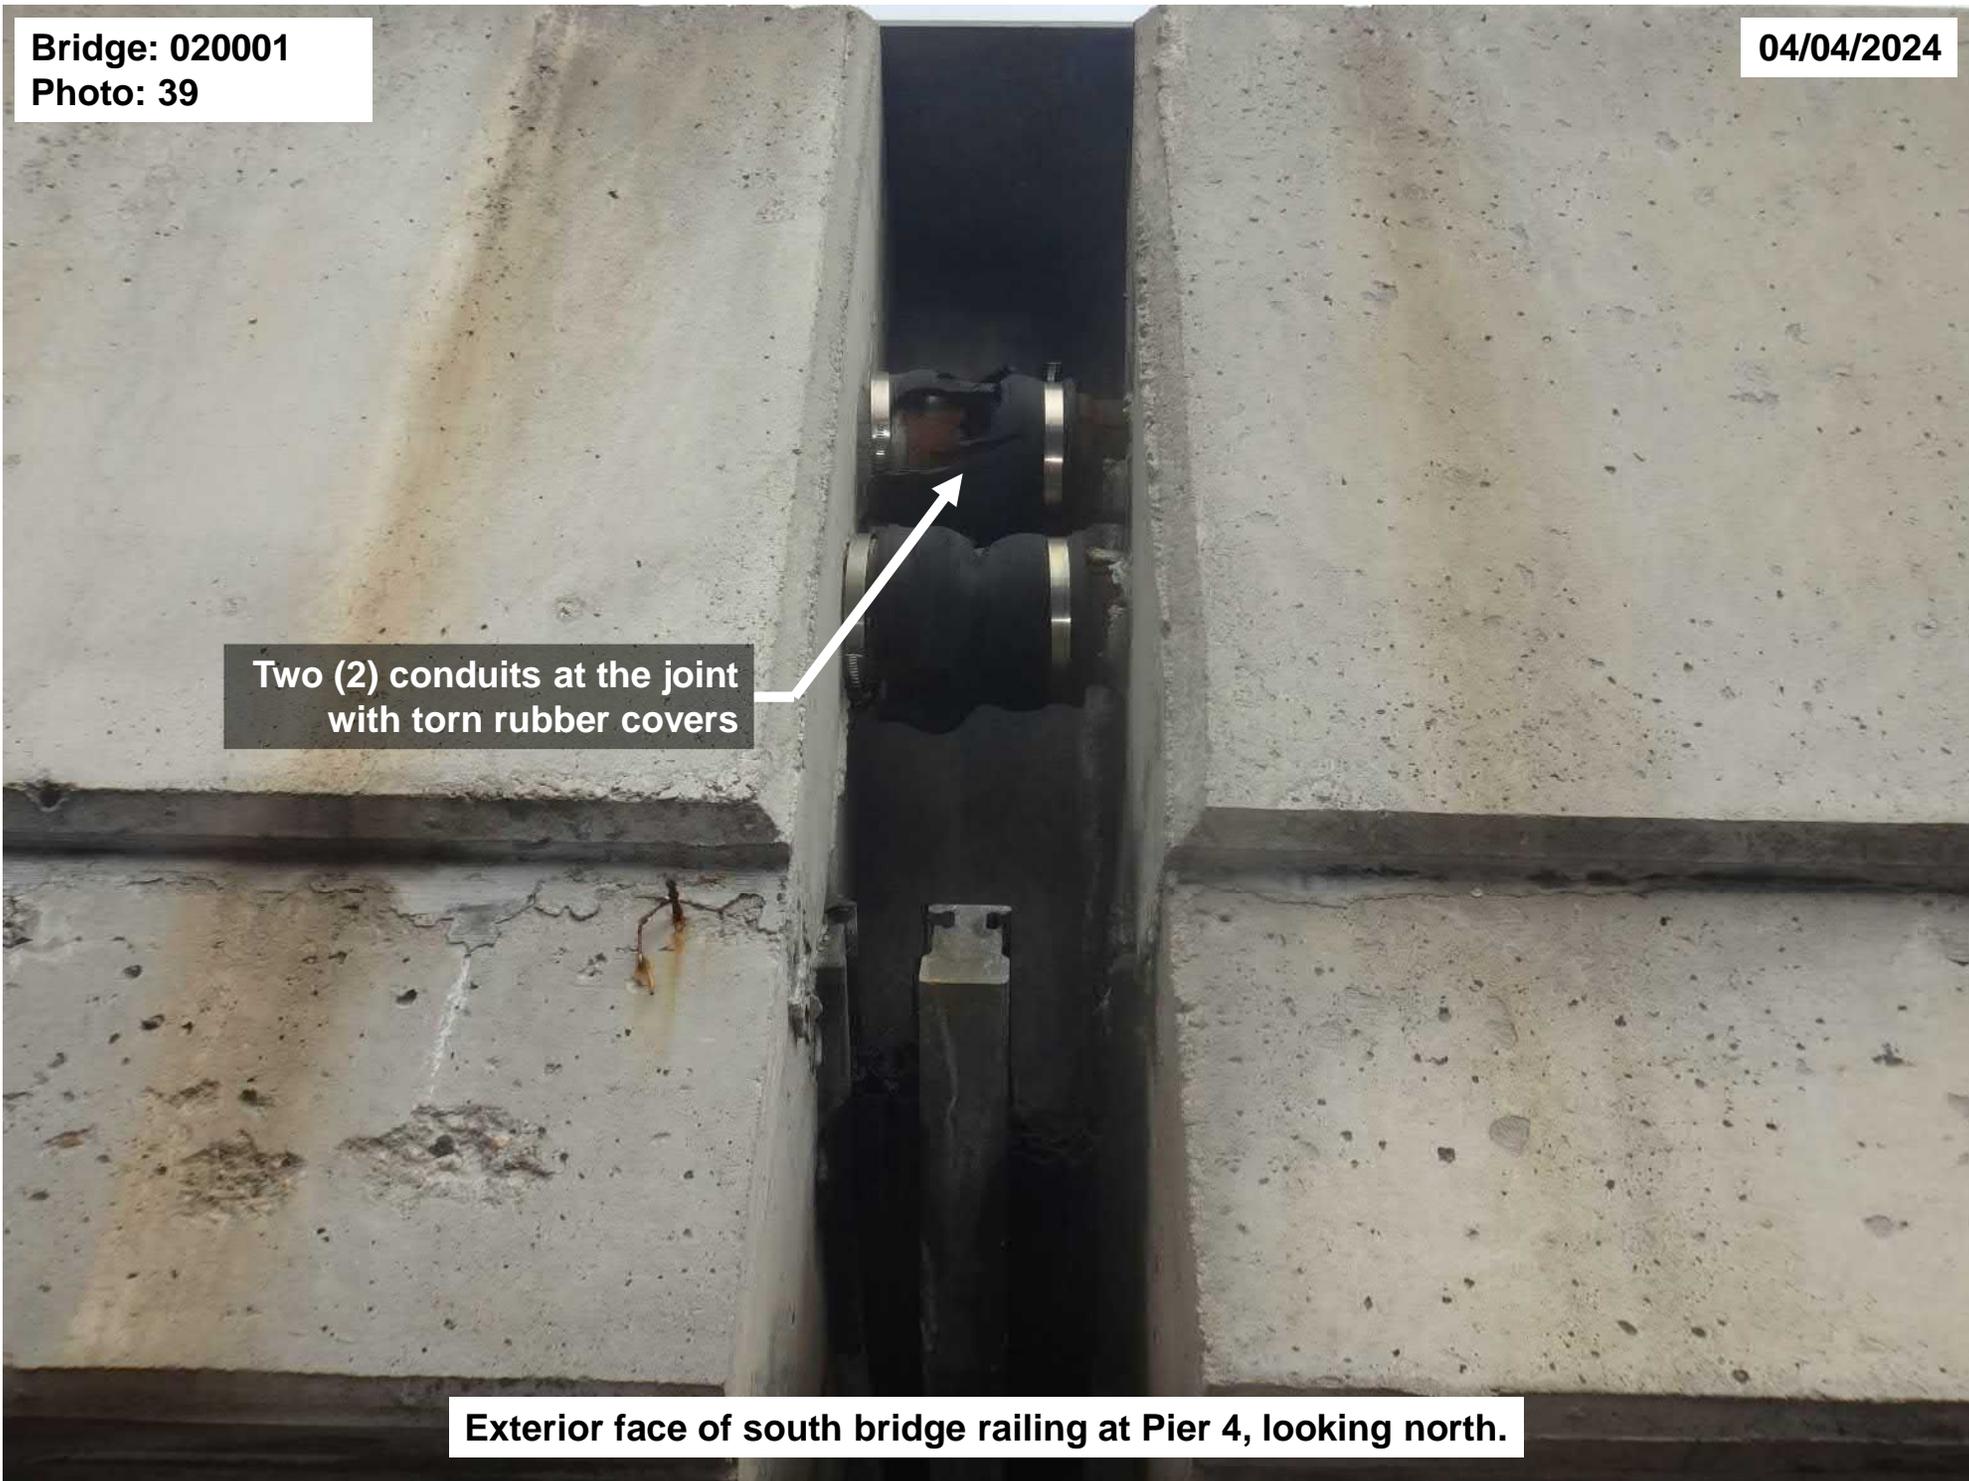
Two (2) conduits at the joint
with torn rubber covers

Exterior face of south bridge railing at Pier 4, looking north.

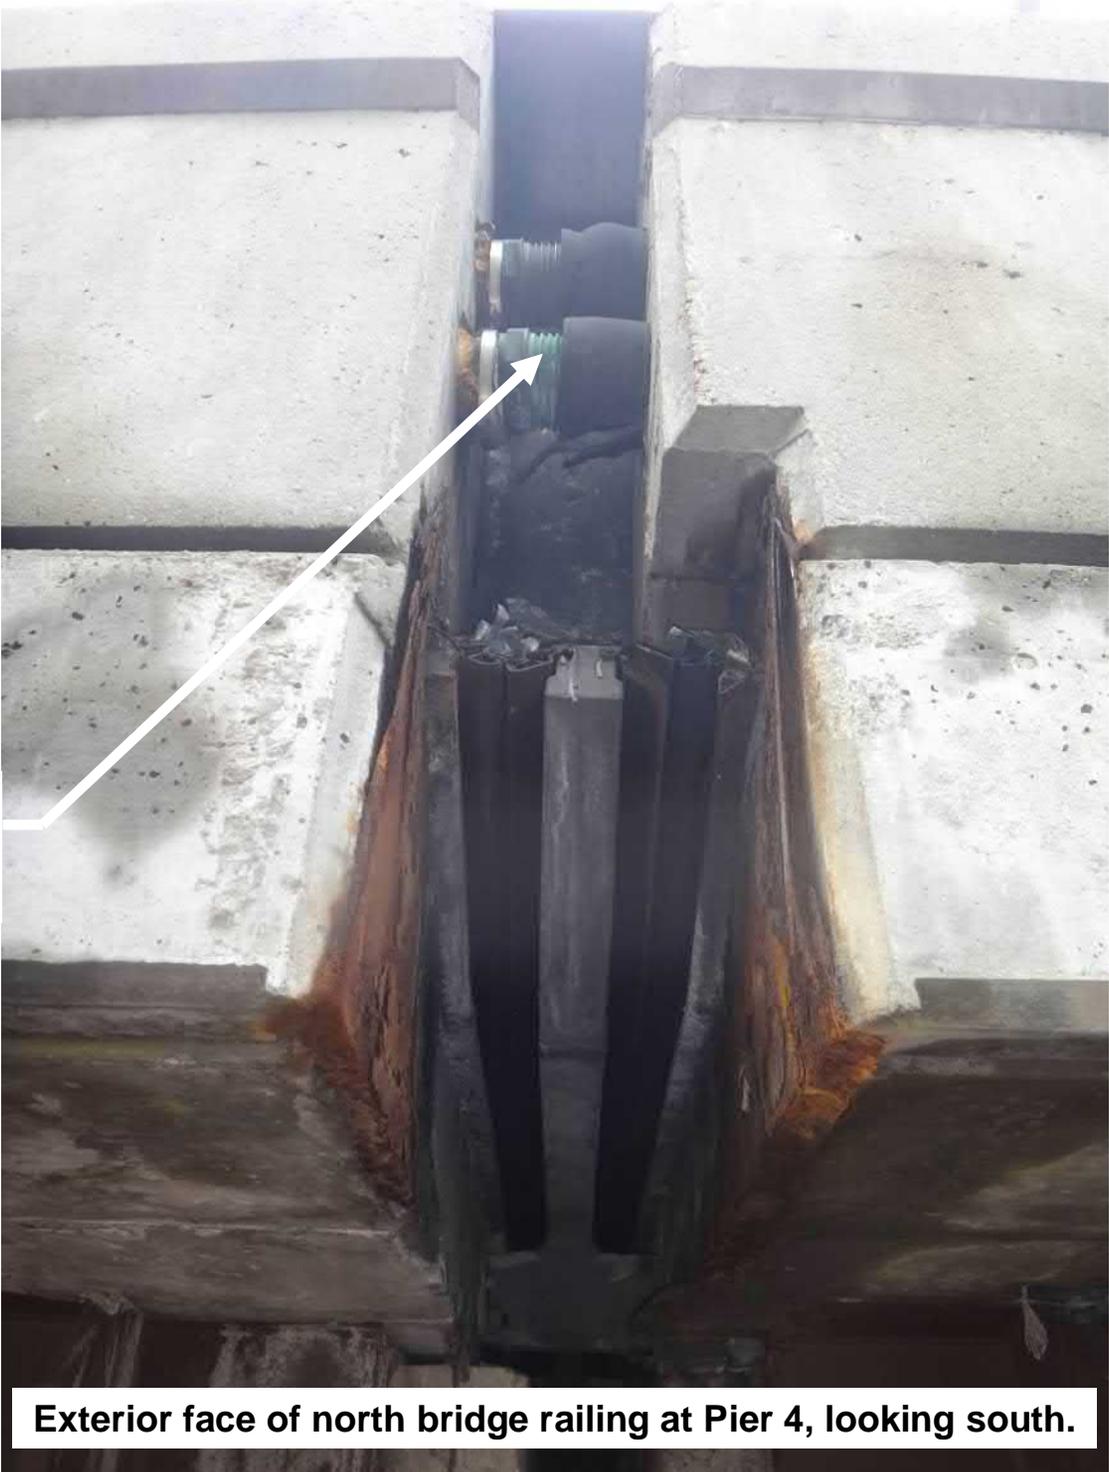
Bridge: 020001
Photo: 40

Two (2) conduits at
the joint with torn
rubber covers

Exterior face of north bridge railing at Pier 4, looking south.

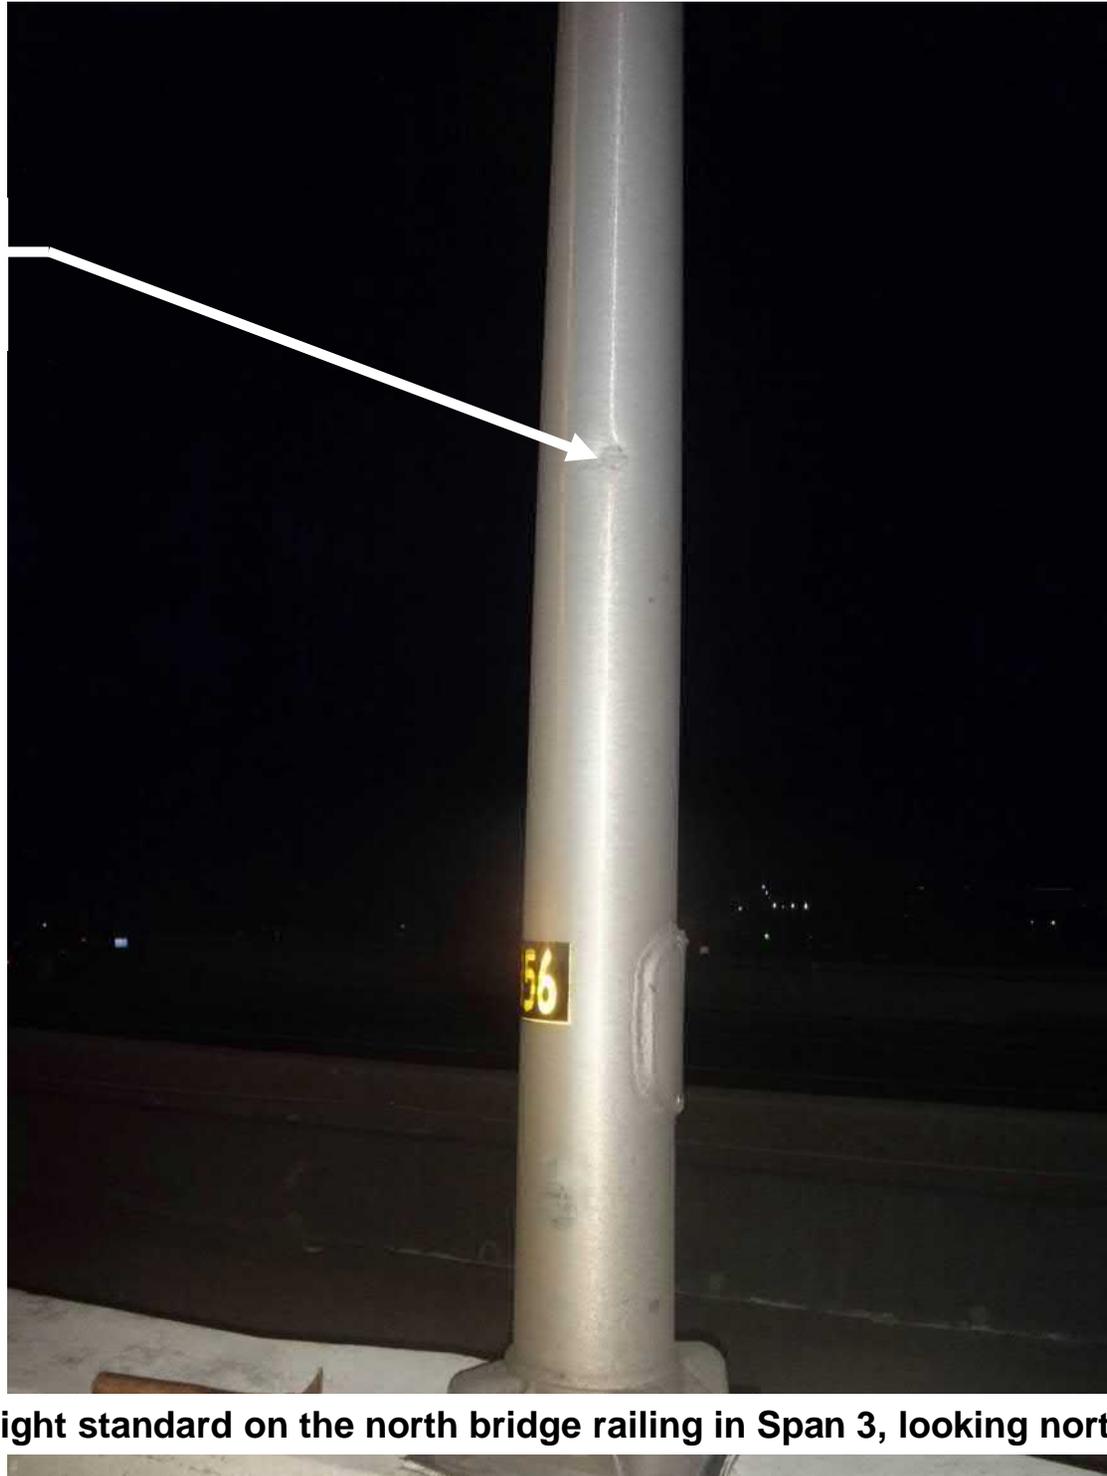
Bridge: 020001
Photo: 43

Impact damage 3'-10"
from base, 3" long x 2"
high x 1/2" deep

Light standard on the north bridge railing in Span 3, looking north.

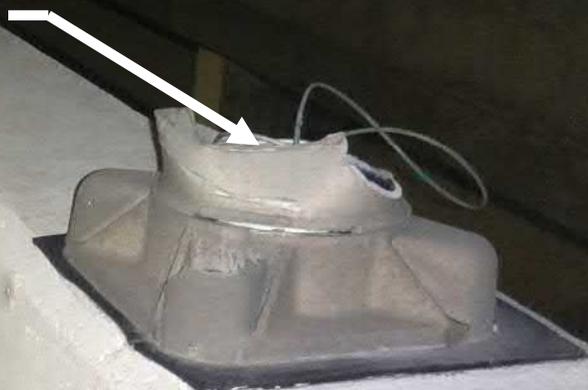
Missing light
standard

Light standard on the south bridge railing at Pier 6, looking east.

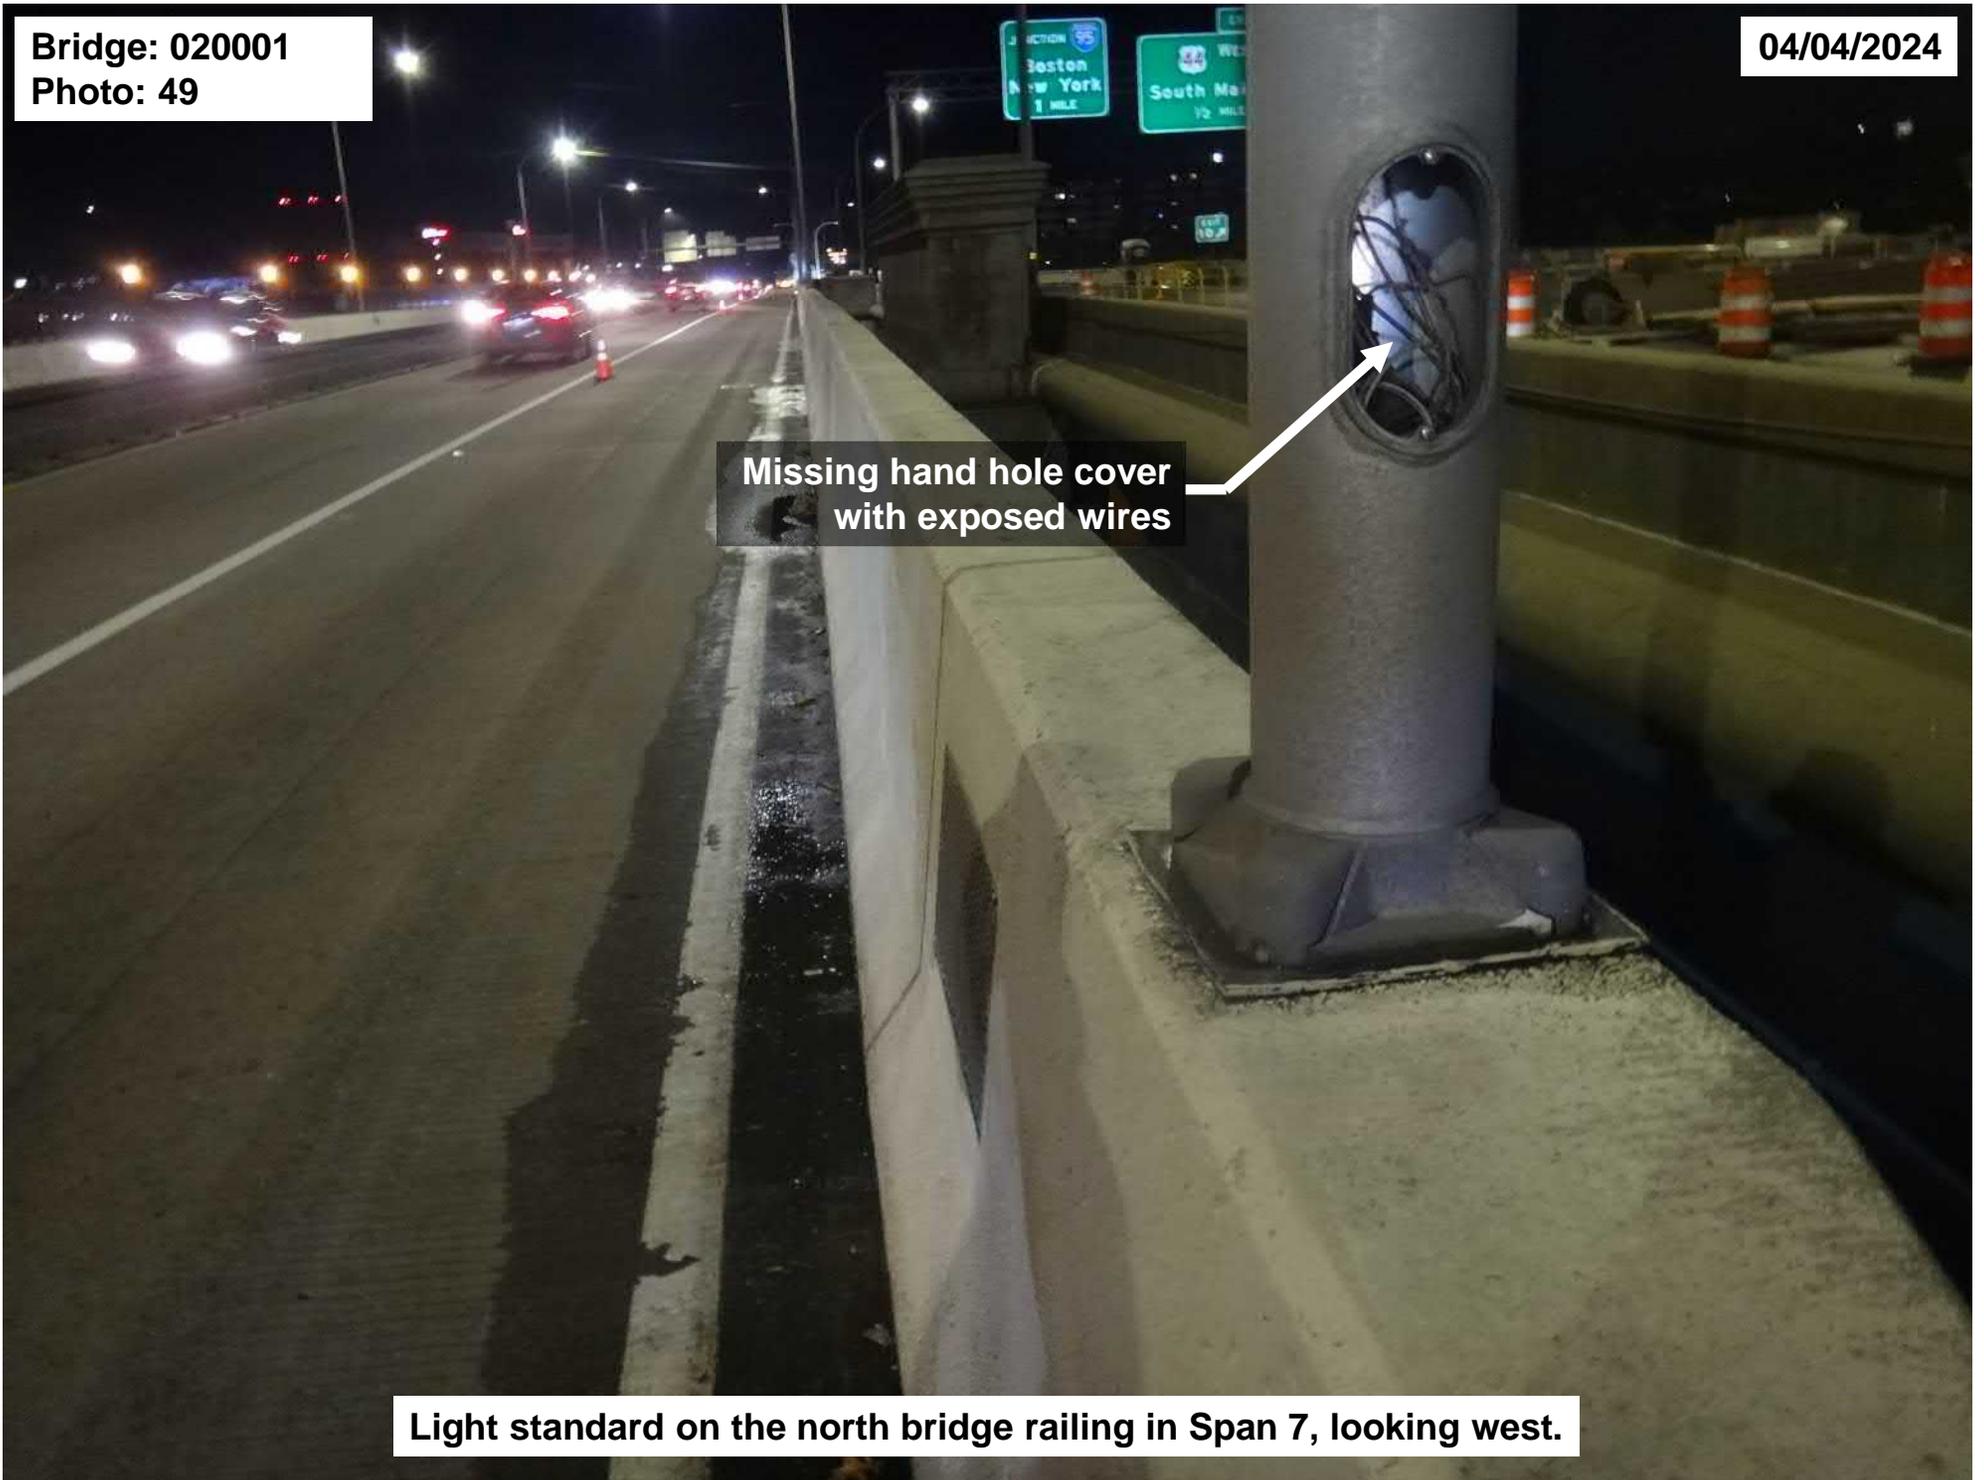
Missing hand hole cover
with exposed wires

Light standard on the north bridge railing in Span 7, looking west.

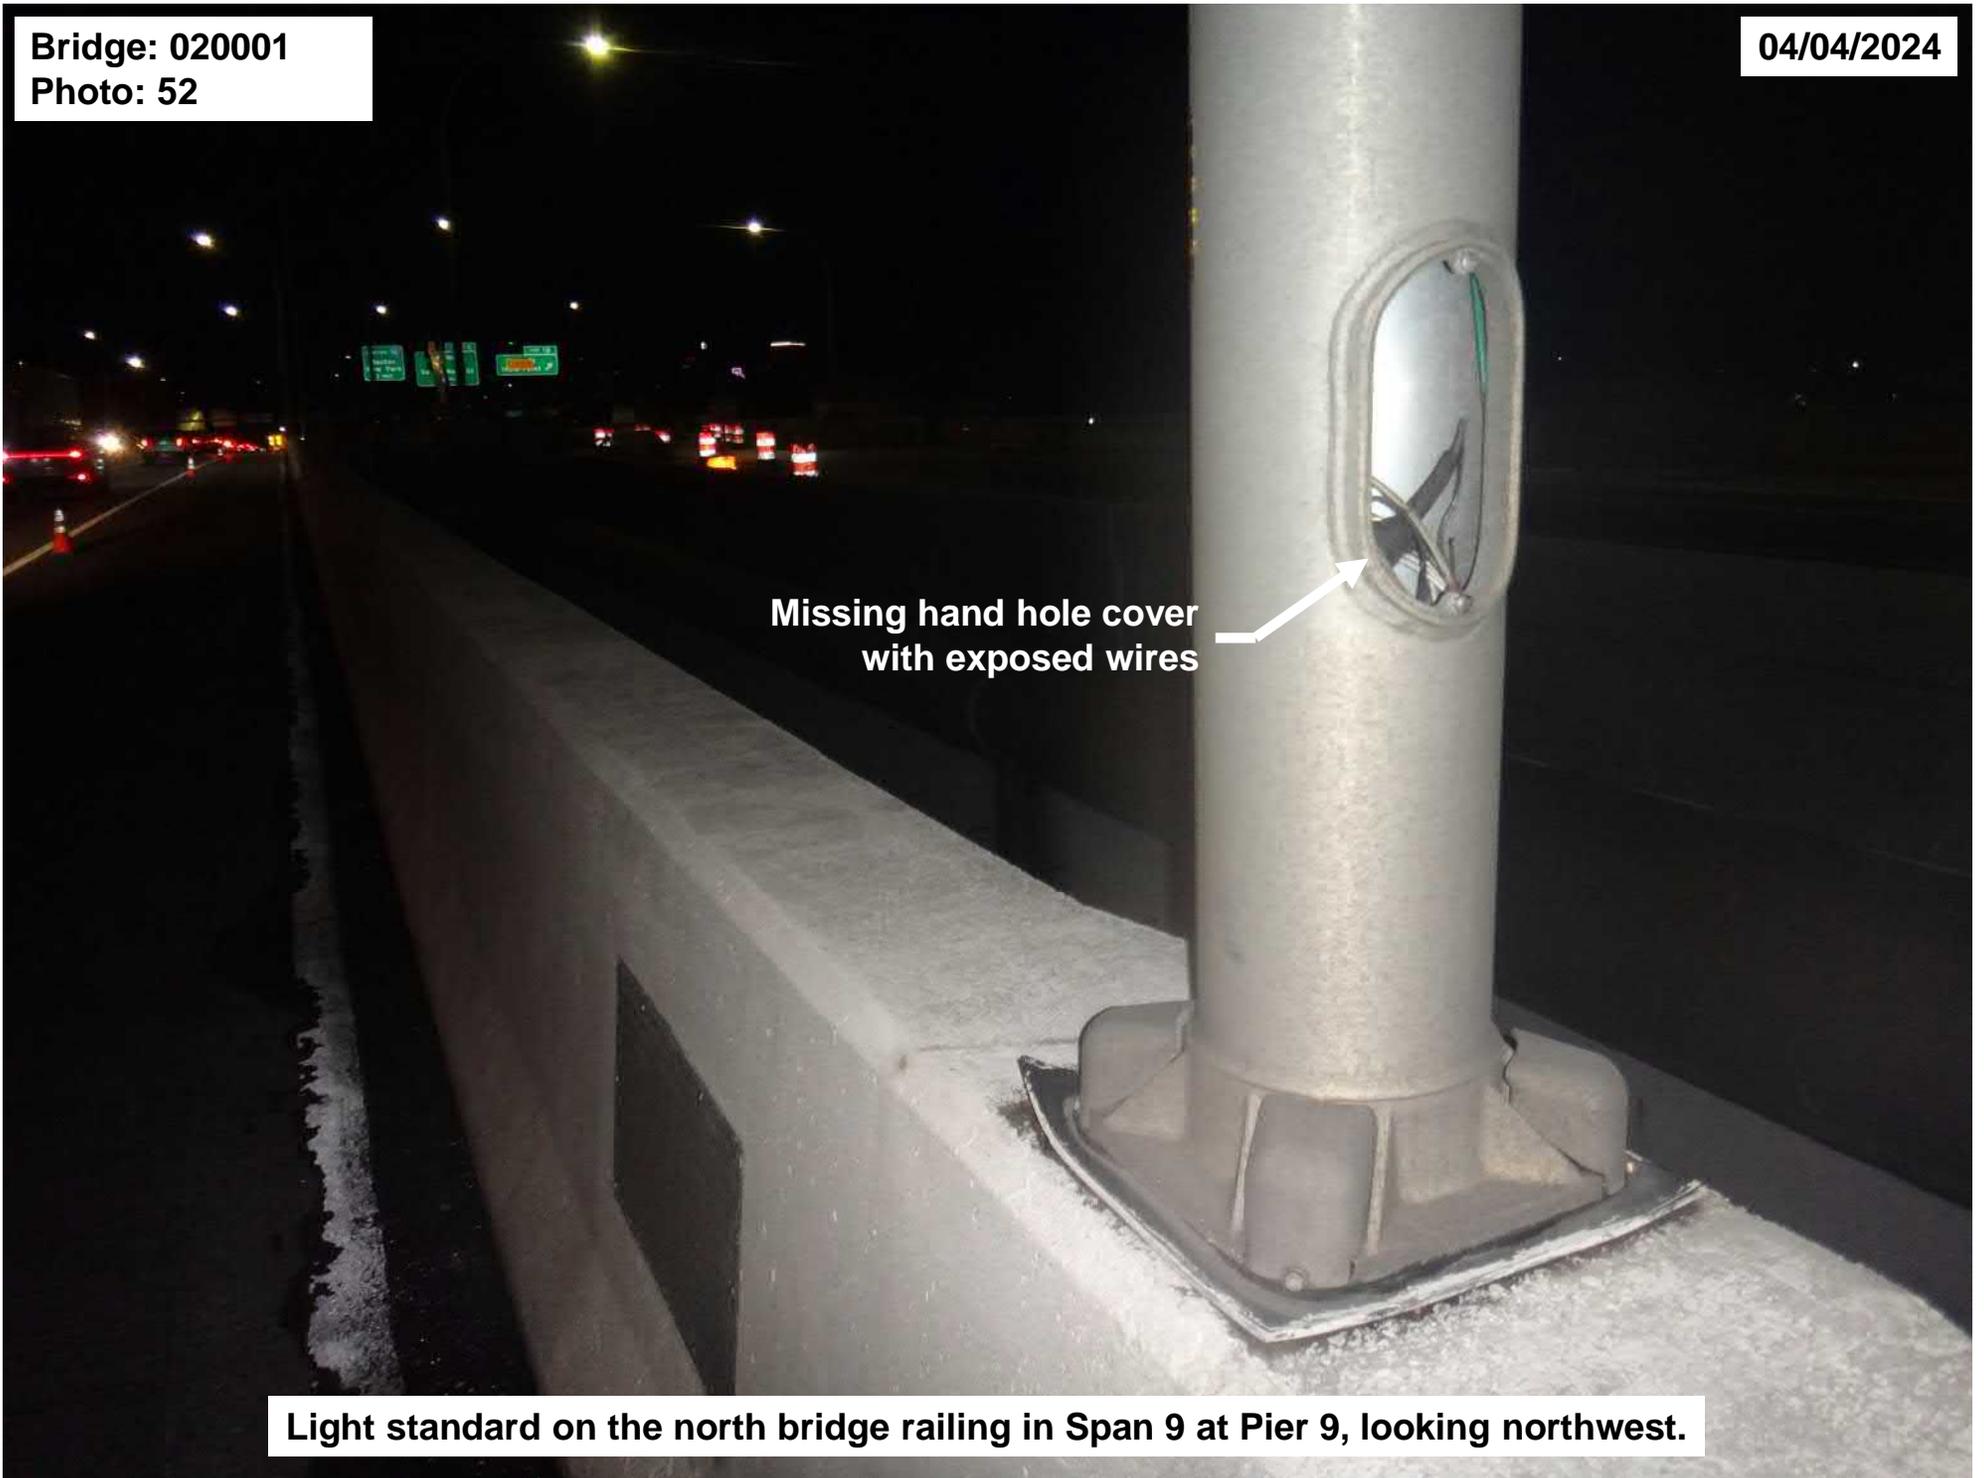
Missing hand hole cover
with exposed wires

Light standard on the north bridge railing in Span 9 at Pier 9, looking northwest.

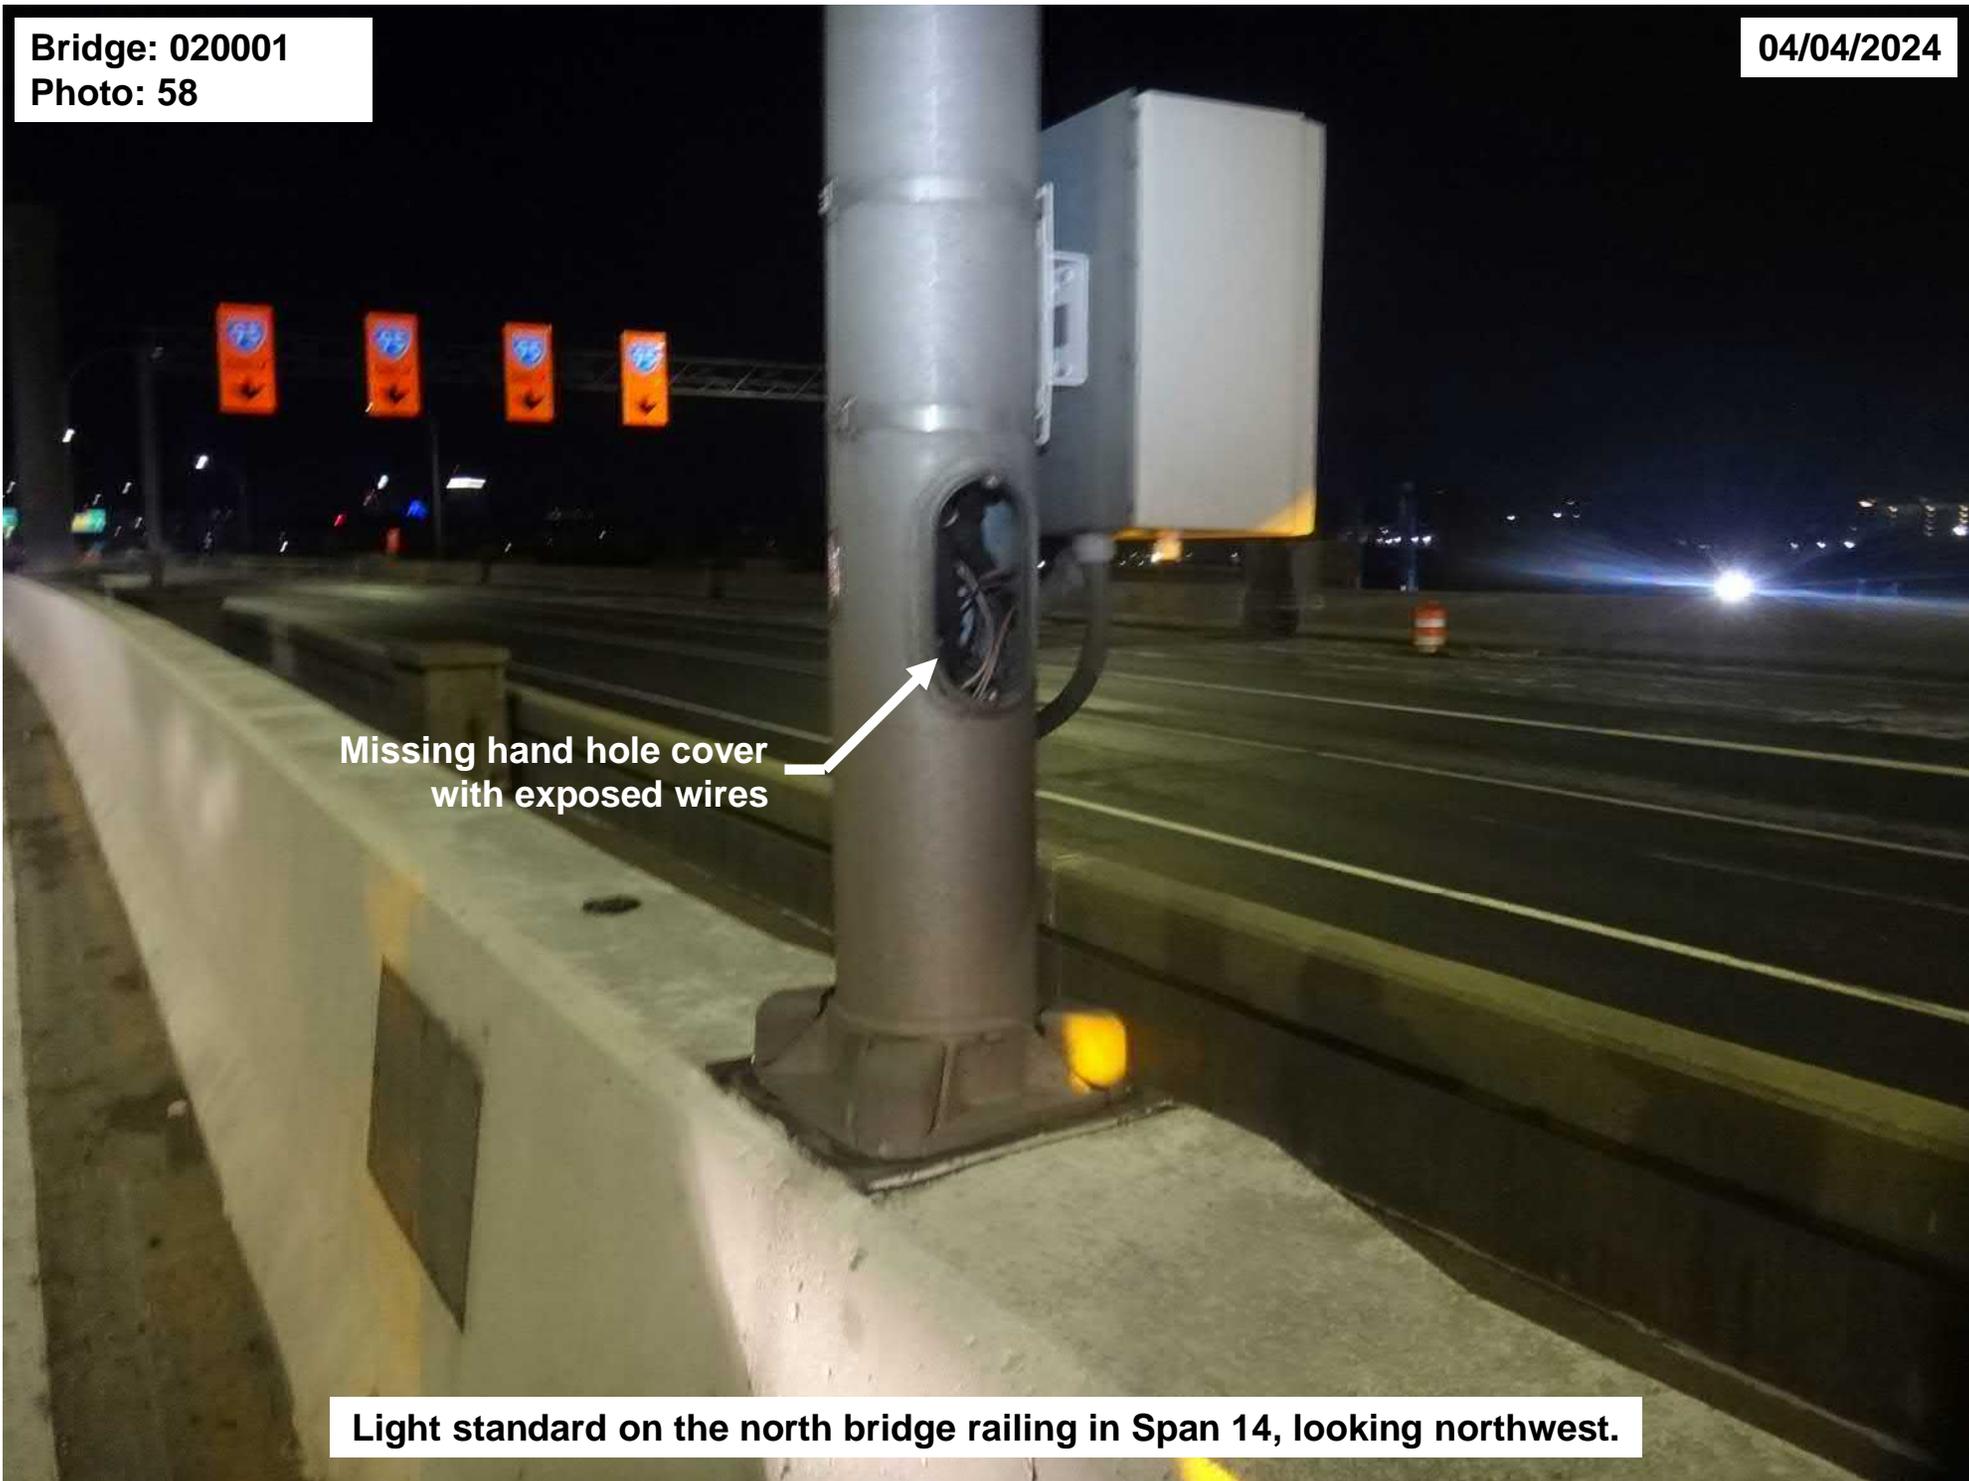
Missing hand hole cover
with exposed wires

Light standard on the north bridge railing in Span 14, looking northwest.

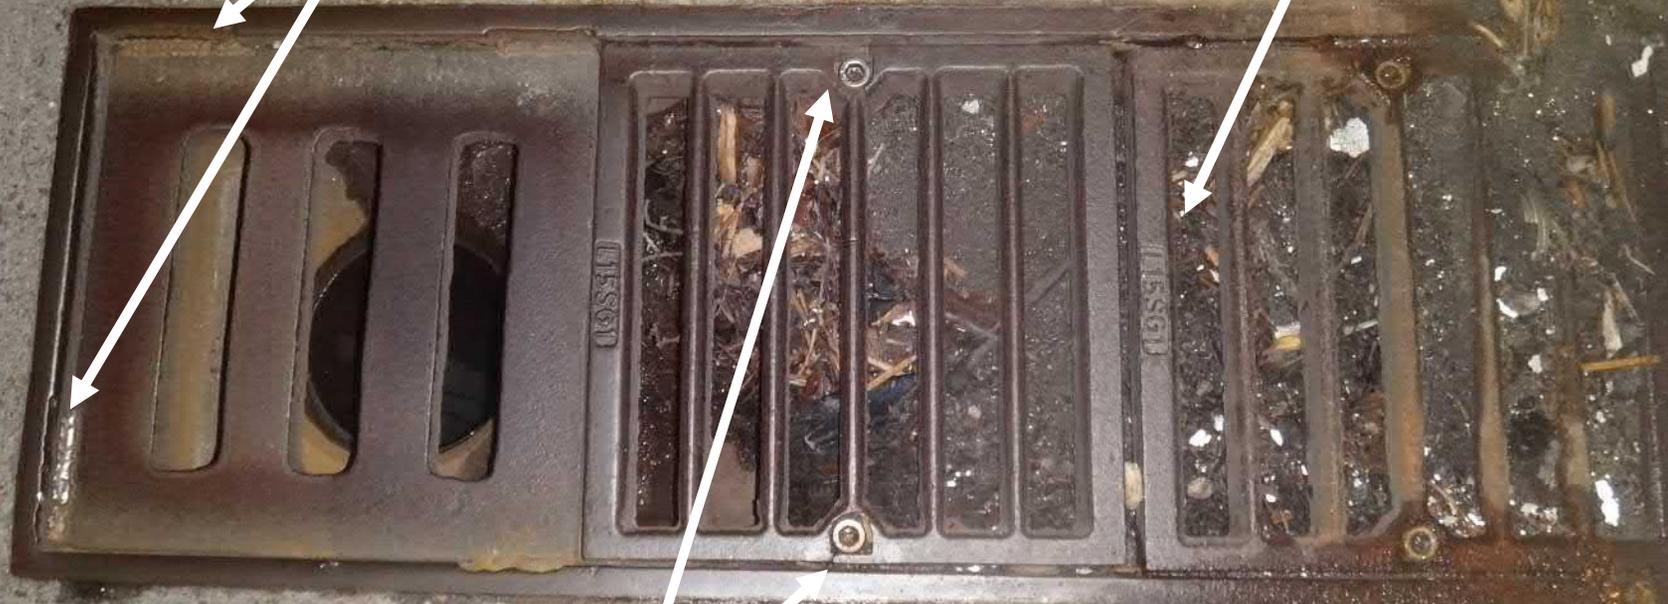
Grate section
cracked at anchor
bolts and loose

North scupper at Pier 3, looking west.

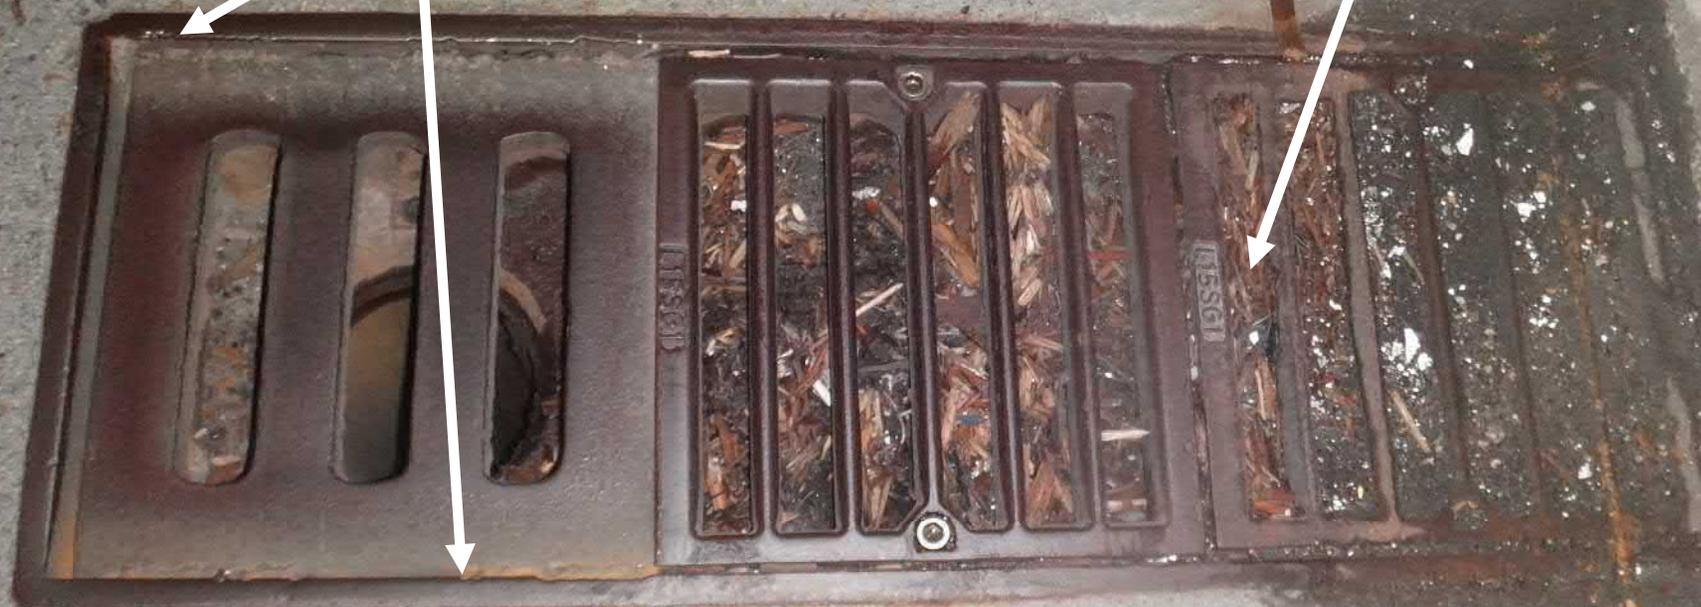
Bridge: 020001
Photo: 63

Replaced grate loose
with cracked tack welds

Scupper partially
clogged

North scupper at Pier 5, looking west.
