Bridge: 020001
Photo: 1

South elevation at the main channel, looking north.

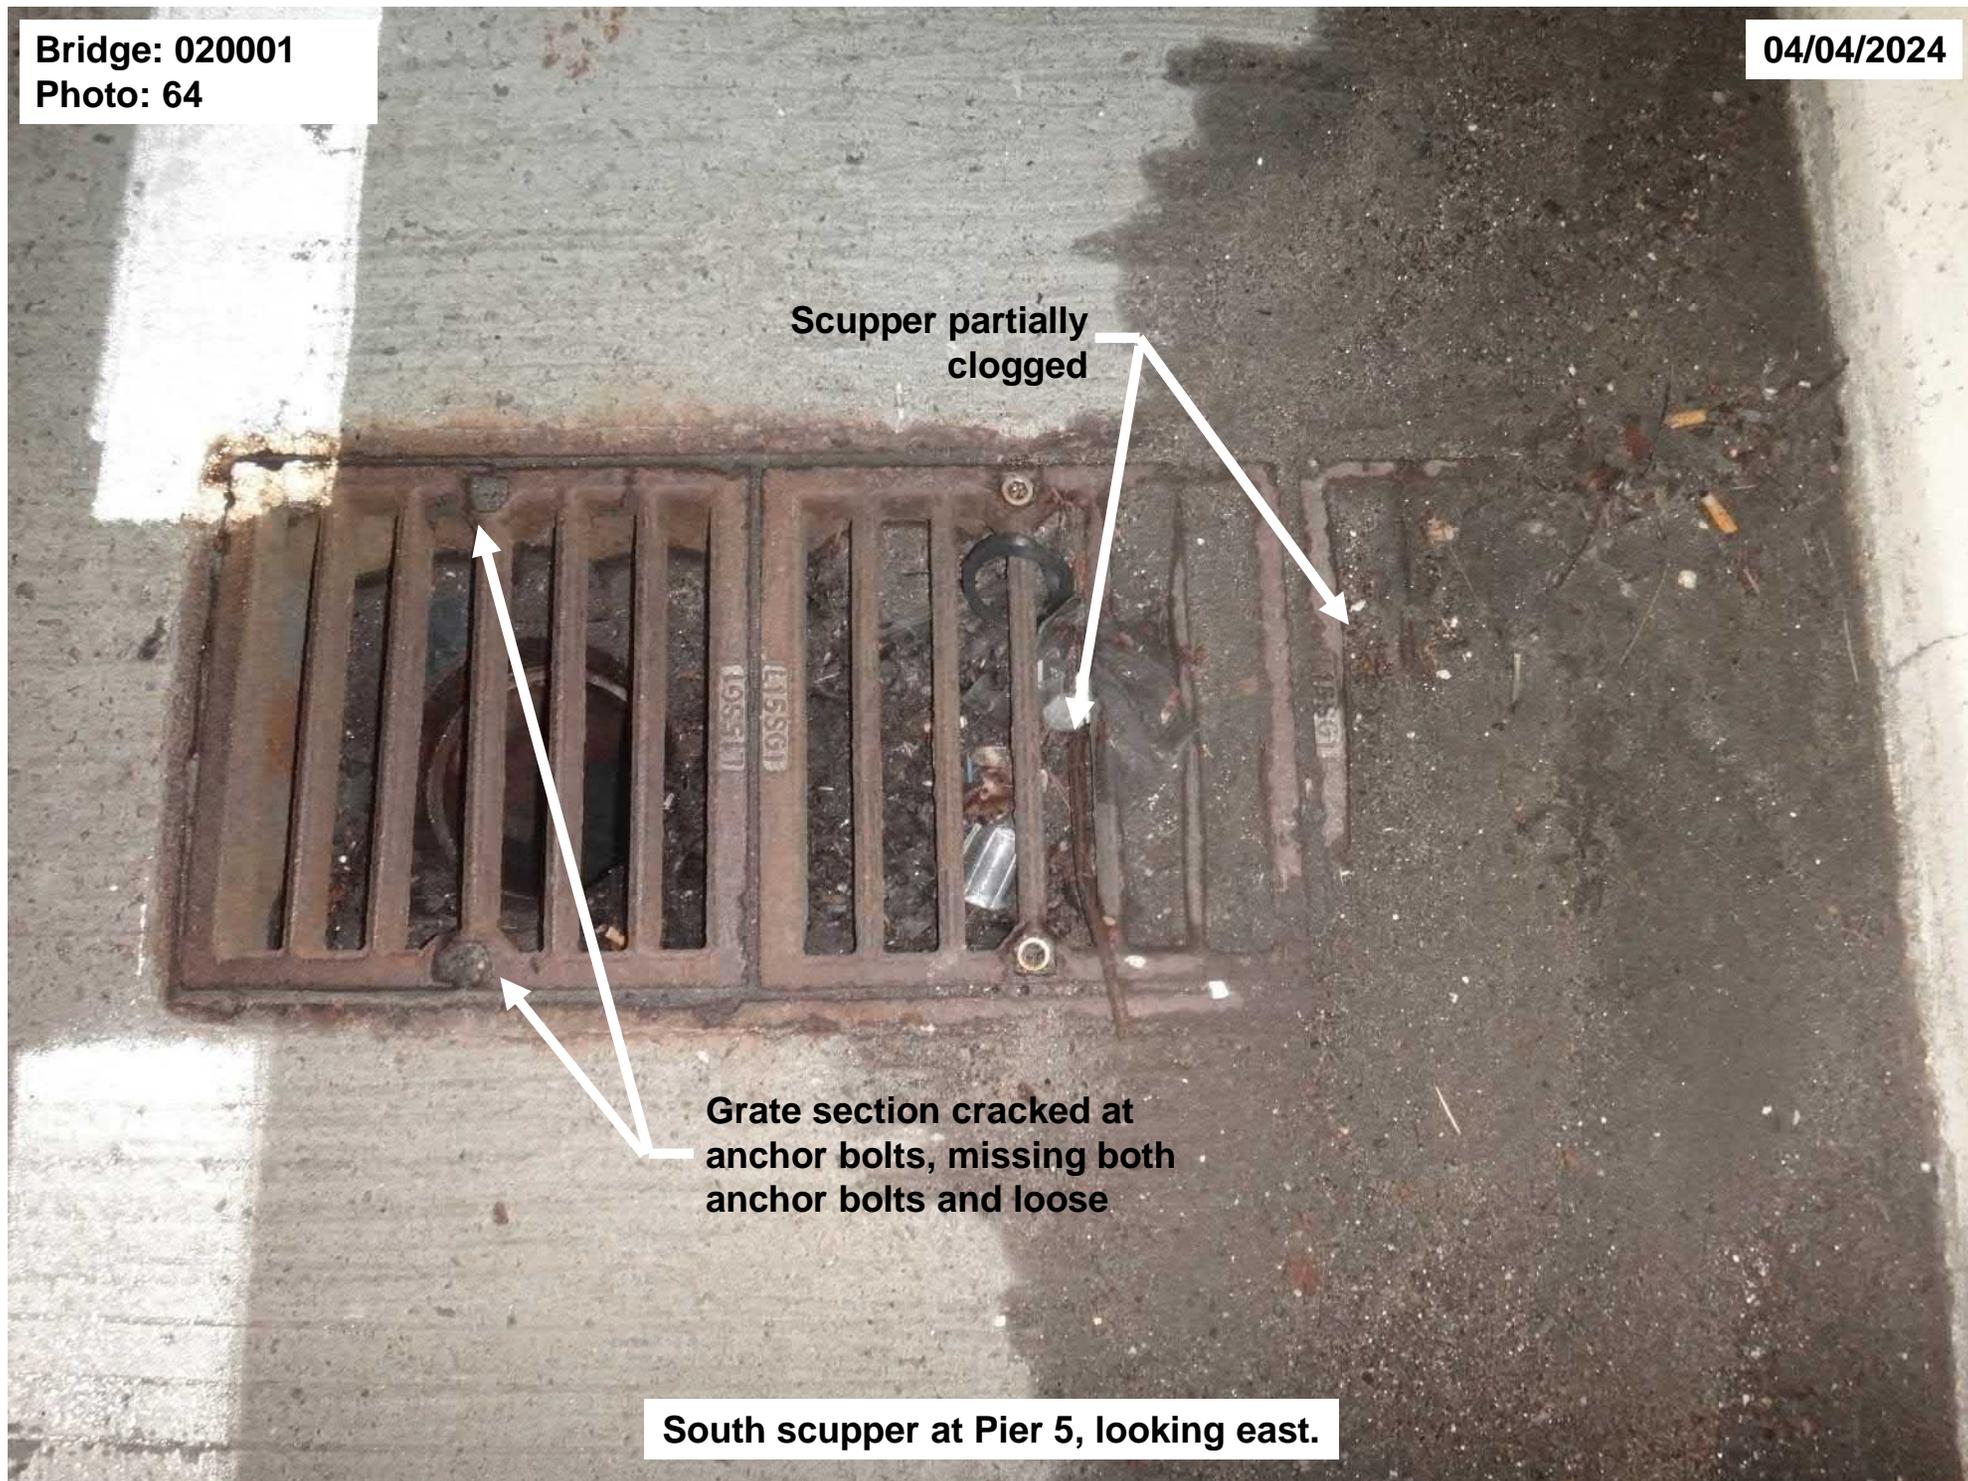
Grate section cracked at
anchor bolts, missing both
anchor bolts and loose

South scupper at Pier 5, looking east.

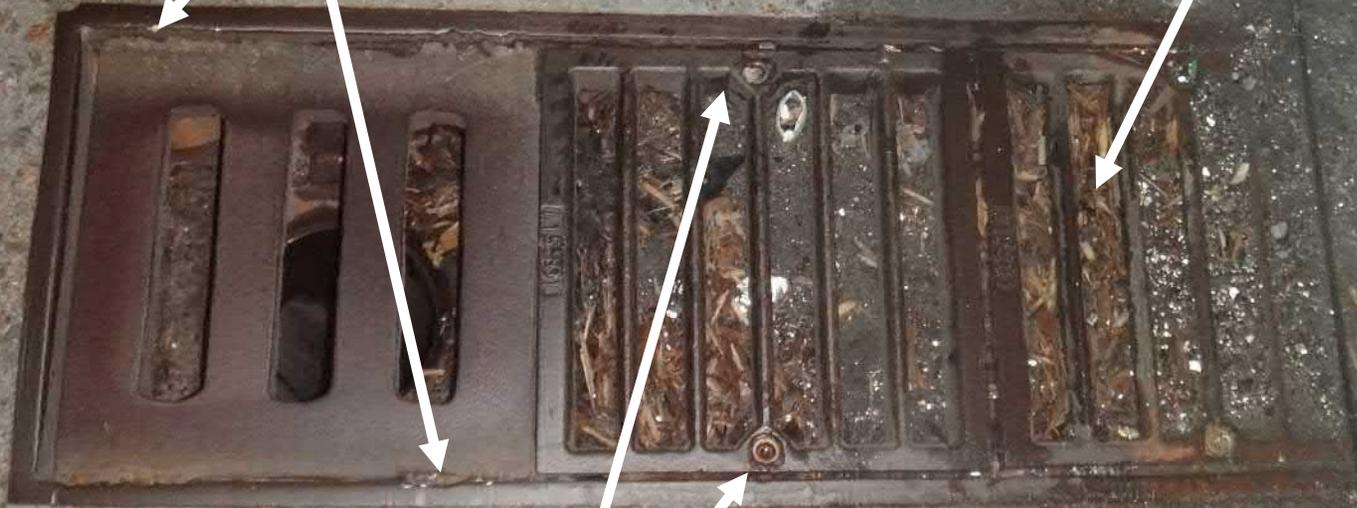
Replaced grate loose
with cracked tack welds

Grate section
cracked at anchor
bolts and loose

North scupper at Pier 6, looking west.

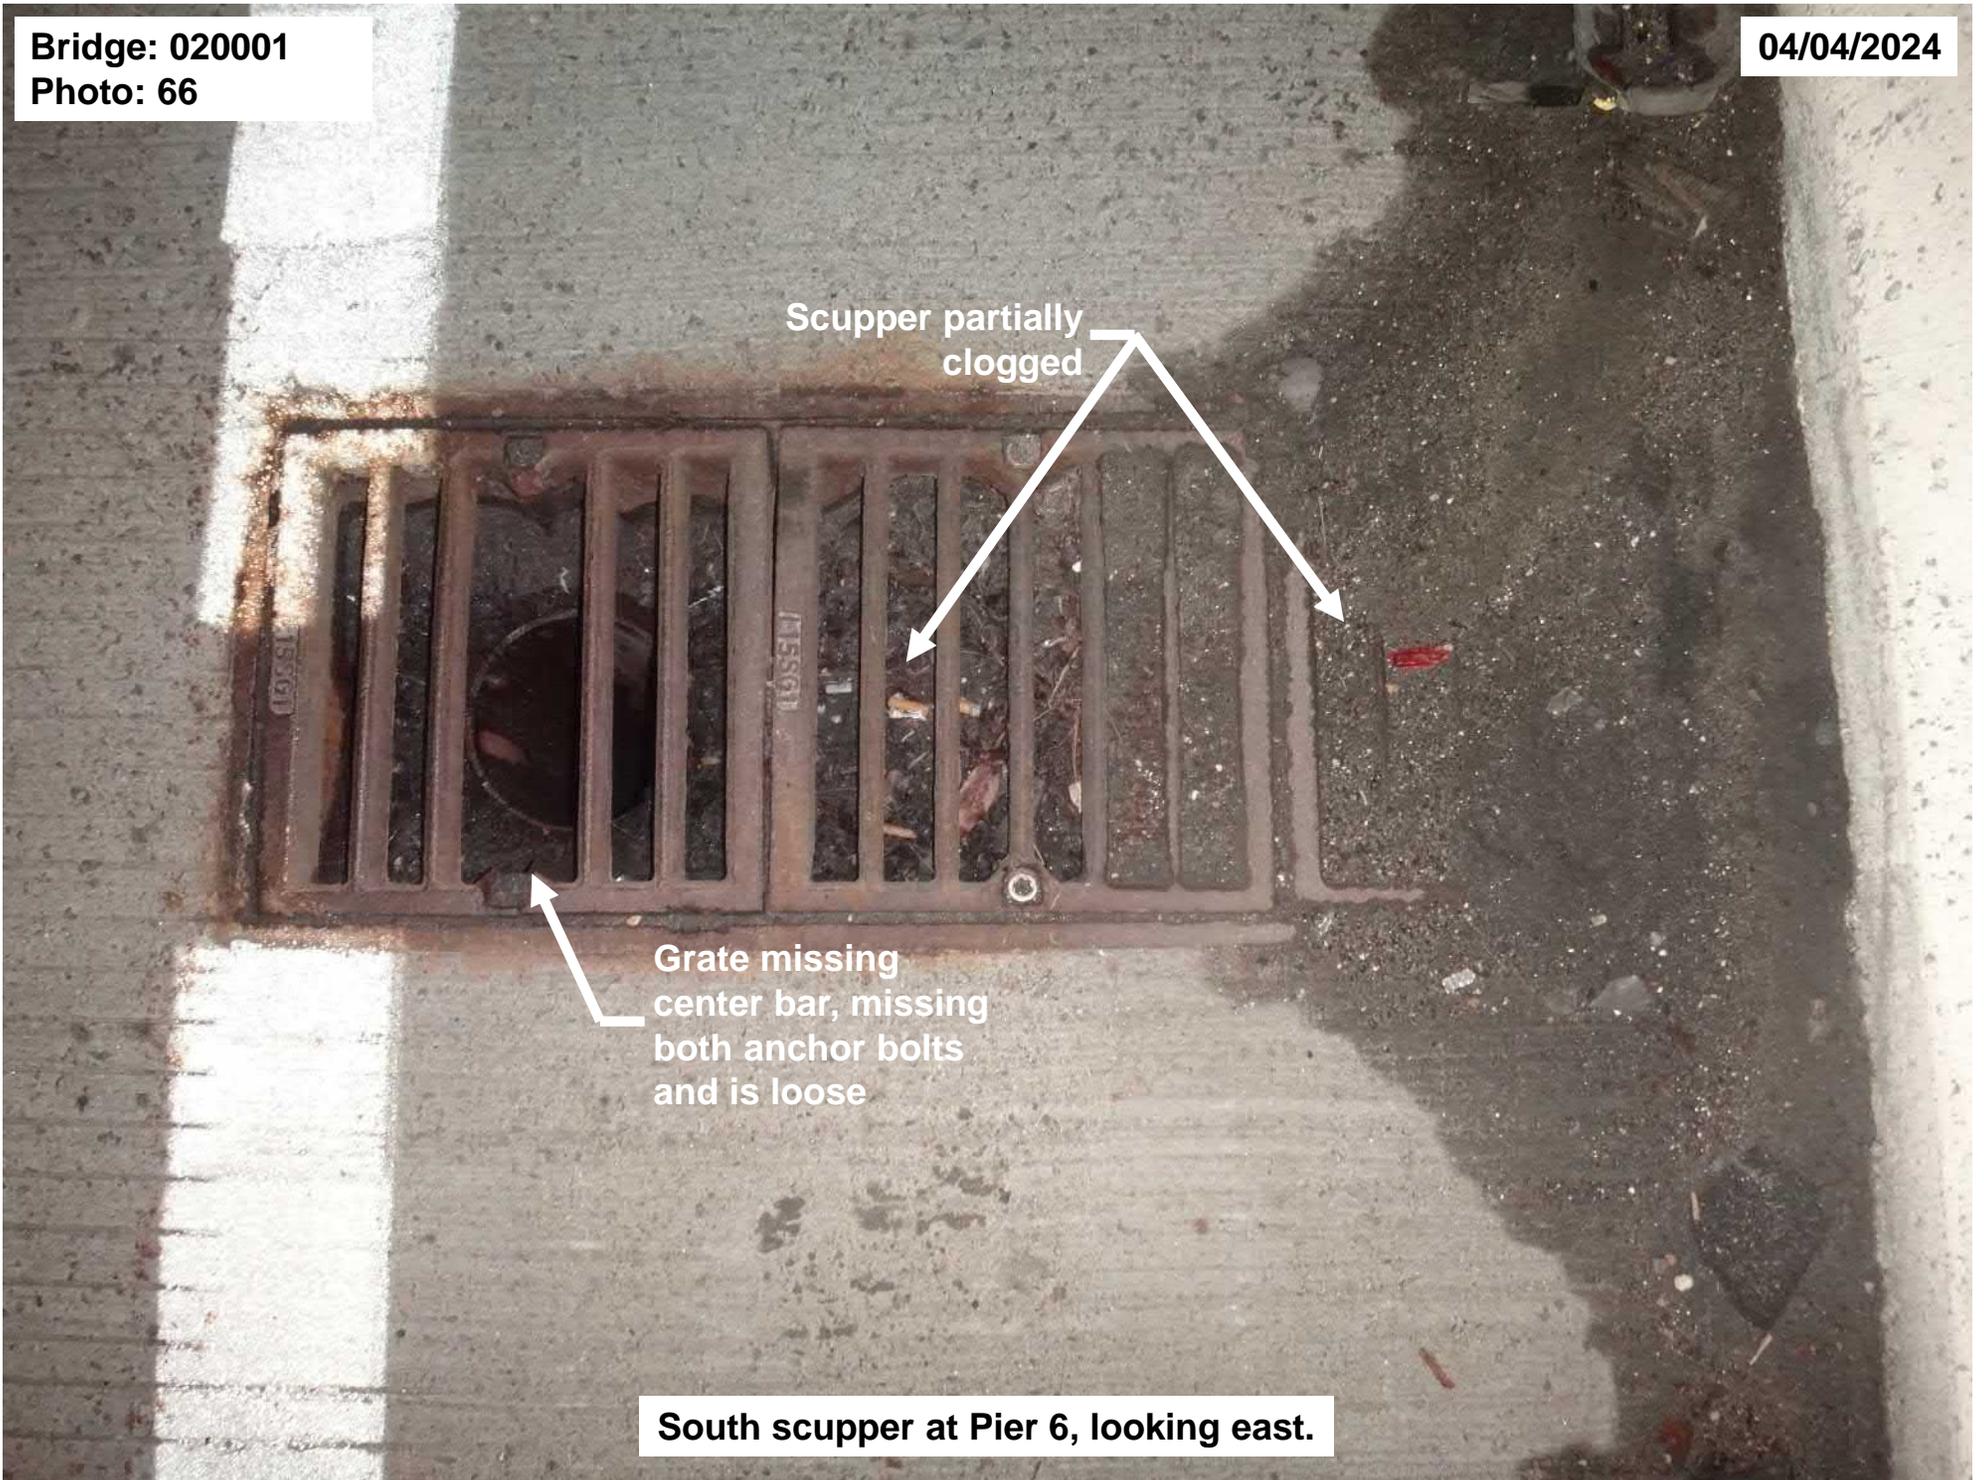
Grate missing
center bar, missing
both anchor bolts
and is loose

South scupper at Pier 6, looking east.

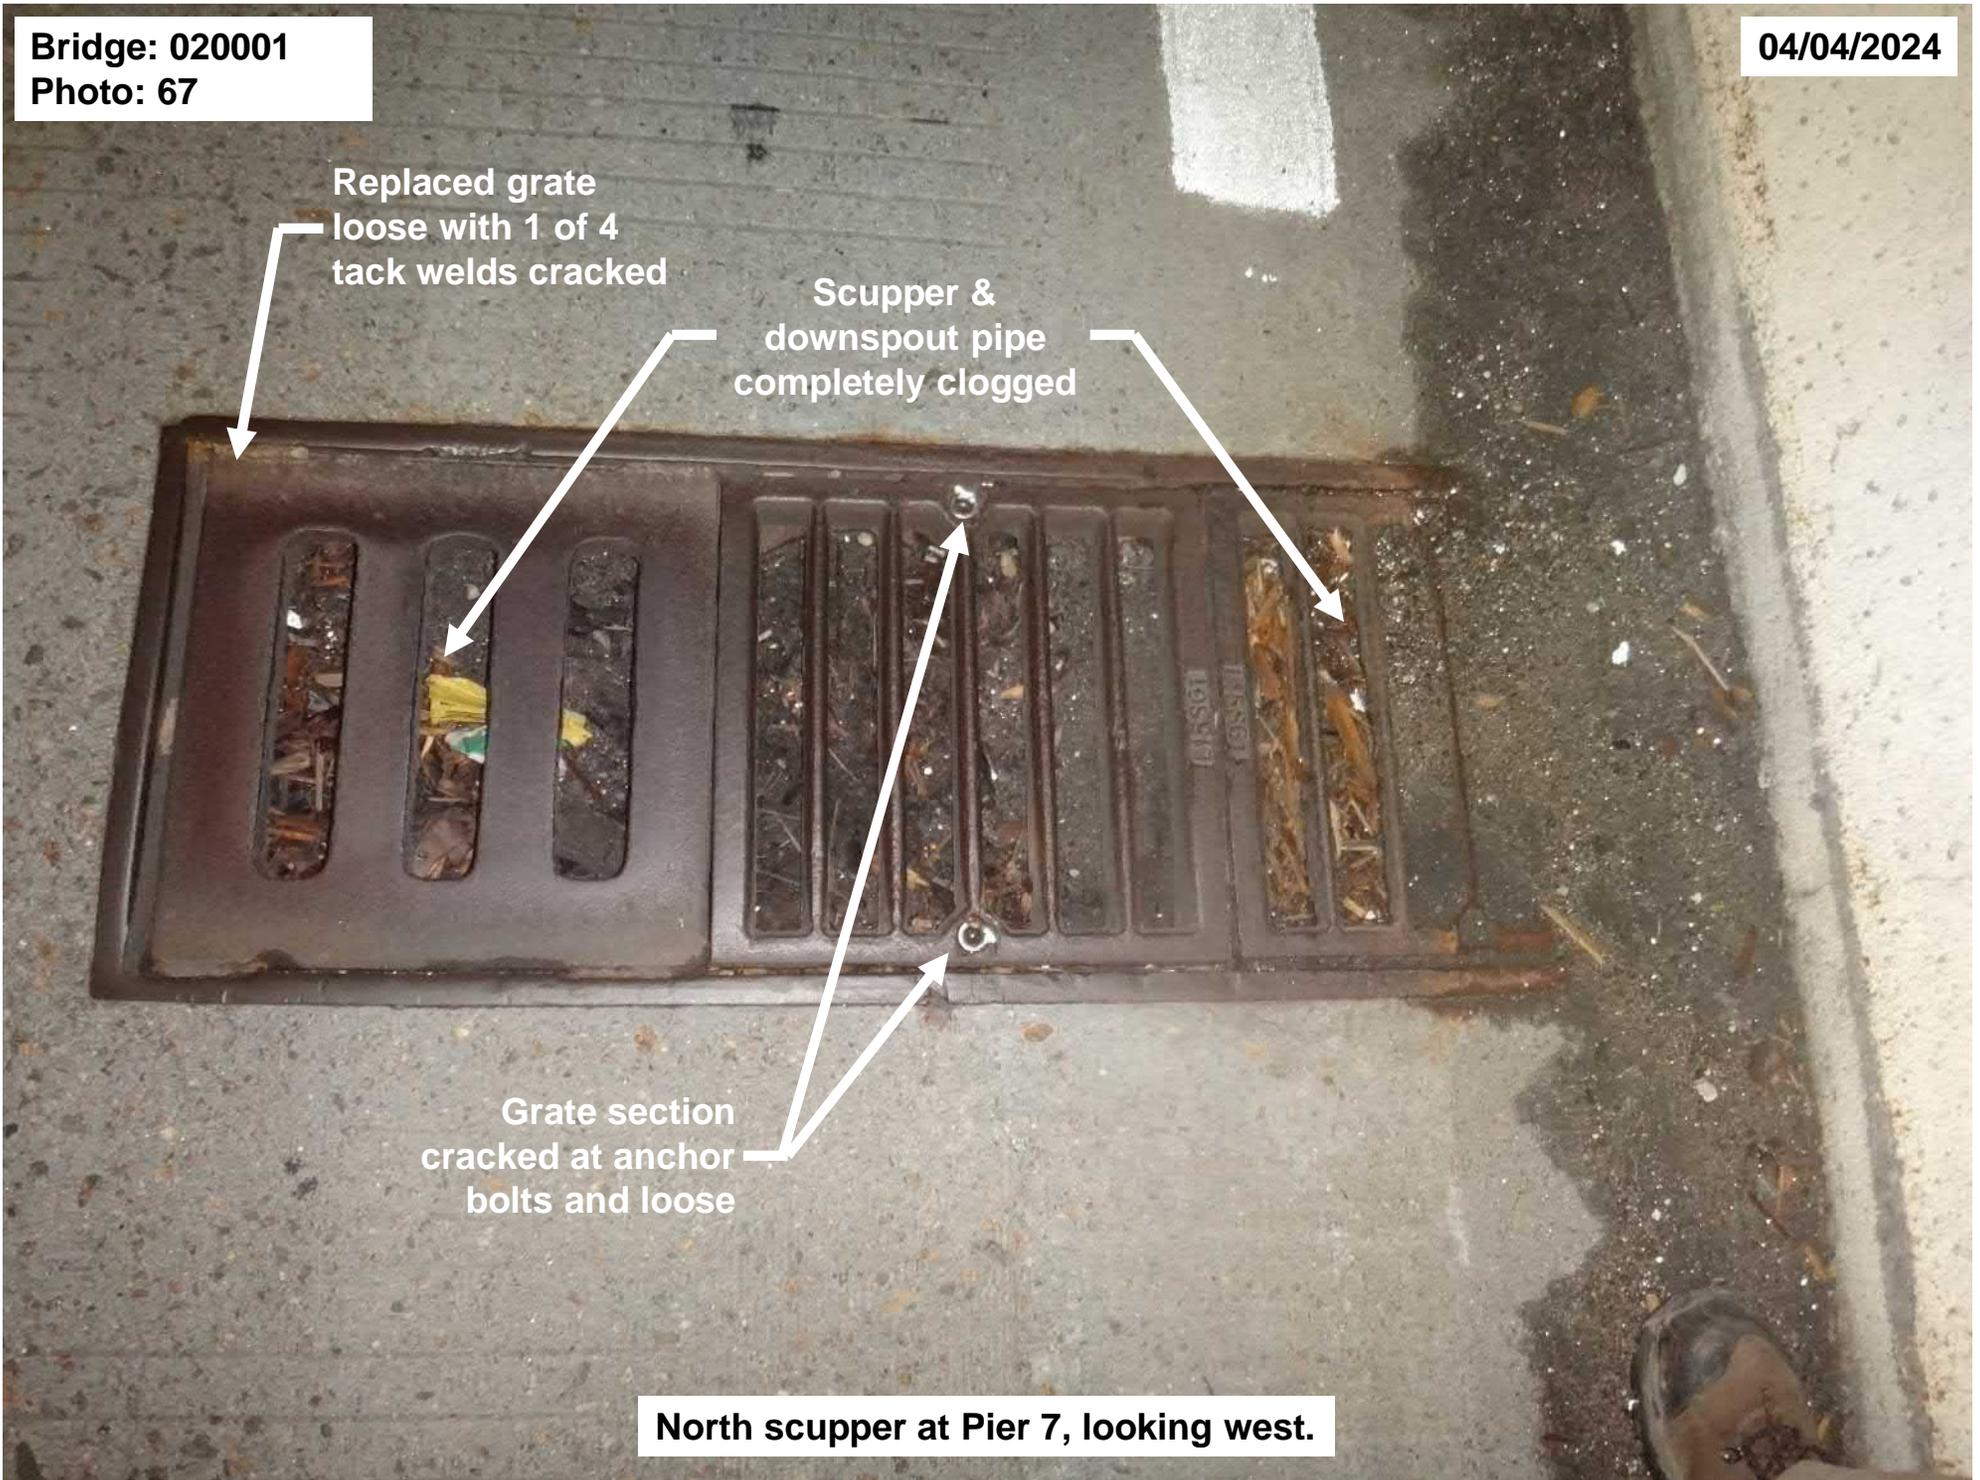
Replaced grate
loose with 1 of 4
tack welds cracked

Grate section
cracked at anchor
bolts and loose

North scupper at Pier 7, looking west.

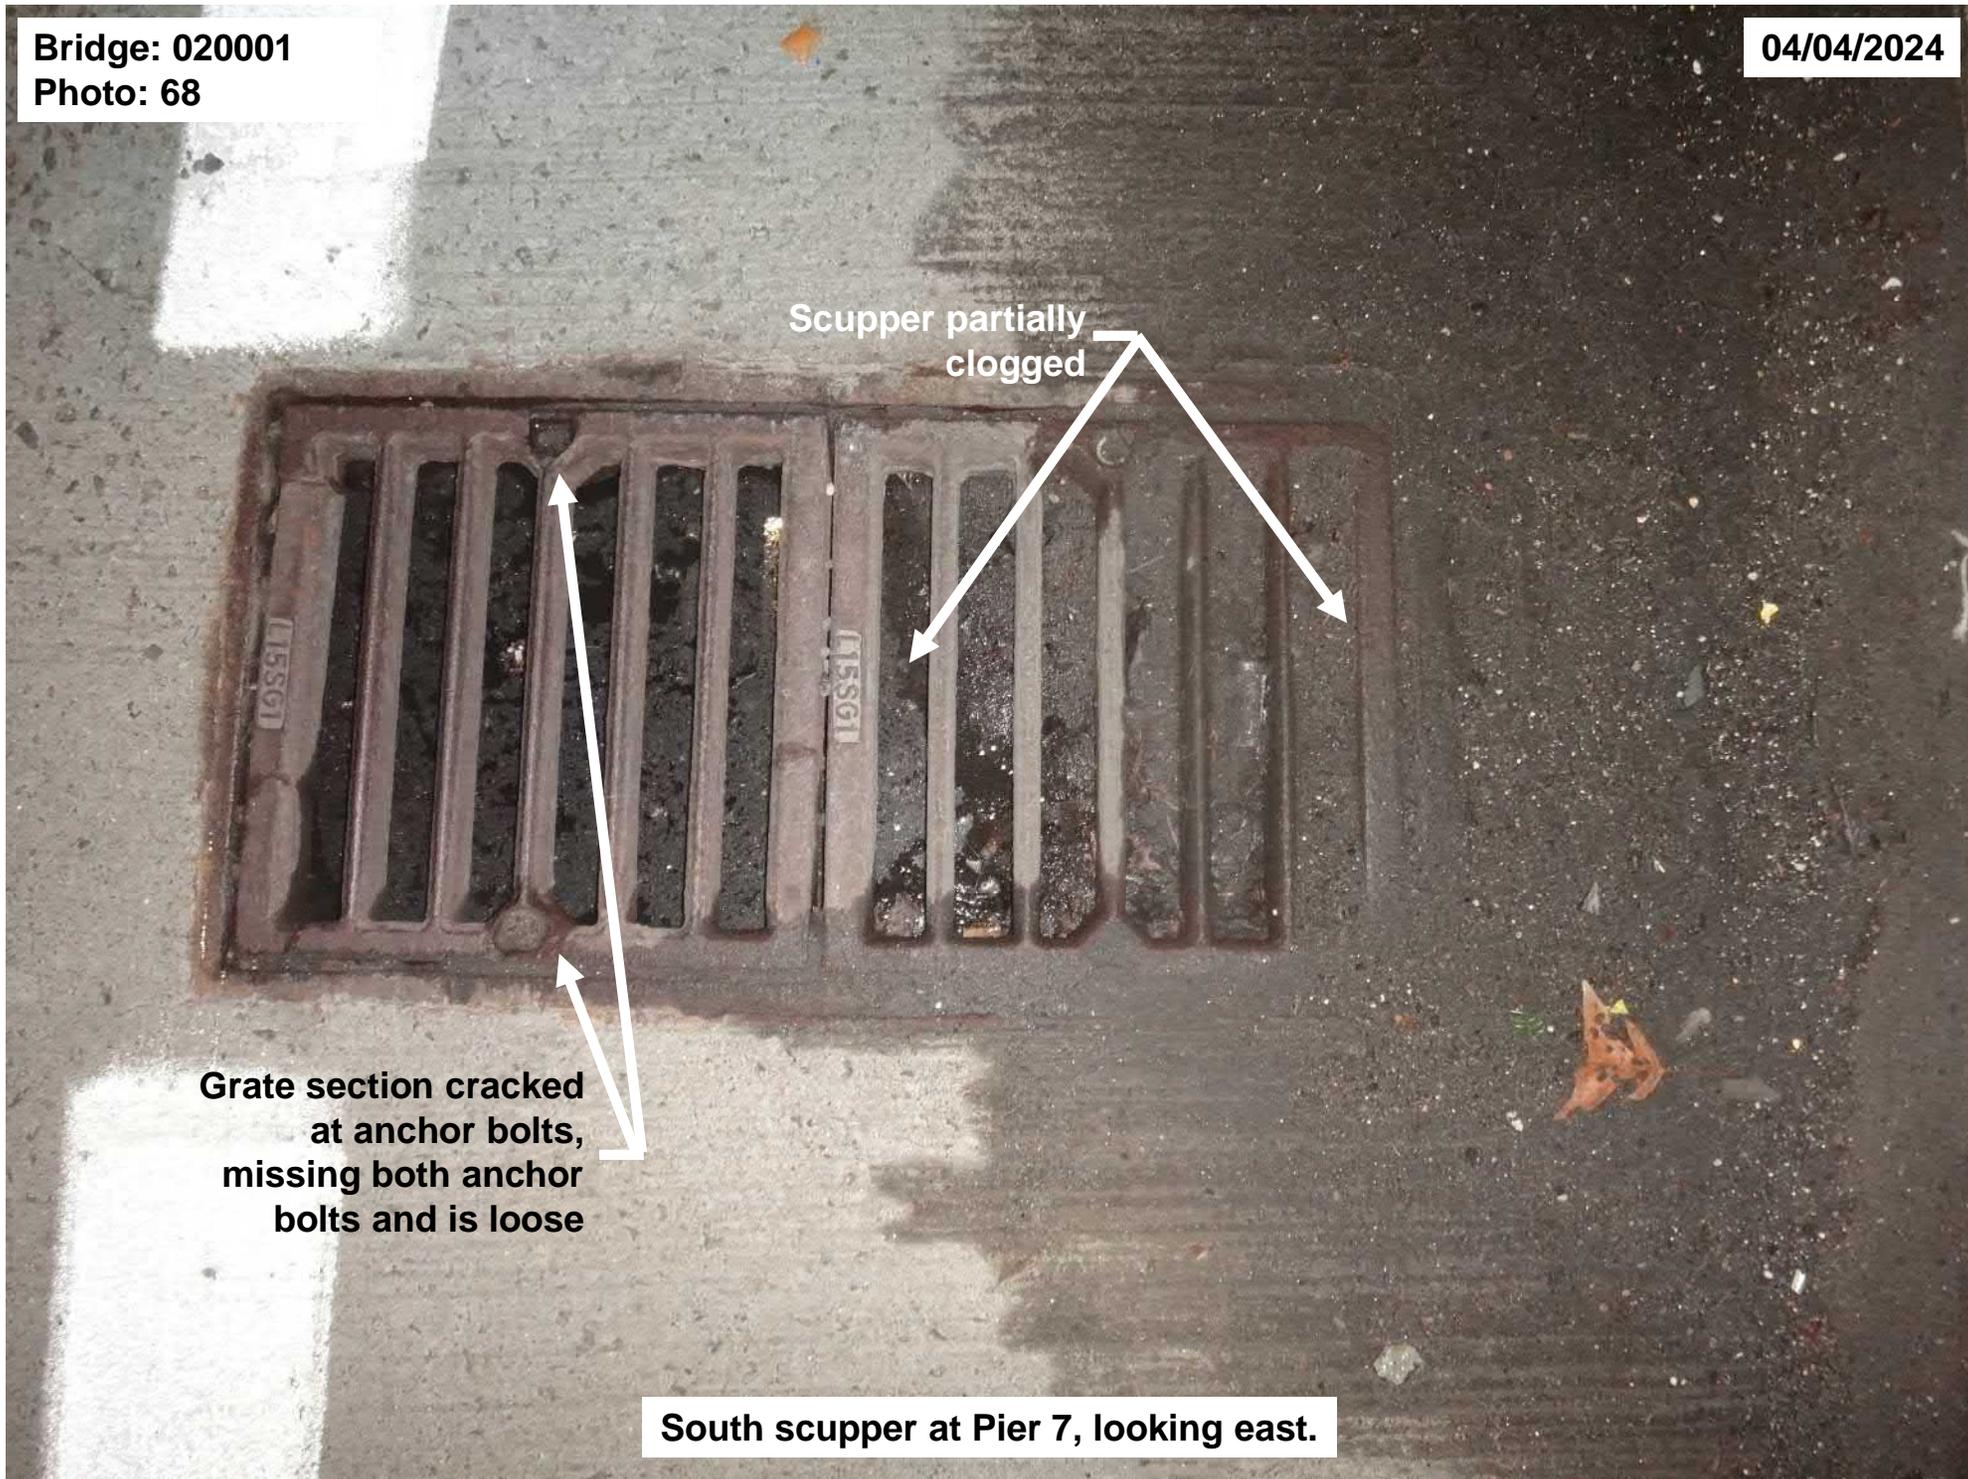
Grate section cracked
at anchor bolts,
missing both anchor
bolts and is loose

South scupper at Pier 7, looking east.

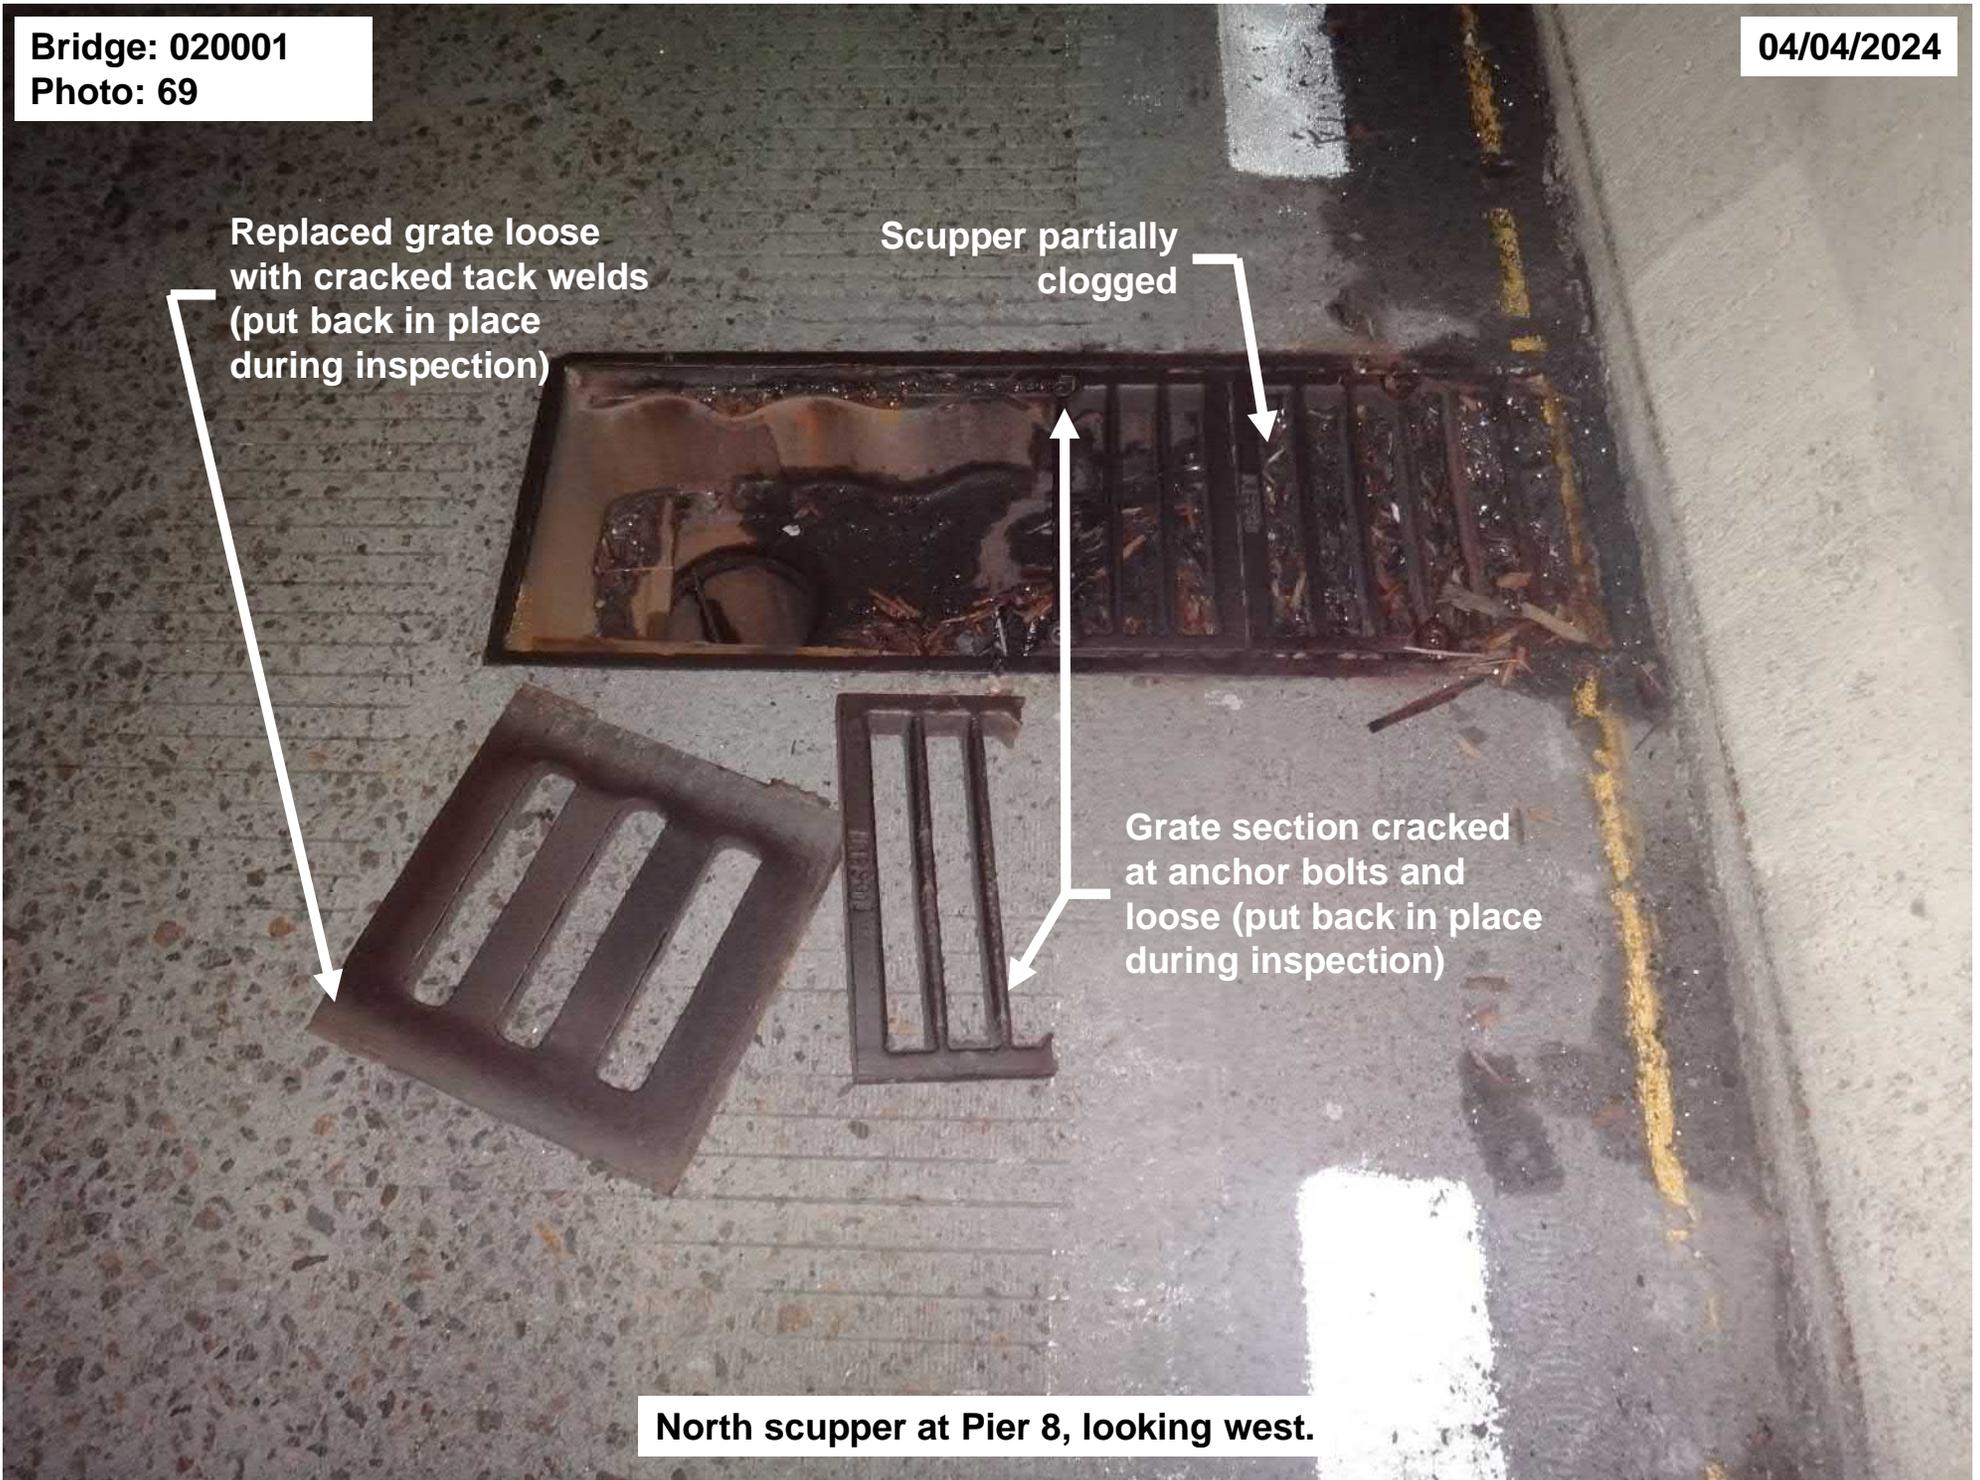
Replaced grate loose
with cracked tack welds
(put back in place
during inspection)

Grate section cracked
at anchor bolts and
loose (put back in place
during inspection)

North scupper at Pier 8, looking west.

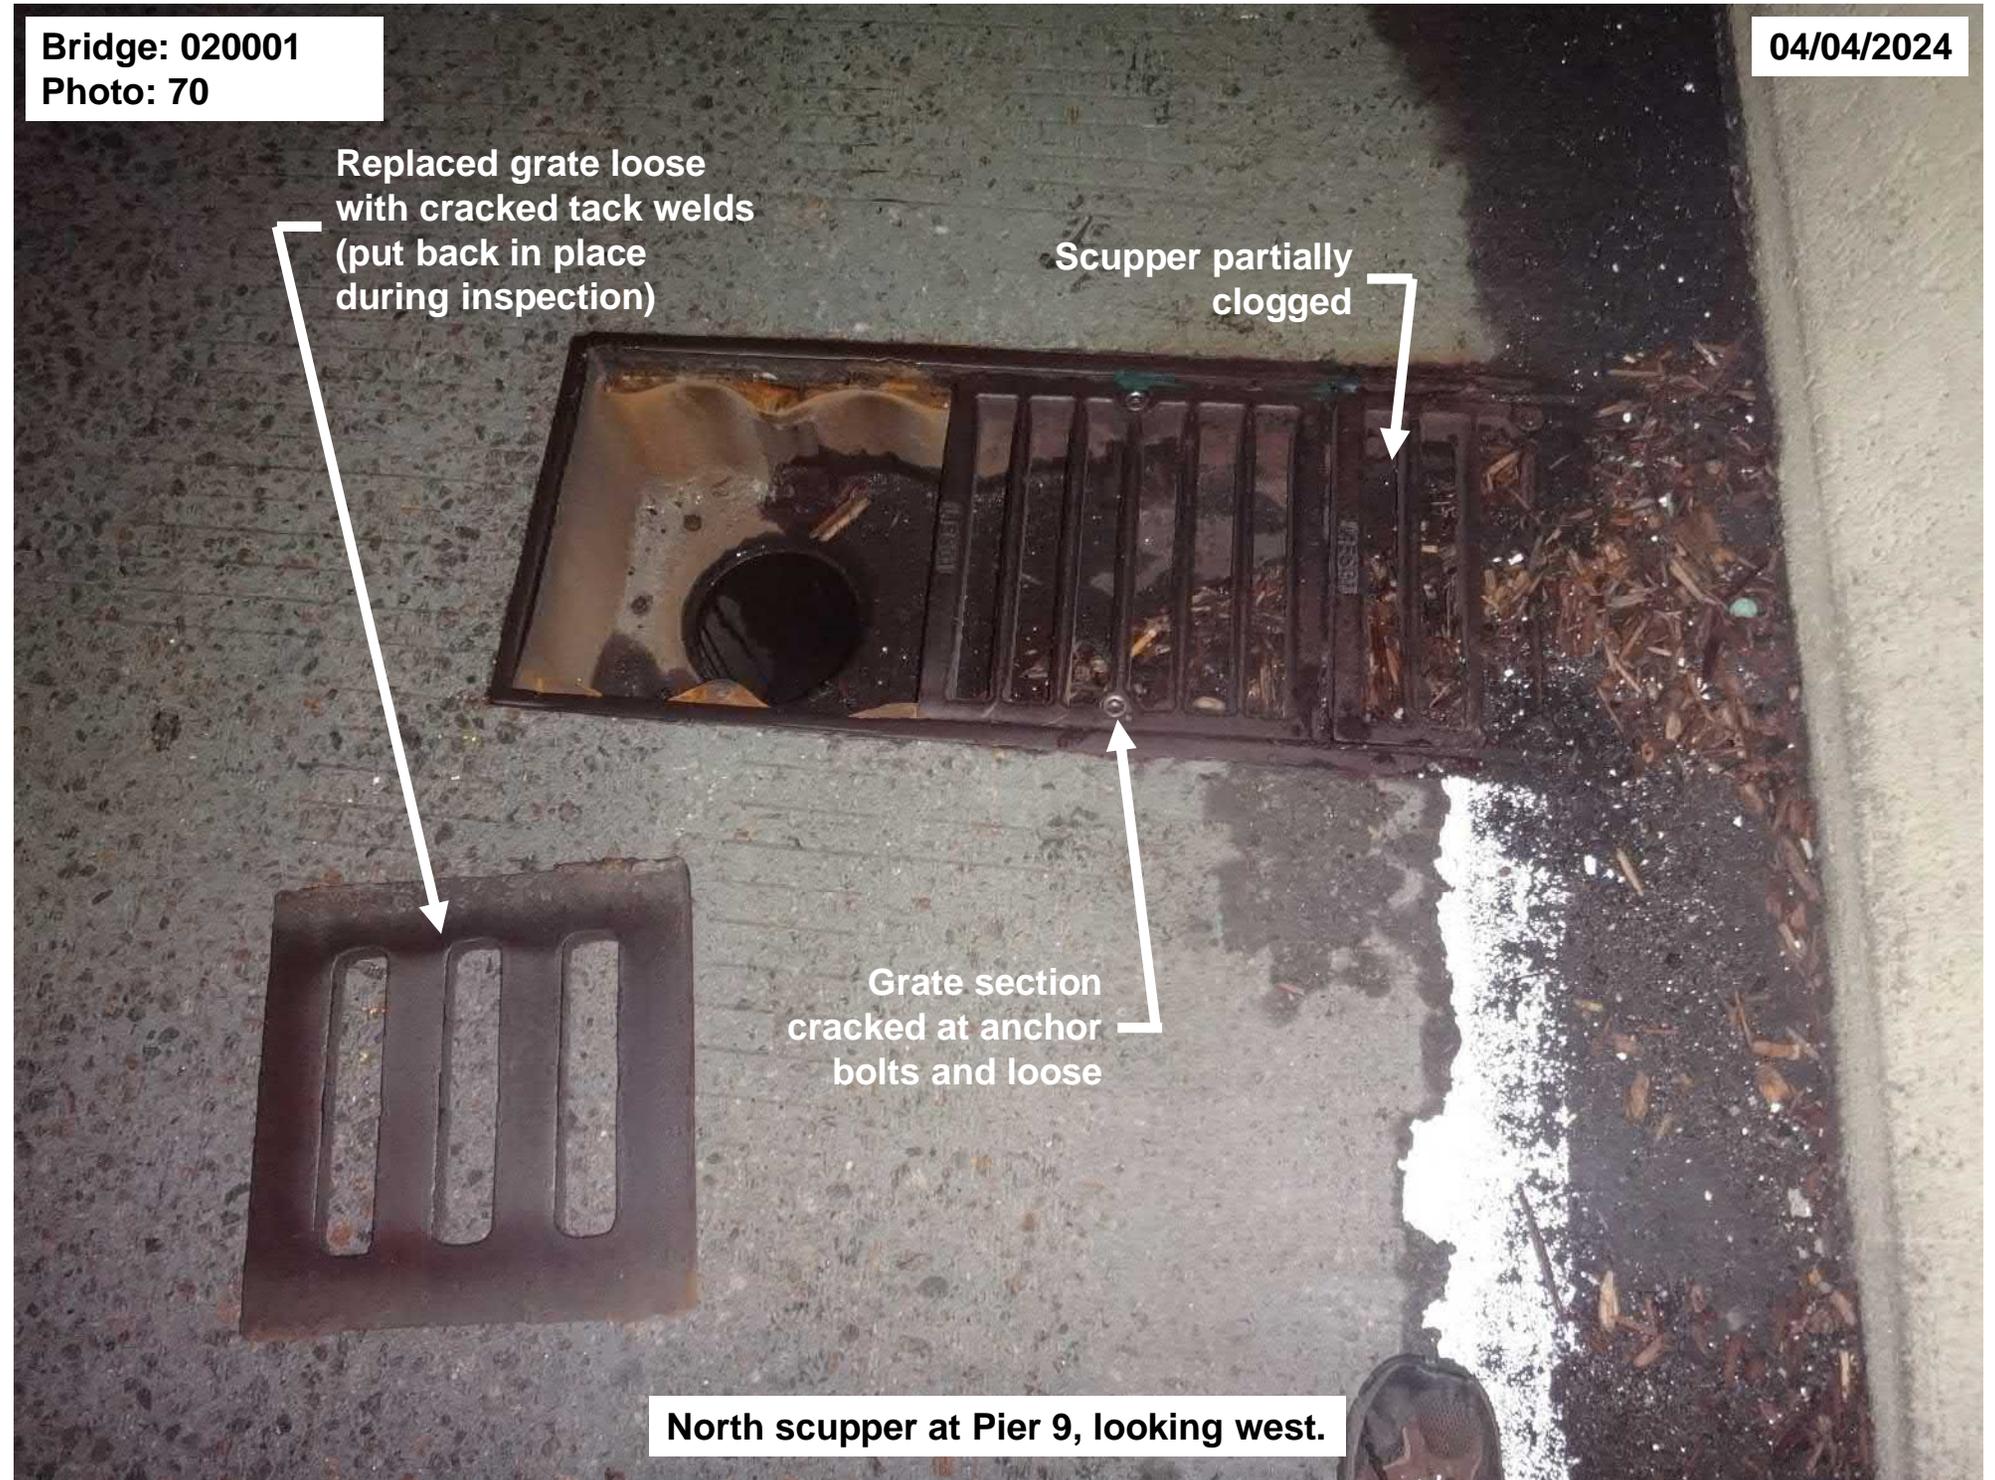
Replaced grate loose
with cracked tack welds
(put back in place
during inspection)

Grate section
cracked at anchor
bolts and loose

North scupper at Pier 9, looking west.

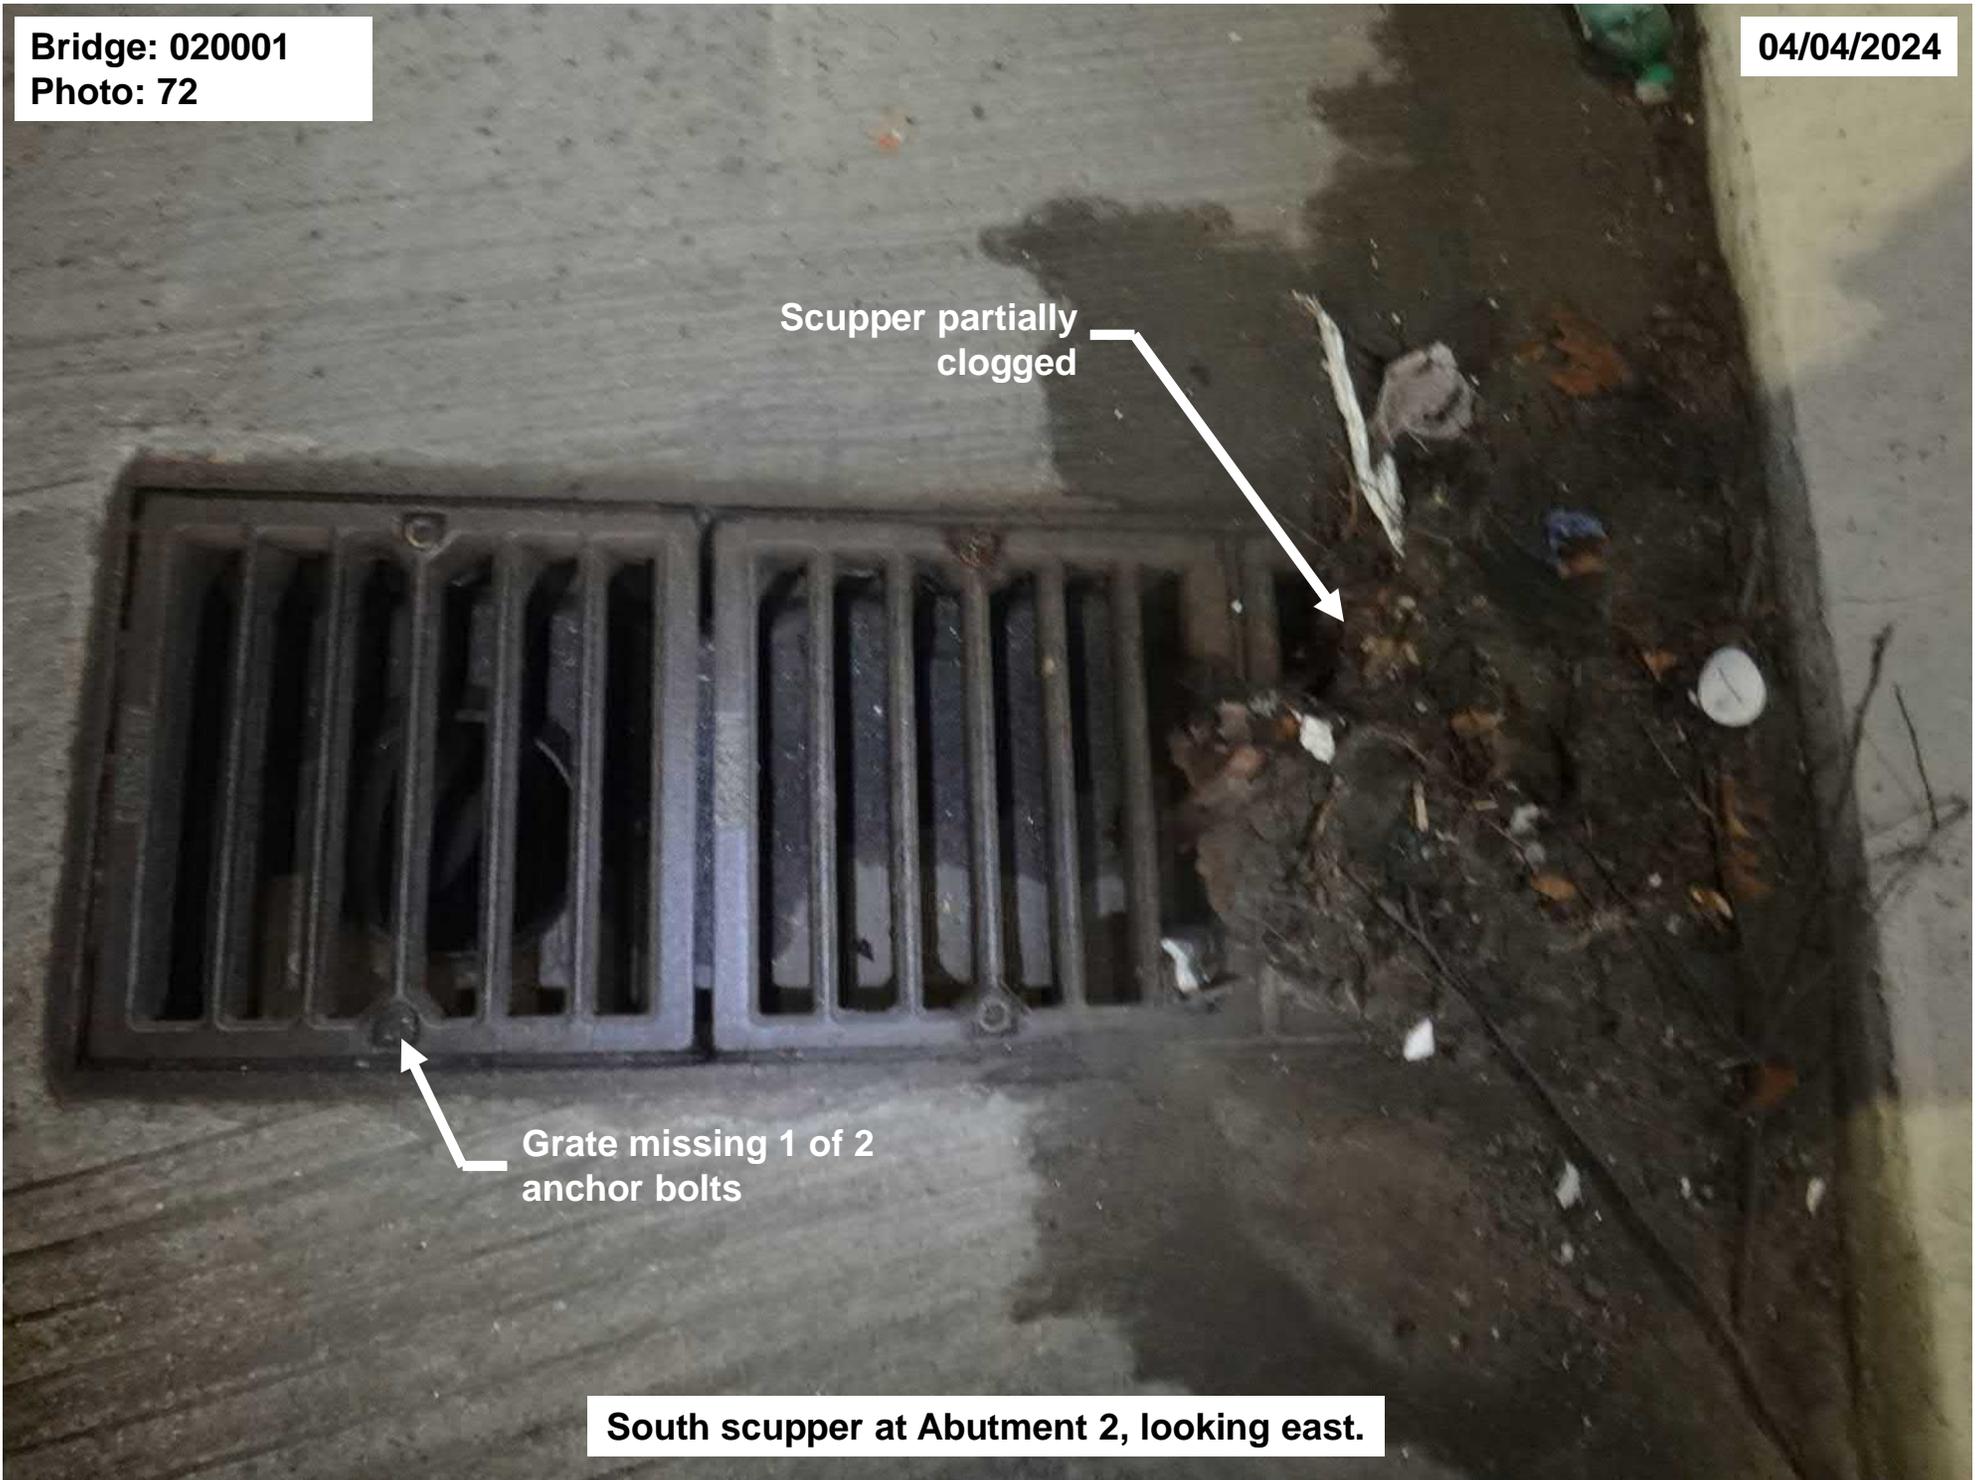
Grate missing 1 of 2
anchor bolts

South scupper at Abutment 2, looking east.
