Bridge: 020001
Photo: 1

South elevation at the main channel, looking north.

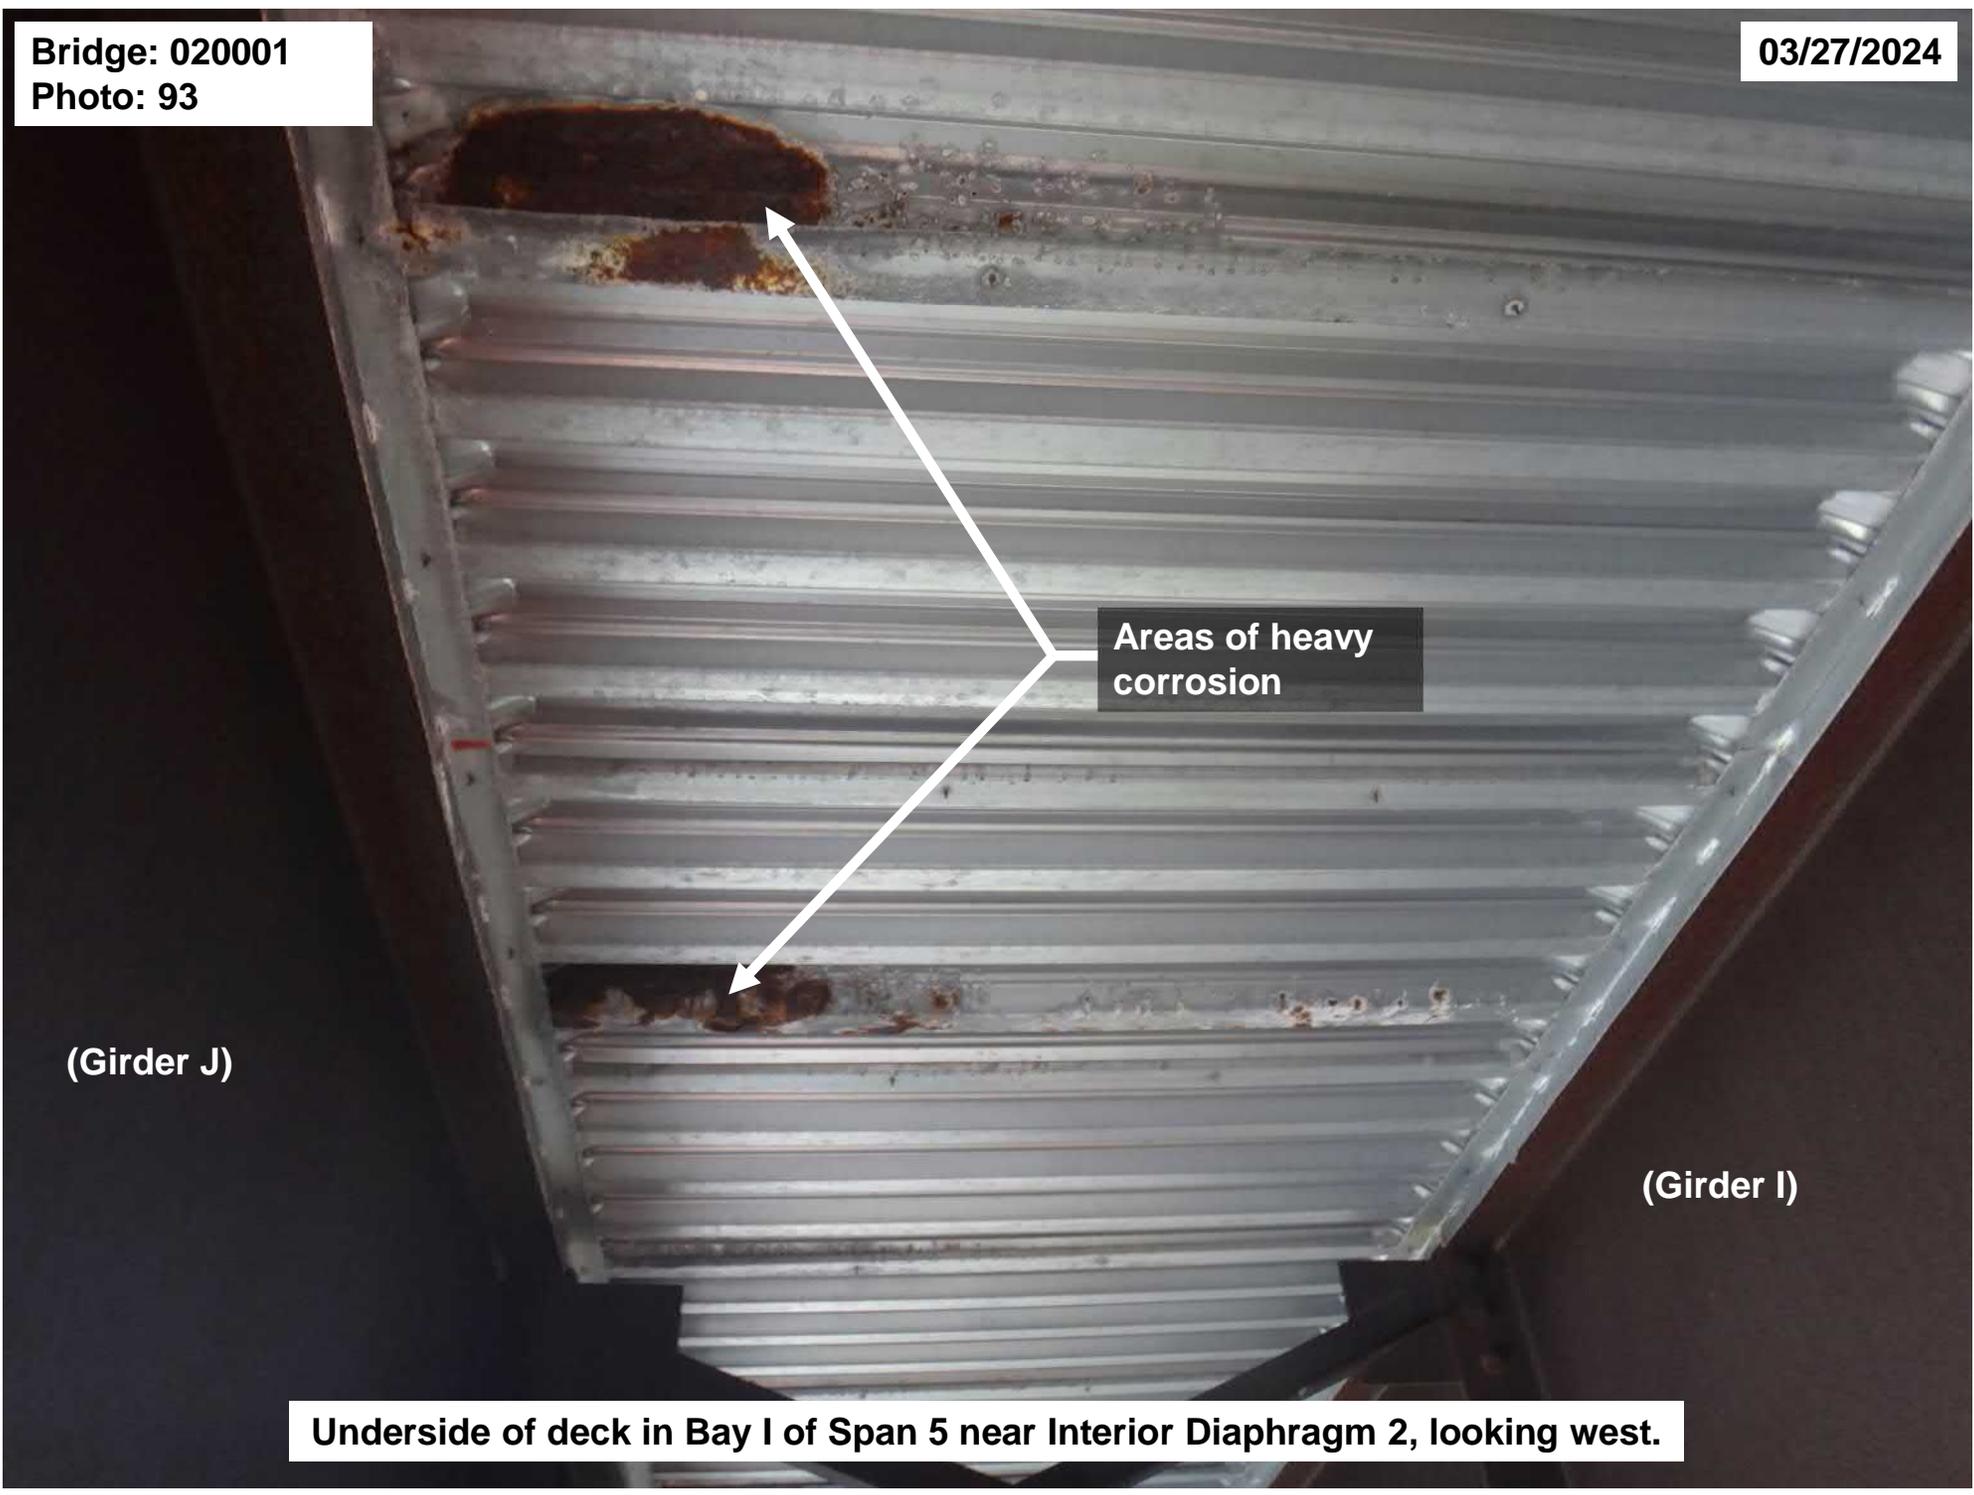
Bridge: 020001
Photo: 93

Areas of heavy corrosion

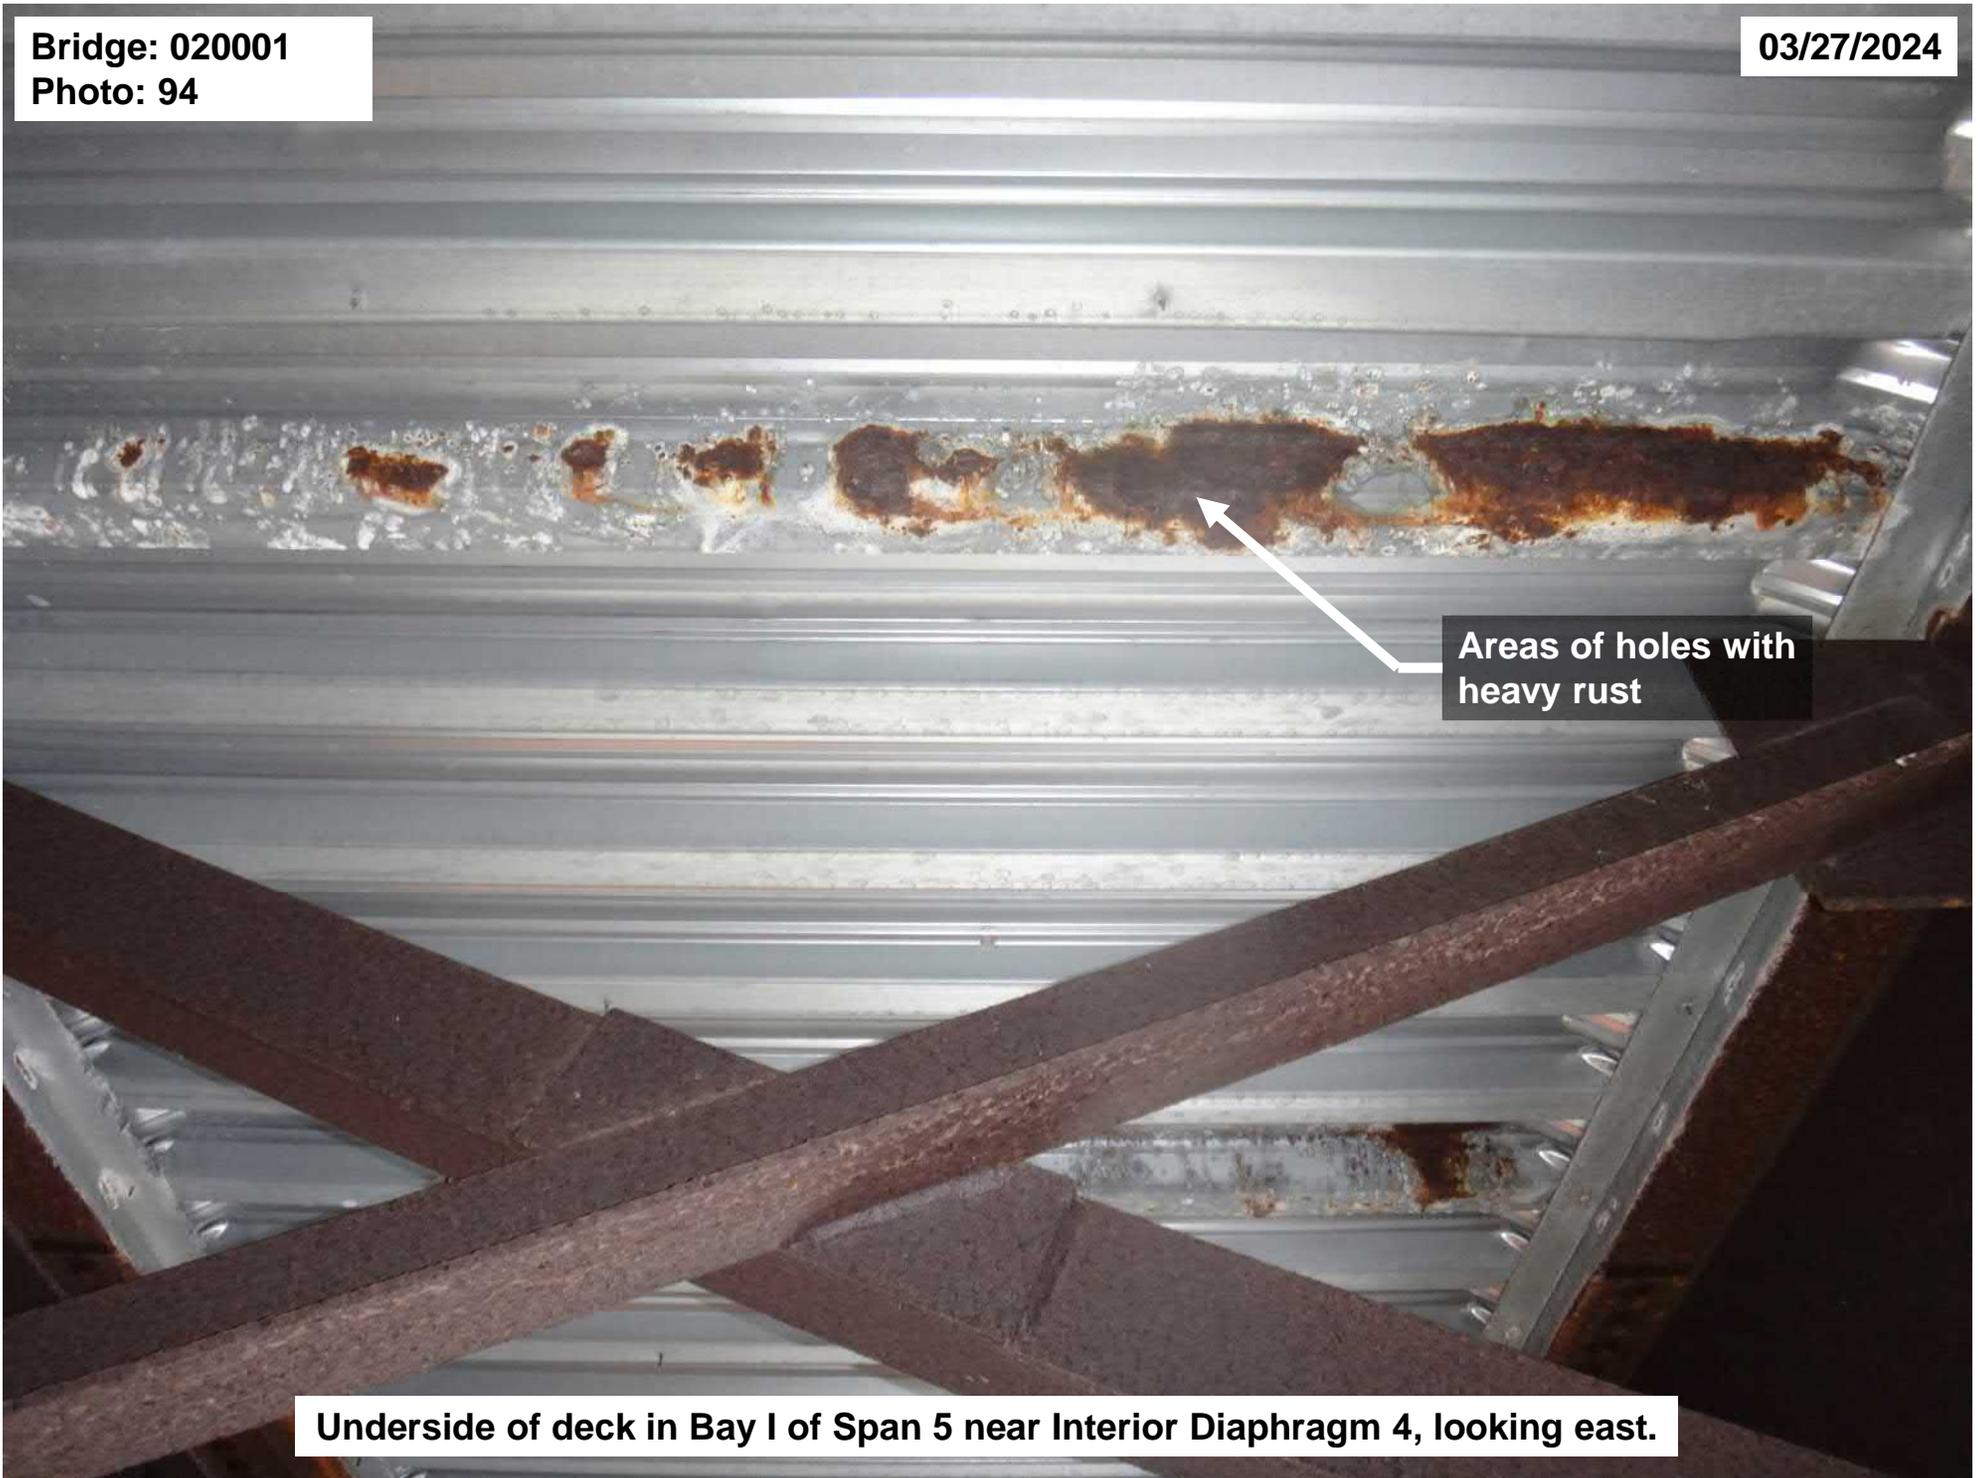
Bridge: 020001
Photo: 94

Areas of holes with heavy rust

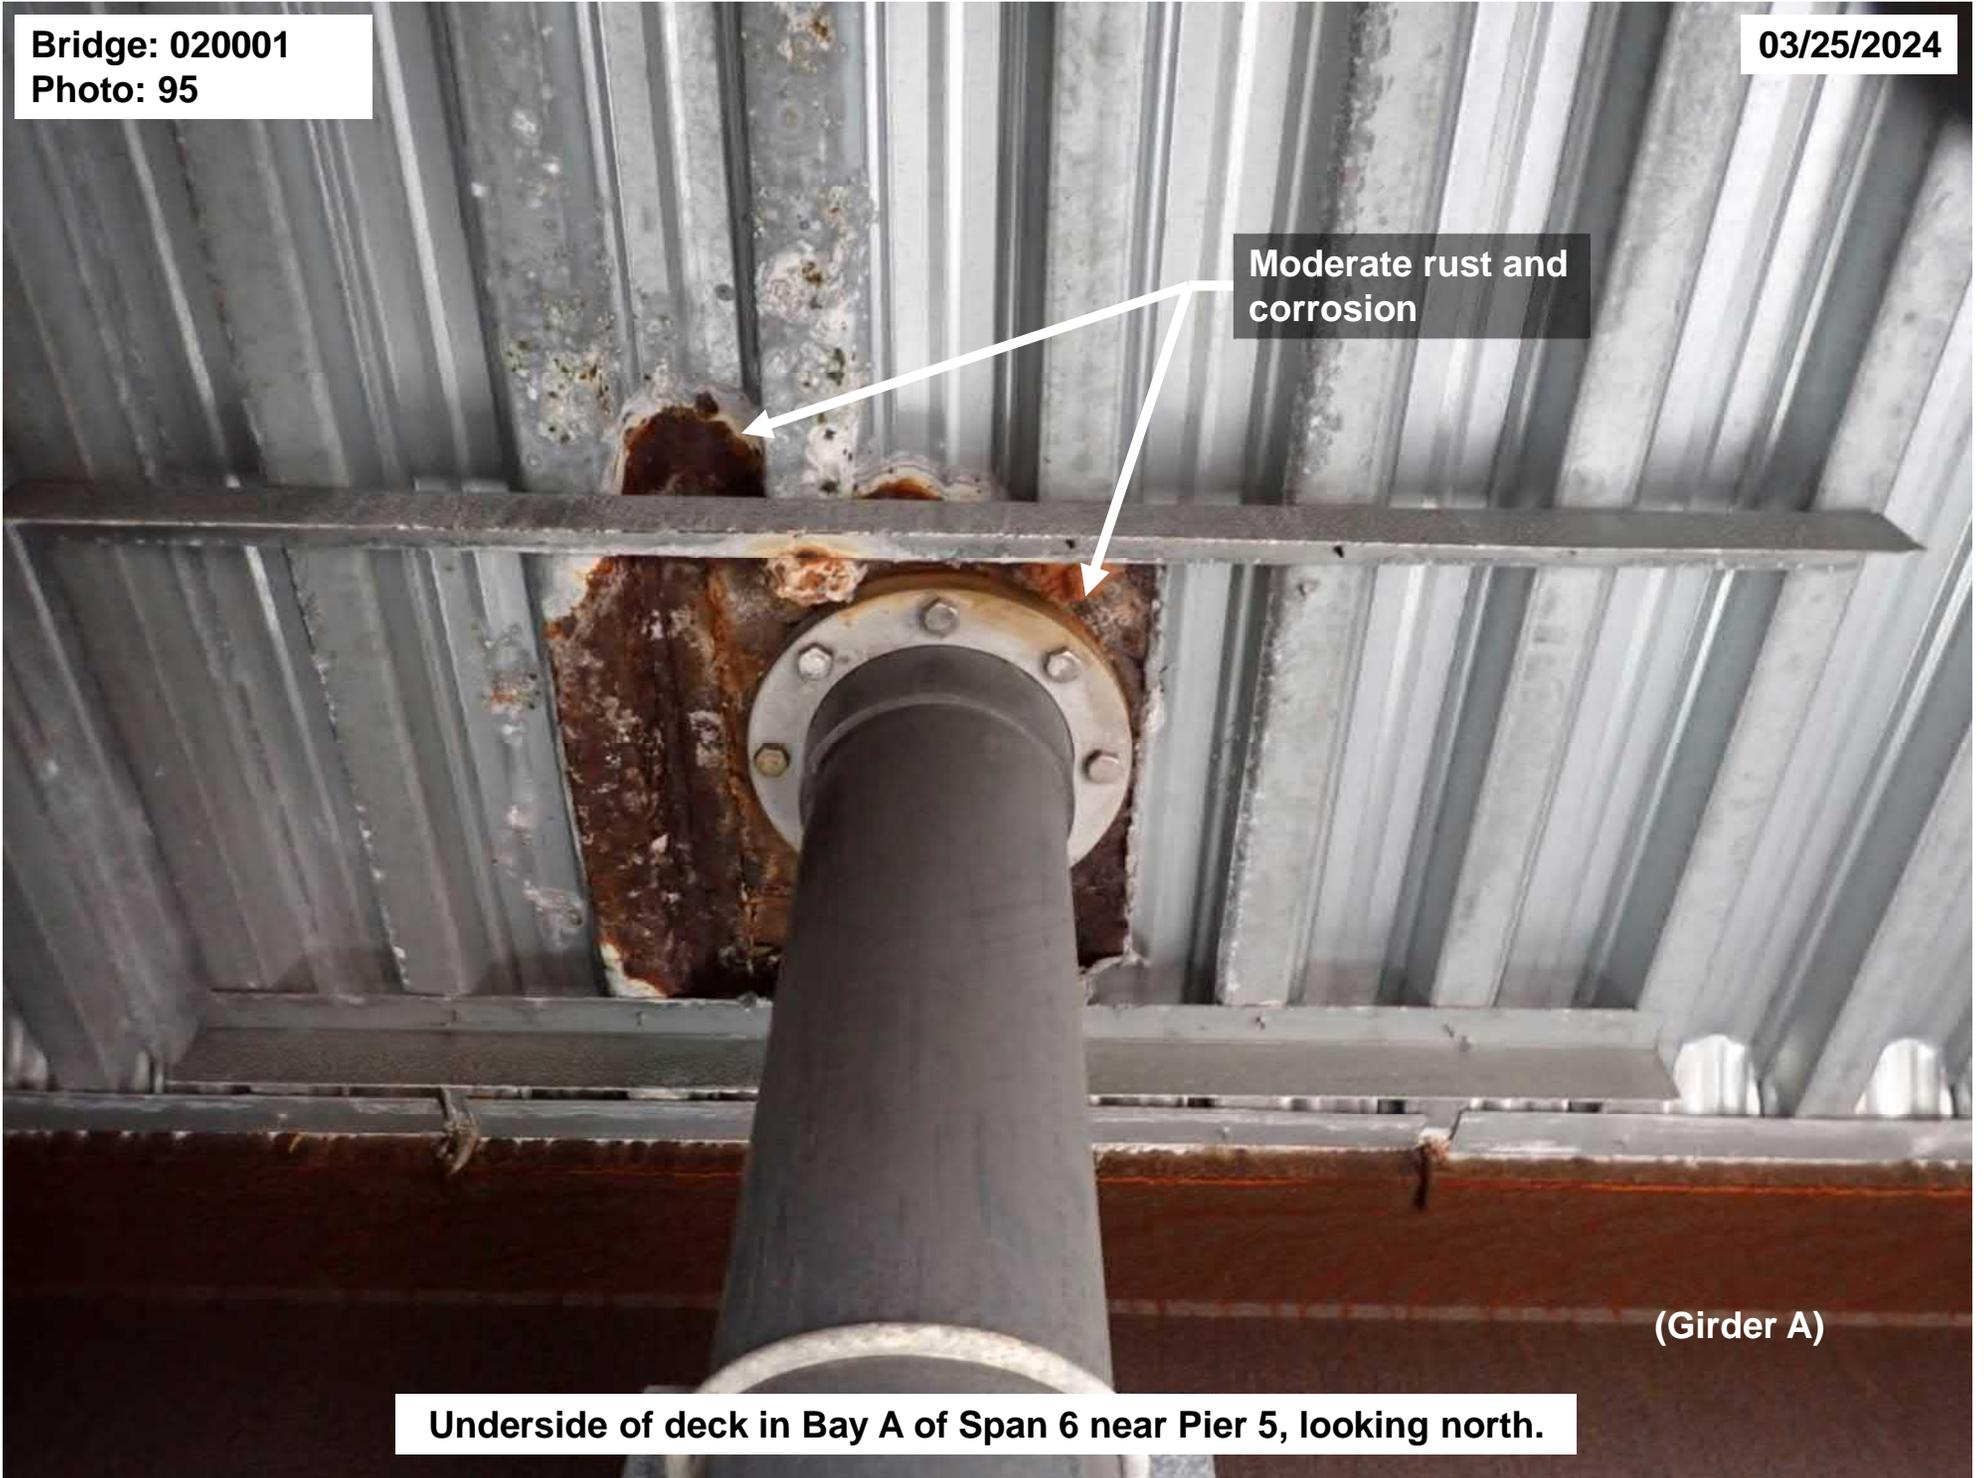
Moderate rust and corrosion

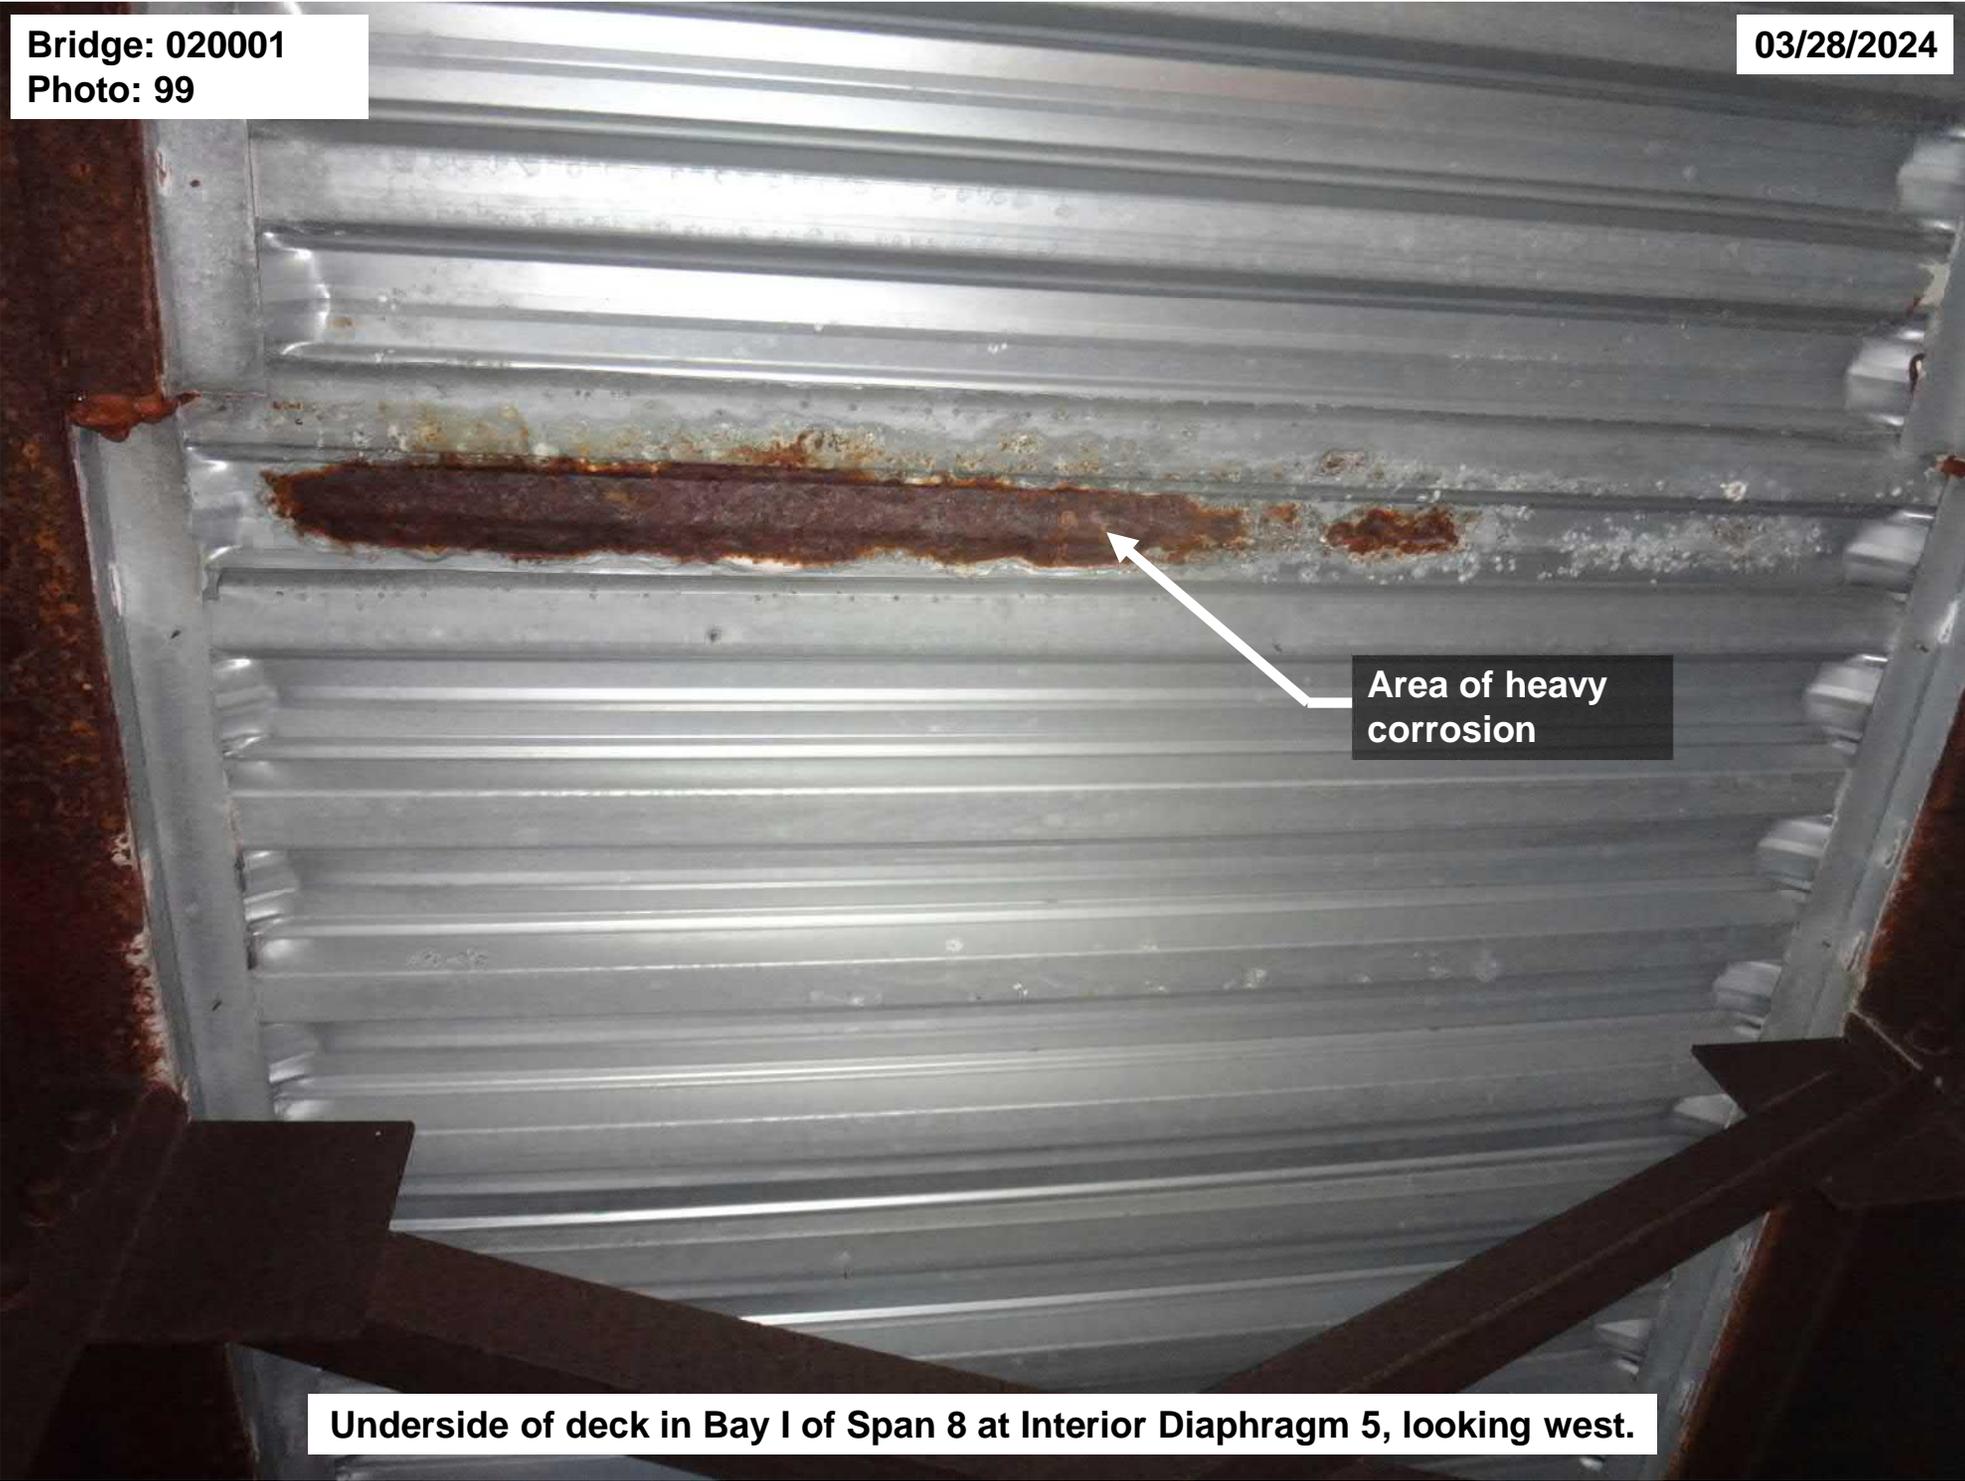
Bridge: 020001
Photo: 99

Area of heavy
corrosion

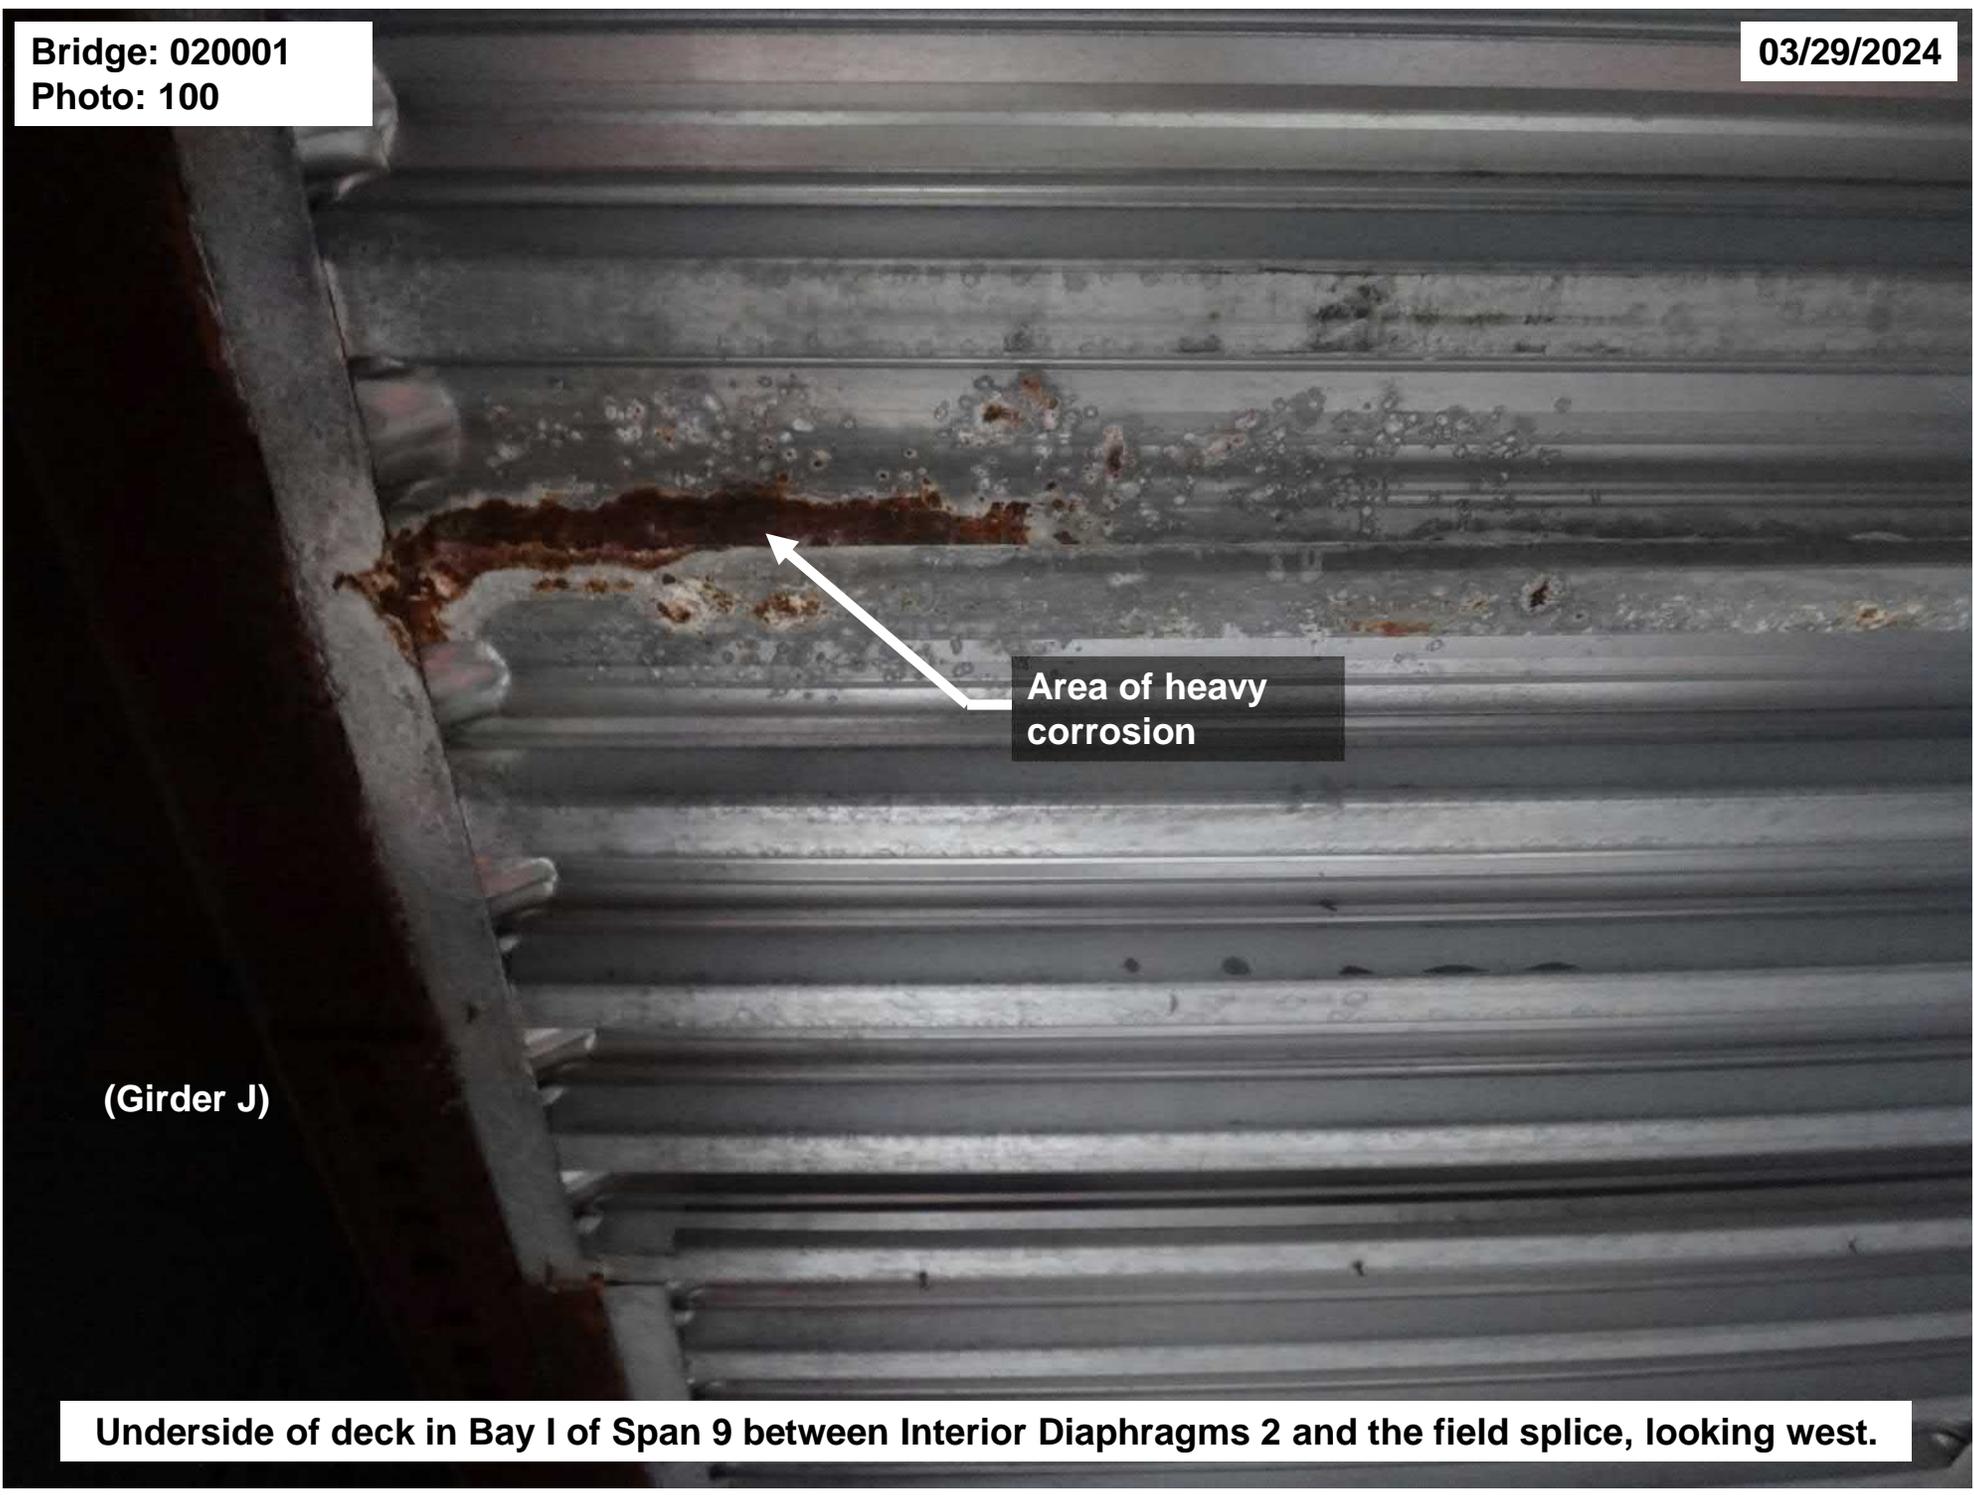
Bridge: 020001
Photo: 100

Area of heavy
corrosion

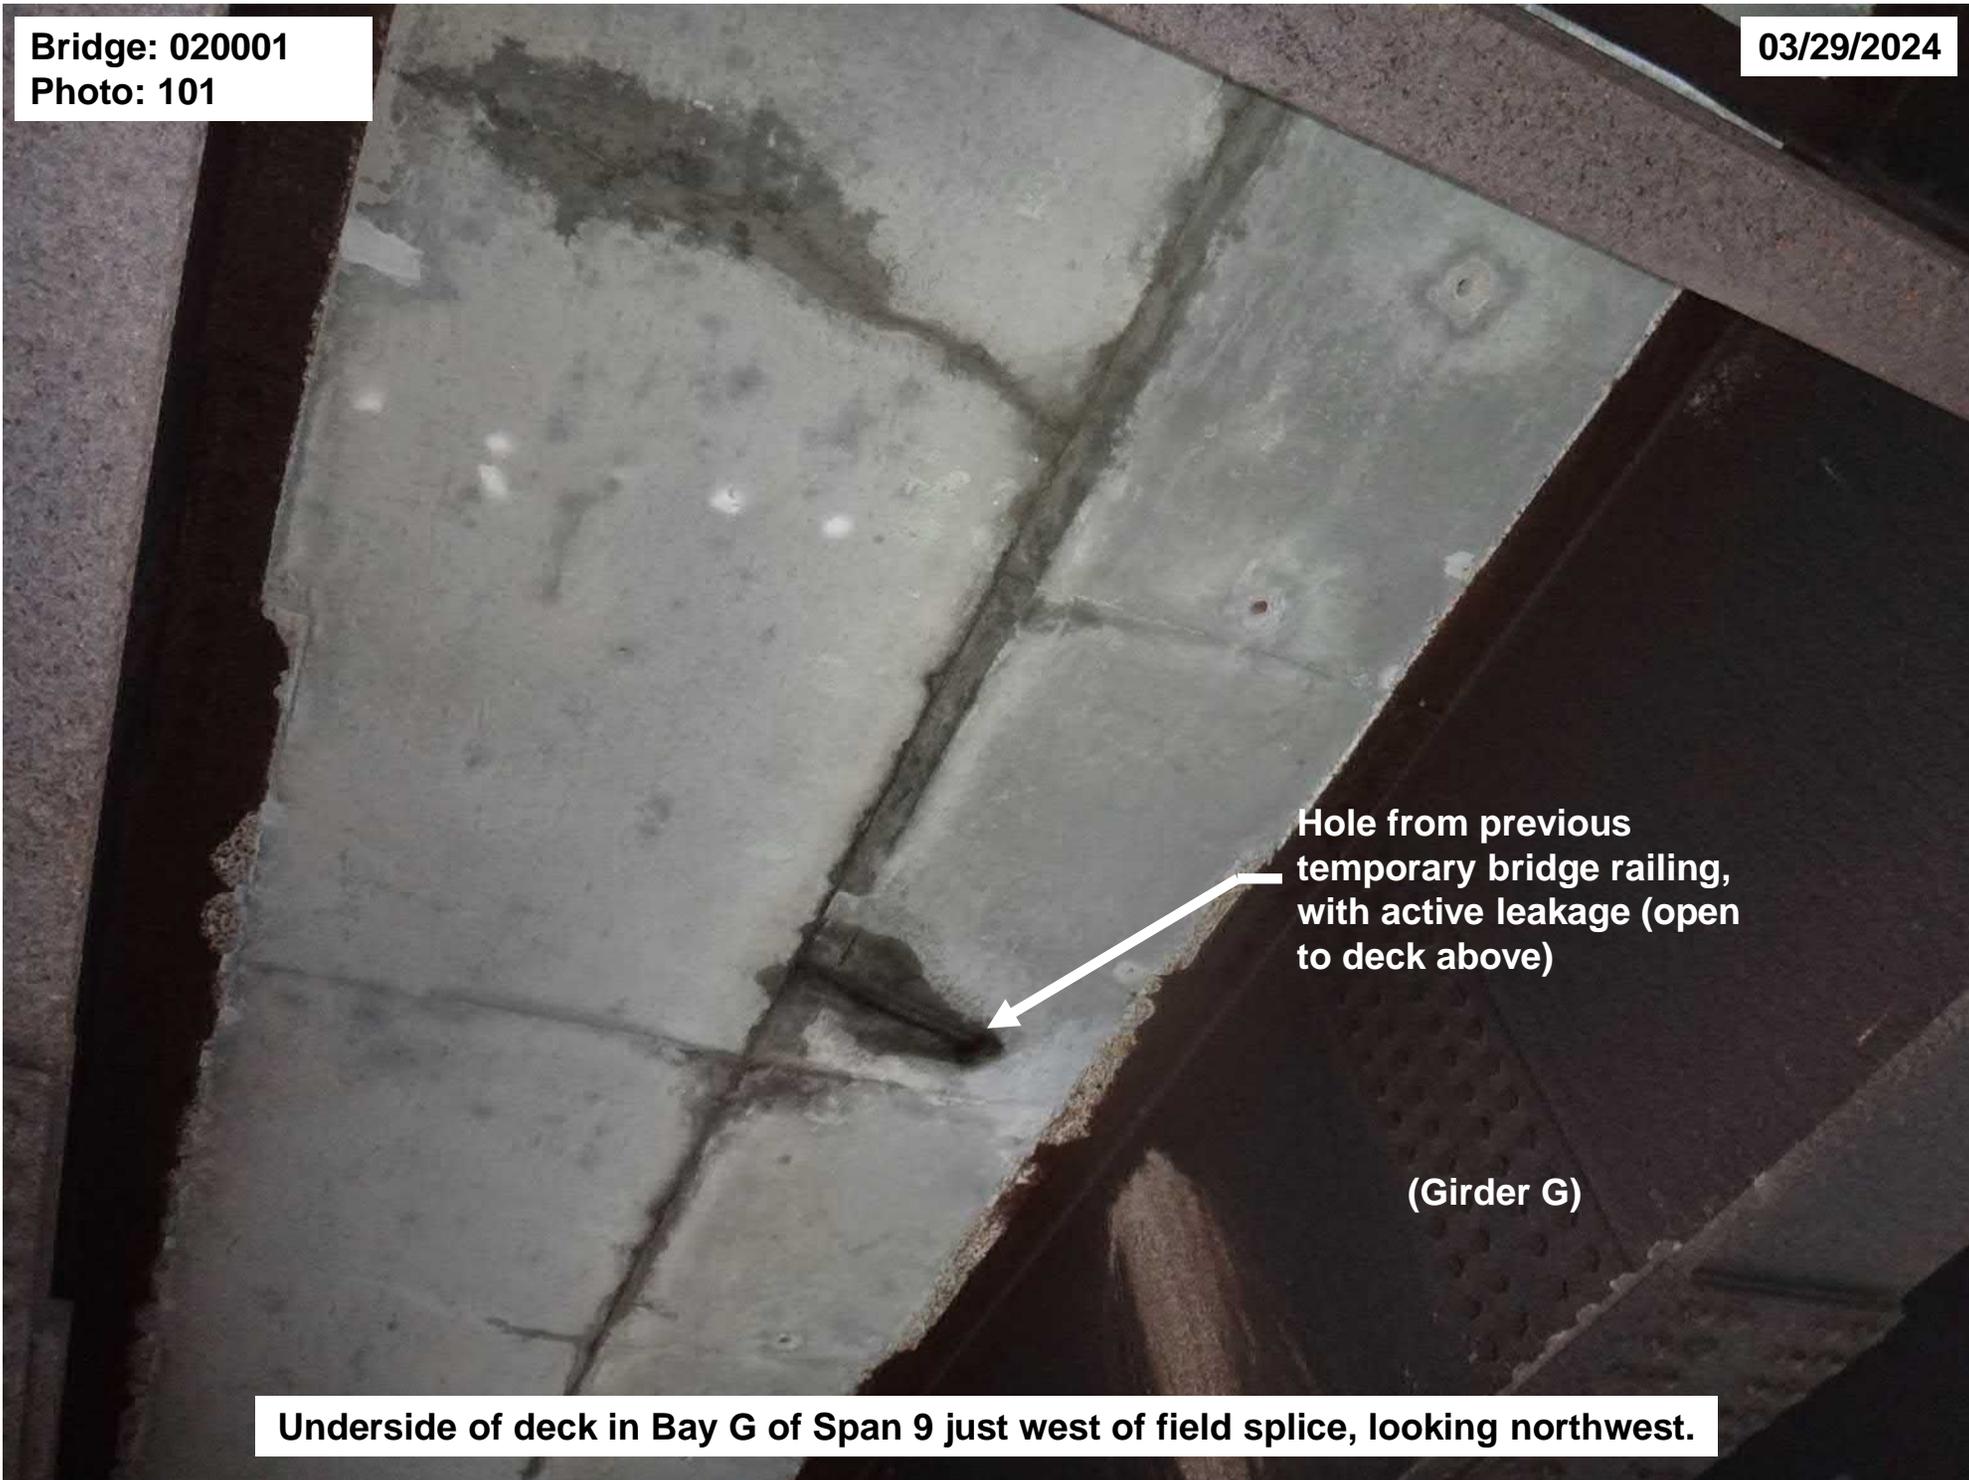
Hole from previous temporary bridge railing, with active leakage (open to deck above)

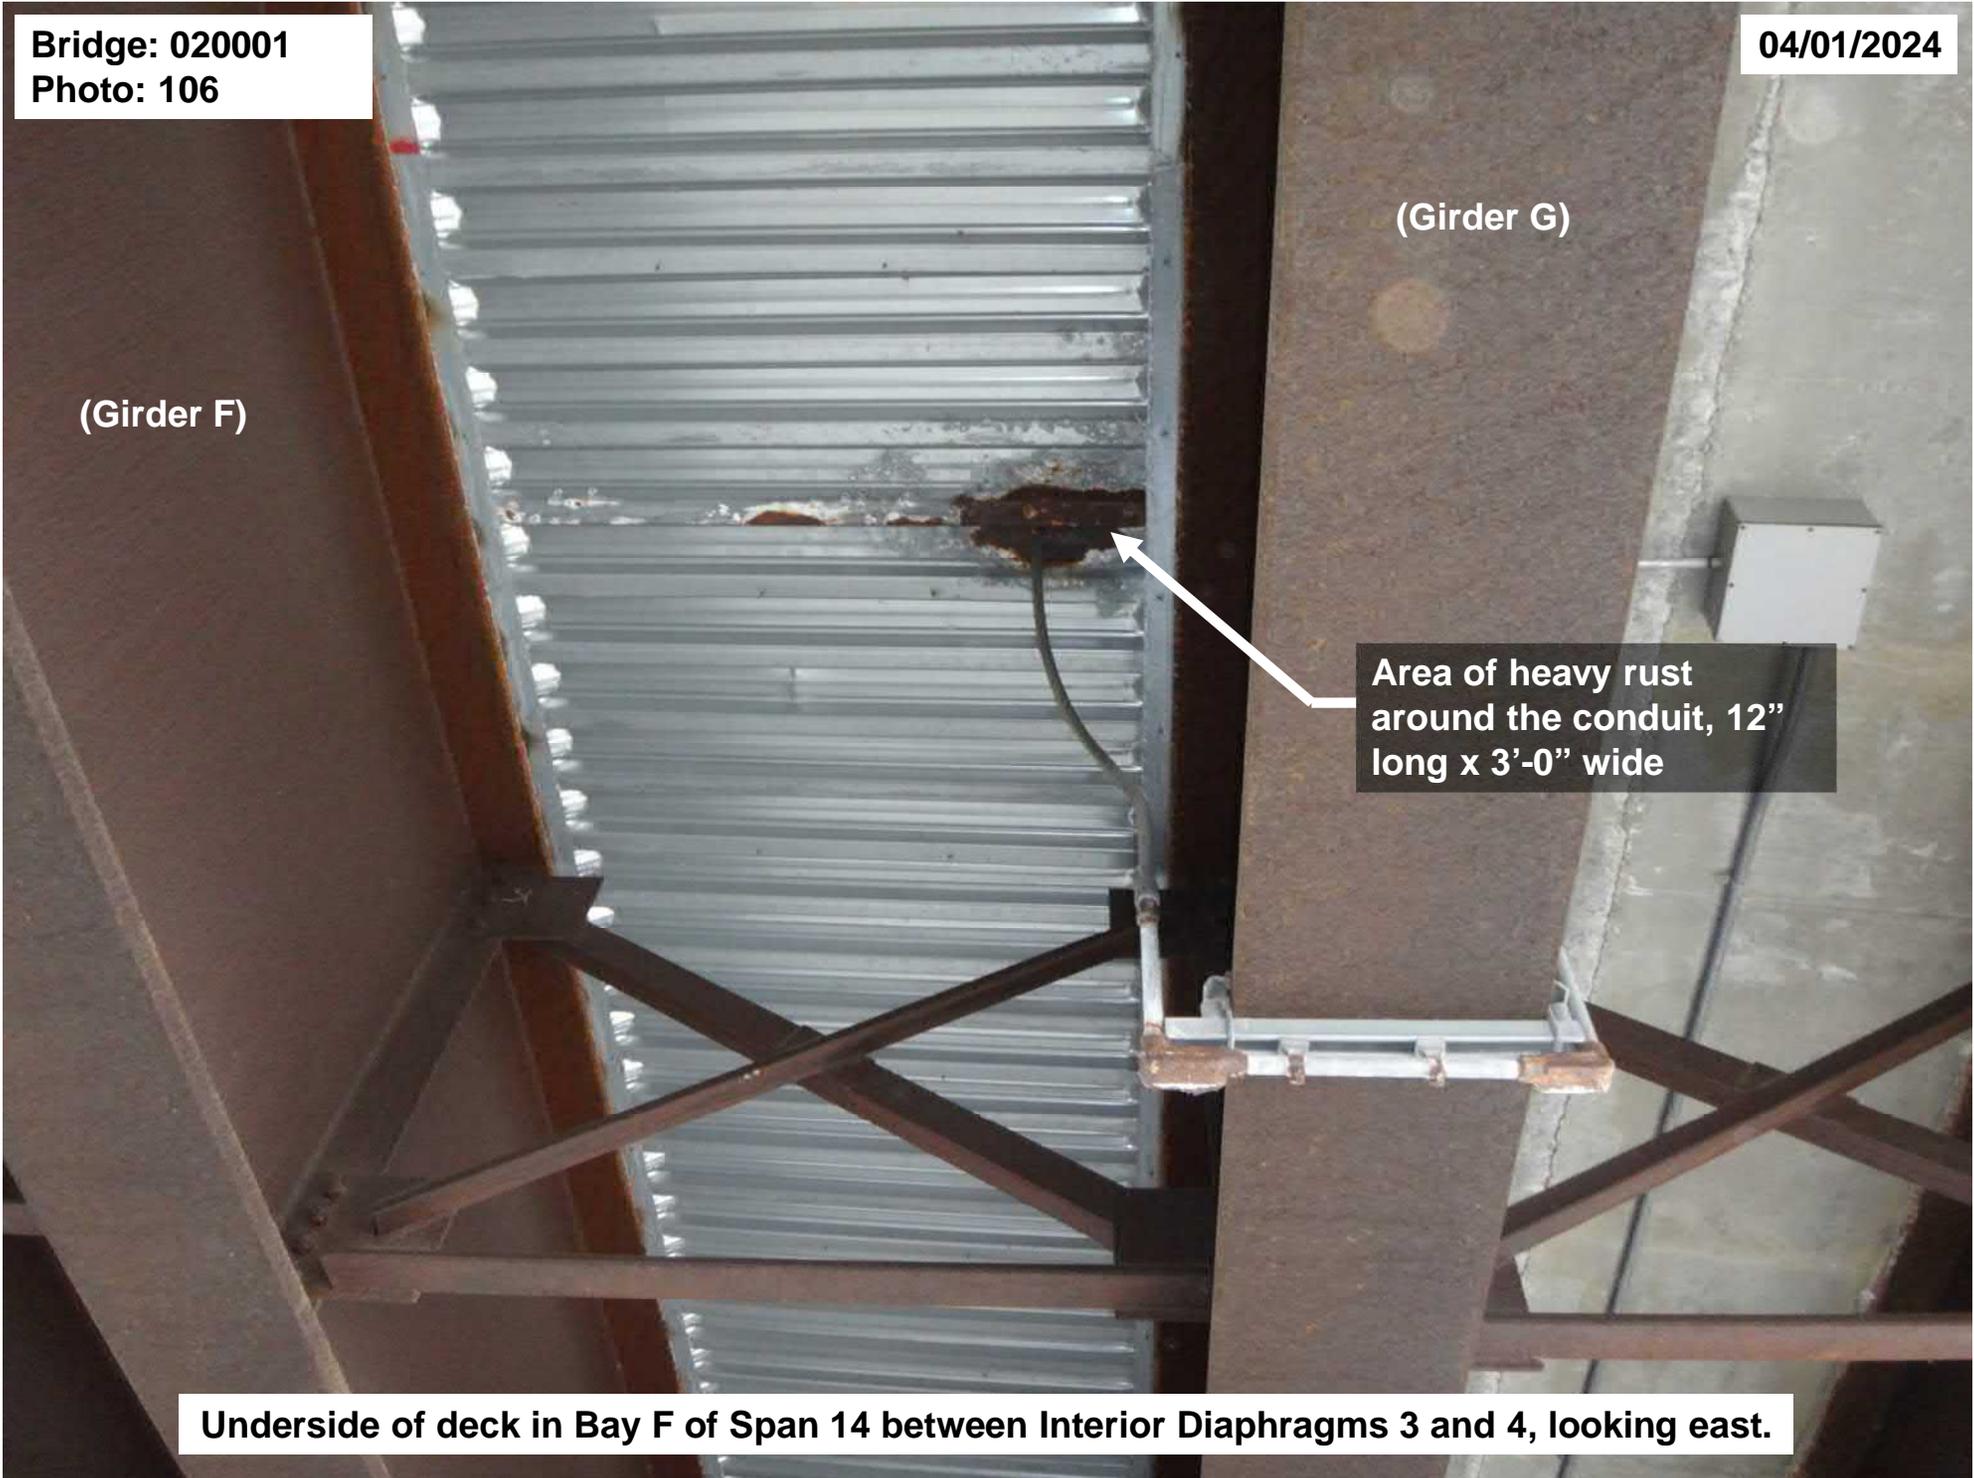
Bridge: 020001
Photo: 106

Area of heavy rust
around the conduit, 12"
long x 3'-0" wide
