Bridge: 020001
Photo: 1

South elevation at the main channel, looking north.

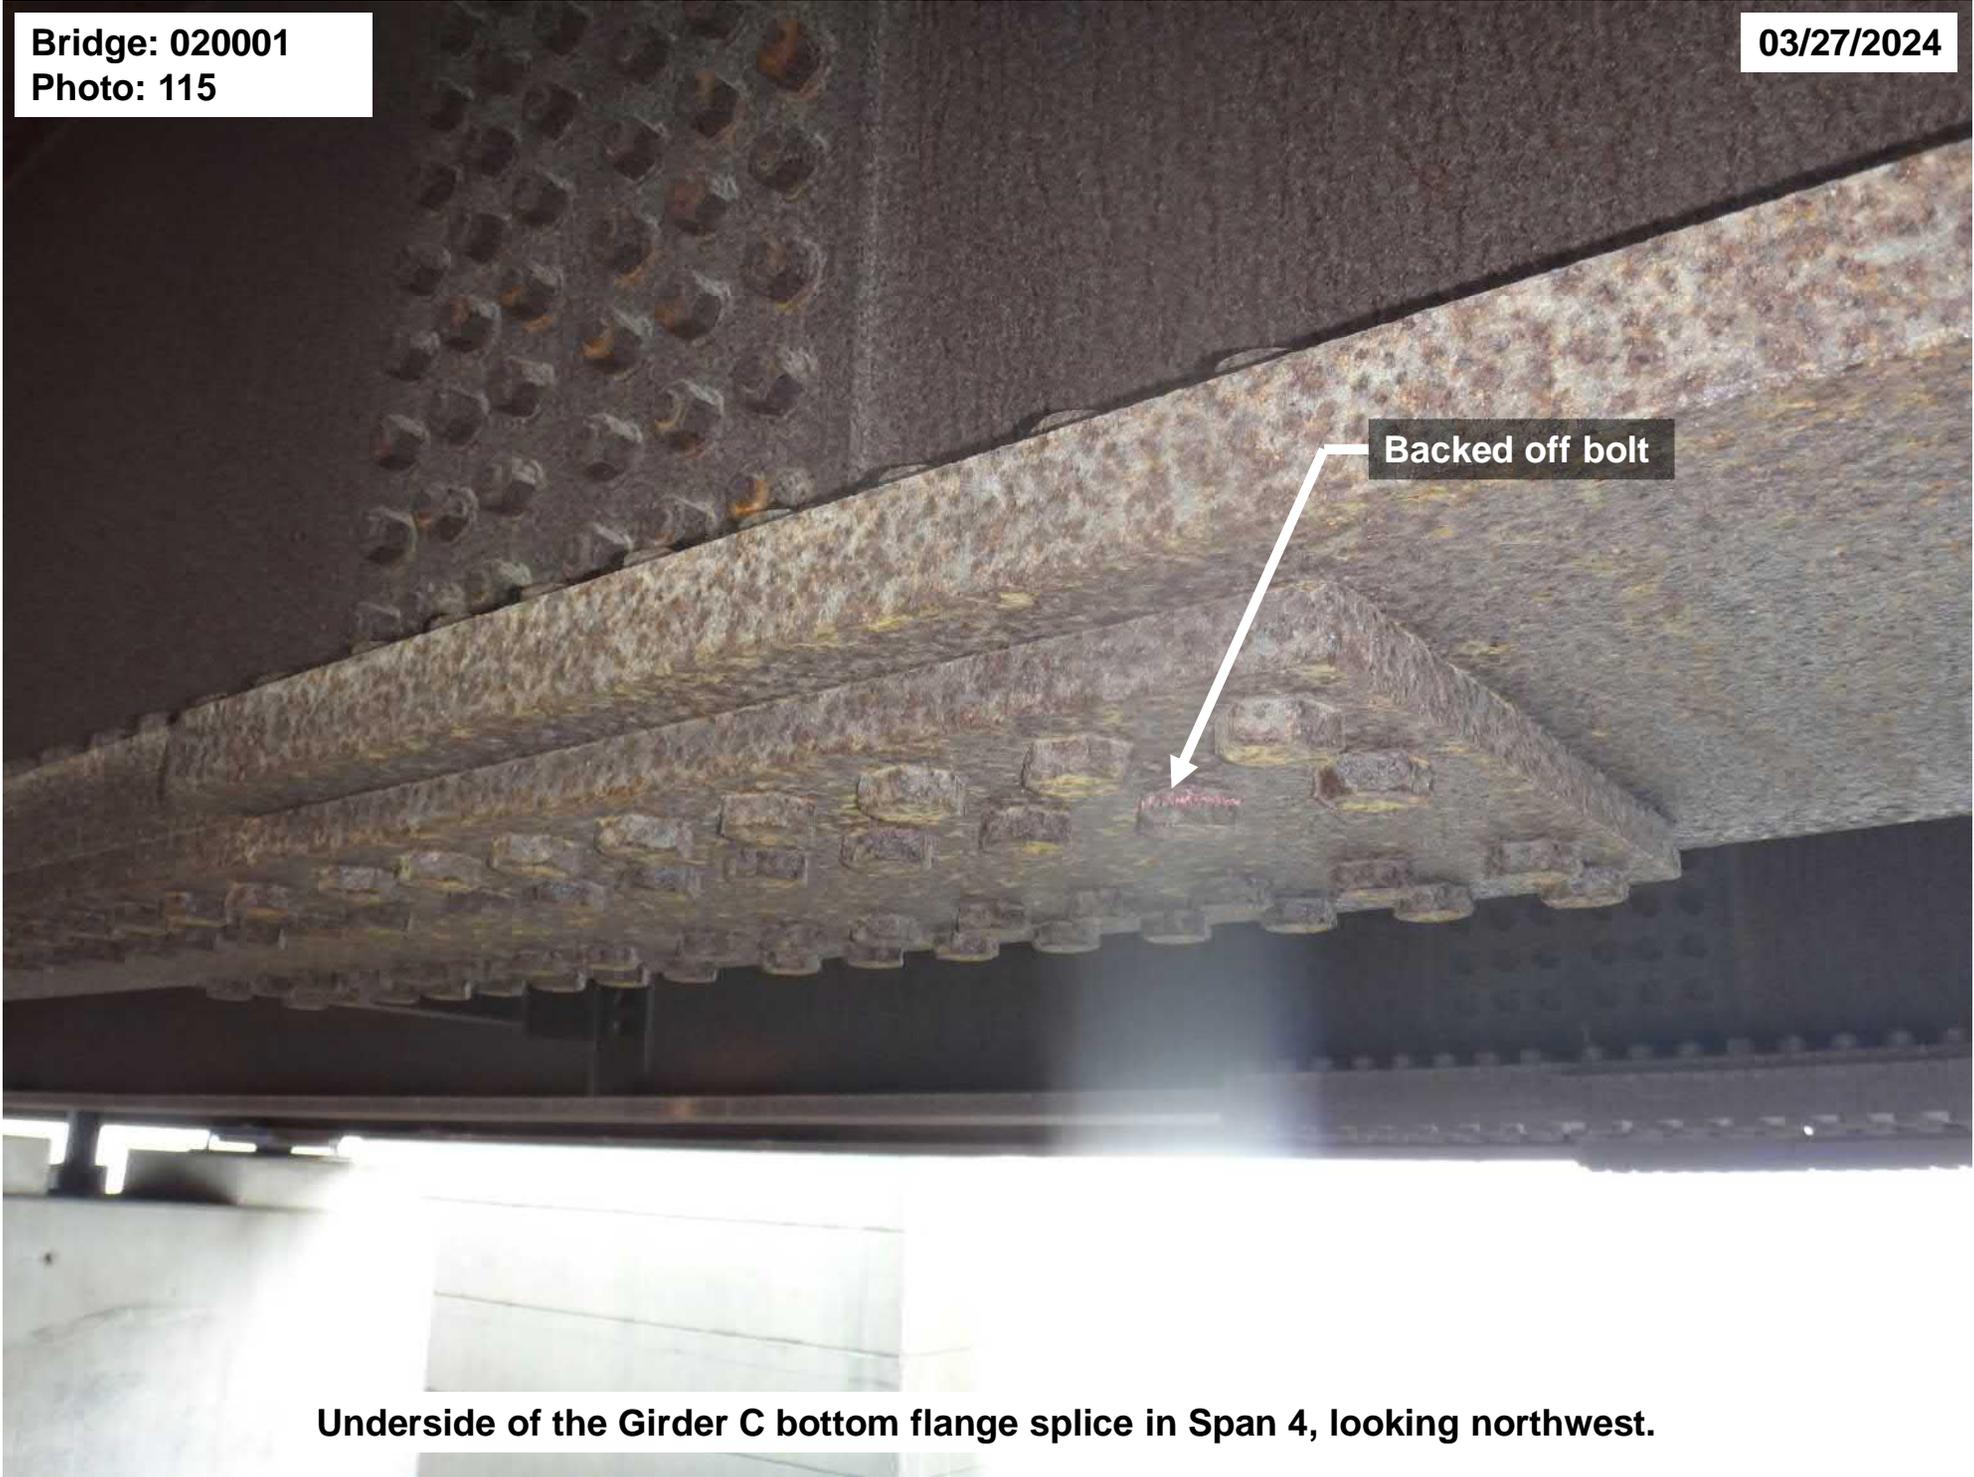
Backed off bolt

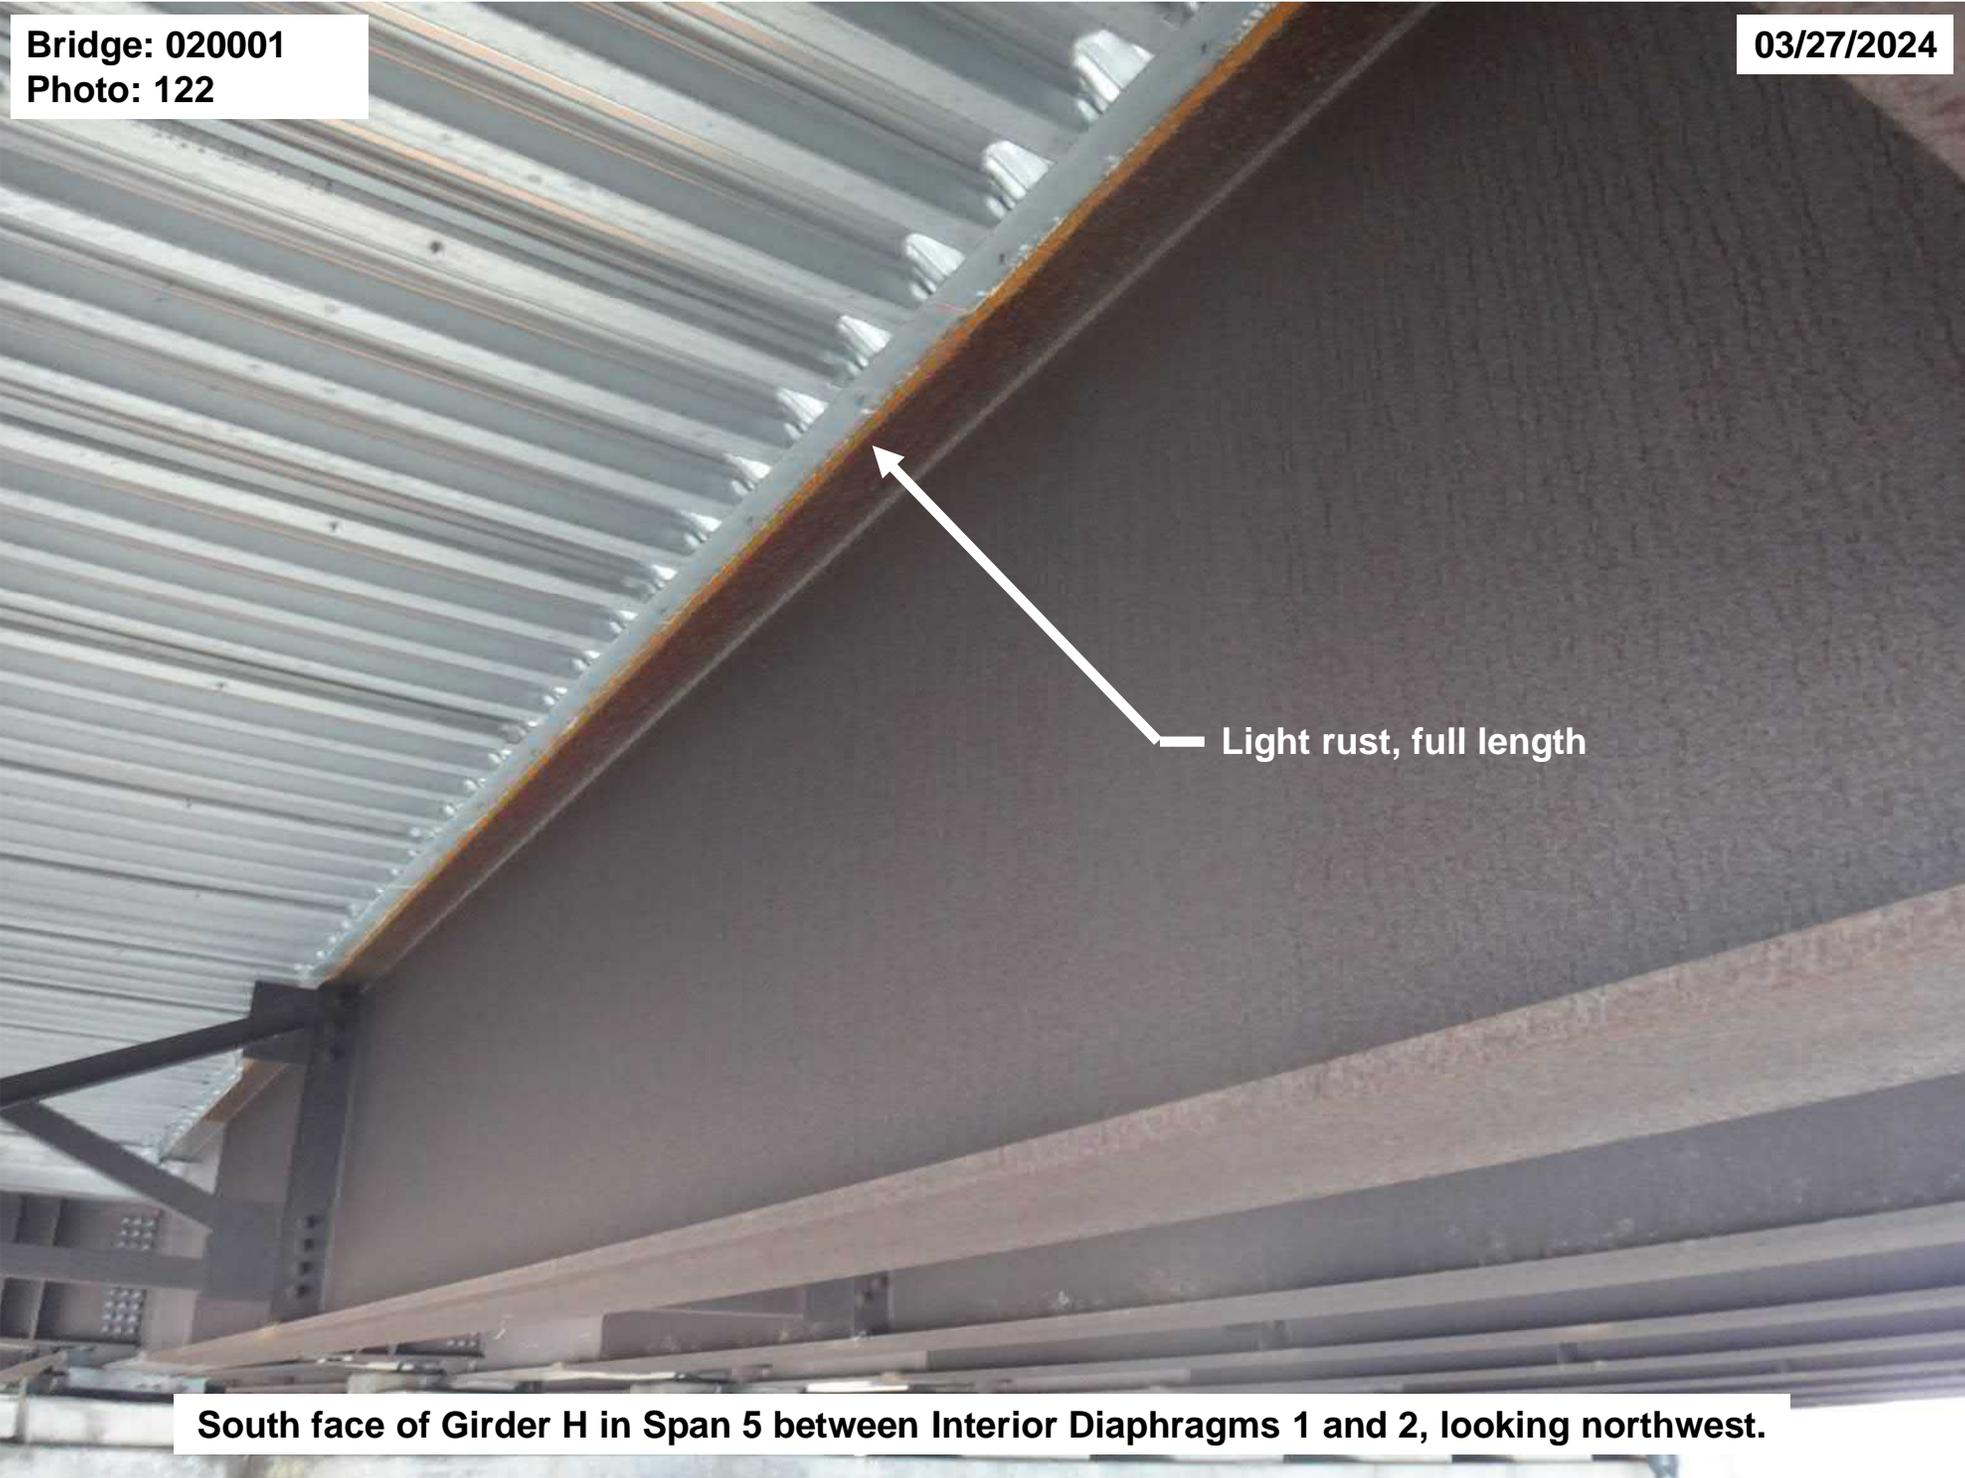
Bridge: 020001
Photo: 122

Light rust, full length

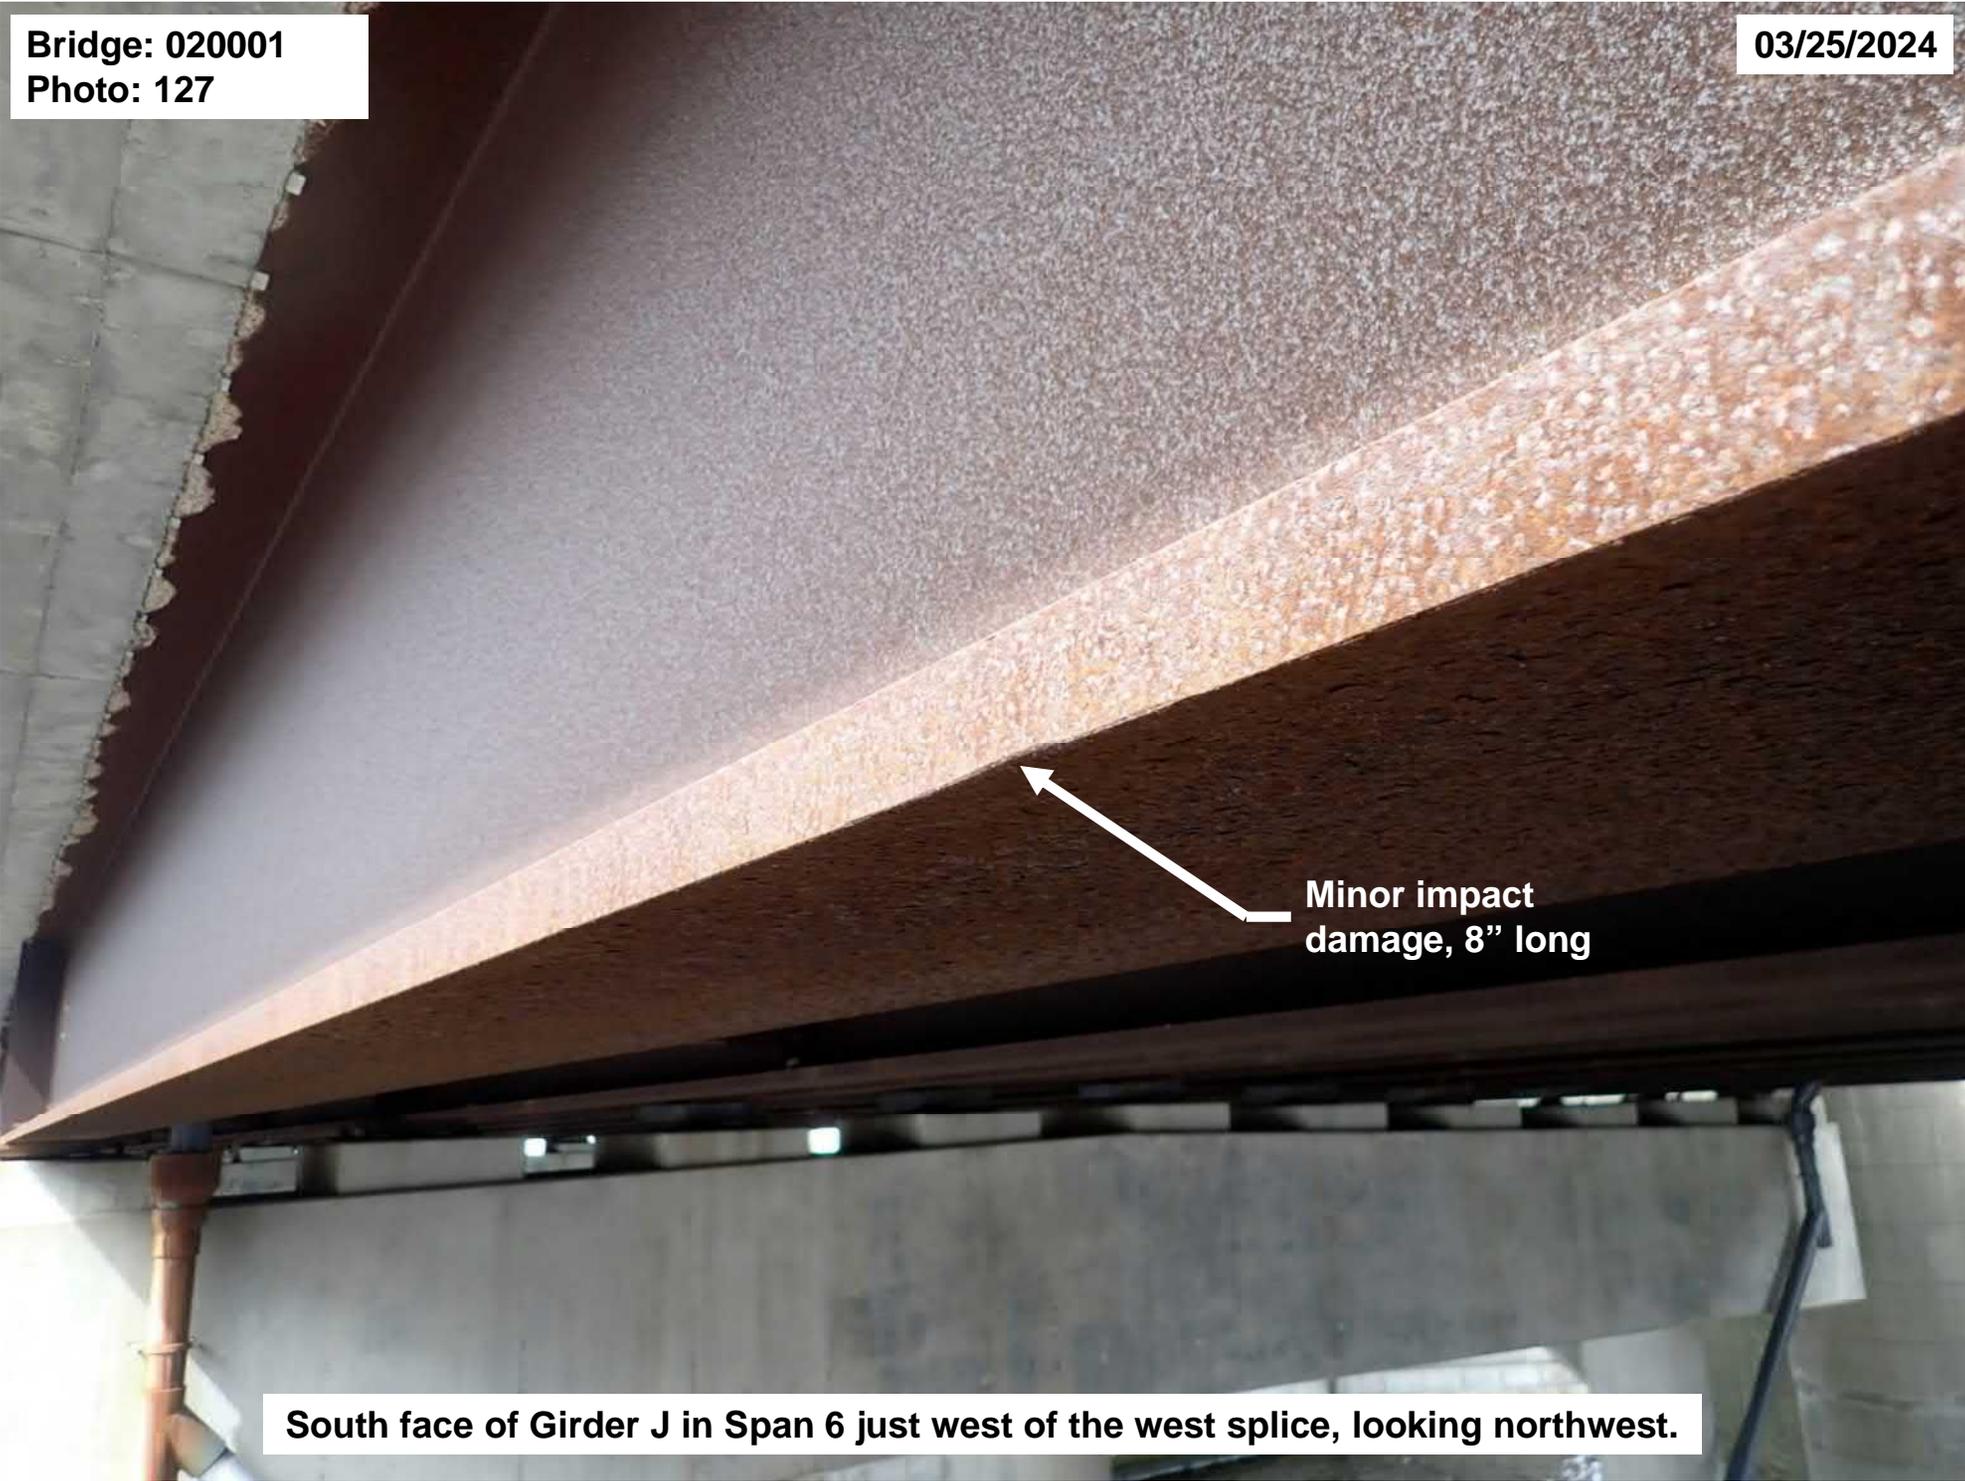
Bridge: 020001
Photo: 127

Minor impact
damage, 8" long

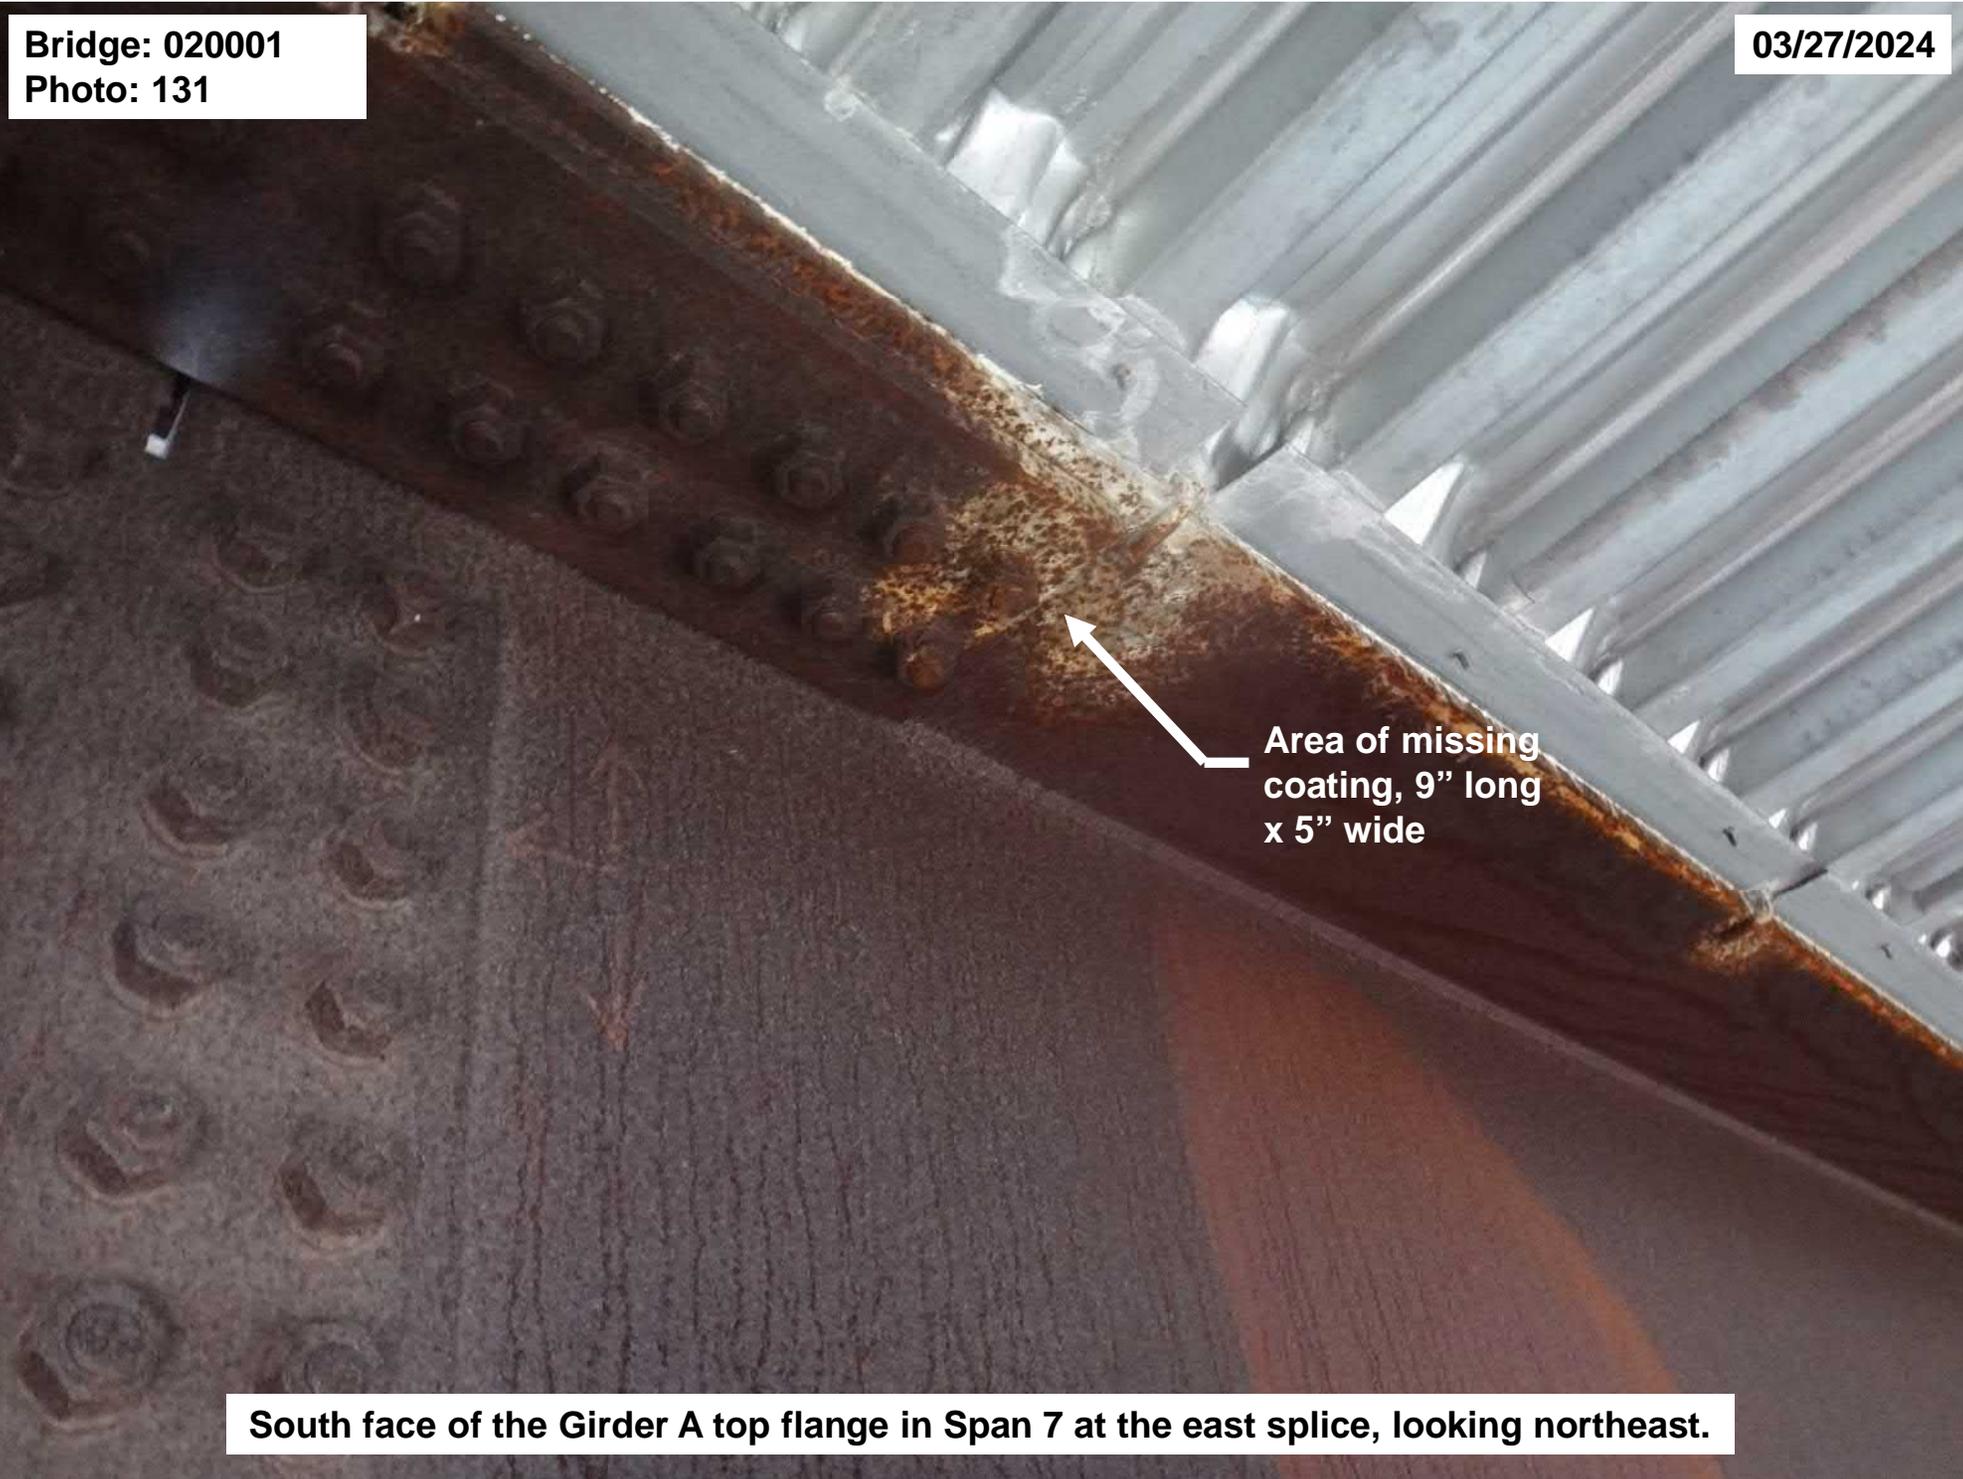
Bridge: 020001
Photo: 131

Area of missing
coating, 9" long
x 5" wide

South face of the Girder A top flange in Span 7 at the east splice, looking northeast.

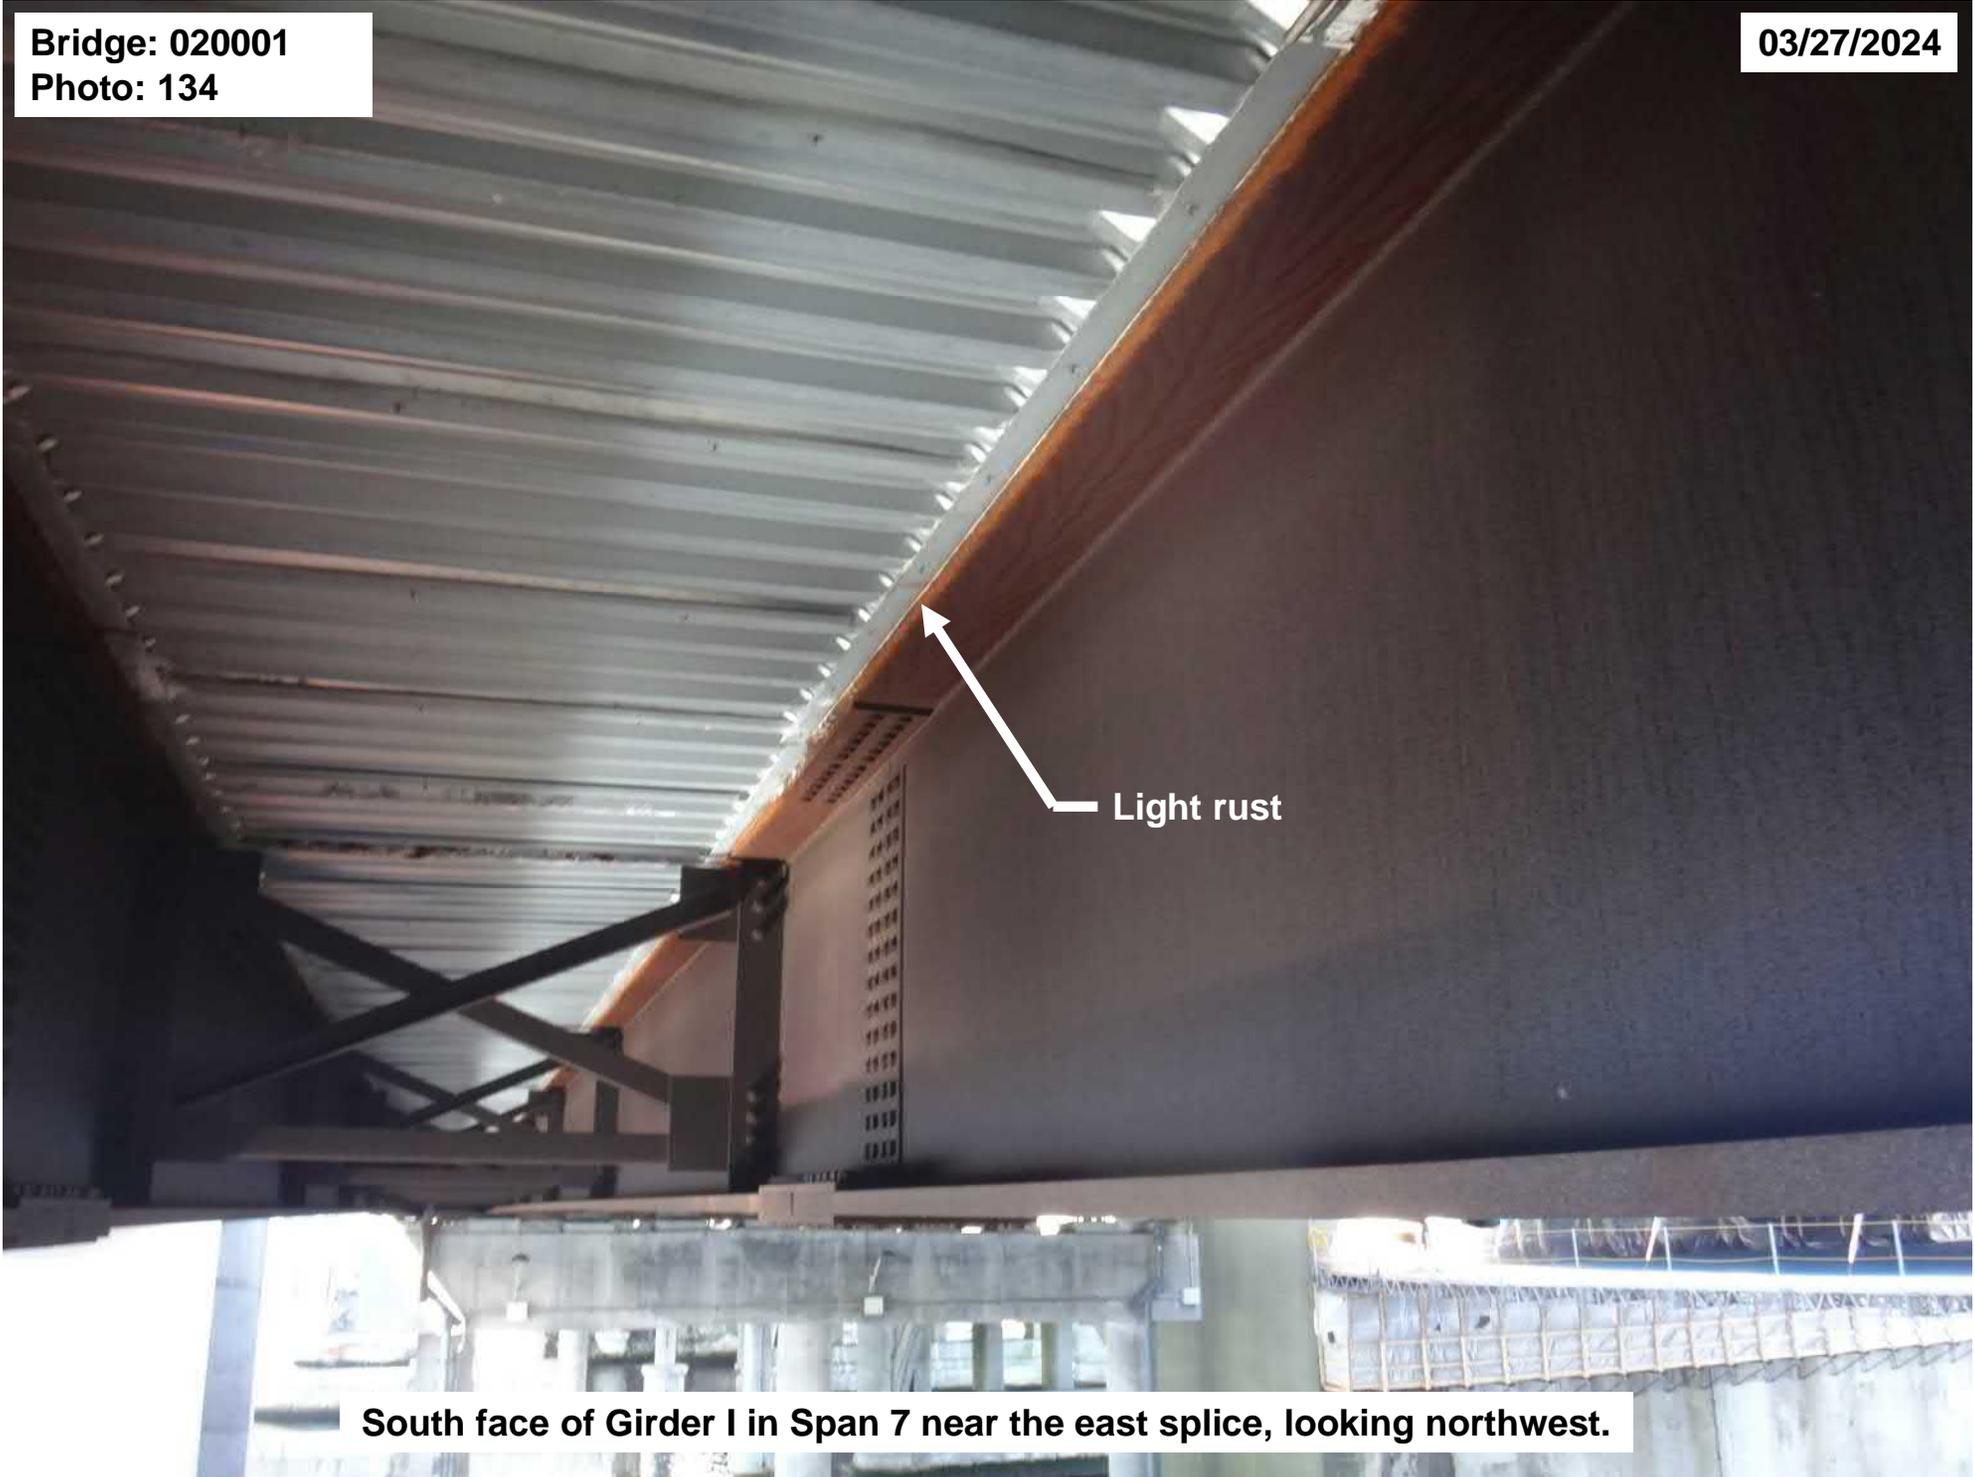
Bridge: 020001
Photo: 134

Light rust

South face of Girder I in Span 7 near the east splice, looking northwest.

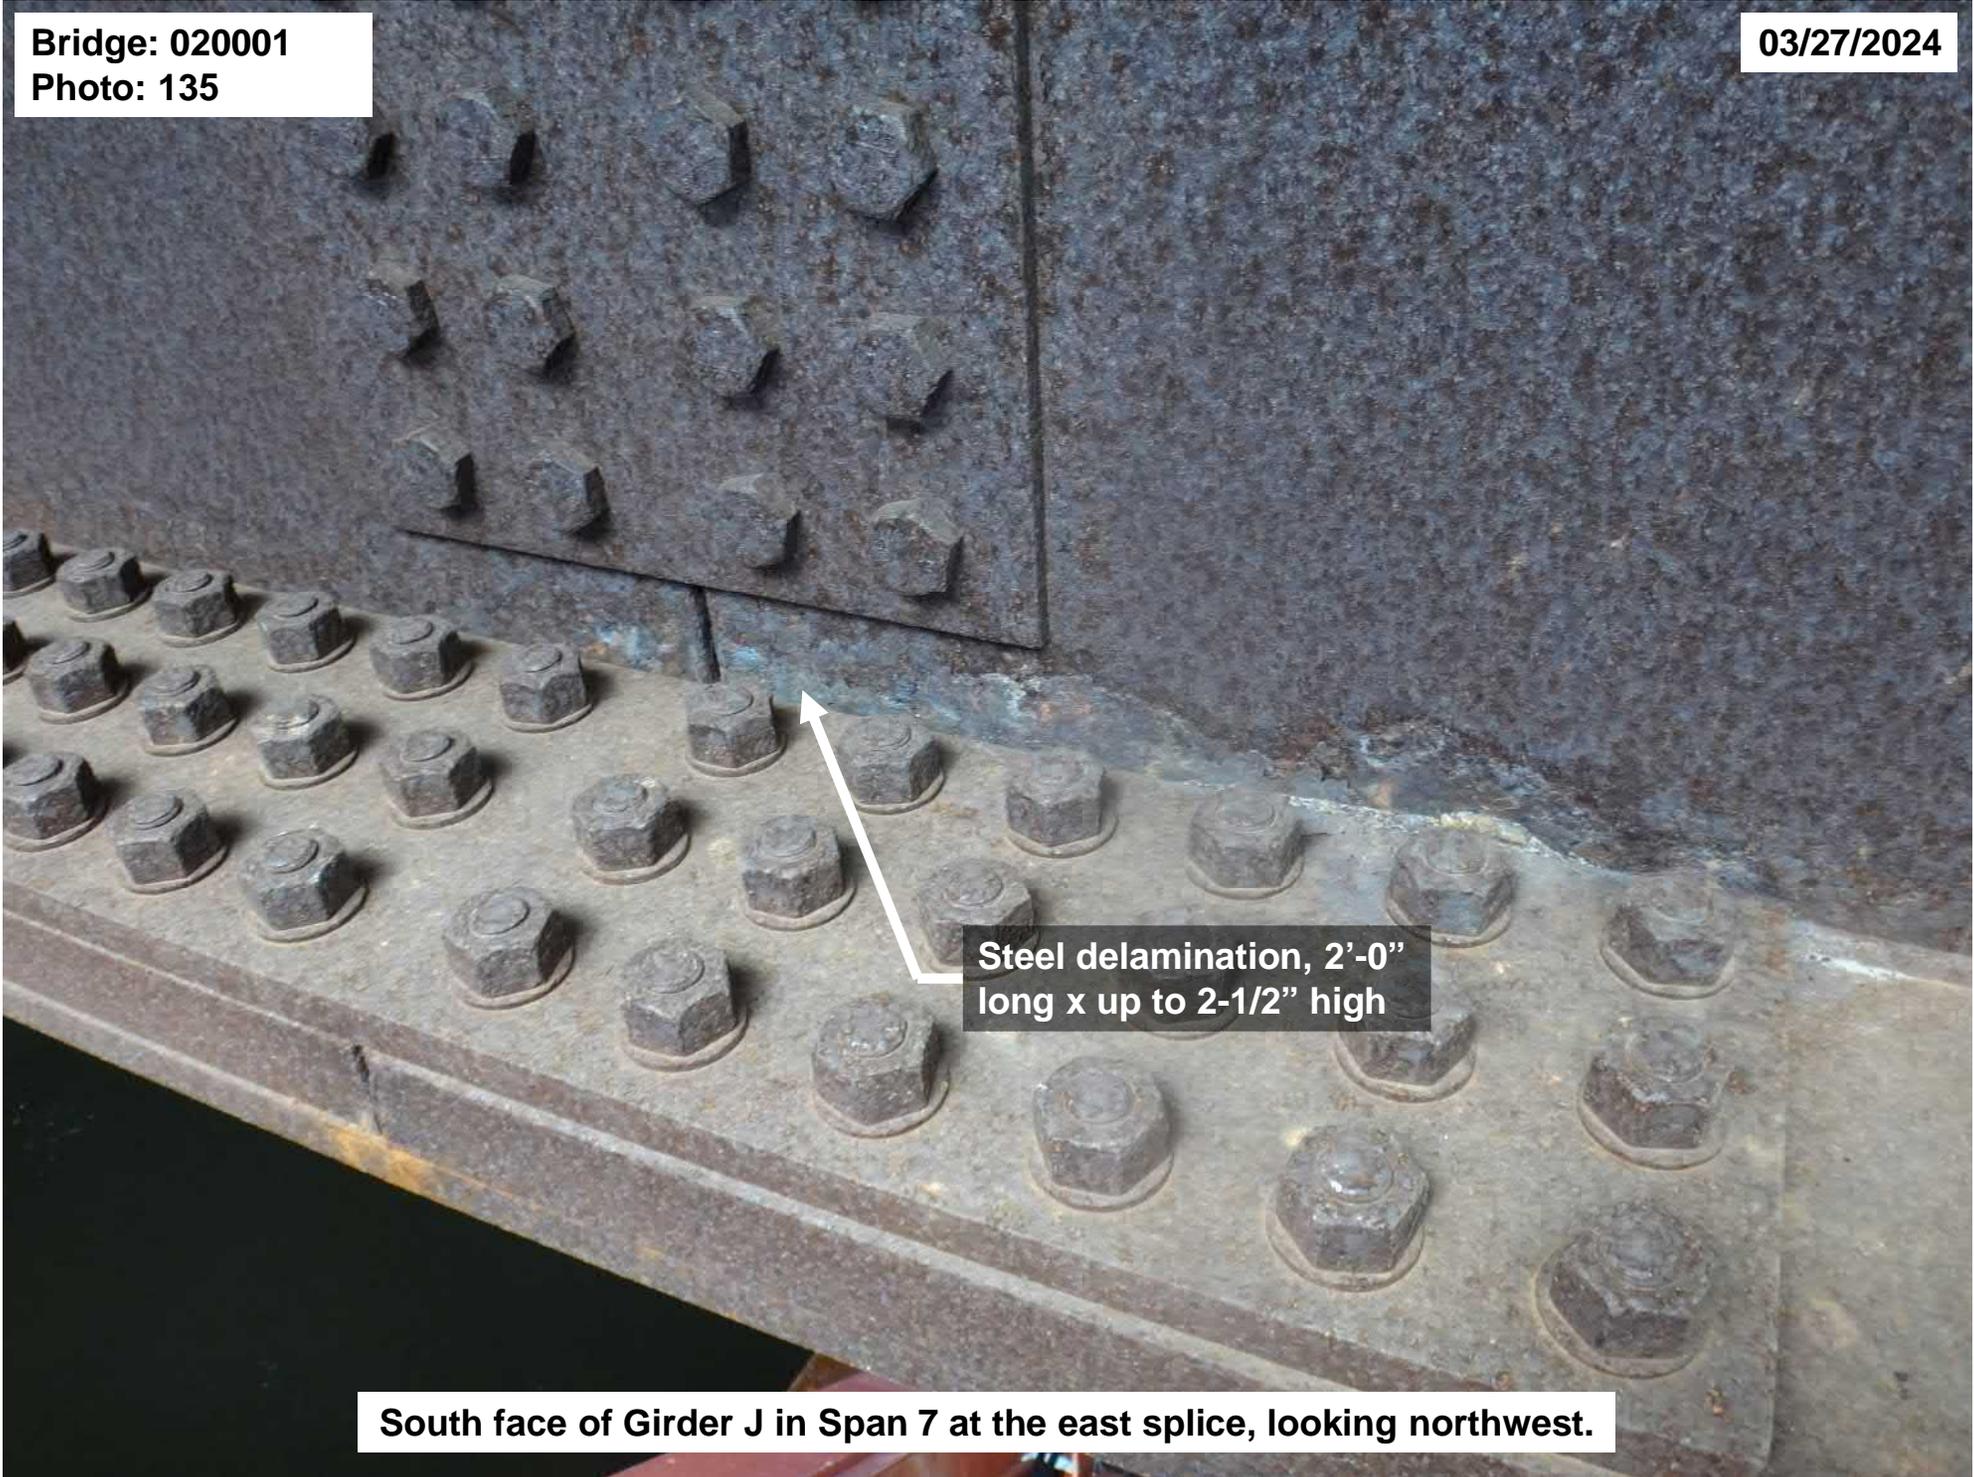
Bridge: 020001
Photo: 135

Steel delamination, 2'-0"
long x up to 2-1/2" high

South face of Girder J in Span 7 at the east splice, looking northwest.

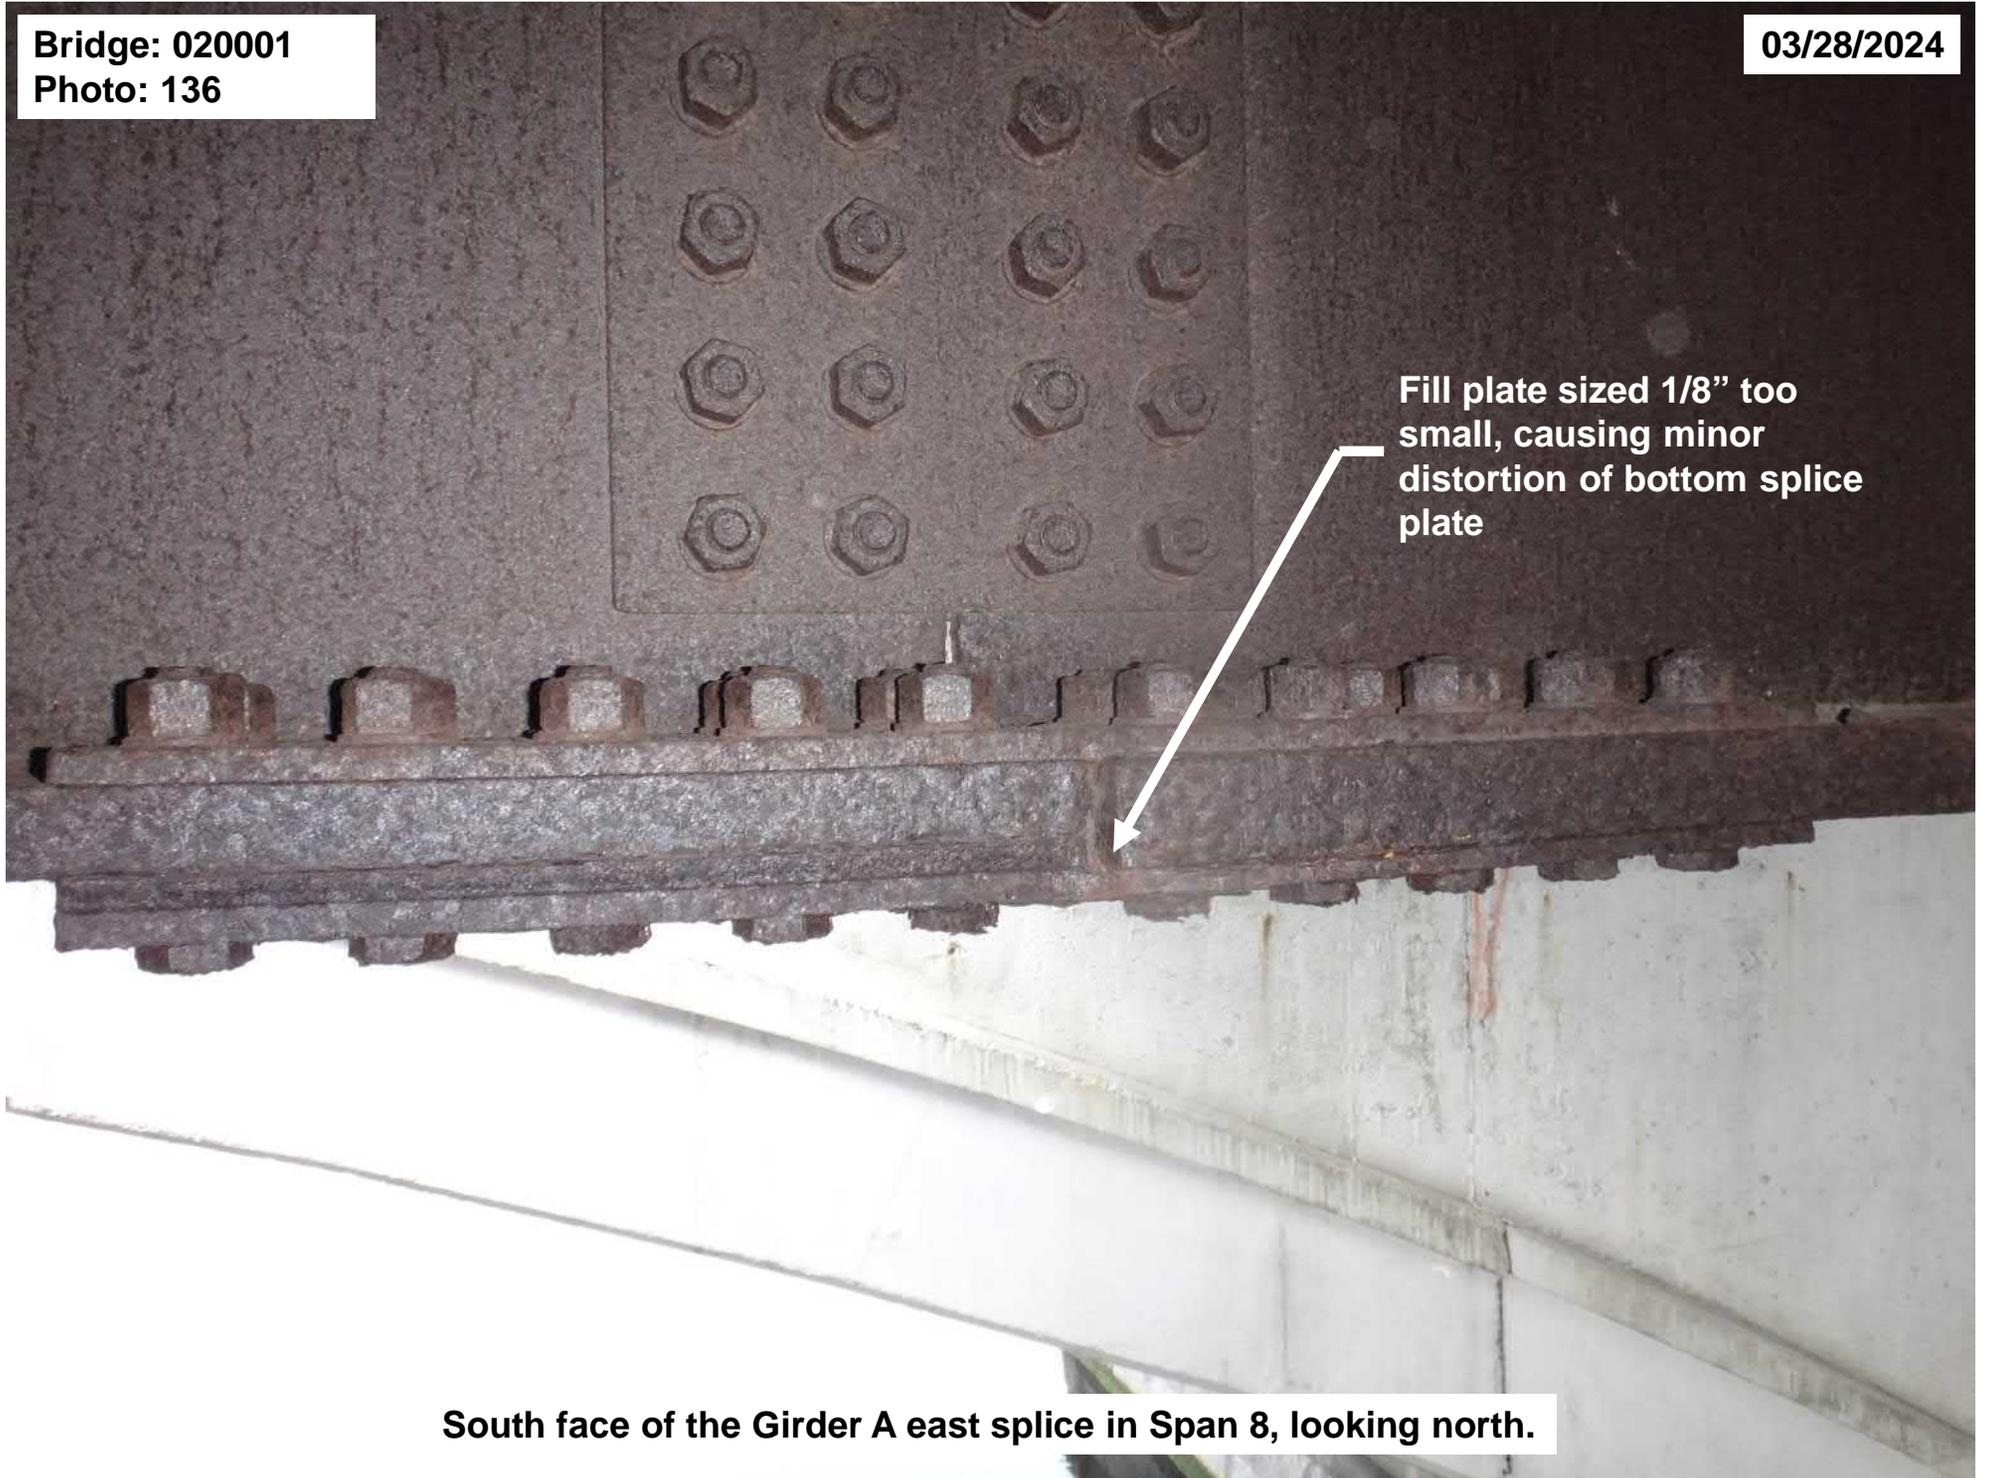
Fill plate sized 1/8" too small, causing minor distortion of bottom splice plate

South face of the Girder A east splice in Span 8, looking north.
