Bridge: 020001
Photo: 1

South elevation at the main channel, looking north.

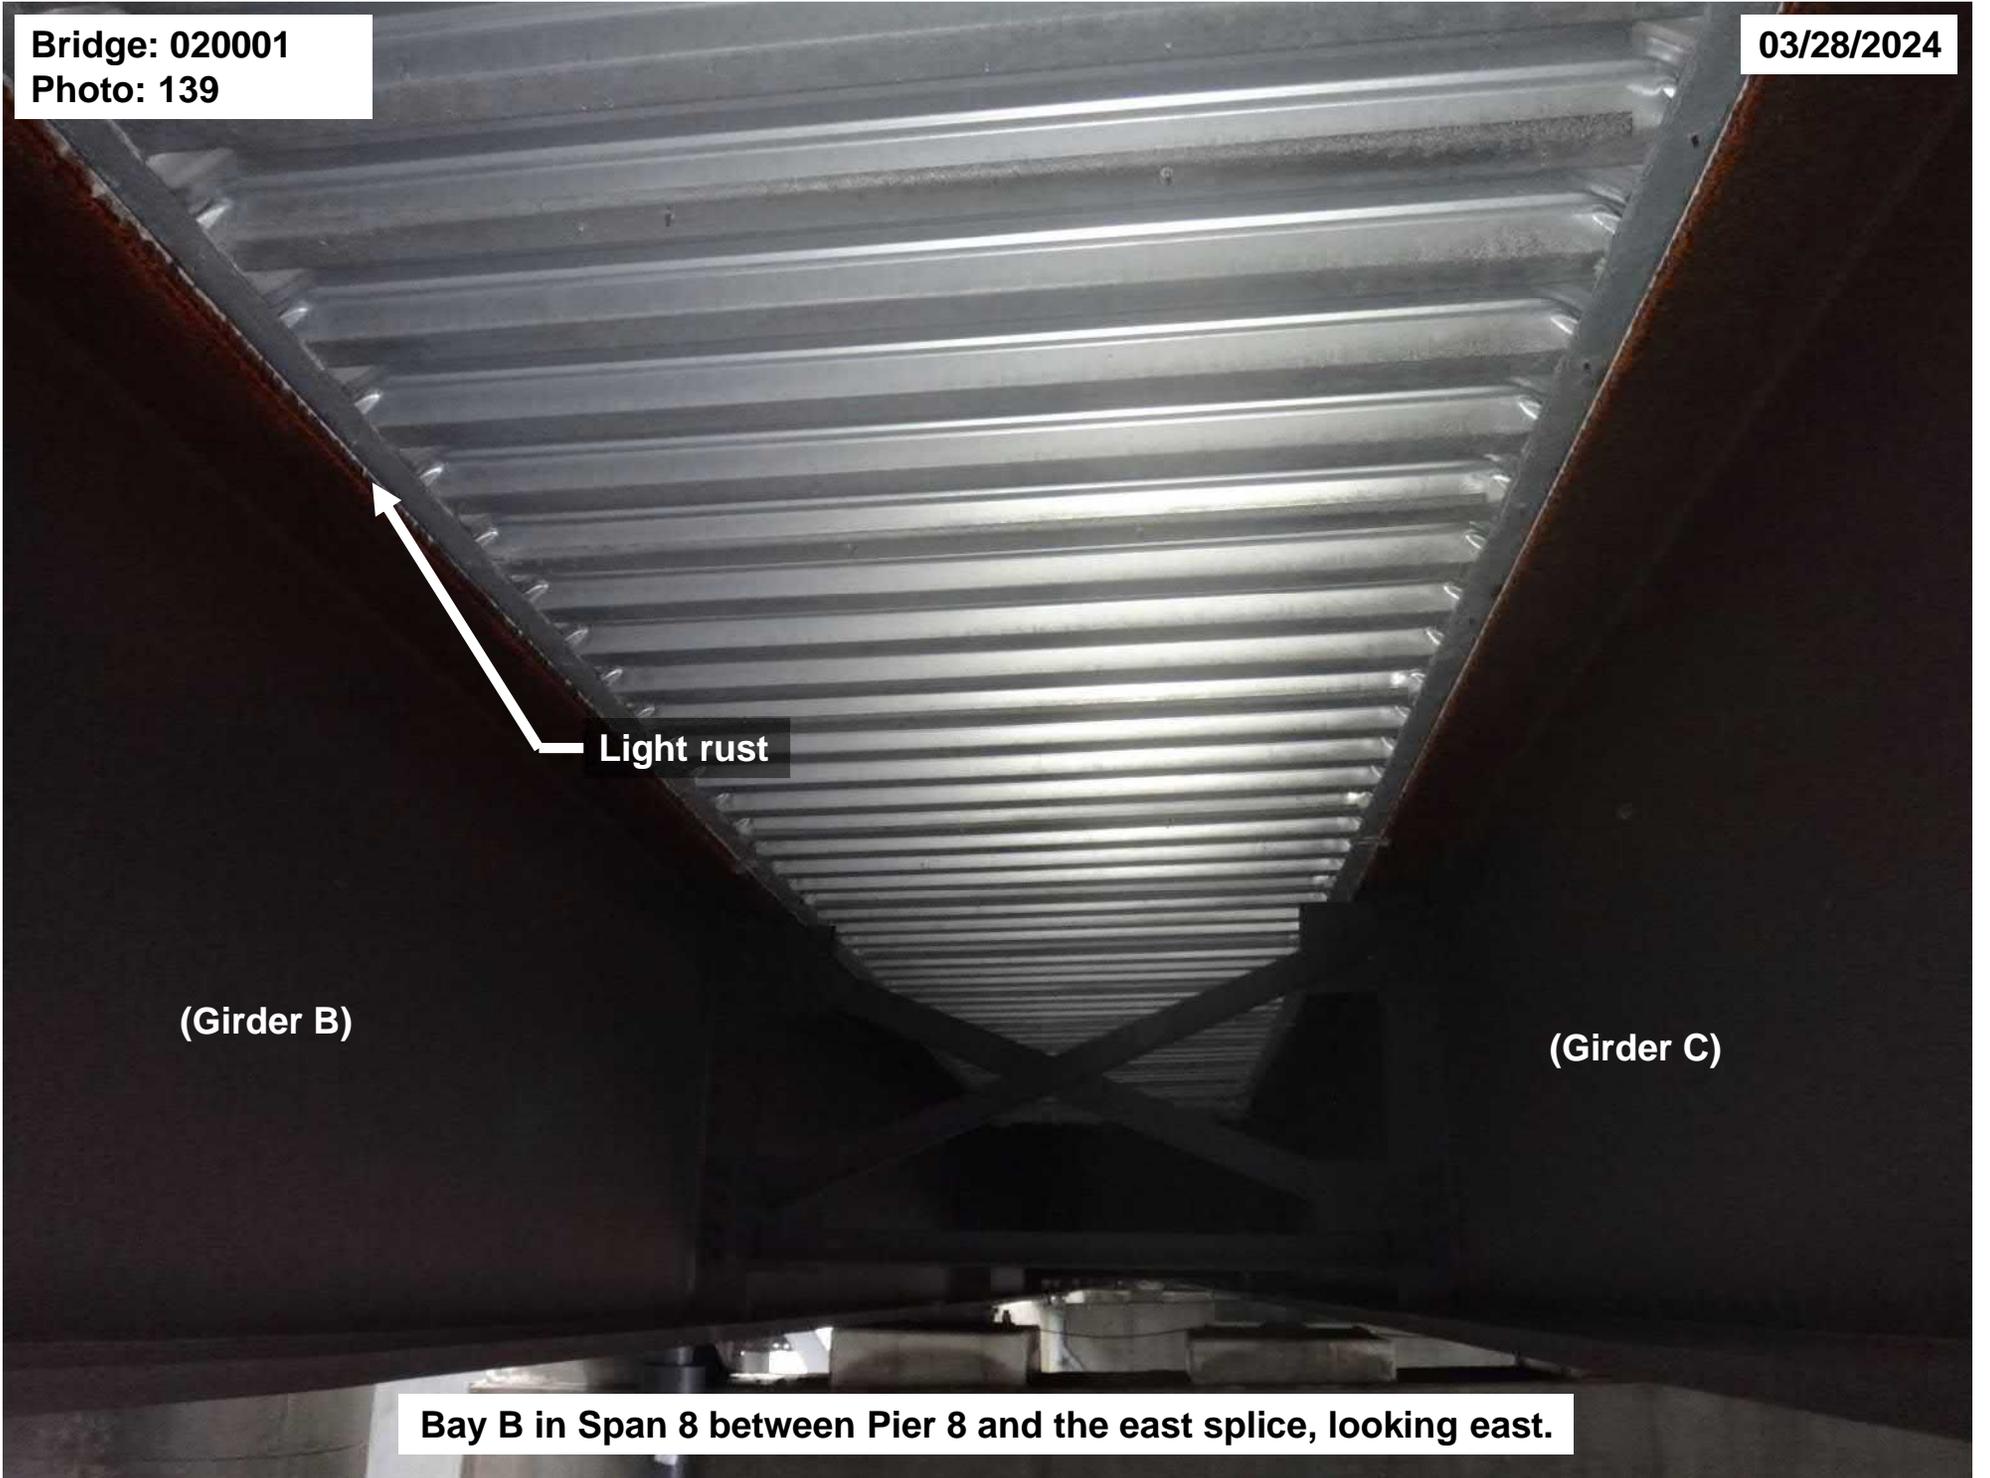
Light rust

Bay B in Span 8 between Pier 8 and the east splice, looking east.

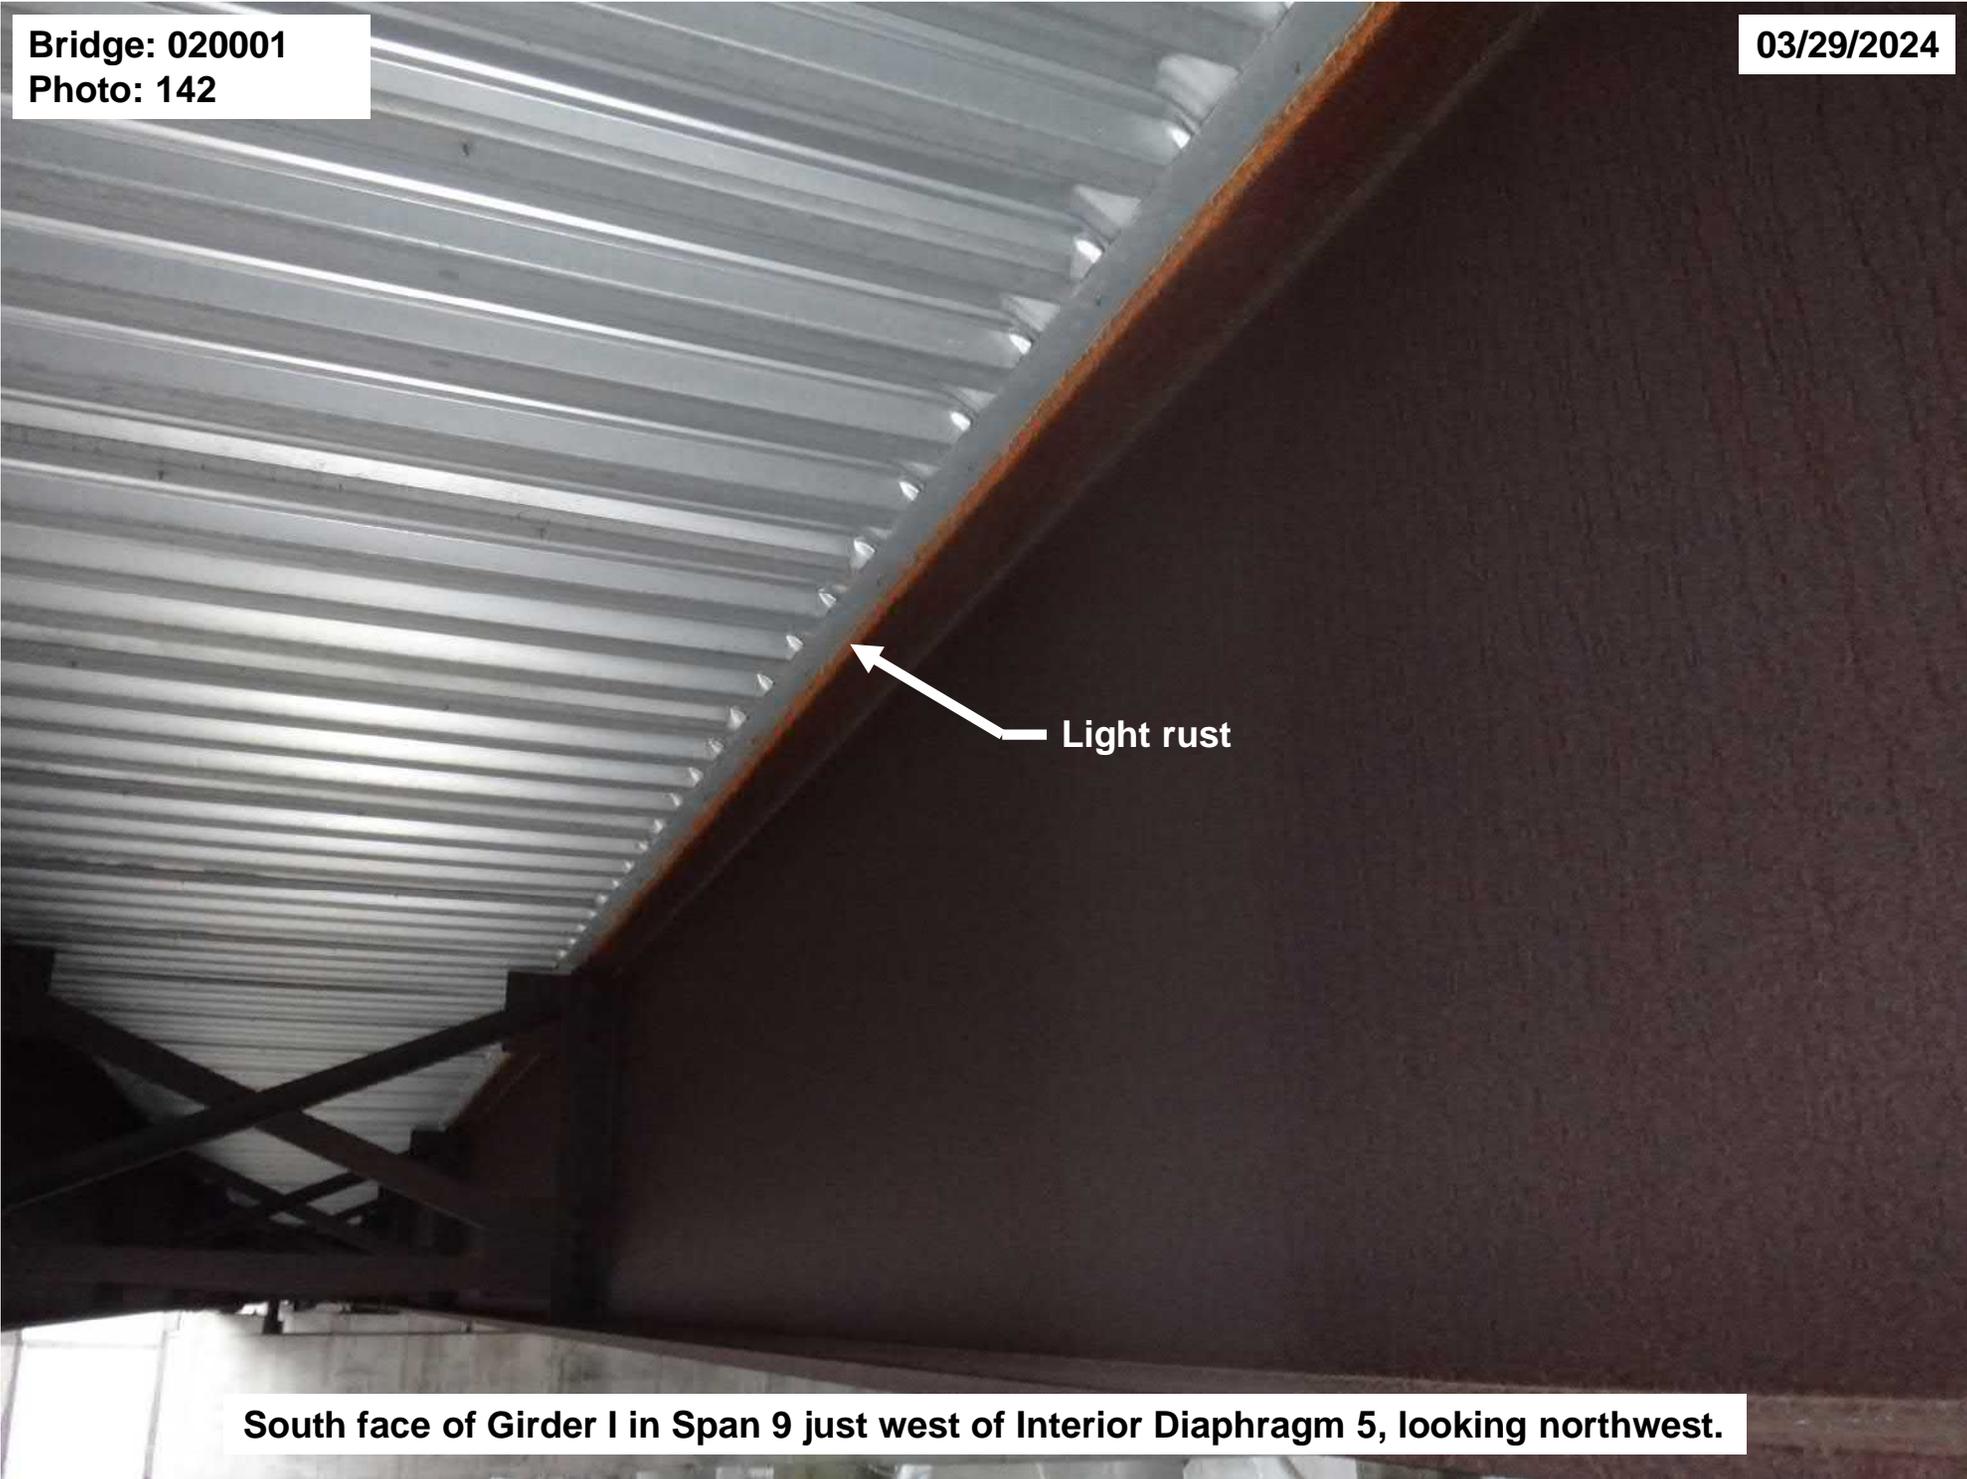
Bridge: 020001
Photo: 142

Light rust

South face of Girder I in Span 9 just west of Interior Diaphragm 5, looking northwest.

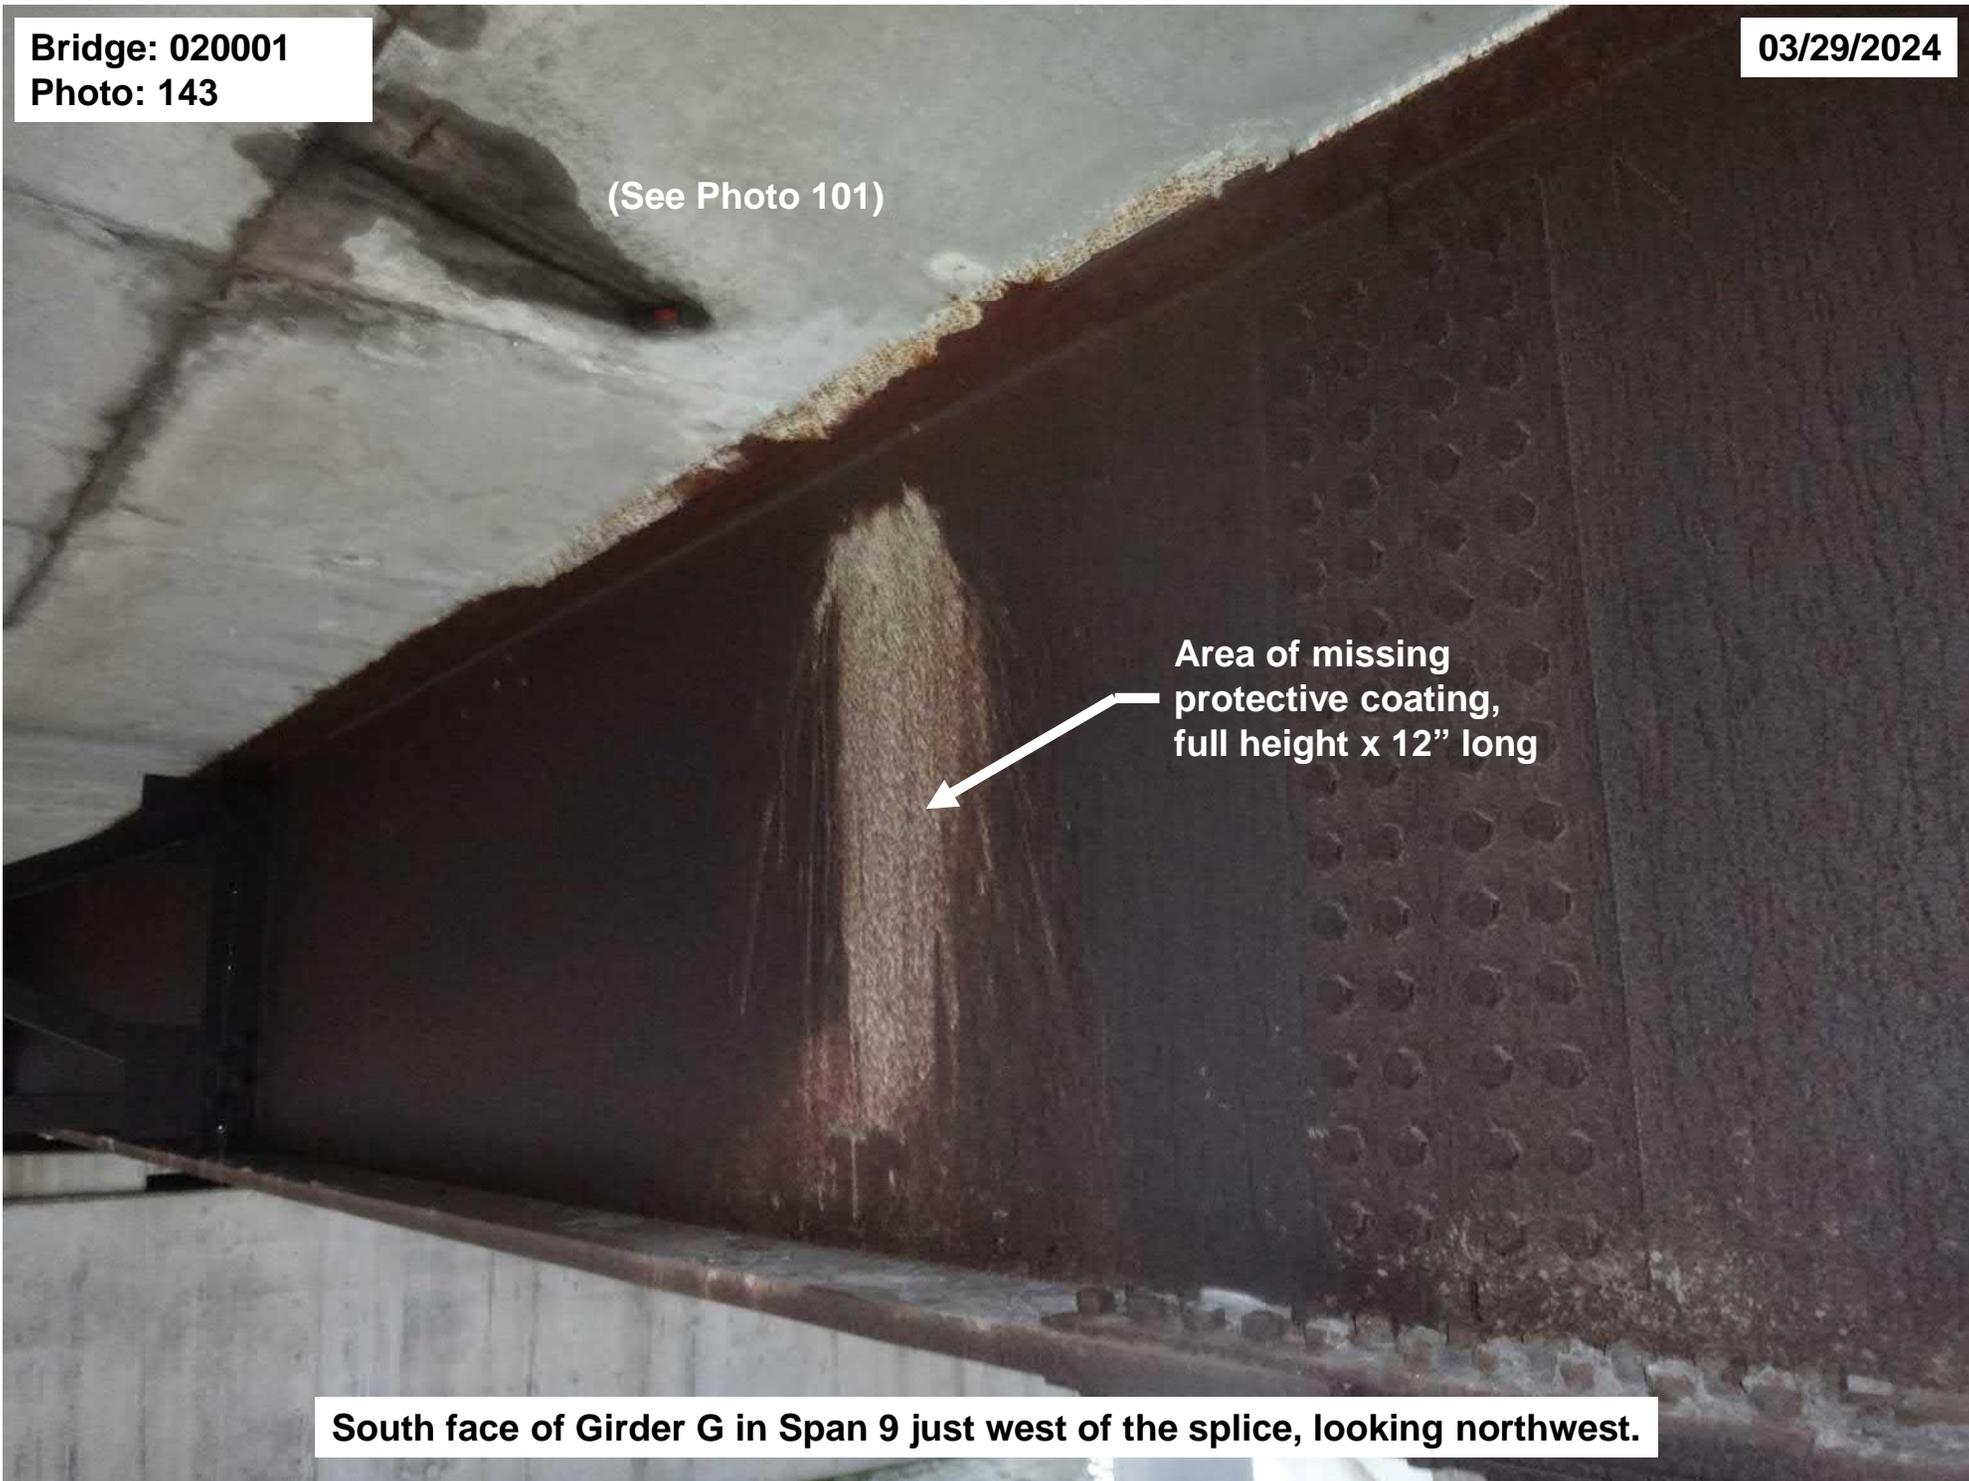
Area of missing
protective coating,
full height x 12" long

South face of Girder G in Span 9 just west of the splice, looking northwest.

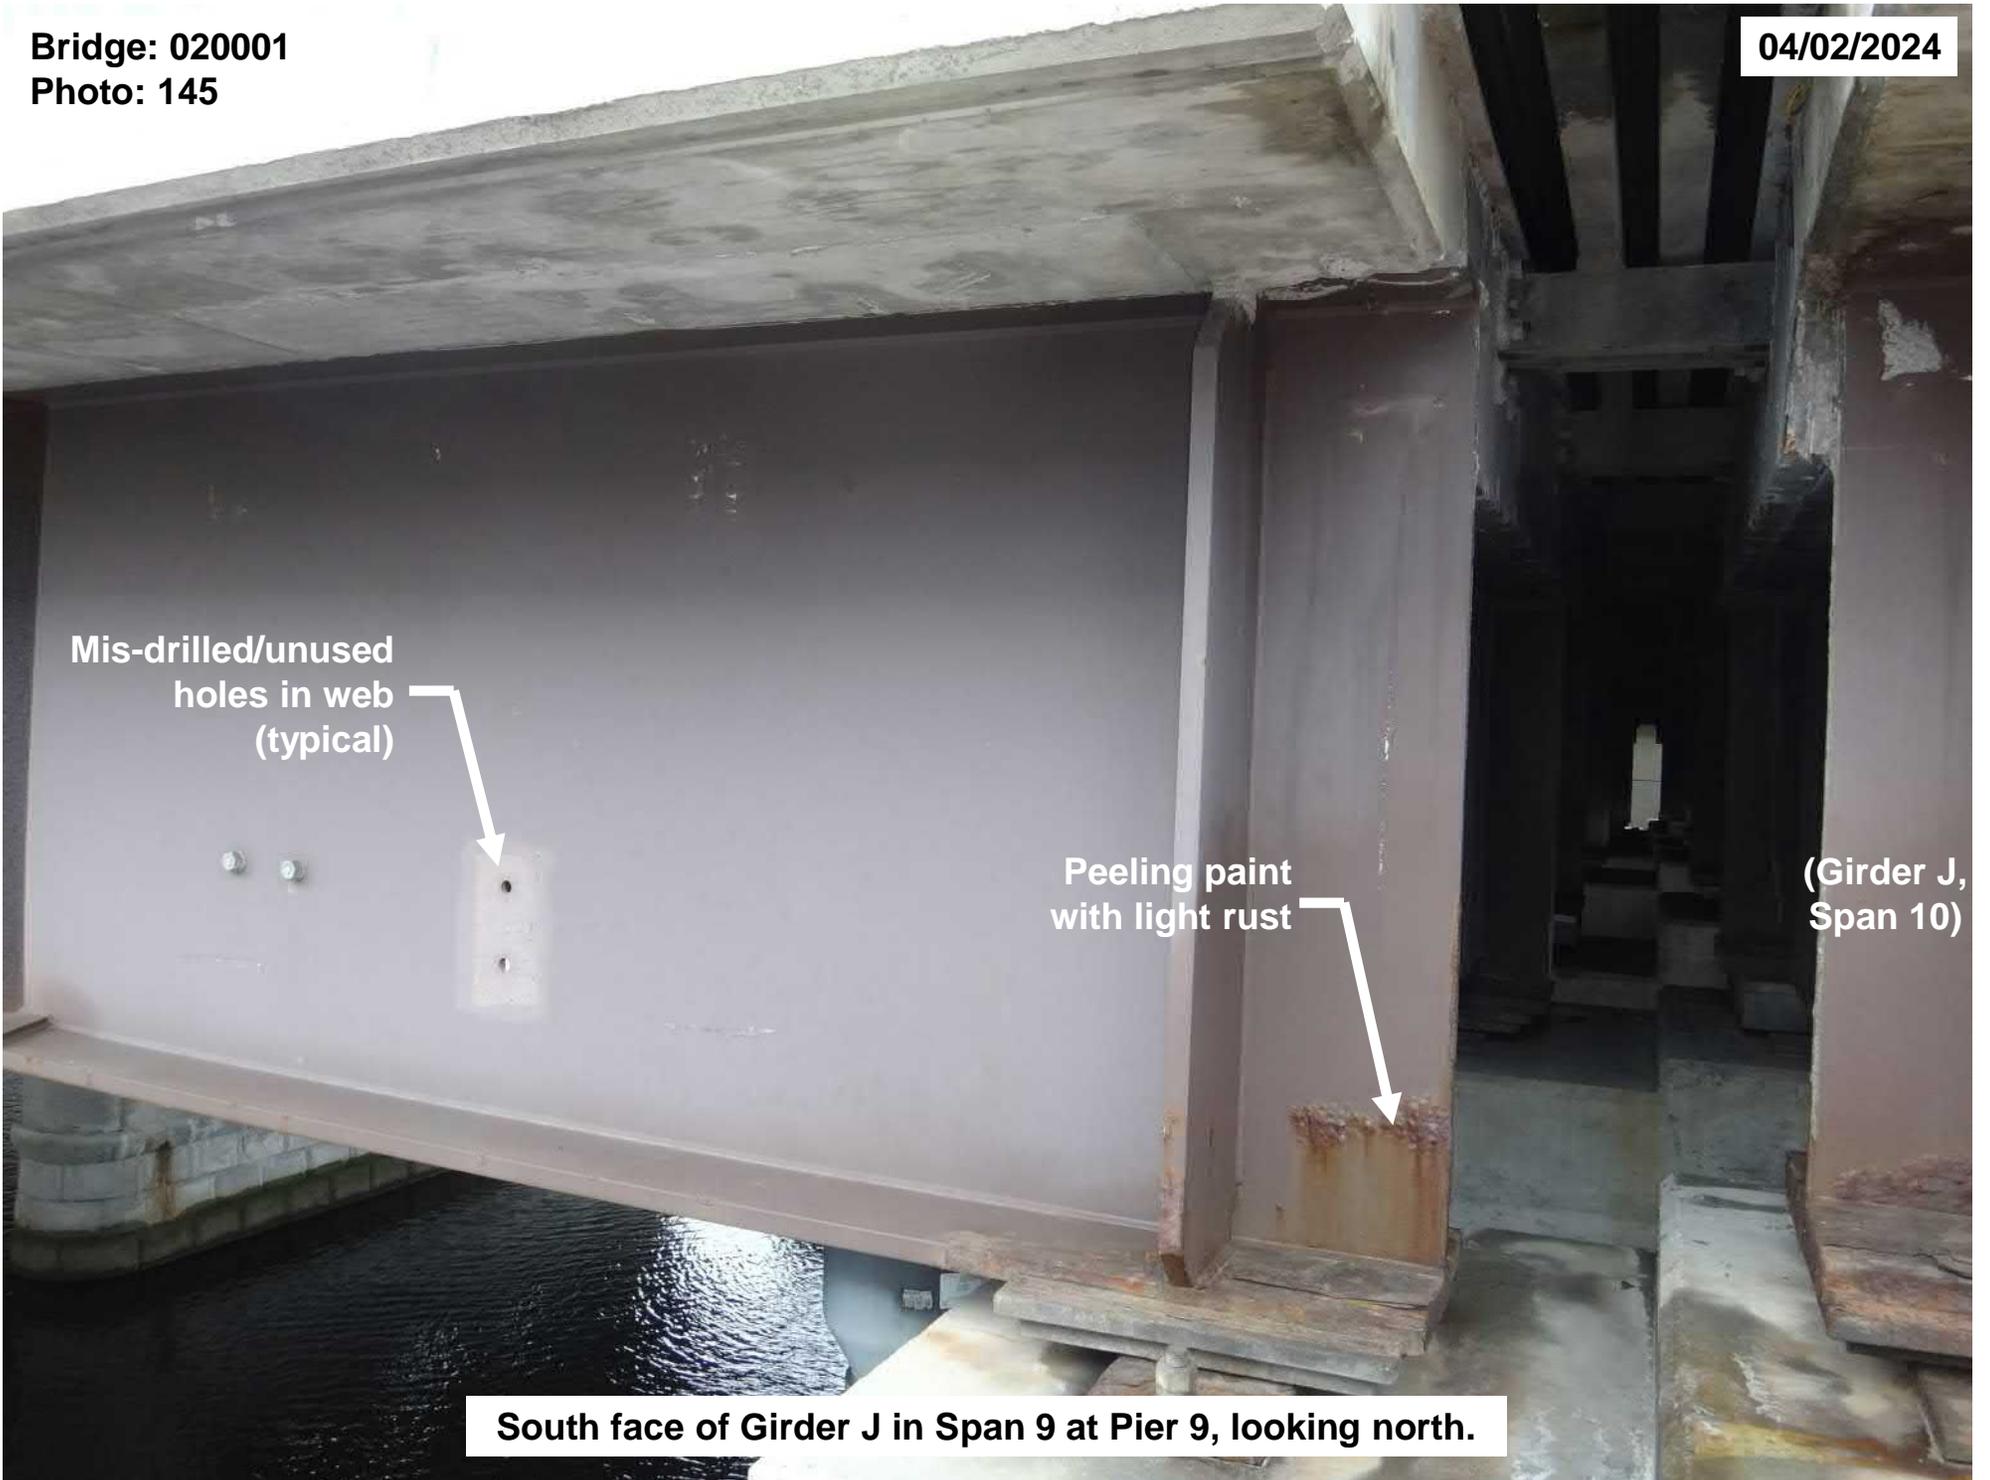
Peeling paint
with light rust

South face of Girder J in Span 9 at Pier 9, looking north.

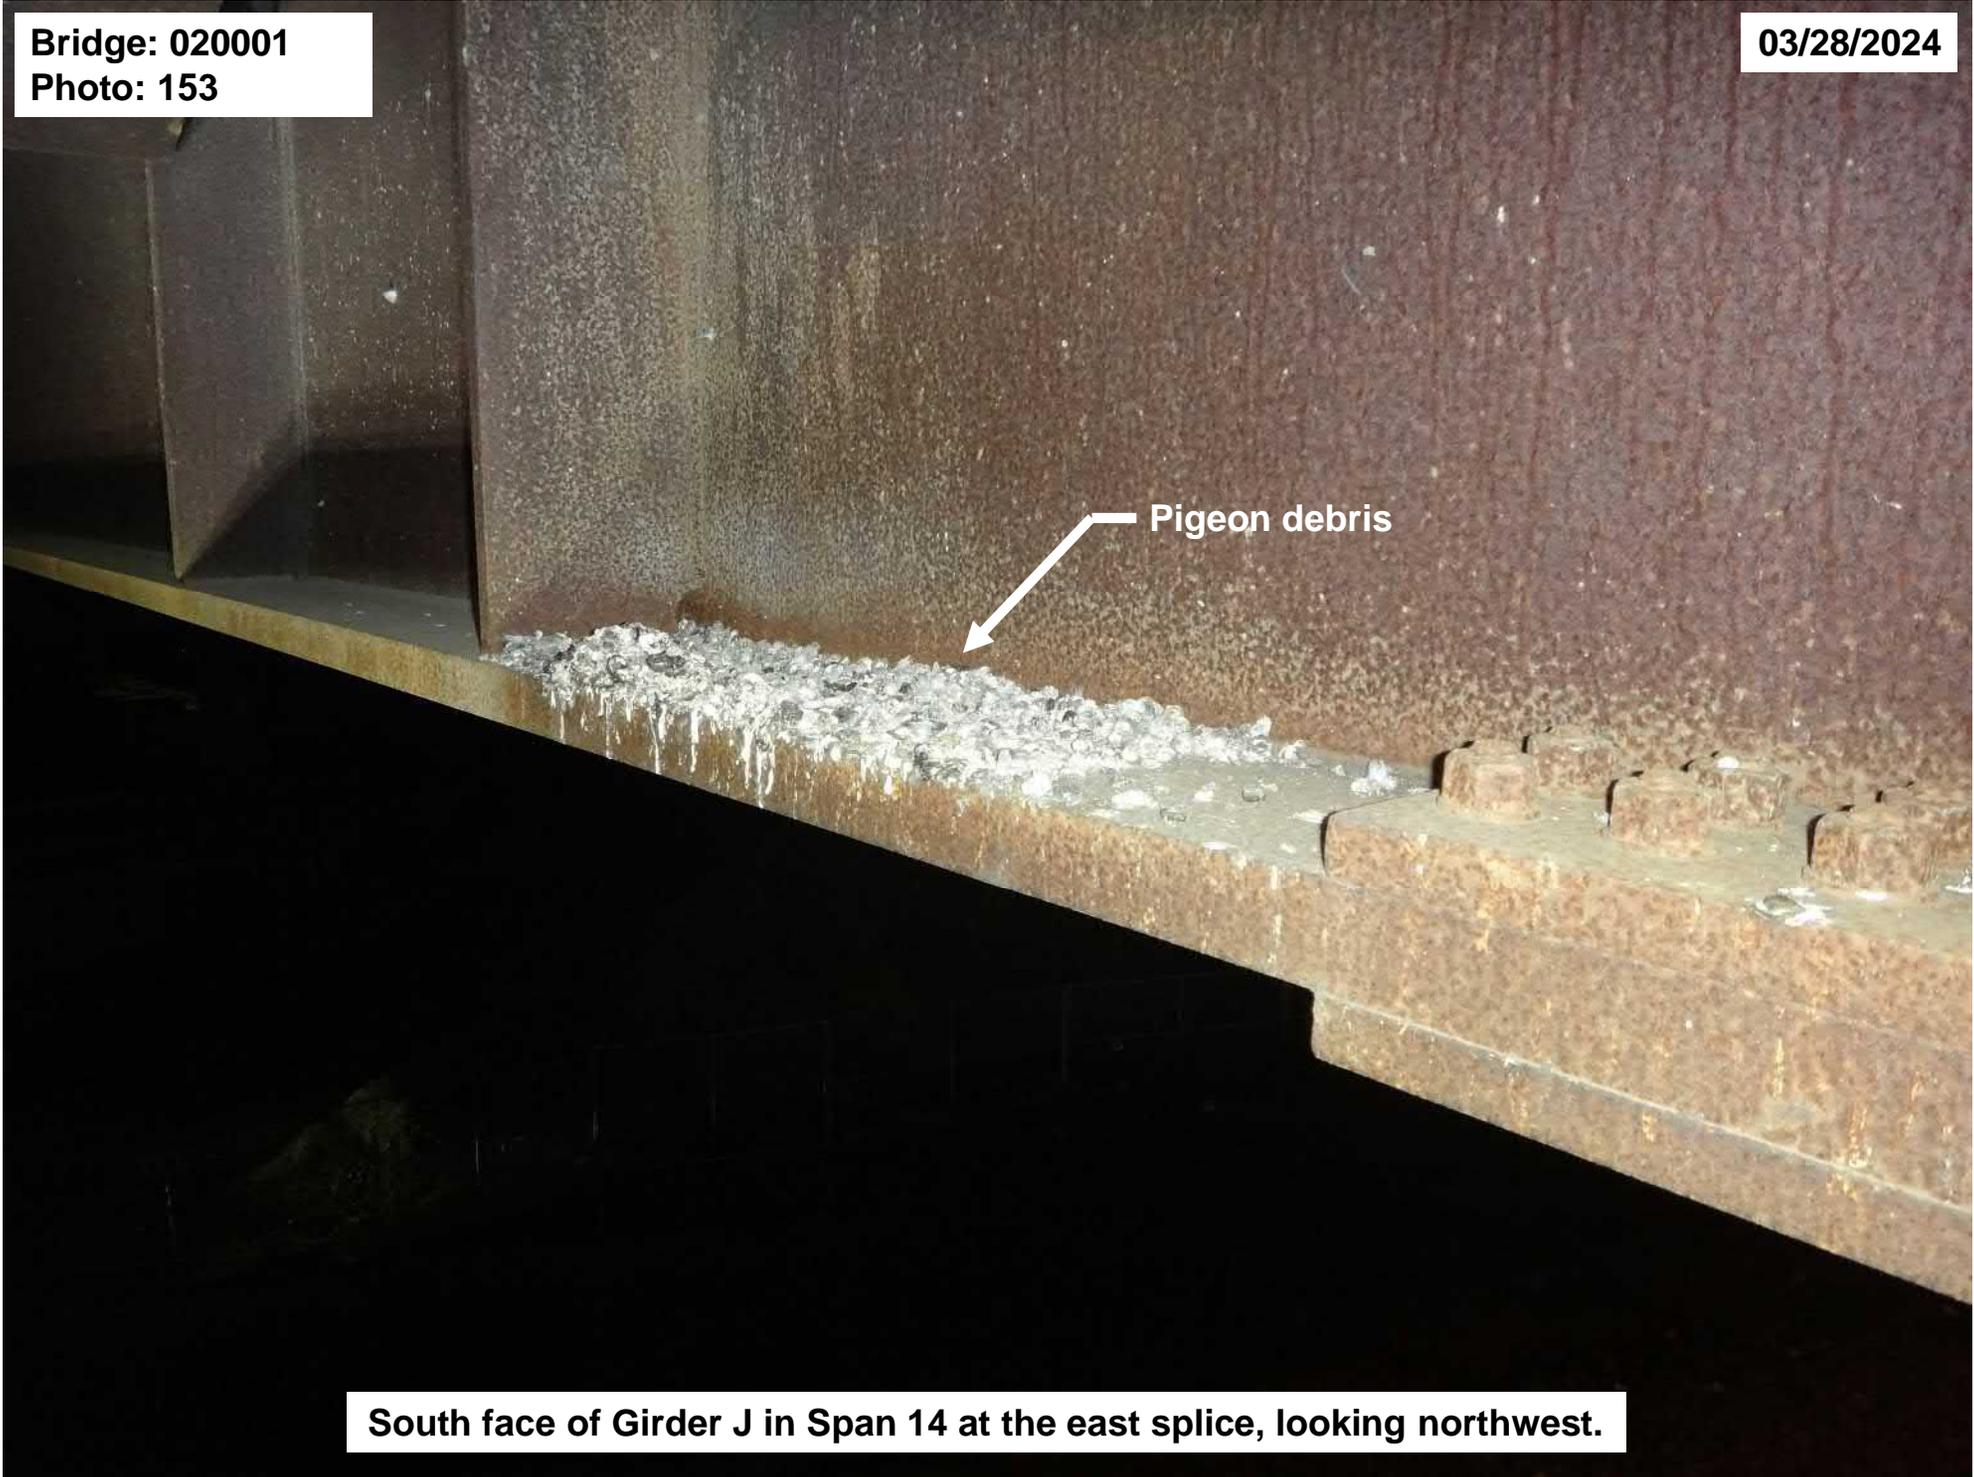
Bridge: 020001
Photo: 153

Pigeon debris

South face of Girder J in Span 14 at the east splice, looking northwest.

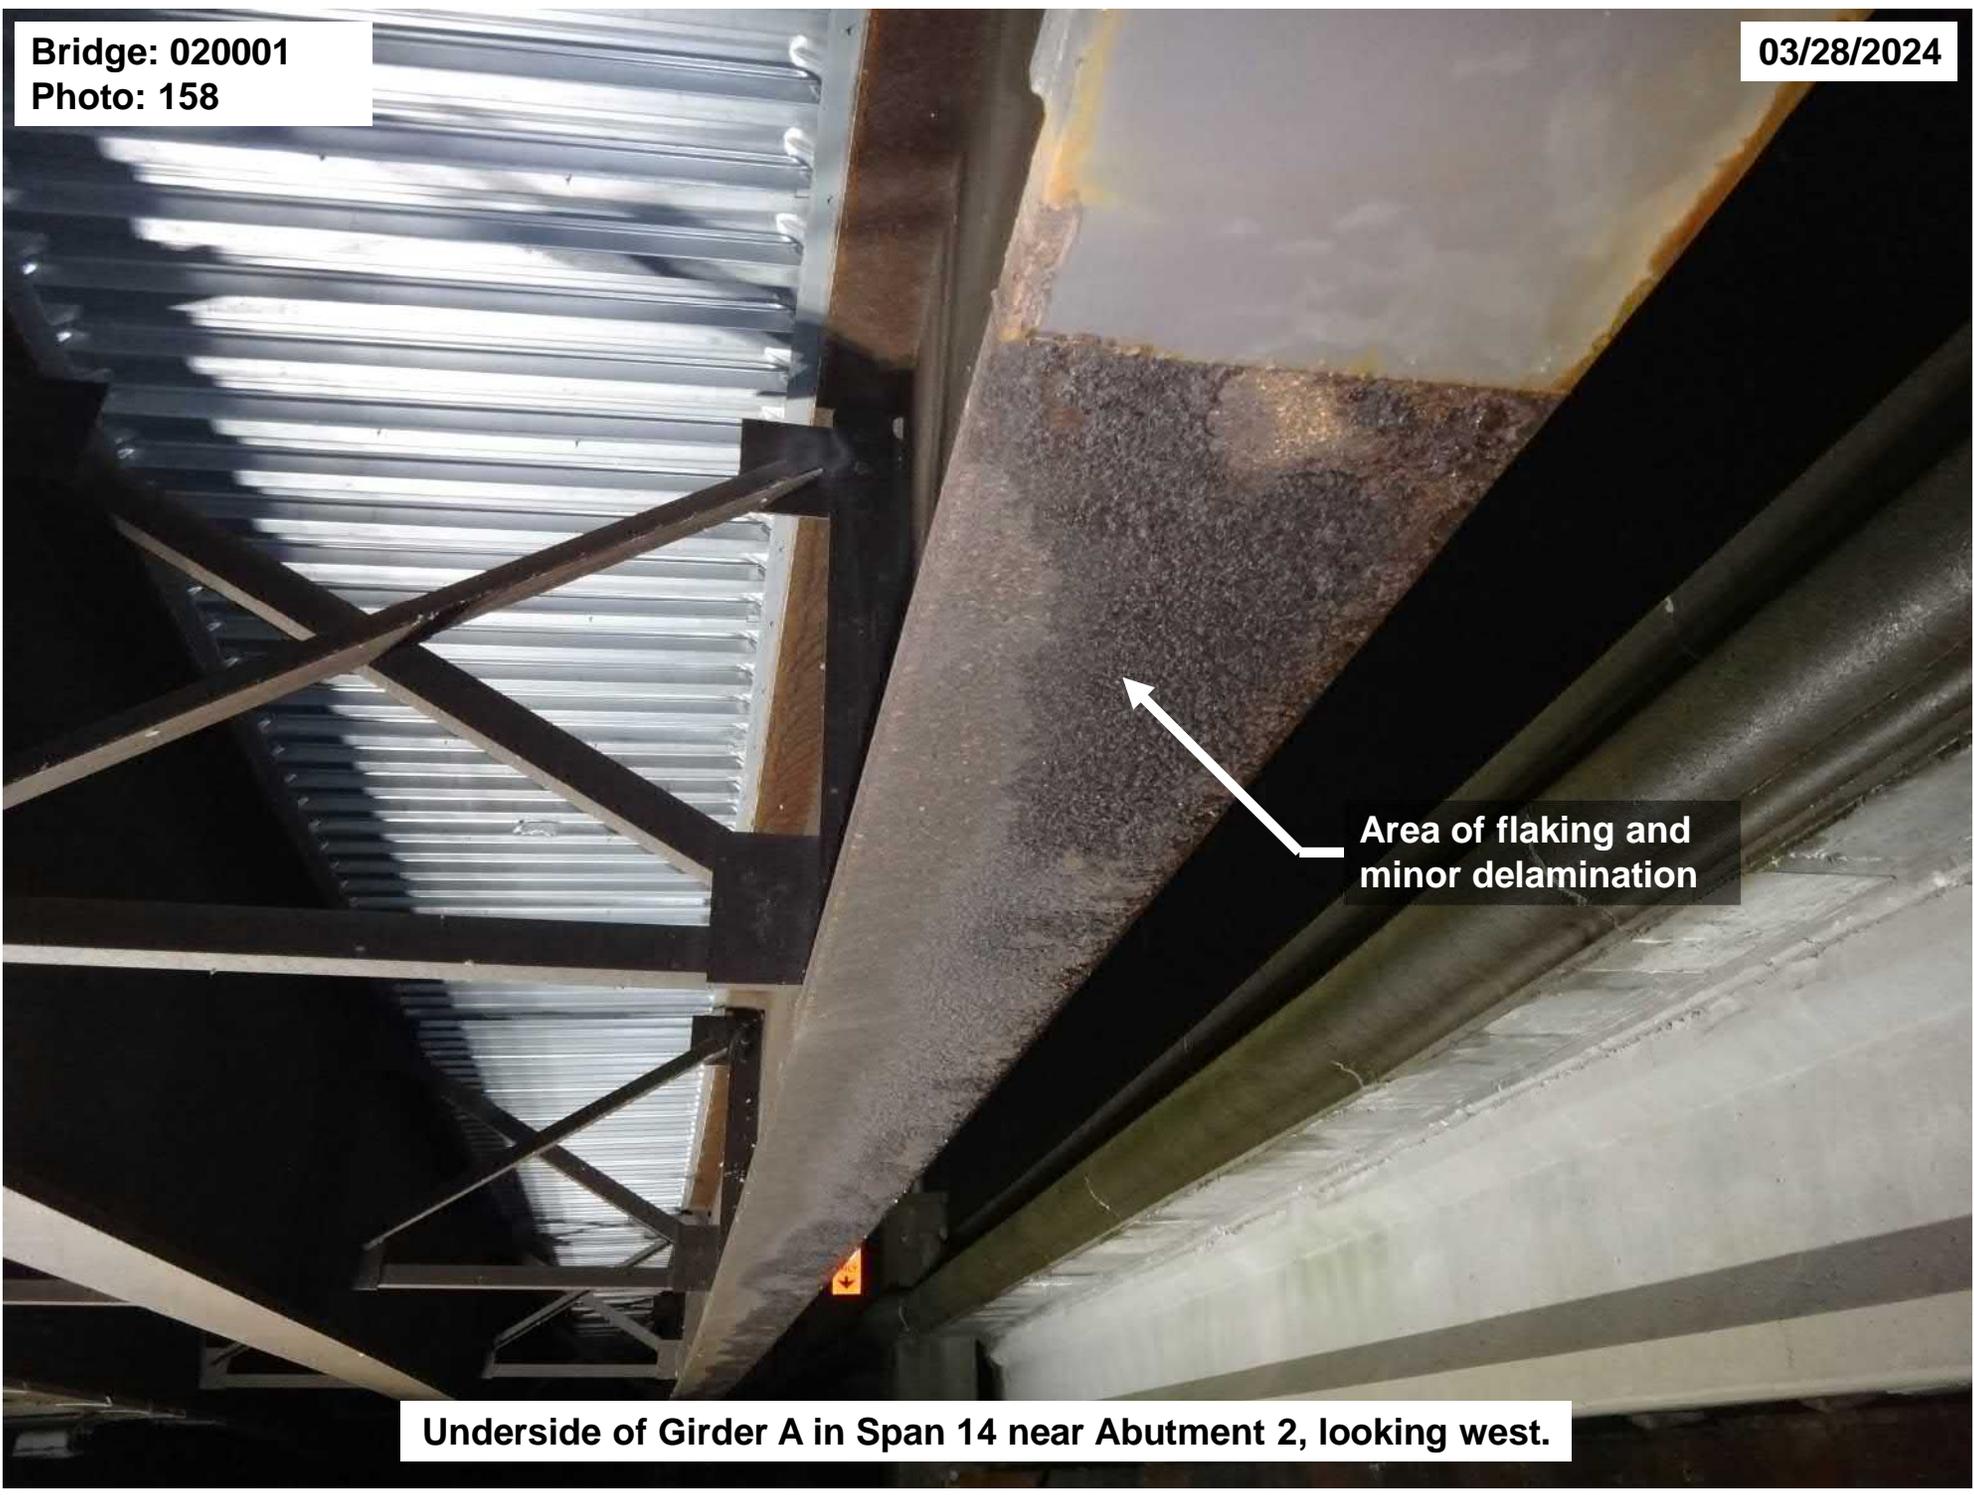
Bridge: 020001
Photo: 158

Area of flaking and
minor delamination

Underside of Girder A in Span 14 near Abutment 2, looking west.

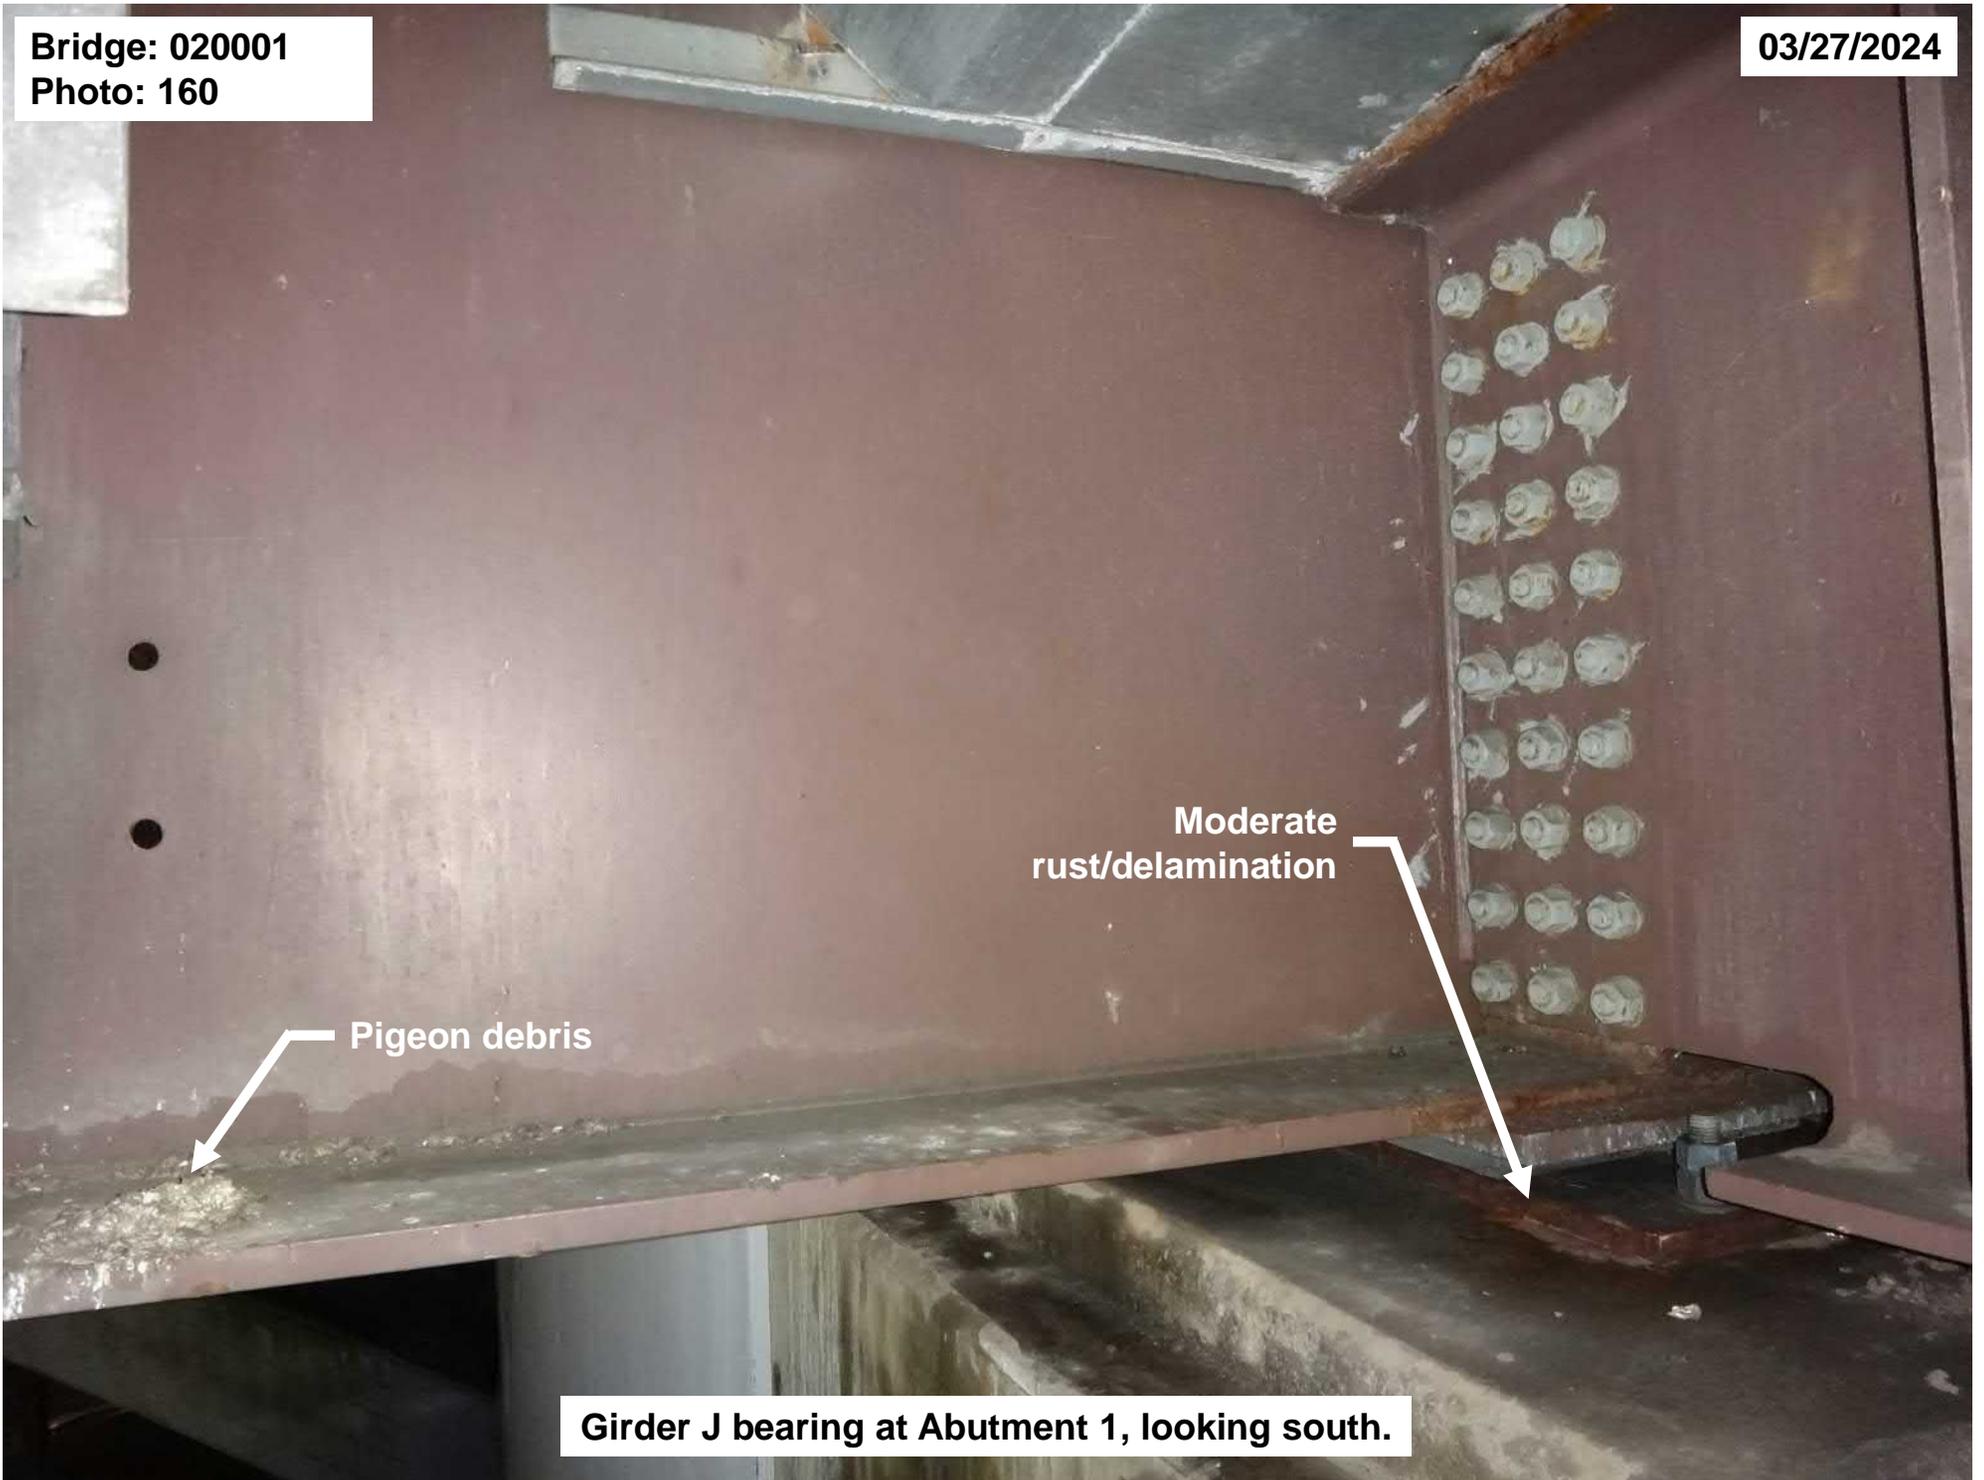
Moderate
rust/delamination

Girder J bearing at Abutment 1, looking south.
