Bridge: 020001
Photo: 1

South elevation at the main channel, looking north.

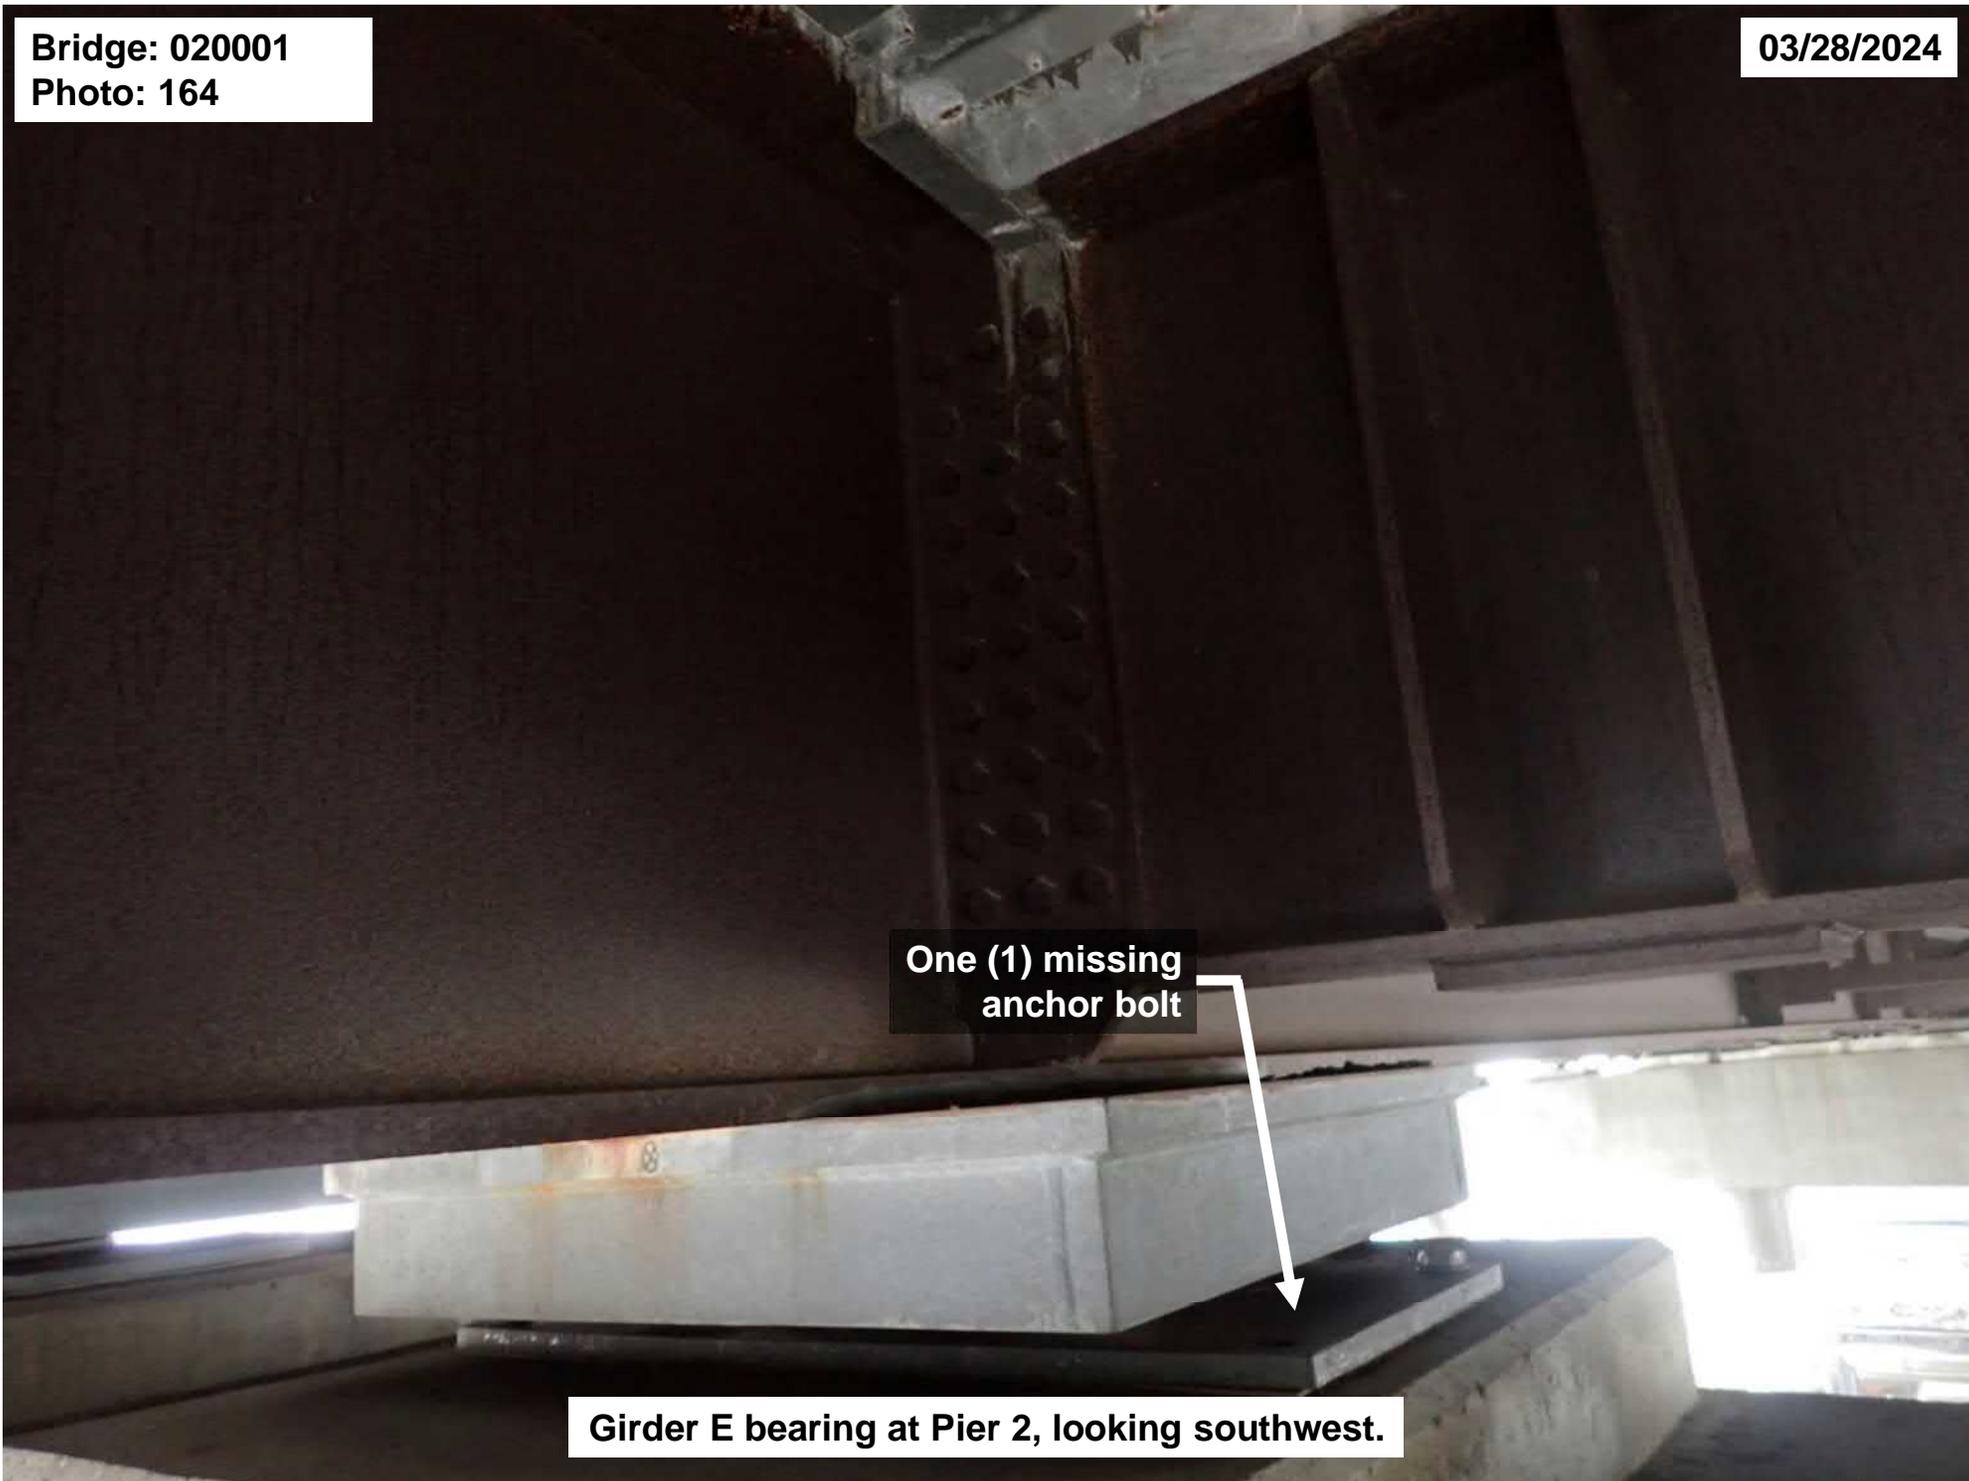
One (1) missing
anchor bolt

Girder E bearing at Pier 2, looking southwest.

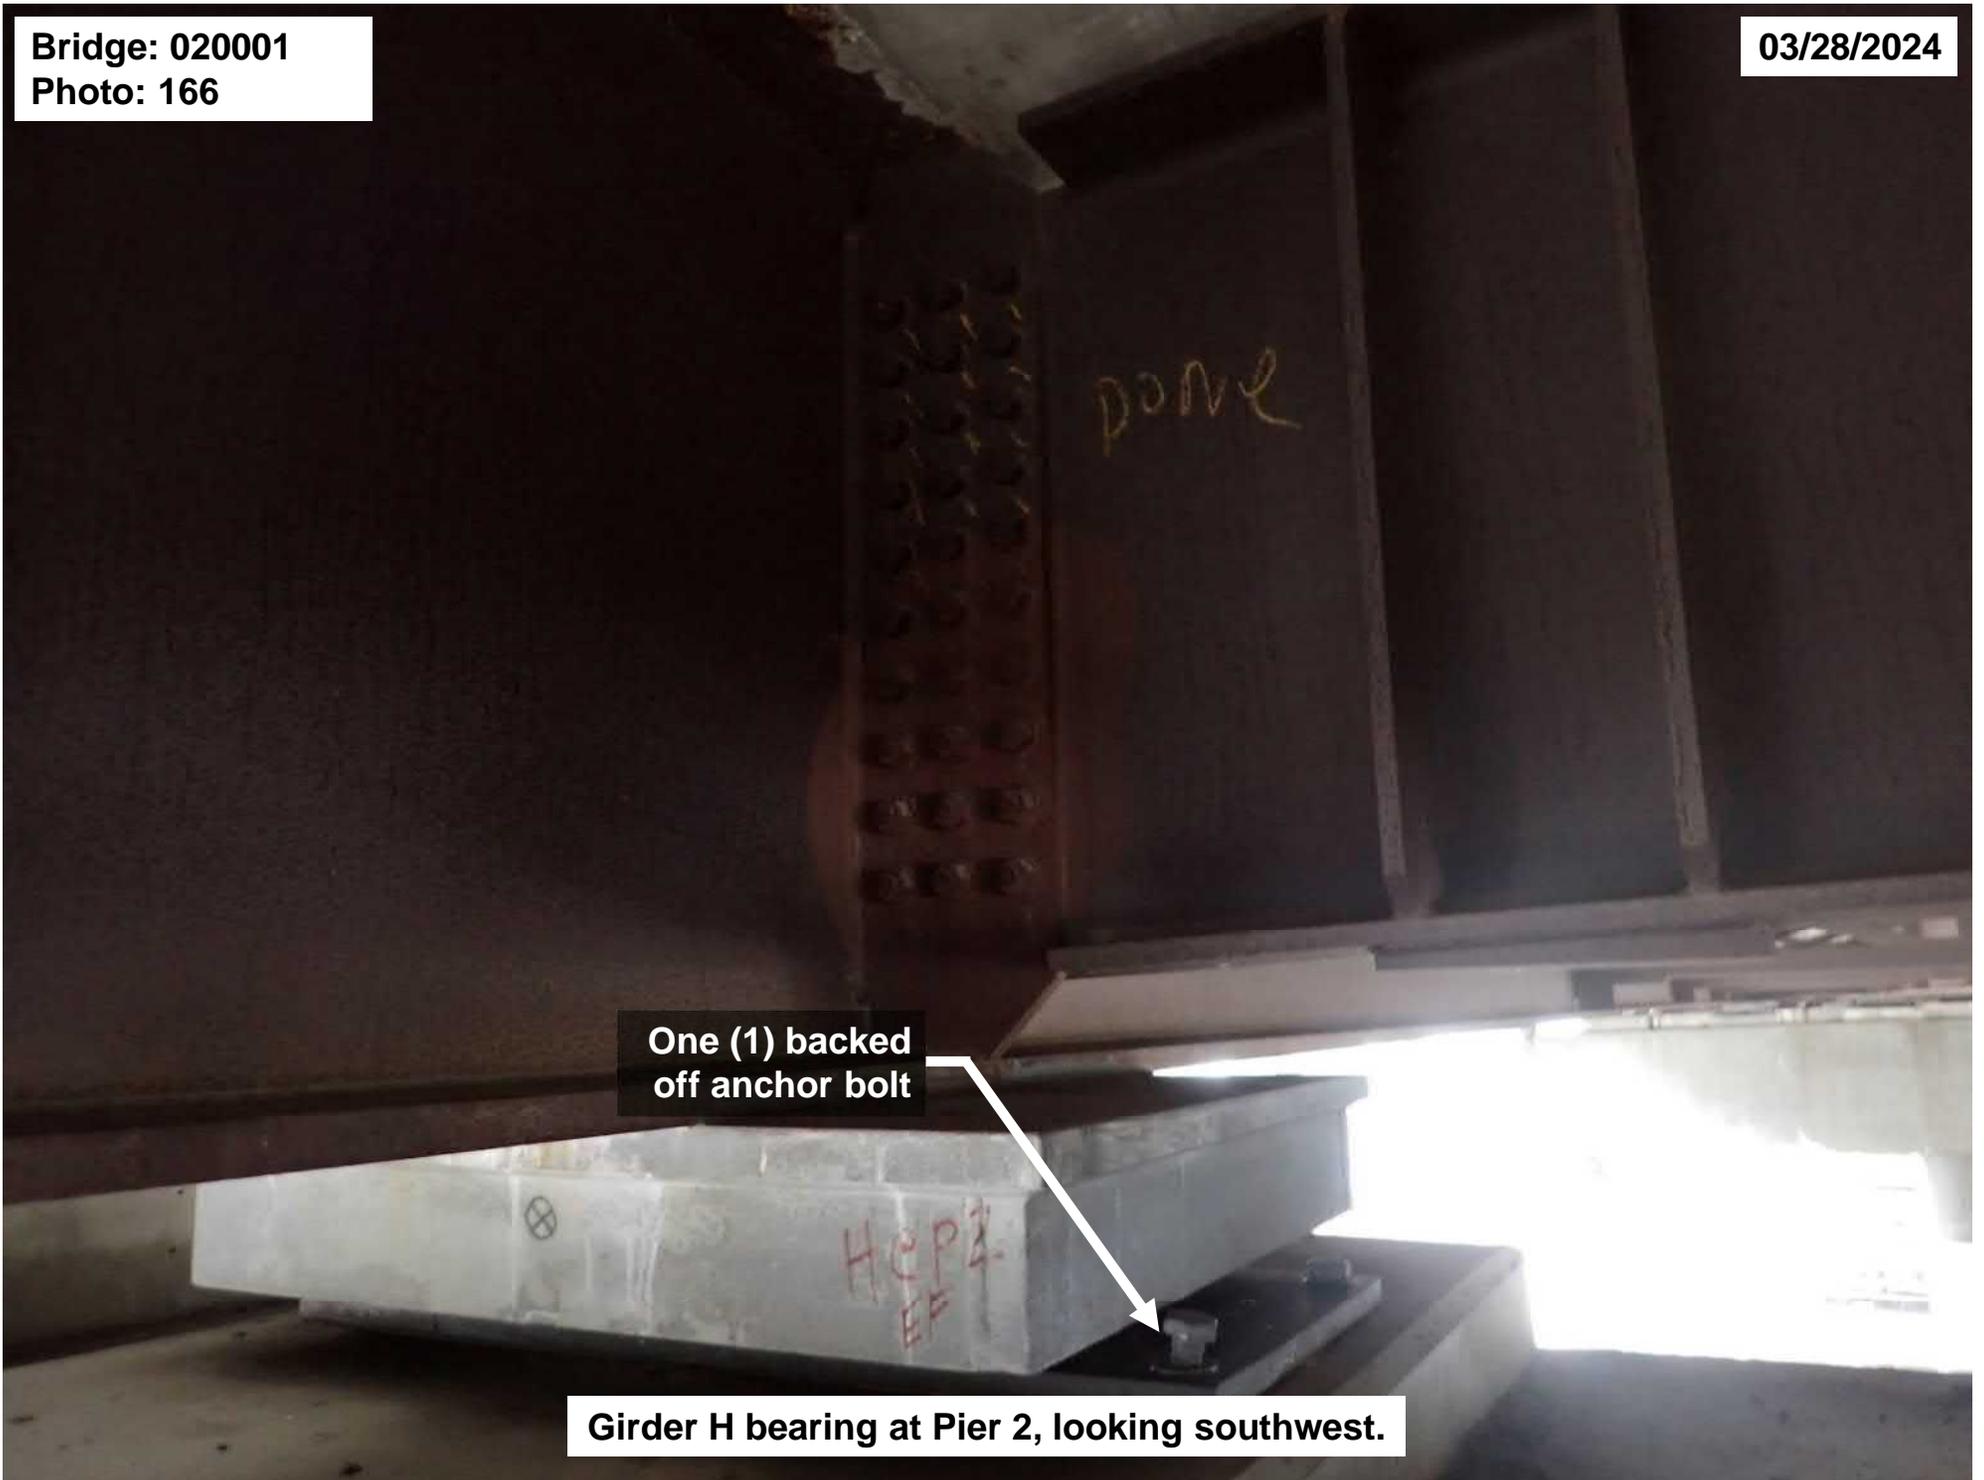
One (1) backed
off anchor bolt

Girder H bearing at Pier 2, looking southwest.

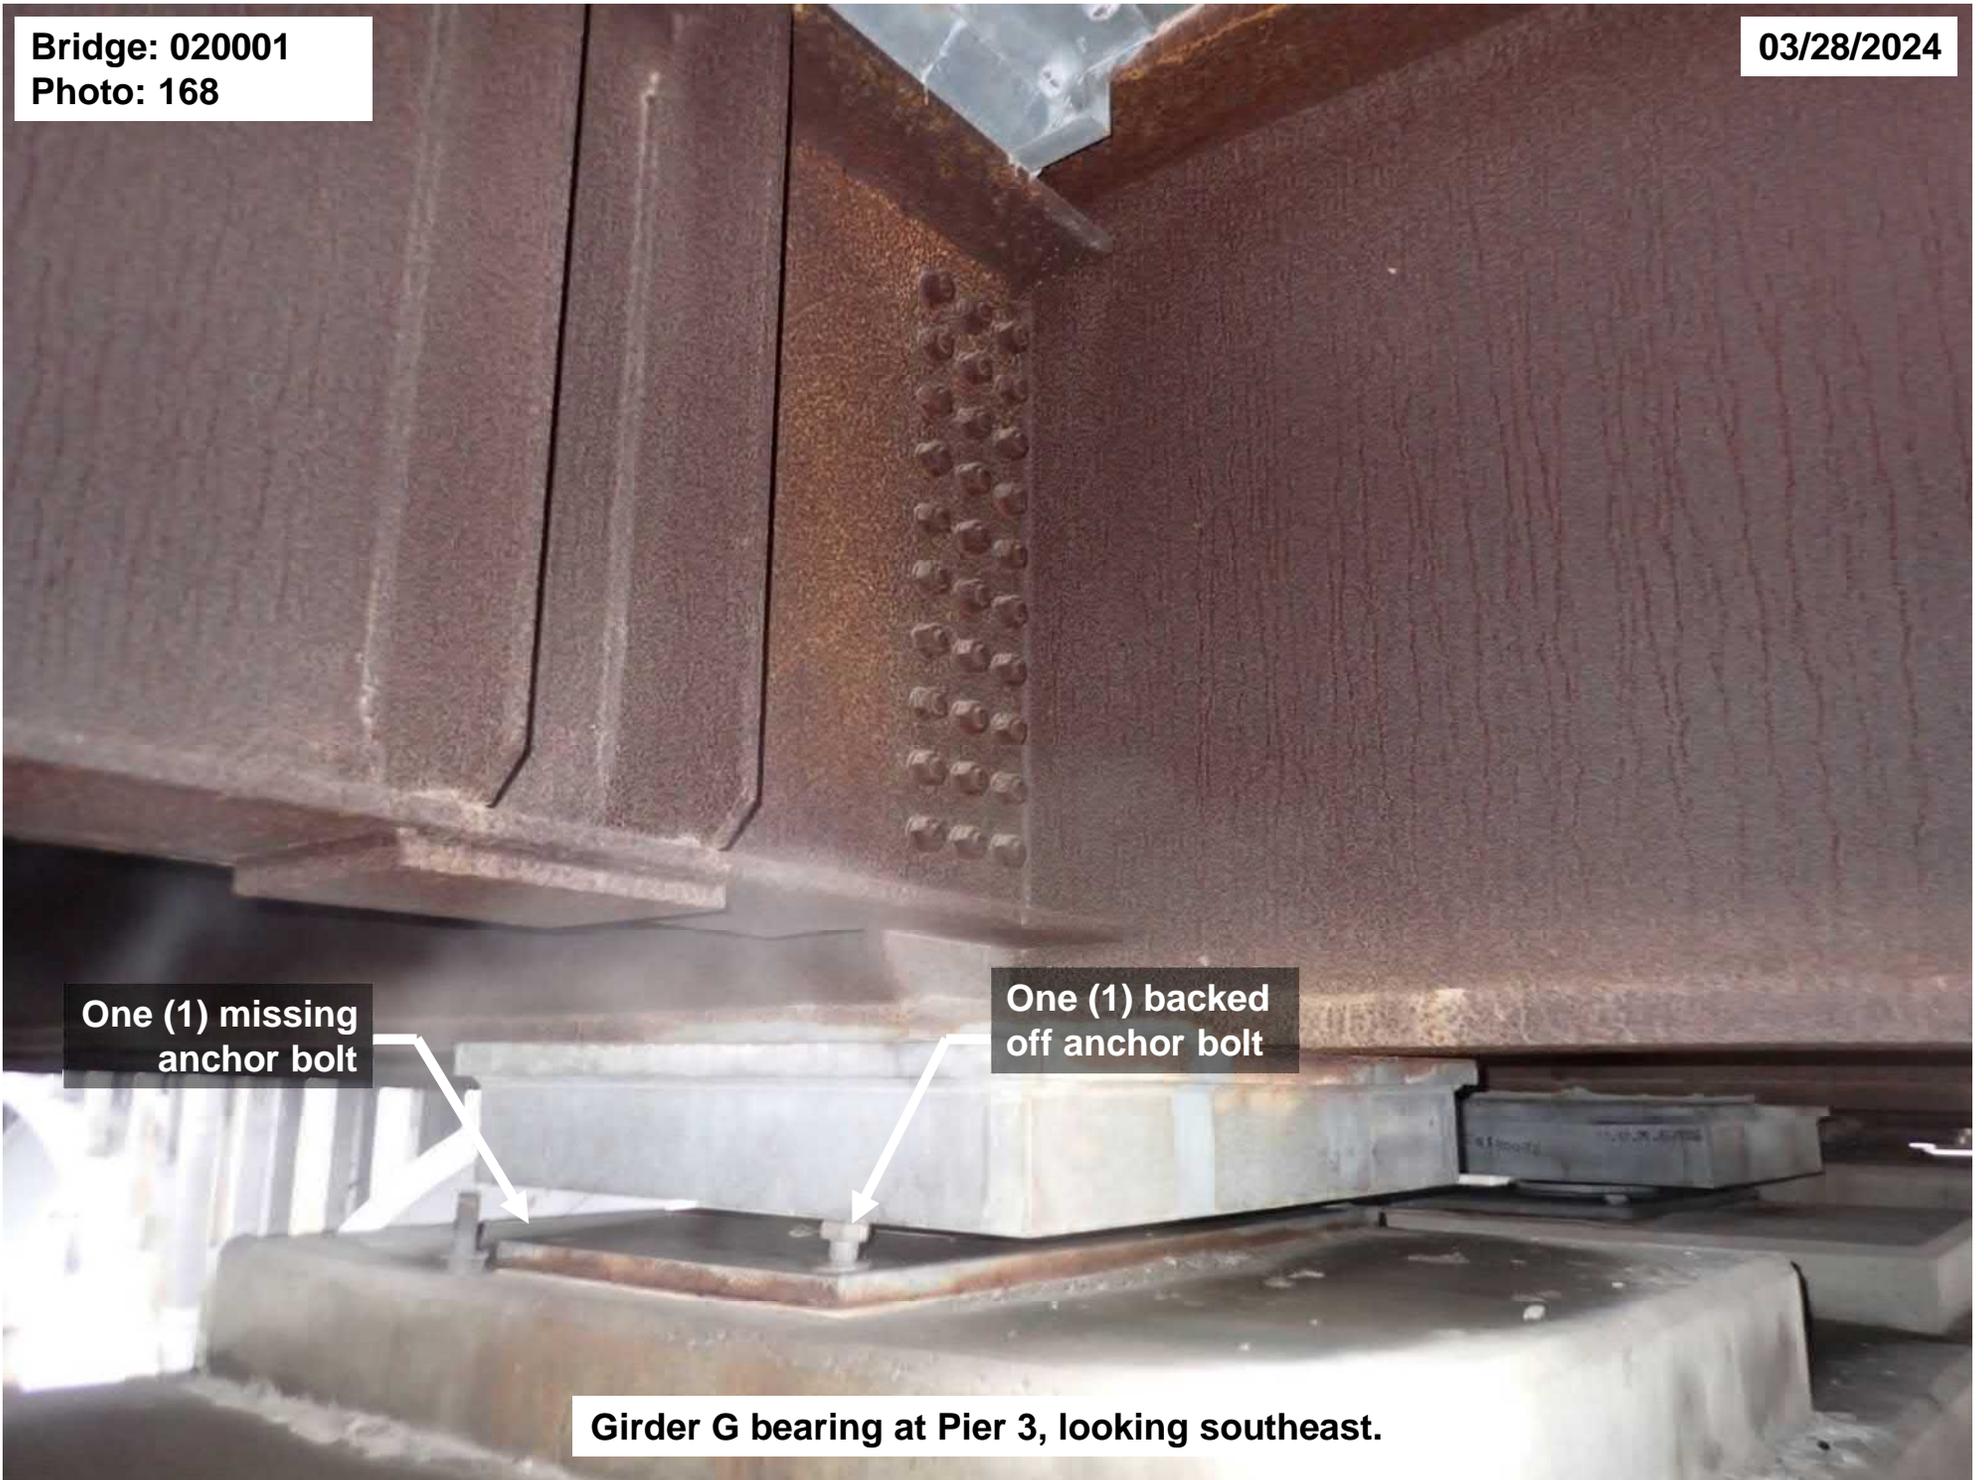
One (1) missing
anchor bolt

One (1) backed
off anchor bolt

Girder G bearing at Pier 3, looking southeast.

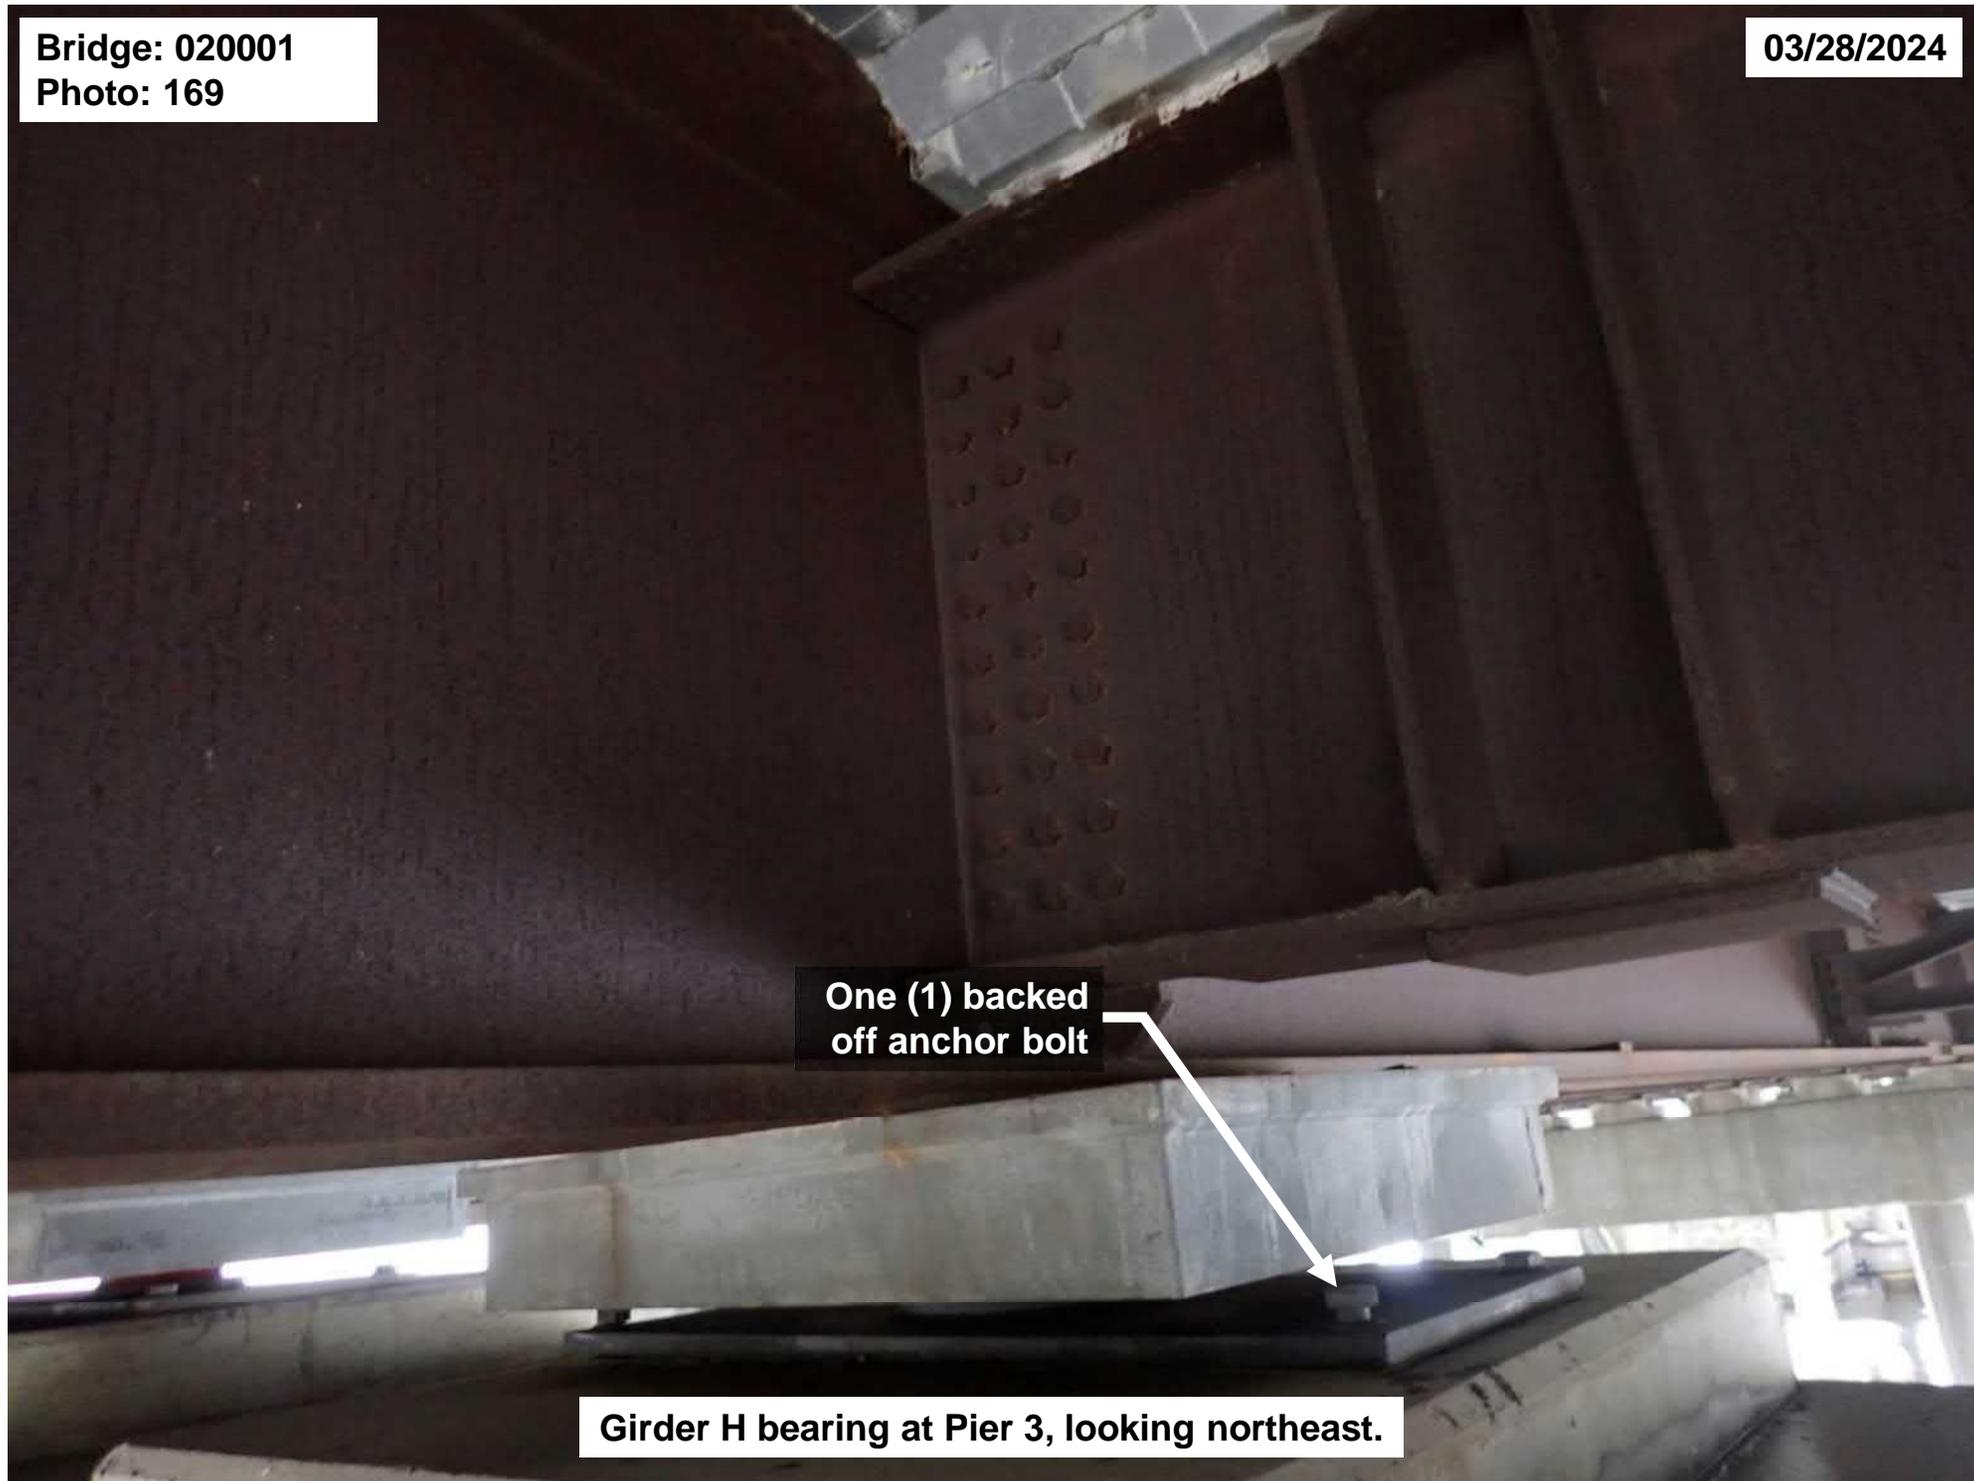
Bridge: 020001
Photo: 169

One (1) backed
off anchor bolt

Girder H bearing at Pier 3, looking northeast.

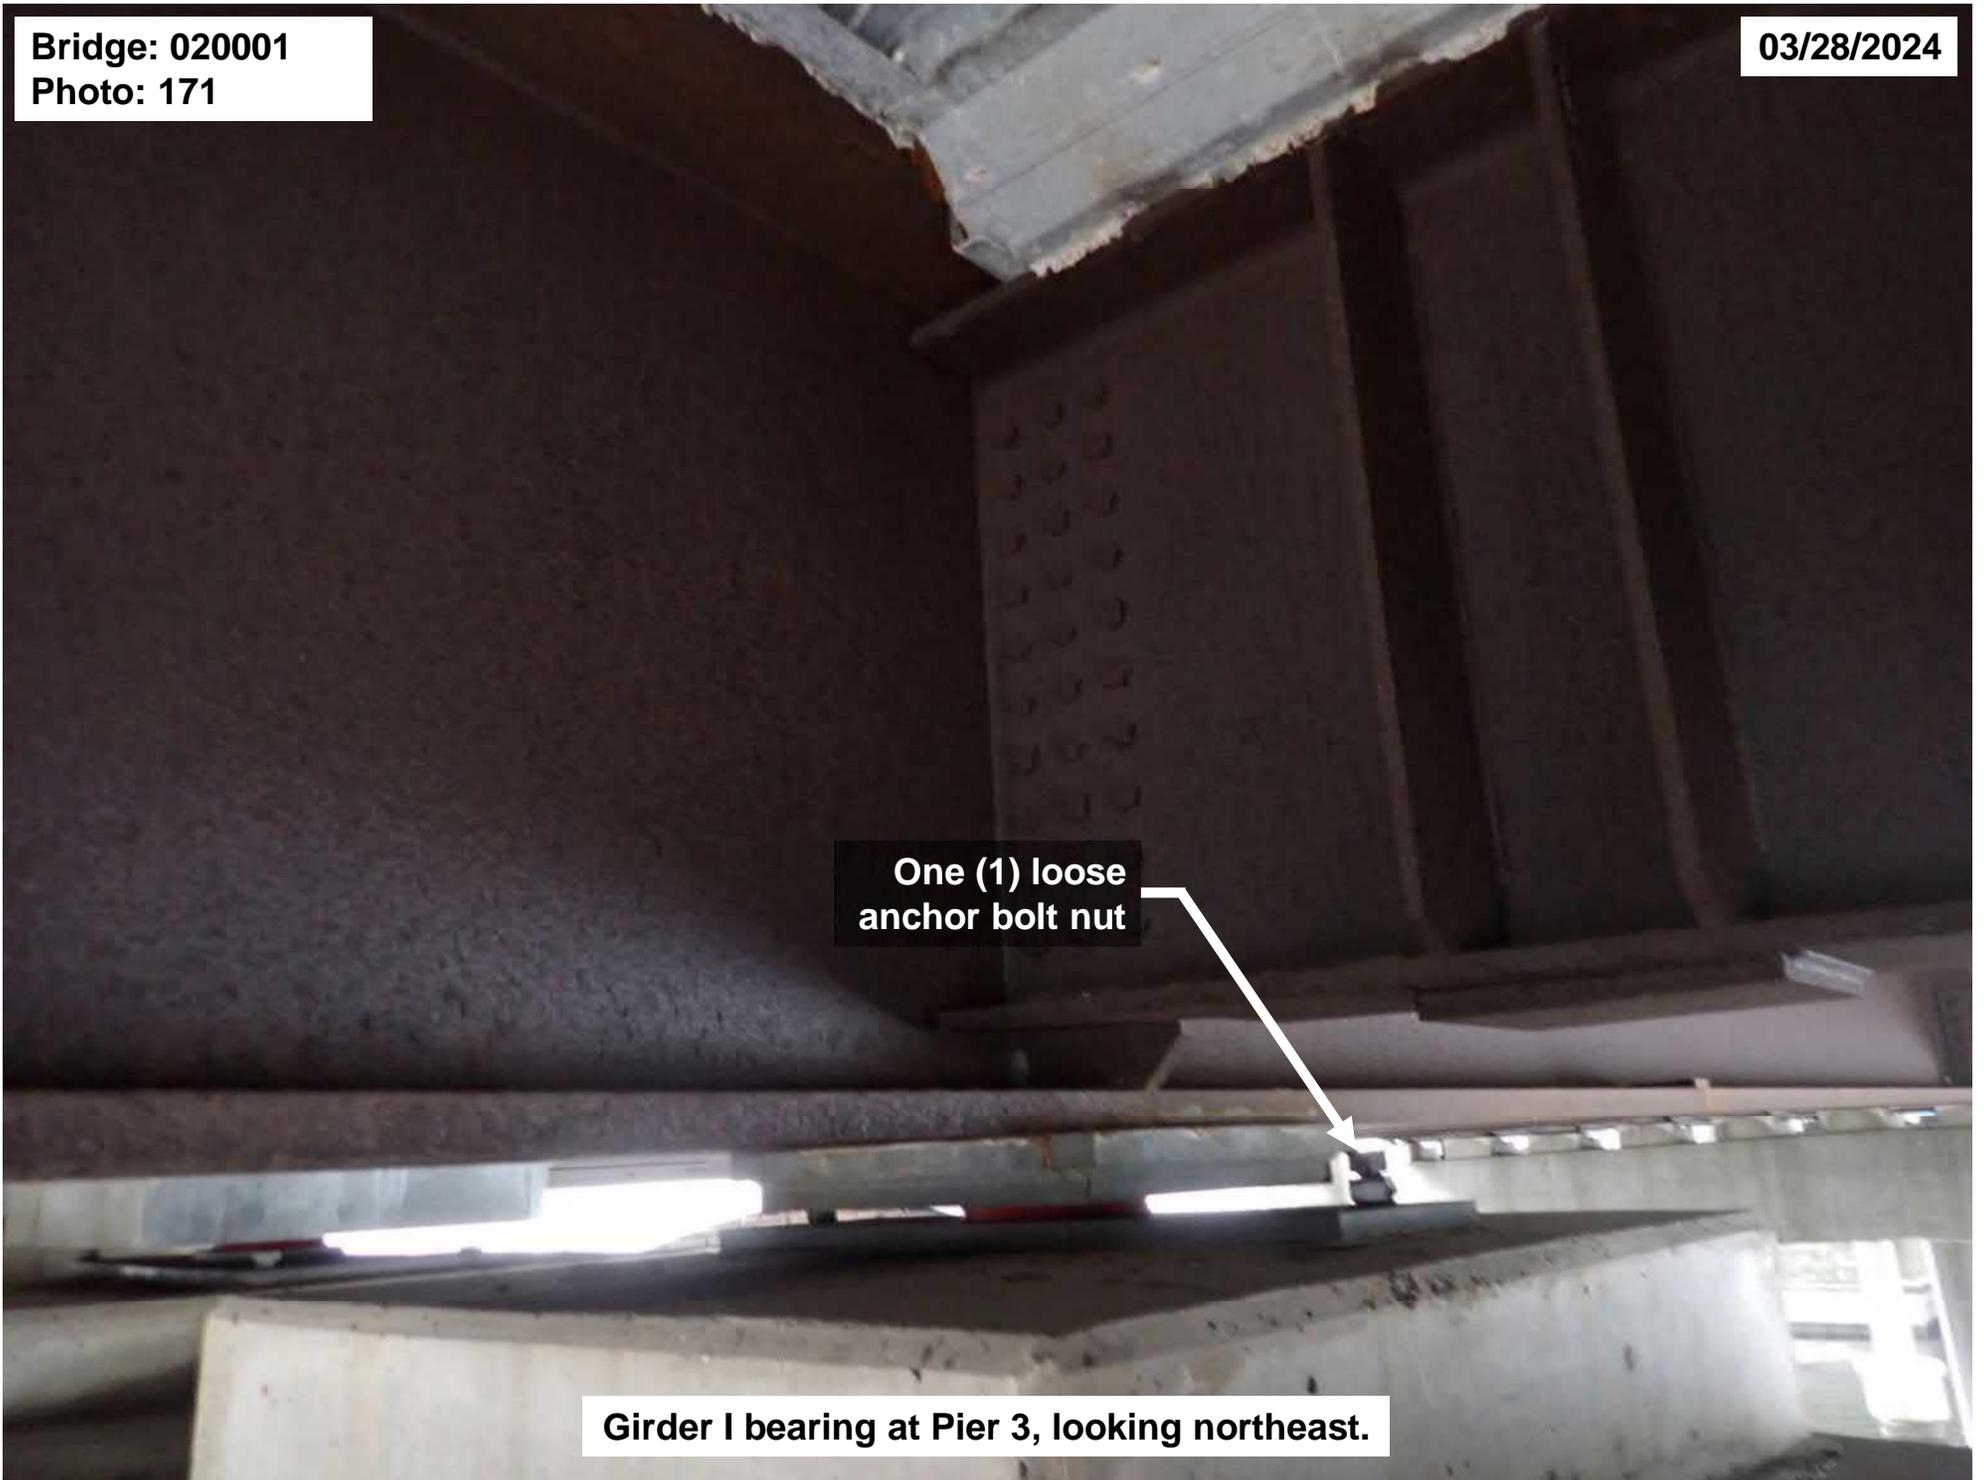
One (1) loose
anchor bolt nut

Girder I bearing at Pier 3, looking northeast.

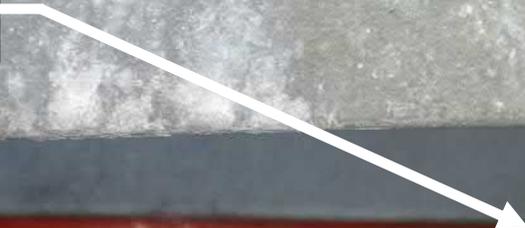
Bearing compressed,
up to 1/8"

Girder E bearing in Span 4 at Pier 4, looking east.

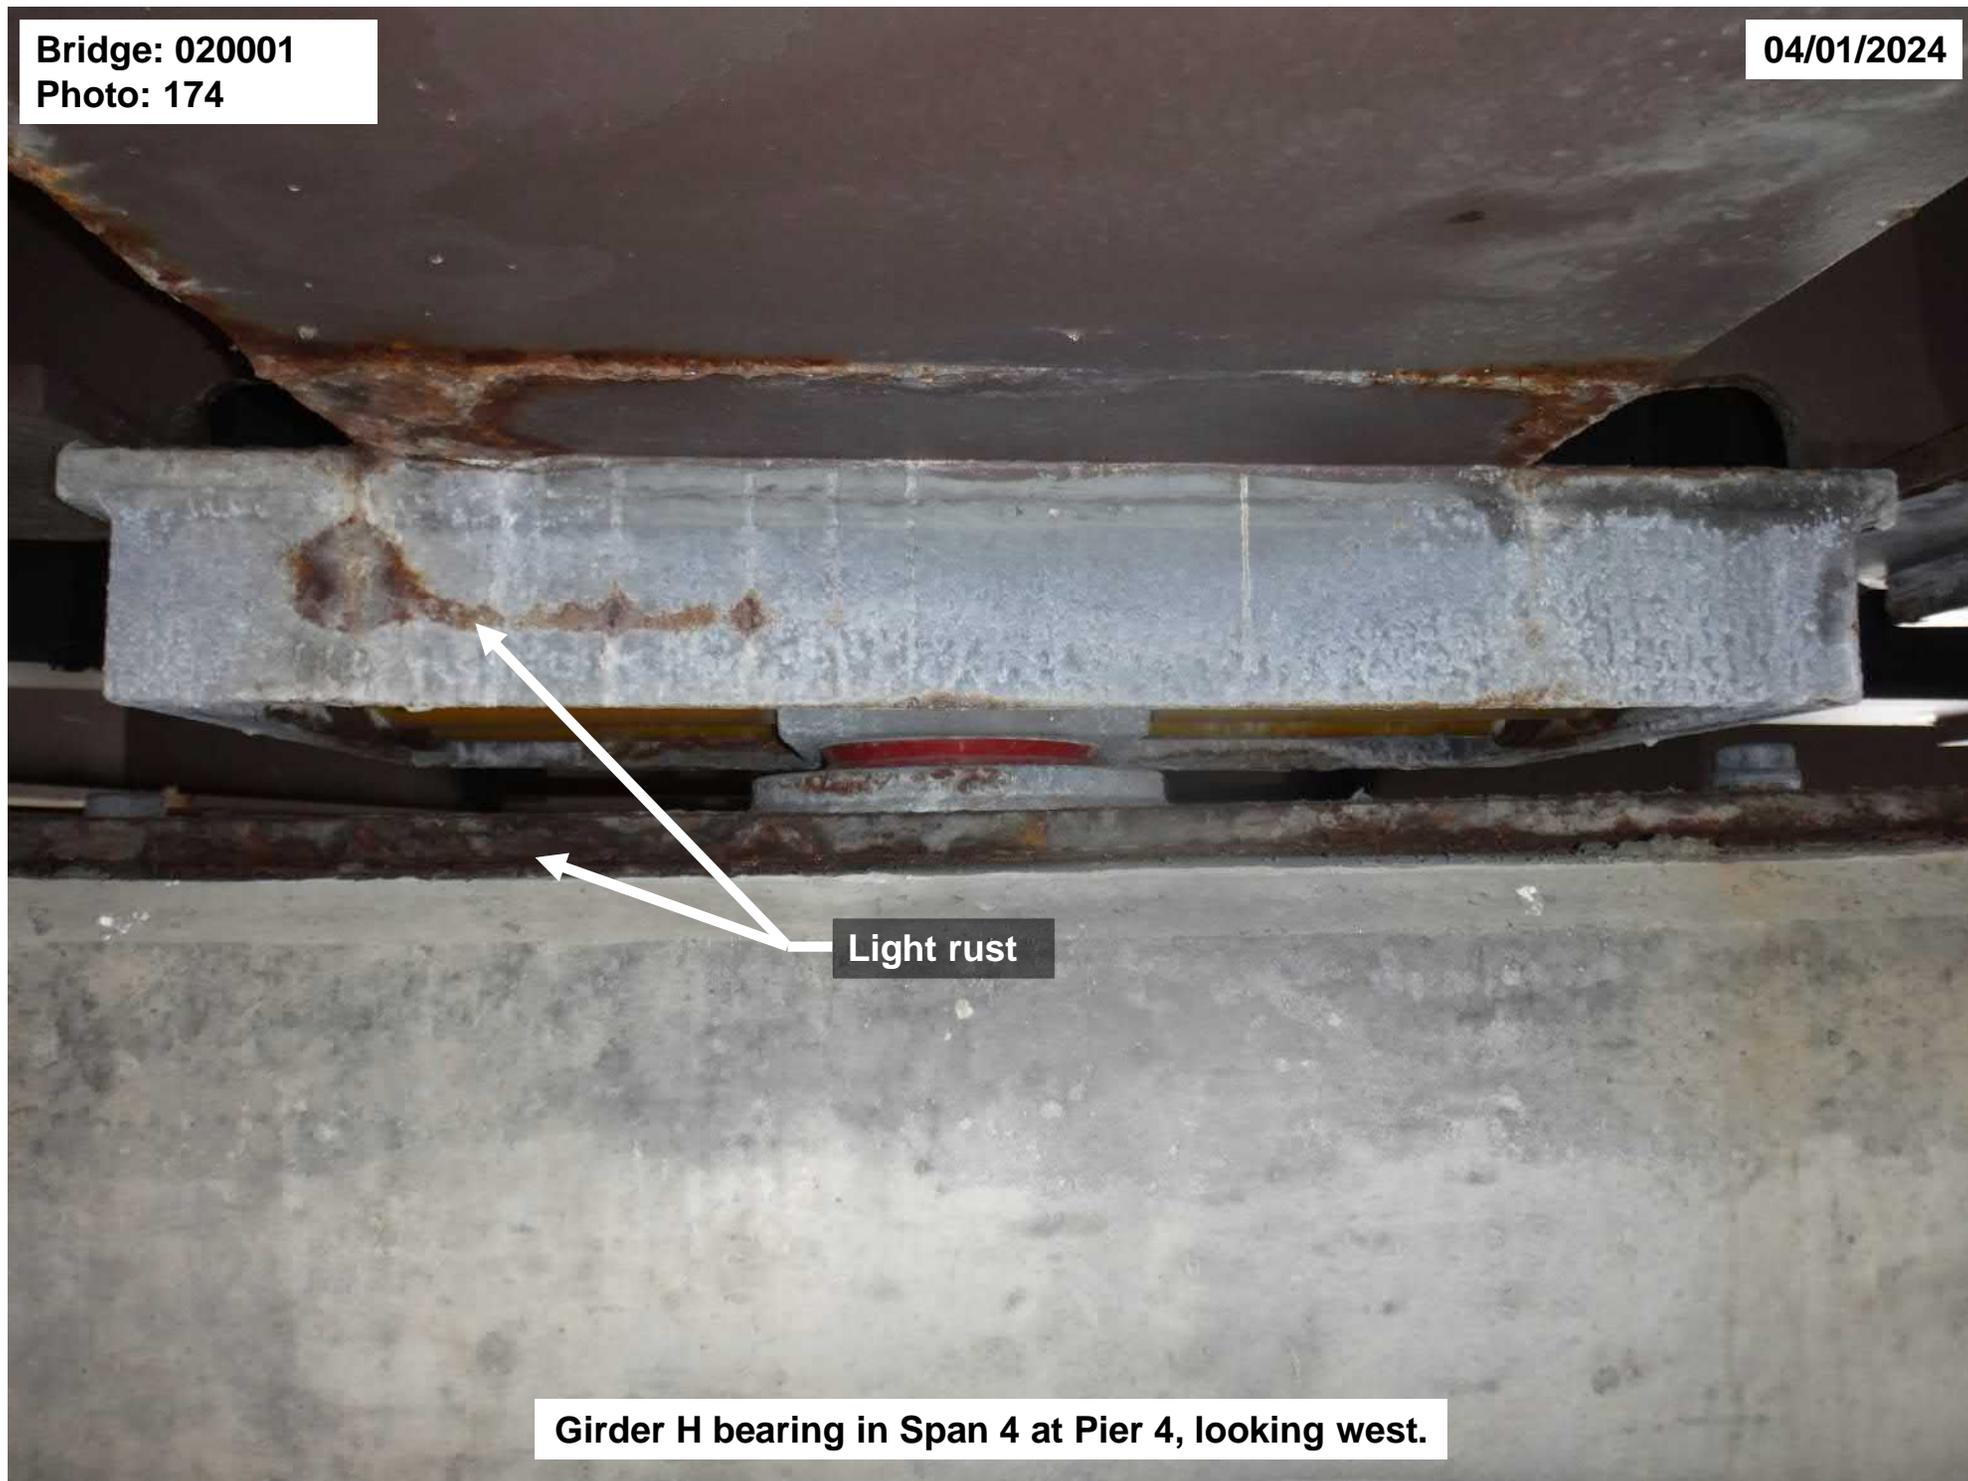
Bridge: 020001
Photo: 174

Light rust

Girder H bearing in Span 4 at Pier 4, looking west.

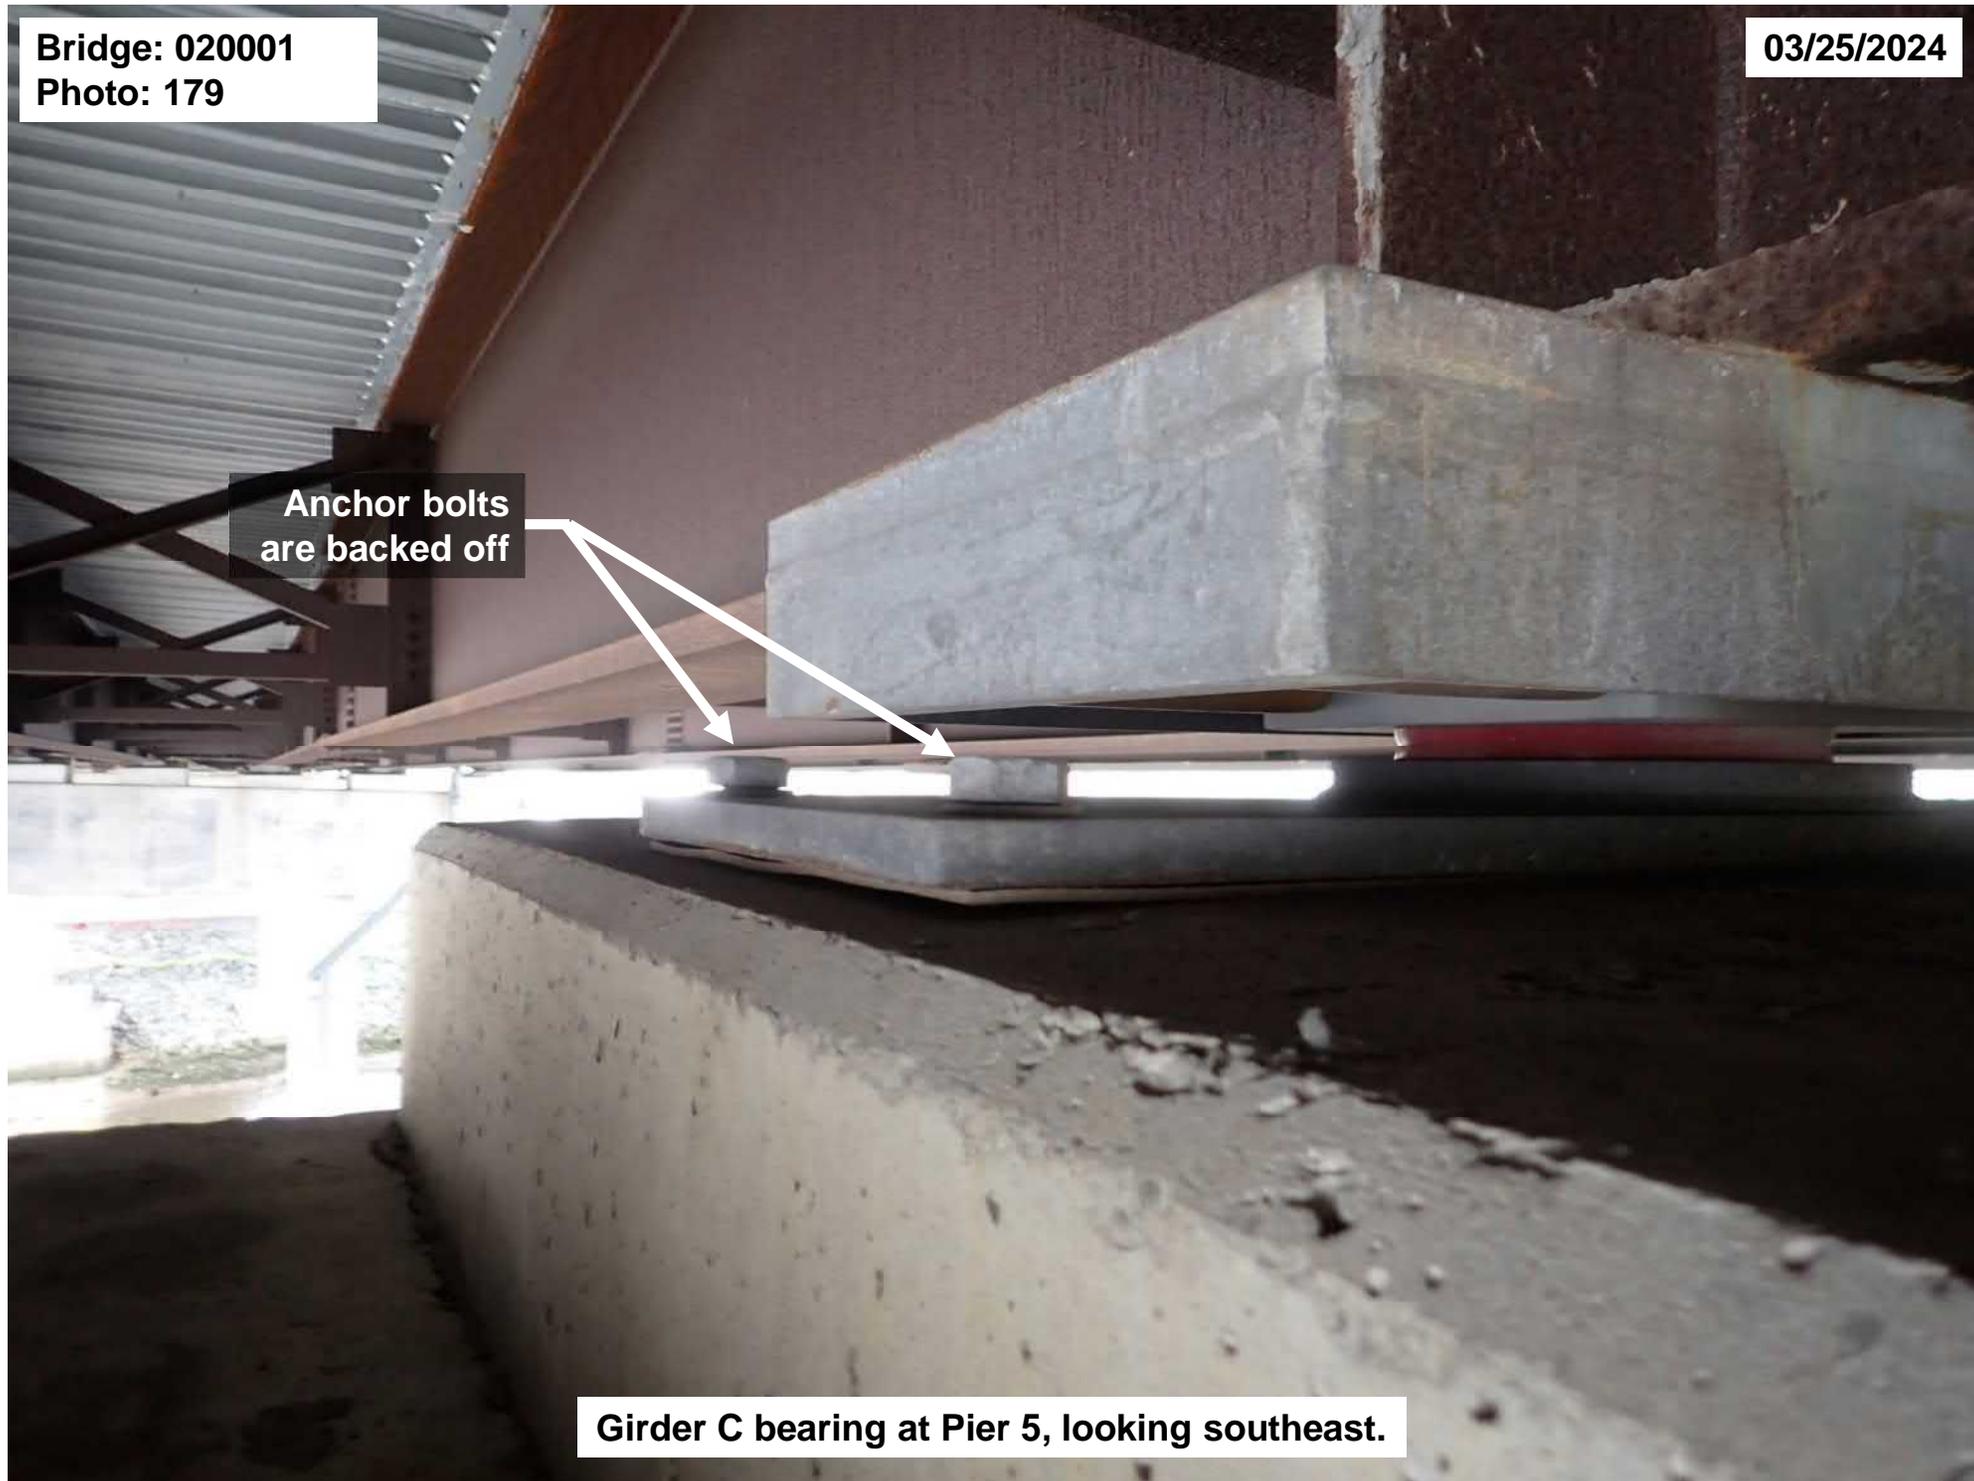
Bridge: 020001
Photo: 179

Anchor bolts
are backed off

Girder C bearing at Pier 5, looking southeast.
