Bridge: 020001
Photo: 1

South elevation at the main channel, looking north.

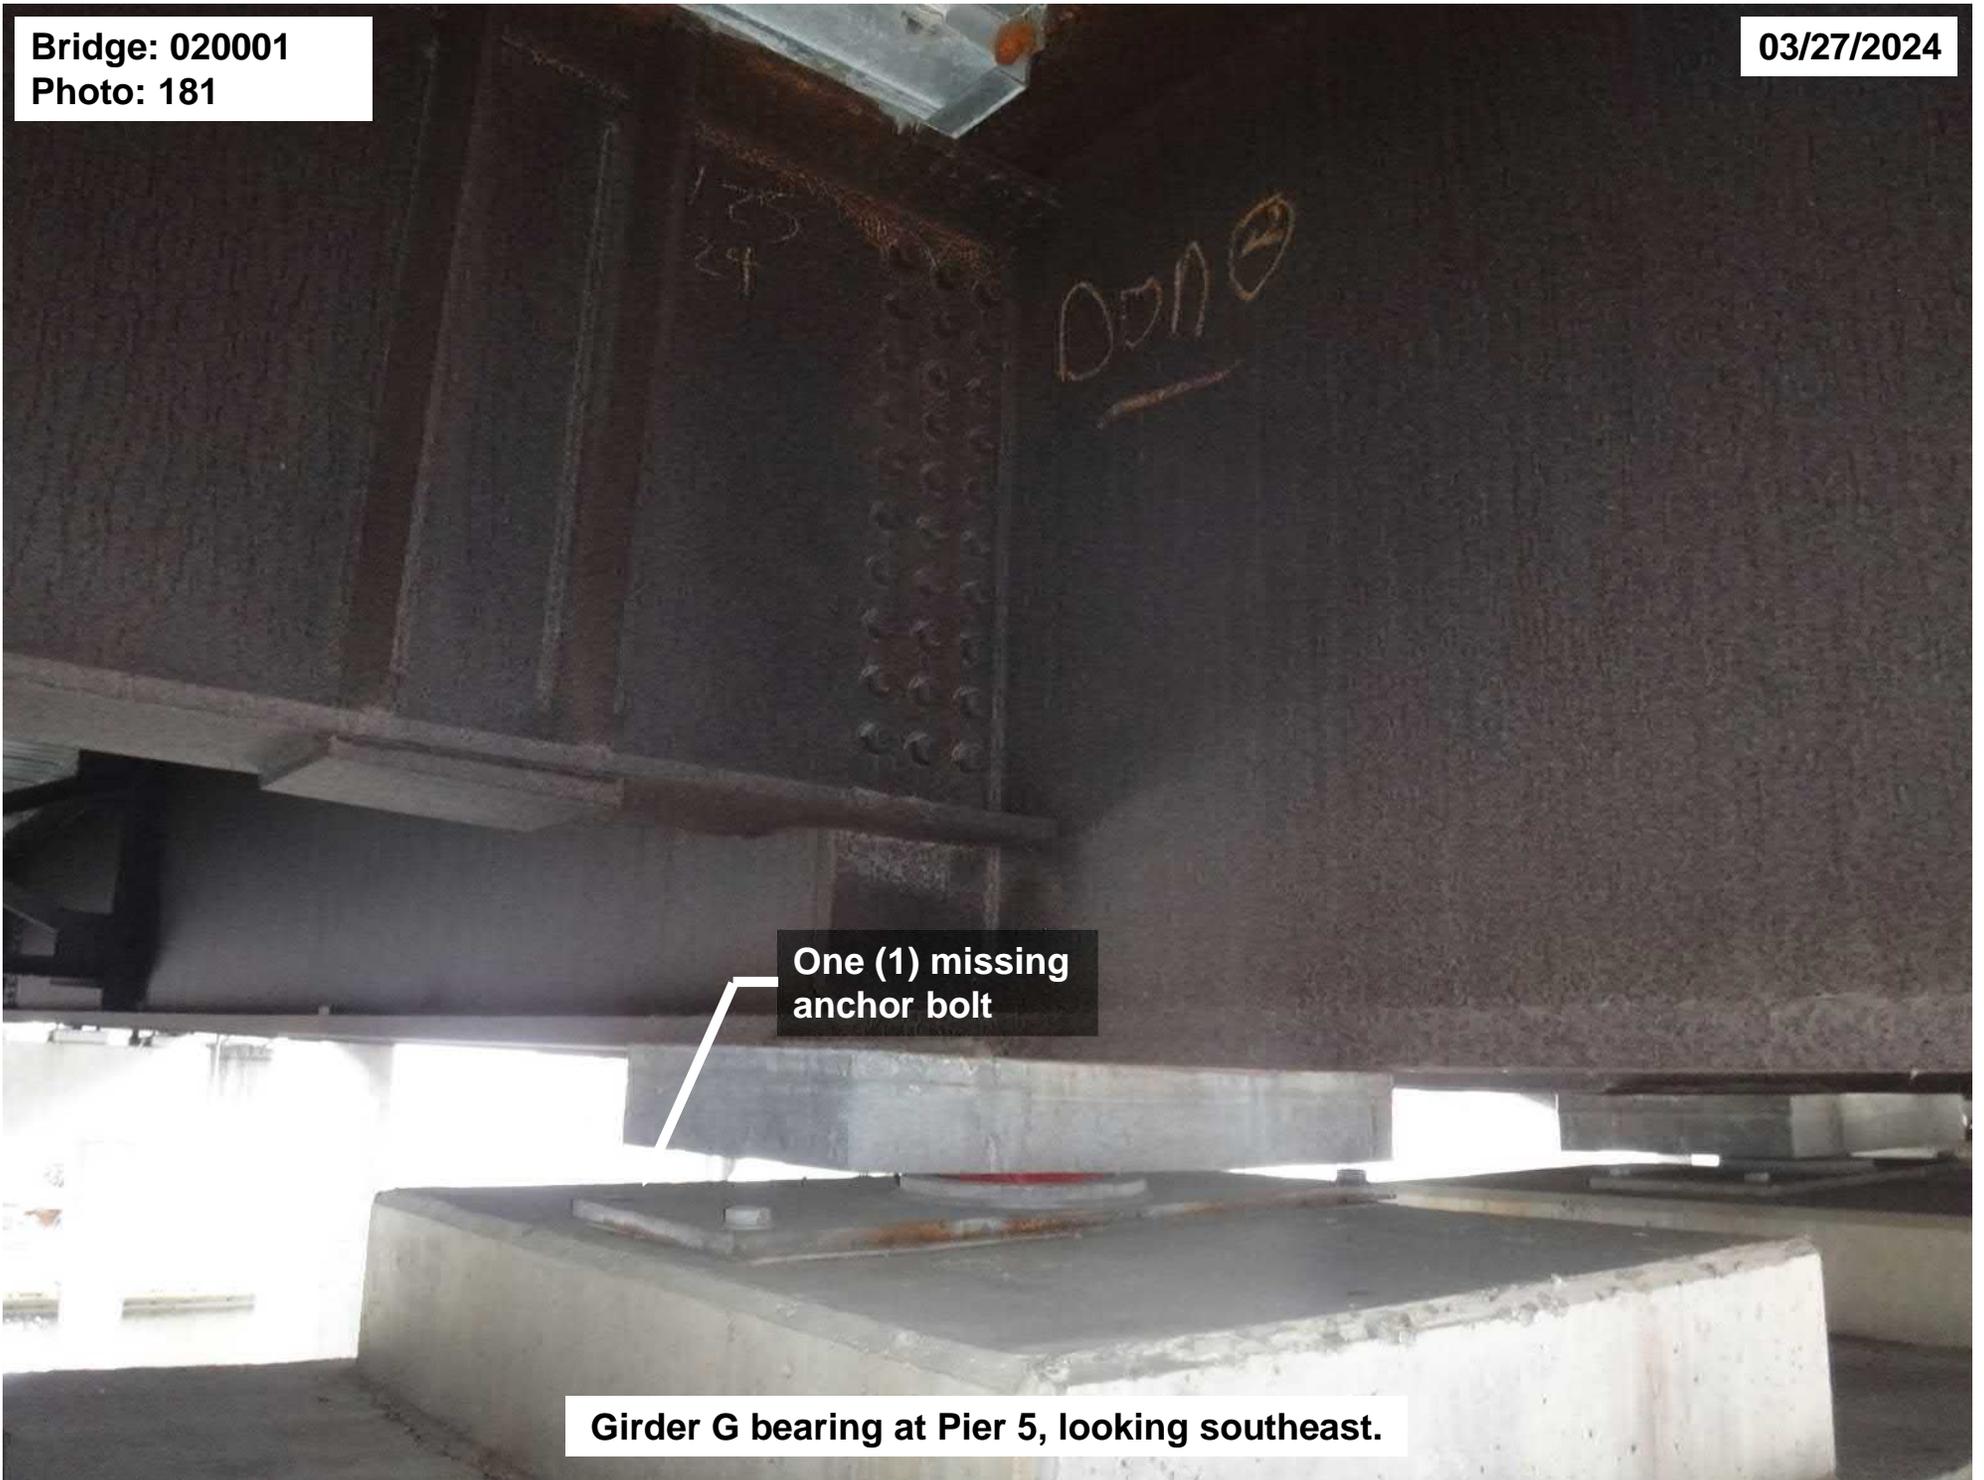
Bridge: 020001
Photo: 181

One (1) missing
anchor bolt

Girder G bearing at Pier 5, looking southeast.

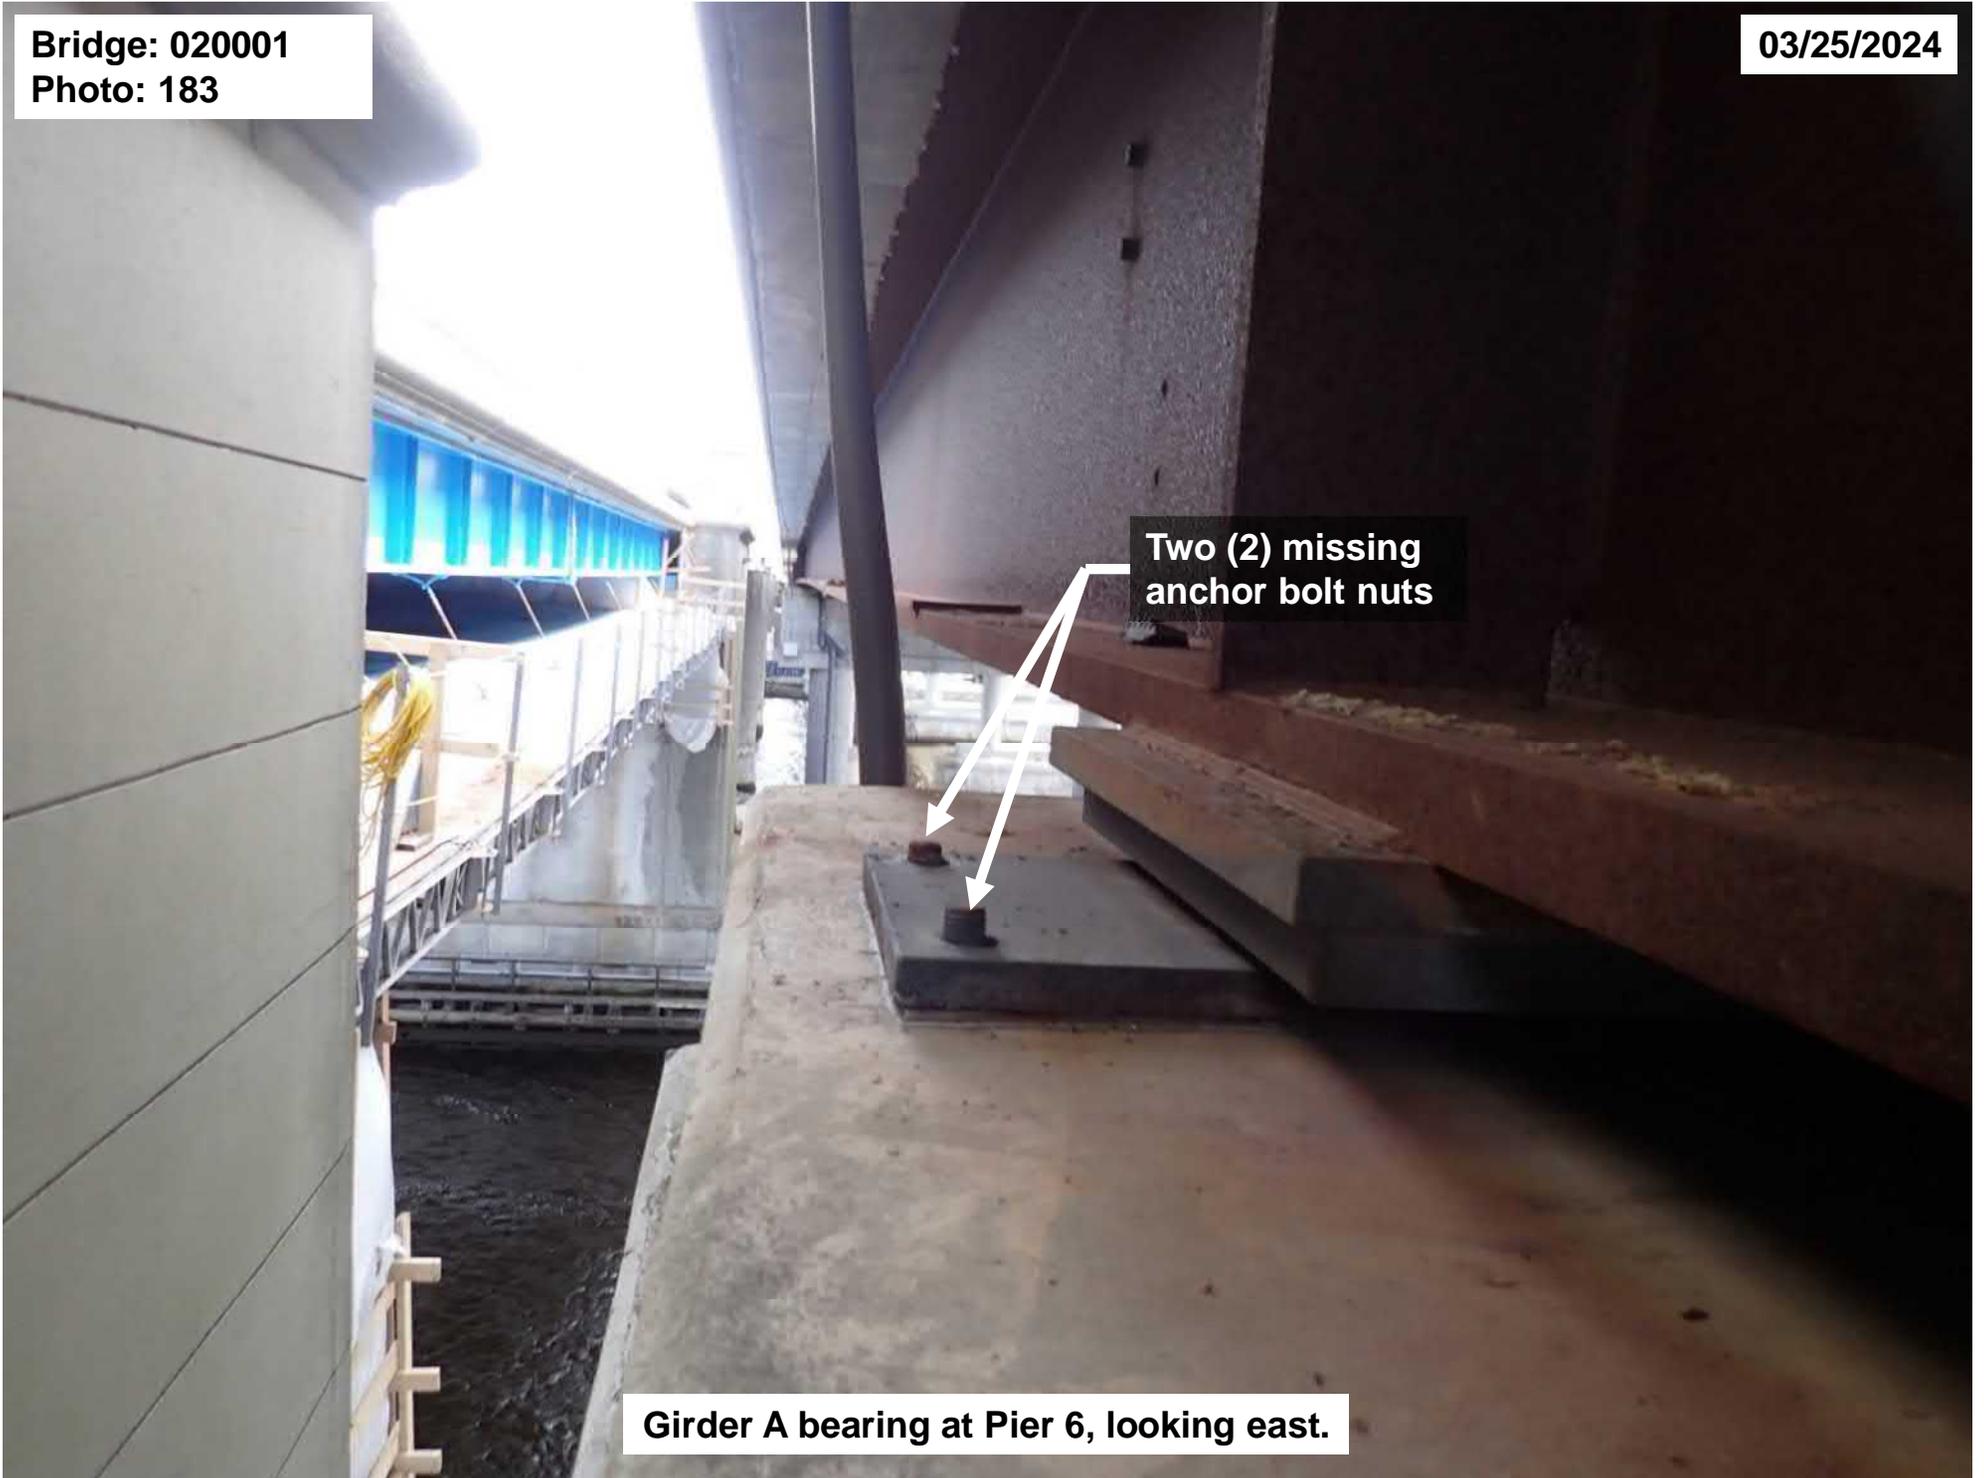
Two (2) missing
anchor bolt nuts

Girder A bearing at Pier 6, looking east.

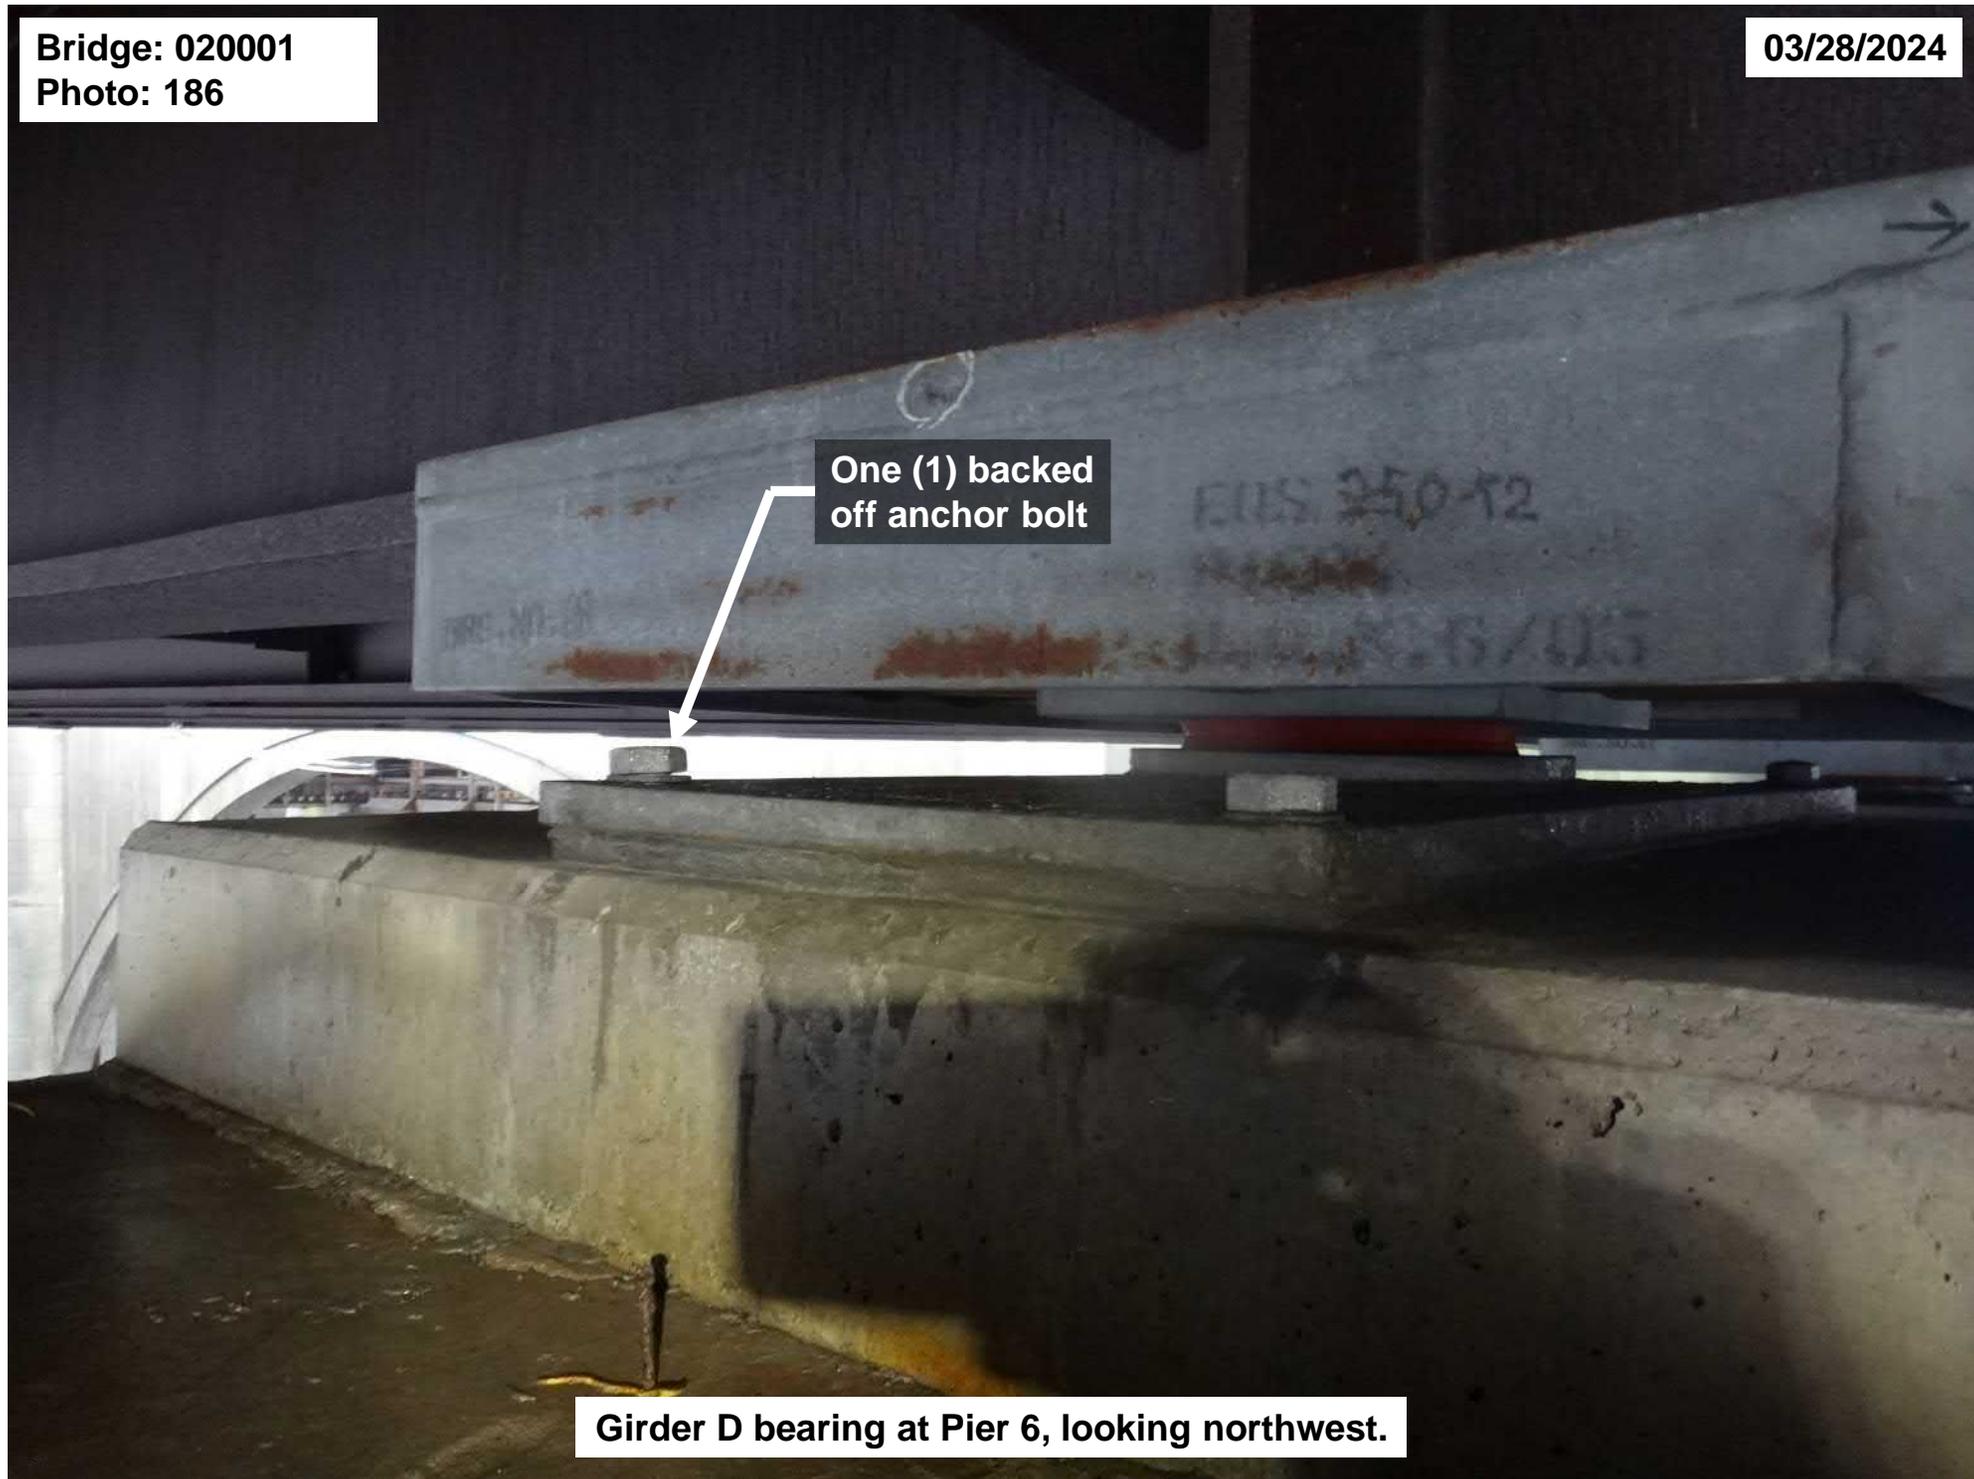
One (1) backed
off anchor bolt

Girder D bearing at Pier 6, looking northwest.

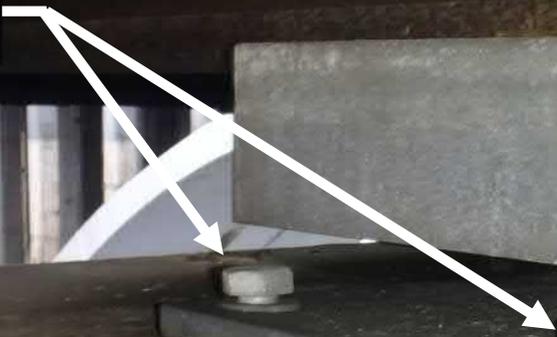
Bridge: 020001
Photo: 194

One (1) anchor bolt
with negative thread

Girder A bearing in Span 9 at Pier 9, looking east.

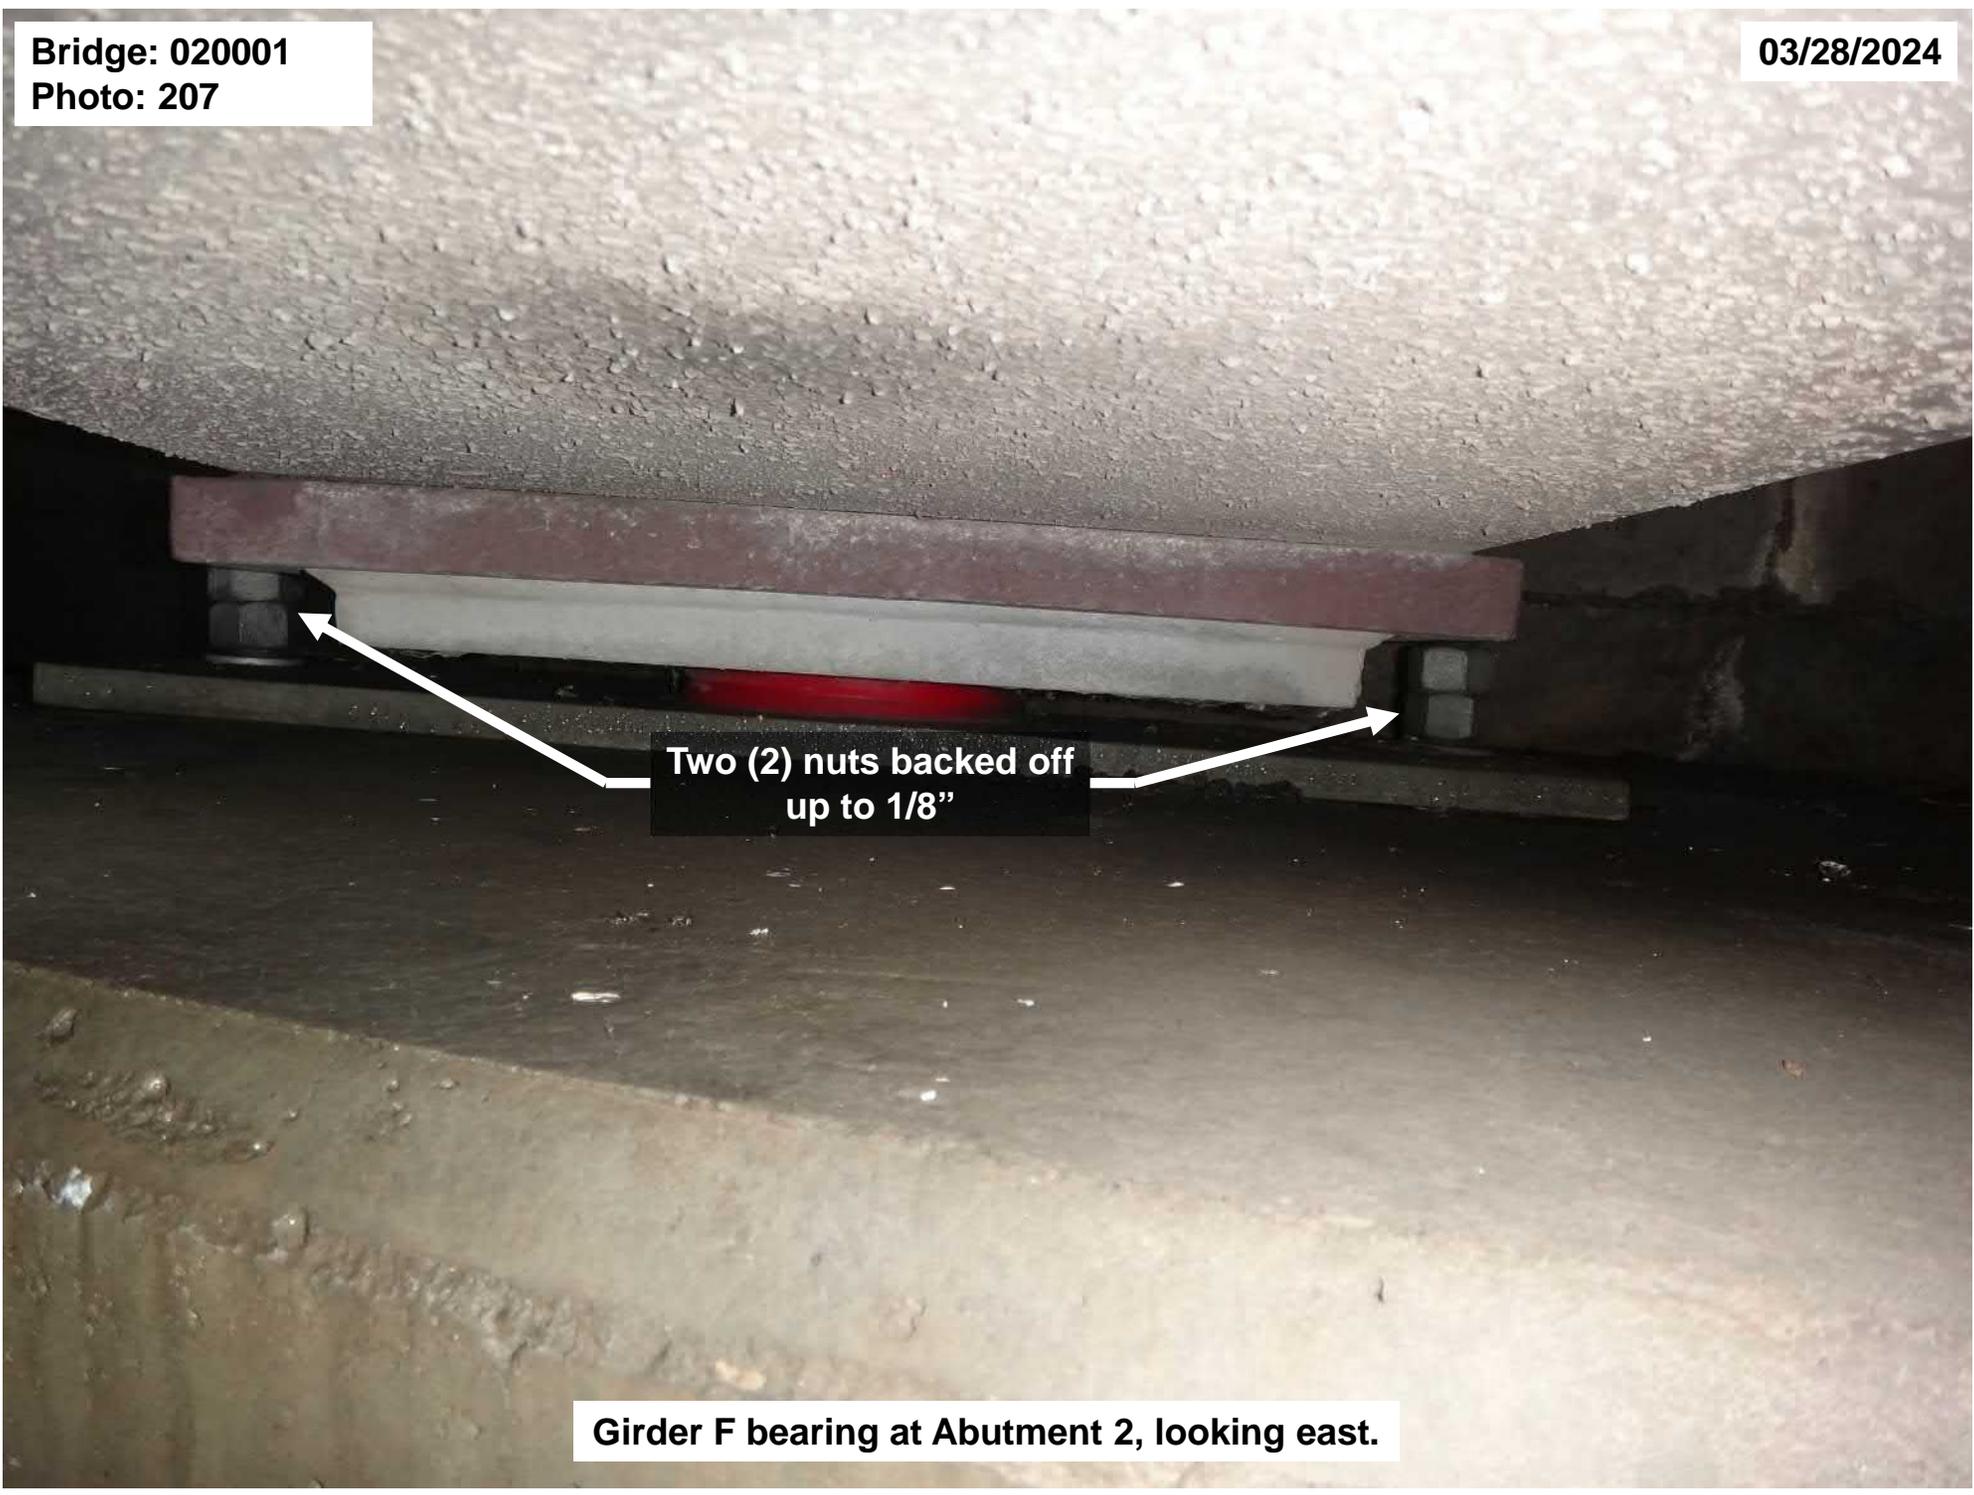
Bridge: 020001
Photo: 207

Two (2) nuts backed off
up to 1/8"

Girder F bearing at Abutment 2, looking east.

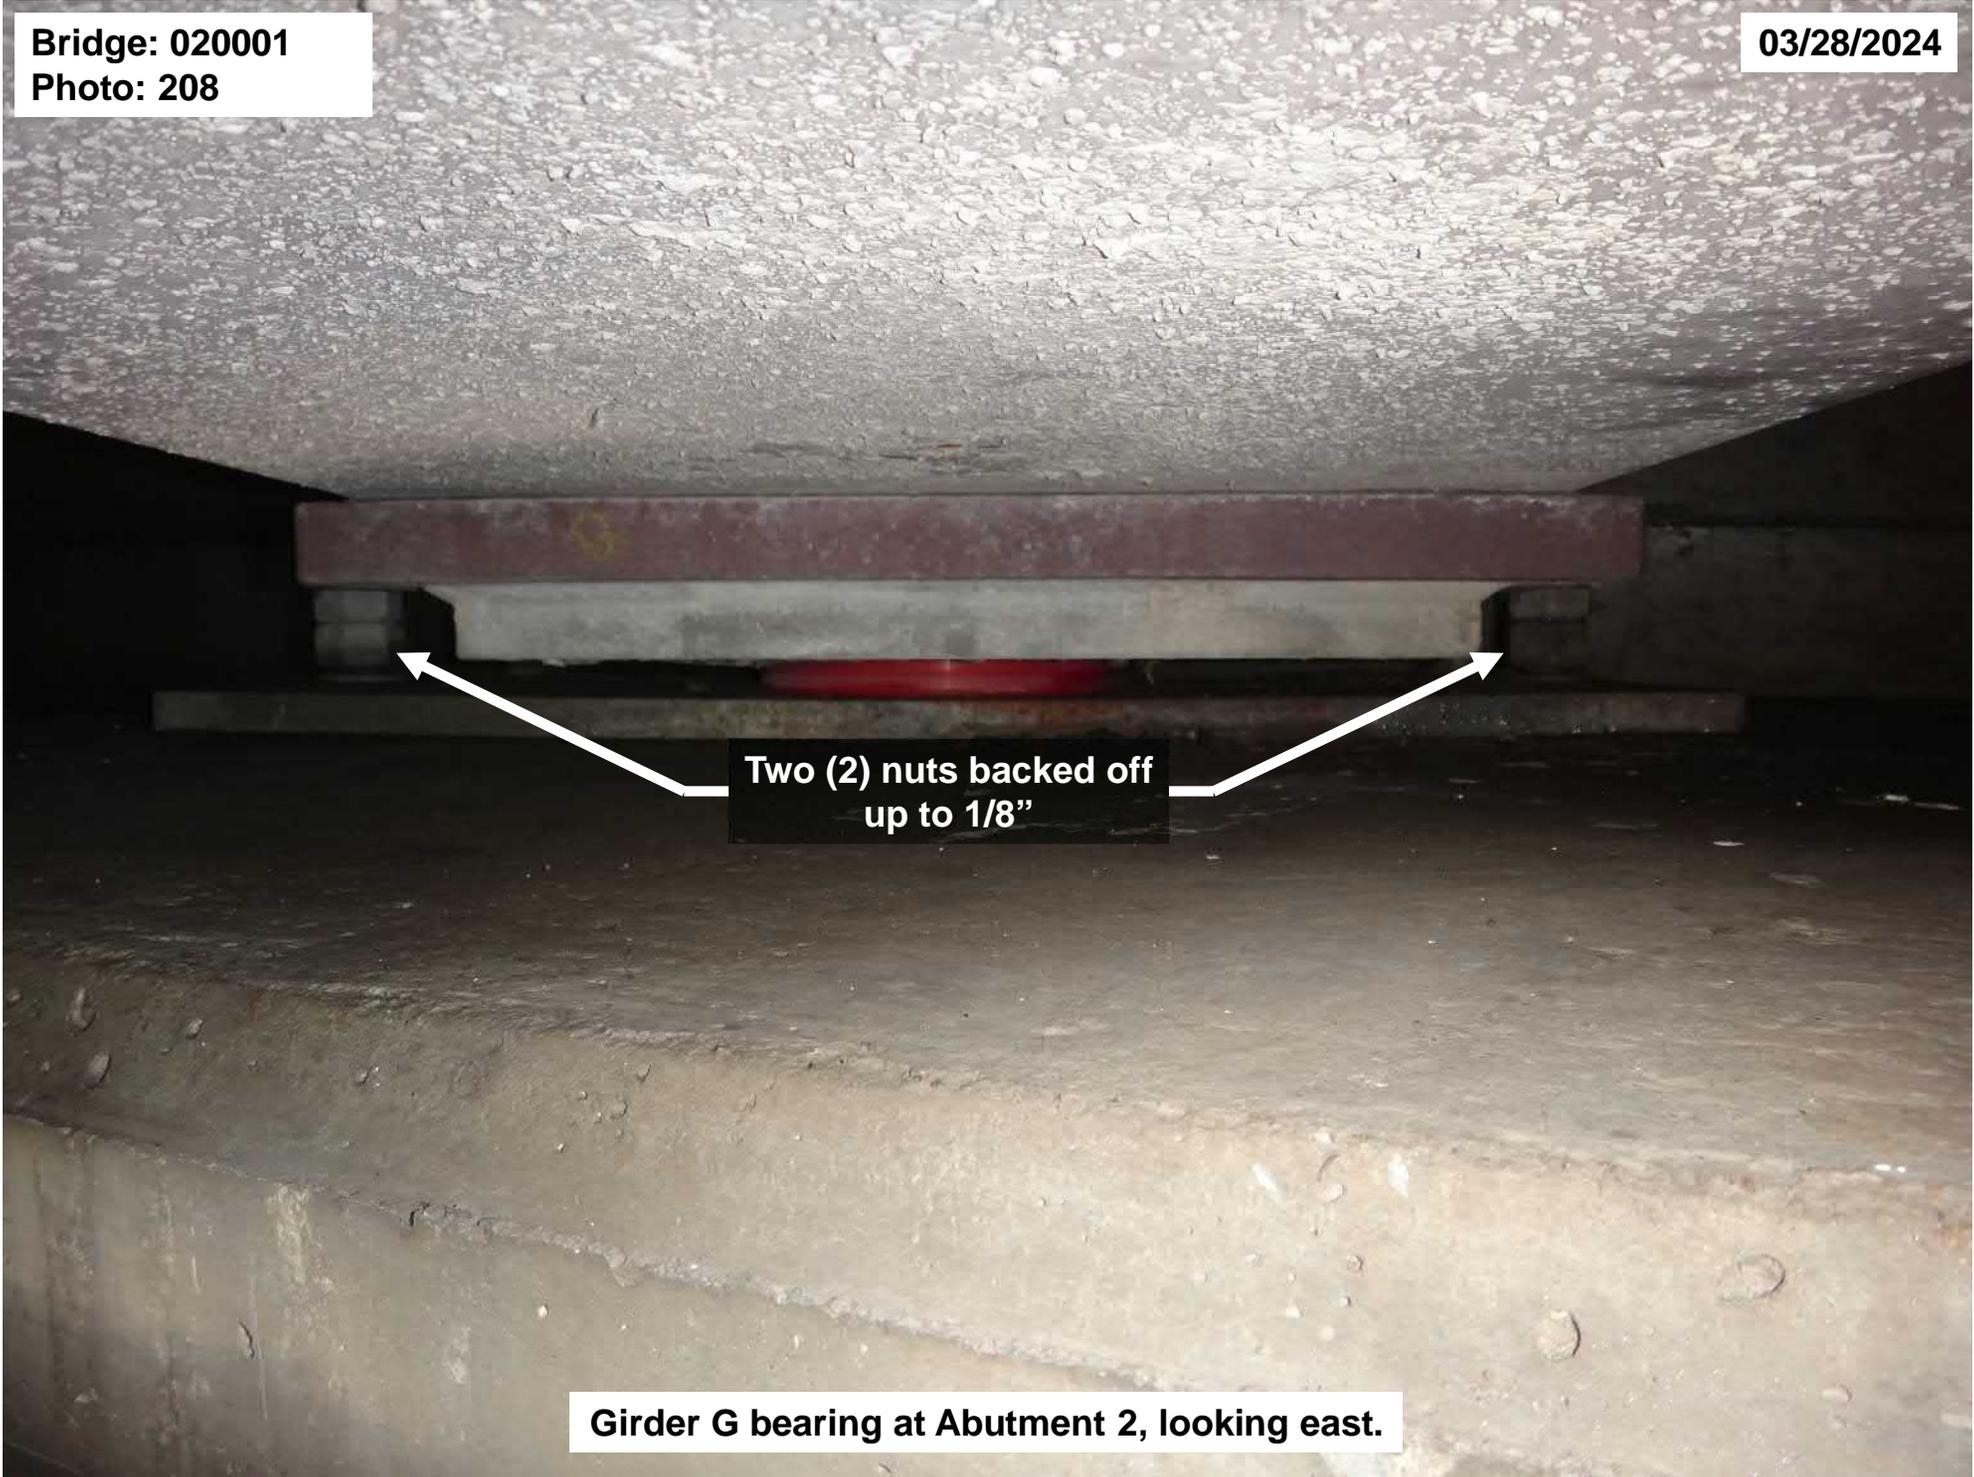
Bridge: 020001
Photo: 208

Two (2) nuts backed off
up to 1/8"

Girder G bearing at Abutment 2, looking east.

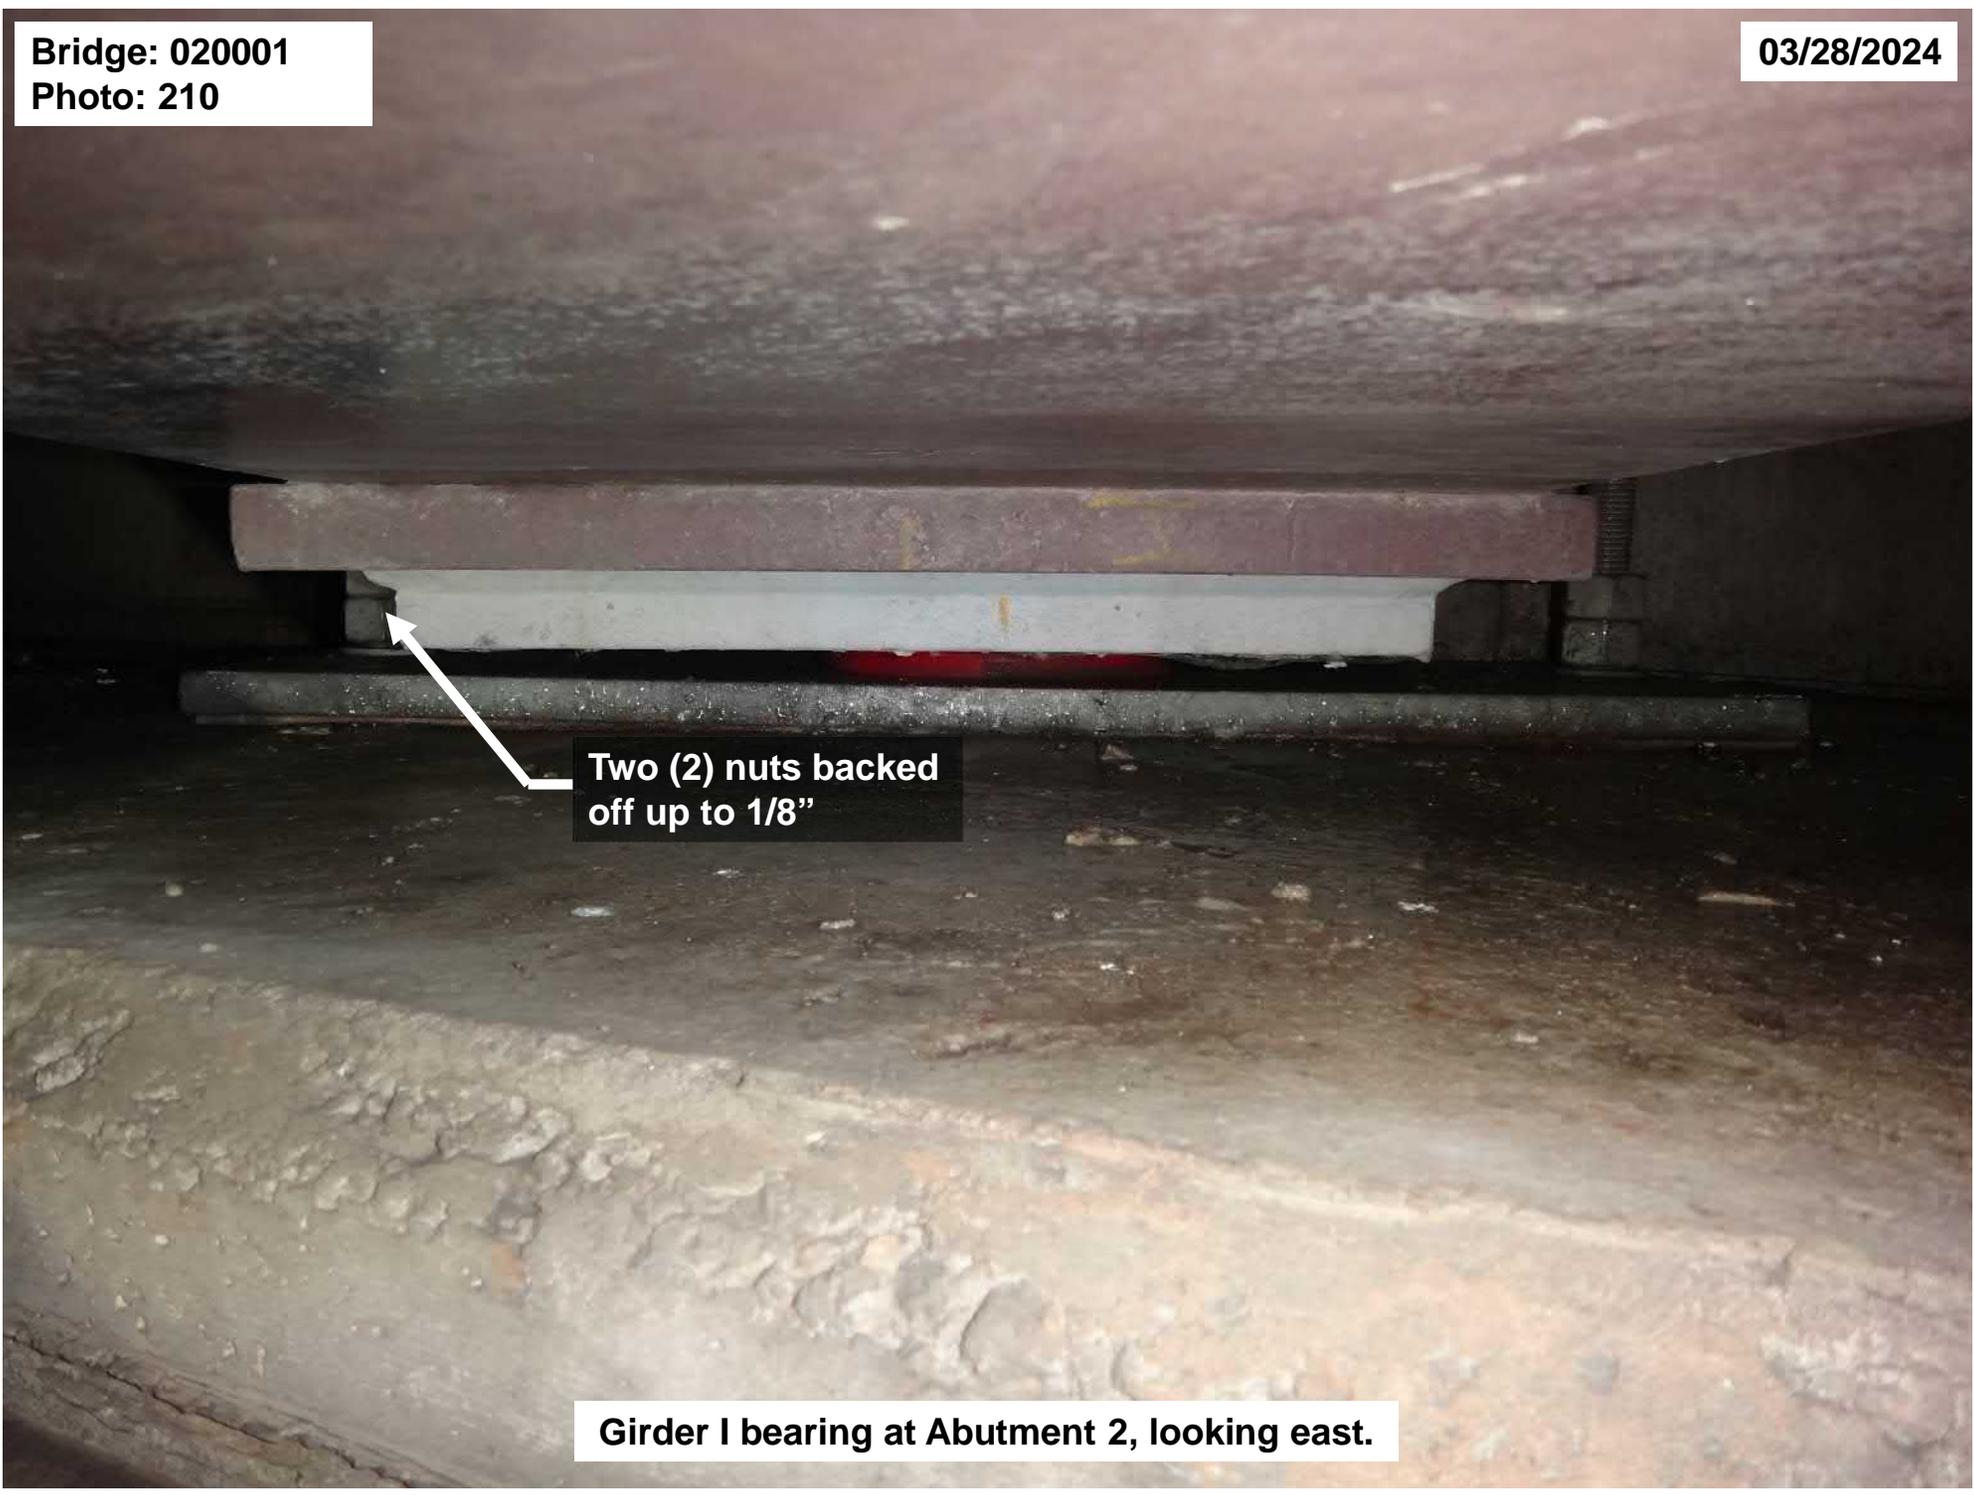
Bridge: 020001
Photo: 210

Two (2) nuts backed
off up to 1/8"

Girder I bearing at Abutment 2, looking east.

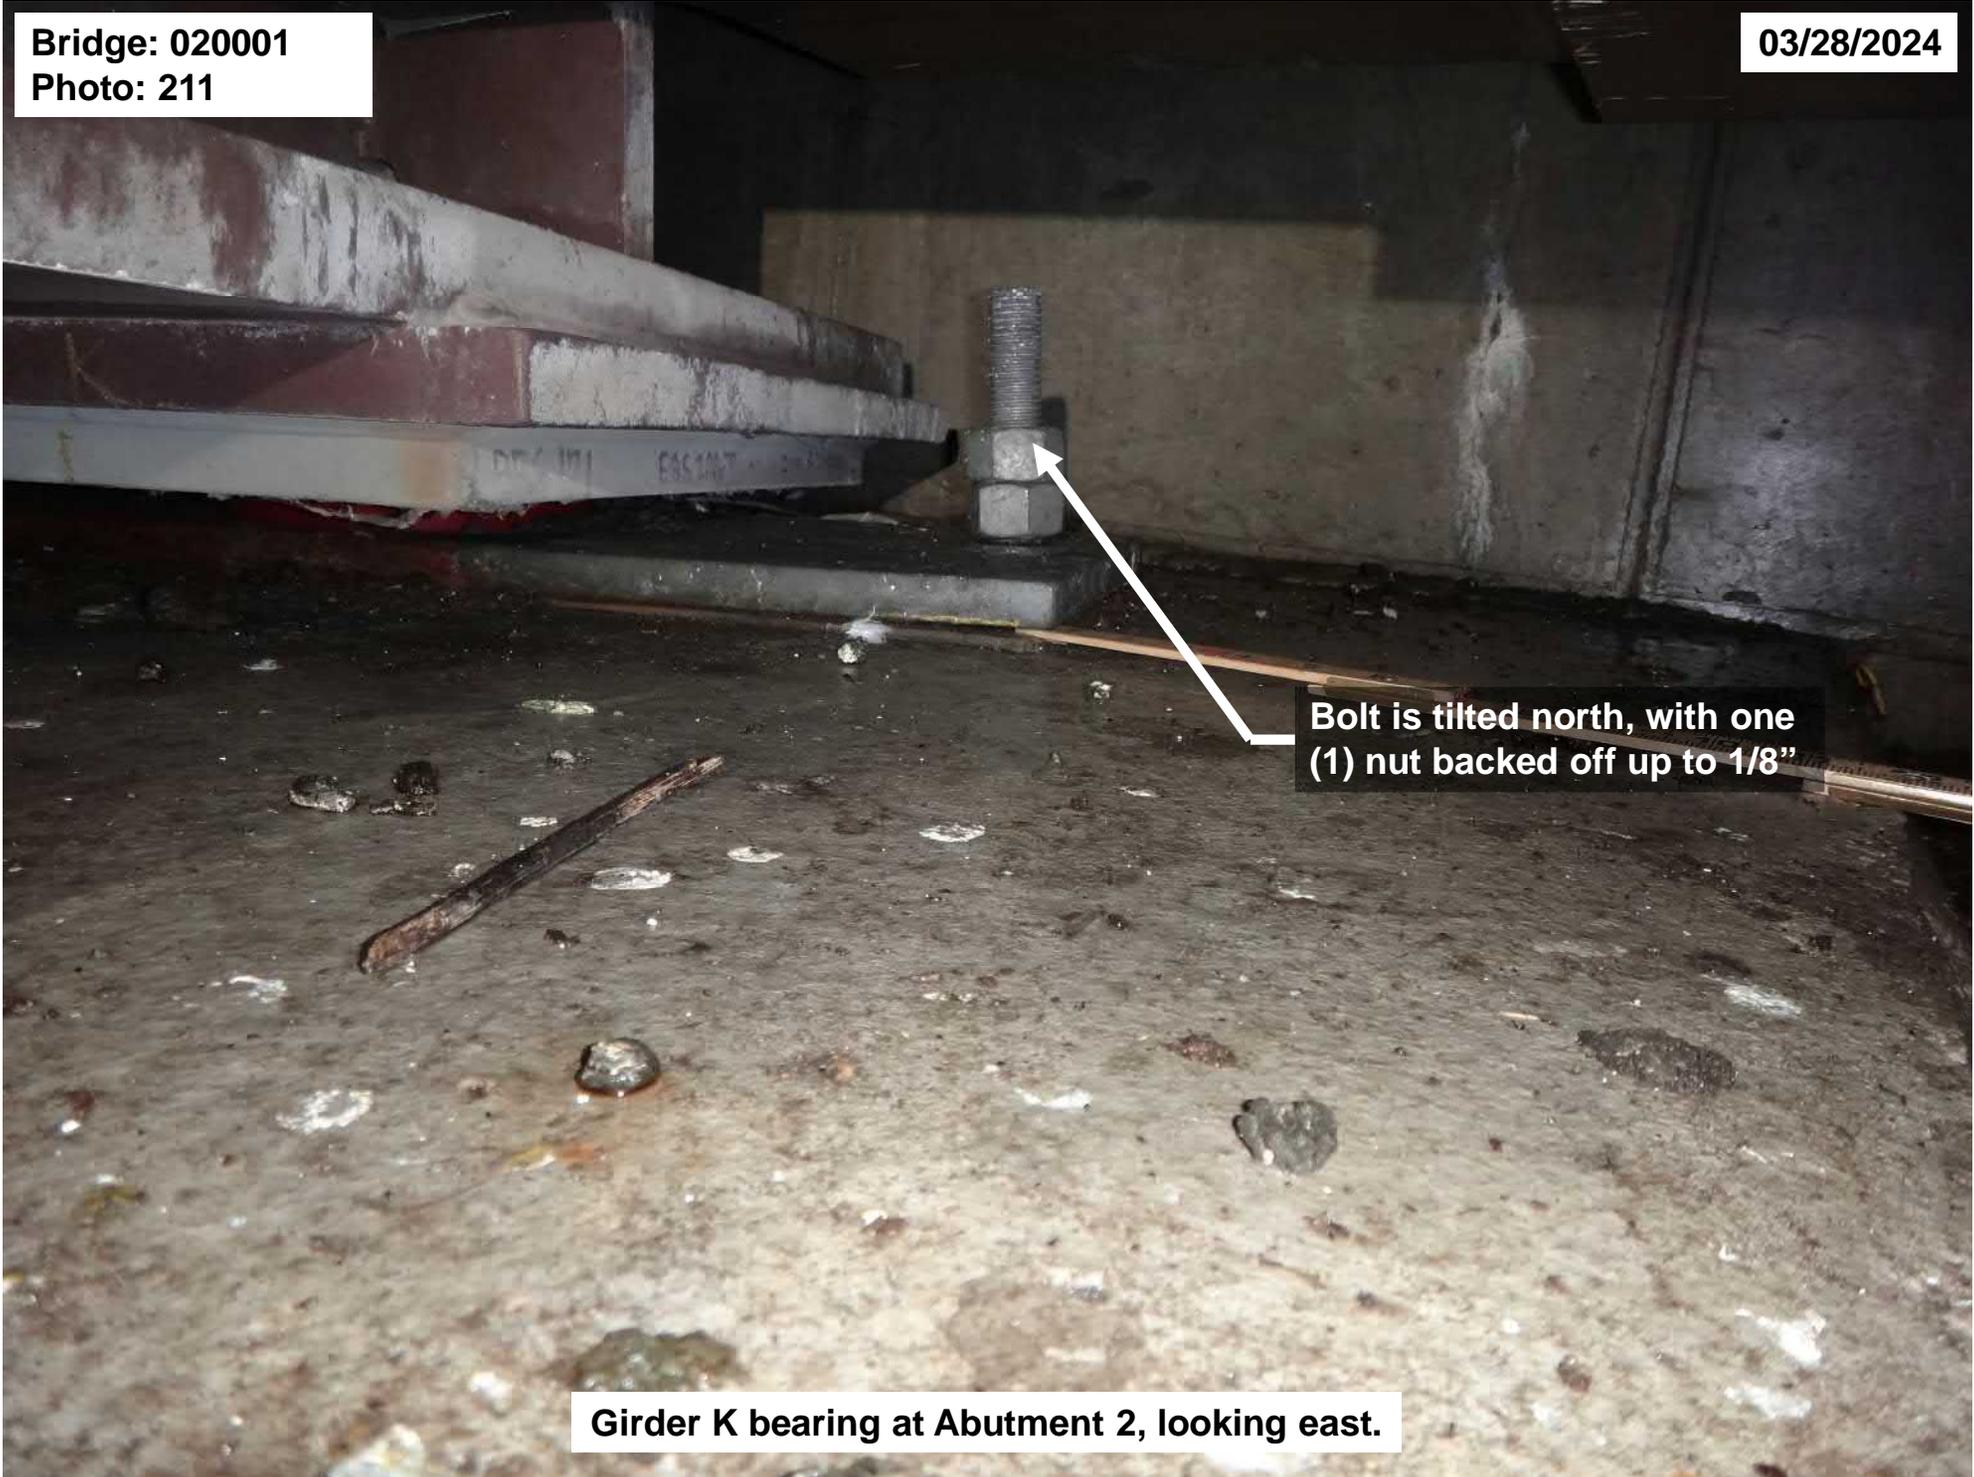
Bridge: 020001
Photo: 211

Bolt is tilted north, with one
(1) nut backed off up to 1/8"

Girder K bearing at Abutment 2, looking east.
