Bridge: 020001
Photo: 1

South elevation at the main channel, looking north.

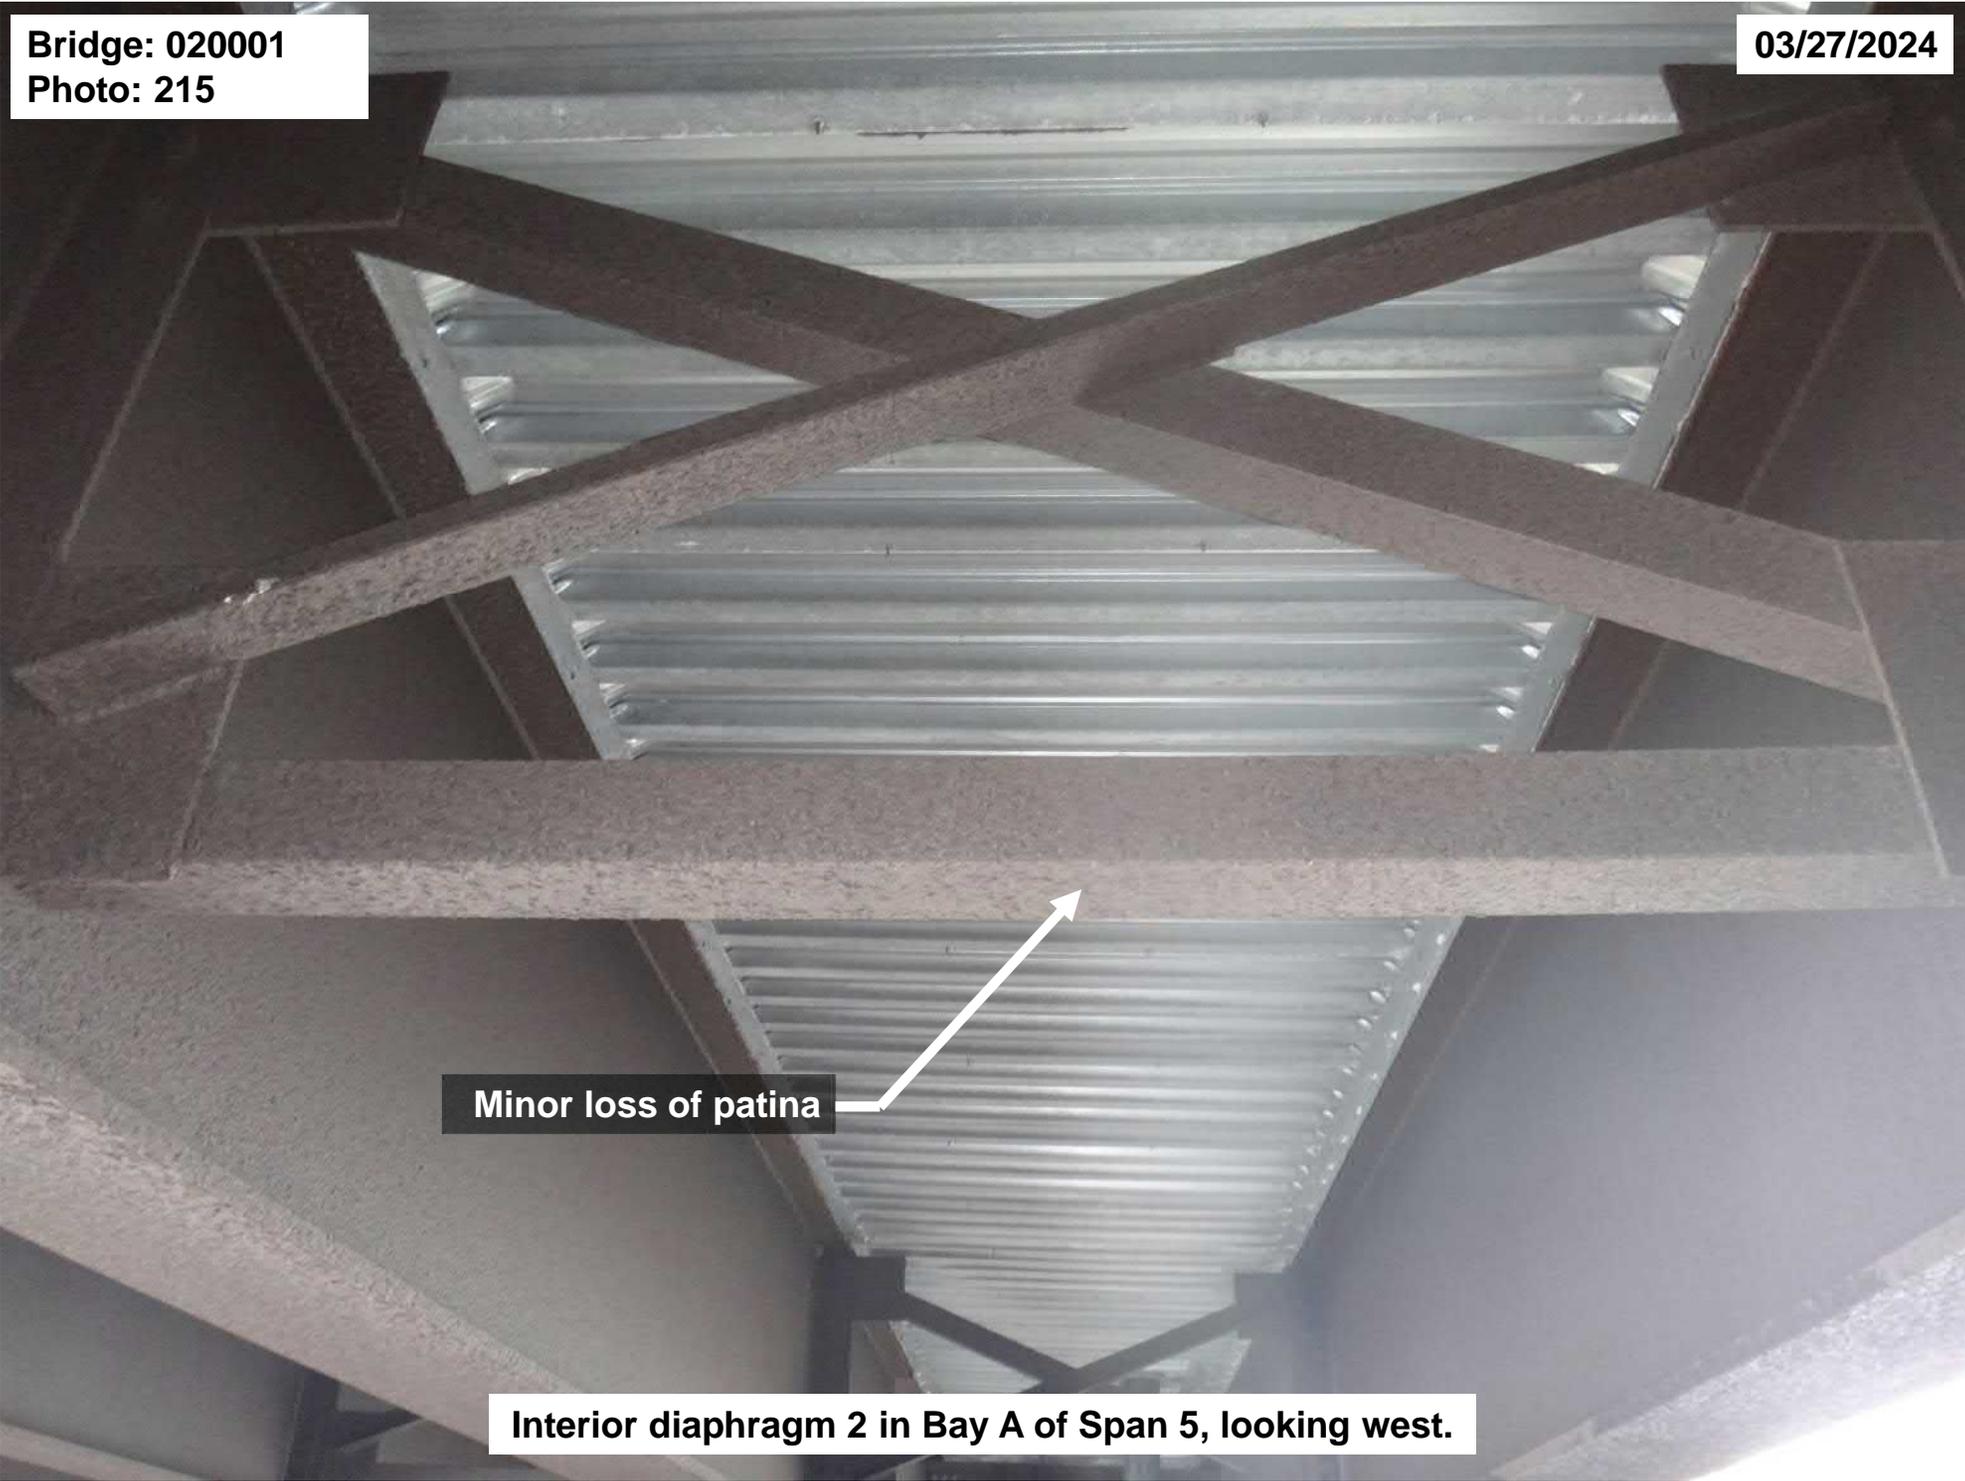
Bridge: 020001
Photo: 215

Minor loss of patina

Interior diaphragm 2 in Bay A of Span 5, looking west.

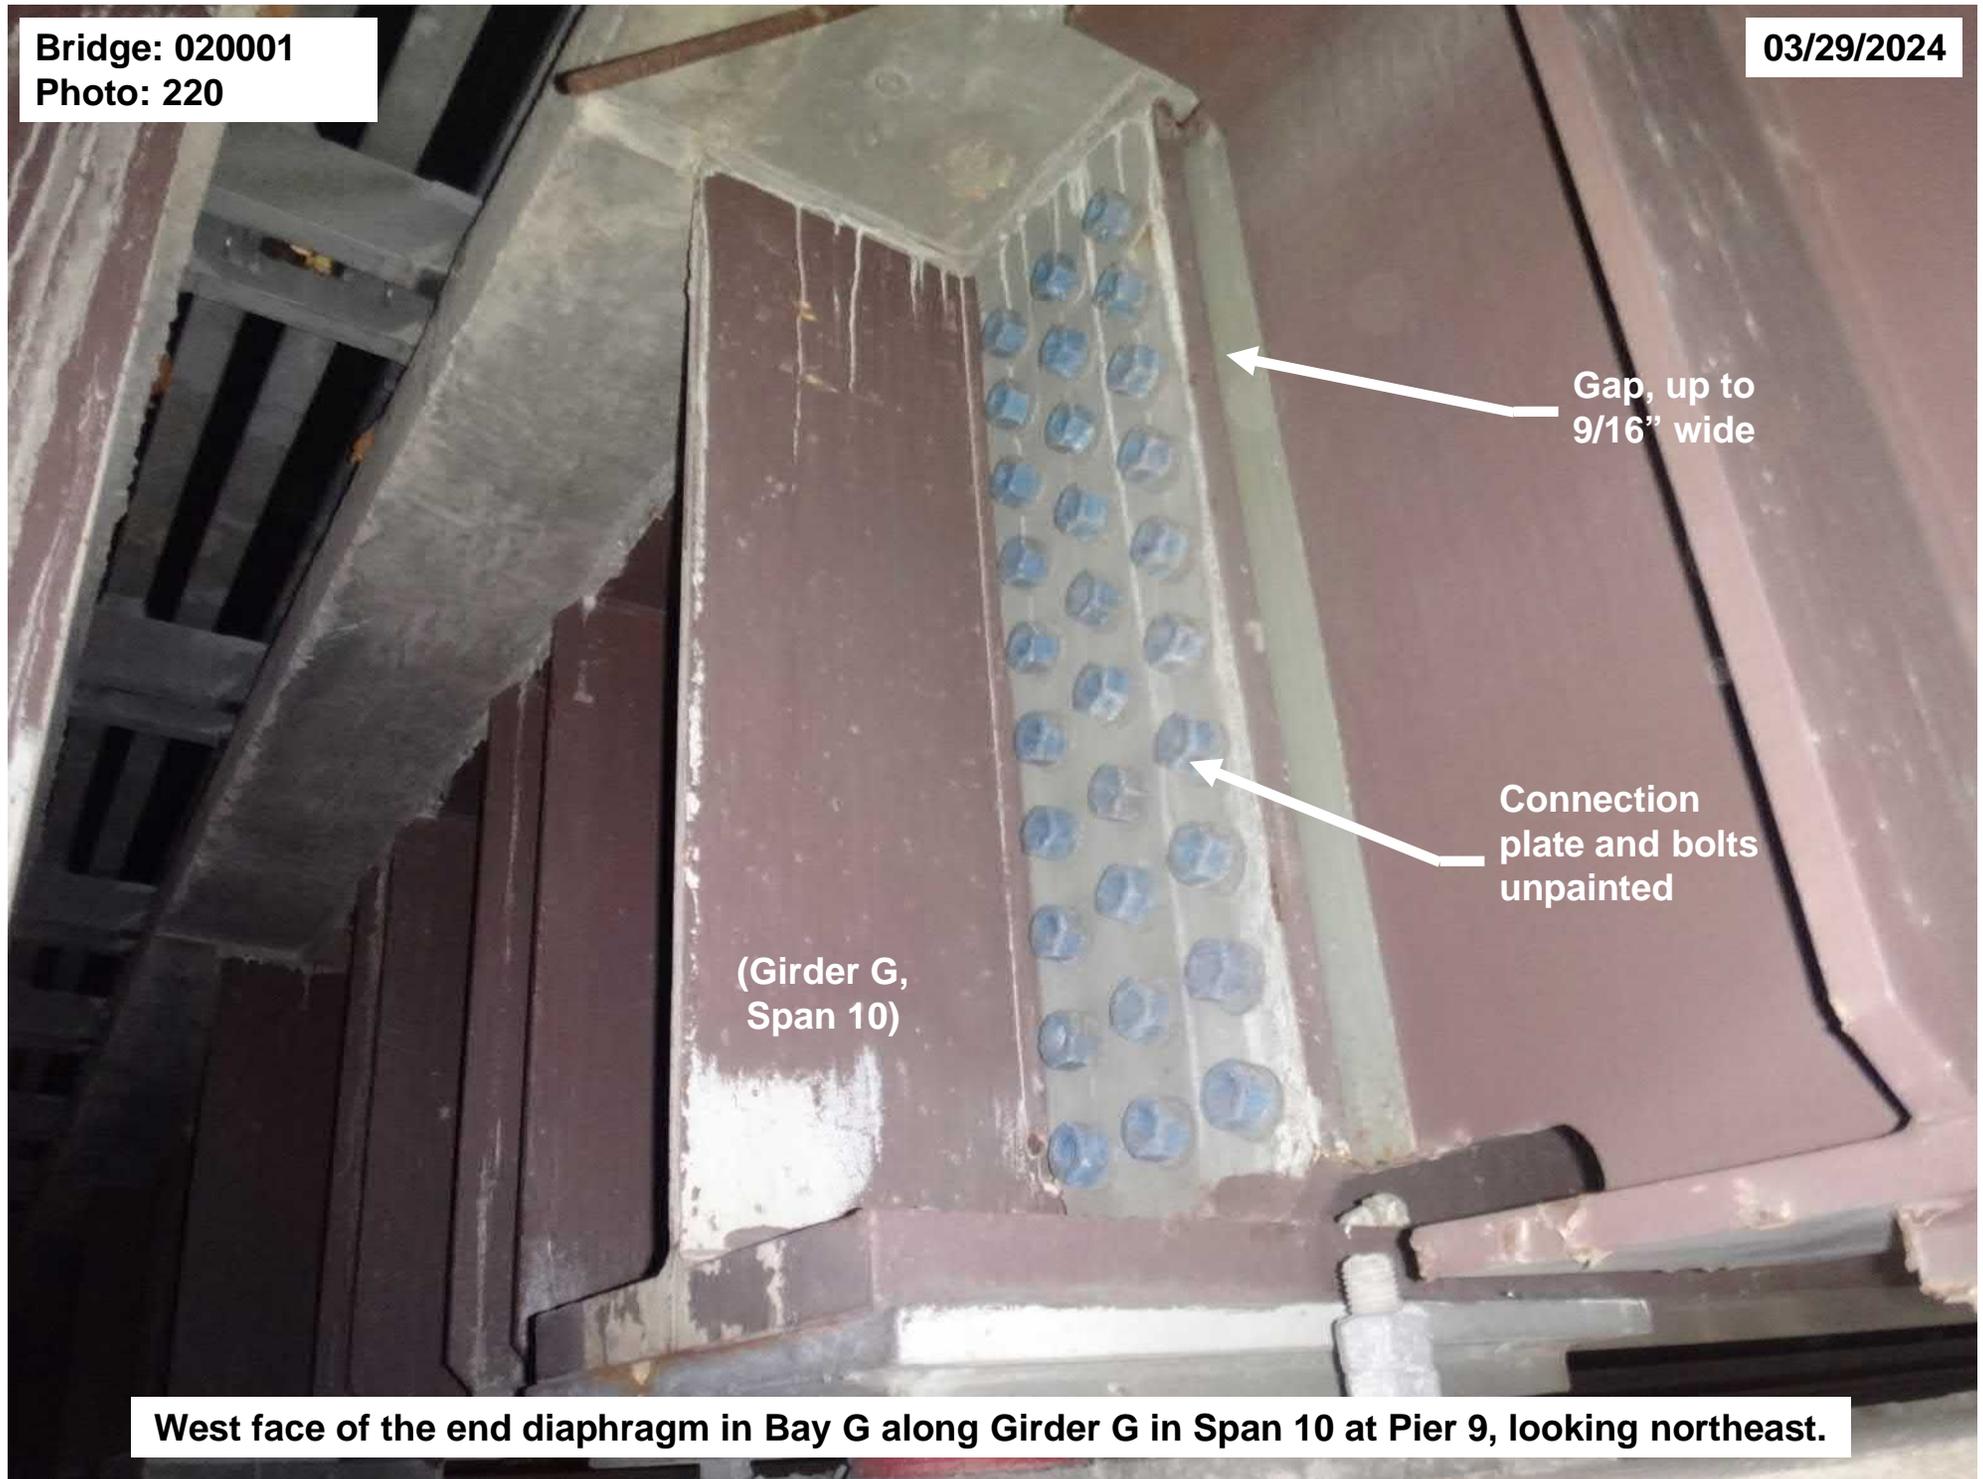
Bridge: 020001
Photo: 220

Gap, up to
9/16" wide

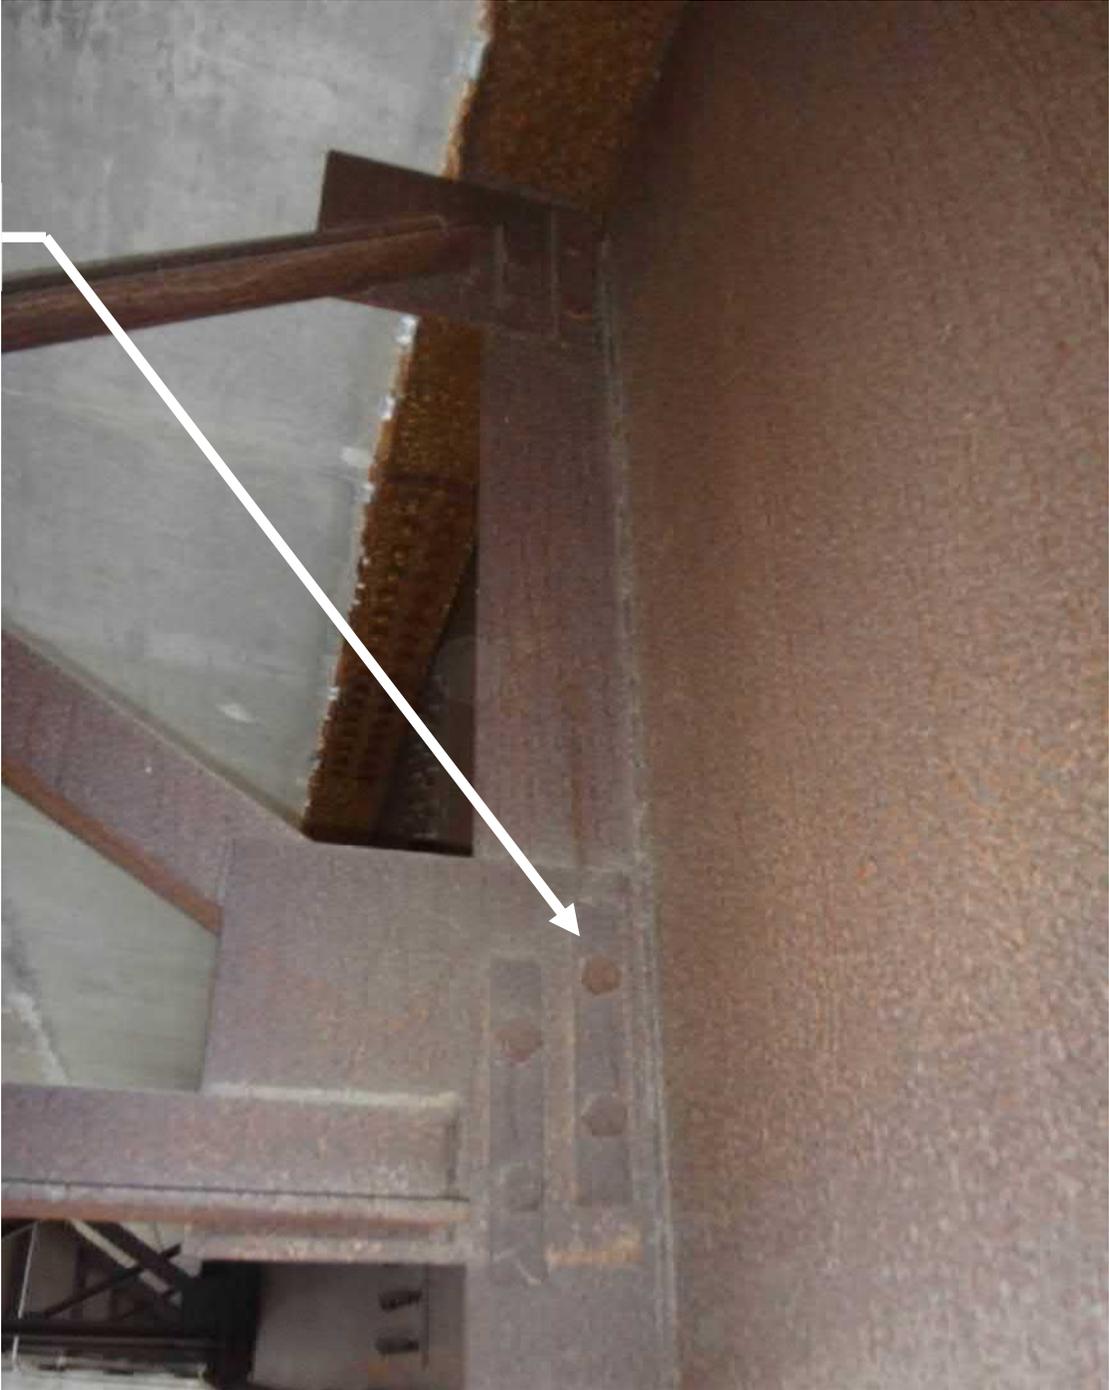
**Bridge: 020001
Photo: 223**

**Typical filler
plates installed**

Interior Diaphragm 1 at the north face of Girder H in Span 14, looking east.

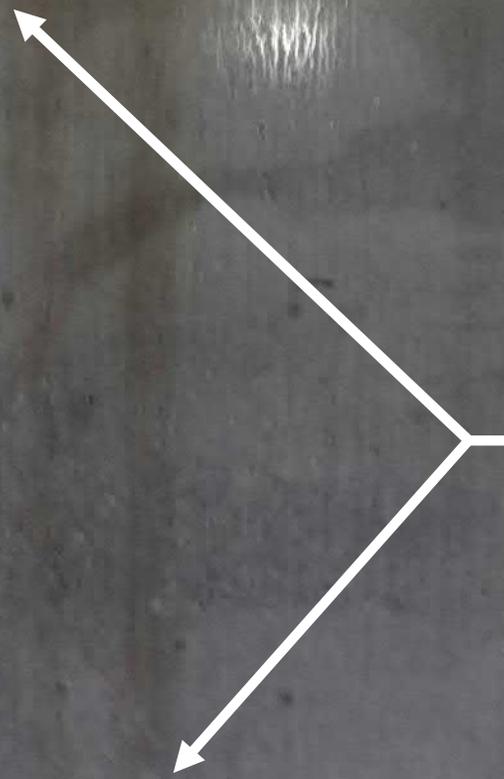
Hairline vertical and diagonal
cracks, some with light
efflorescence

West face of the Pier 8 cap below Girder H, looking east.

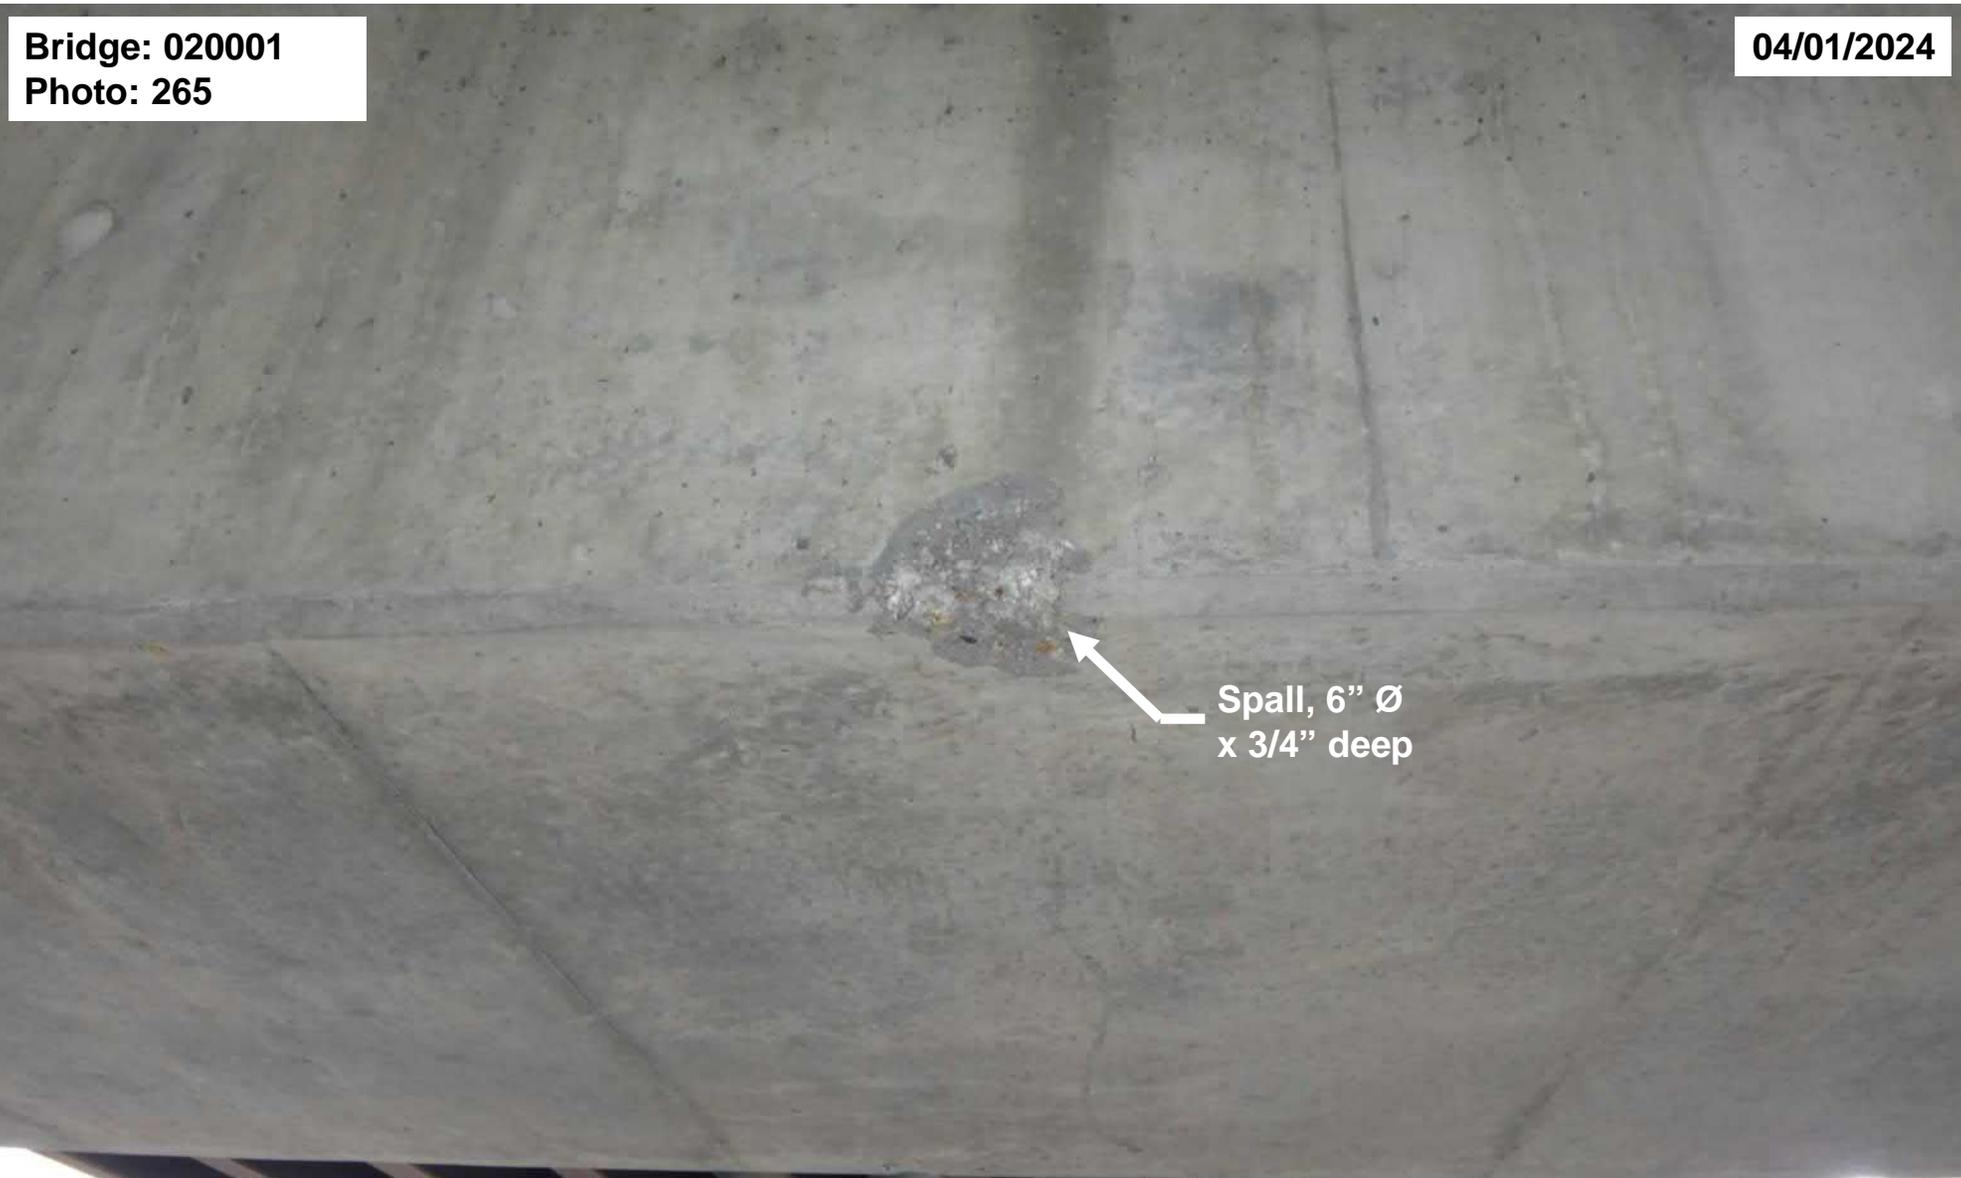
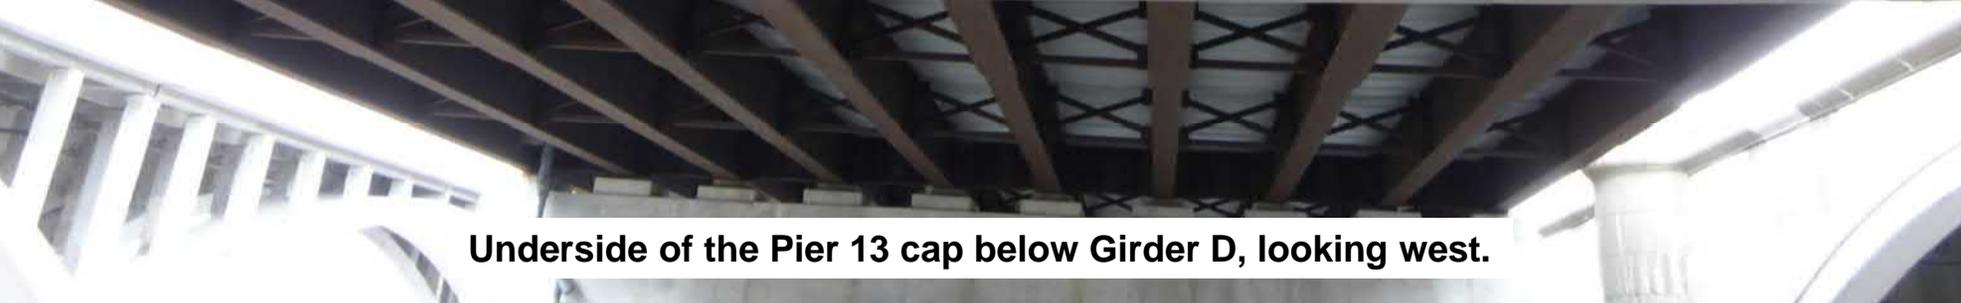
Spall, 6" Ø
x 3/4" deep

Underside of the Pier 13 cap below Girder D, looking west.
